NC DEPARTMENT OF TRANSPORTATION  
 DIVISION OF HIGHWAYS  
 STRUCTURE MANAGEMENT UNIT

ATTENTION: prompt action request, sketches revised, vertical clearances revised

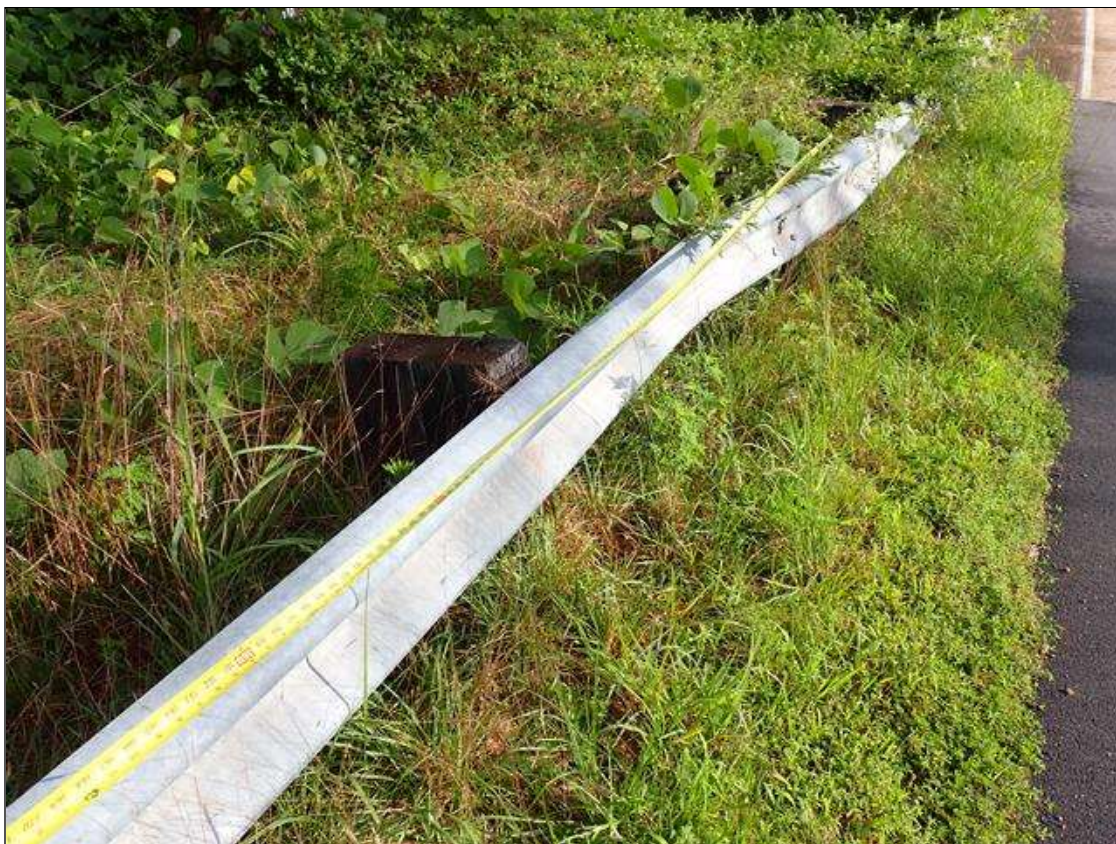
(PAR) southwest guardrail, approximately 15 feet from bridge, impact damage (15 feet)

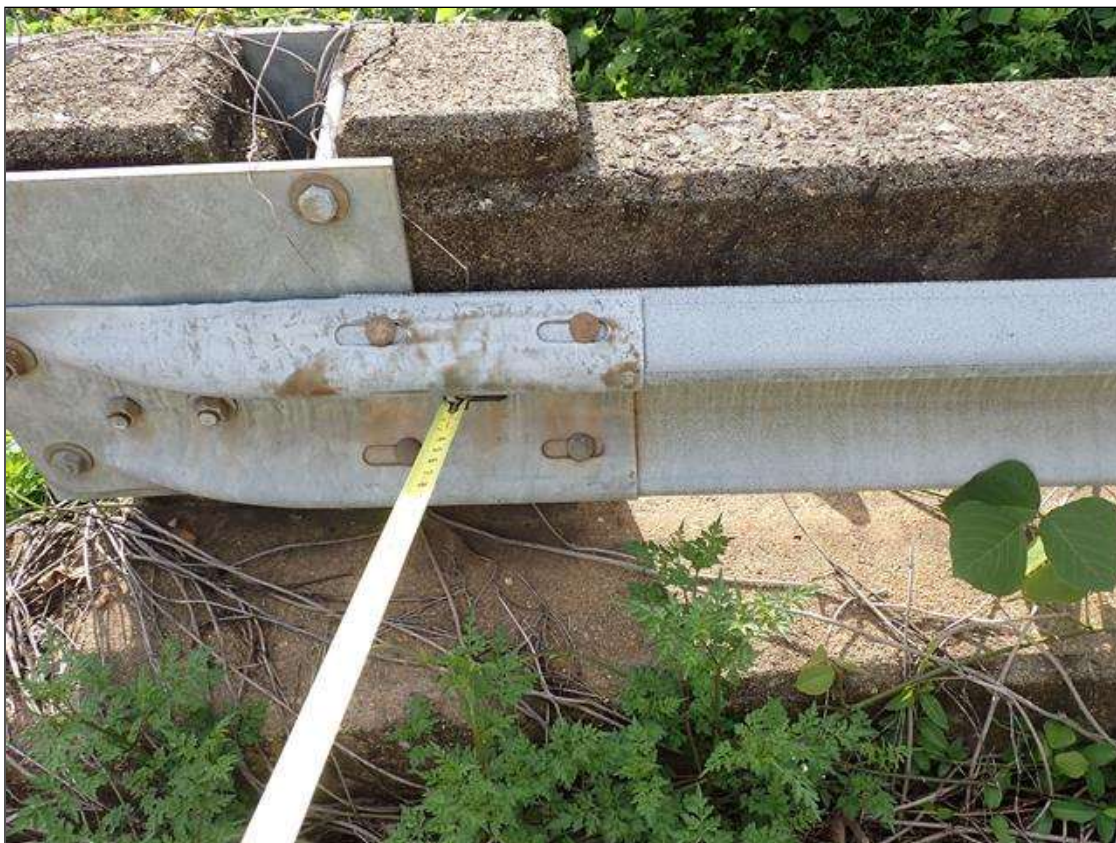
(PAR) southeast guardrail attachment, improper lap

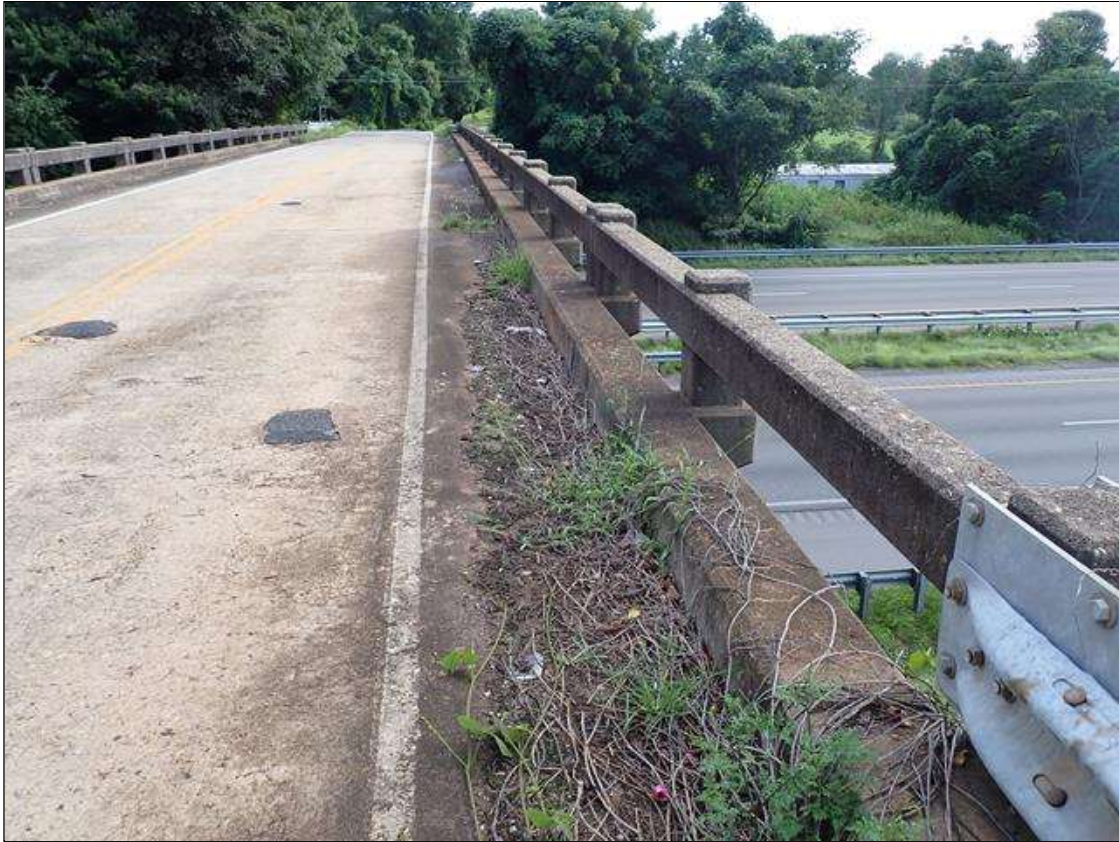
along the curblines, areas of debris accumulation (up to 2 feet wide x 3 inches high) with vegetation, partially obstructing deck drains

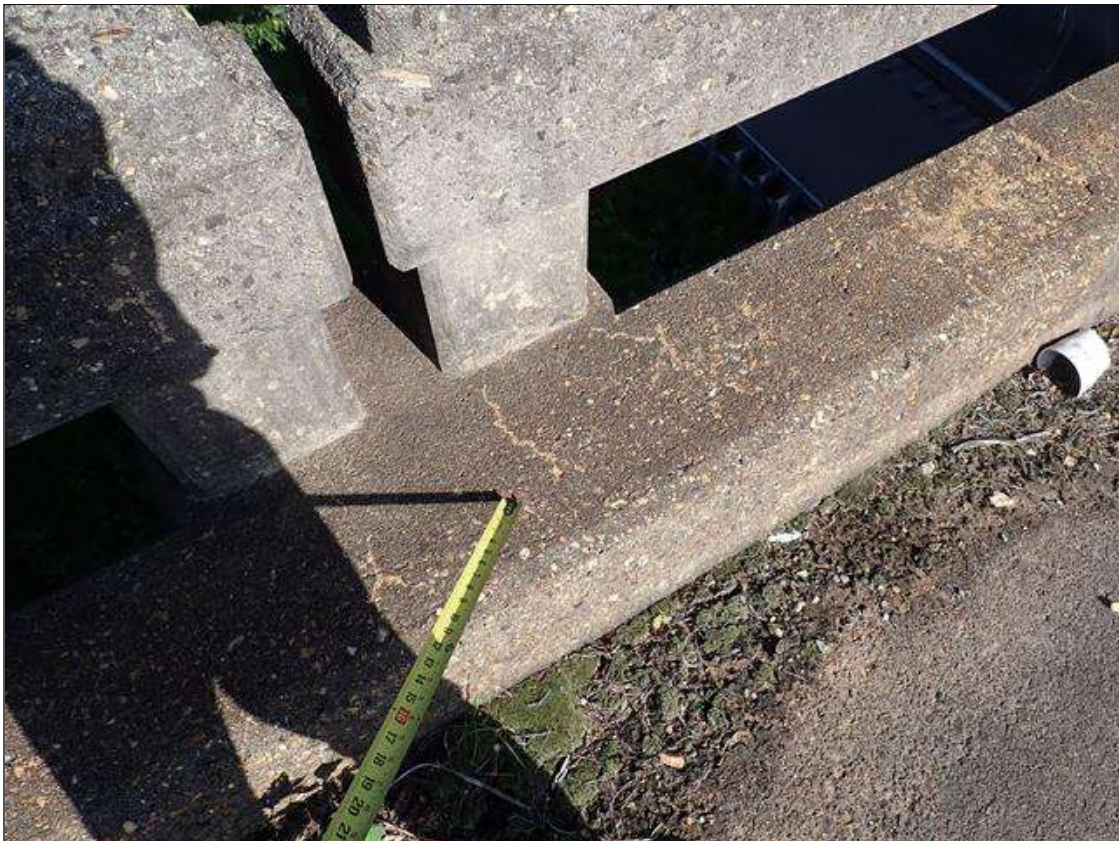
Span 1 Left Bridge Rail: along the curb, areas of map cracks (hairline) at random

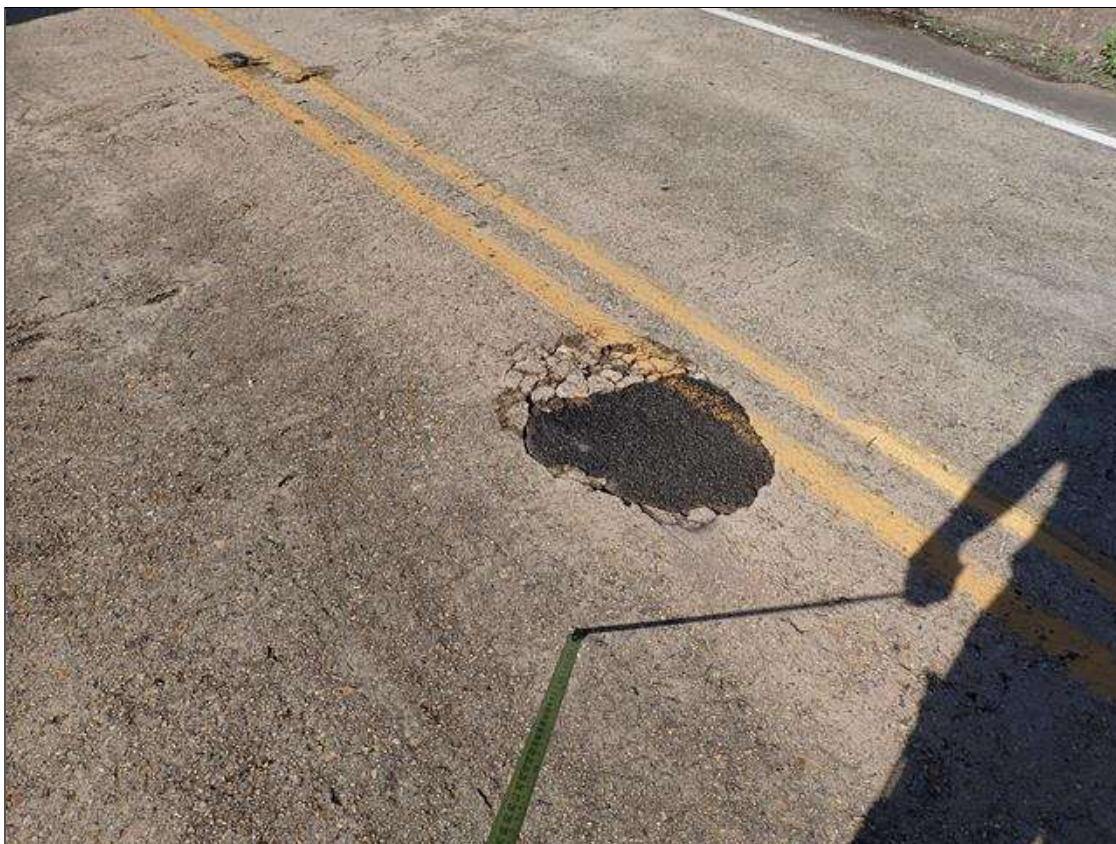
Span 1 Deck: throughout top of deck, asphalt patches (up to 2 foot diameter)

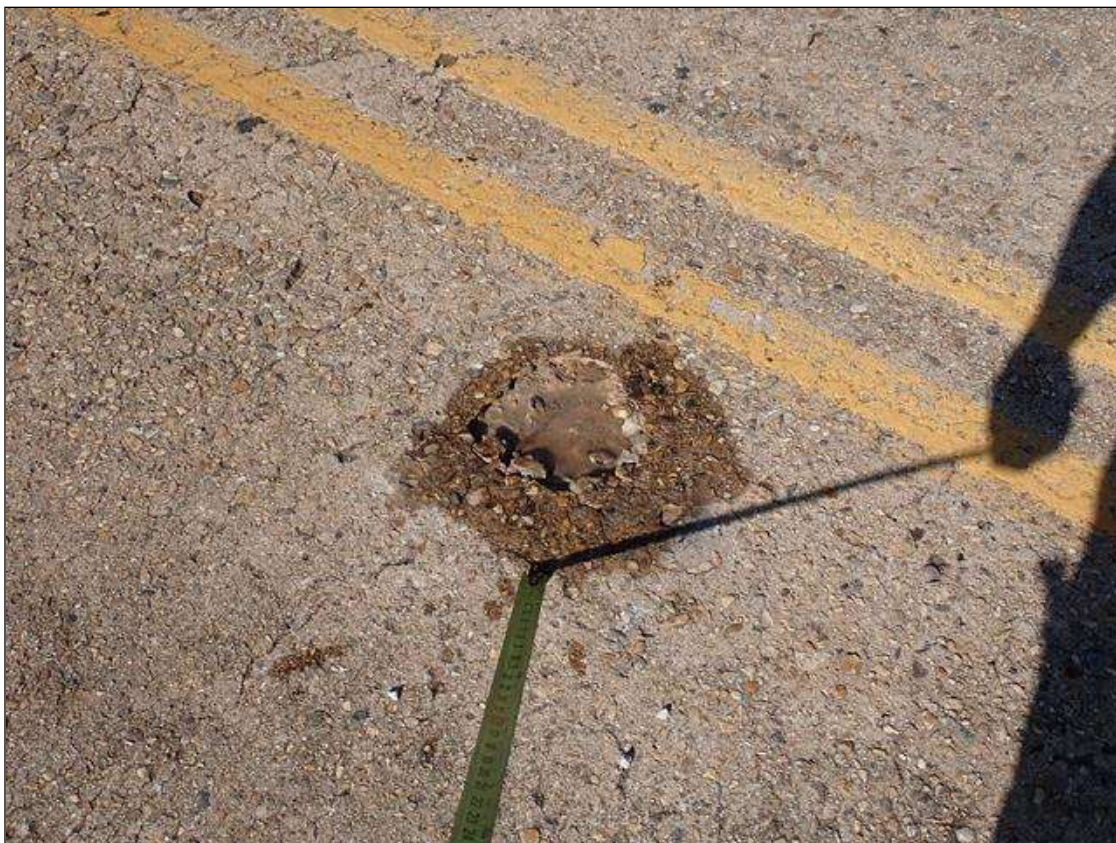
Span 1 Deck: (PAR) throughout top of deck, scattered delaminations/spalls (up to 2 foot x 1 foot x 1.5 inch deep), some with exposed rusted rebar

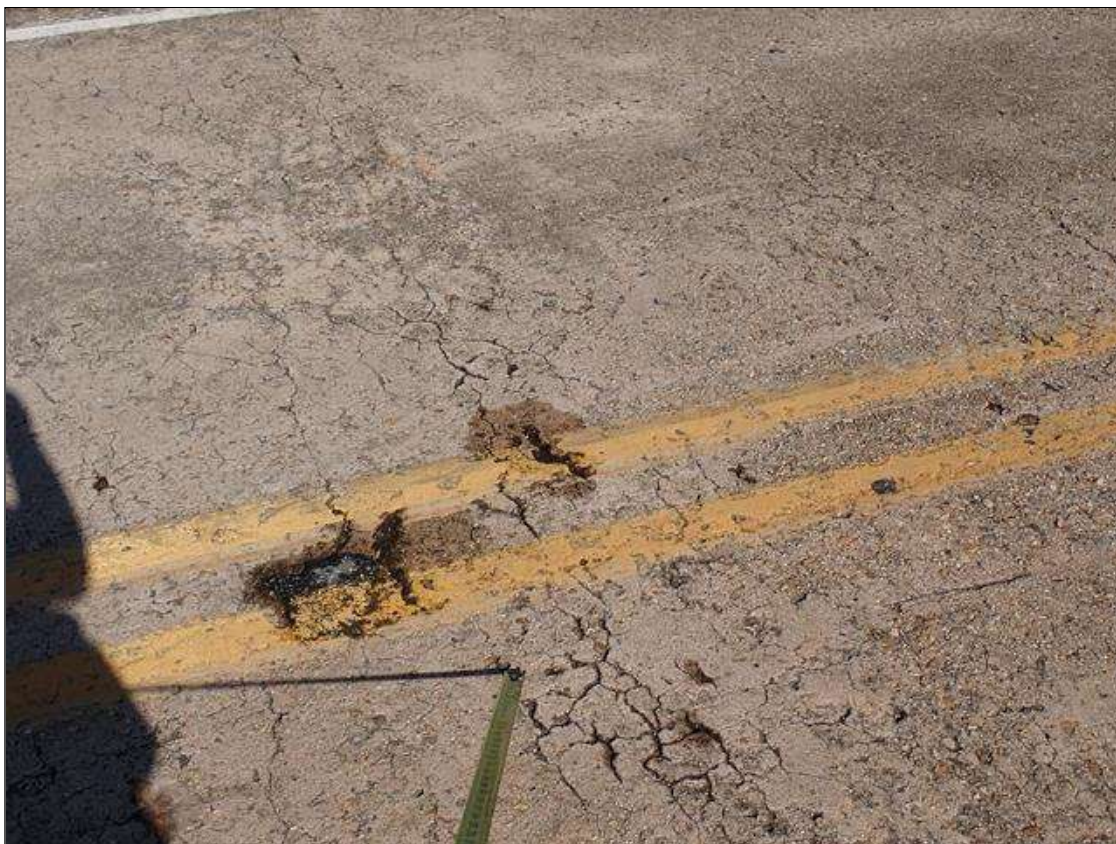
Span 1 Deck: (PAR) throughout top of deck, scattered delaminations/spalls (up to 2 foot x 1 foot x 1.5 inch deep), some with exposed rusted rebar

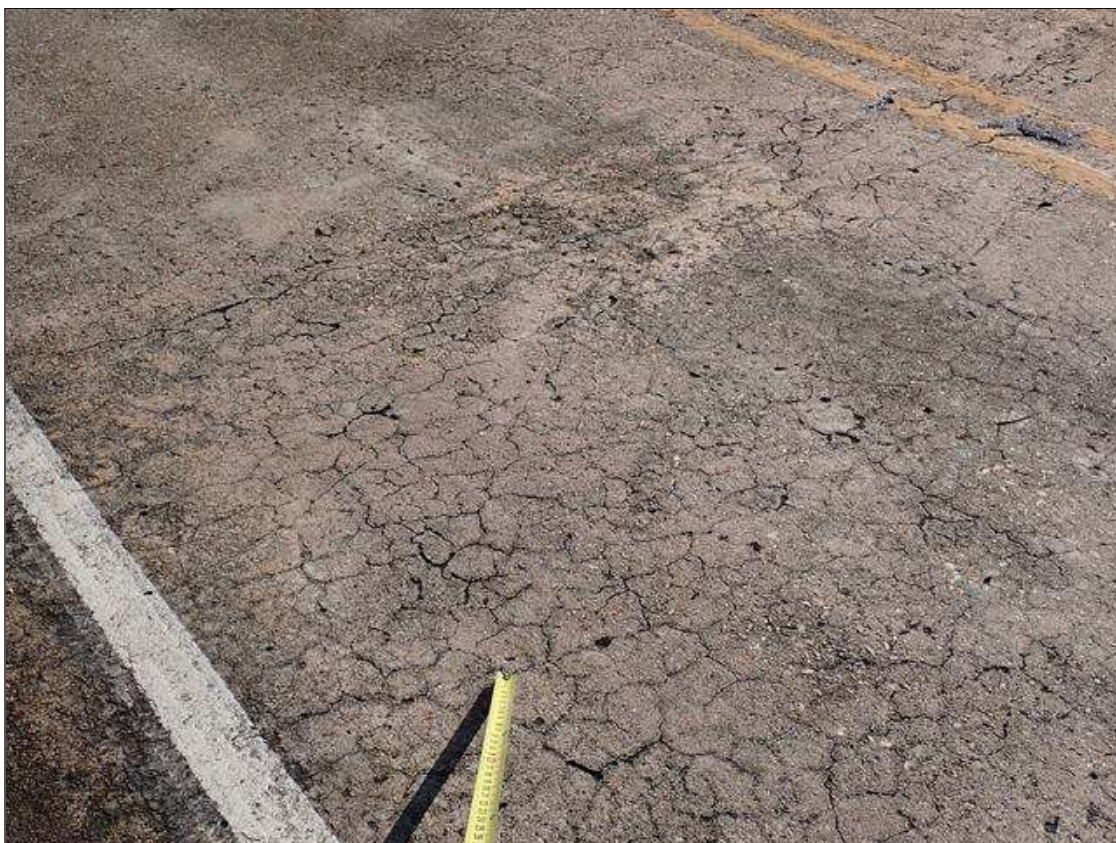
Span 1 Deck: throughout top of deck, map cracks (up to 1/16 inch) and transverse cracks (up to 1/16 inch x 15 feet) at random

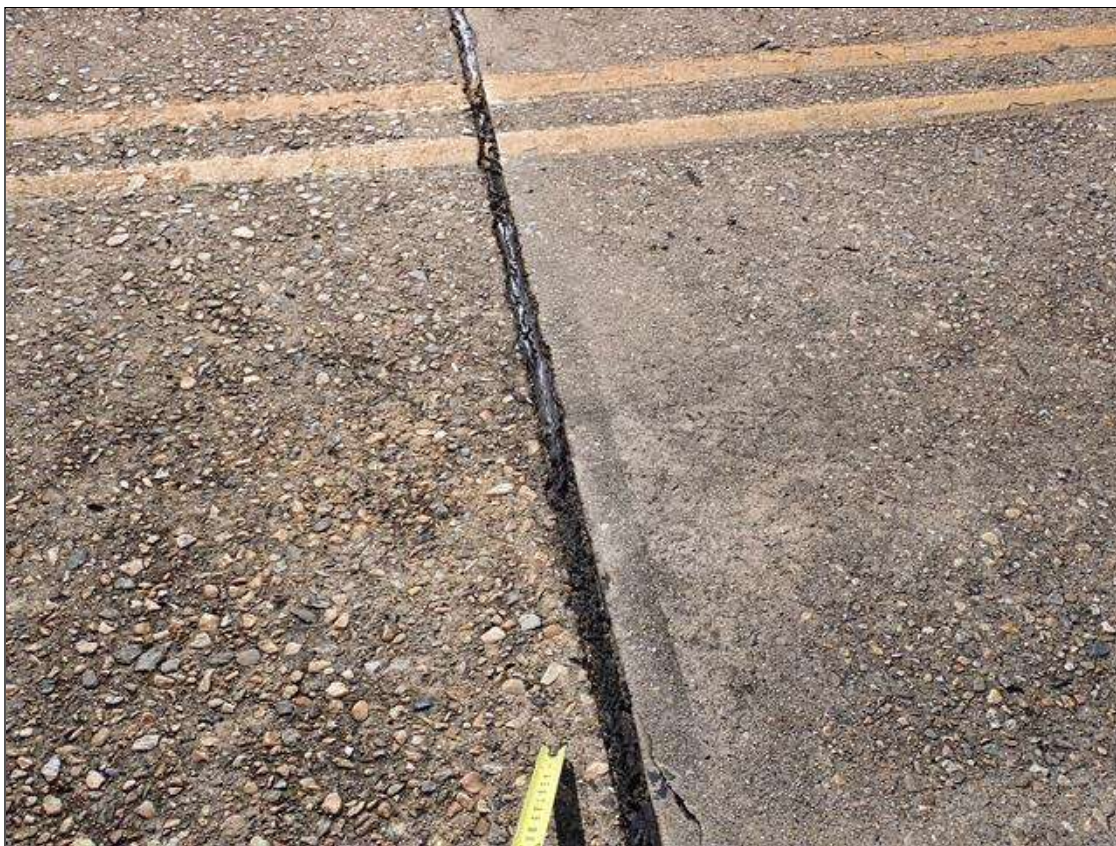
Span 2 Bent 1 Joint: along the length of the joint, deteriorated seal at random

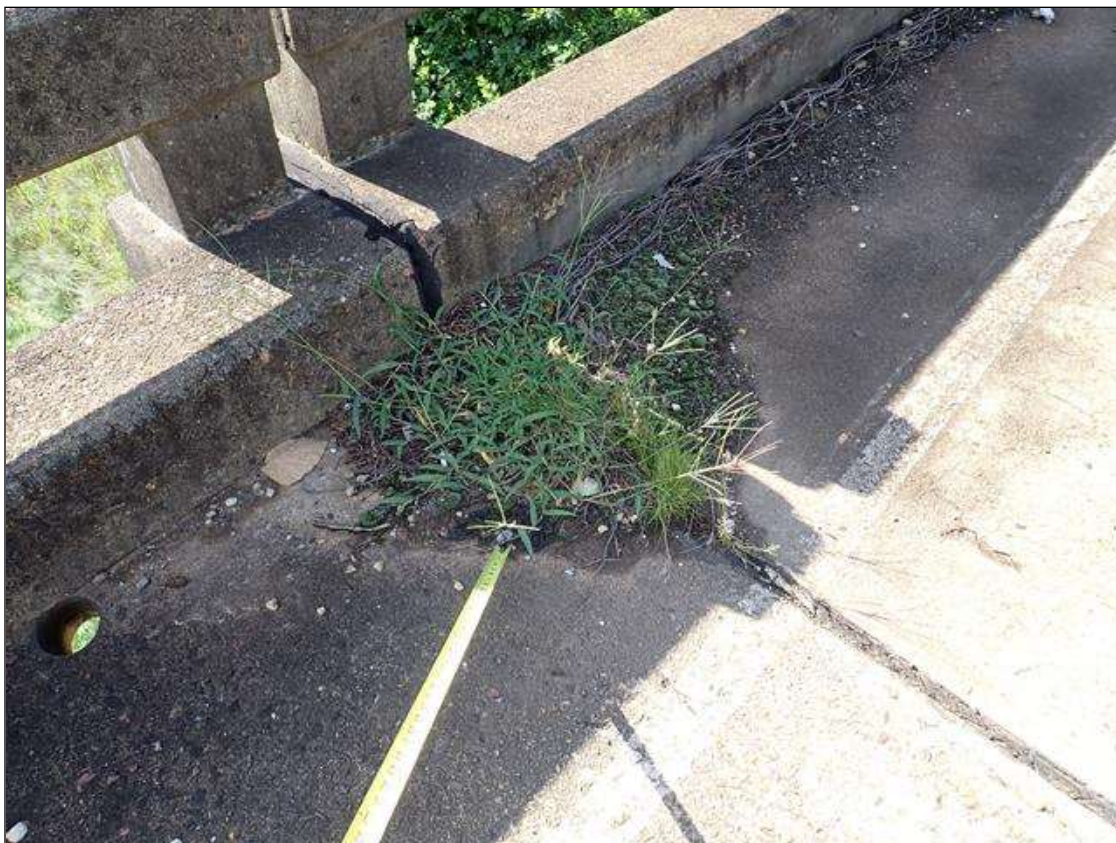
Span 2 Bent 1 Joint: both shoulders, debris accumulation

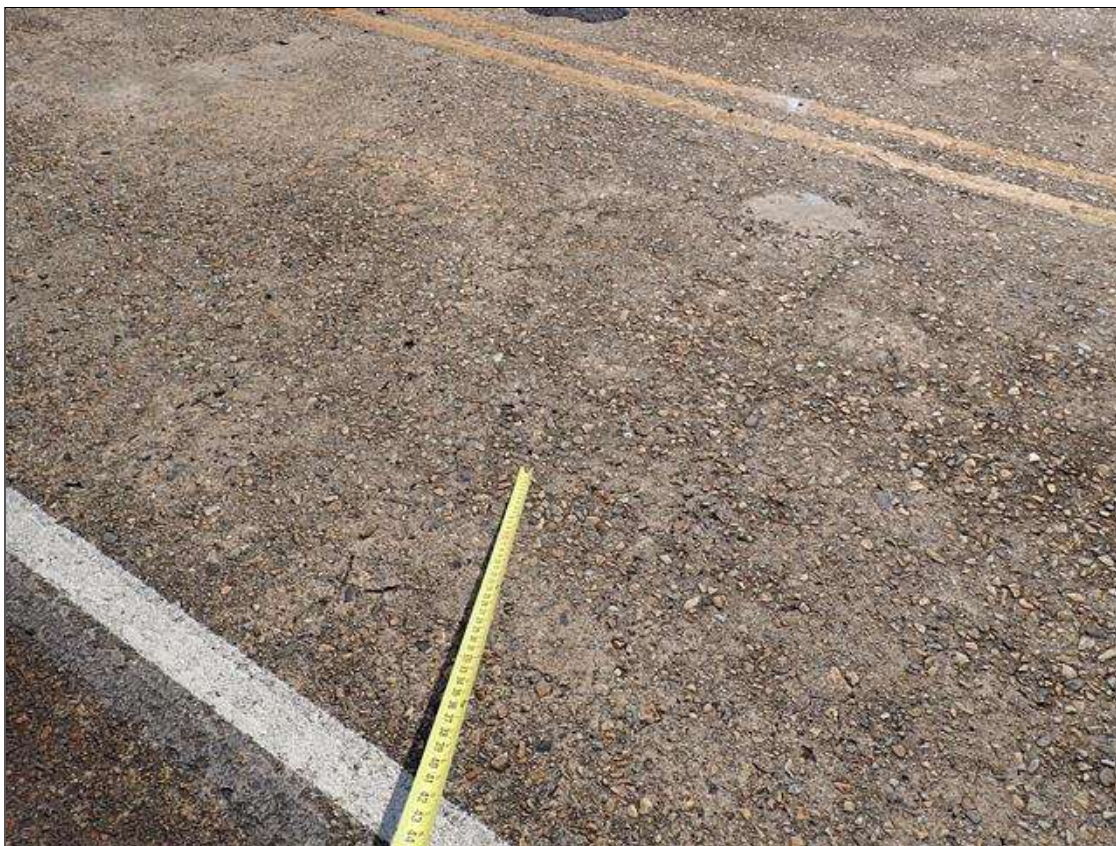
Span 2 Deck: throughout top of deck, wear with secure aggregate

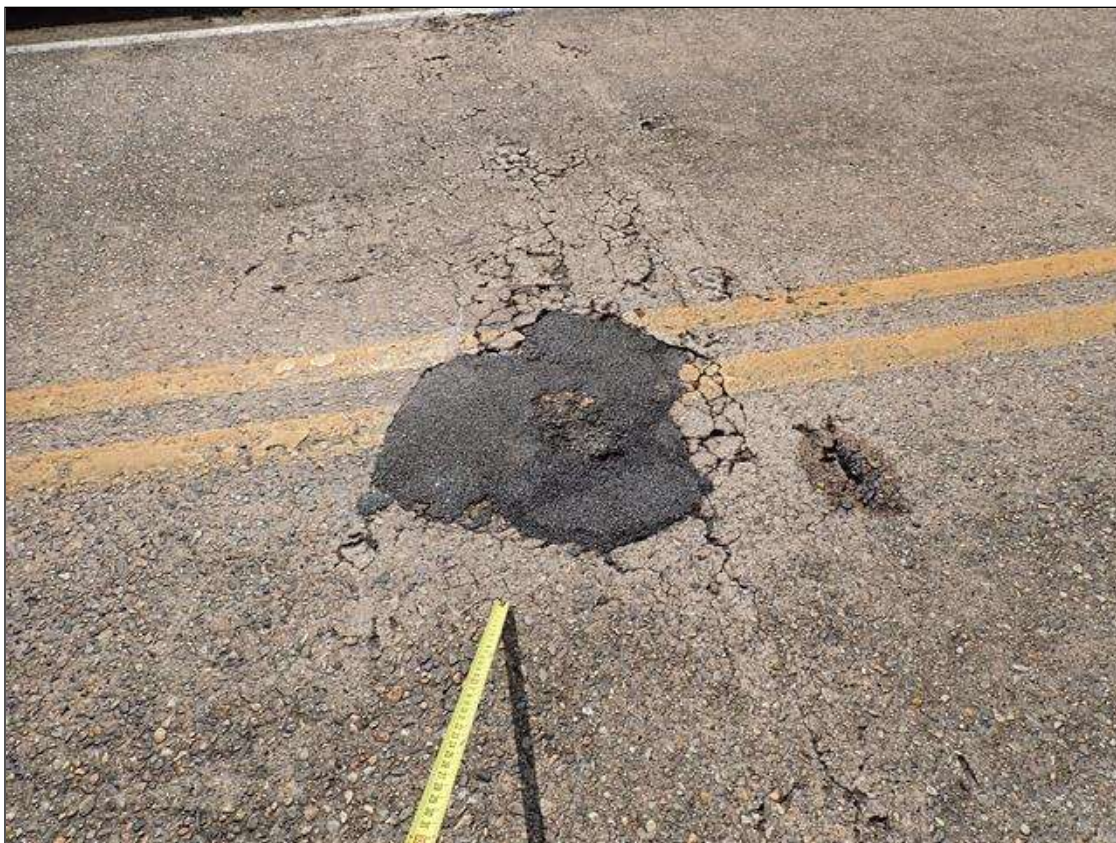
Span 3 Deck: 2 - TOP OF DECK HAS ASPHALT PATCHED AREAS ALONG THE CENTER LINE UP TO 2.5 FEET X 3 FEET.

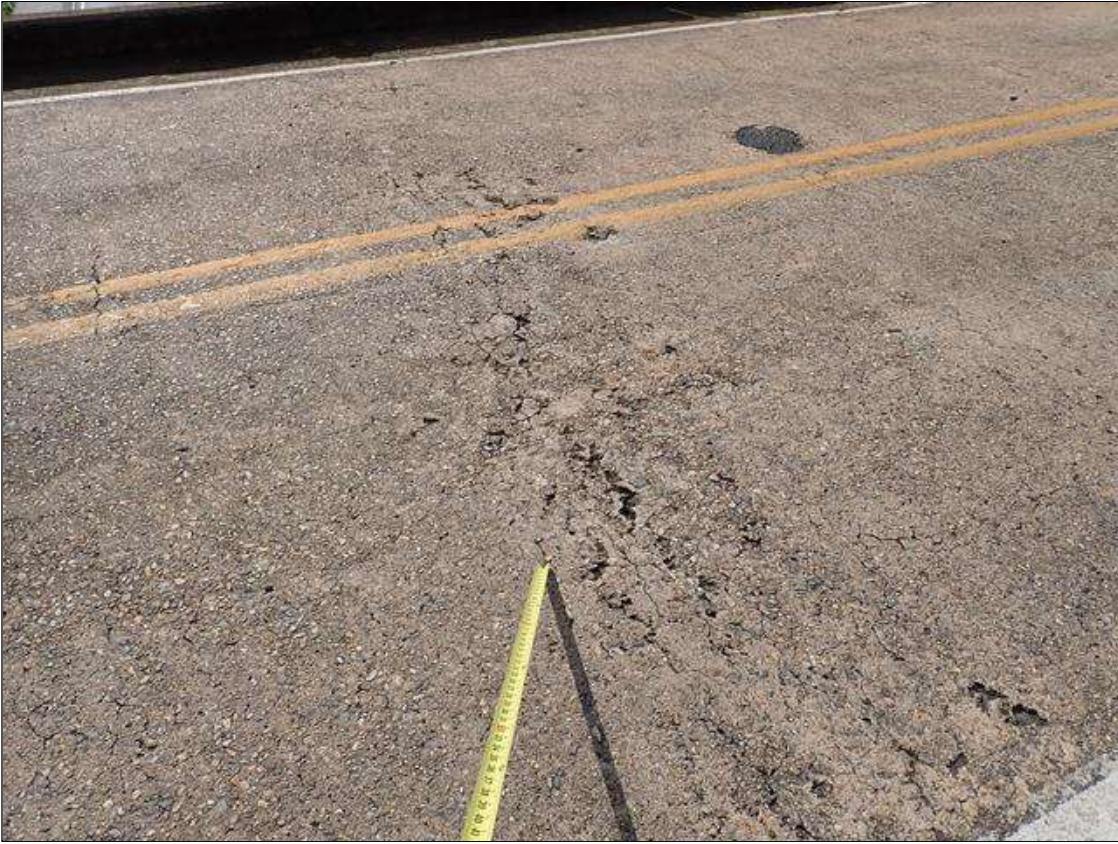
Span 3 Deck: throughout top of deck, scattered delaminations/spalls (up to 2 foot x 1 foot x 1 inch deep)

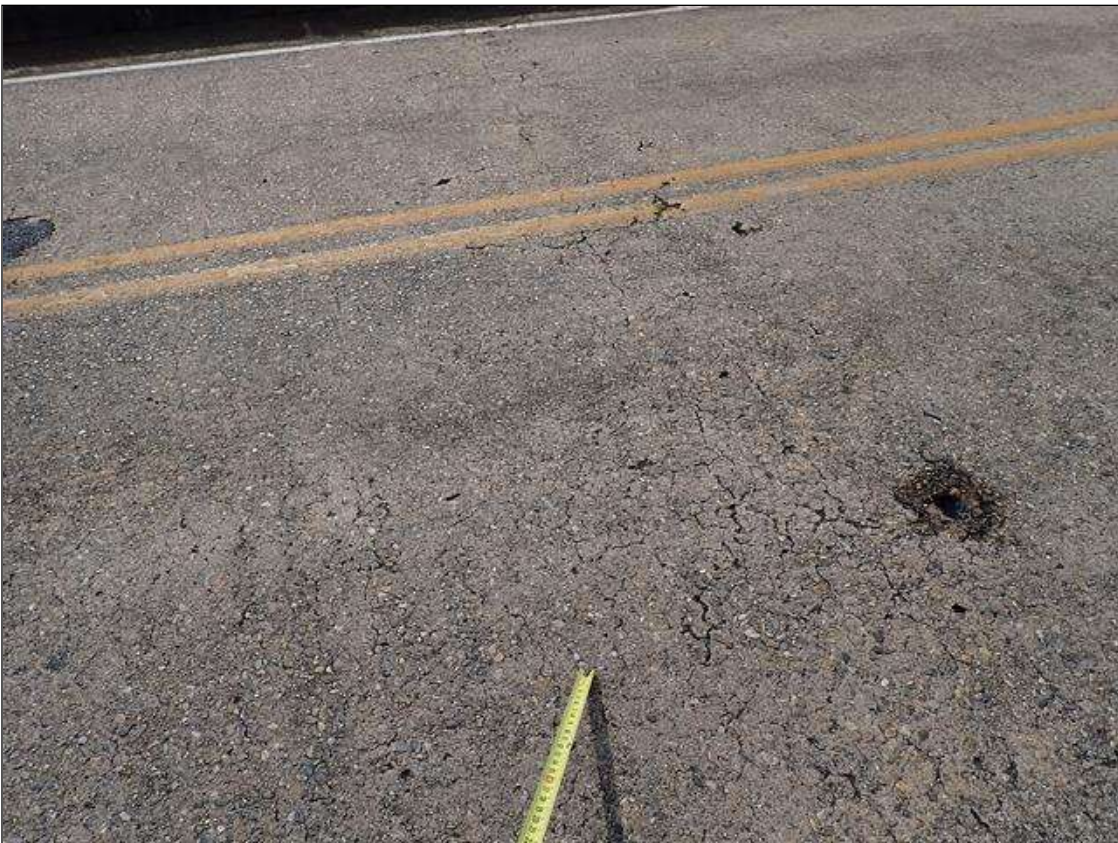
Span 3 Deck: throughout top of deck, map cracks (up to 1/16 inch) and transverse cracks (up to 1/16 inch x 15 feet) at random

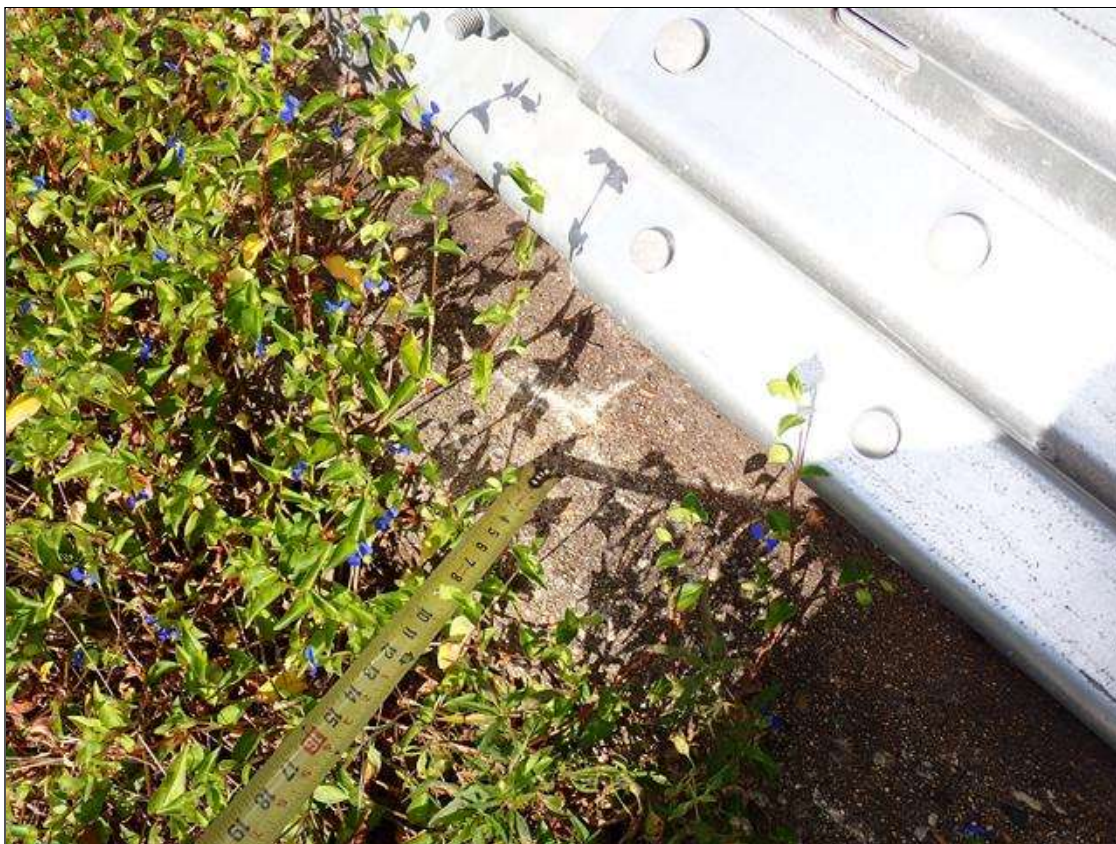
Span 4 Left Bridge Rail: along the curb, areas of map cracks (hairline) at random, some with efflorescence

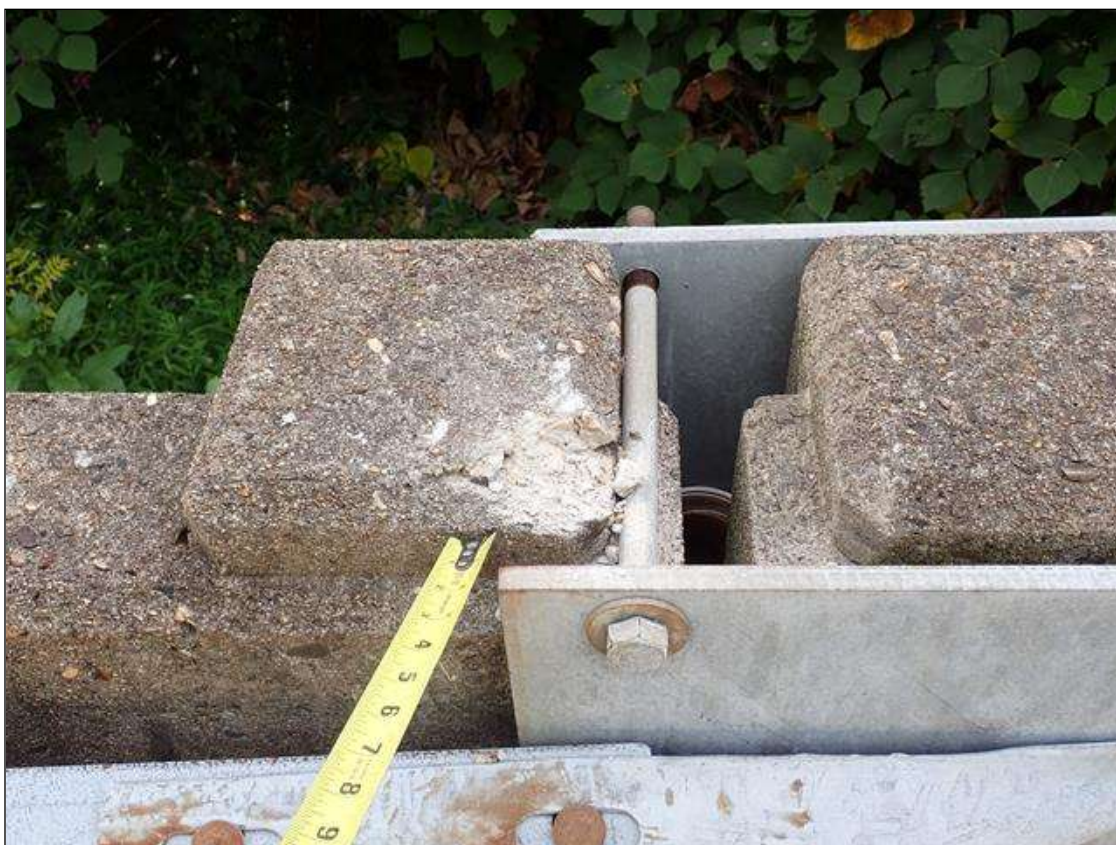
Span 4 Right Bridge Rail: top of rail post 7, spall (4 inch diameter x 1 inch deep)

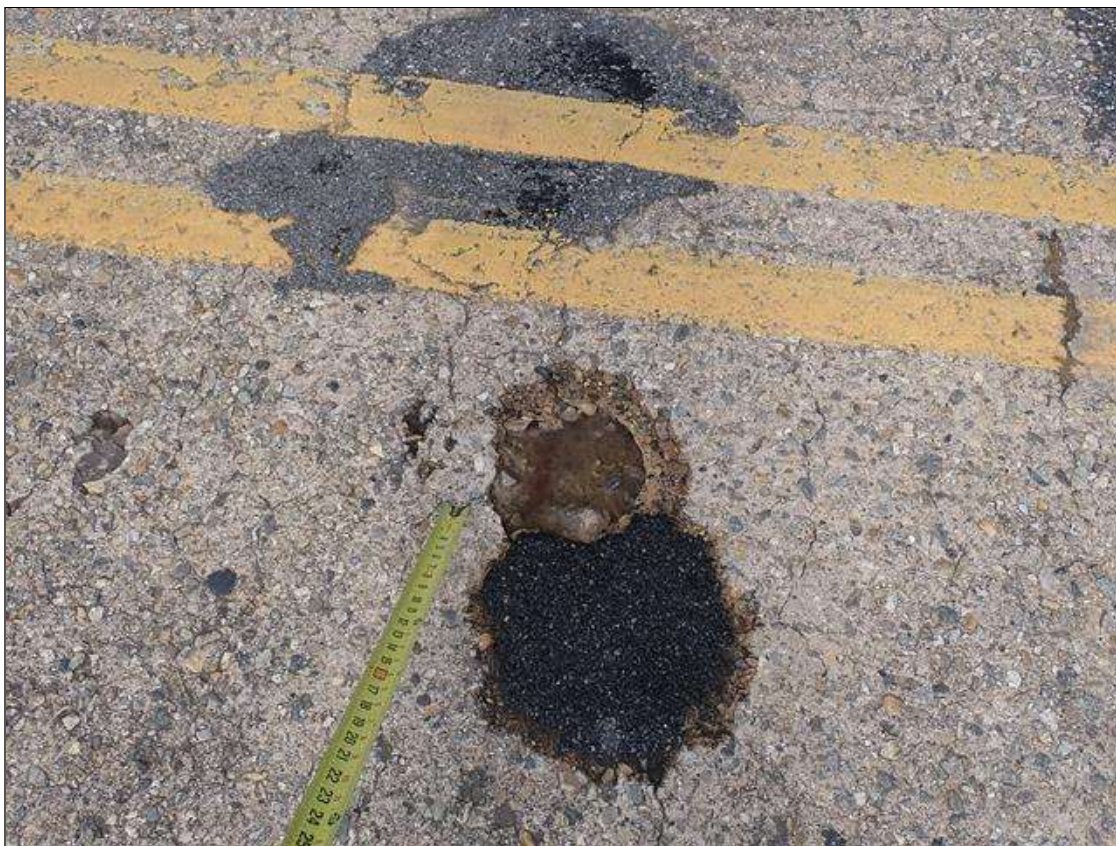
Span 4 Deck: (PAR) throughout top of deck, scattered delaminations/spalls (up to 1 foot diameter x 1.5 inch deep), some with exposed rusted rebar

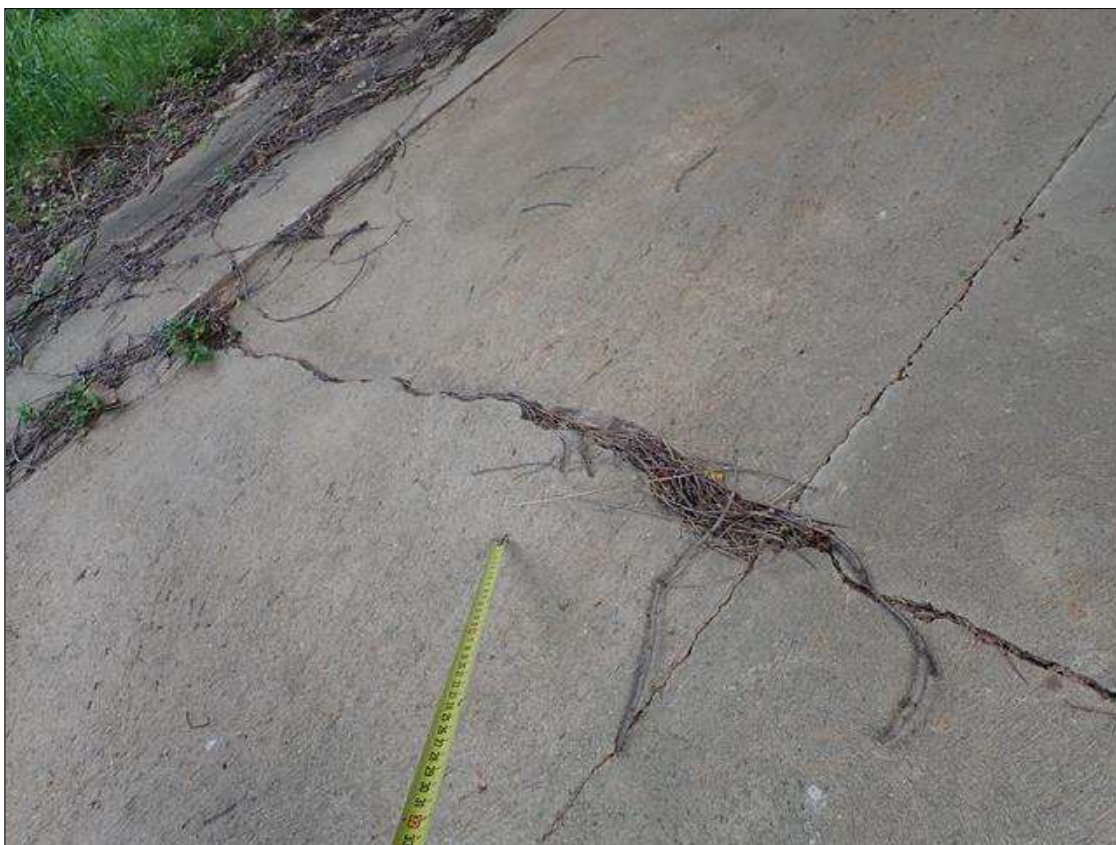
end bent 2 slope protection, transverse crack (up to 1 inch wide) with settlement (up to 1.5 inches)

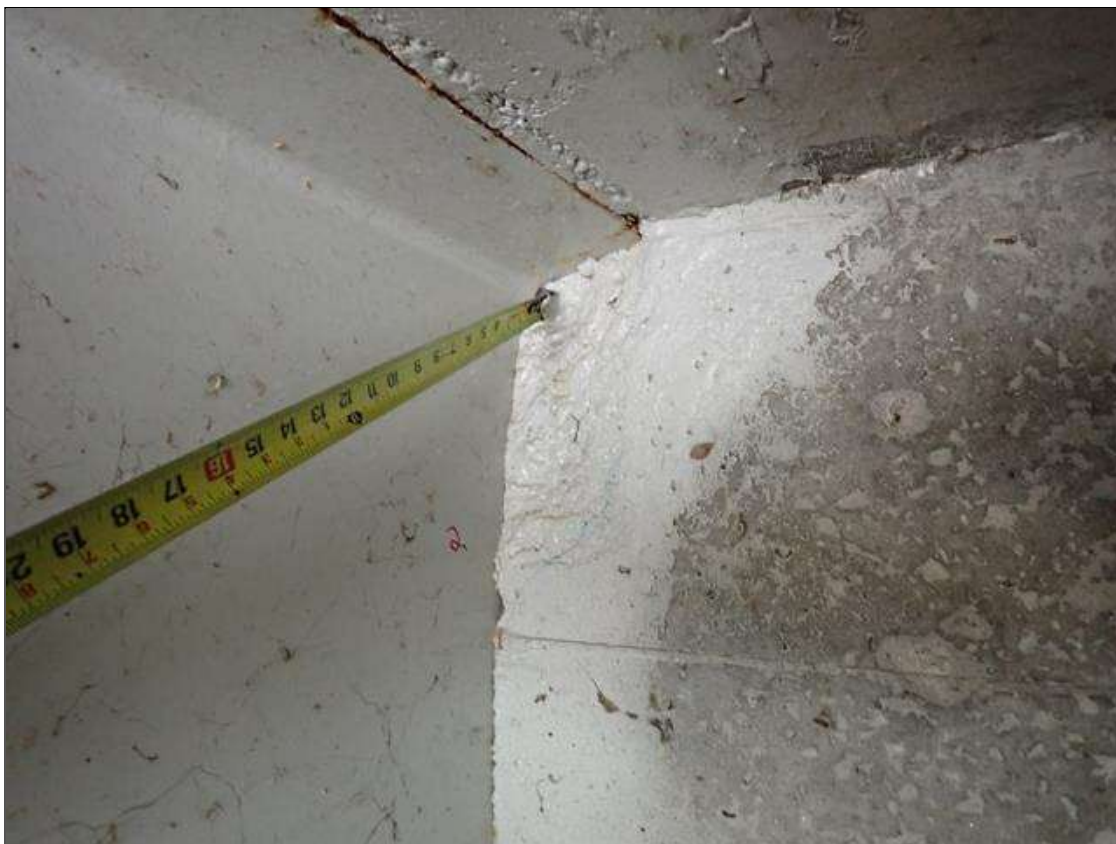
End Bent 2 Abutment: in bay 2 adjacent to East face of beam 2, spall [5 inch x 11 inch x up to 1.5 inch deep]

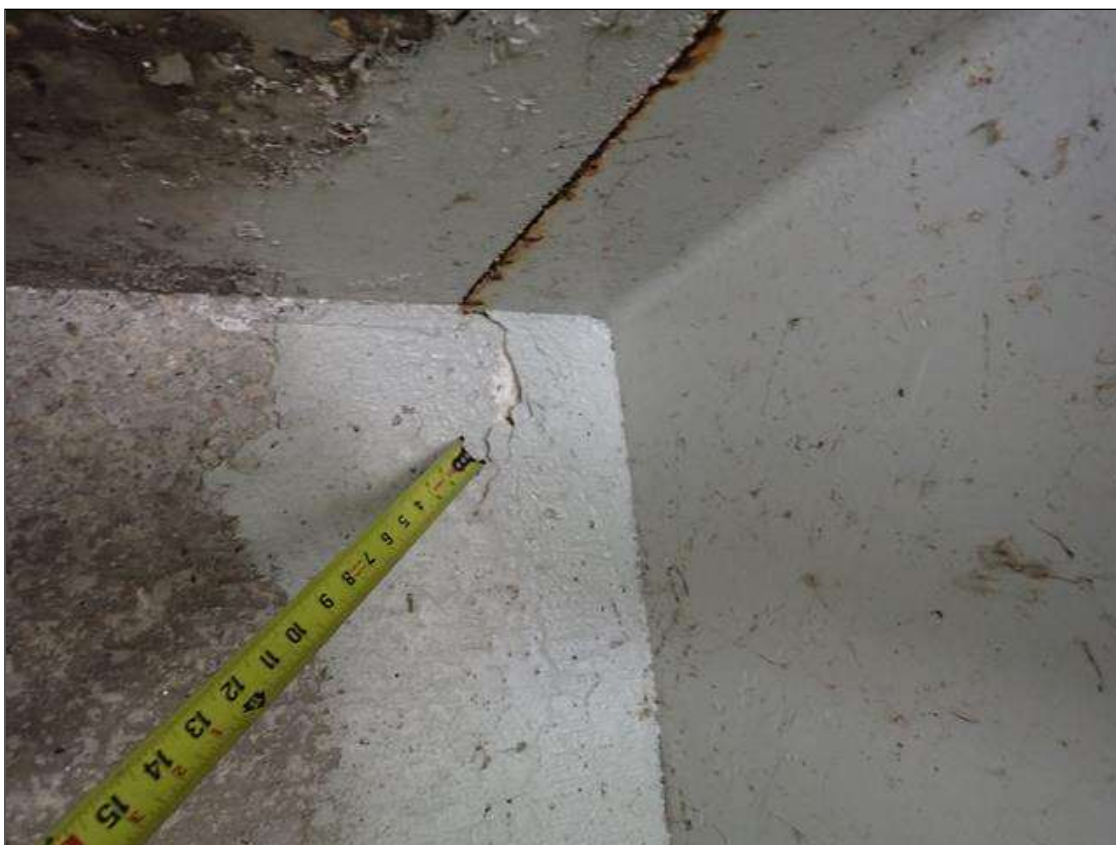
End Bent 2 Abutment: in bay 1, adjacent to bay 2, delamination (9 inch x 5 inch)

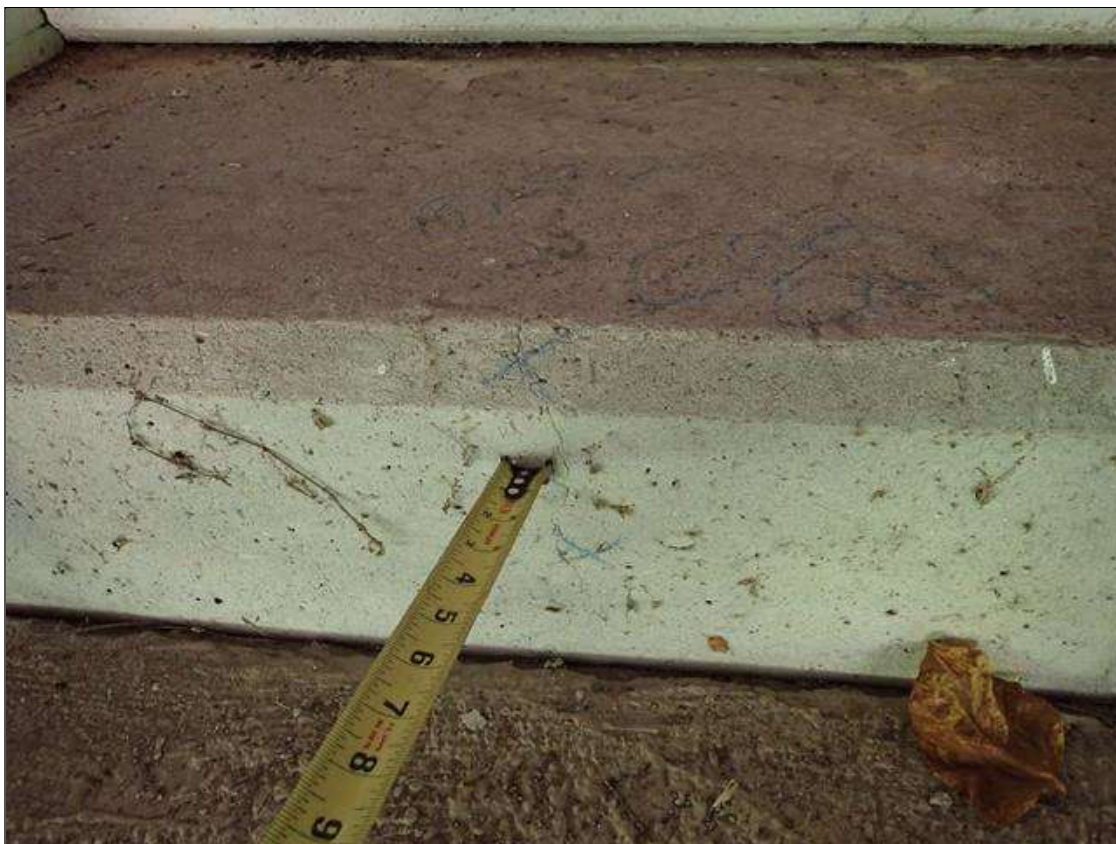
End Bent 2 Abutment: along length of cap, multiple vertical cracks [up to full height x 1/64 inch]

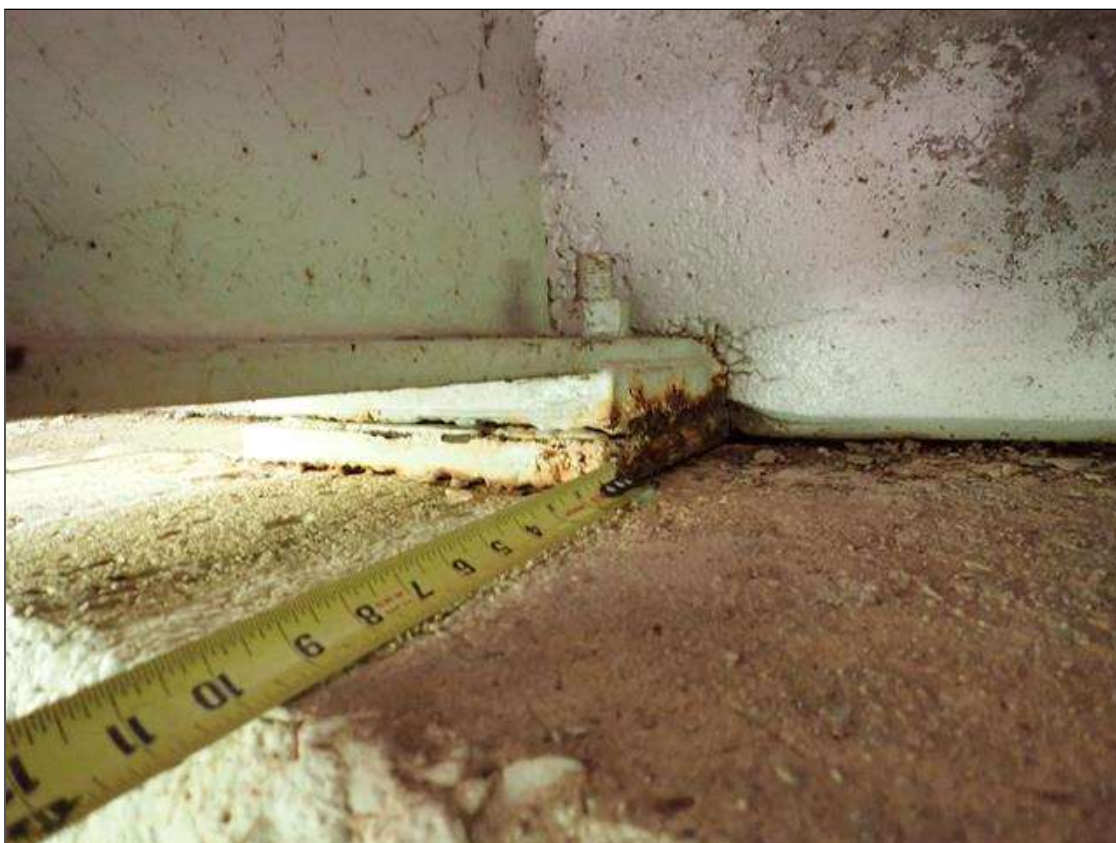
Span 4 Beam 1 - Far Bearing 1: rust scale

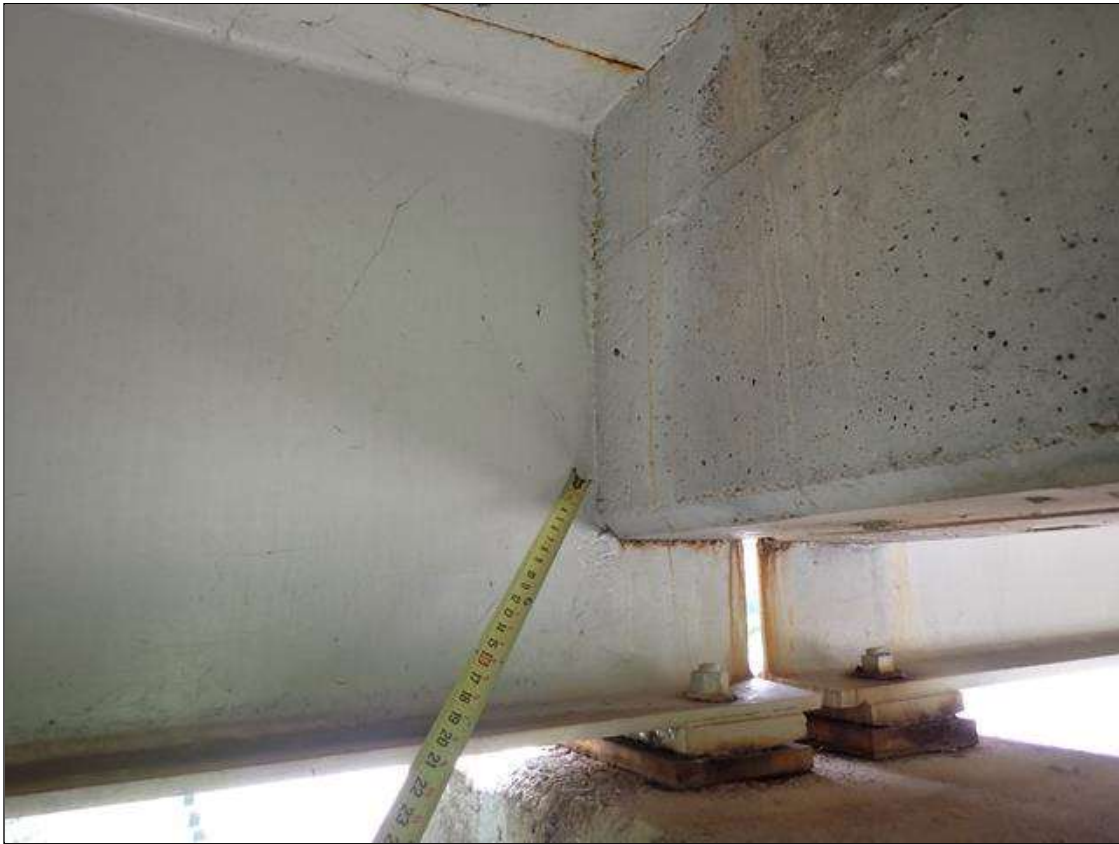
Span 4 Beam 4: at bent 3, painted over section loss: web adjacent to diaphragm (7/16 inch average remaining x 1 inch x 2 feet); lower web, painted over pitting (up to 1/16 inch deep x 1 foot) with corrosion reinitiated

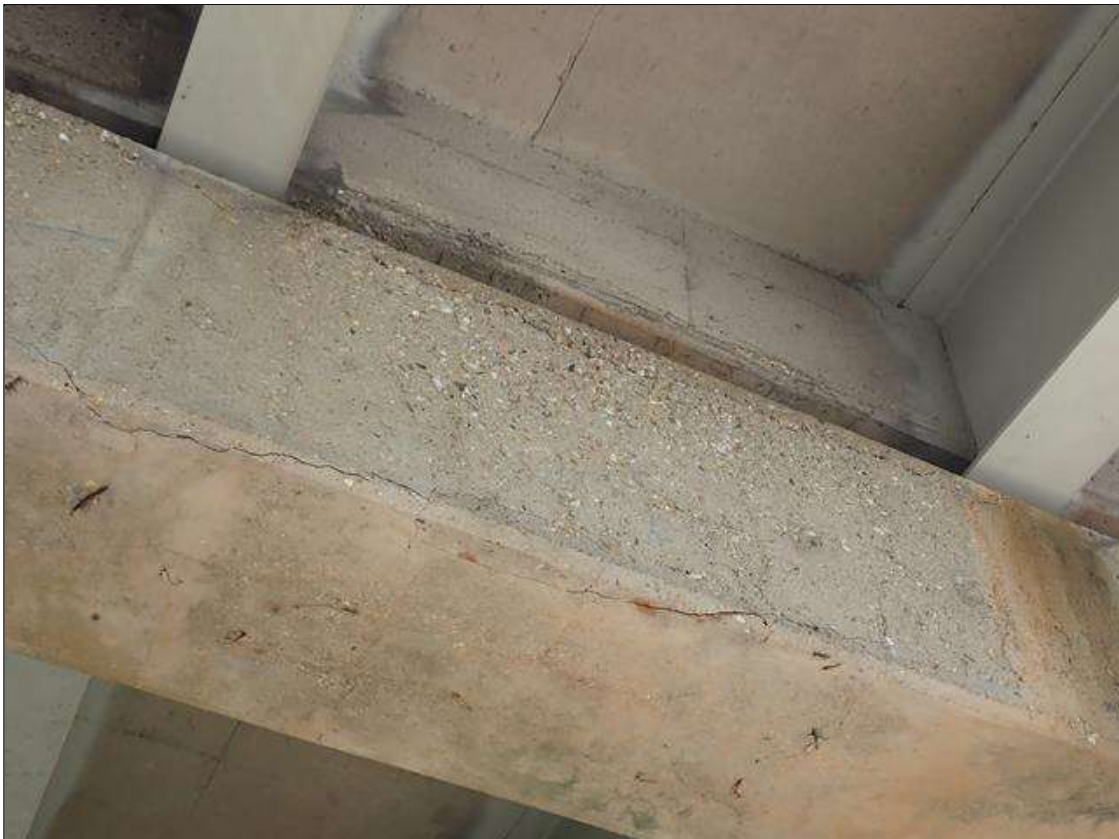
Bent 3 Cap 1: (PAR) along the length of the cap, delaminations/spalls (up to full length x 10 inches high x 1.5 inch deep) with cracks (up to 1/8 inch) with some rust stains
