NC DEPARTMENT OF TRANSPORTATION  
 DIVISION OF HIGHWAYS  
 STRUCTURE MANAGEMENT UNIT

ATTENTION: prompt action request, sketches revised, vertical clearances revised

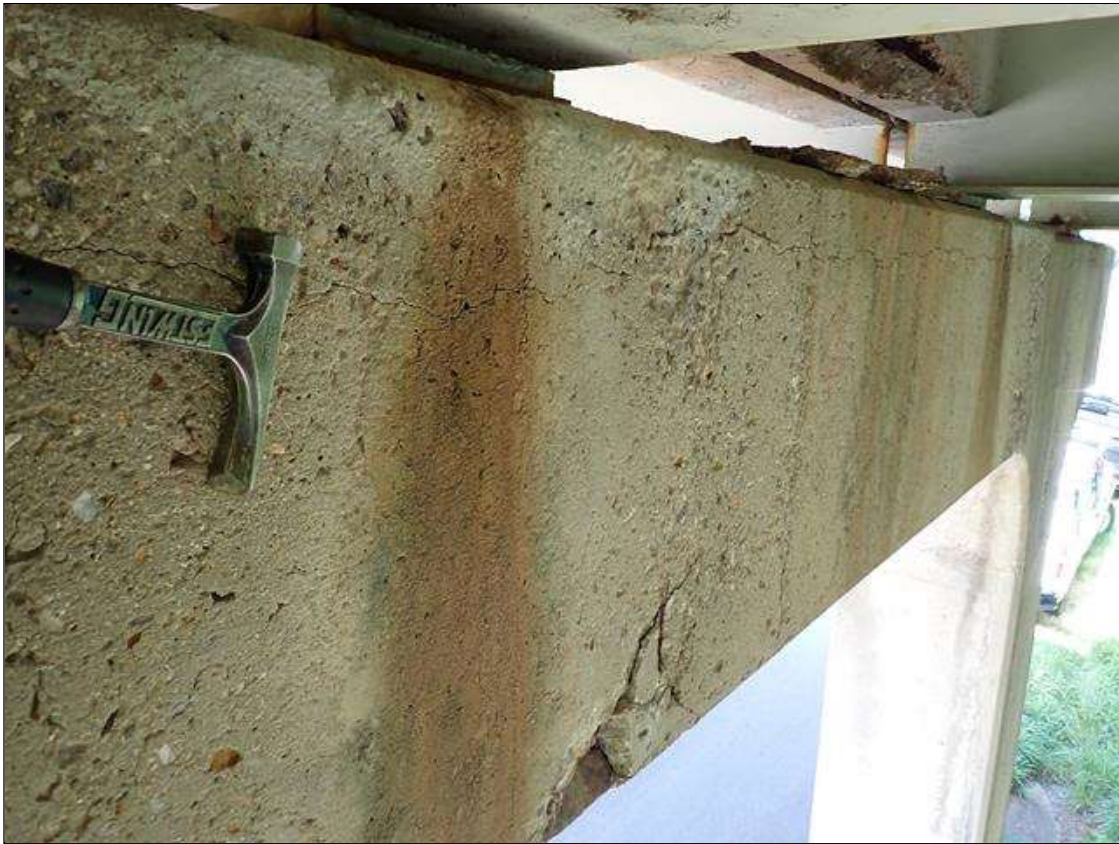
Bent 3 Cap 1: (PAR) along the length of the cap, delaminations/spalls (up to full length x 10 inches high x 1.5 inch deep) with cracks (up to 1/8 inch) with some rust stains

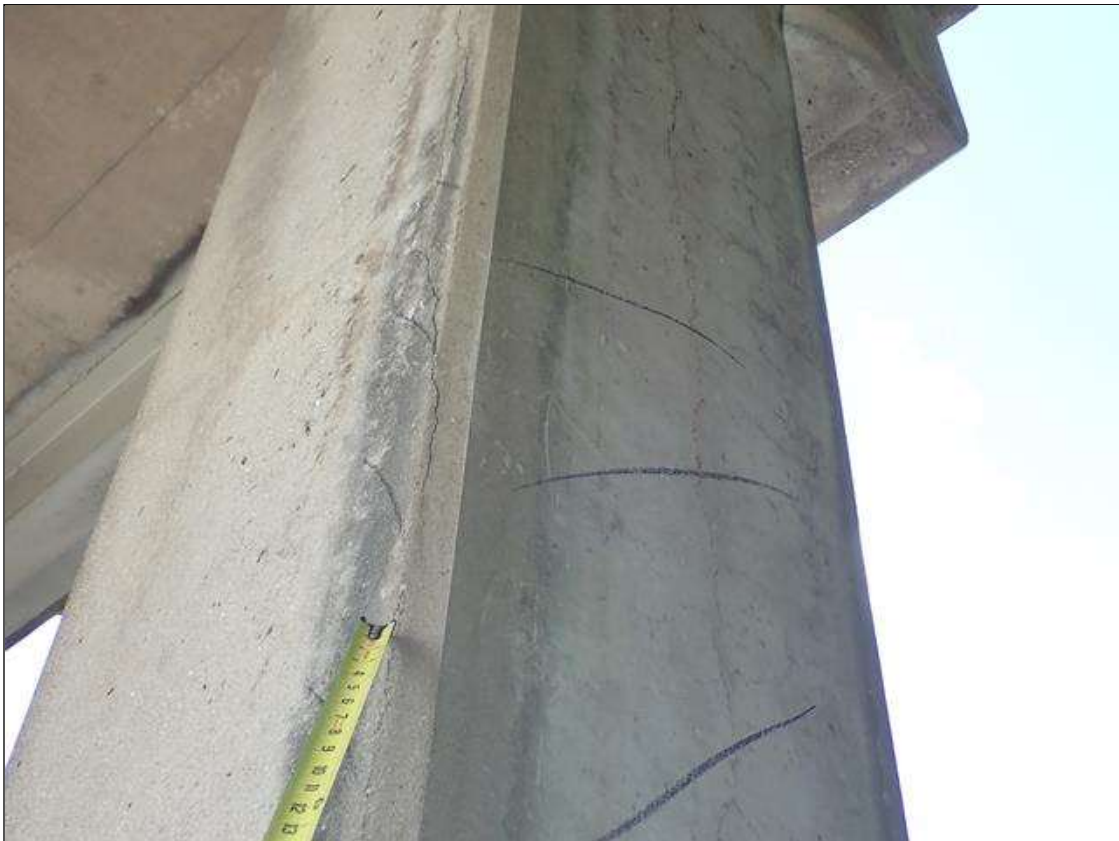
Bent 3 Pile 1: 7 FOOT X UP TO 1/16 INCH VERTICAL CRACKS ON EAST, WEST AND NORTH FACES AT BOTTOM OF CAP with associated delamination [5 feet x 2.5 feet]

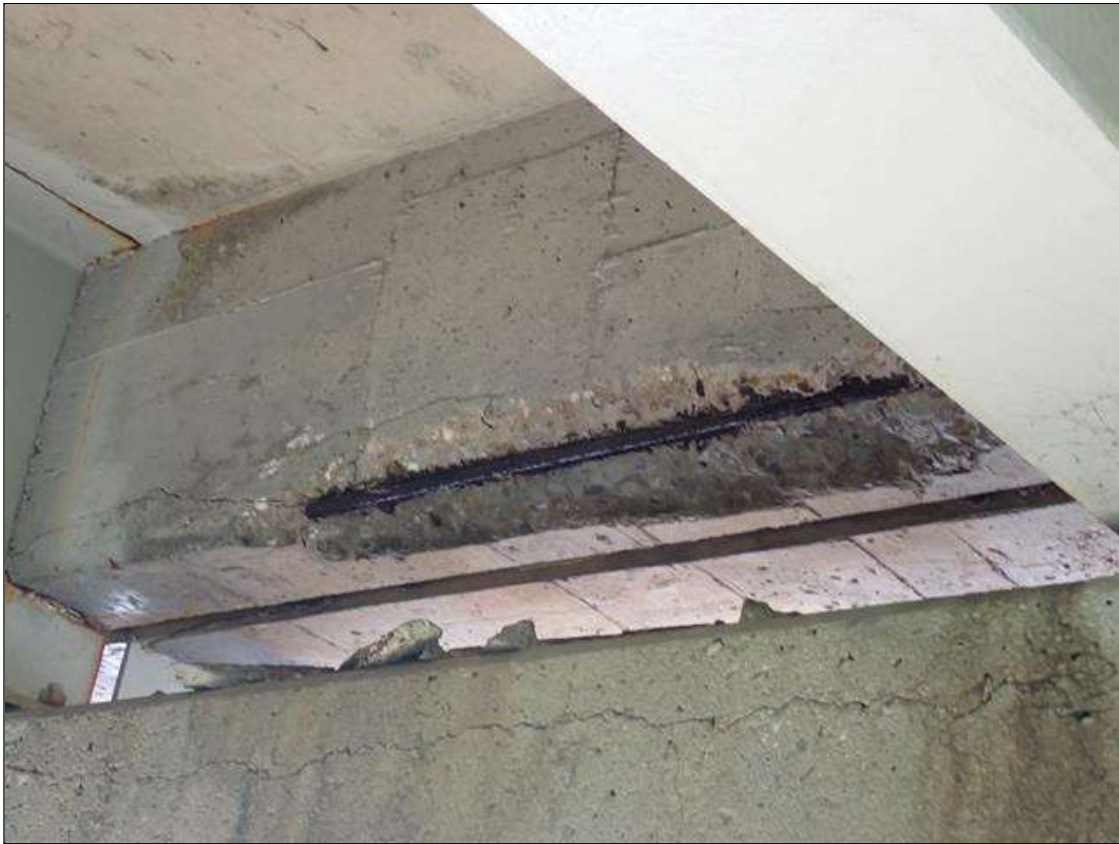
Span 4 Deck: at bent 3, end diaphragm in all bays, spalls/delaminations (up to full bay width x 10 inches x 2.5 inches deep) with exposed rusted rebar, with associated cracks (up to 1/16 inch)

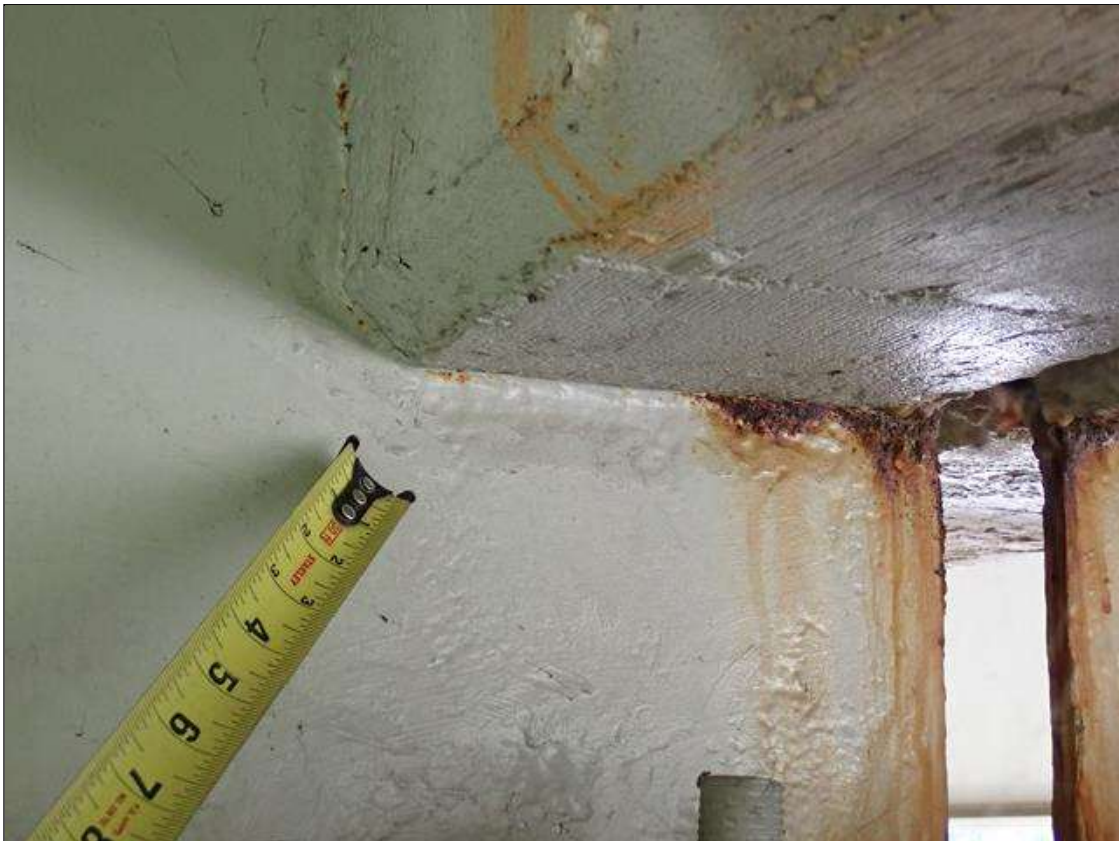
Span 4 Beam 2: (PAR) at bent 3, web adjacent to diaphragm, painted over section loss (5/16 inch average remaining x 9 inch x 2 inch); lower web, painted over pitting (up to 1/8 inch deep x 6 inch x 6 inch) with corrosion reinitiated

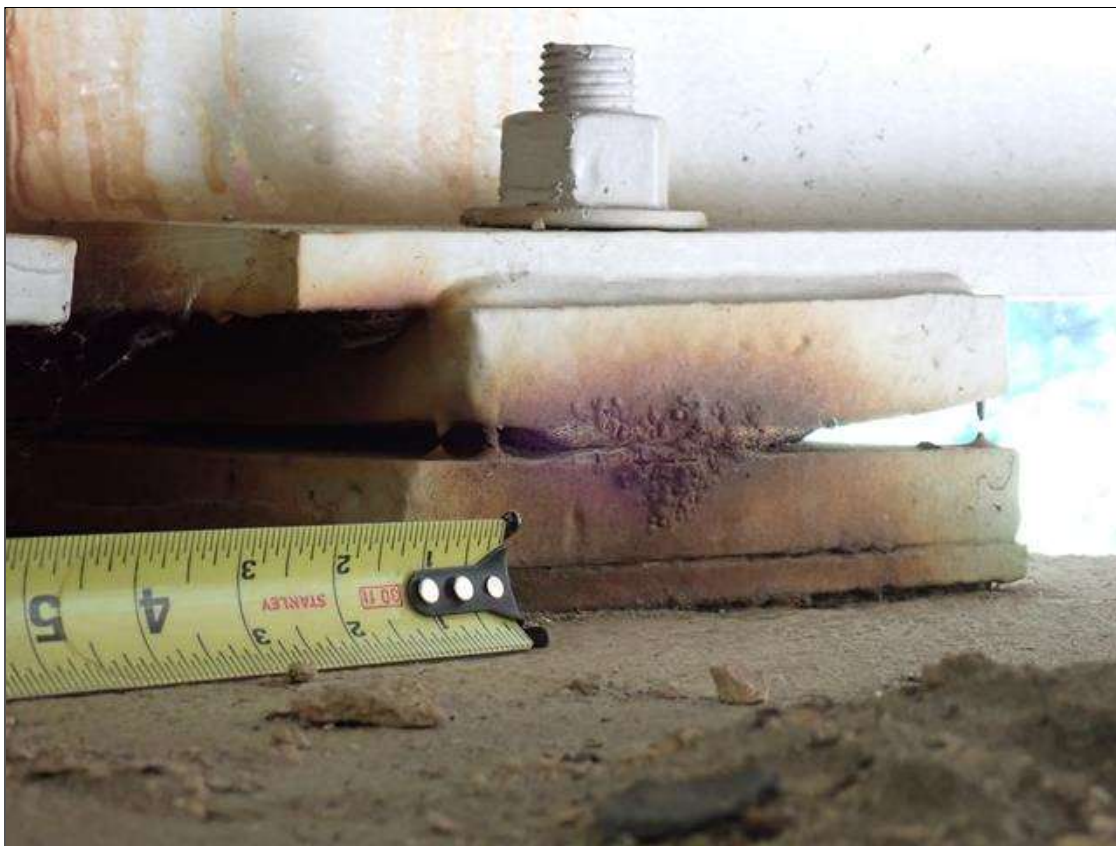
Span 3 Beam 2 - Far Bearing 2: SPAN 3 BEAM 2 FAR BEARING HAS SURFACE RUST/PACK RUST ON BEARING PLATE.

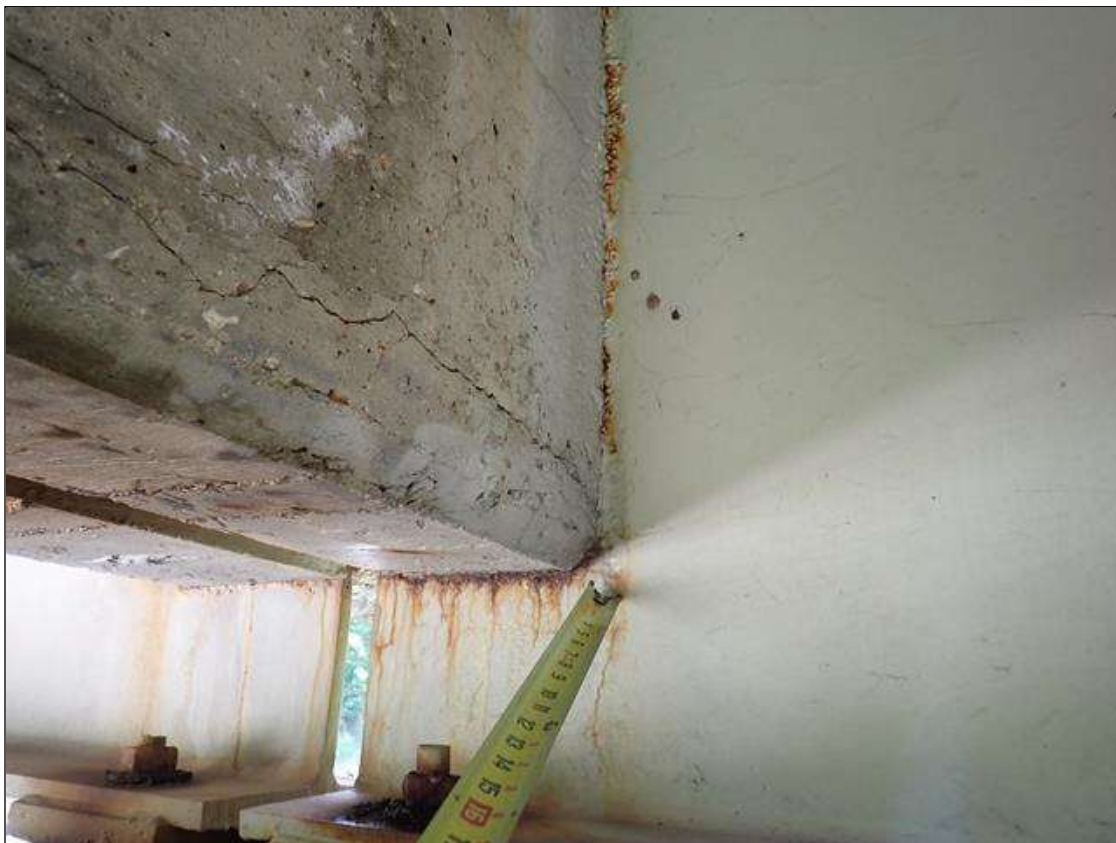
Span 4 Beam 1: at bent 3, web adjacent to diaphragm, painted over section loss (7/16 inch average remaining x 9 inch x 2 feet) with corrosion reinitiated

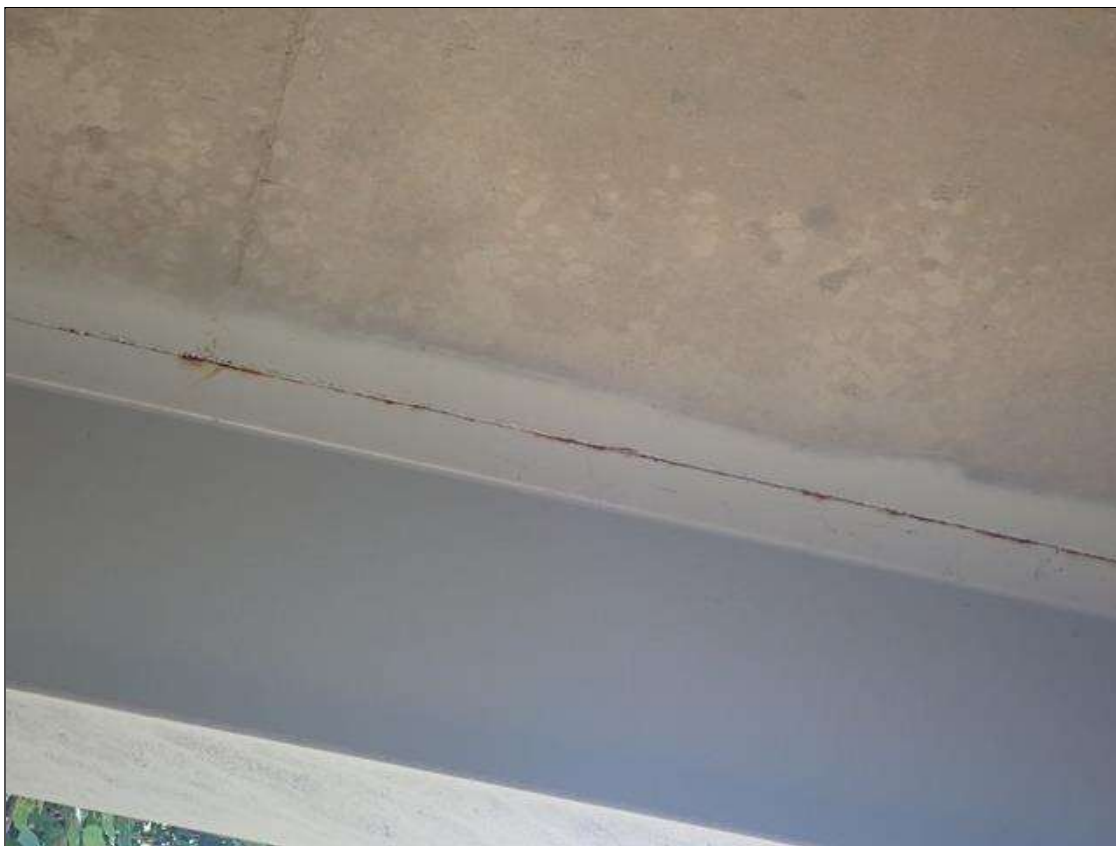
Span 4 Beam 4: along the edge of the top flange, near bent 3, surface rust

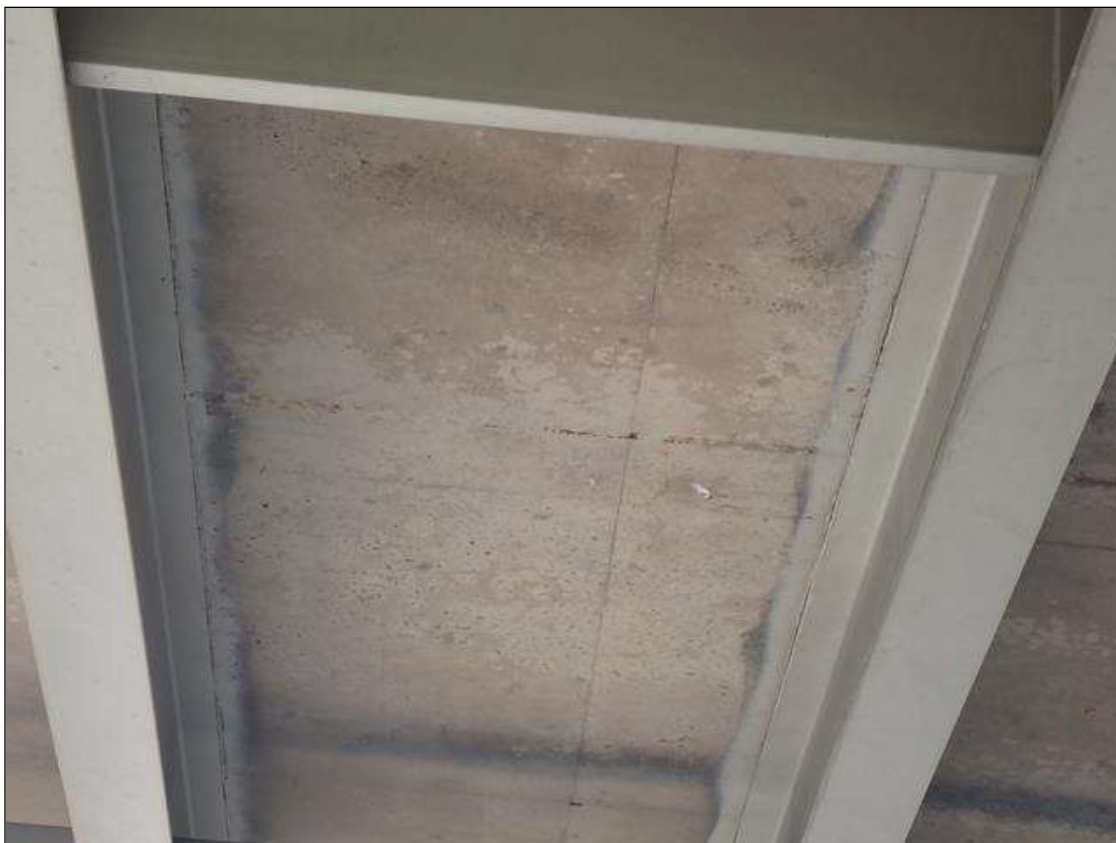
Span 3 Deck: SPAN 3 BOTTOM OF DECK HAS HAIRLINE MAP CRACKING WITH SOME EFFLORESCENCE IN ALL BAYS; BOTH OVERHANGS, TRANSVERSE CRACKS (HAIRLINE X FULL WIDTH), SOME WITH EFFLORESCENCE

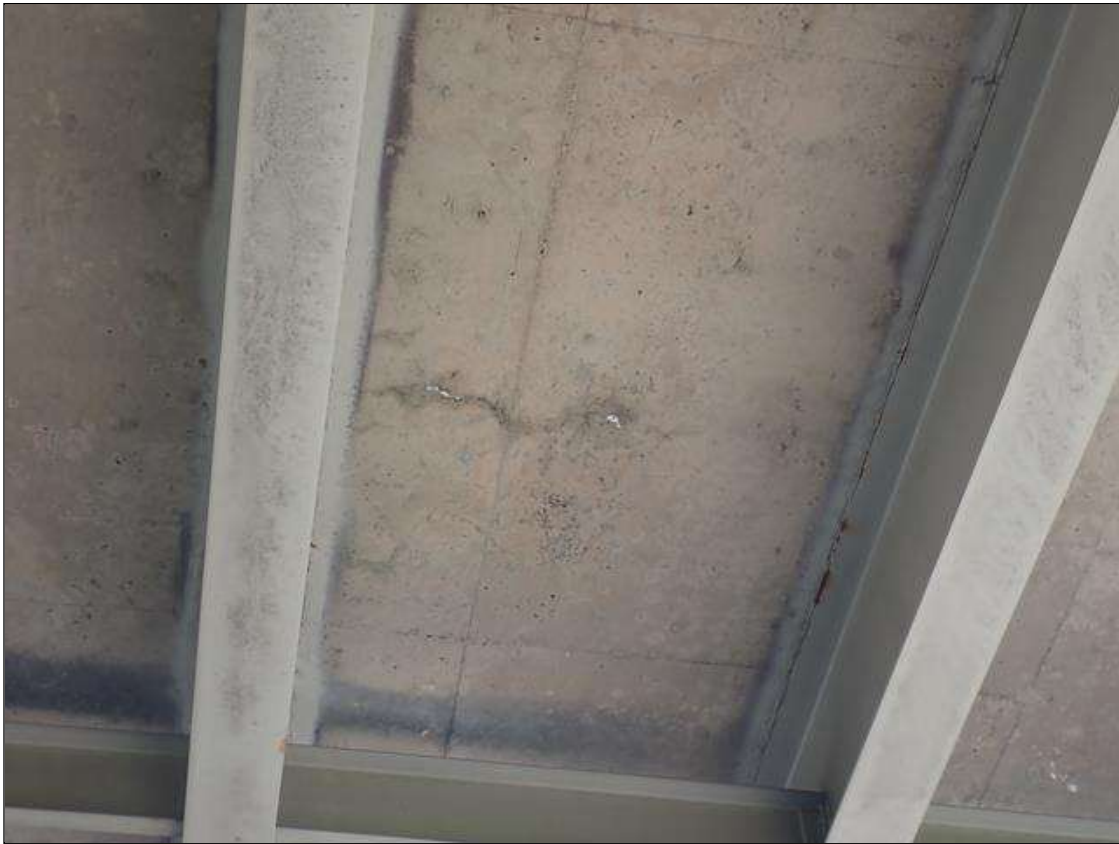
Span 2 Deck: SPAN 2 BOTTOM OF DECK HAS hairline map cracking, some WITH EFFLORESCENCE IN ALL BAYS; BOTH OVERHANGS, TRANSVERSE CRACKS (HAIRLINE X FULL WIDTH), SOME WITH EFFLORESCENCE

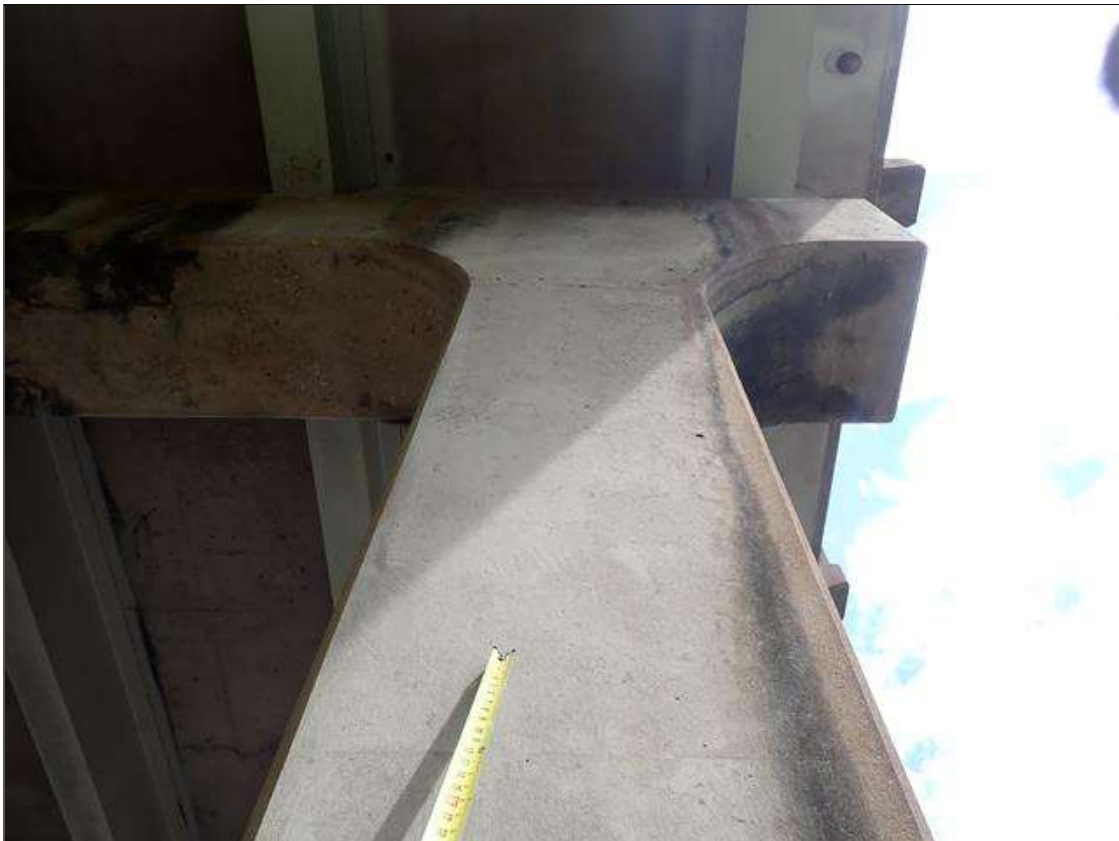
Bent 1 Pile 2: all faces, vertical cracks (up to 1/32 inch x 7 feet) and areas of map cracking (hairline) at random

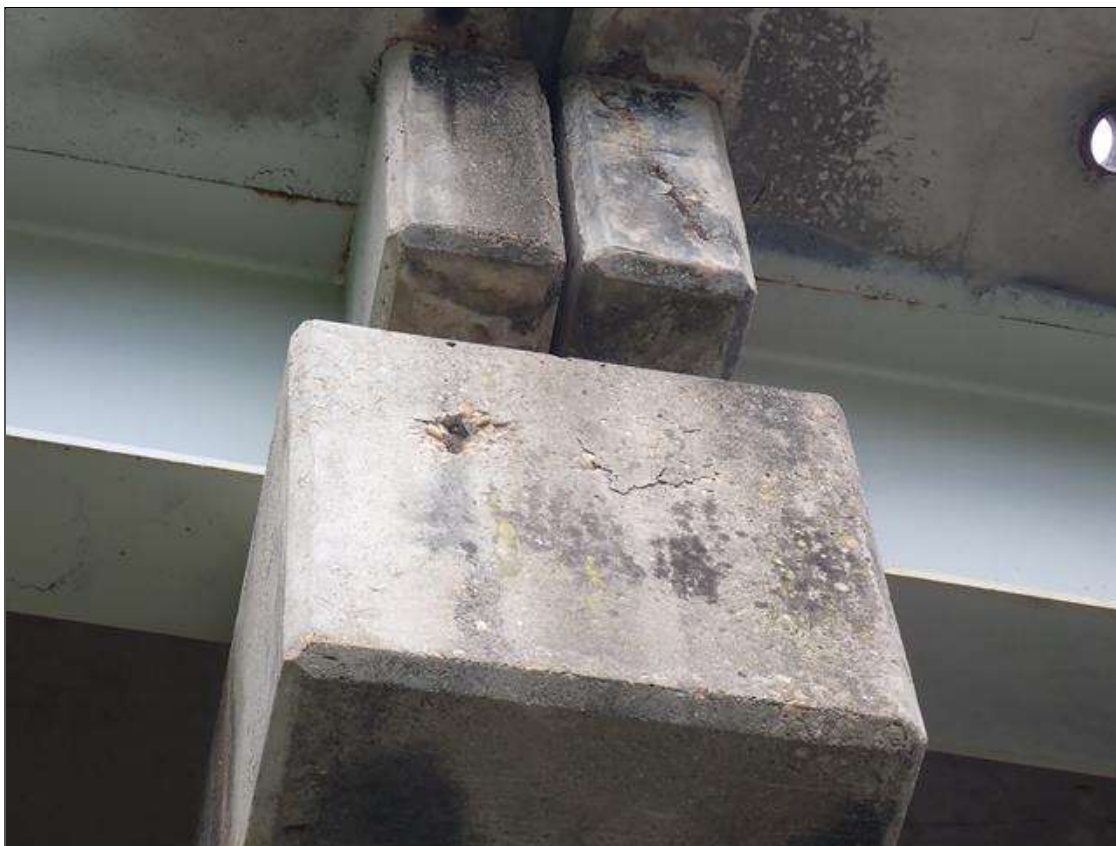
Bent 1 Cap 1: RIGHT END OF CAP HAS A SPALL AREA 5 INCH X 5 INCH X 3/4 INCH DEEP WITH REBAR EXPOSED AND 6 INCH DIAMETER DELAMINATION.

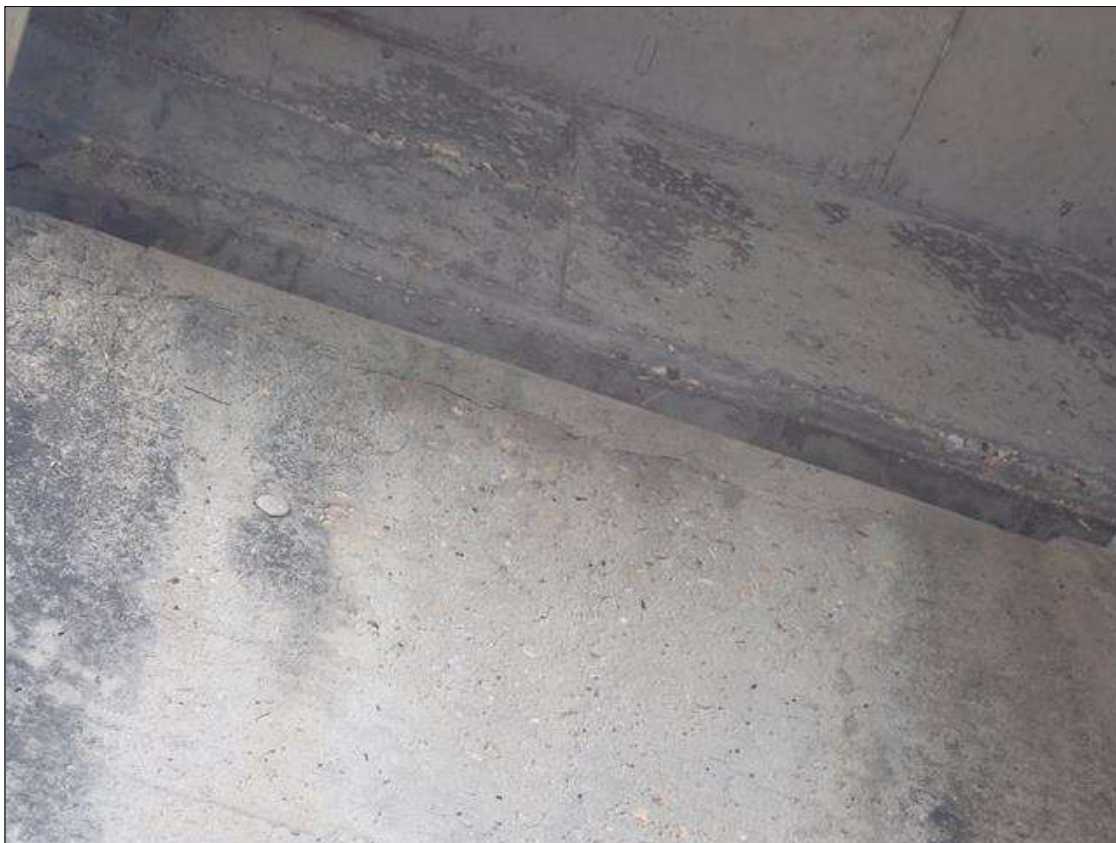
Bent 1 Cap 1: along the length of the cap, delaminations (up to 7 feet x 6 inch) with cracks (up to 1/16 inch)

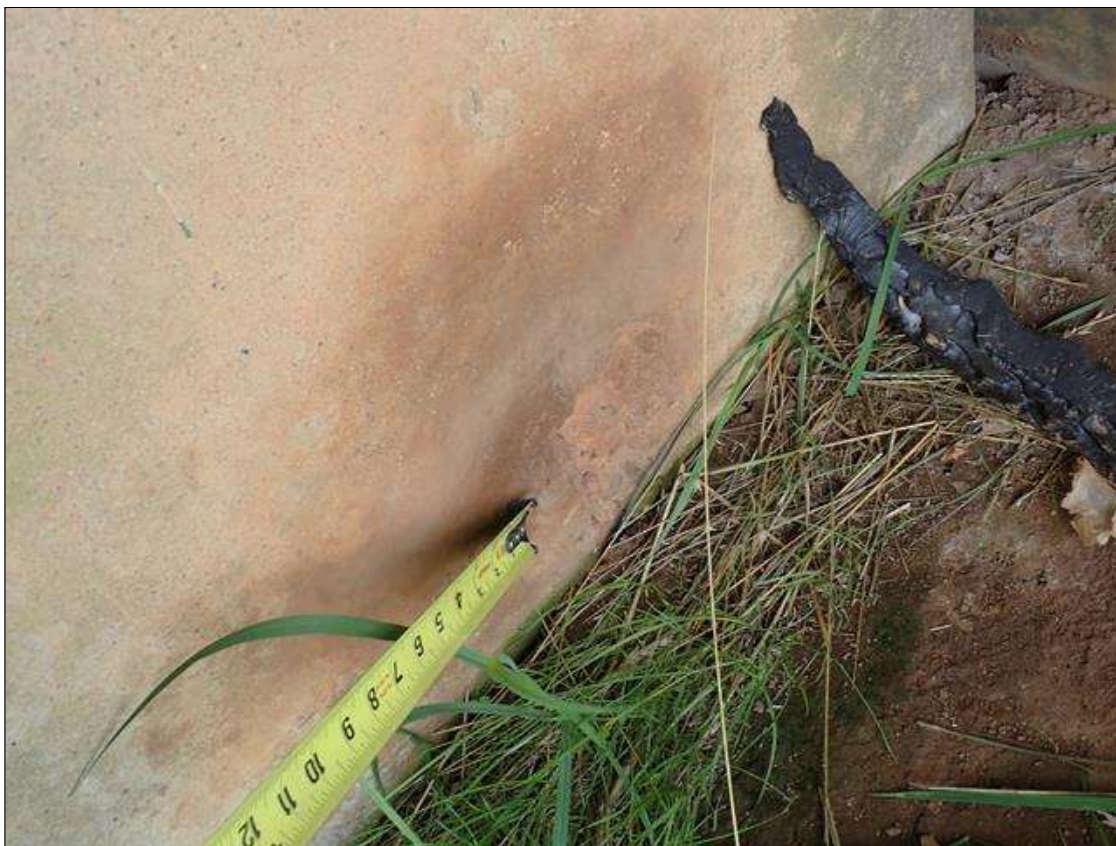
Bent 1 Pile 1: east face, at ground, spall (5 inch x 4 inch x 1 inch deep)

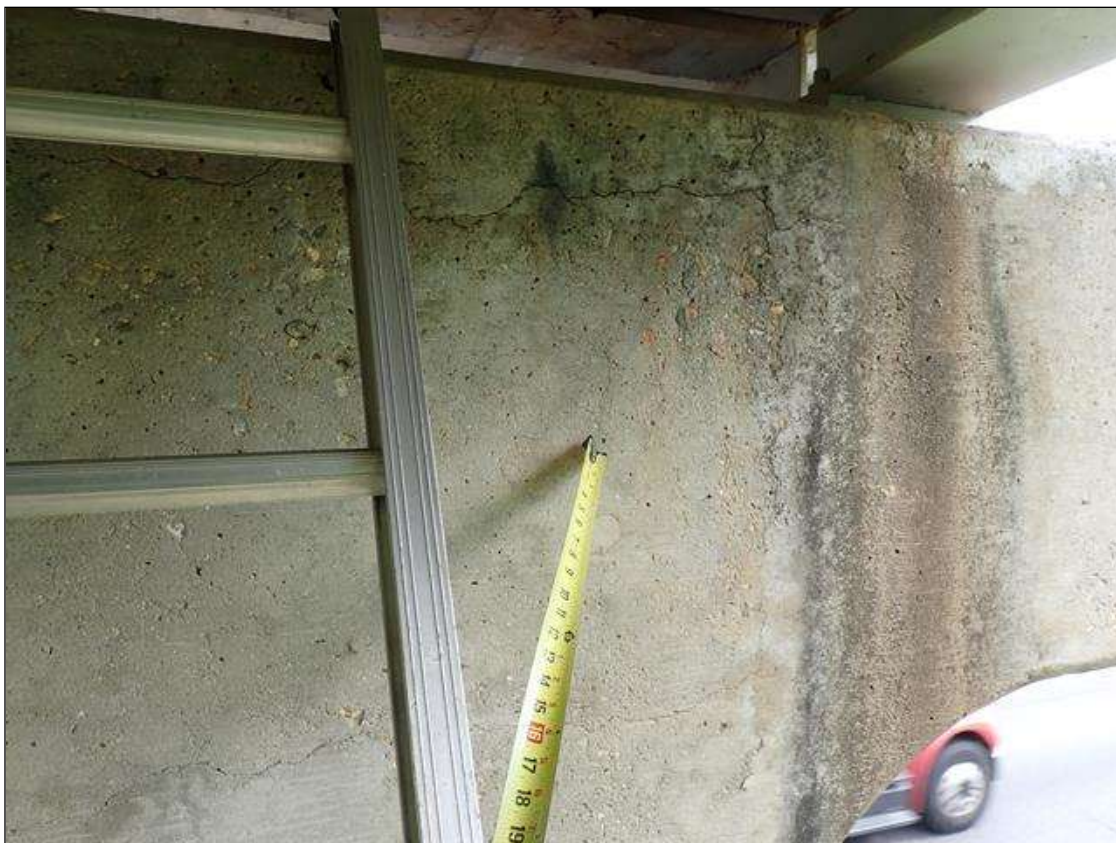
Bent 1 Cap 1: along the length of the cap, delaminations (up to 7 feet x 6 inch) with cracks (up to 1/16 inch)

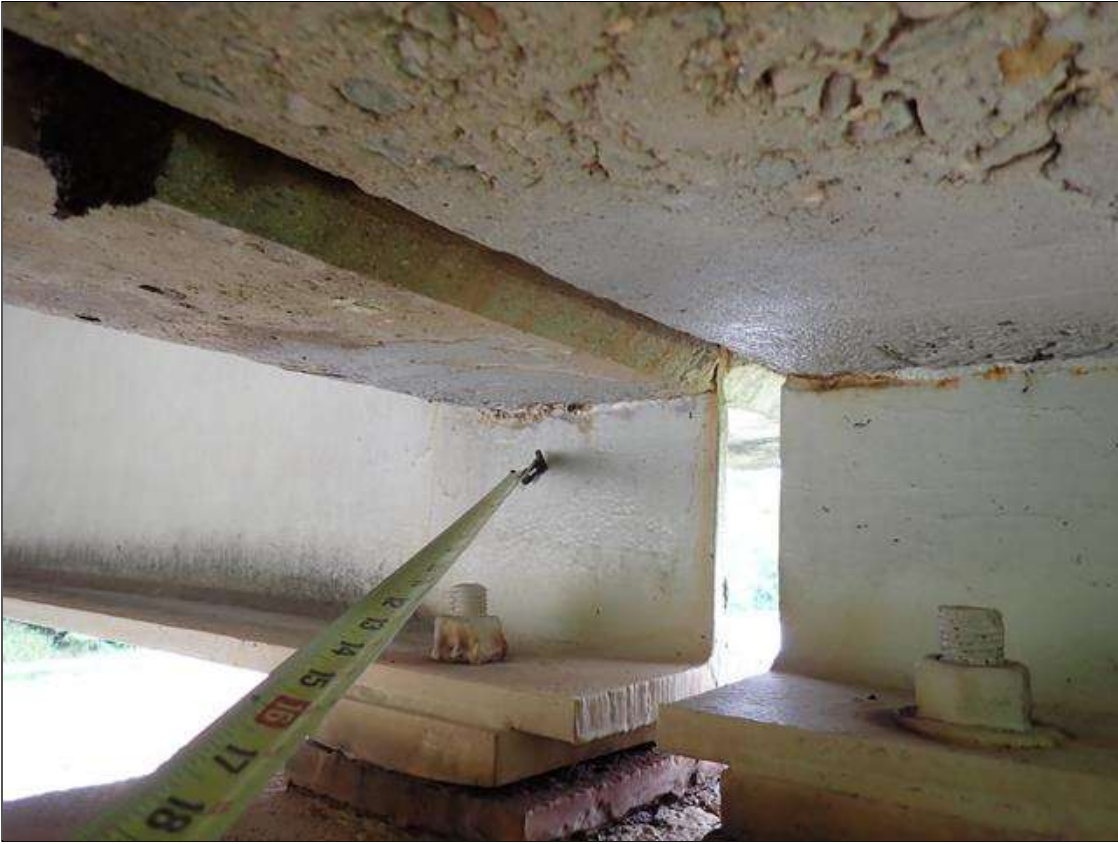
Span 2 Beam 4: at bent 1, web adjacent to diaphragm, painted over section loss (1/2 inch average remaining x 10 inch x 1 inch) with corrosion reinitiated

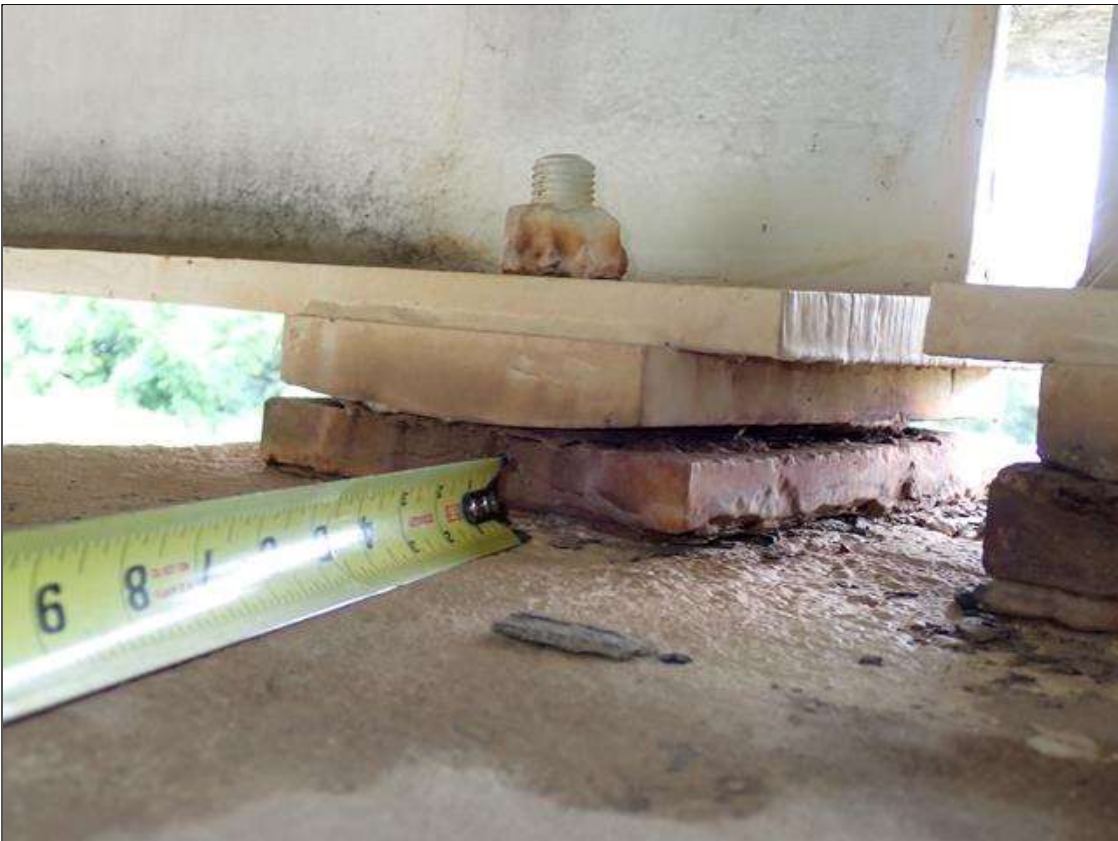
Span 2 Beam 4 - Near Bearing 4: painted over section loss (up to 1/8 inch deep) with corrosion reinitiated

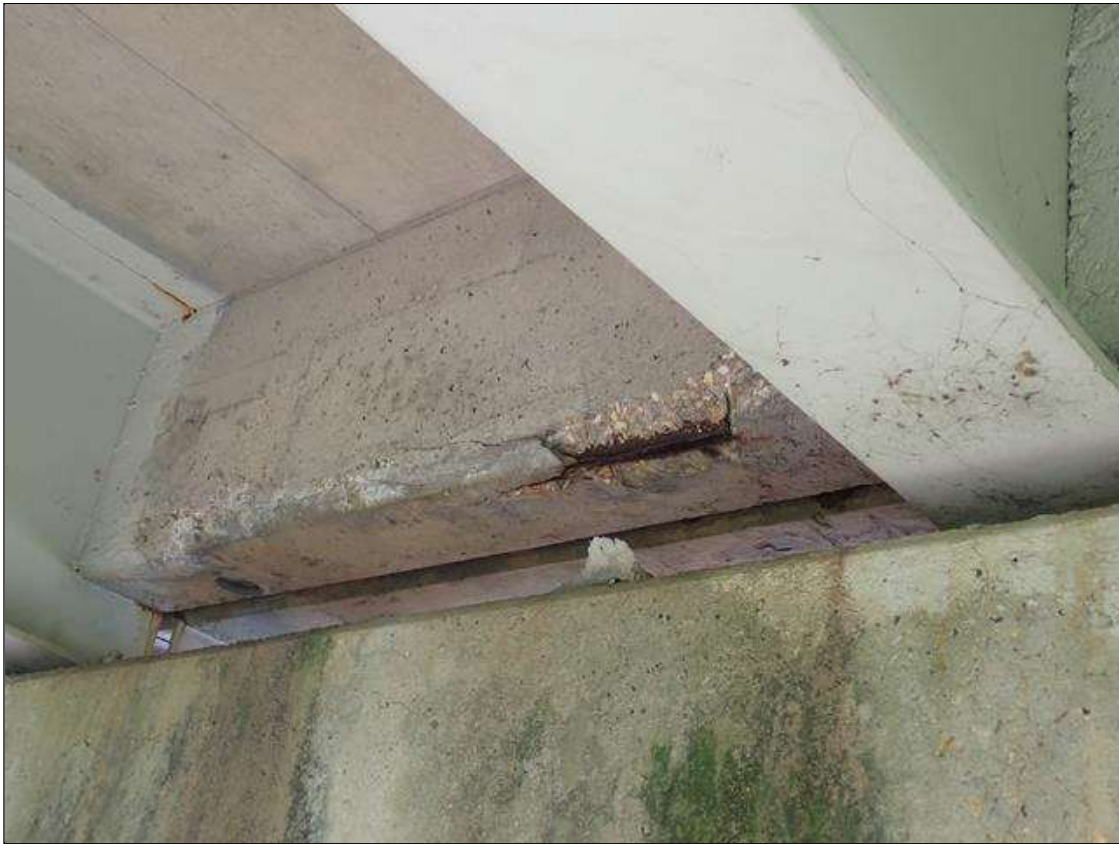
Span 1 Deck: at bent 1, end diaphragm in all bays, spalls/delaminations (up to full bay width x 6 inch wide x 15 inch deep) with exposed rusted rebar and associated cracks (up to 1/16 inch)

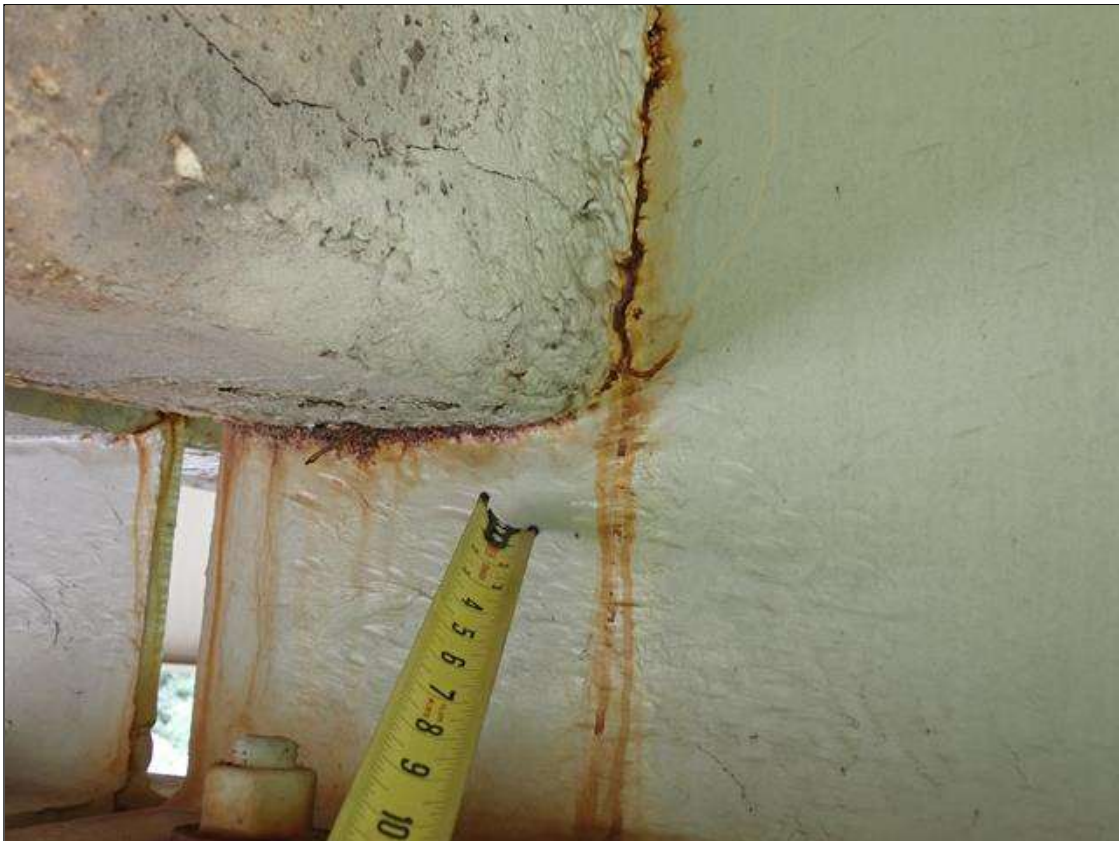
Span 1 Beam 2: at bent 1, web adjacent to diaphragm, painted over section loss (7/16 inch average remaining x 7 inch x 4 inch) with corrosion reinitiated

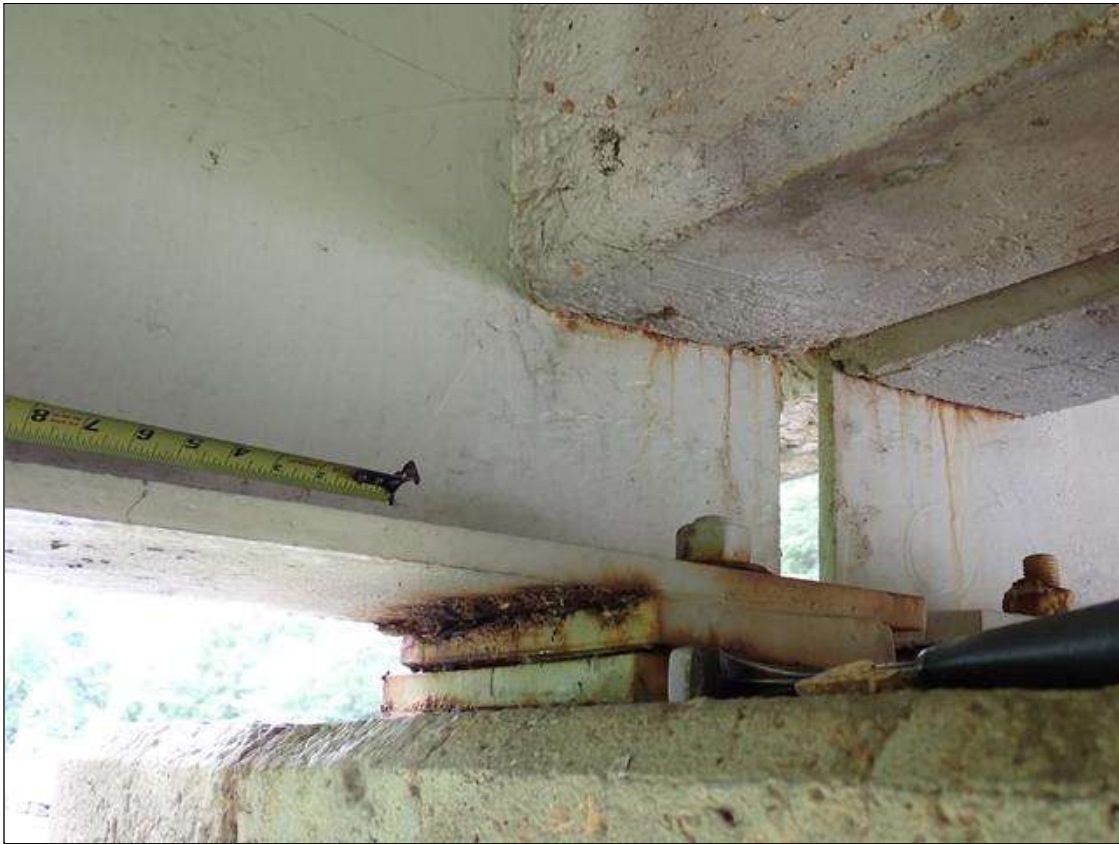
Span 1 Beam 1: at bent 1, web adjacent to diaphragm, painted over section loss (9/16 inch average remaining x 4 inch x 1 inch) with corrosion reinitiated; bottom flange, rust scale

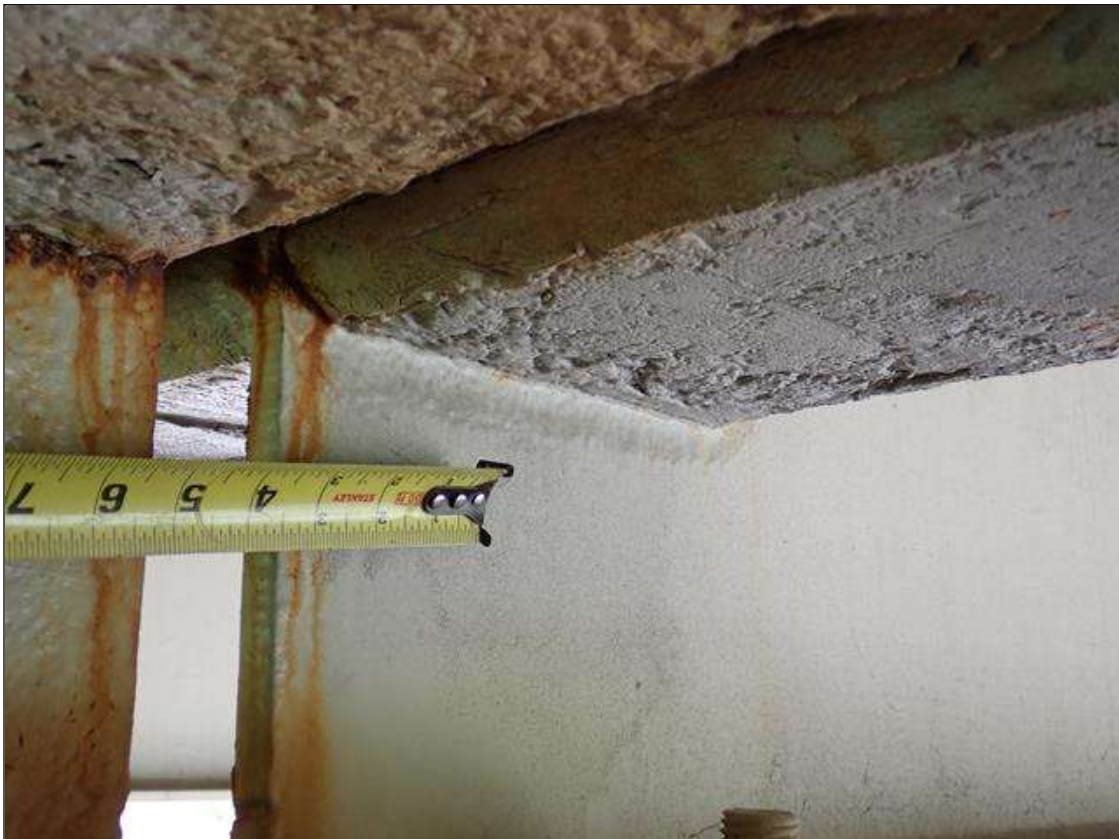
Span 2 Beam 2: (PAR) at bent 1, web adjacent to diaphragm, painted over section loss (3/8 inch average remaining x 10 inch x up to 2 inch) with corrosion reinitiated

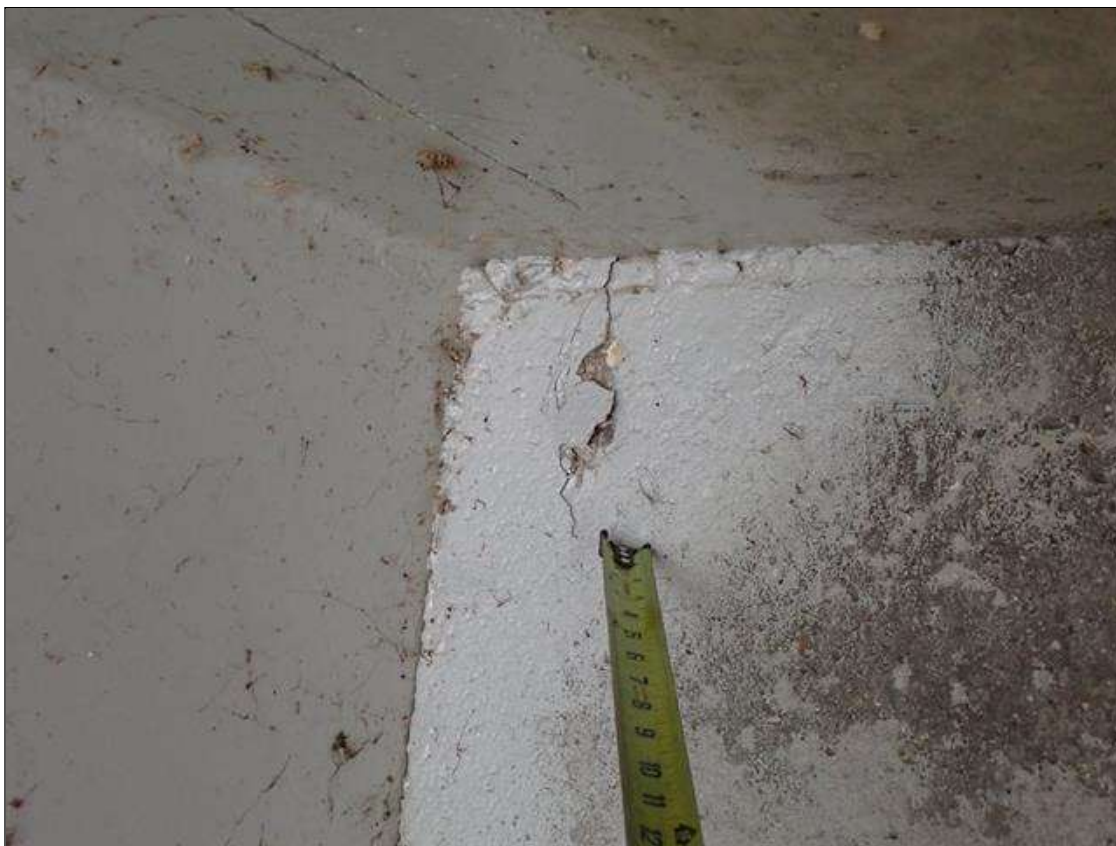
End Bent 1 Abutment: adjacent to all beams, delaminations/spalls [up to 2 feet x 13 inch x 1/2 inch deep]

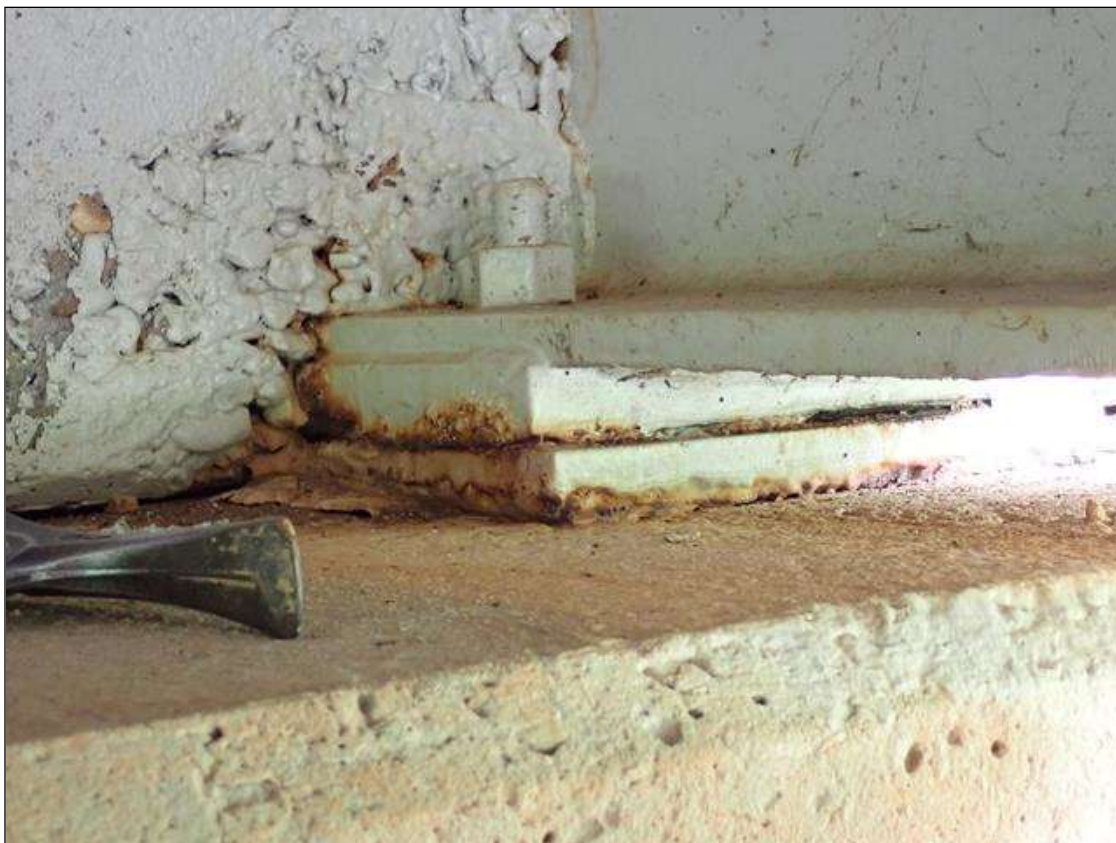
Span 1 Beam 1 - Near Bearing 1: painted over section loss (up to 3/16 inch deep) with corrosion reinitiated

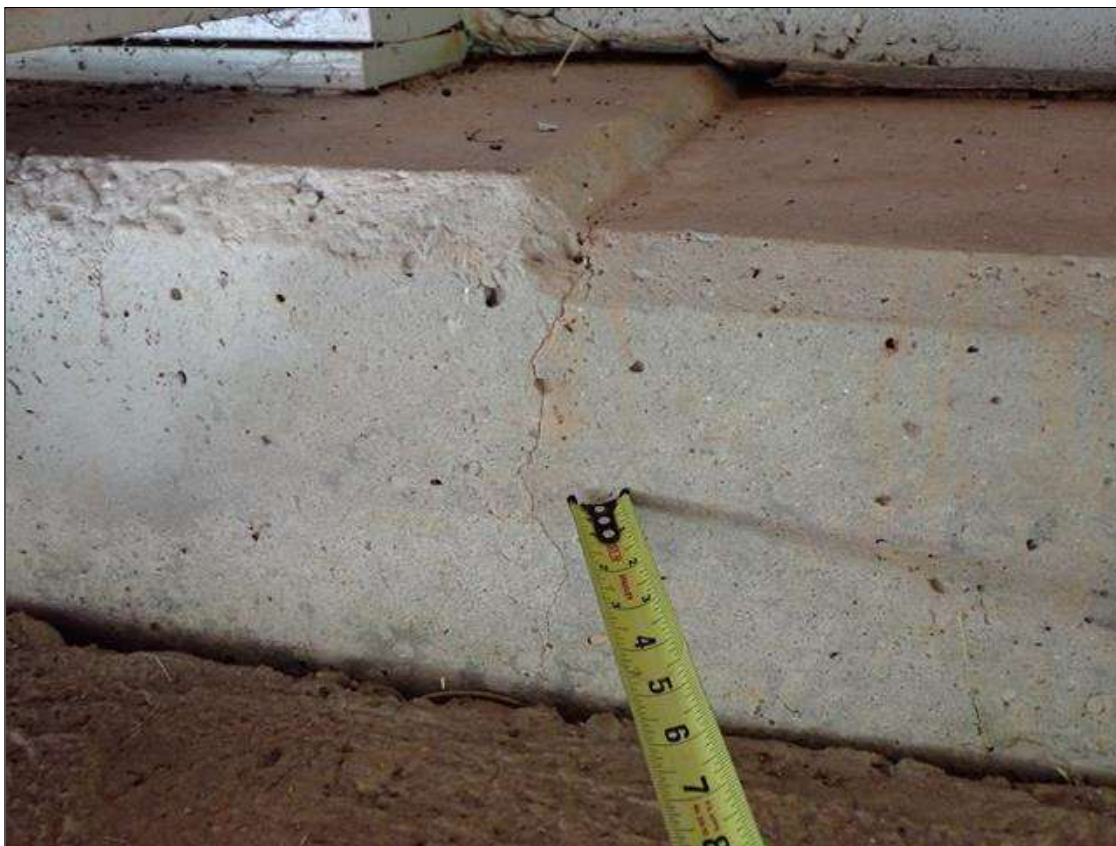
End Bent 1 Cap 1: along length, multiple vertical cracks [up to full height x 1/32 inch]
