NC DEPARTMENT OF TRANSPORTATION  
 DIVISION OF HIGHWAYS  
 STRUCTURE MANAGEMENT UNIT

ATTENTION: prompt action request, sketches revised, vertical clearances revised

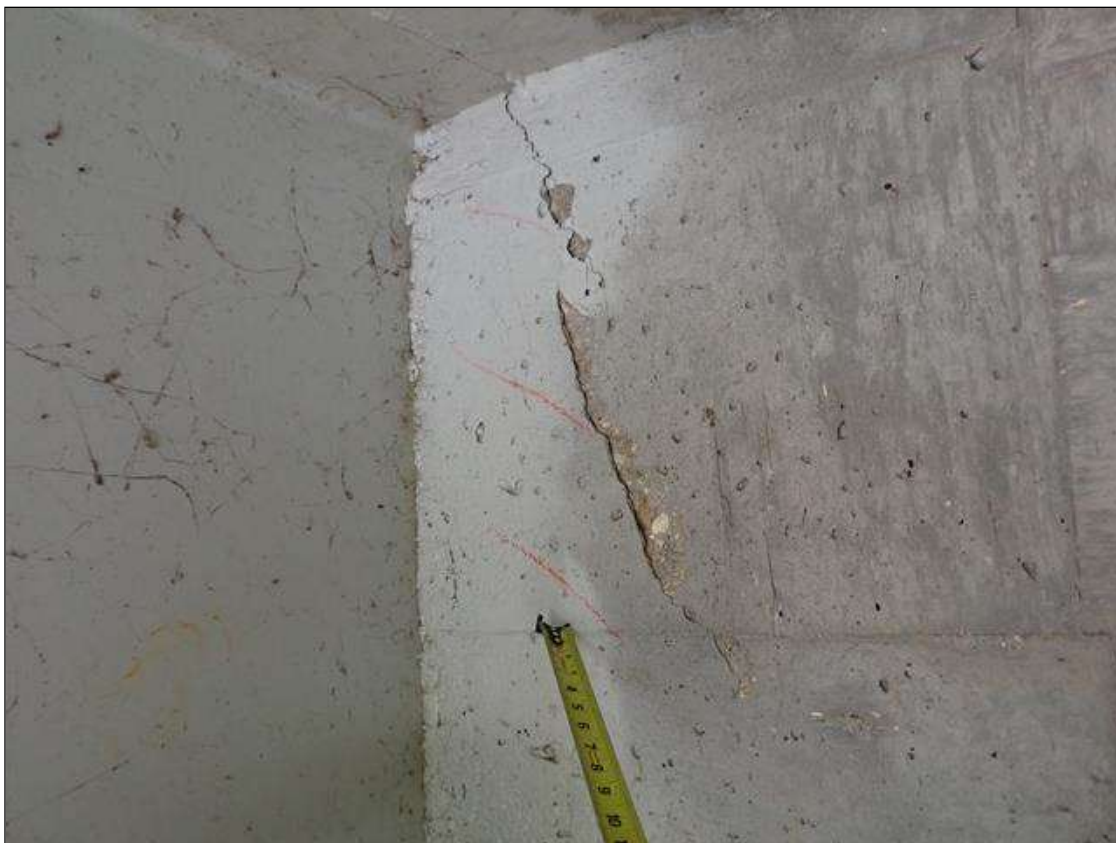
End Bent 1 Abutment: adjacent to all beams, delaminations/spalls [up to 2 feet x 13 inch x 1/2 inch deep]

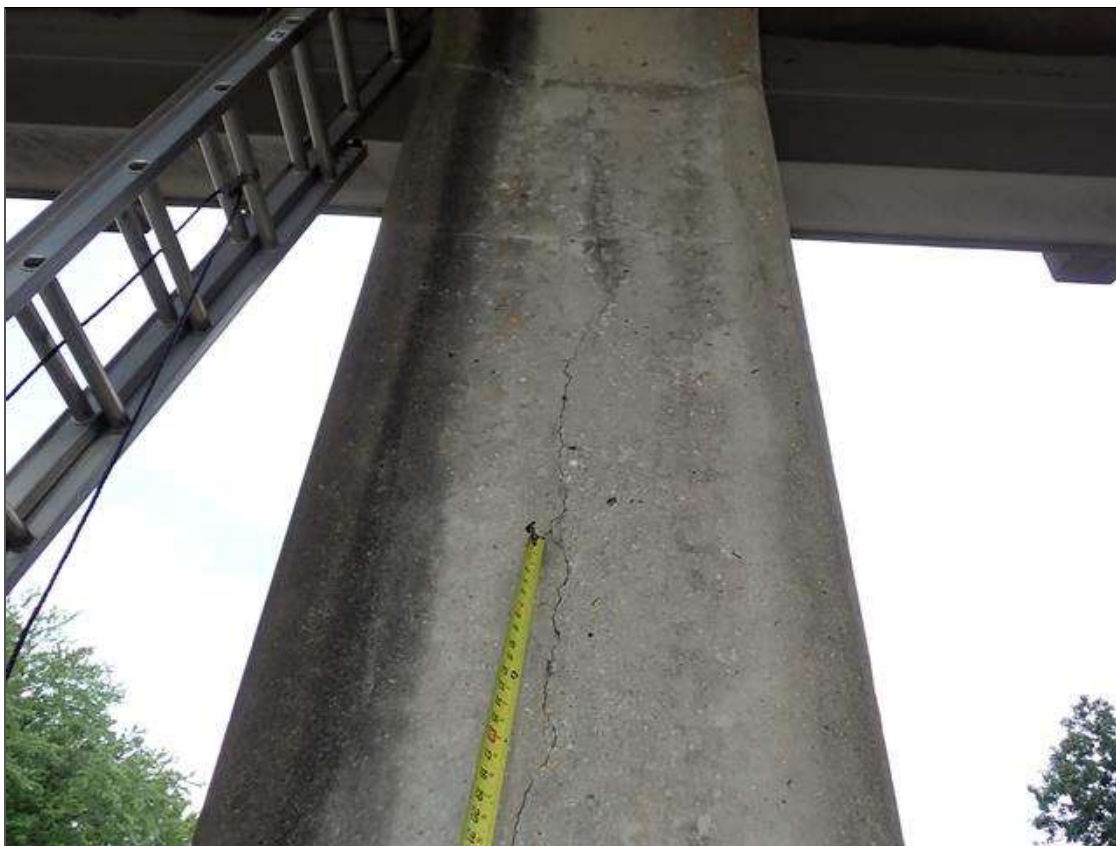
Bent 2 Pile 1: UP TO 11 FOOT X UP TO 1/16 INCH VERTICAL CRACKS ON EAST AND WEST FACES.

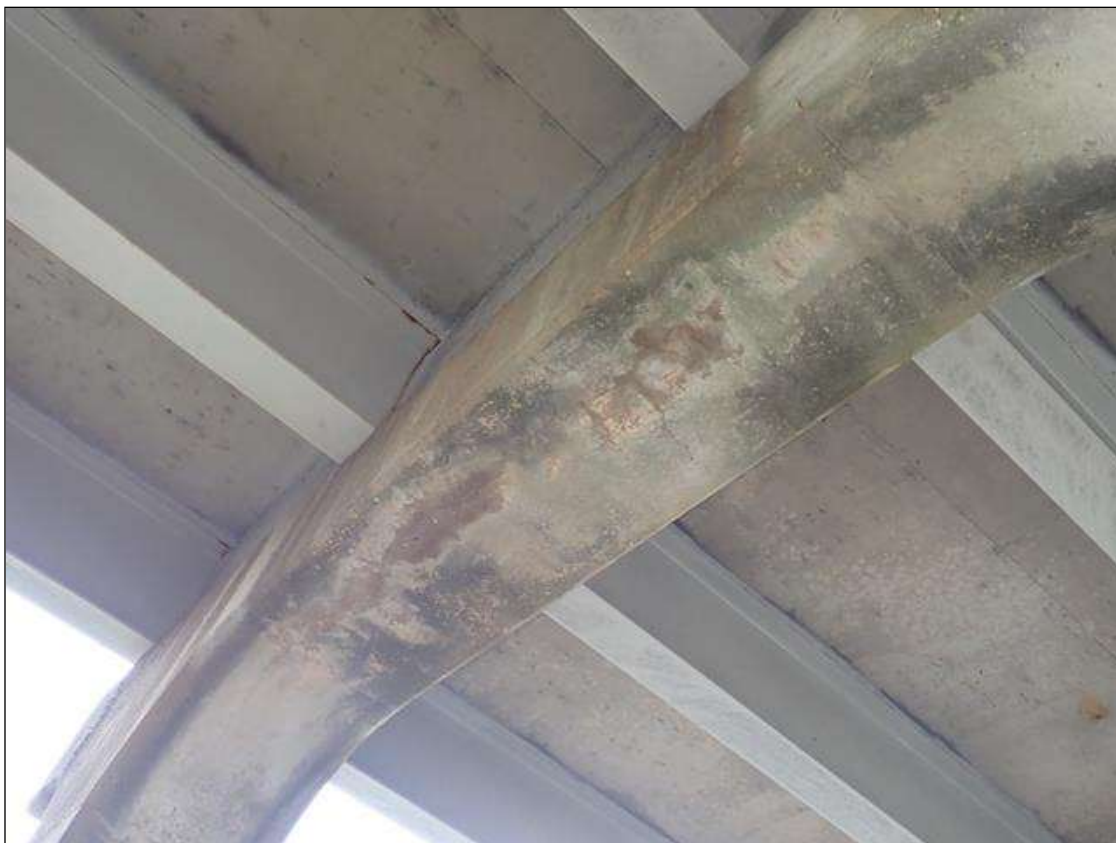
Bent 2 Cap 1: south and north faces, and underside, delaminations (up to 5 feet x 6 inch) with associated longitudinal cracks (up to 1/16 inch); areas of map cracks (hairline) at random

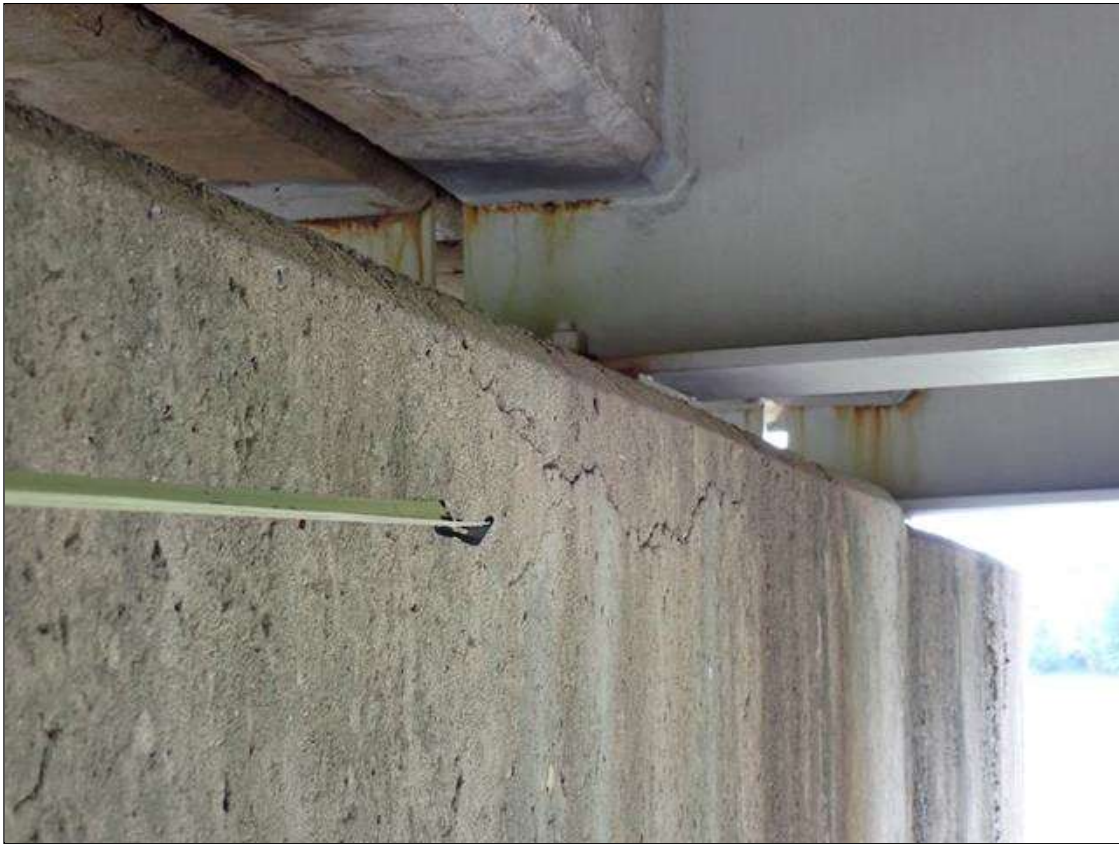
Bent 2 Cap 1: south and north faces, and underside, delaminations (up to 5 feet x 6 inch) with associated longitudinal cracks (up to 1/16 inch); areas of map cracks (hairline) at random

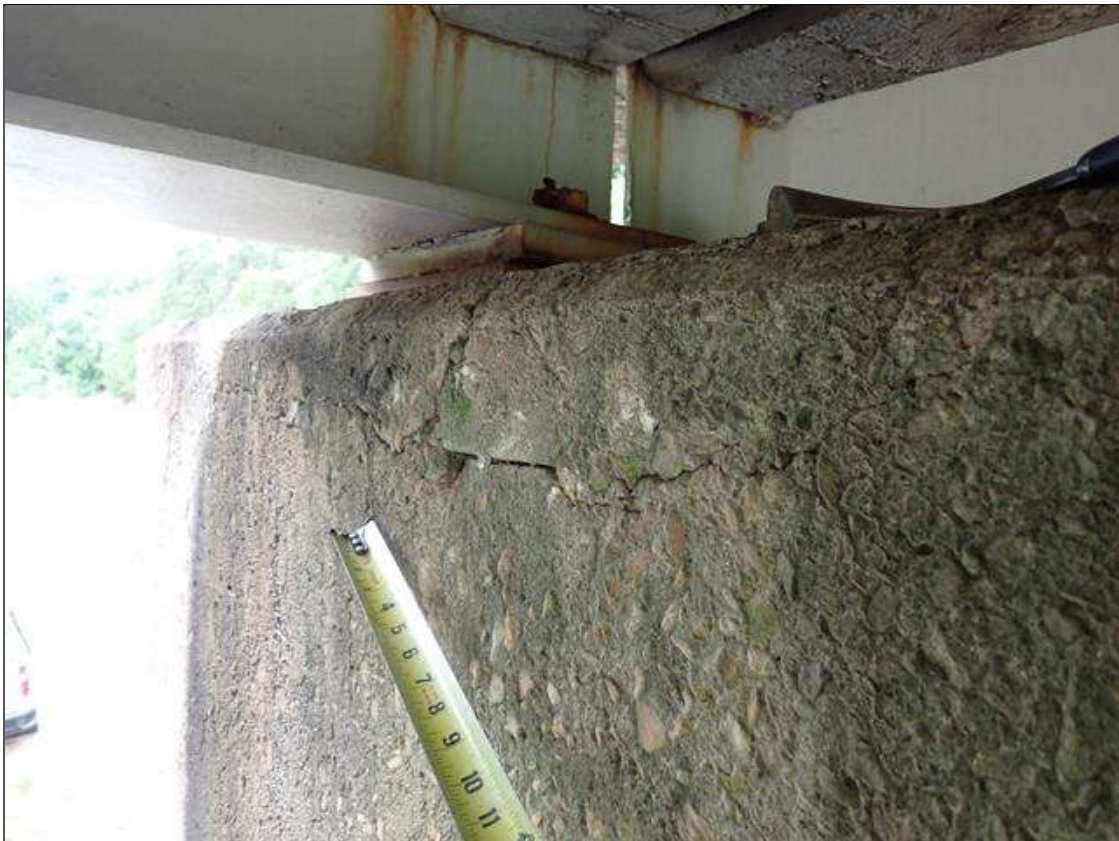
Bent 2 Cap 1: south and north faces, and underside, delaminations (up to 5 feet x 6 inch) with associated longitudinal cracks (up to 1/16 inch); areas of map cracks (hairline) at random

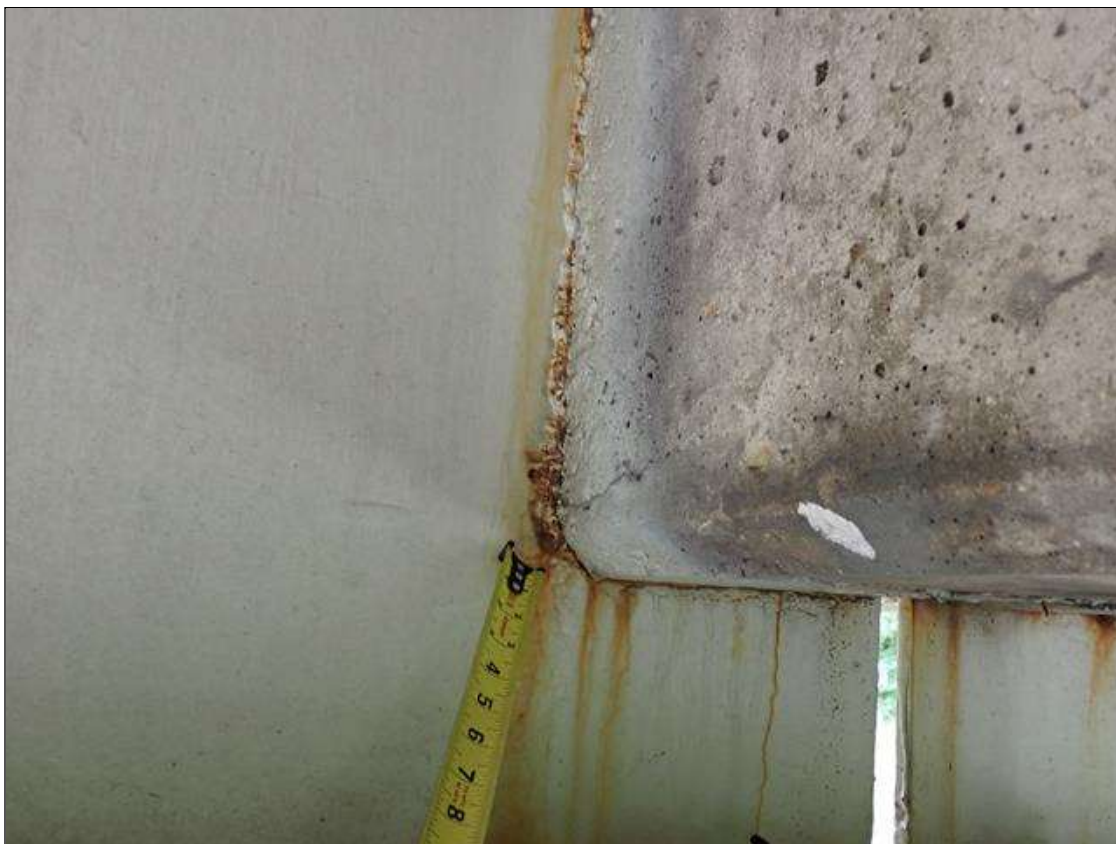
Span 2 Beam 1: at bent 2, web adjacent to diaphragm, painted over section loss (1/2 inch average remaining x 1 inch x 6 inch) with corrosion reinitiated

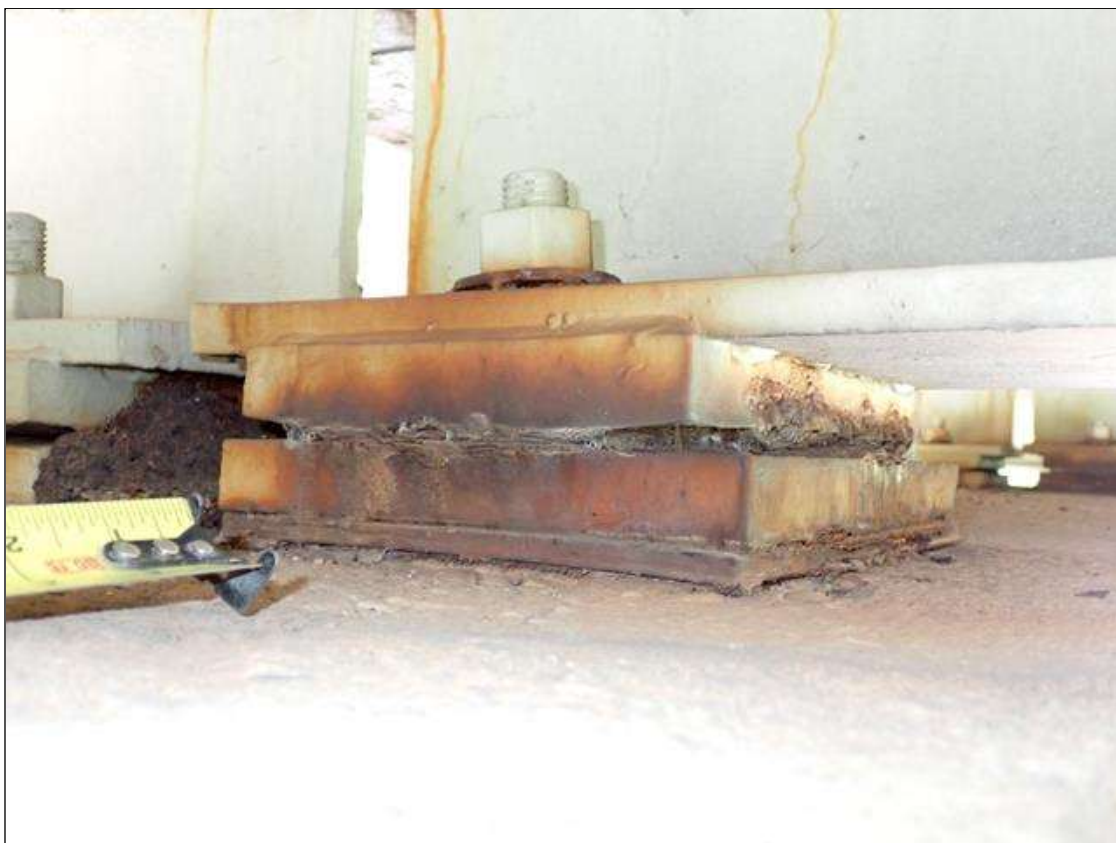
Span 2 Beam 2 - Far Bearing 2: RUST SCALE/PACK RUST ON THE BEARING PLATE.

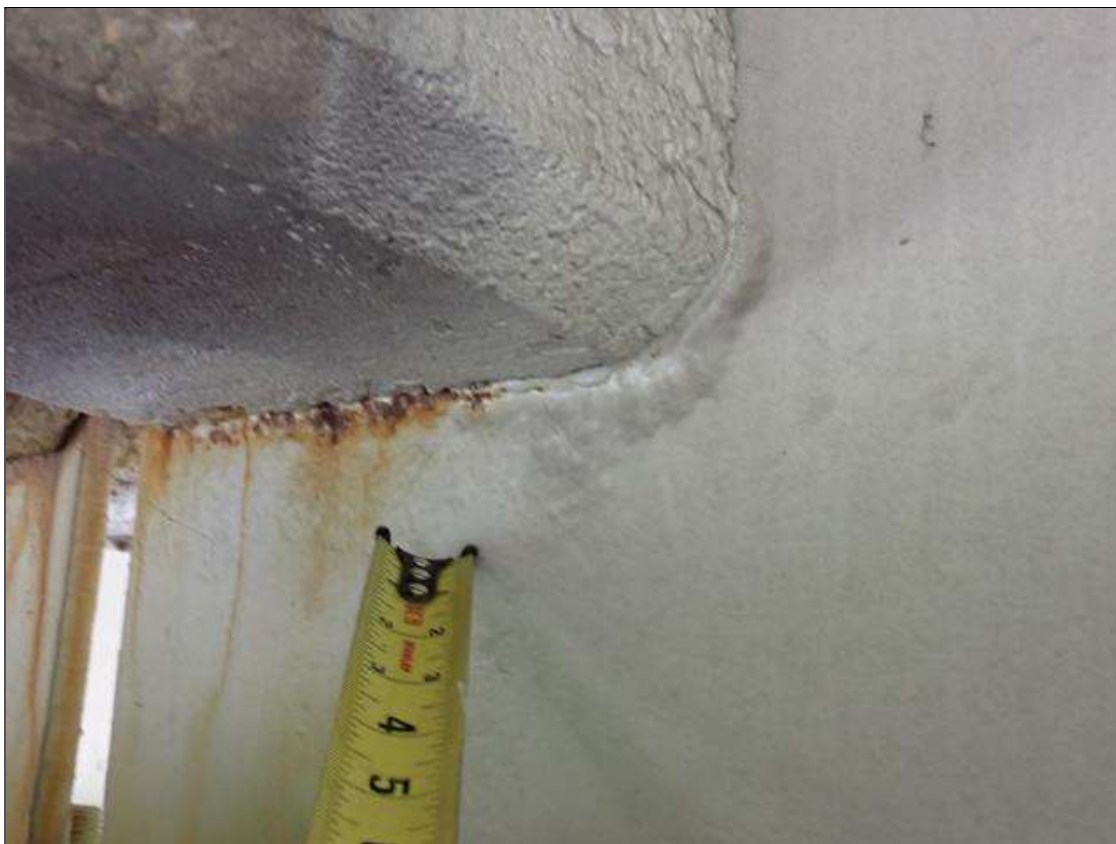
Span 2 Beam 3: at bent 2, web adjacent to diaphragm, painted over section loss (7/16 inch average remaining x 7 inch x 1.5 inch) with corrosion reinitiated

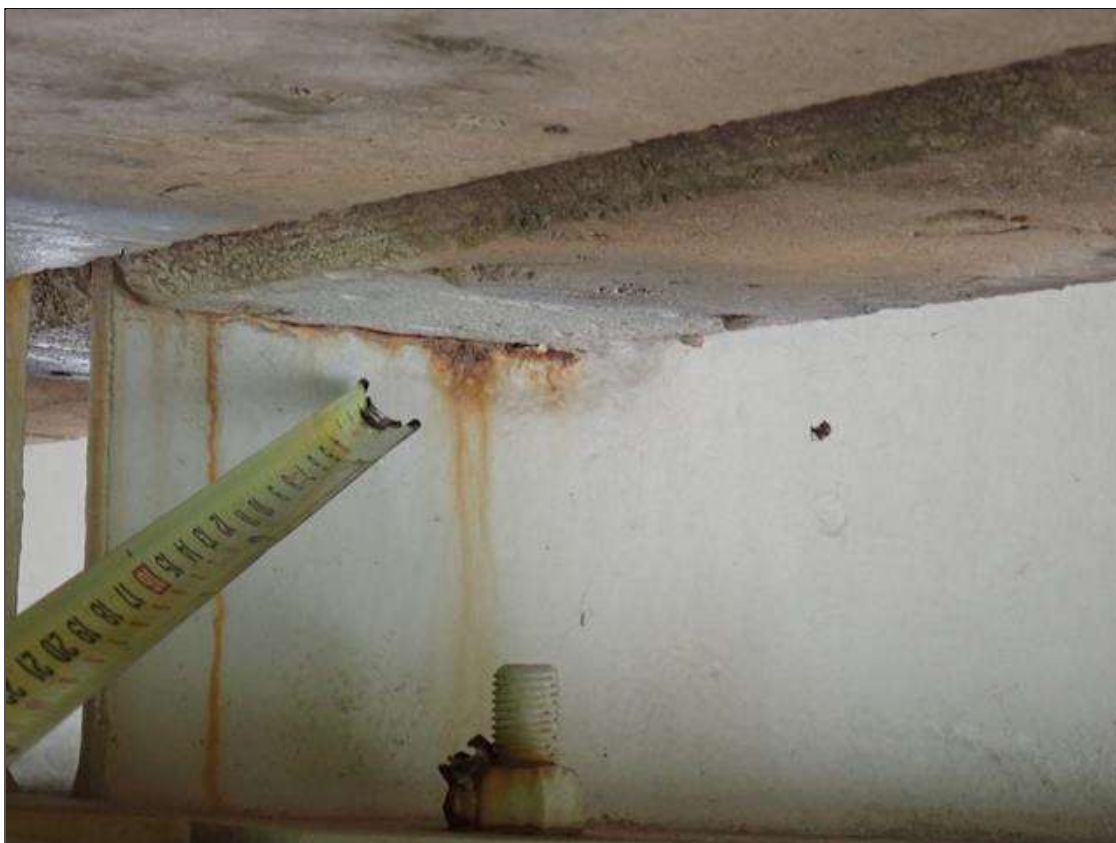
Span 3 Beam 3: (PAR) at bent 2, web adjacent to diaphragm, painted over section loss (3/8 inch average remaining x 10 inch x 1 inch) with corrosion reinitiated

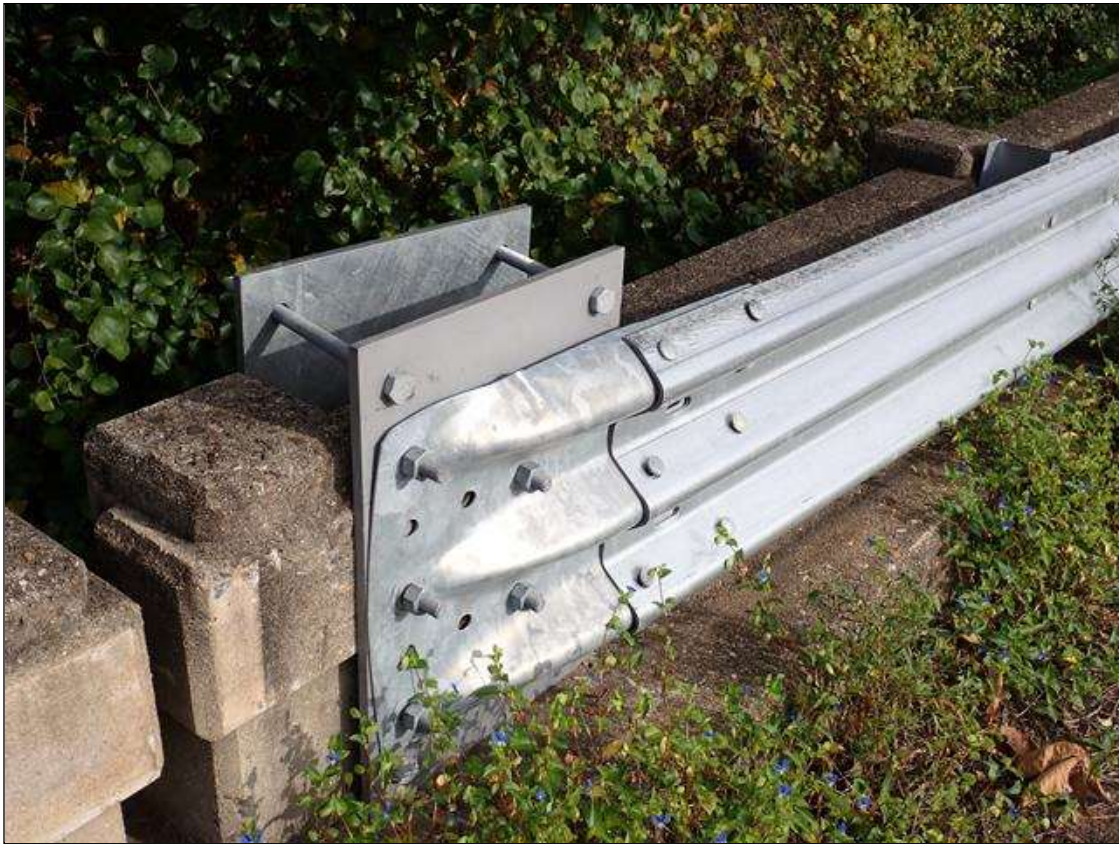
(PAR) northwest guardrail attachment, (2) bolts missing

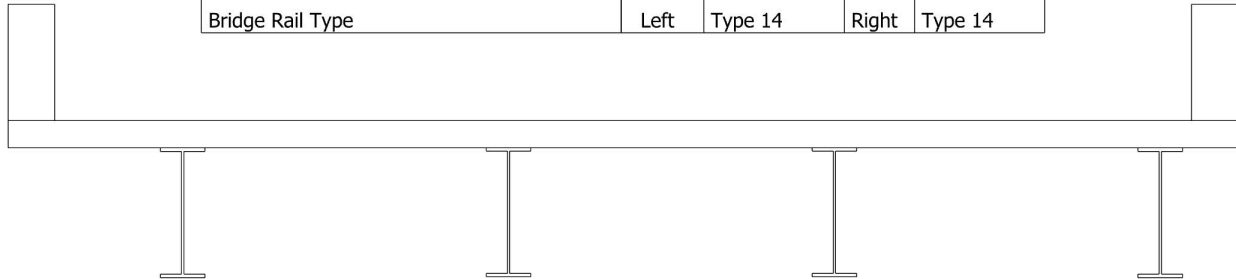
Measurements for Span #	1-4		
Deck Thickness	7in	Left Overhang	3.625ft
Top of Rail to Bottom of Beam (Avg)	5.875ft	Right Overhang	3.625ft
