NC DEPARTMENT OF TRANSPORTATION  
 DIVISION OF HIGHWAYS  
 STRUCTURE MANAGEMENT UNIT

ATTENTION: prompt action request, sketches revised, clearances revised; span 2 beams heat straightened and repainted since previous inspection

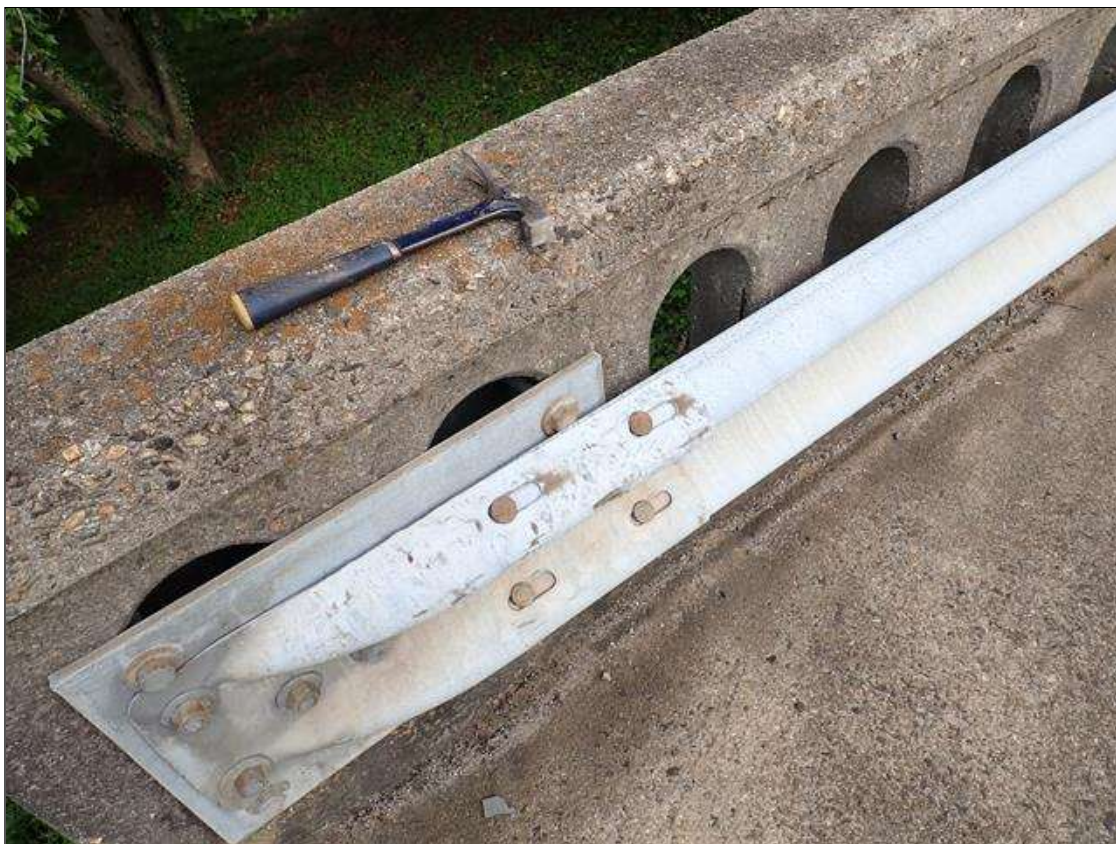
(PAR) northwest guardrail attachment, improper lap

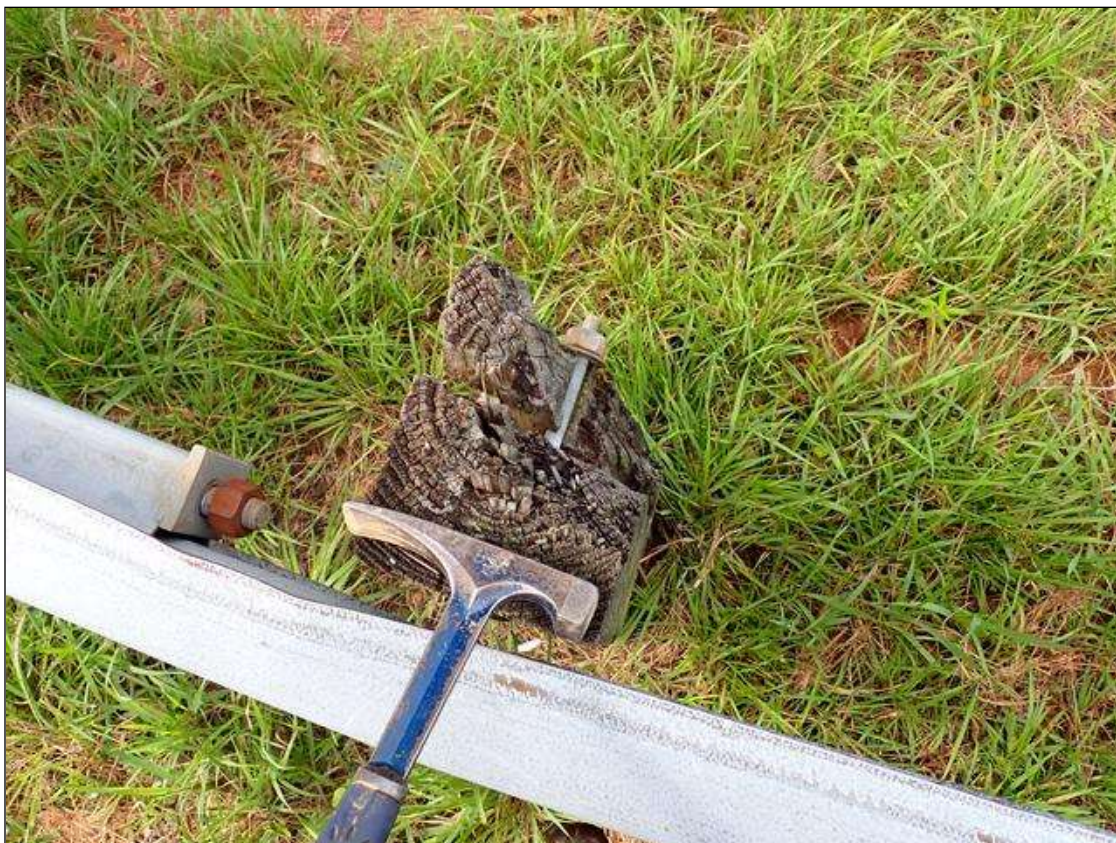
(PAR) northeast guardrail, near termination, area of impact damage (6 feet long); multiple decayed posts (up to 75 percent section loss) and twisted spacer blocks

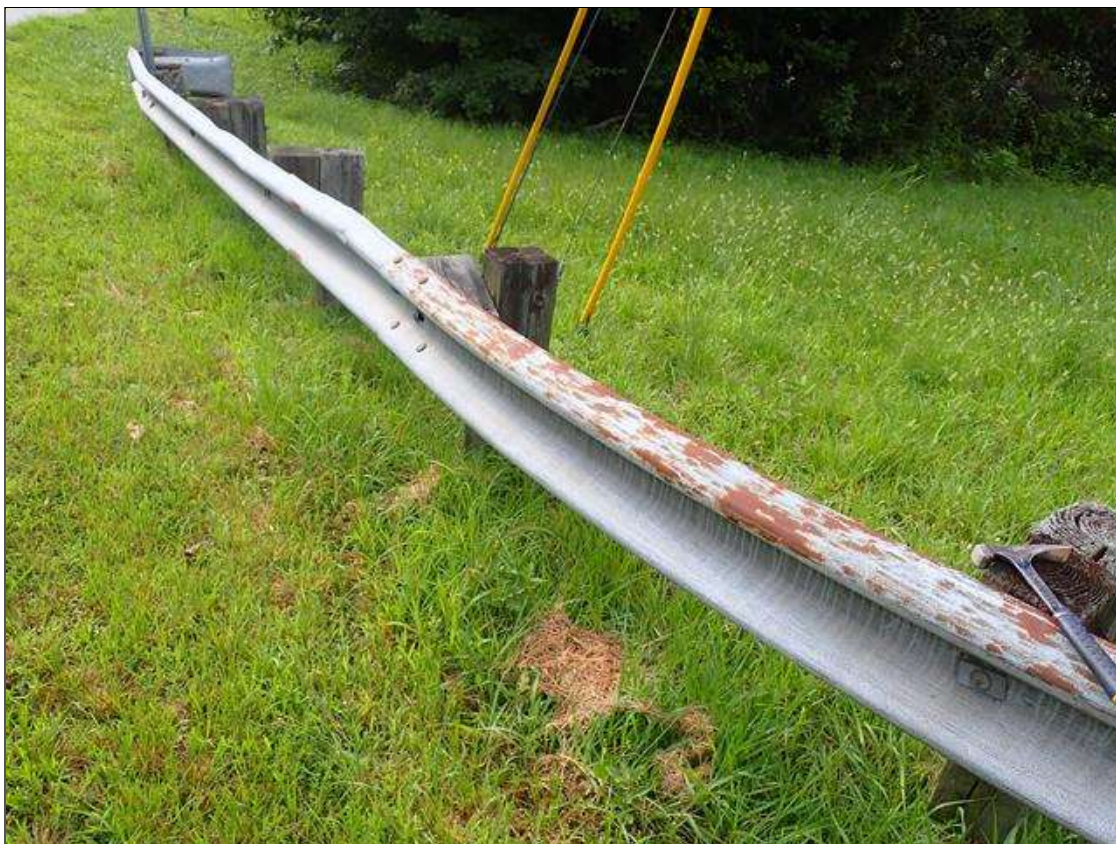
(PAR) northeast guardrail, near termination, area of impact damage (6 feet long); multiple decayed posts (up to 75 percent section loss) and twisted spacer blocks

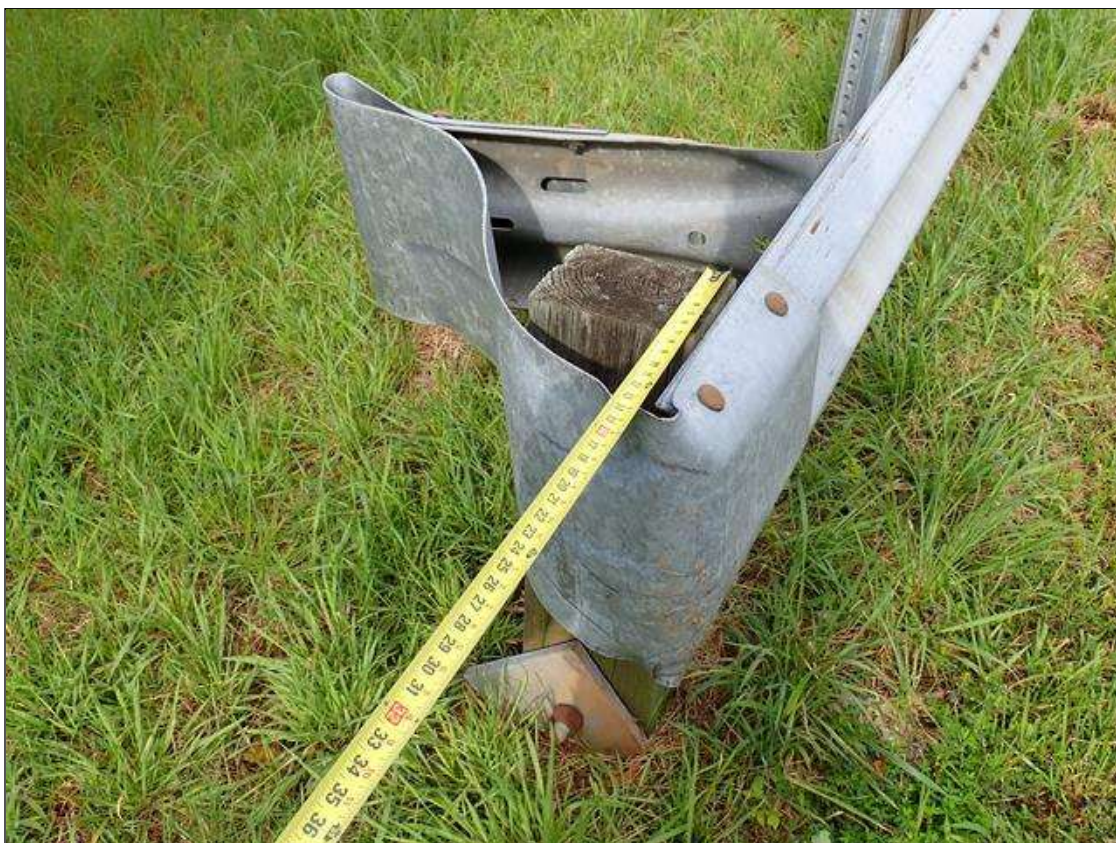
(PAR) northeast guardrail termination, impact damage (1 foot)

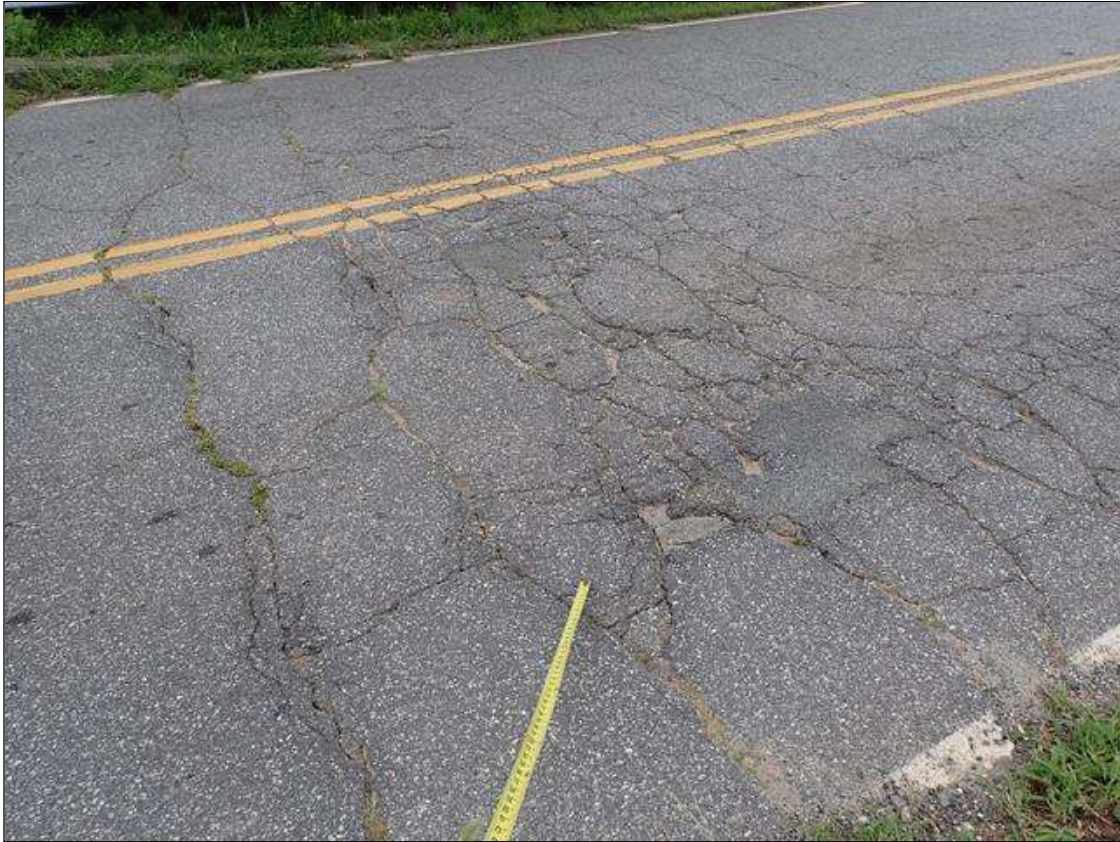
south and north approach asphalt, broken asphalt with cracks (up to 1 inch wide) and spalls (up to 8 inch diameter x 1.5 inch deep); settled (up to 1 inch) in relation to bridge

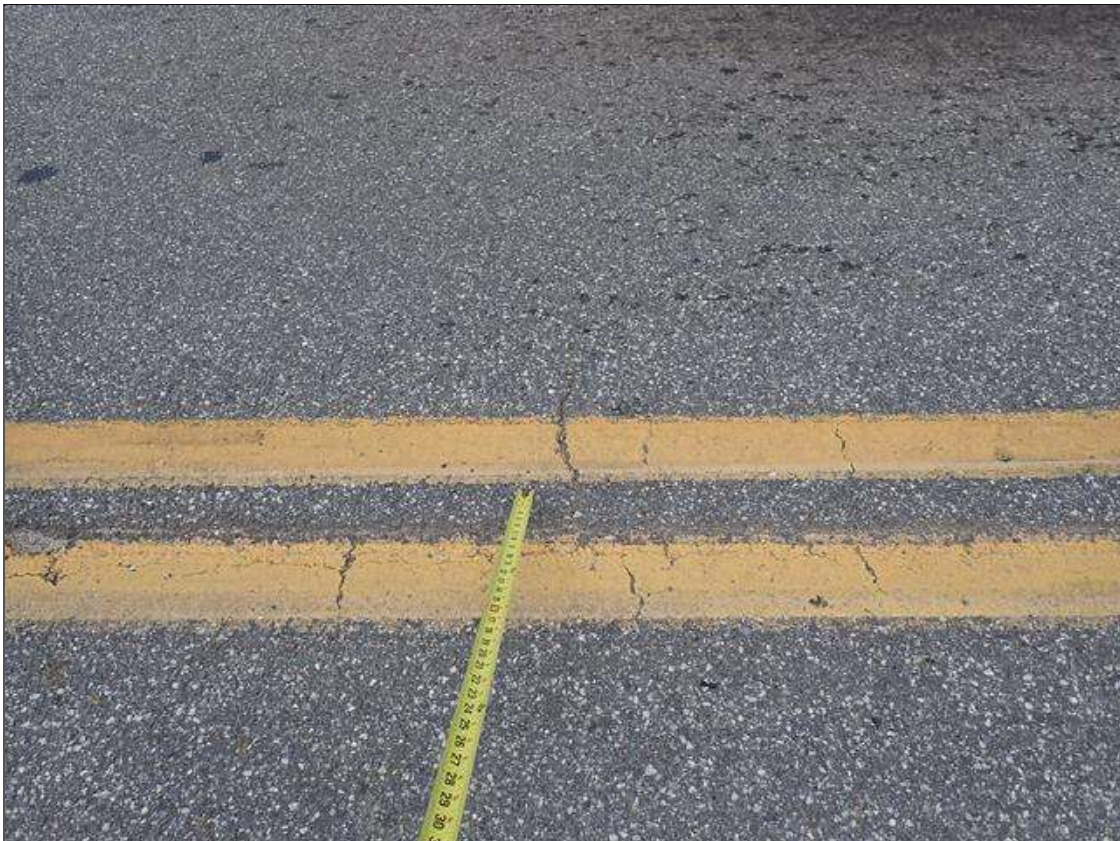
Span 4 Wearing Surface: SPAN 4 WEARING SURFACE HAS SCATTERED TRANSVERSE AND LONGITUDINAL CRACKS [up to 5 feet x UP TO 1/4 INCH]

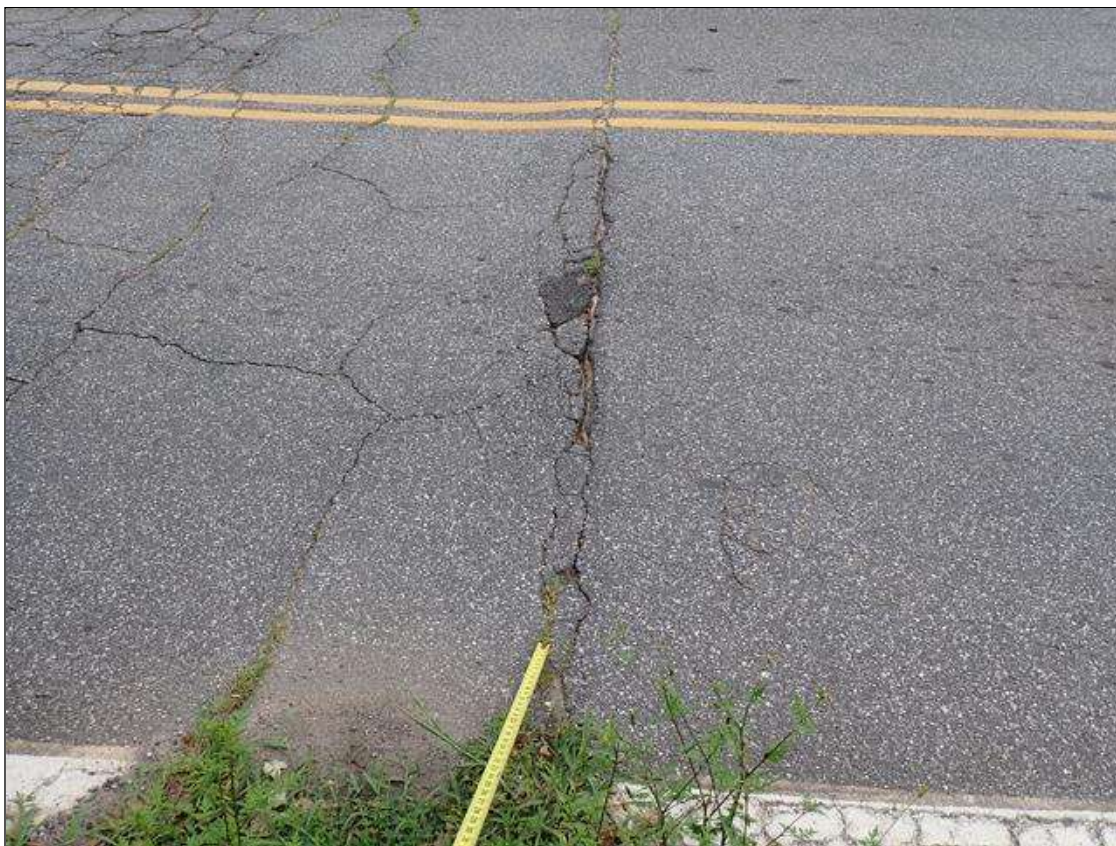
Span 4 Wearing Surface: over end bent 2, transverse crack (up to 1 inch wide x full width of roadway) with edge spalls (up to 3 inch wide x 1.5 inch deep) and vegetation

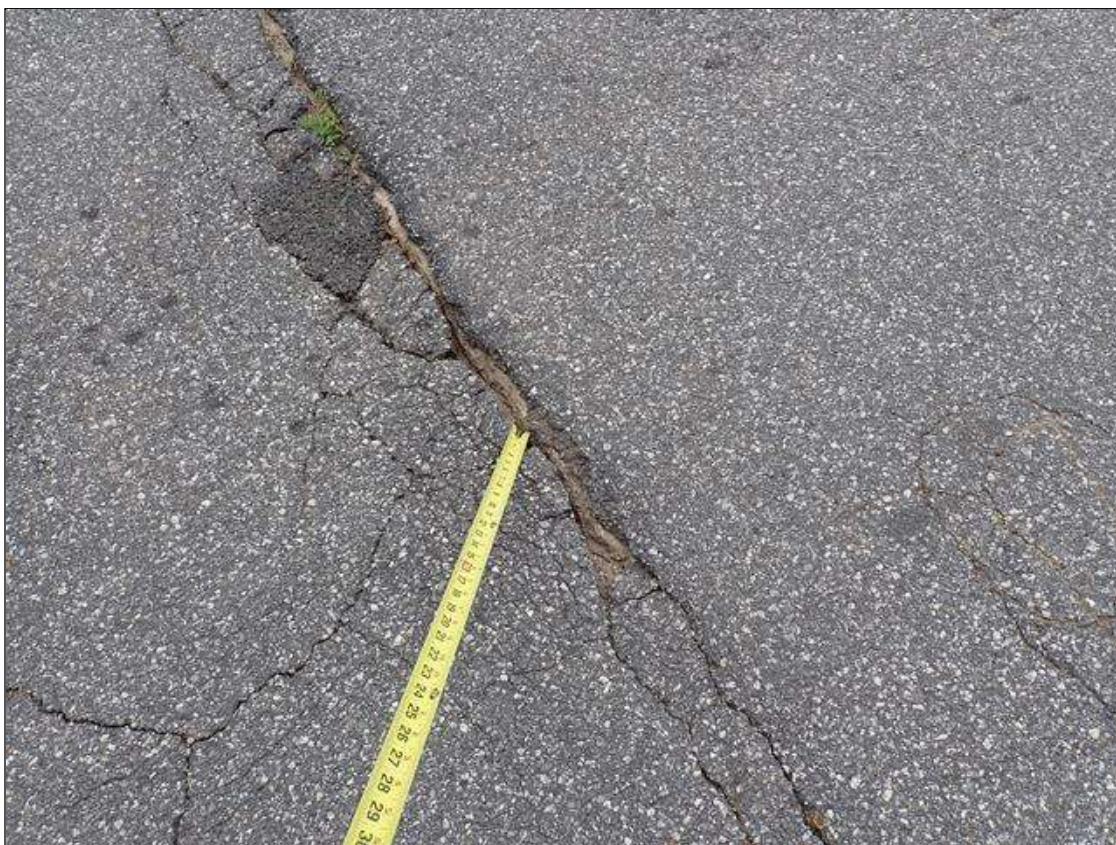
Span 4 Deck: top of deck, at end bent 2, at areas of missing wearing surface, edge spalls (up to 1.5 feet x 2 inch x 1 inch deep)

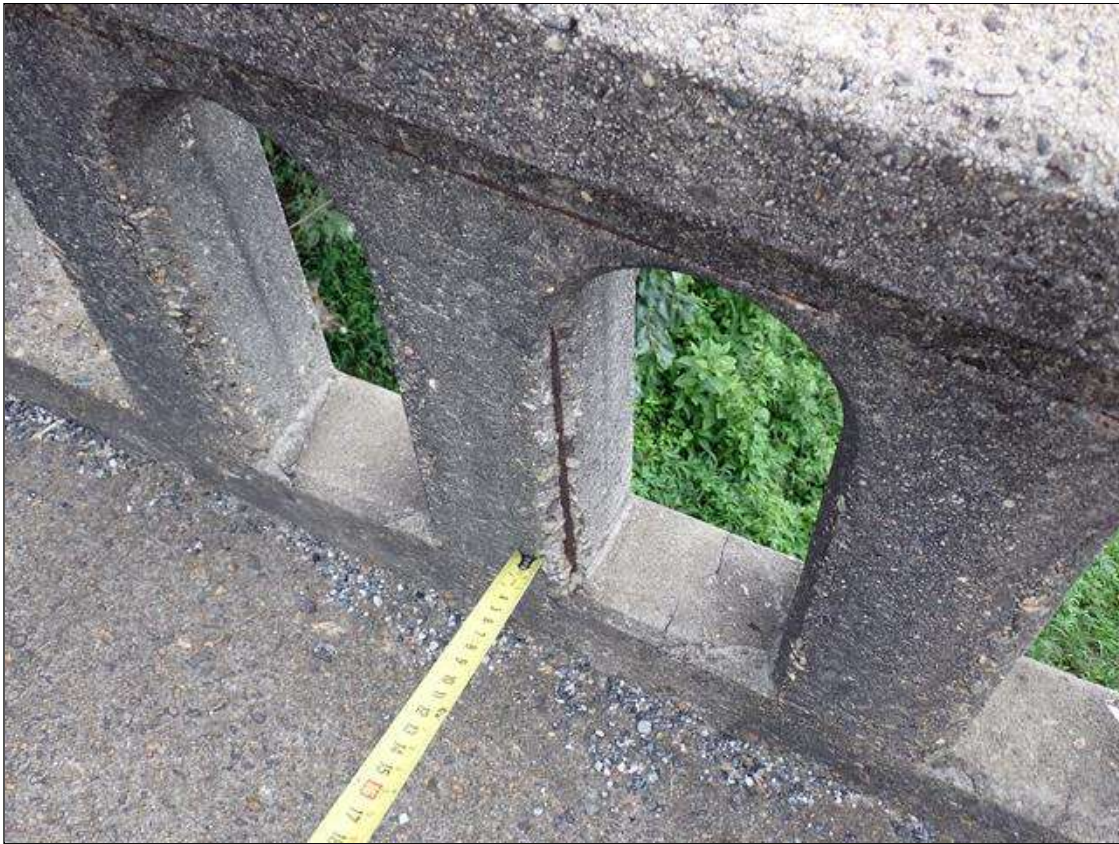
Span 4 Right Bridge Rail: RIGHT RAIL HAS SCATTERED AREAS THAT ARE CRACK/SPALL [up to 18 inch x 2 inch x 1 inch deep] AND DELAMINATED WITH REBAR EXPOSED [no section loss]

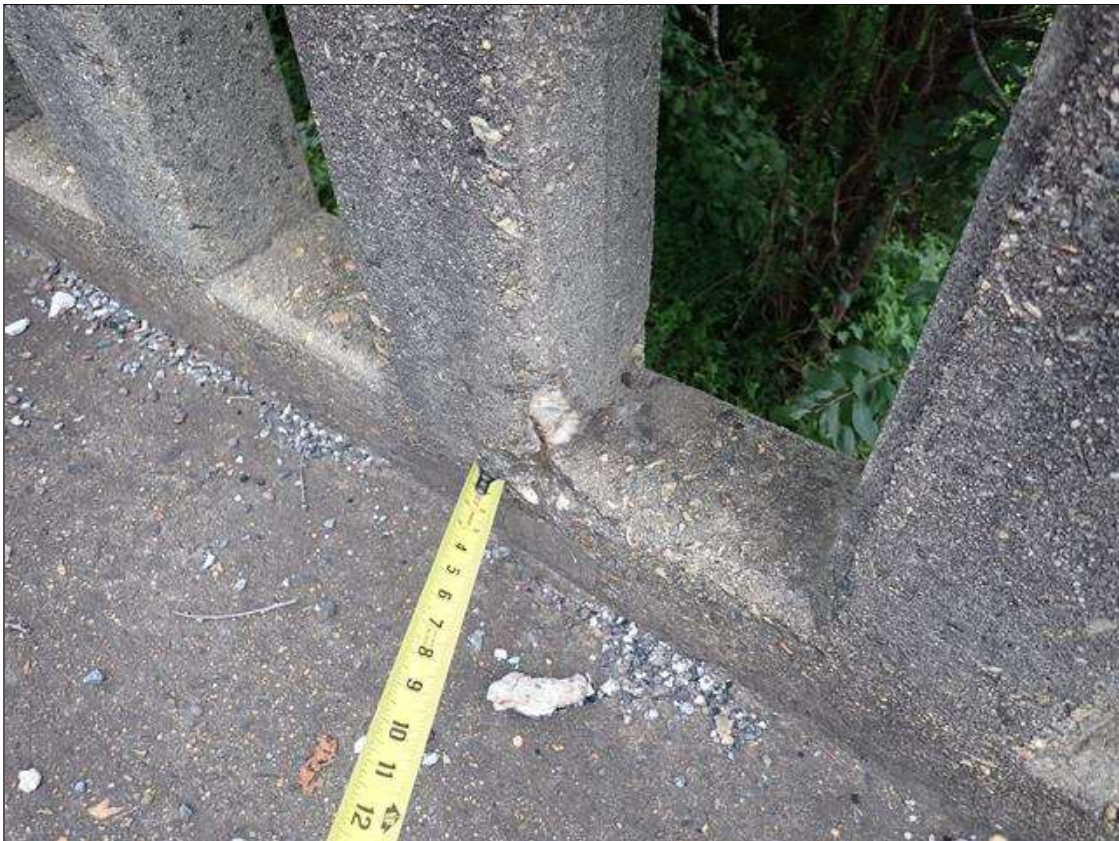
Span 4 Right Bridge Rail: RIGHT RAIL HAS SCATTERED AREAS THAT ARE CRACK/SPALL [up to 18 inch x 2 inch x 1 inch deep] AND DELAMINATED WITH REBAR EXPOSED [no section loss]

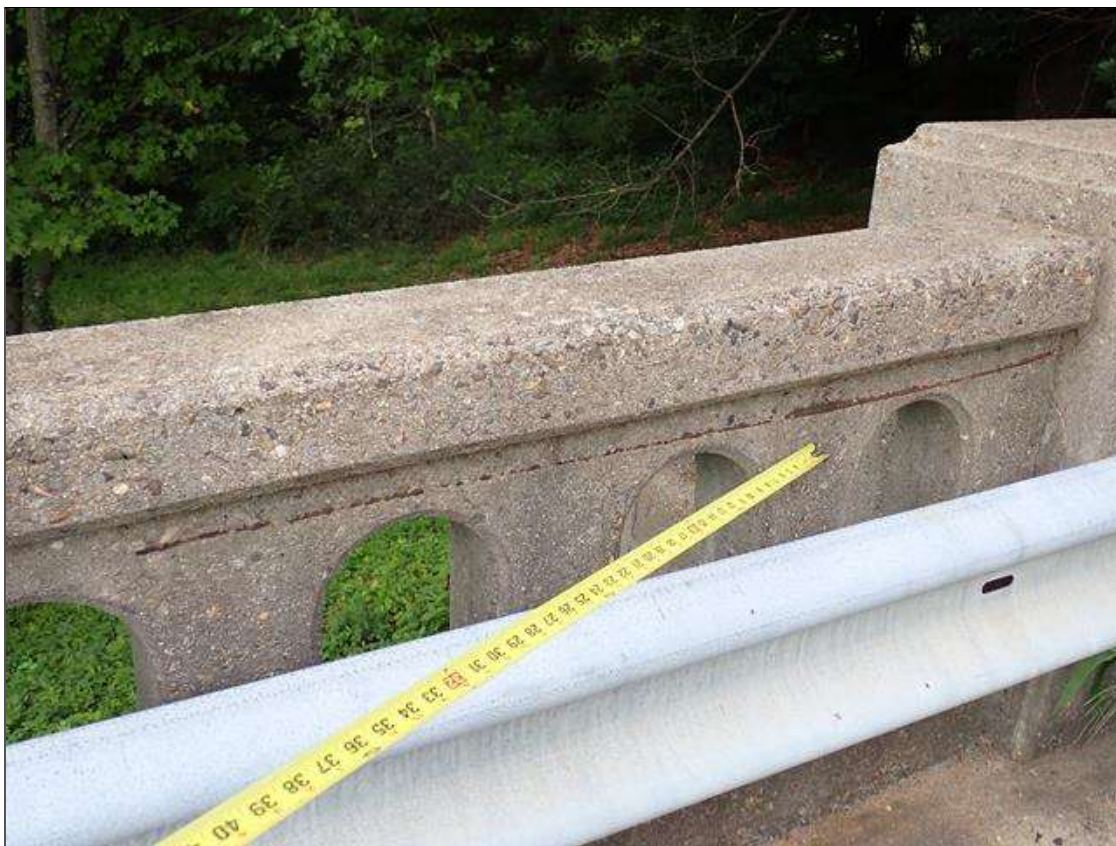
Span 4 Left Bridge Rail: top of rail, at end bent 2, shallow rebar

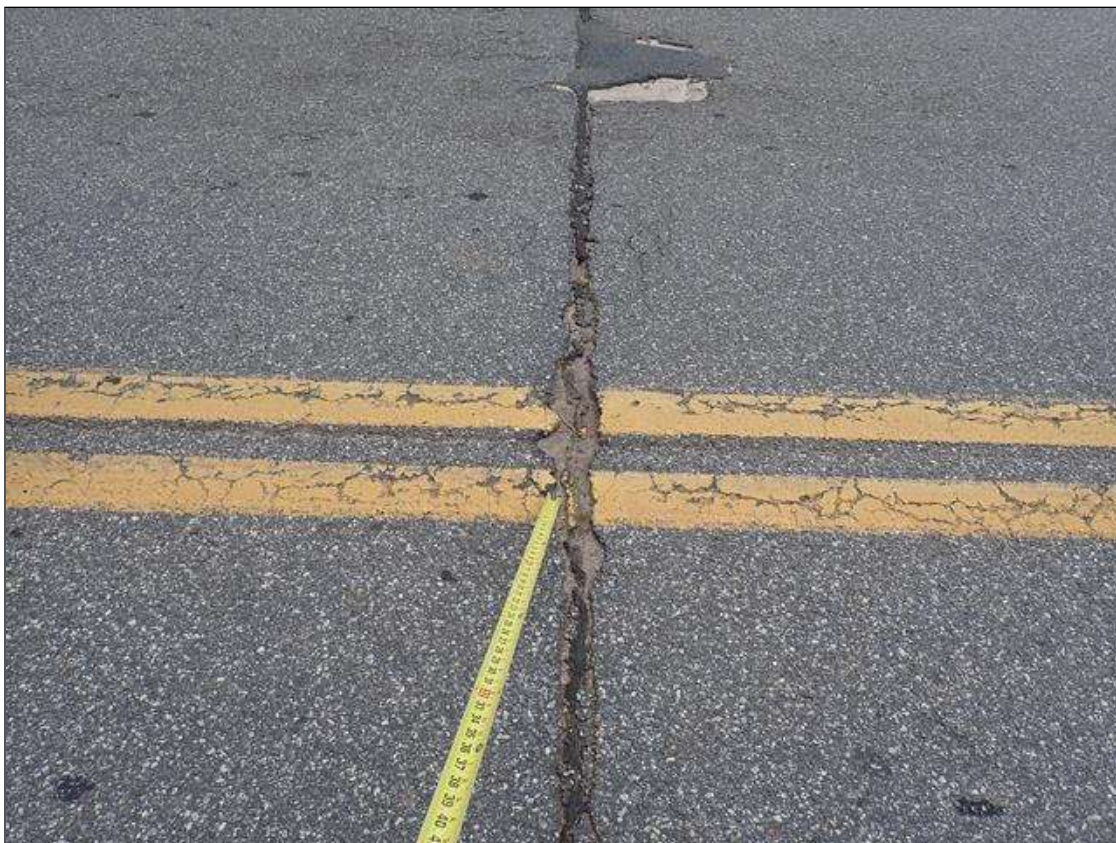
Span 4 Expansion Joint 3: along the length of the joint, areas of deteriorated seal

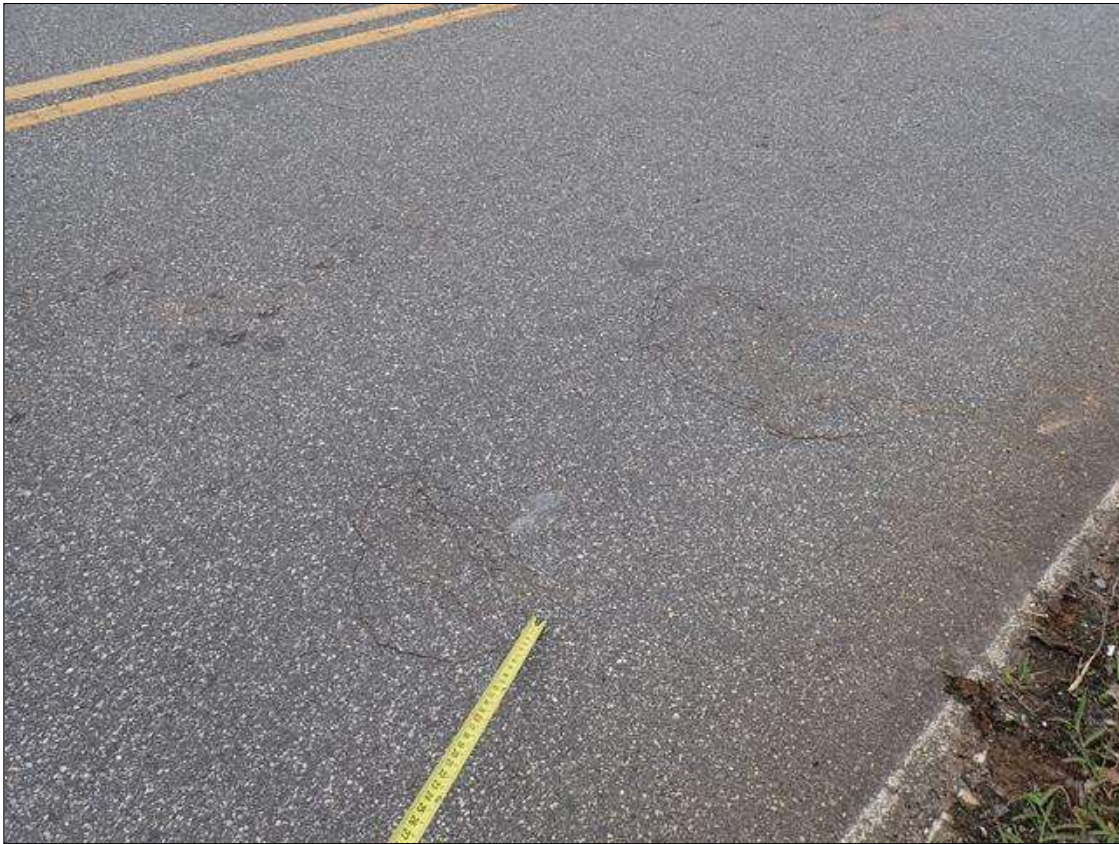
Span 3 Wearing Surface: (PAR) throughout wearing surface, areas of delaminations (up to 3 feet x 2 feet) with cracks (up to 1/4 inch); northbound lane, spalls (up to 27 inch x 2 feet x full depth)

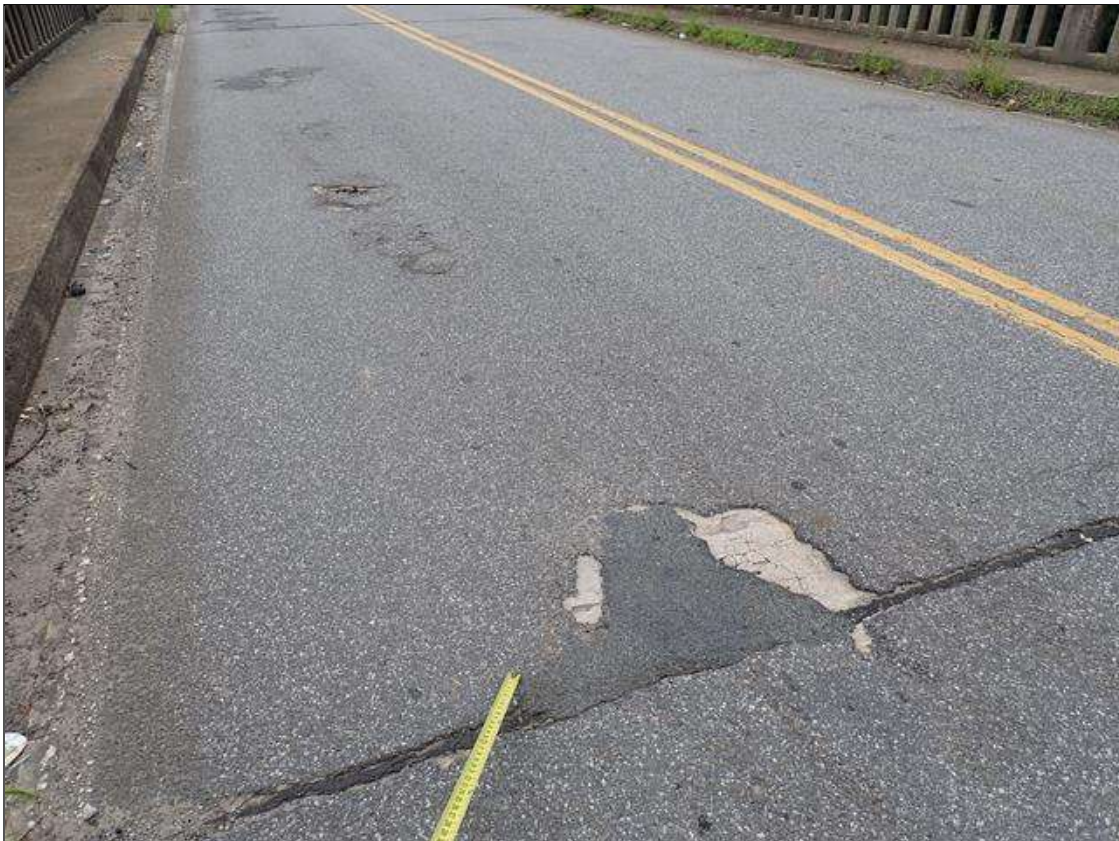
Span 3 Wearing Surface: (PAR) throughout wearing surface, areas of delaminations (up to 3 feet x 2 feet) with cracks (up to 1/4 inch); northbound lane, spalls (up to 27 inch x 2 feet x full depth)

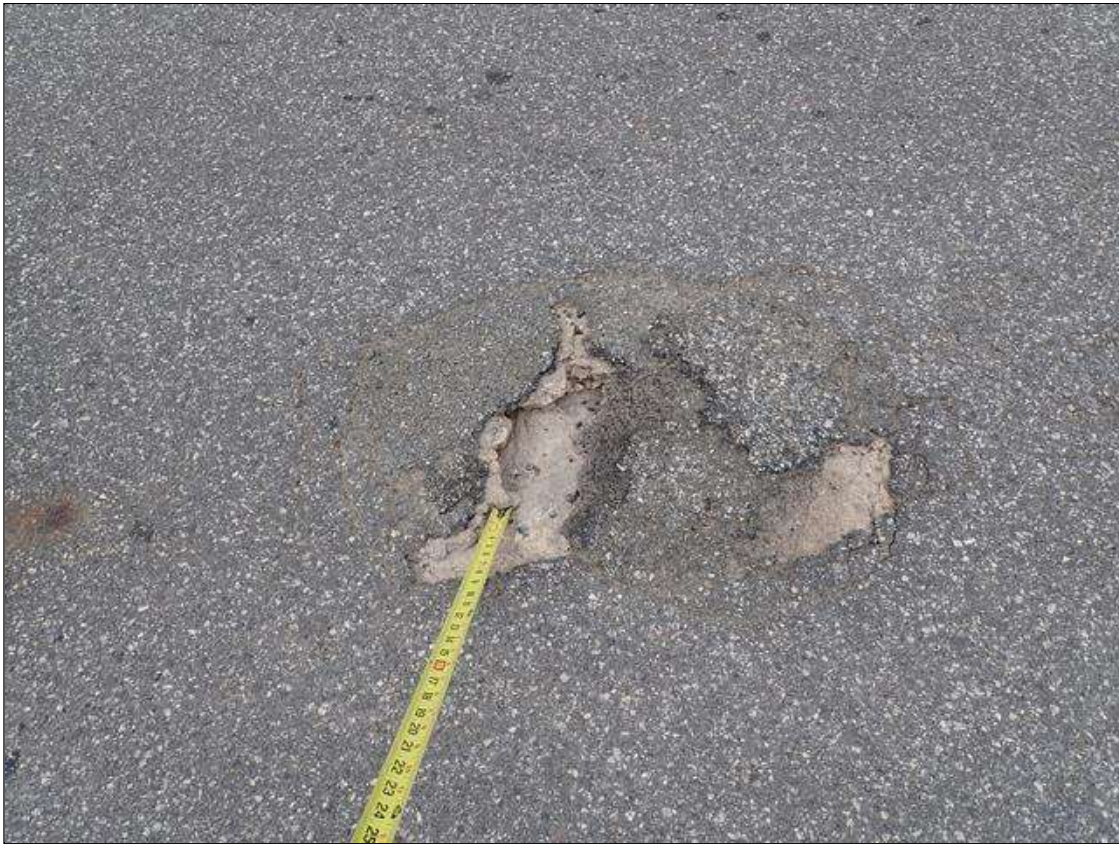
Span 3 Deck: (PAR) top of deck, in northbound lane, at areas of missing asphalt, spalls/delaminations (up to 27 inch x 2 feet x 1.5 inch deep), some with exposed rusted rebar

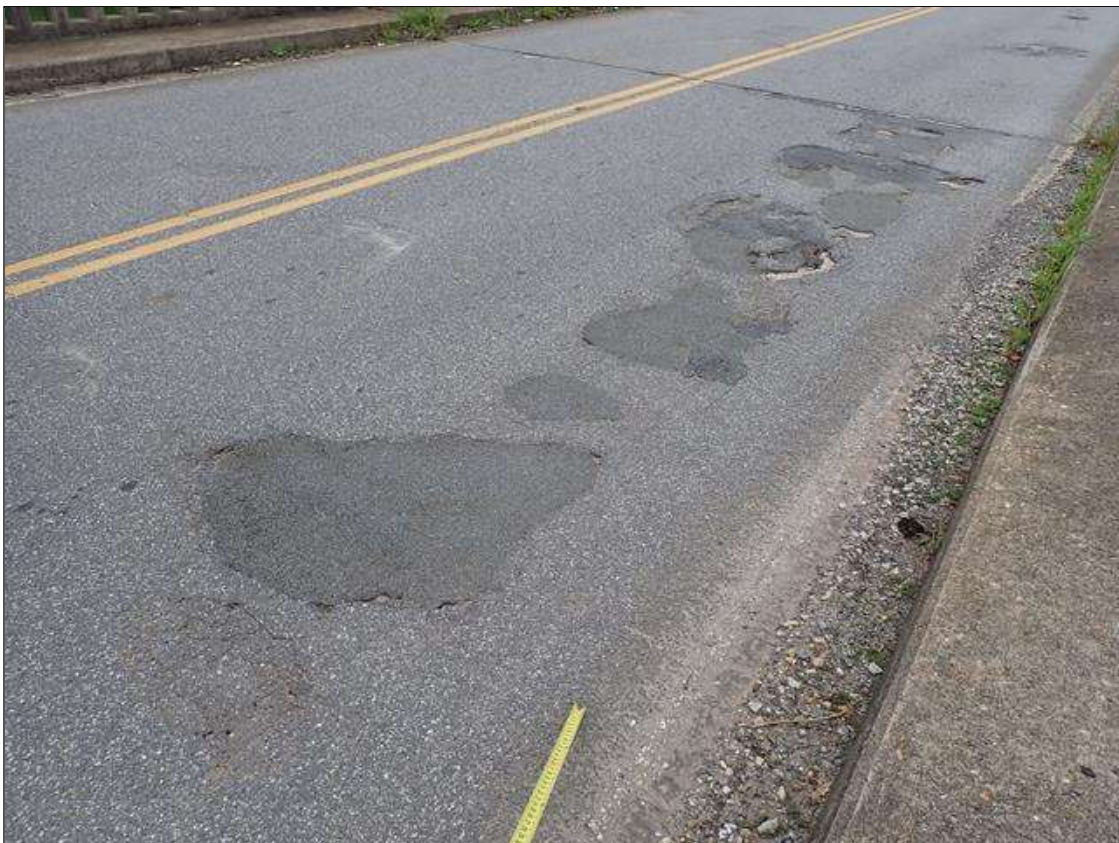
Span 2 Wearing Surface: (PAR) throughout wearing surface, areas of delaminations (up to 18 inch diameter) with cracks (up to 1/4 inch); both travel lanes, spalls/failed patches (up to 4.5 feet x 4 feet x full depth)

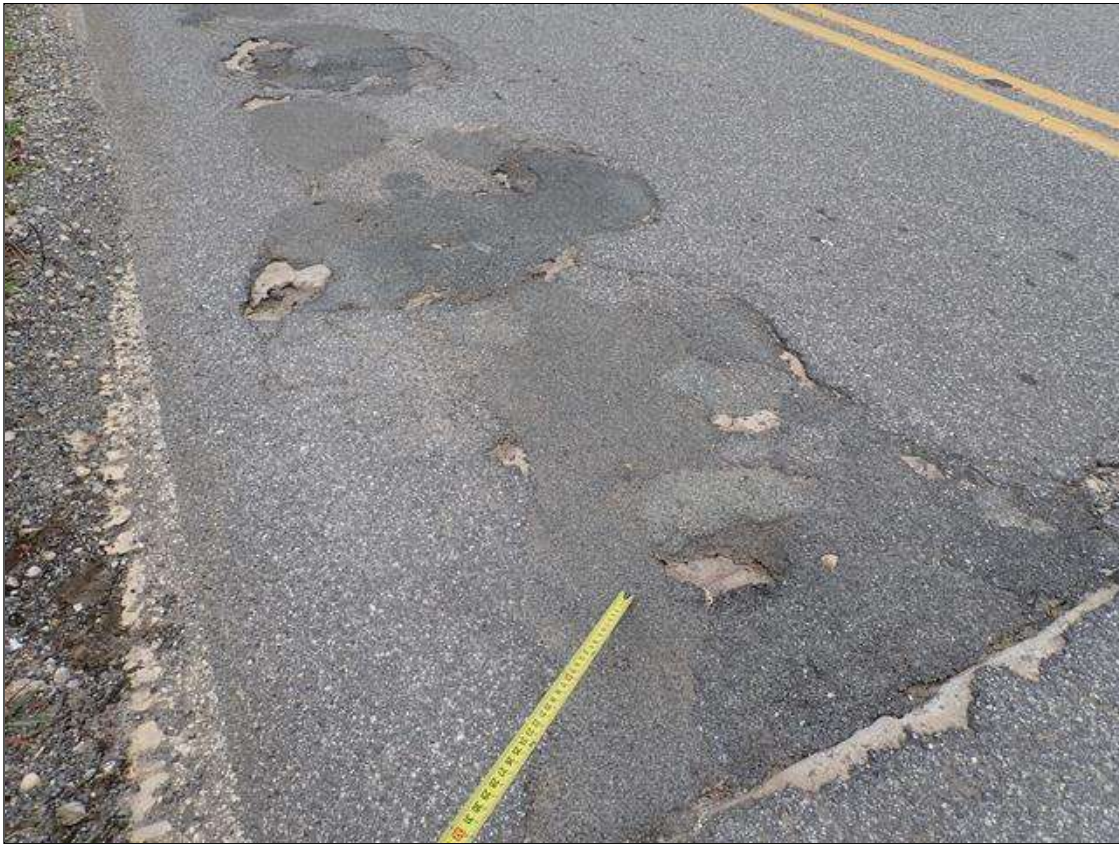
Span 2 Deck: (PAR) throughout top of deck, at areas of missing asphalt, spalls/delaminations (up to 28 inch x 1 foot x 1.5 inch deep), some with exposed rusted rebar

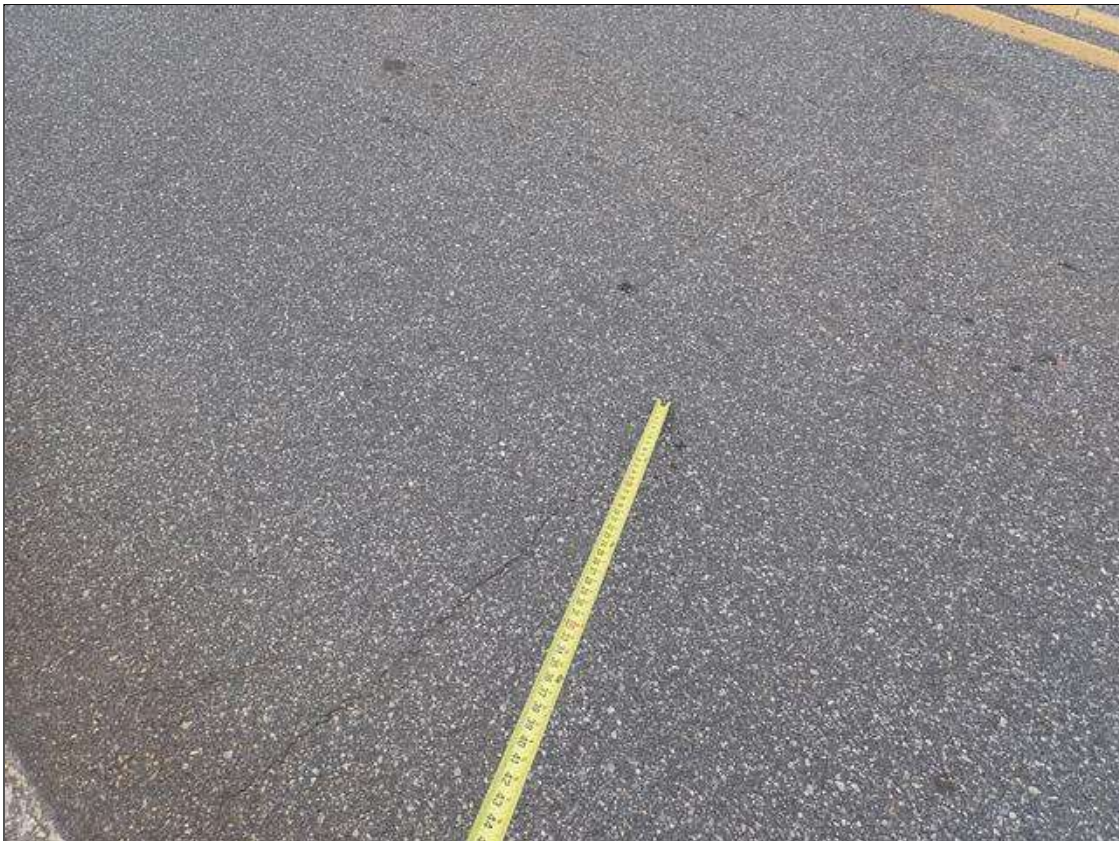
Span 2 Wearing Surface: WEARING SURFACE HAS SCATTERED MAP/TRANSVERSE AND LONGITUDINAL CRACKS [up to 12 feet x UP TO 1/8 INCH]

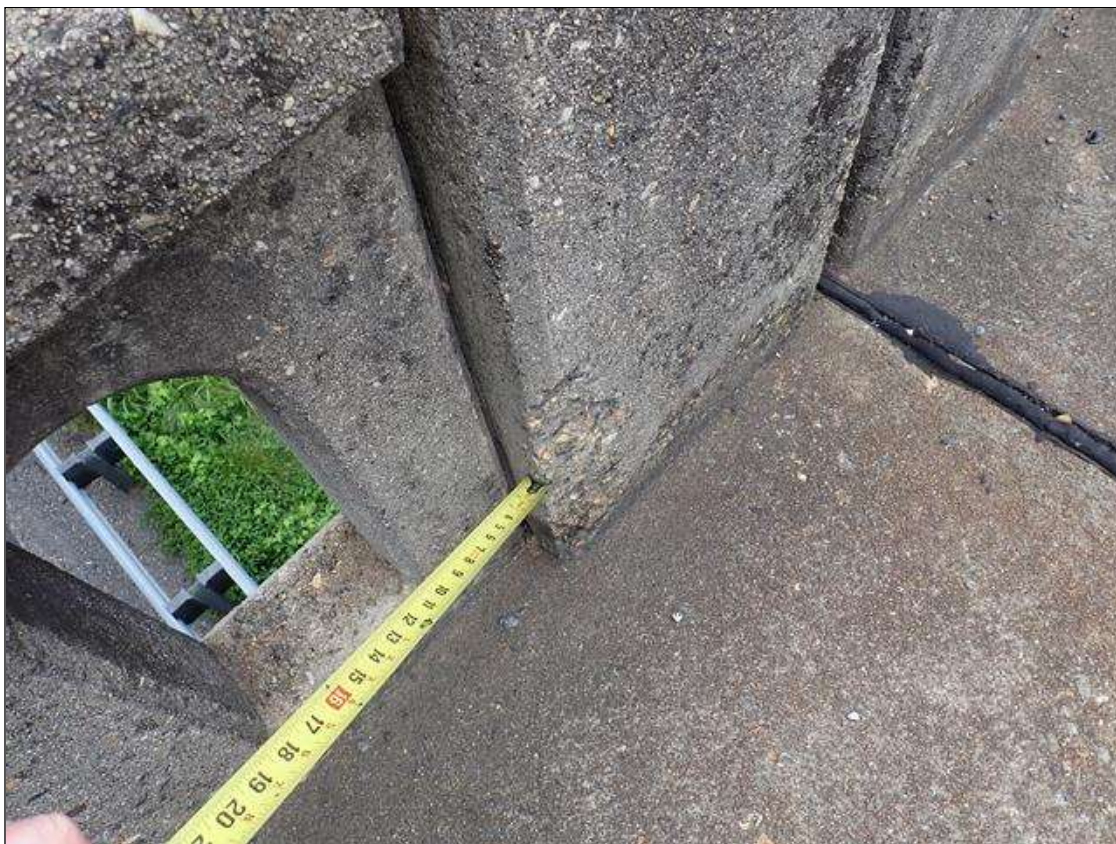
Span 2 Left Bridge Rail: along the length of the rail, spalls (up to 14 inch x 4 inch x 1 inch deep), some with exposed rusted rebar

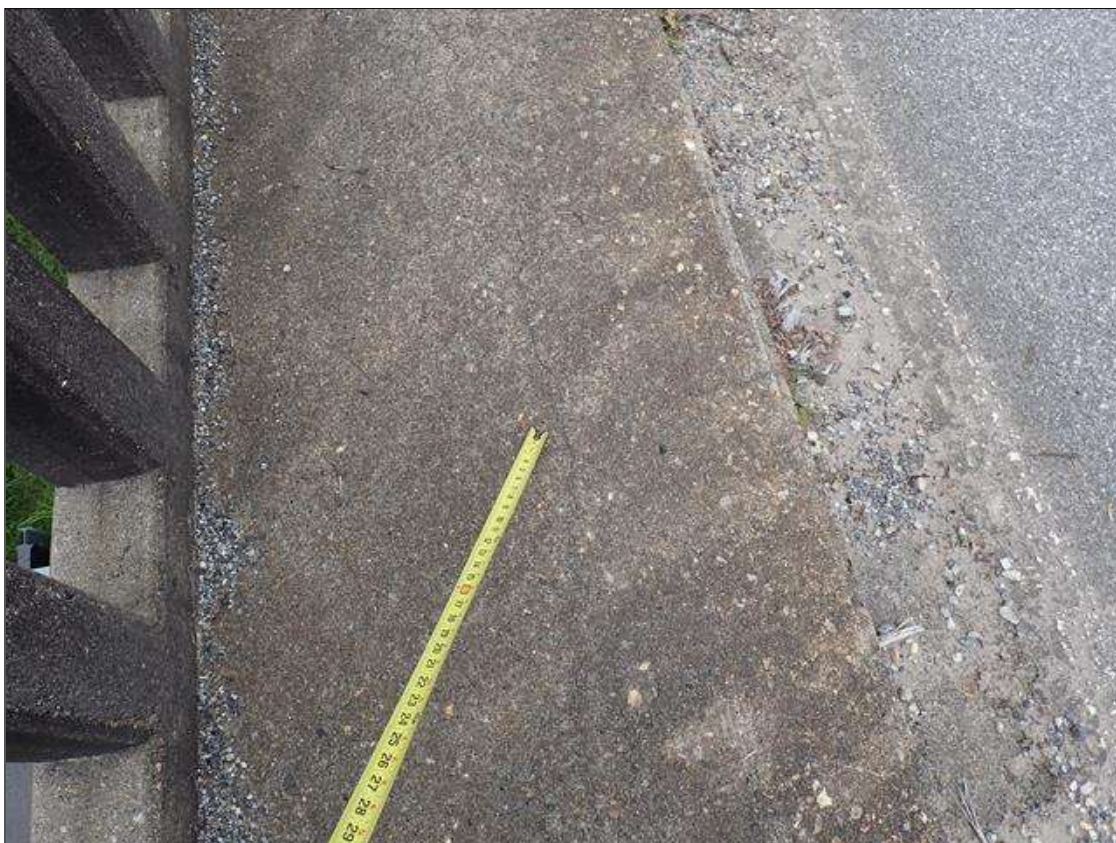
Span 2 Right Bridge Rail: sidewalk near bent 1, longitudinal/map cracks (up to 1/32 inch)

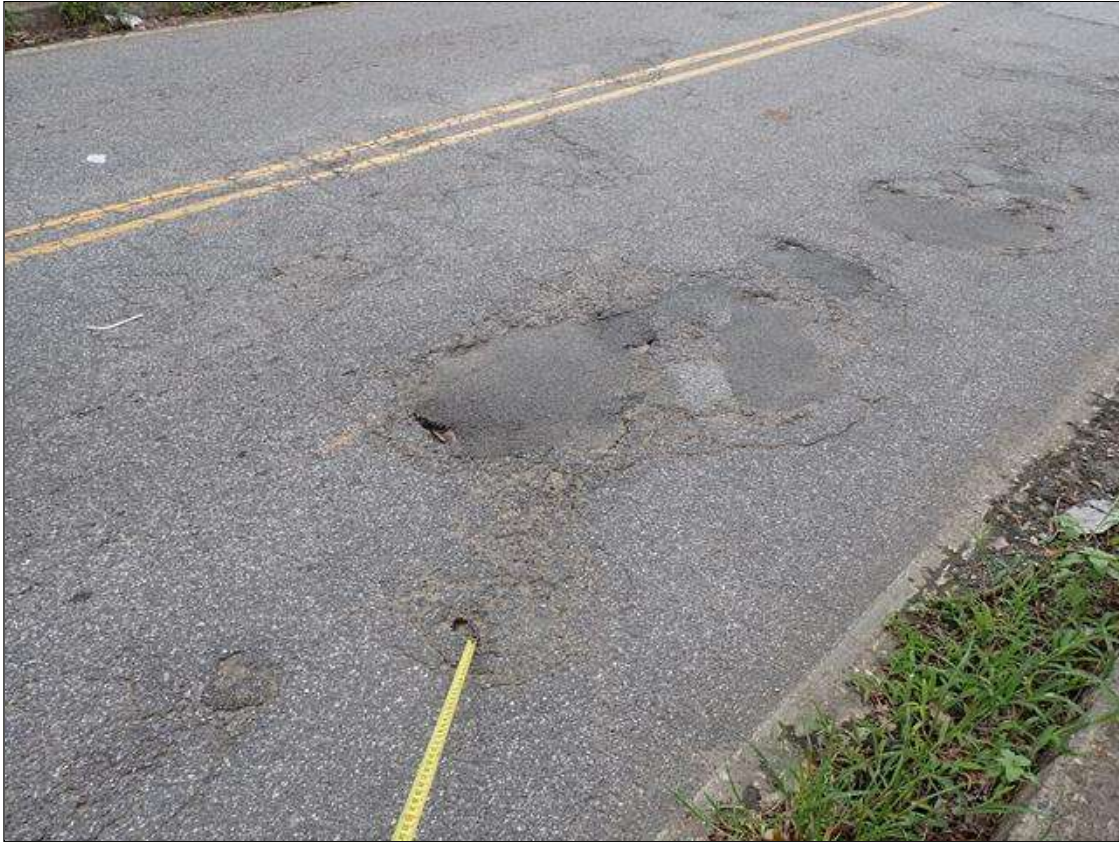
Span 1 Wearing Surface: (PAR) throughout wearing surface, areas of delaminations (up to 3.5 foot diameter) with cracks (up to 1/4 inch); both travel lanes, spalls/failed patches (up to 7 feet x 4 feet x full depth)

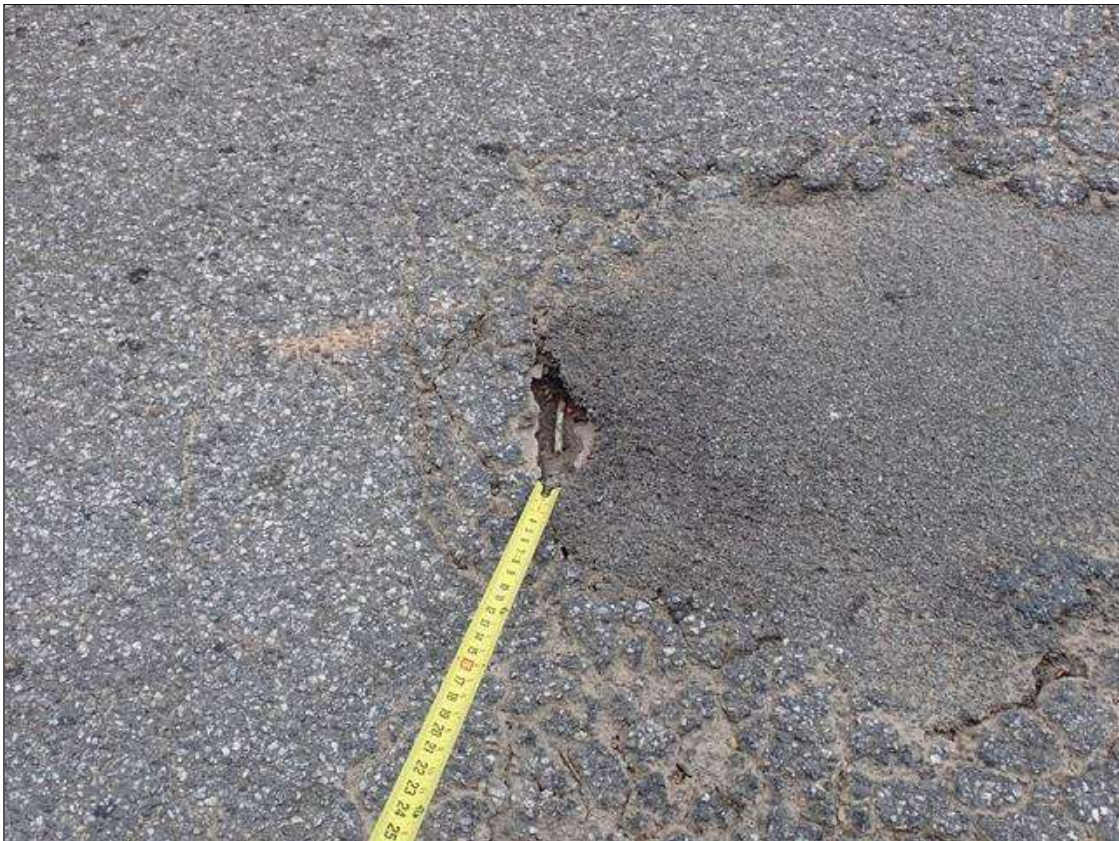
Span 1 Deck: (PAR) throughout top of deck, at areas of missing asphalt, spalls/delaminations (up to 2 foot x 1 foot x 1.5 inch deep), some with exposed rusted rebar

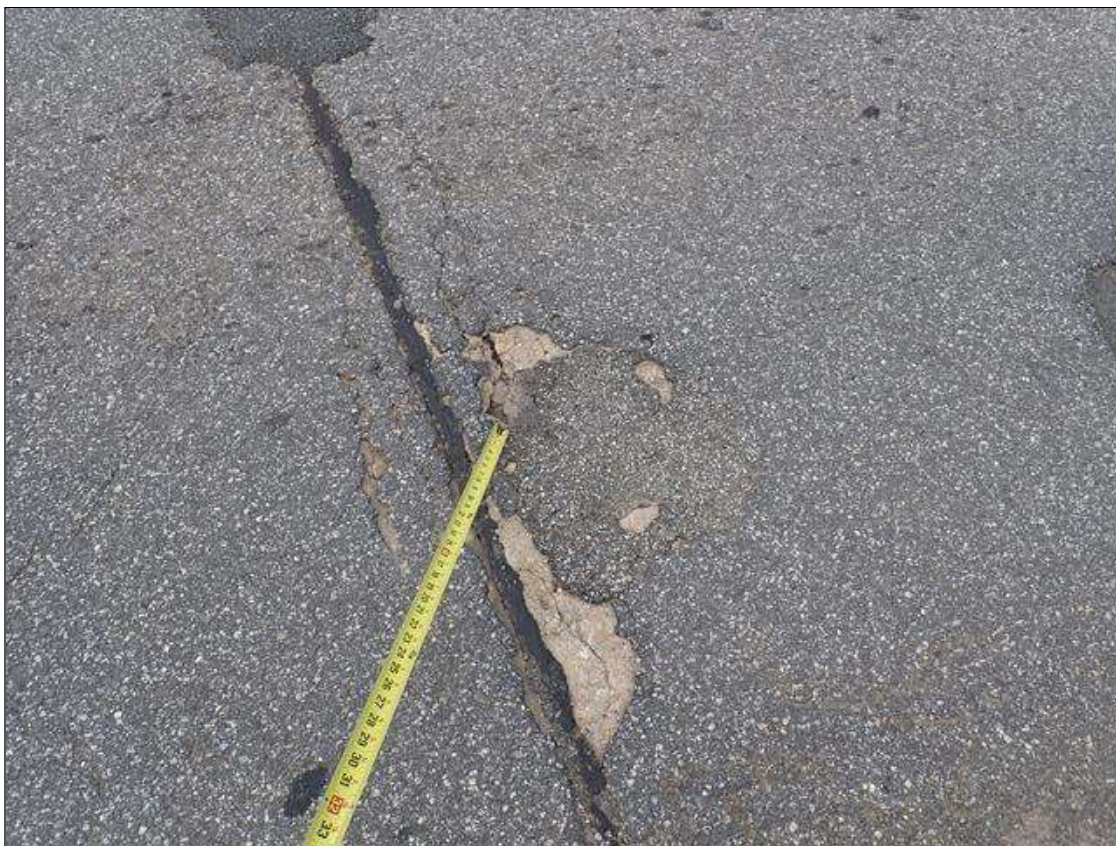
Span 1 Deck: (PAR) throughout top of deck, at areas of missing asphalt, spalls/delaminations (up to 2 foot x 1 foot x 1.5 inch deep), some with exposed rusted rebar
