NC DEPARTMENT OF TRANSPORTATION  
 DIVISION OF HIGHWAYS  
 STRUCTURE MANAGEMENT UNIT

ATTENTION: prompt action request, sketches revised, clearances revised; span 2 beams heat straightened and repainted since previous inspection

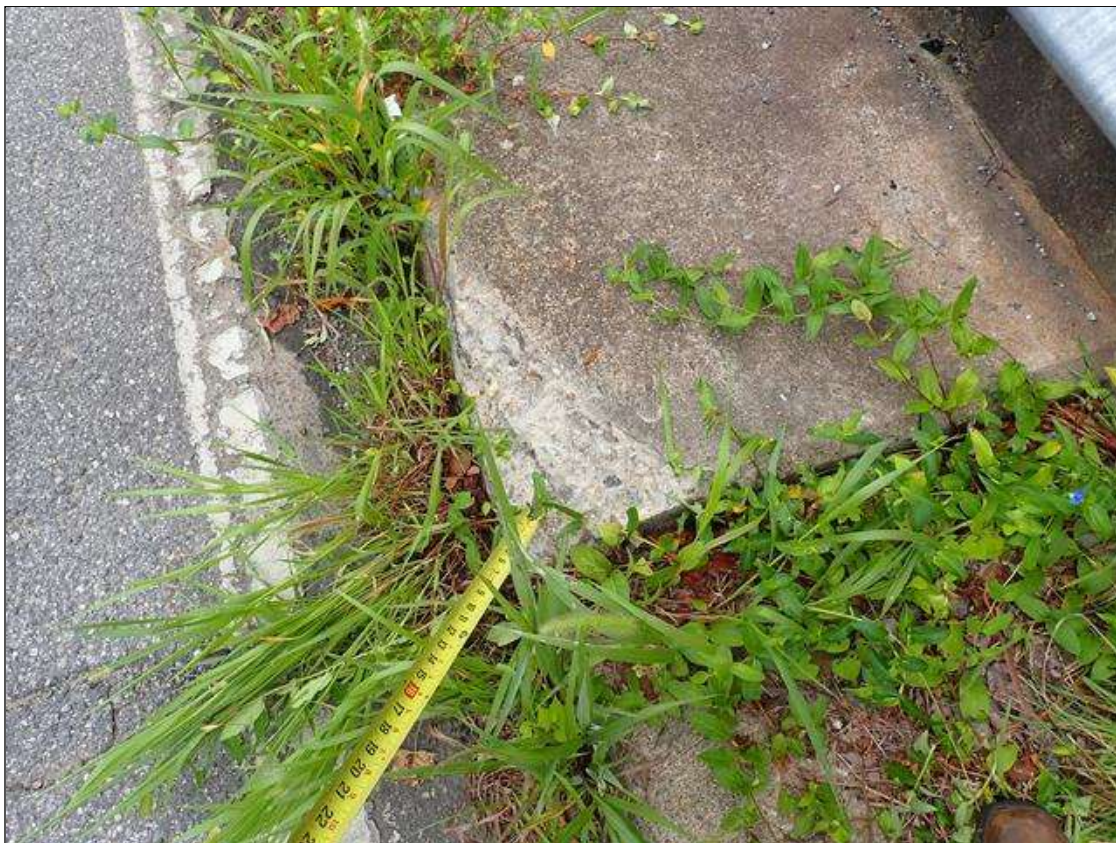
Span 1 Right Bridge Rail: at corner of sidewalk adjacent to end bent 1, spall [18 inch x 10 inch x 4 inch deep] no exposed rusted reinforcing

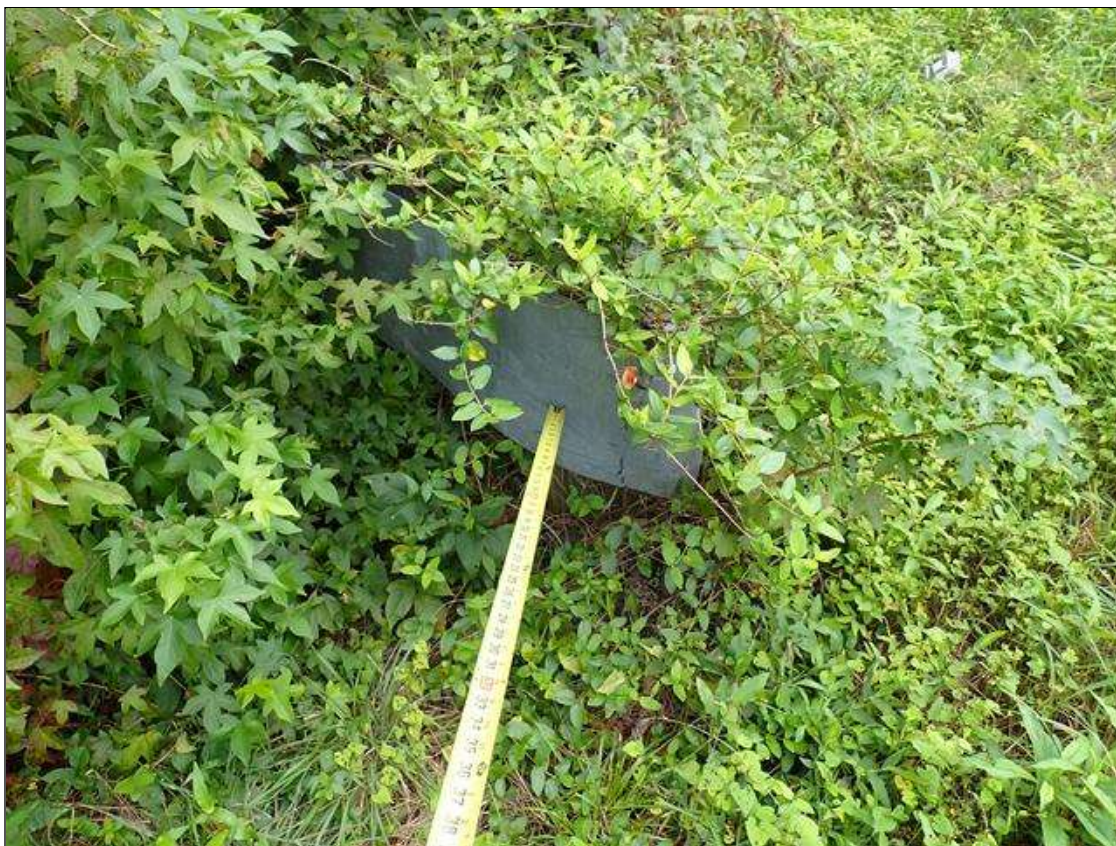
(PAR) southwest guardrail termination, impact damage (1 foot)

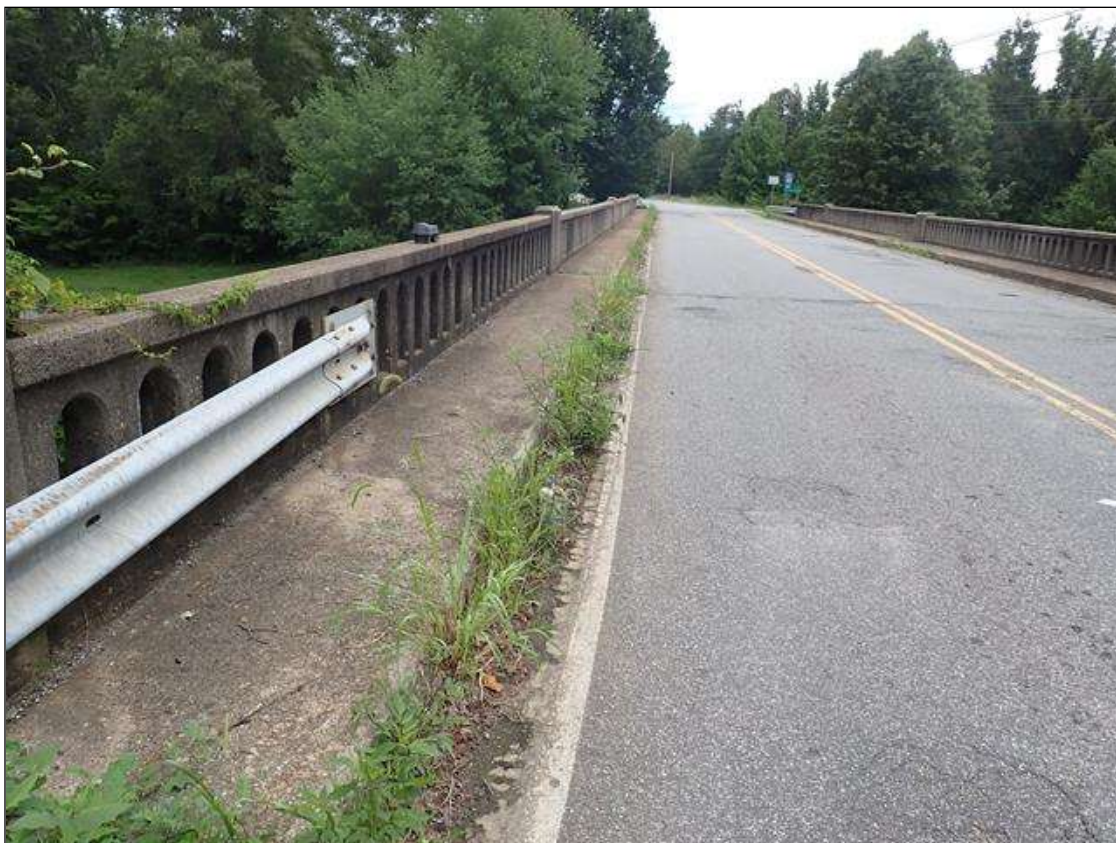
along the curblines, debris accumulation (up to 15 inches high x 3 inches wide) with vegetation, obstructing deck drainage

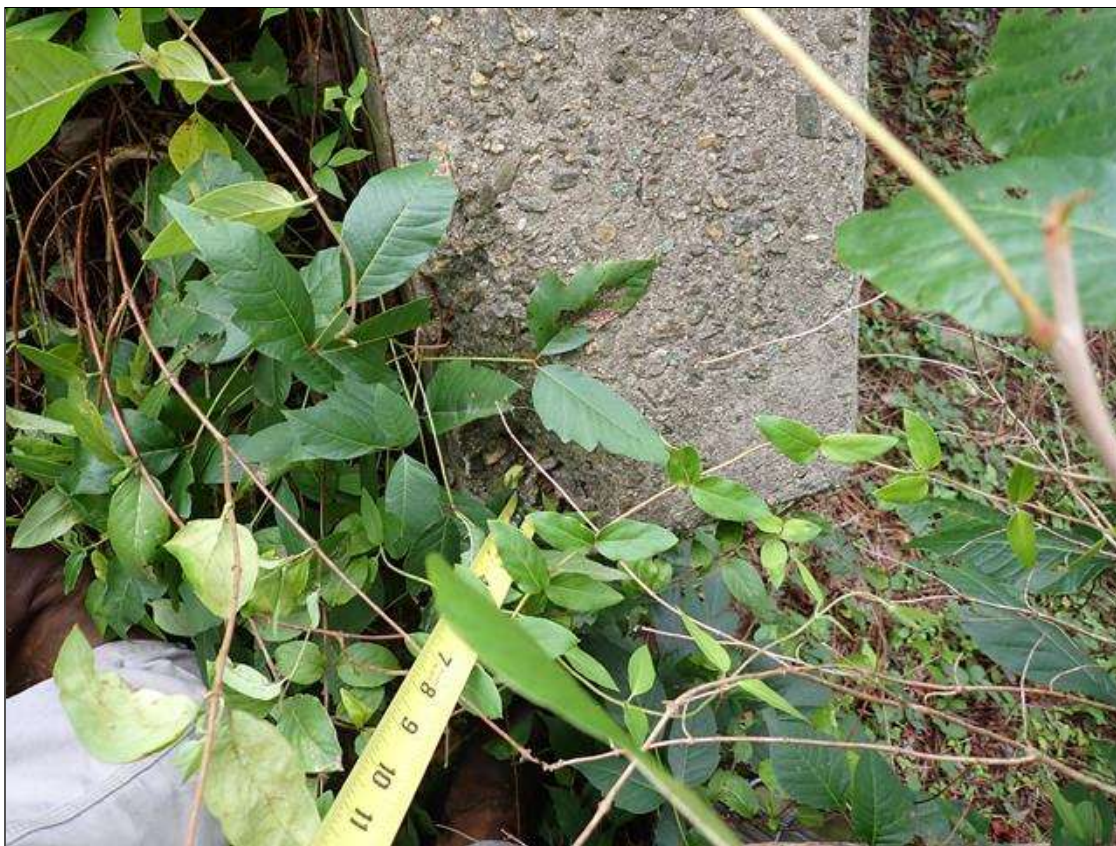
southeast wingwall, at end, spall (9 inch x 6 inch x 2 inch deep)

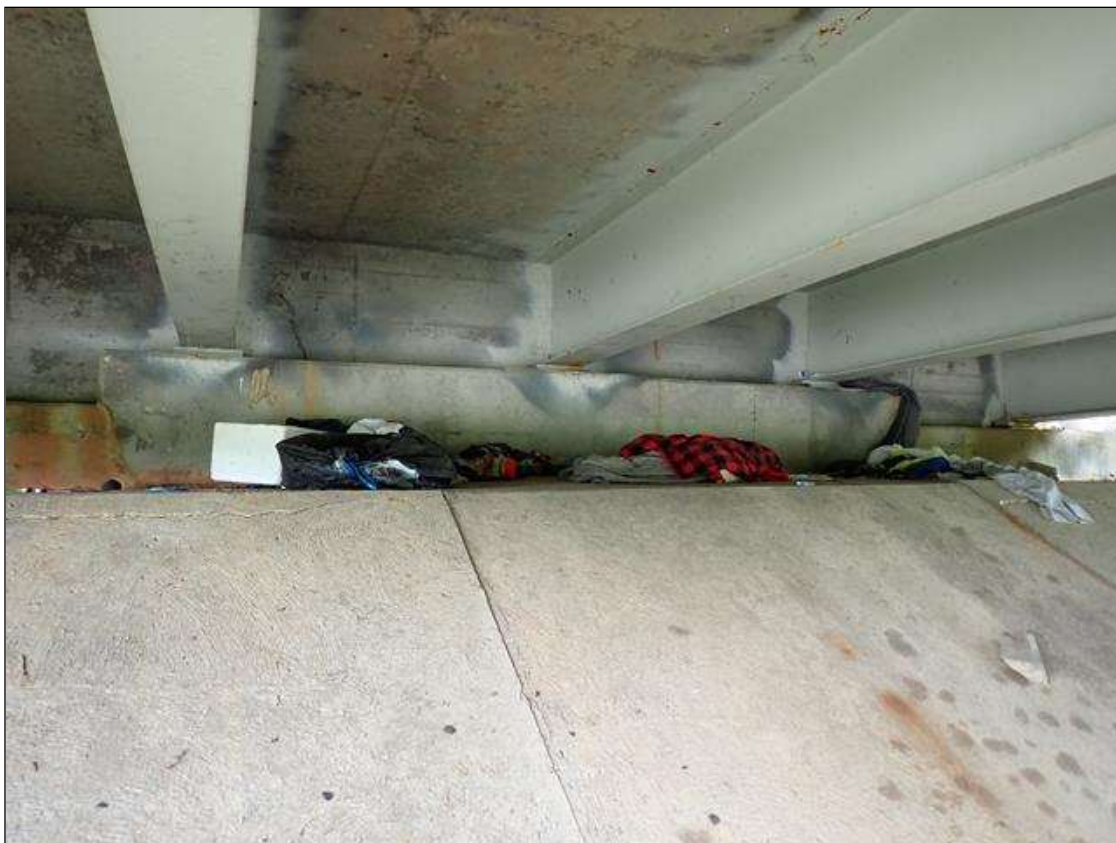
at end bent 1, homeless belongings

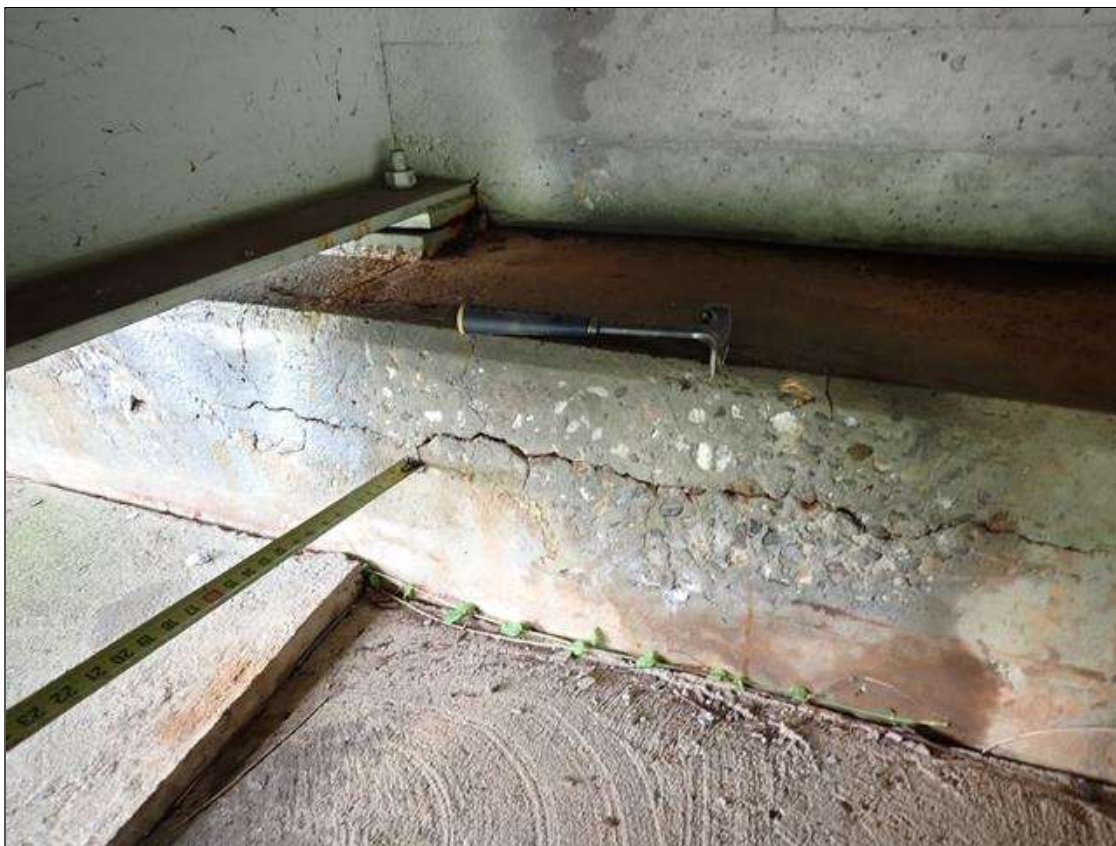
End Bent 1 Cap 1: (PAR) in bays 1 and 4, delaminations (up to 6 feet x 10 inch) with cracks (up to 1/4 inch wide) and rust stains

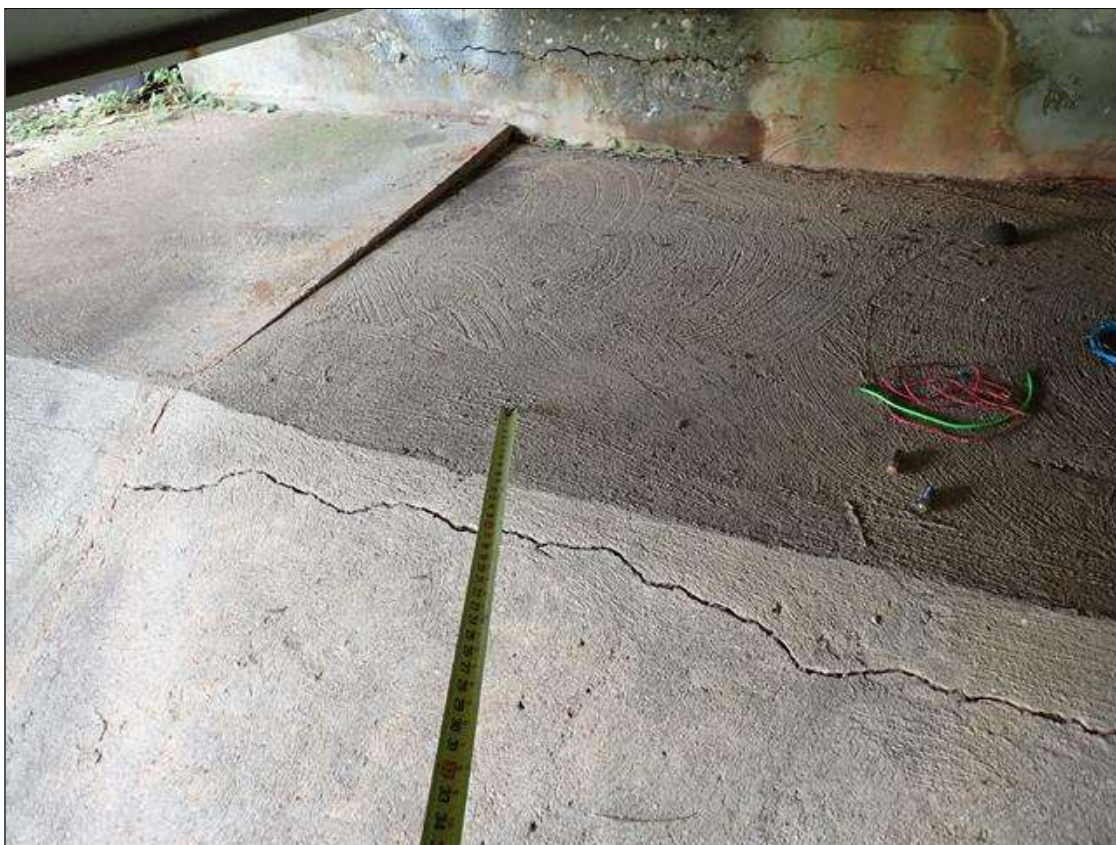
end bent 1 slope protection, below all bays, settlement (up to 2 inches) with longitudinal crack (1/4 inch x 8 feet)

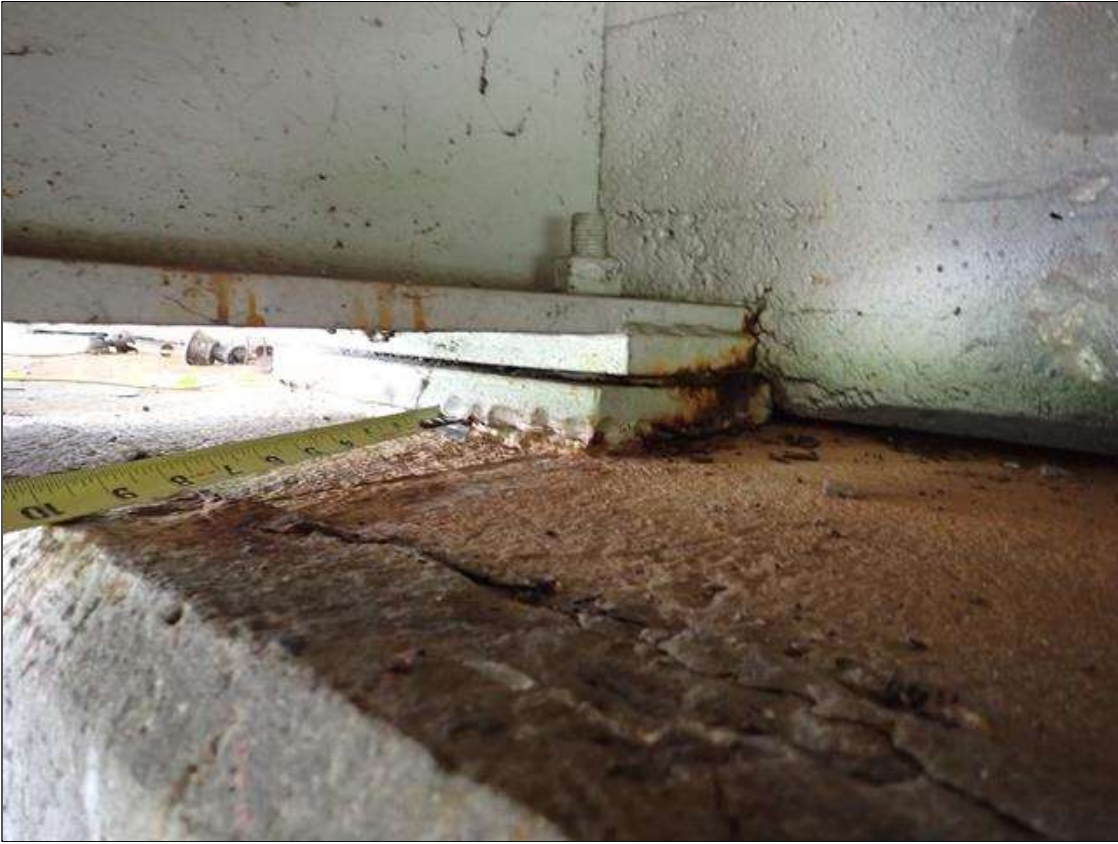
Span 1 Beam 5 - Near Bearing 5: painted over section loss (up to 1/4 inch deep) with corrosion reinitiated

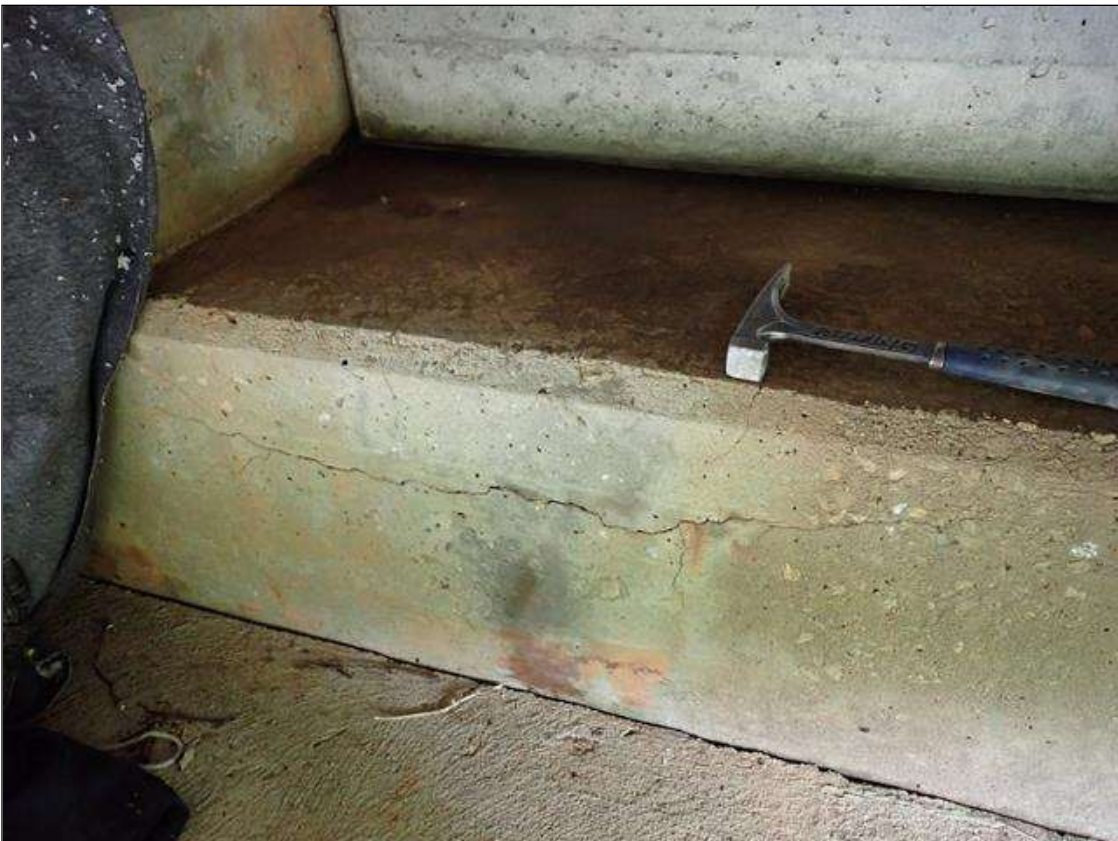
End Bent 1 Cap 1: (PAR) in bays 1 and 4, delaminations (up to 6 feet x 10 inch) with cracks (up to 1/4 inch wide) and rust stains

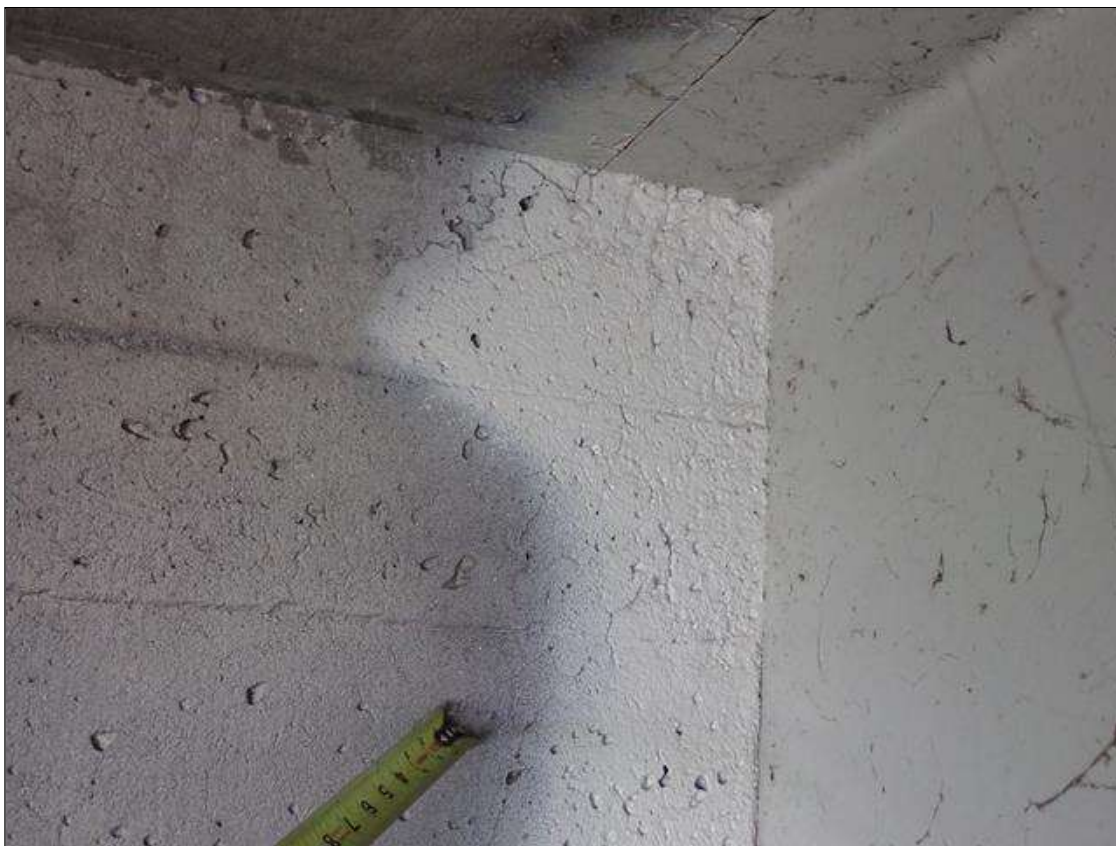
End Bent 1 Abutment: HAIRLINE MAP CRACKING AT RANDOM THROUGHOUT.

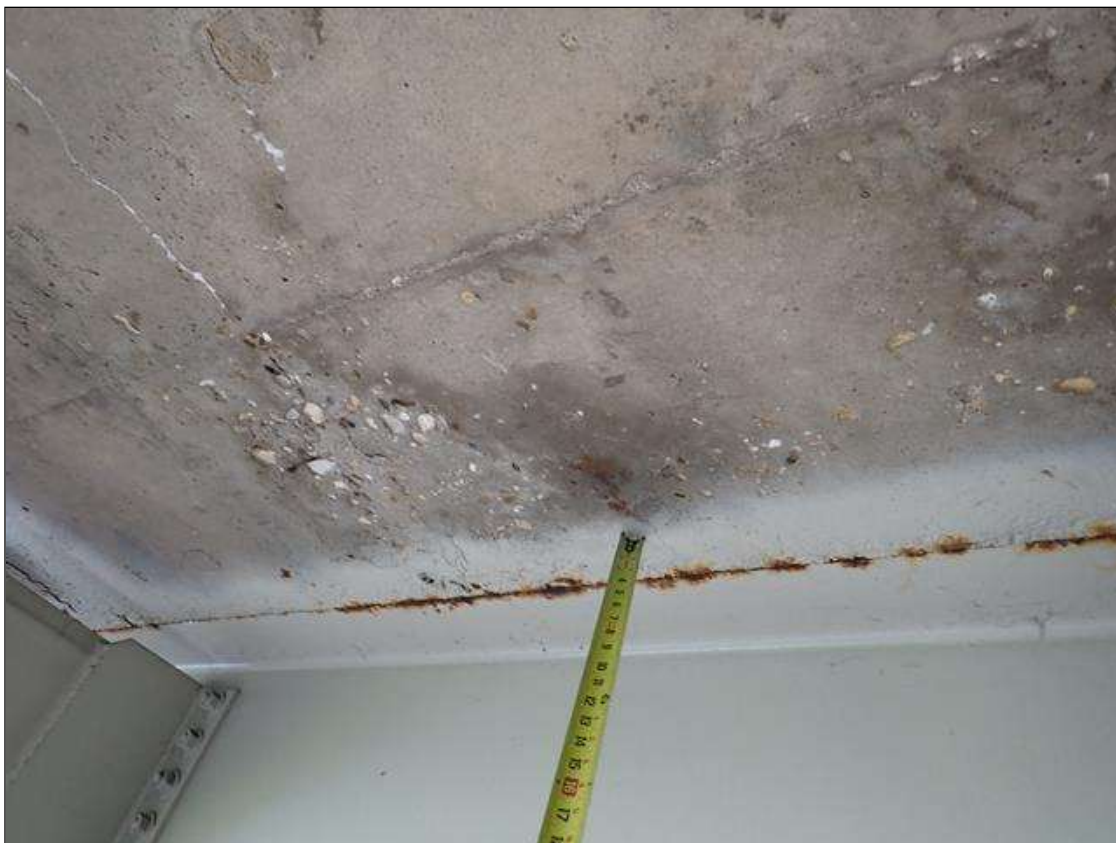
Span 1 Deck: (PAR) BOTTOM OF DECK UP TO 1/32 INCH MAP CRACKING AT RANDOM THROUGHOUT SOME WITH EFFLORESCENCE AND RUST STAINS

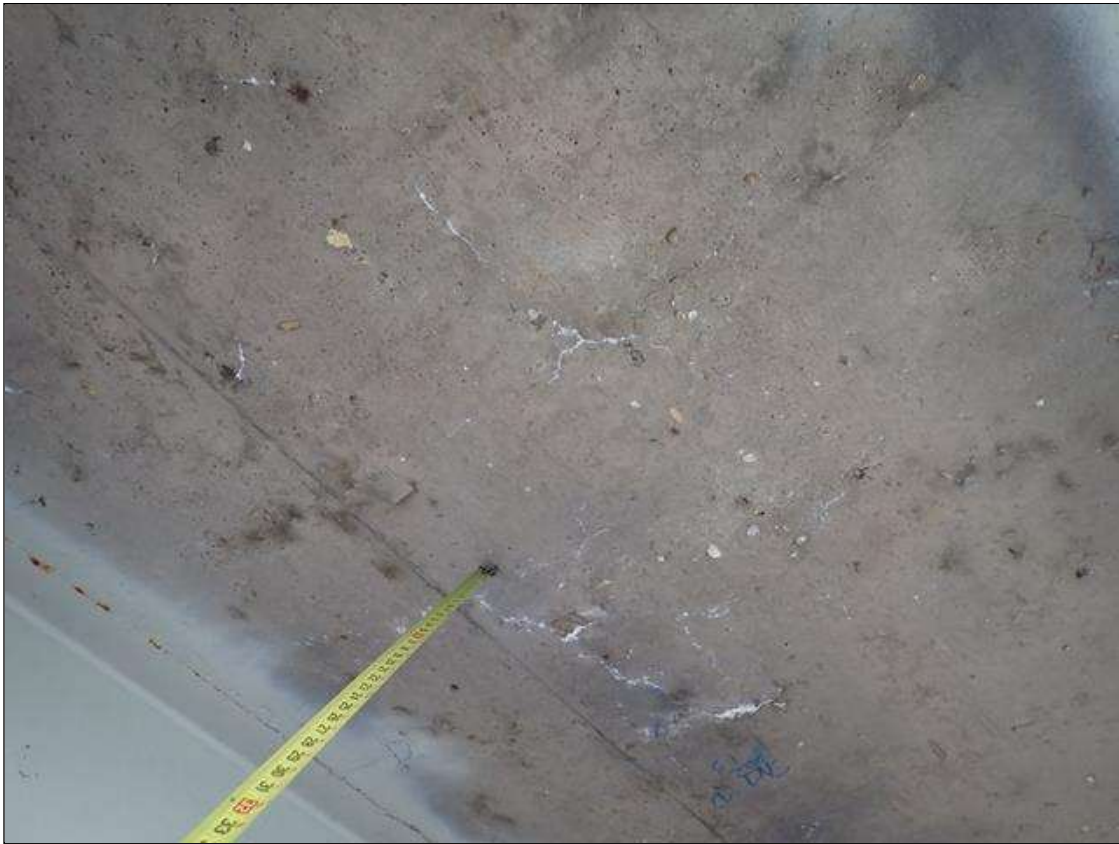
Span 1 Deck: (PAR) BOTTOM OF DECK UP TO 1/32 INCH MAP CRACKING AT RANDOM THROUGHOUT SOME WITH EFFLORESCENCE AND RUST STAINS

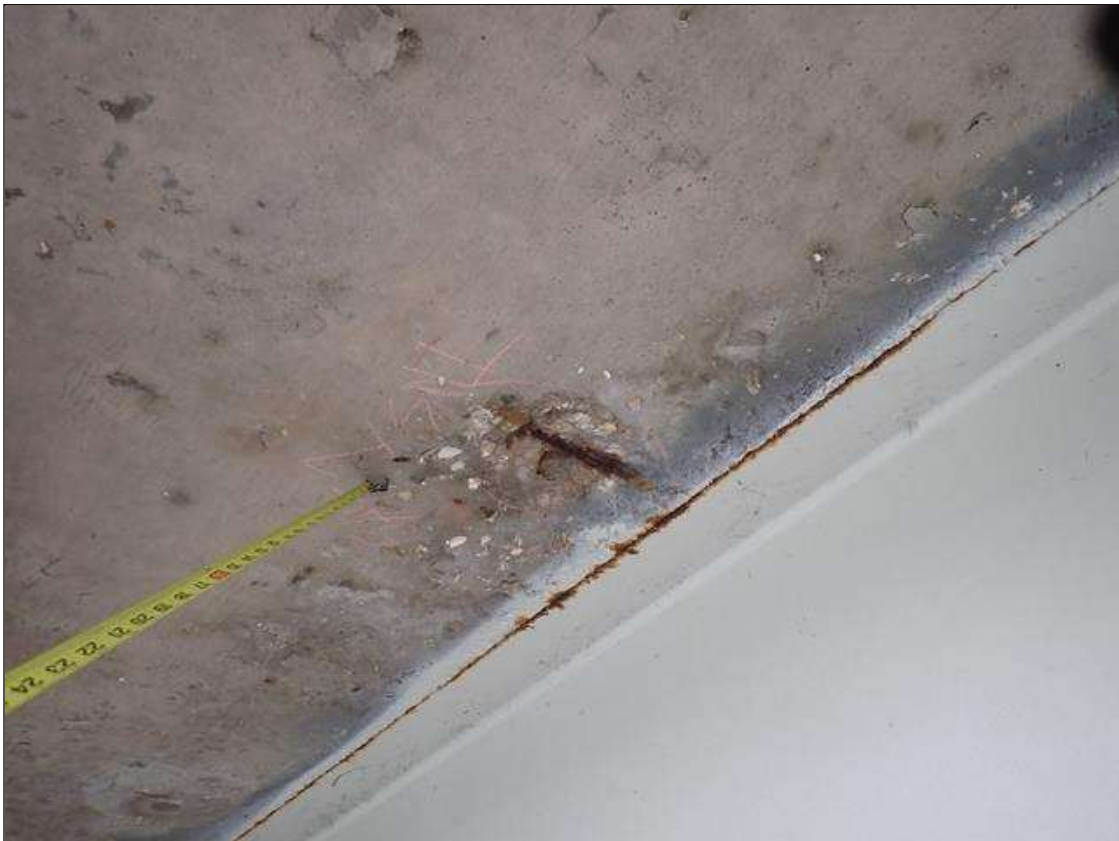
Span 1 Deck: (PAR) underside of bays 1 and 4, and both overhangs at bent 1, spalls/delaminations (up to 2.5 feet x 15 inch x 2.5 inches deep) with exposed rusted rebar; rebar has approximately 10 percent section loss

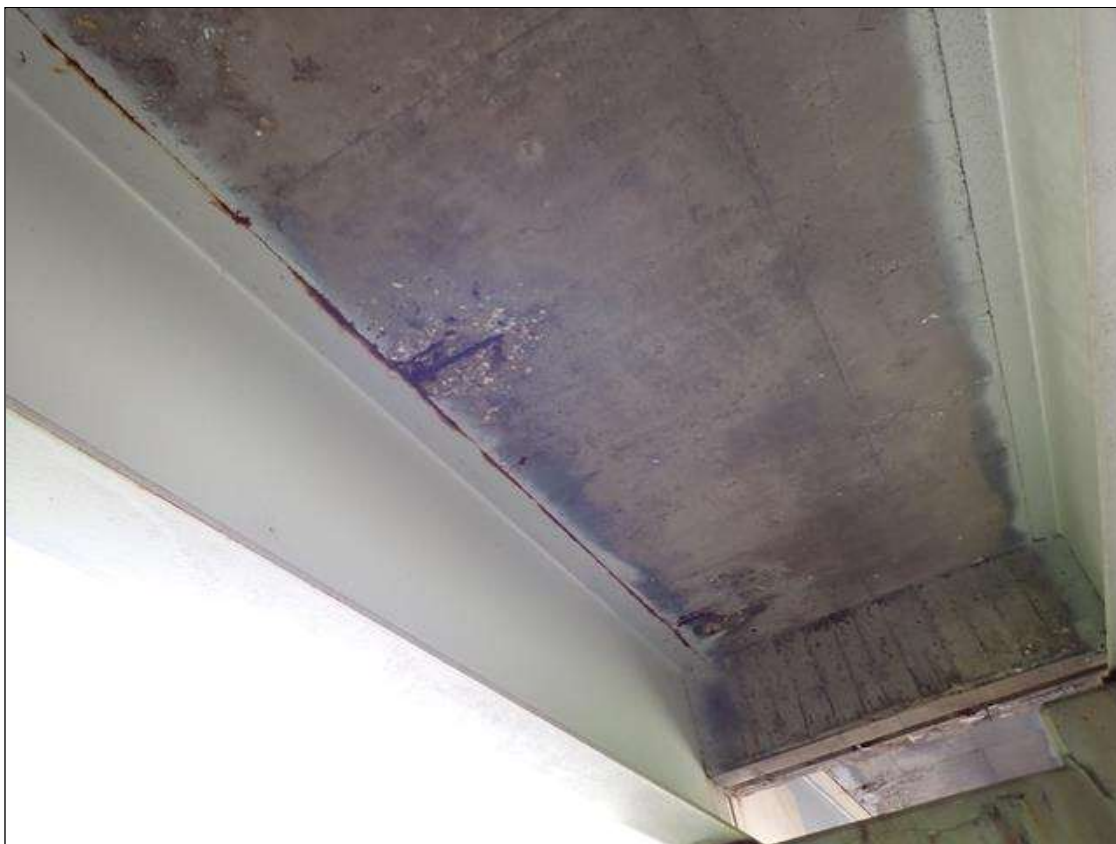
Span 1 Deck: (PAR) underside of bays 1 and 4, and both overhangs at bent 1, spalls/delaminations (up to 2.5 feet x 15 inch x 2.5 inches deep) with exposed rusted rebar; rebar has approximately 10 percent section loss

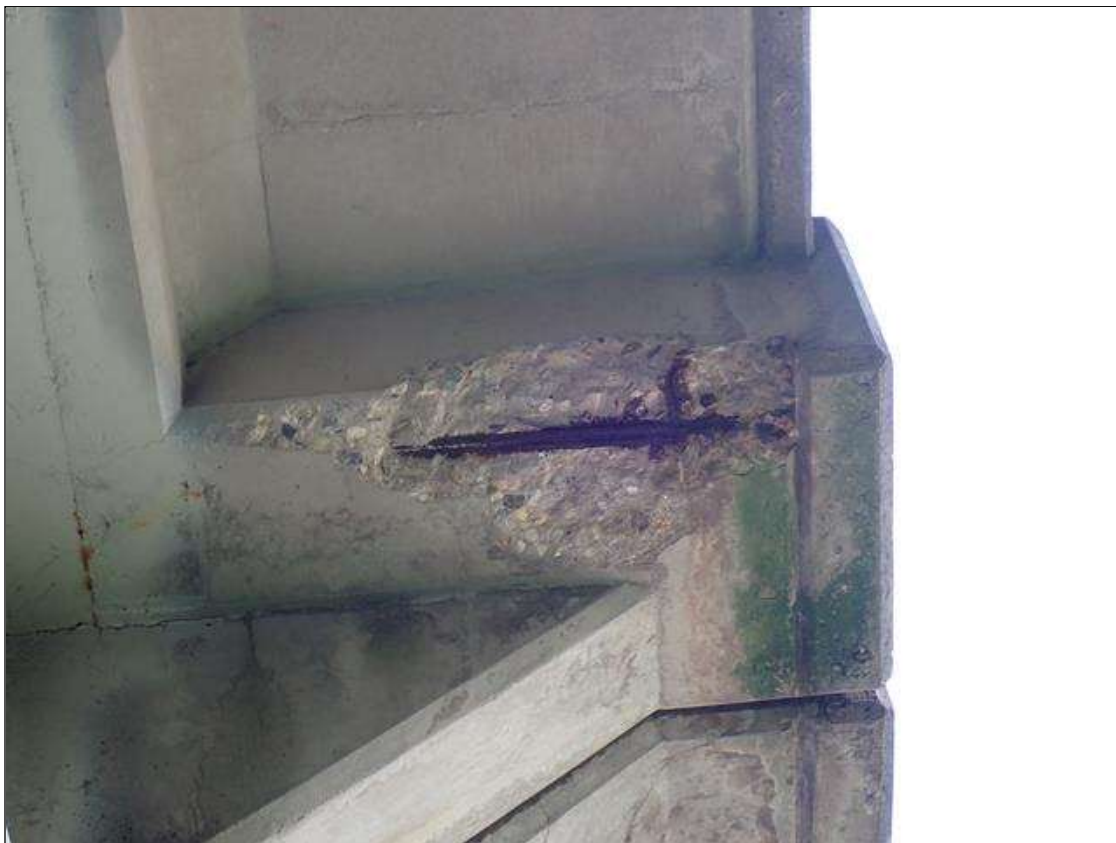
Span 1 Deck: (PAR) underside of bays 1 and 4, and both overhangs at bent 1, spalls/delaminations (up to 2.5 feet x 15 inch x 2.5 inches deep) with exposed rusted rebar; rebar has approximately 10 percent section loss

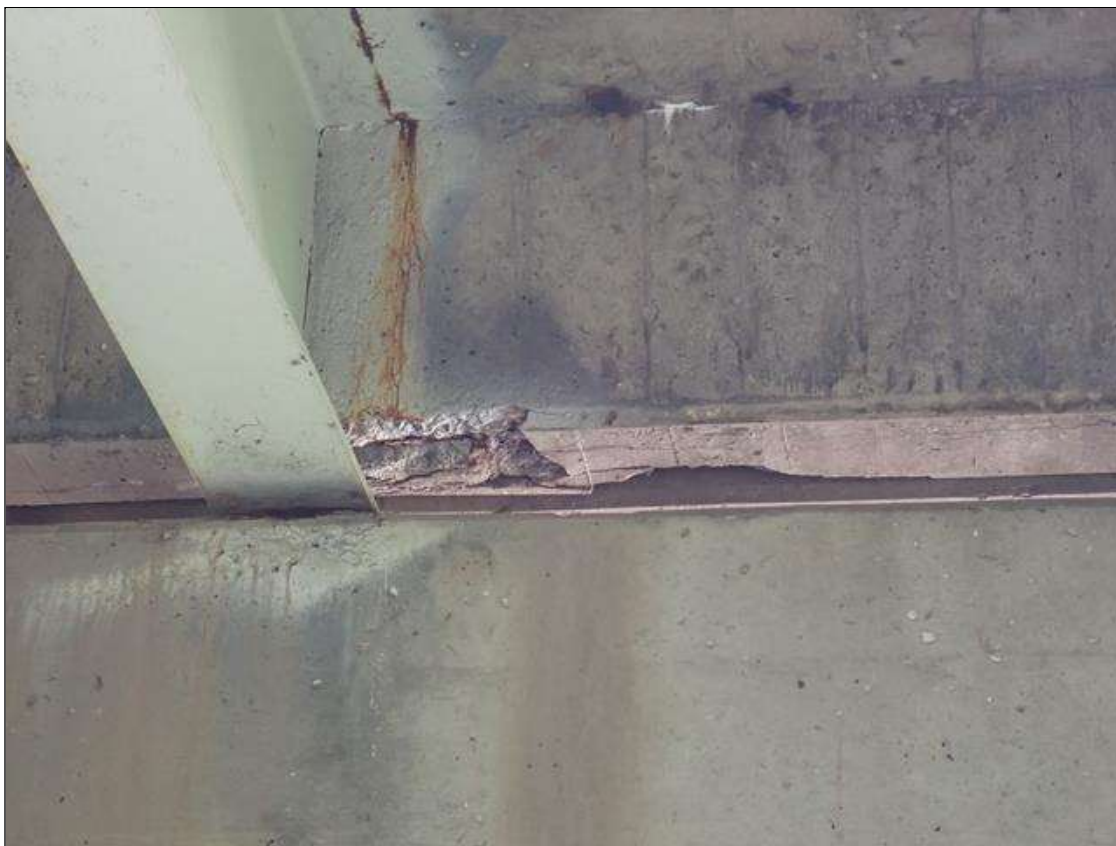
Span 1 Deck: at bent 1, bay 3 end diaphragm, spall/delamination (2.5 feet x 8 inch x 2 inches deep) with exposed rusted rebar

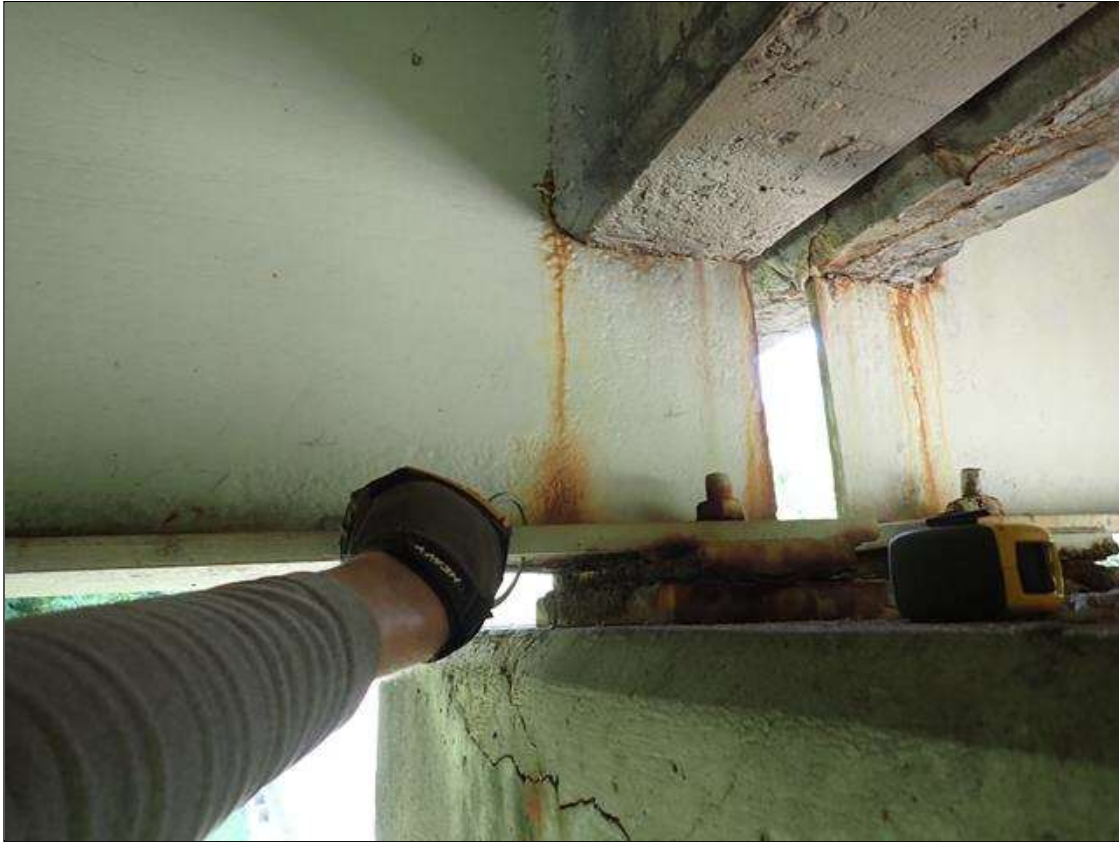
Span 1 Beam 1: at bent 1, painted over section loss: web adjacent to diaphragm (1/2 inch average remaining x 6 inch x 3 inch), lower web (1/2 inch average remaining x 13 inch x 4 inch) with corrosion reinitiated; bottom flange, corrosion with section loss (0.85 inch average remaining x 8 inches)

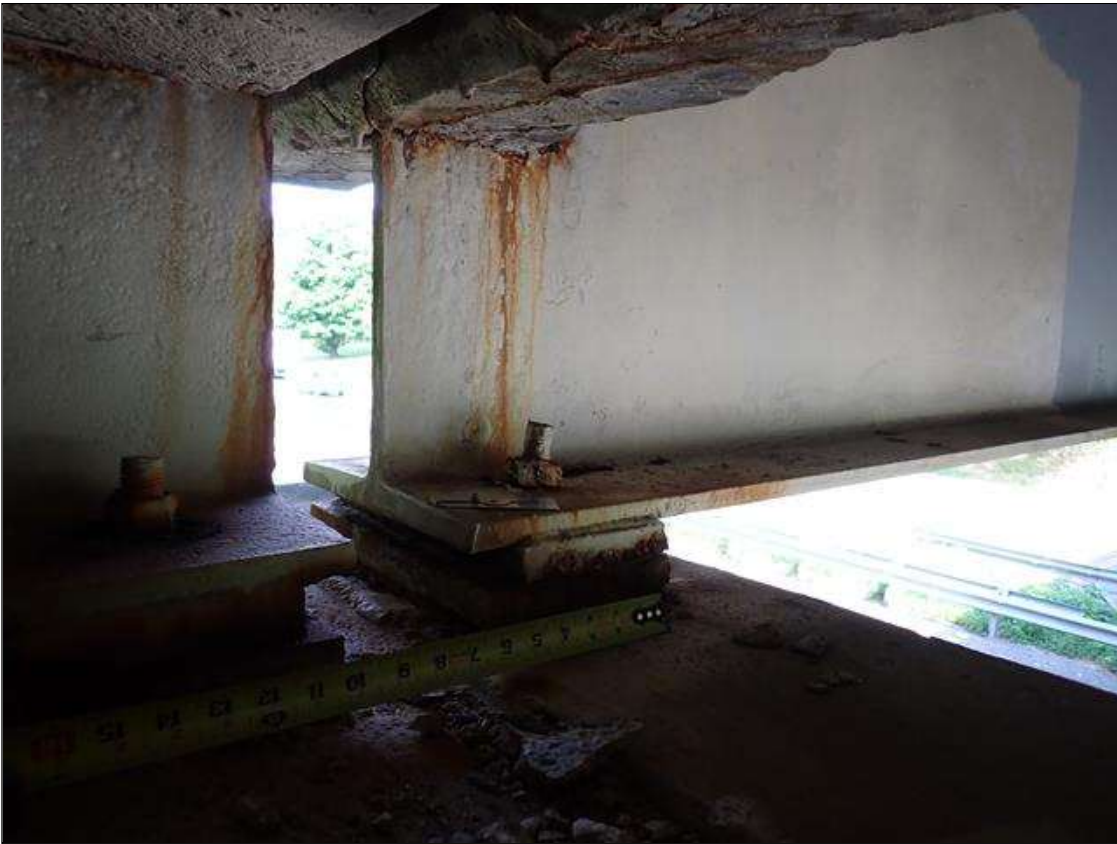
Span 2 Beam 1: at bent 1, web adjacent to diaphragm, painted over section loss (1/2 inch average remaining x 4 inch x 5 inch); bottom flange, painted over pitting (up to 1/8 inch deep x 1.5 feet) with corrosion reinitiated

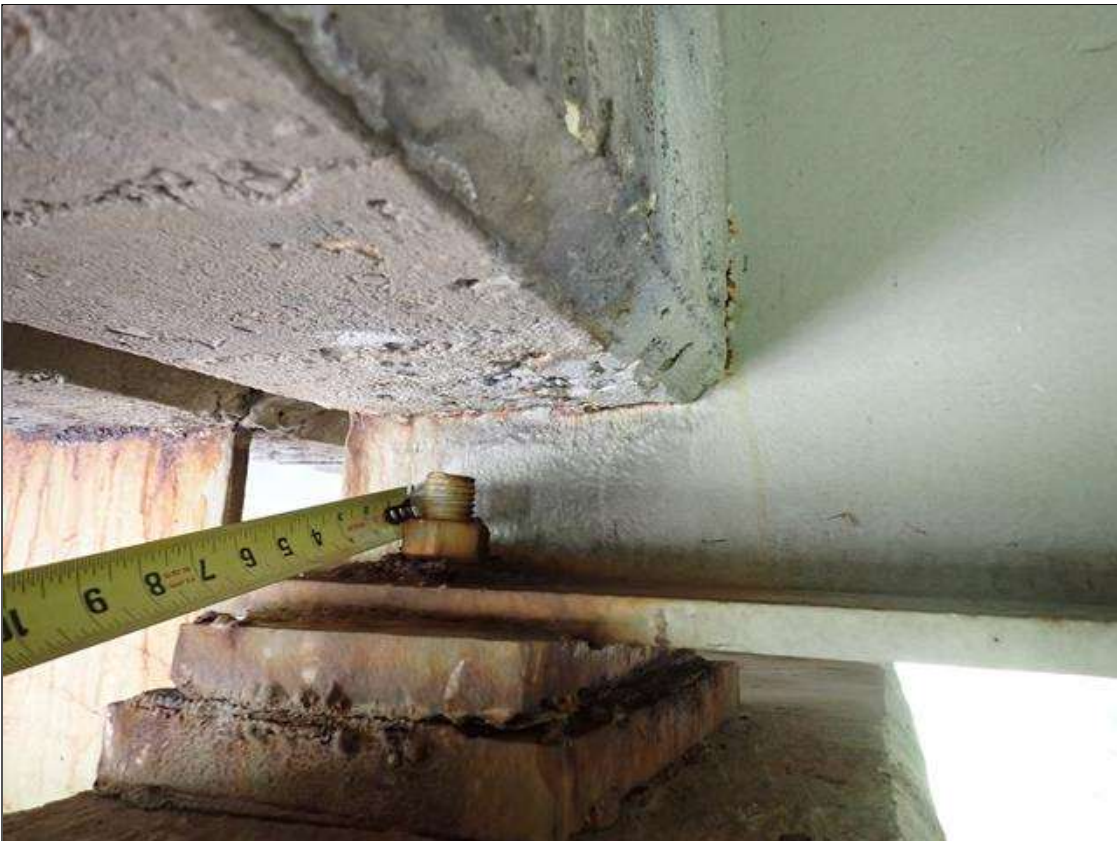
Span 1 Beam 2: at bent 1, web adjacent to diaphragm, painted over section loss (7/16 inch average remaining x 9 inch x 1 inch) with adjacent pitting (up to 1/8 inch deep) with corrosion reinitiated

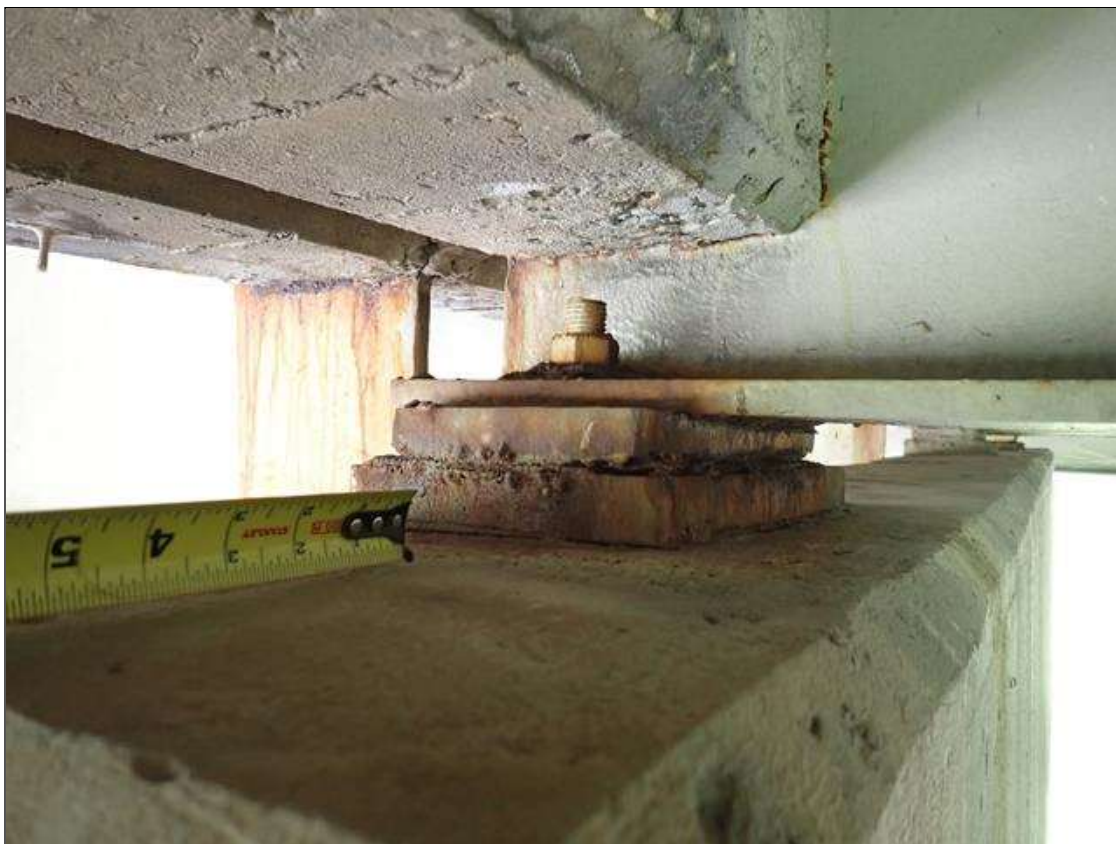
Span 1 Beam 2 - Far Bearing 2: SPAN 1 FAR BEARING HAS RUST SCALE/PACK RUST

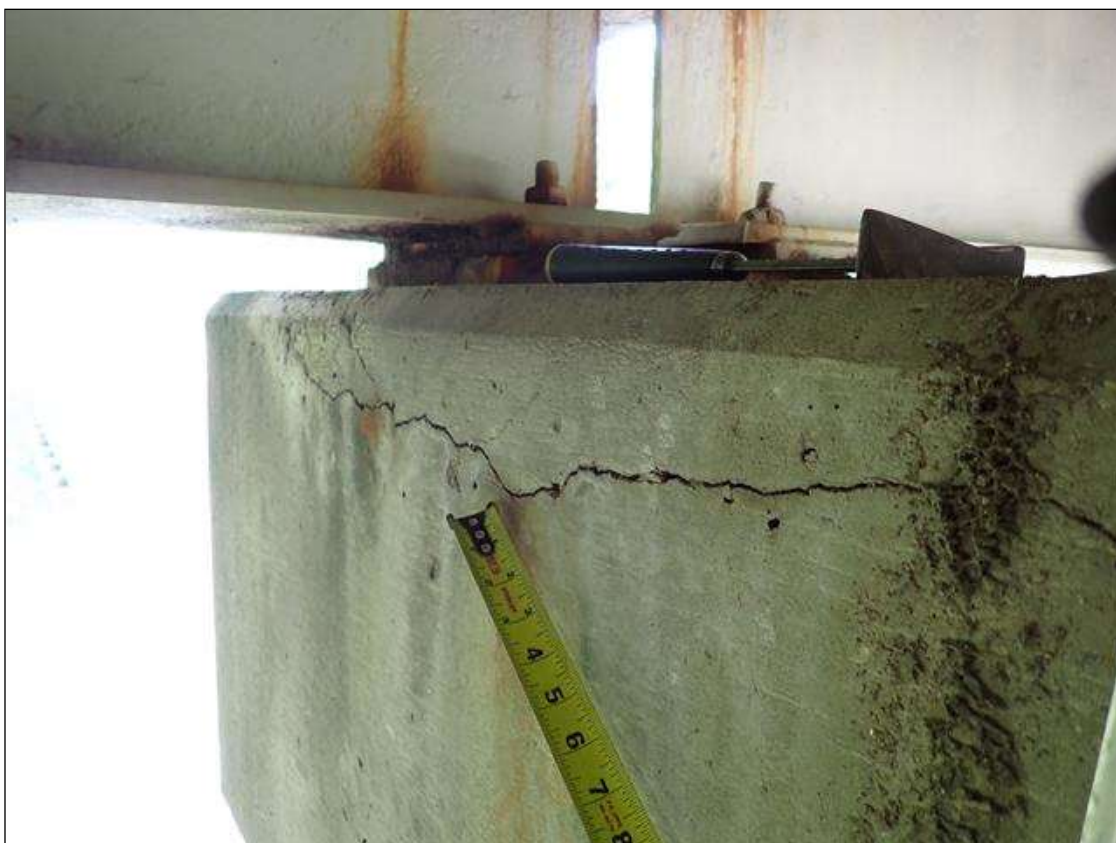
Bent 1 Cap 1: (PAR) south and north faces, below all bays, delaminations (up to 5.5 feet x 6 inch) with cracks (up to 1/8 inch) and rust stains

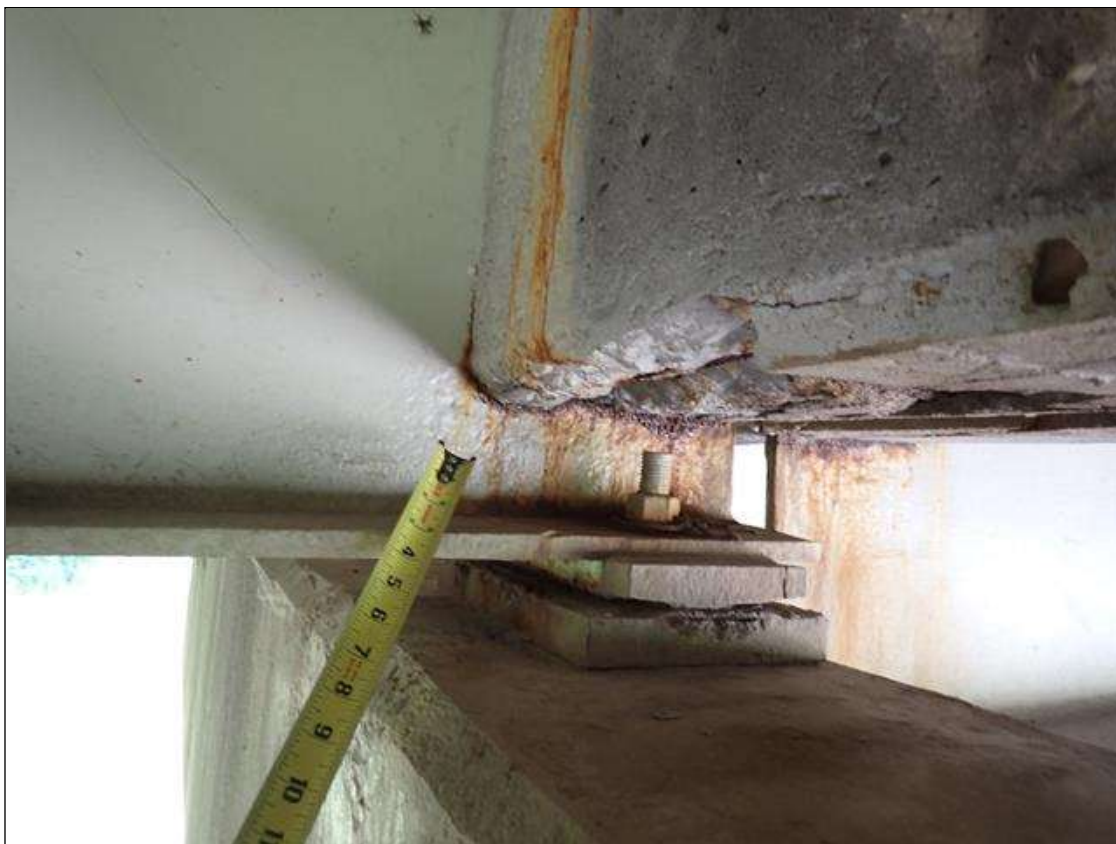
Span 1 Beam 3: (PAR) at bent 1, web adjacent to diaphragm, painted over section loss (3/8 inch average remaining x 10 inch x 2 inch) with corrosion reinitiated

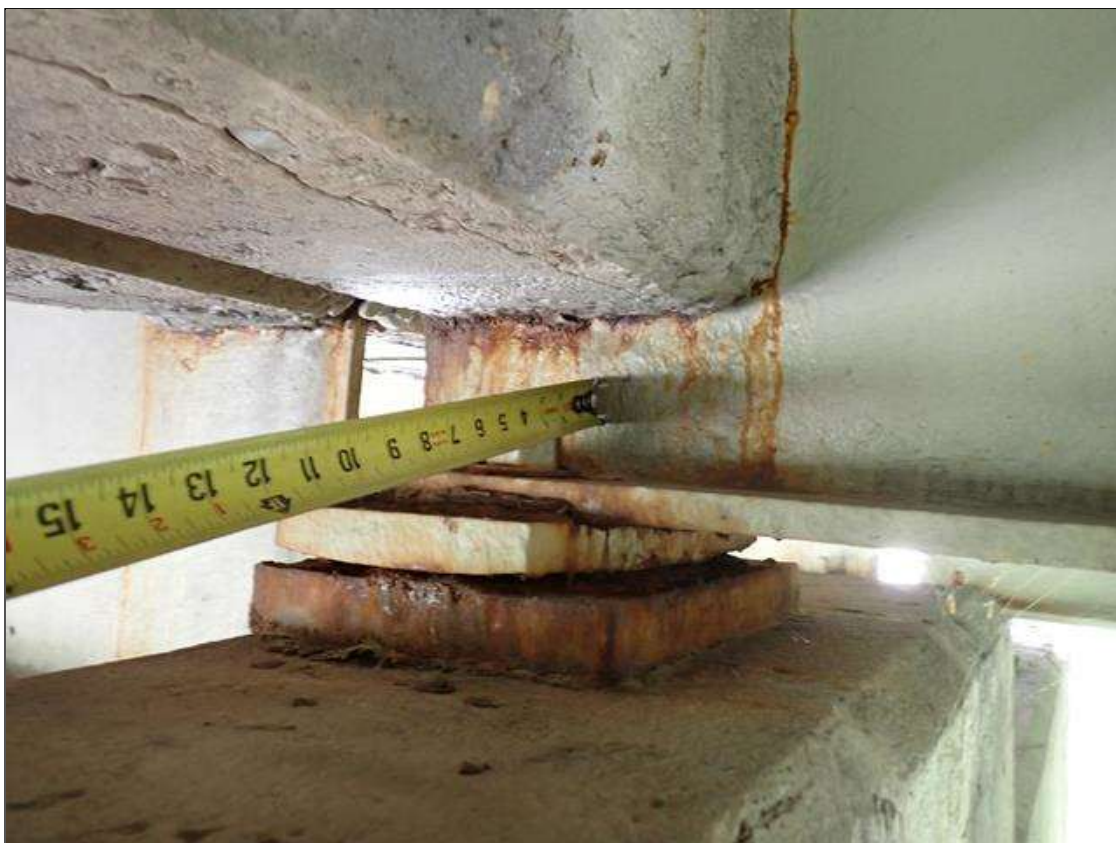
Span 1 Beam 4: (PAR) at bent 1, web adjacent to diaphragm, painted over section loss (3/8 inch average remaining x 9 inch x 4 inch) with corrosion reinitiated
