NC DEPARTMENT OF TRANSPORTATION  
 DIVISION OF HIGHWAYS  
 STRUCTURE MANAGEMENT UNIT

ATTENTION: prompt action request, sketches revised, clearances revised; span 2 beams heat straightened and repainted since previous inspection

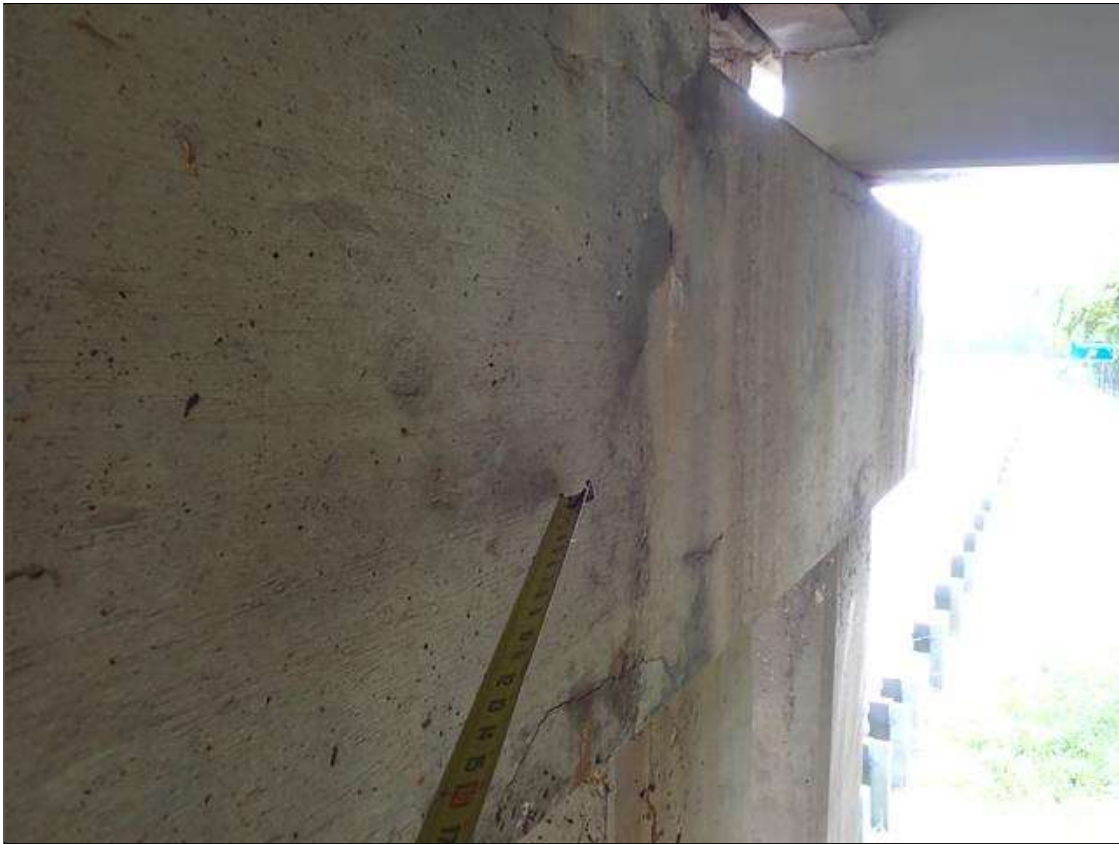
Bent 1 Cap 1: (PAR) south and north faces, below all bays, delaminations (up to 5.5 feet x 6 inch) with cracks (up to 1/8 inch) and rust stains

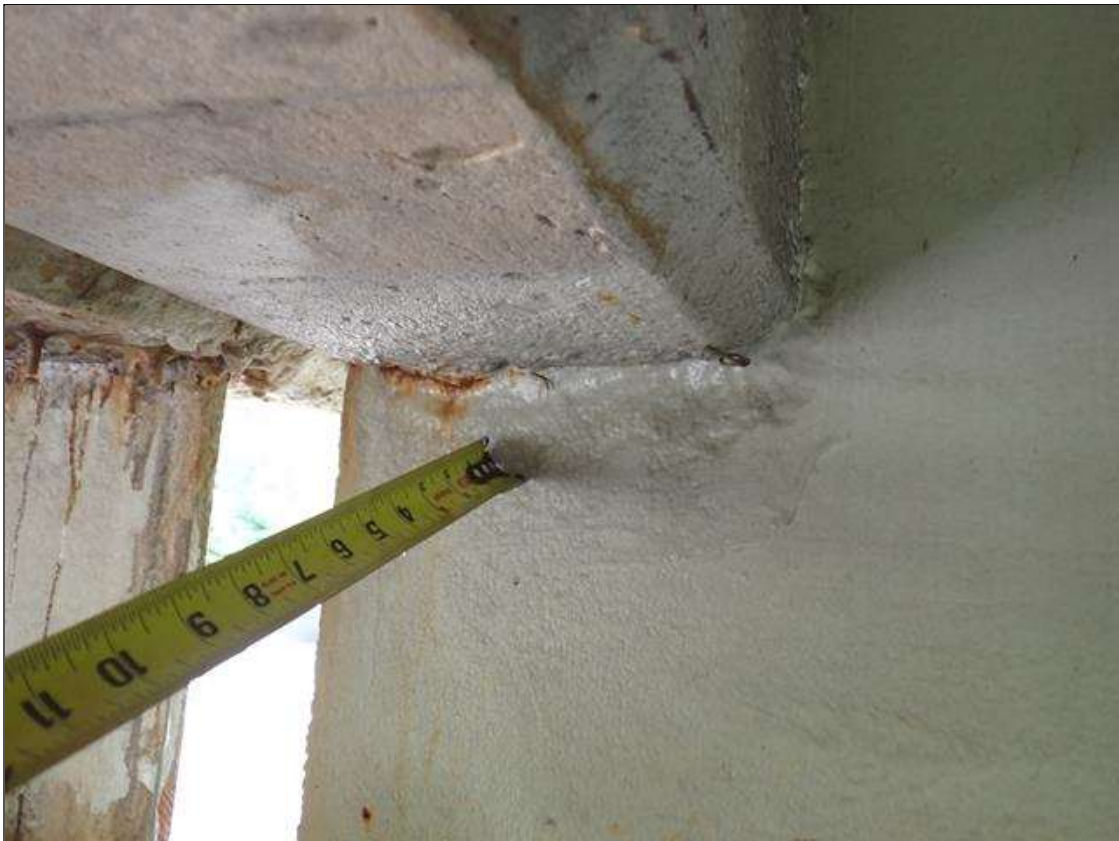
Span 1 Beam 5: at bent 1, web adjacent to diaphragm, painted over section loss (1/2 inch average remaining x 10 inch x 2 inch) with corrosion reinitiated

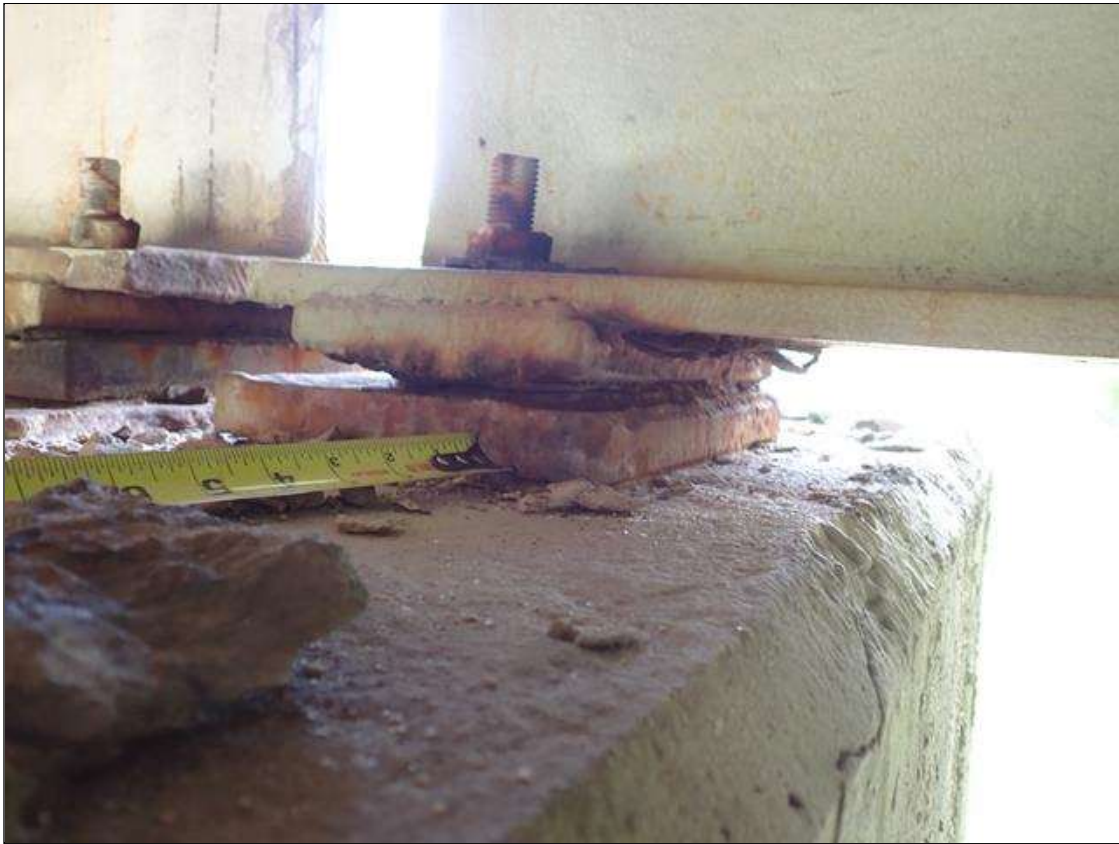
Span 1 Beam 5 - Far Bearing 5: painted over section loss (up to 3/16 inch deep) with corrosion reinitiated; pack rust

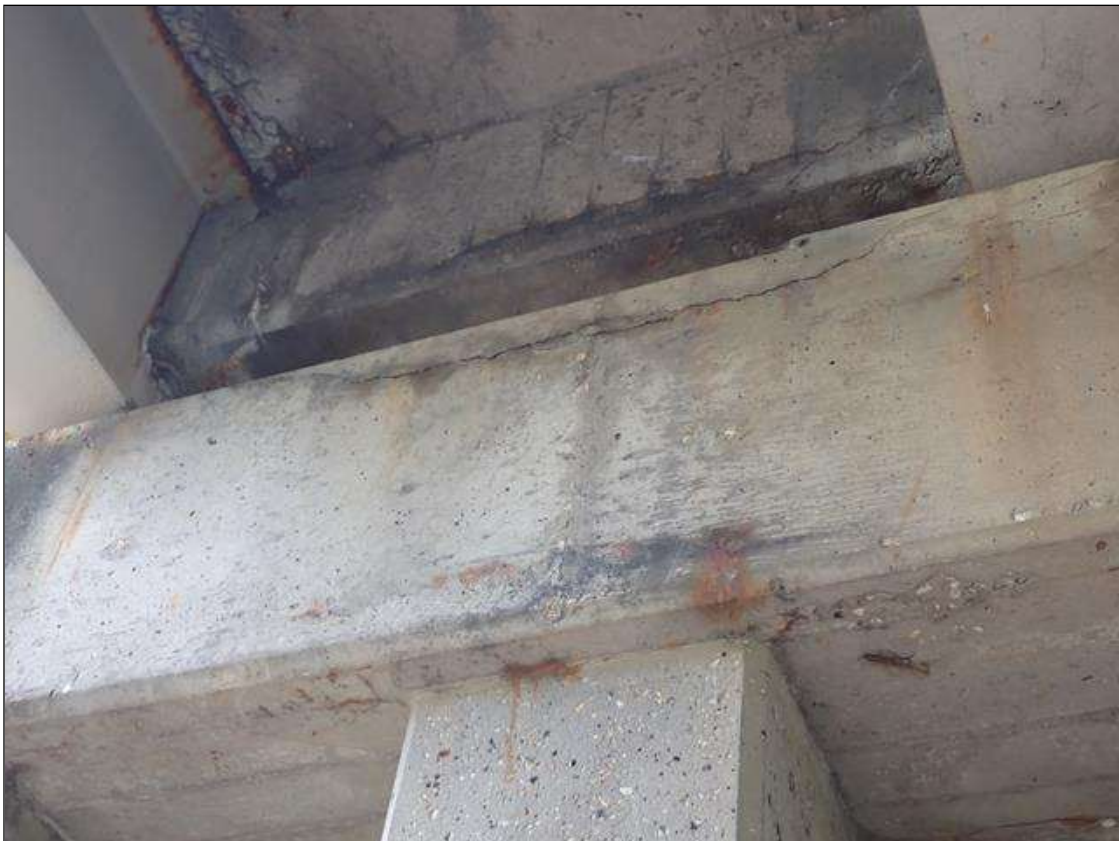
Bent 1 Cap 1: (PAR) south and north faces, below all bays, delaminations (up to 5.5 feet x 6 inch) with cracks (up to 1/8 inch) and rust stains

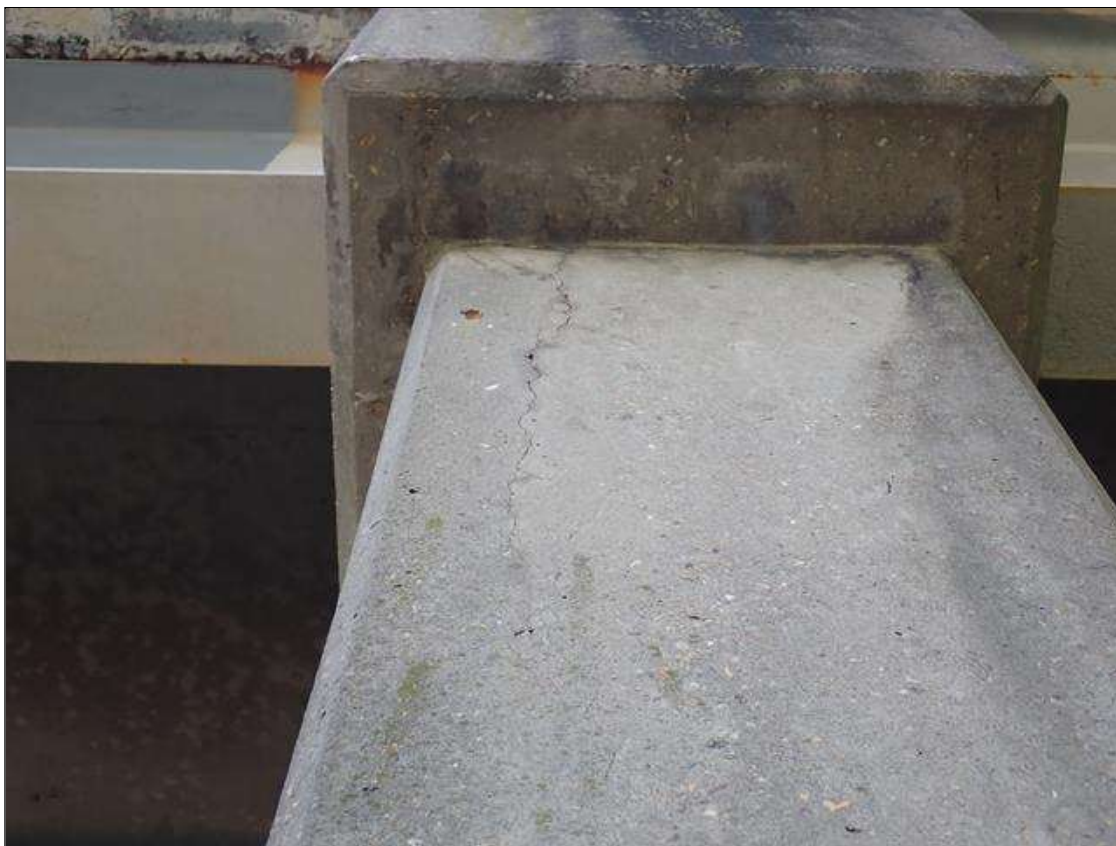
Bent 1 Pile 1: northwest corner, adjacent to cap, delamination (2.5 feet x 6 inch) with cracks (up to 1/32 inch)

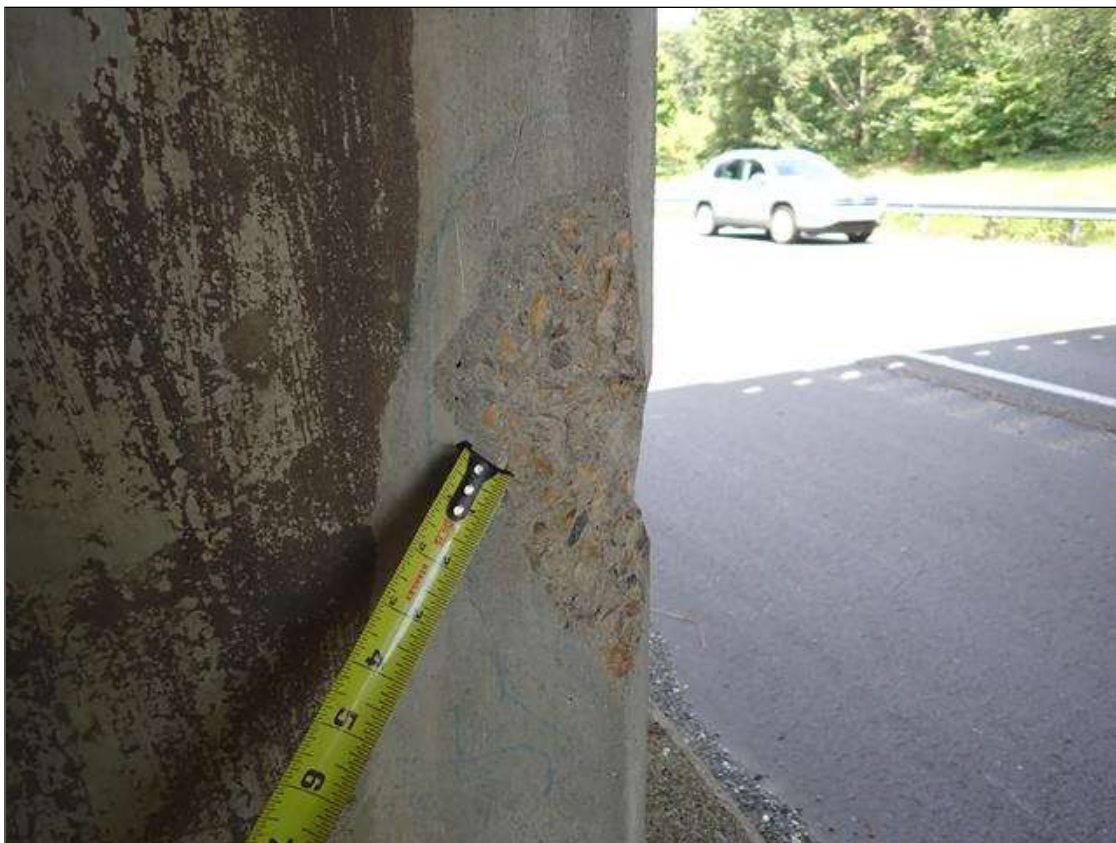
Bent 1 Pile 1: northeast corner, near mid-height, (2) spalls (up to 10 inch x 4 inch x 1 inch deep)

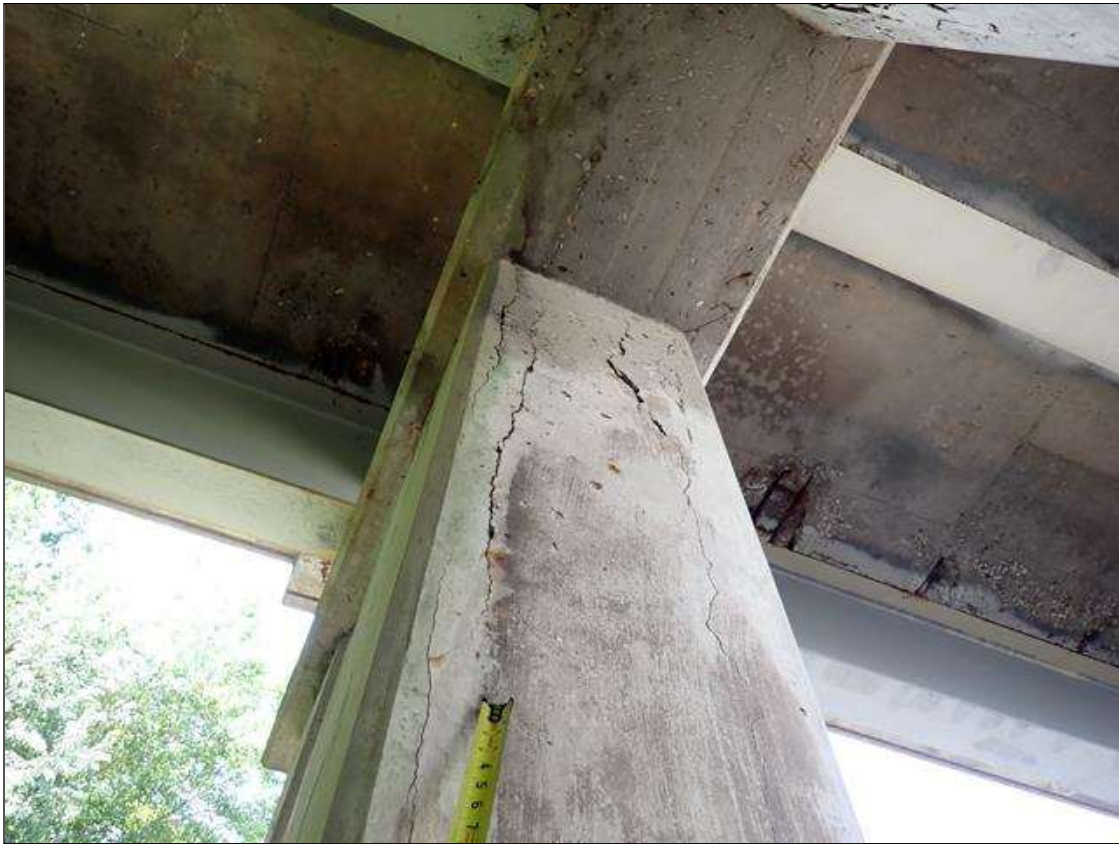
Bent 1 Pile 2: west, east and south faces, near cap, spalls/delaminations (up to 5.5 feet x 8 inch x 1 inch deep) with cracks (up to 3/16 inch)

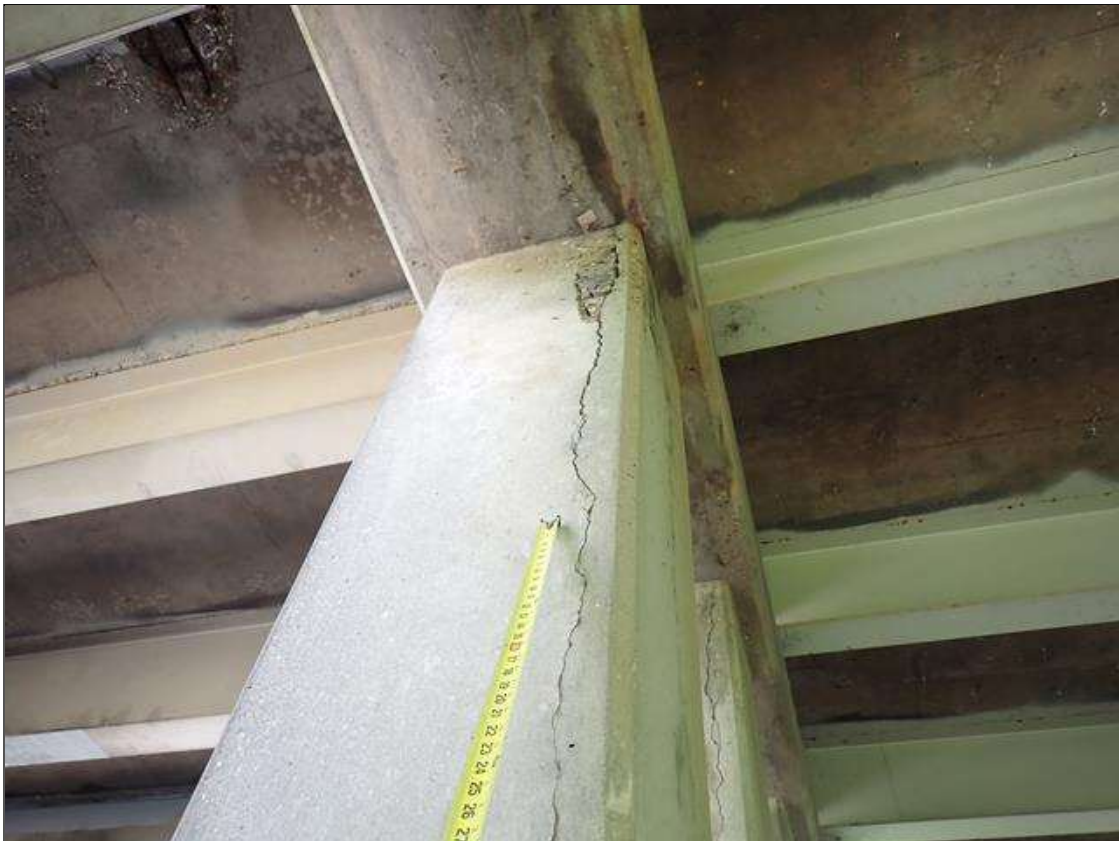
Bent 1 Pile 2: west, east and south faces, near cap, spalls/delaminations (up to 5.5 feet x 8 inch x 1 inch deep) with cracks (up to 3/16 inch)

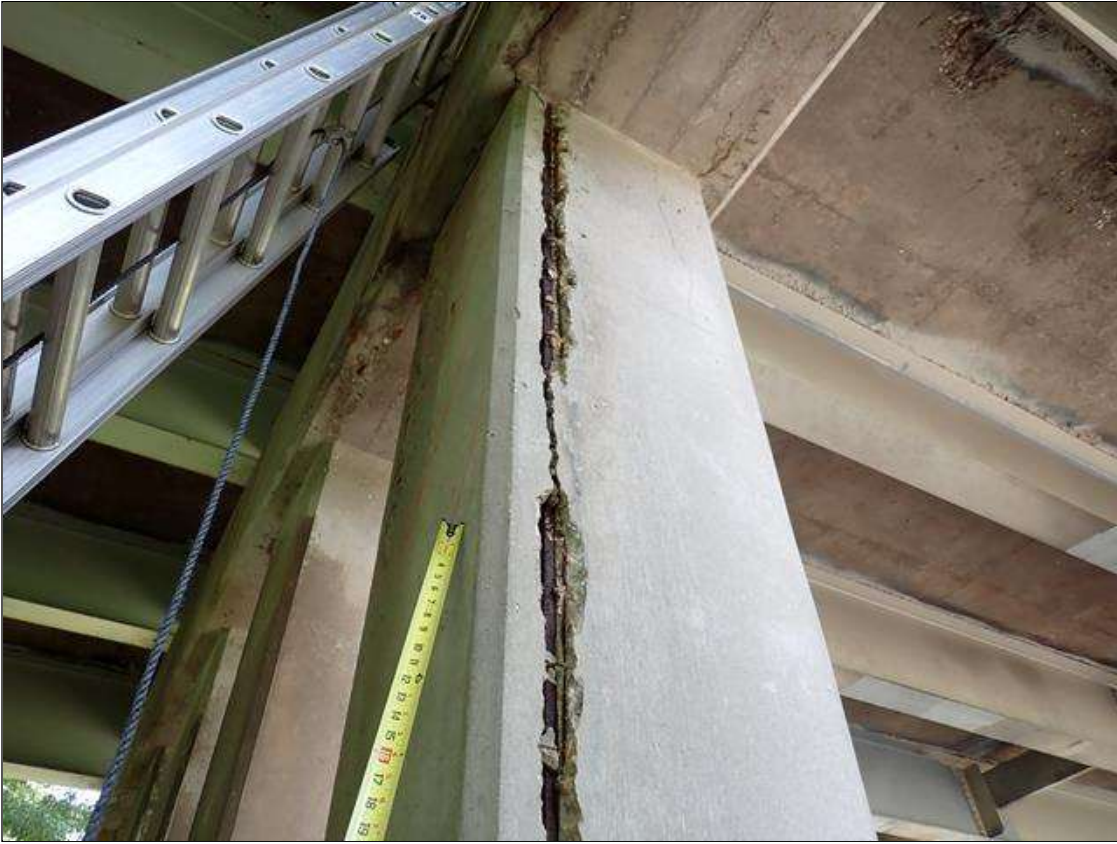
Bent 1 Pile 6: (PAR) west, east and south faces, spalls/delaminations (up to 11 feet x 18 inch x 1 inch deep) with cracks (up to 1/4 inch) and exposed H-pile flanges; flanges have rust scale

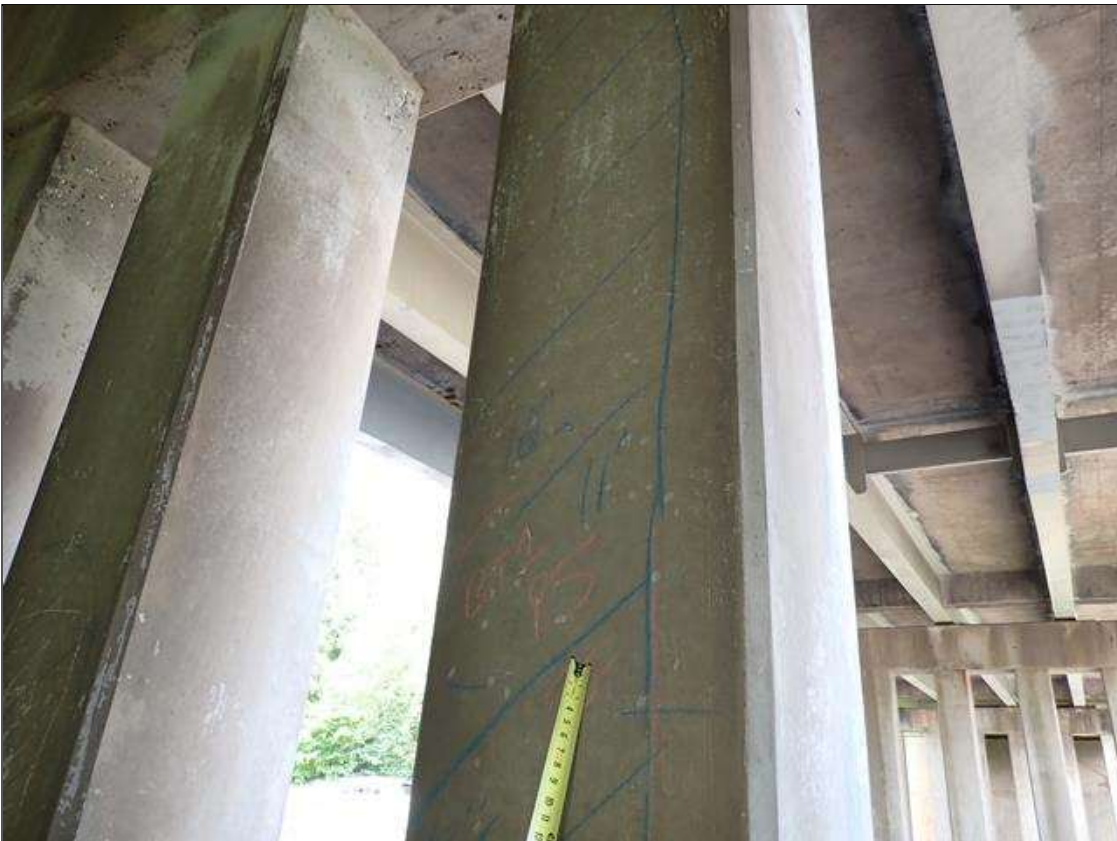
Bent 1 Pile 5: (PAR) west, east and south faces, spalls/delaminations (up to full height x 17 inch x 1 inch deep) with cracks (up to 1/8 inch) and exposed H-pile flanges; flanges have rust scale

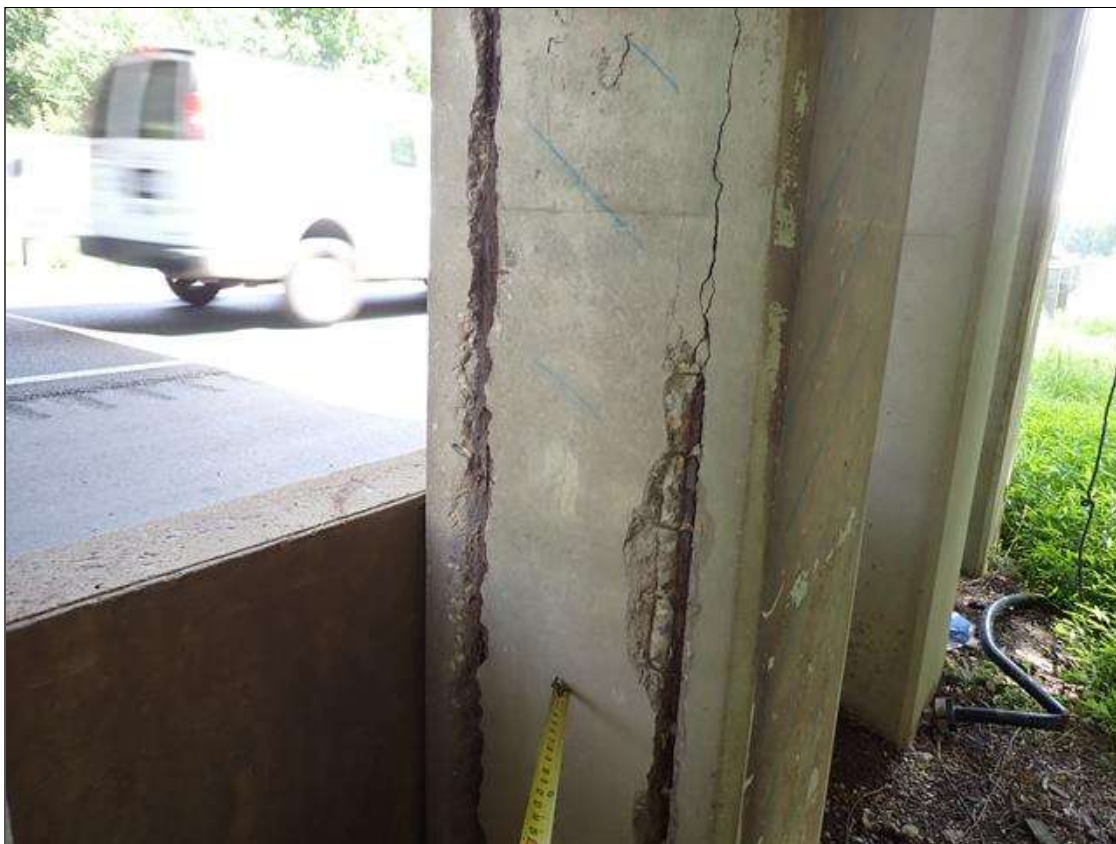
Bent 1 Pile 5: (PAR) west, east and south faces, spalls/delaminations (up to full height x 17 inch x 1 inch deep) with cracks (up to 1/8 inch) and exposed H-pile flanges; flanges have rust scale

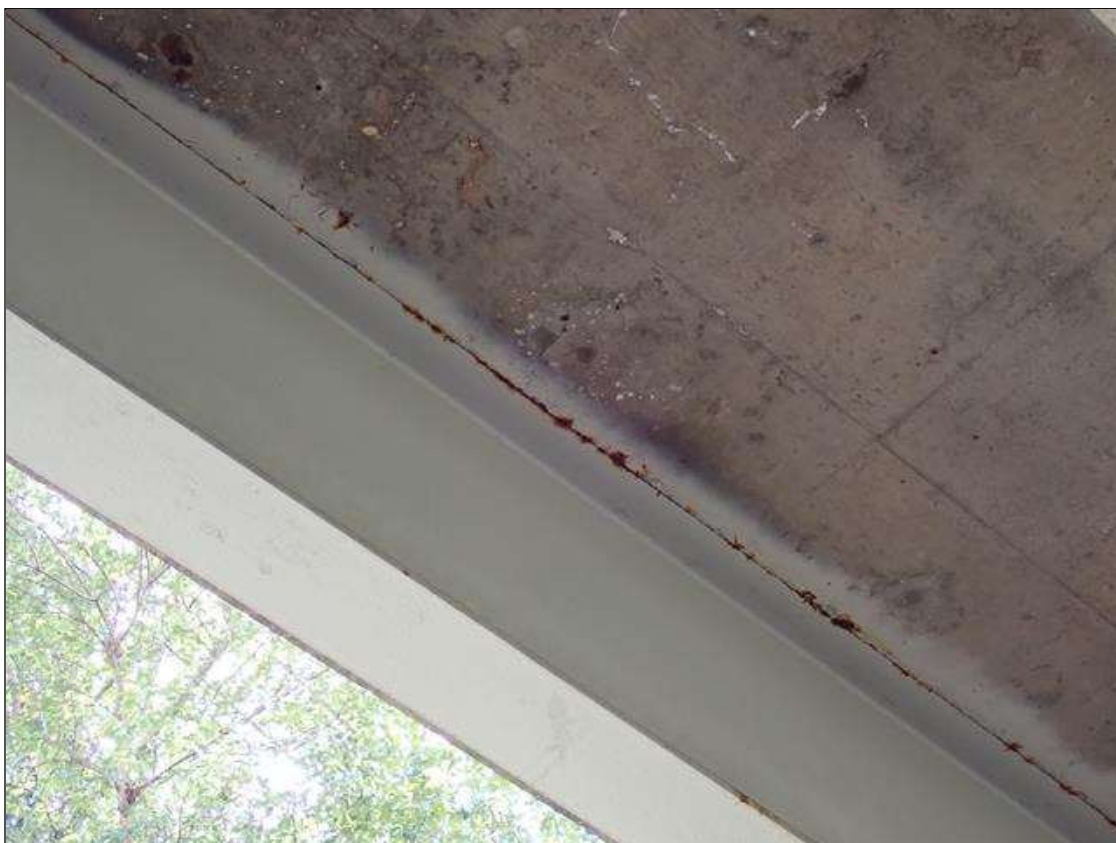
Span 1 Beam 5: along the top flange, surface rust at random

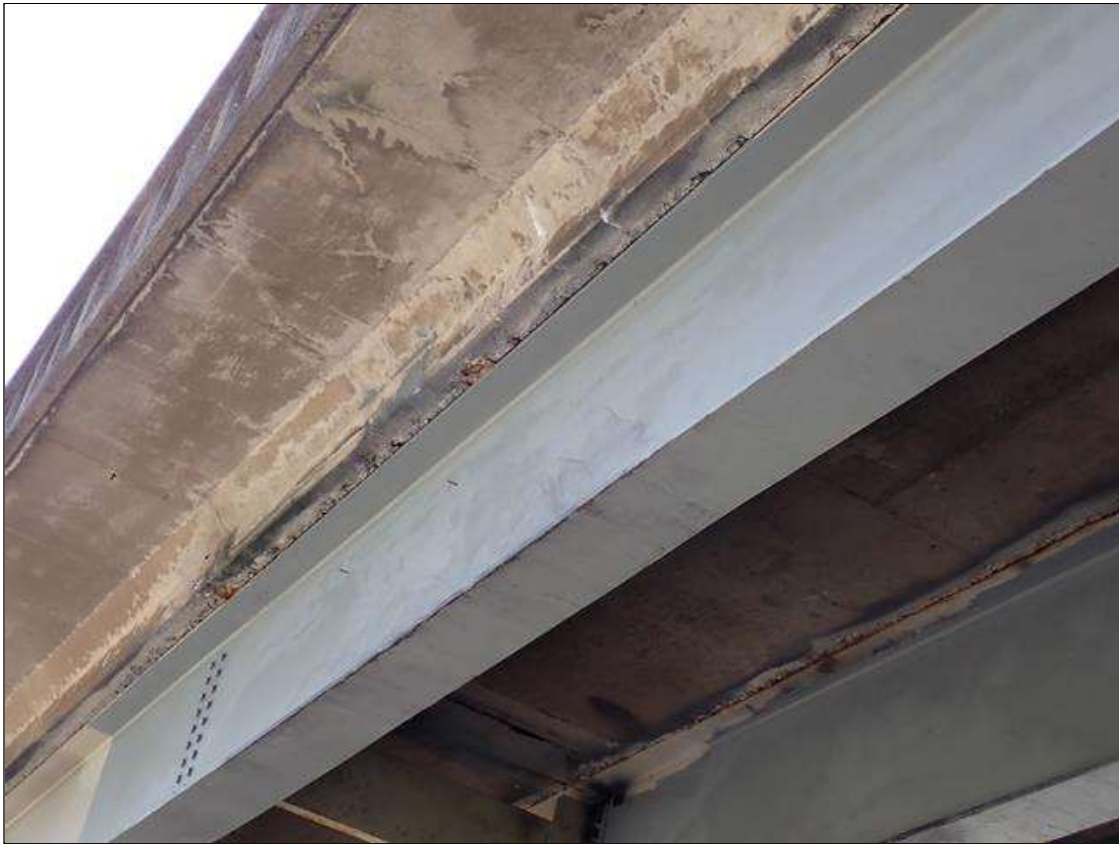
DIAPHRAGM IN BAY 1 AT PIER 1 BETWEEN beams. 1 AND 2 SPALLED WITH EXPOSED REBAR 22 INCHES HIGH  
 X 22 INCHES WIDE X 3 INCHES DEEP. INTERIOR METAL DIAPHRAGM IN BAY 1 AT 25 FEET-9 INCHES FROM  
 NORTH FACE OF PIER 1 IS BENT EASTWARD 21 INCHES HIGH X UP TO 3/4 INCH WIDE AND BENT NORTH 7  
 INCHES (2016 SUPPLEMENTAL INSPECTION)

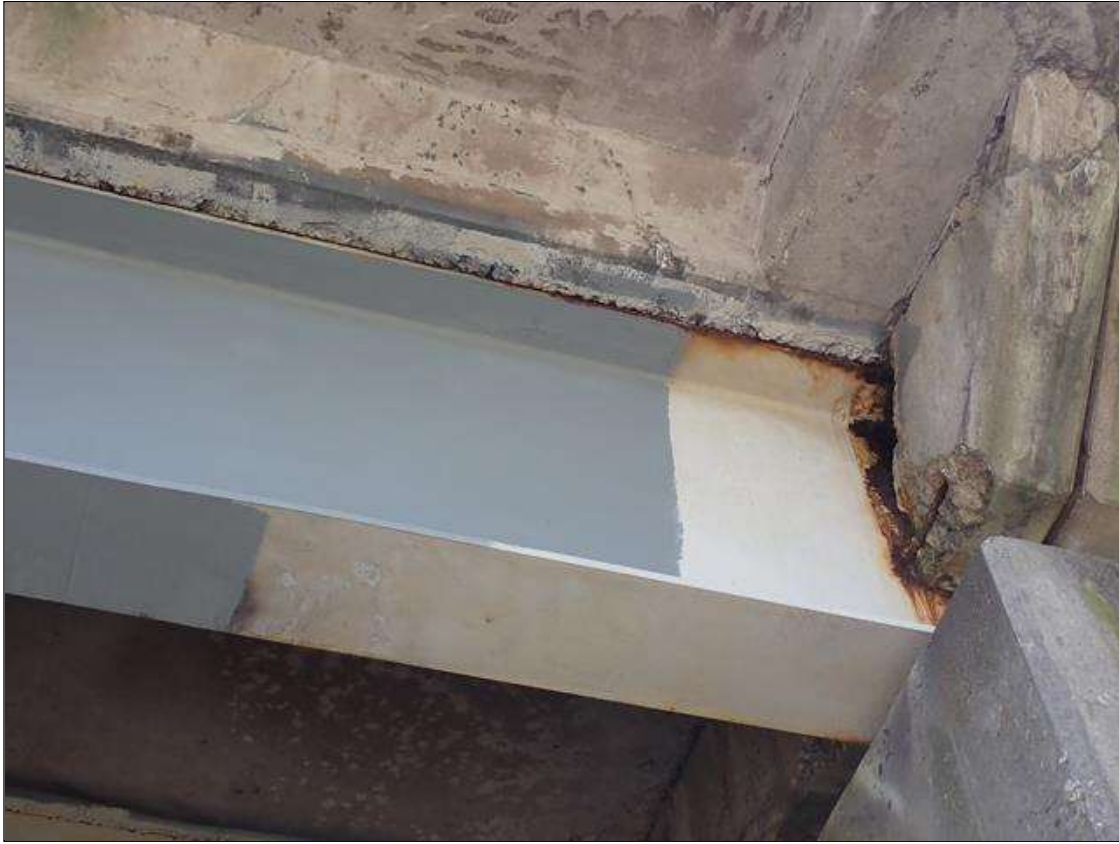
DIAPHRAGM IN BAY 1 AT PIER 1 BETWEEN beams. 1 AND 2 SPALLED WITH EXPOSED REBAR 22 INCHES HIGH  
 X 22 INCHES WIDE X 3 INCHES DEEP. INTERIOR METAL DIAPHRAGM IN BAY 1 AT 25 FEET-9 INCHES FROM  
 NORTH FACE OF PIER 1 IS BENT EASTWARD 21 INCHES HIGH X UP TO 3/4 INCH WIDE AND BENT NORTH 7  
 INCHES (2016 SUPPLEMENTAL INSPECTION)

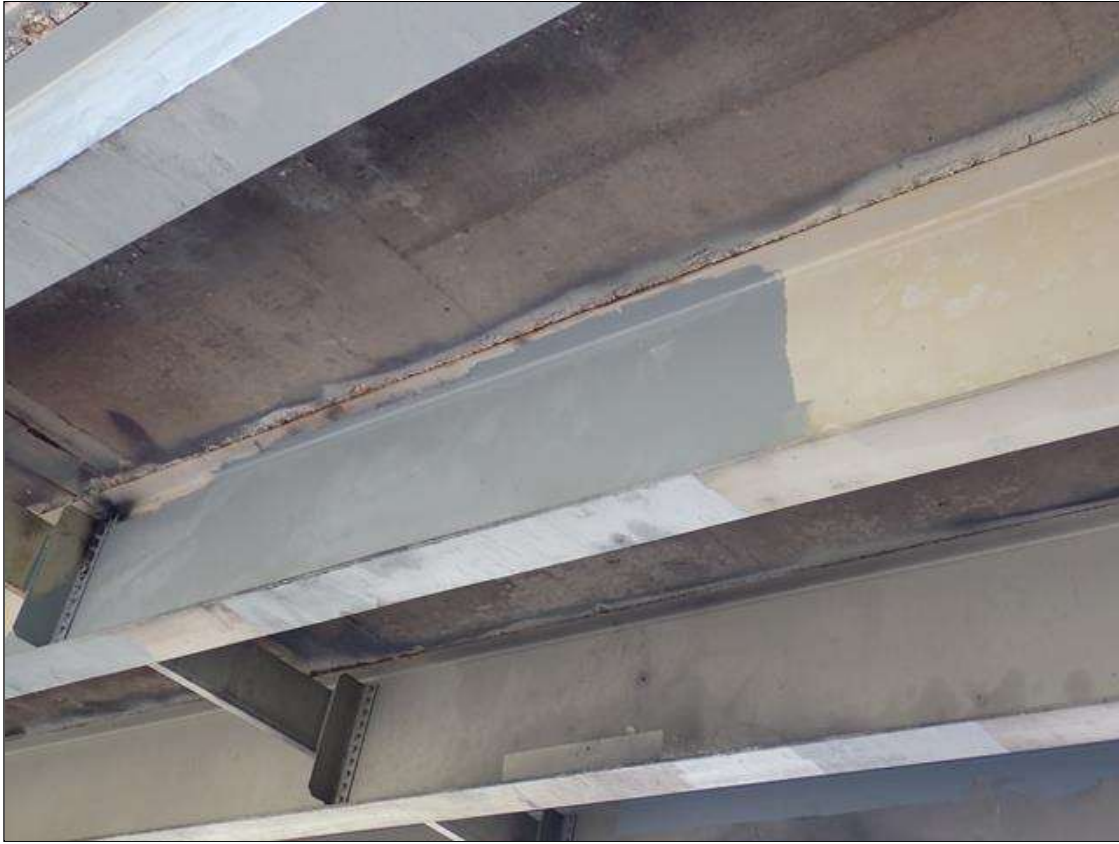
Span 2 Beam 2: (PAR) 2023 repainted with no apparent new damage; previously noted as: -----  
-----BEAM 2 SPAN 2 BENT EASTWARD 10 INCHES AT POINT OF  
IMPACT. POINT OF IMPACT IS 19 FEET FROM NORTH OF PIER 1. BEAM. 2 HAS A 1 1/4 INCH BEND EAST UP TO  
14 FEET WIDE AT POINT OF IMPACT. THE BEAM IS TWISTED 26 FEET STARTING AT PIER 1. THE BEAM HAS  
PULLED AWAY 1/12 INCH AT TOP. THE METAL INTERMEDIATE. DIAPHRAGM BAY 1 AT THE BEAM 2  
CONNECTION IS BENT EAST 1 INCH AT BOTTOM FOR 3 INCHES HIGH. THE METAL INTERMEDIATE.  
DIAPHRAGM IN BAY 2 AT THE BEAM 2 CONNECTION IS BENT EAST FOR 1 INCH AT BOTTOM FOR 3 INCHES  
HIGH (2016 SUPPLEMENTAL INSPECTION).

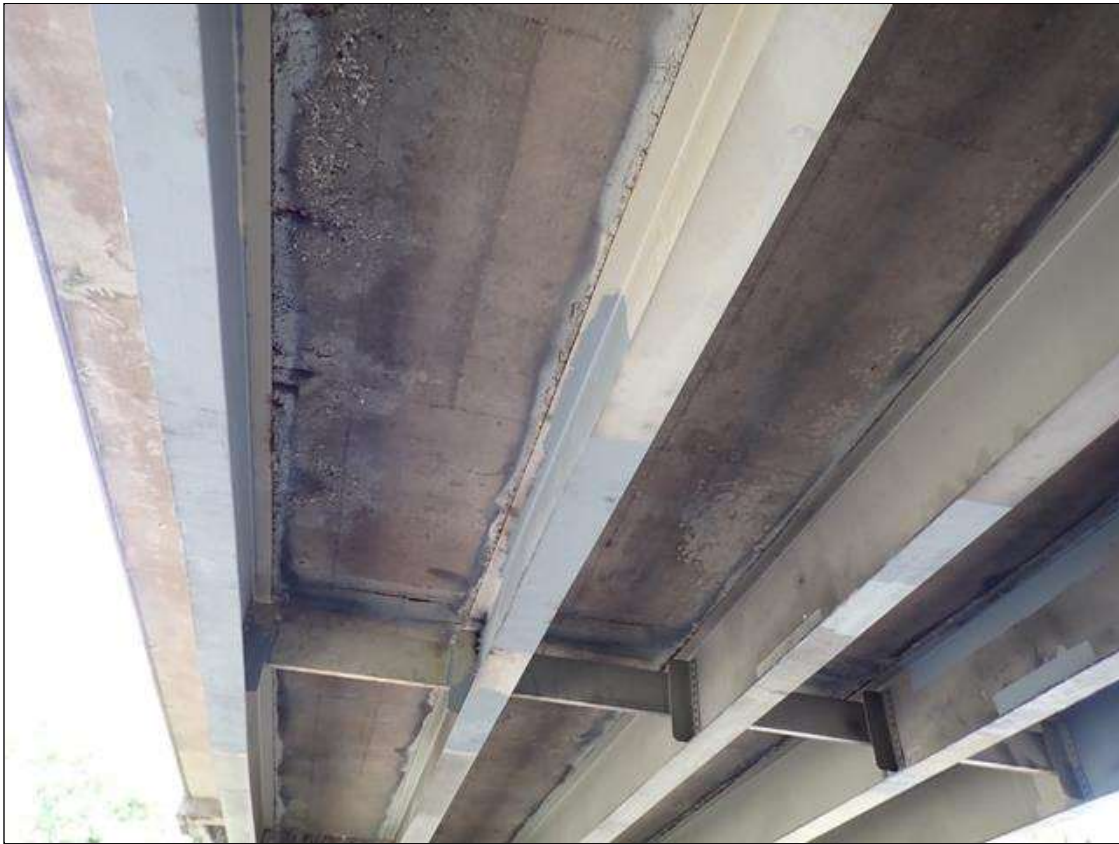
Span 2 Beam 2: (PAR) 2023 repainted with no apparent new damage; previously noted as: -----  
-----BEAM 2 SPAN 2 BENT EASTWARD 10 INCHES AT POINT OF  
IMPACT. POINT OF IMPACT IS 19 FEET FROM NORTH OF PIER 1. BEAM. 2 HAS A 1 1/4 INCH BEND EAST UP TO  
14 FEET WIDE AT POINT OF IMPACT. THE BEAM IS TWISTED 26 FEET STARTING AT PIER 1. THE BEAM HAS  
PULLED AWAY 1/12 INCH AT TOP. THE METAL INTERMEDIATE. DIAPHRAGM BAY 1 AT THE BEAM 2  
CONNECTION IS BENT EAST 1 INCH AT BOTTOM FOR 3 INCHES HIGH. THE METAL INTERMEDIATE.  
DIAPHRAGM IN BAY 2 AT THE BEAM 2 CONNECTION IS BENT EAST FOR 1 INCH AT BOTTOM FOR 3 INCHES  
HIGH (2016 SUPPLEMENTAL INSPECTION).

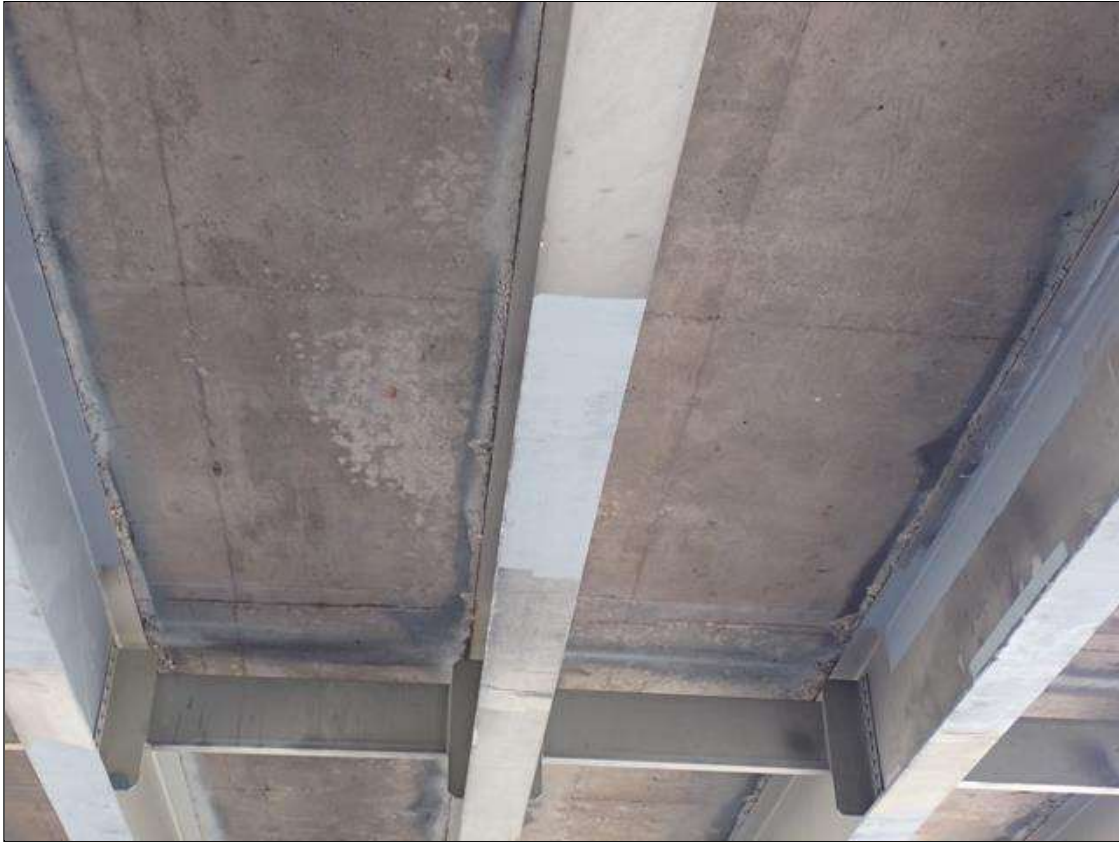
Span 2 Beam 3: (PAR) 2023 repainted with no apparent new damage; previously noted as: -----  
-----BEAM 3 SPAN 2 PULLED AWAY FROM DECK UP TO 1/2 INCH  
STARTING AT 10 FEET PIER 1 NORTH FACE FOR 17 FEET LONG. POINT OF IMPACT IS 19 FEET-1 INCH FROM  
NORTH FACE OF PIER 1. THERE ARE TWO GOUGES 5 1/2 INCHES LONG X 1/4 INCH DEEP AT 18 FEET-6  
INCHES ALONG THE BOTTOM FLANGE (2016 SUPPLEMENTAL INSPECTION).

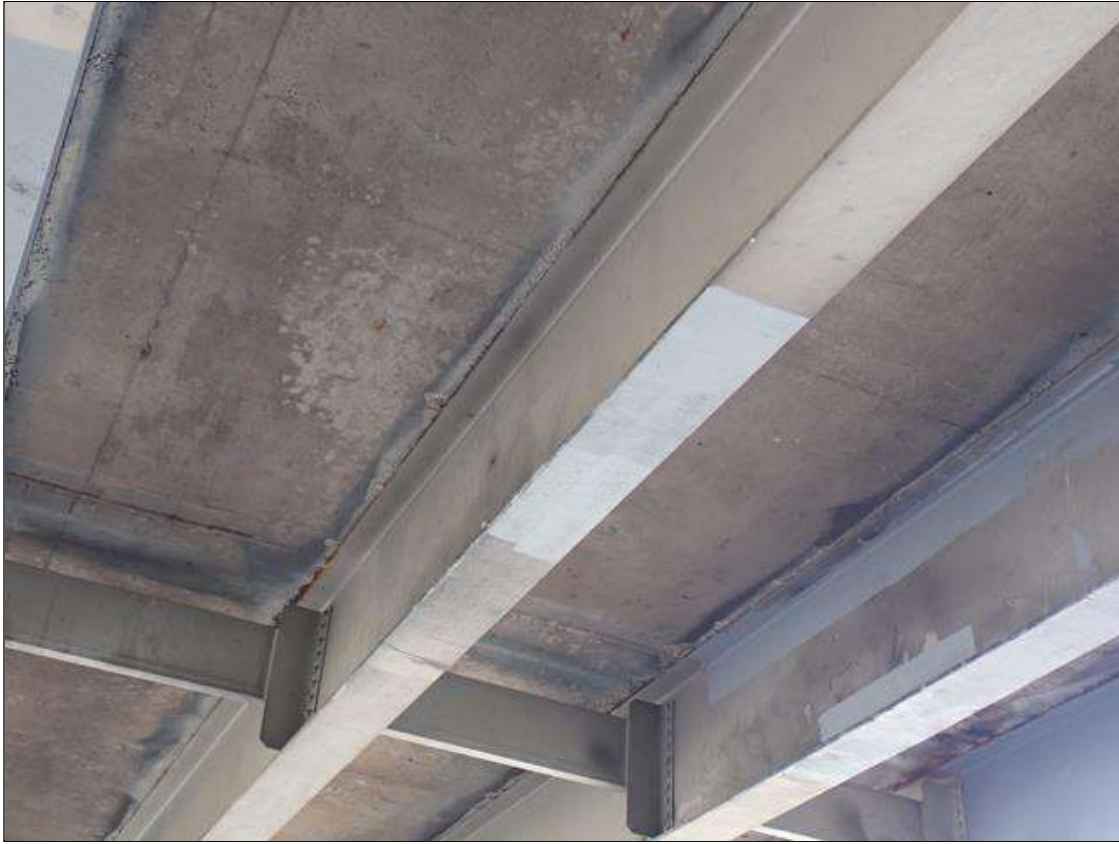
Span 2 Beam 3: (PAR) 2023 repainted with no apparent new damage; previously noted as: -----  
-----BEAM 3 SPAN 2 PULLED AWAY FROM DECK UP TO 1/2 INCH  
STARTING AT 10 FEET PIER 1 NORTH FACE FOR 17 FEET LONG. POINT OF IMPACT IS 19 FEET-1 INCH FROM  
NORTH FACE OF PIER 1. THERE ARE TWO GOUGES 5 1/2 INCHES LONG X 1/4 INCH DEEP AT 18 FEET-6  
INCHES ALONG THE BOTTOM FLANGE (2016 SUPPLEMENTAL INSPECTION).

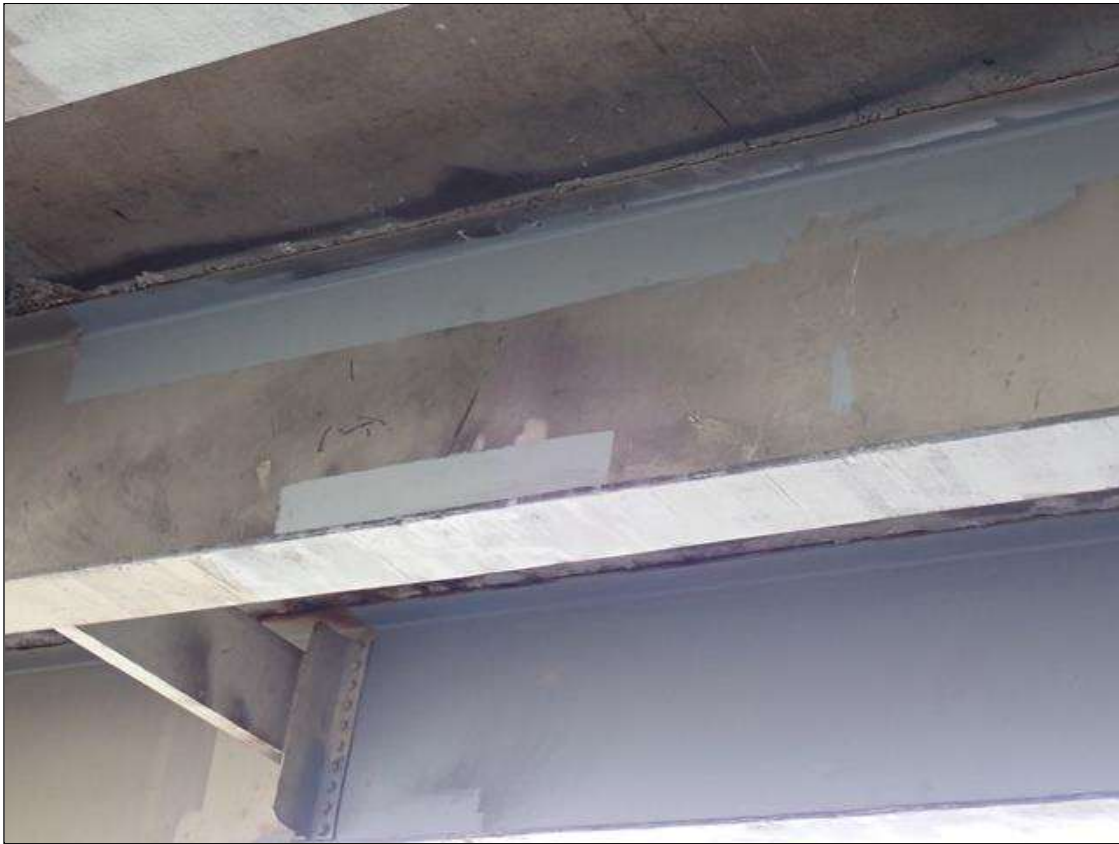
Span 2 Beam 4: (PAR) 2023 2023 heat straightened and repainted with no apparent new damage; previously noted as: -----2021 new impact damage to bottom flange, 2 feet wide with 3 inch upward deflection of West and 1 inch downward deflection of East side of bottom flange, request supplemental damage inspection -----

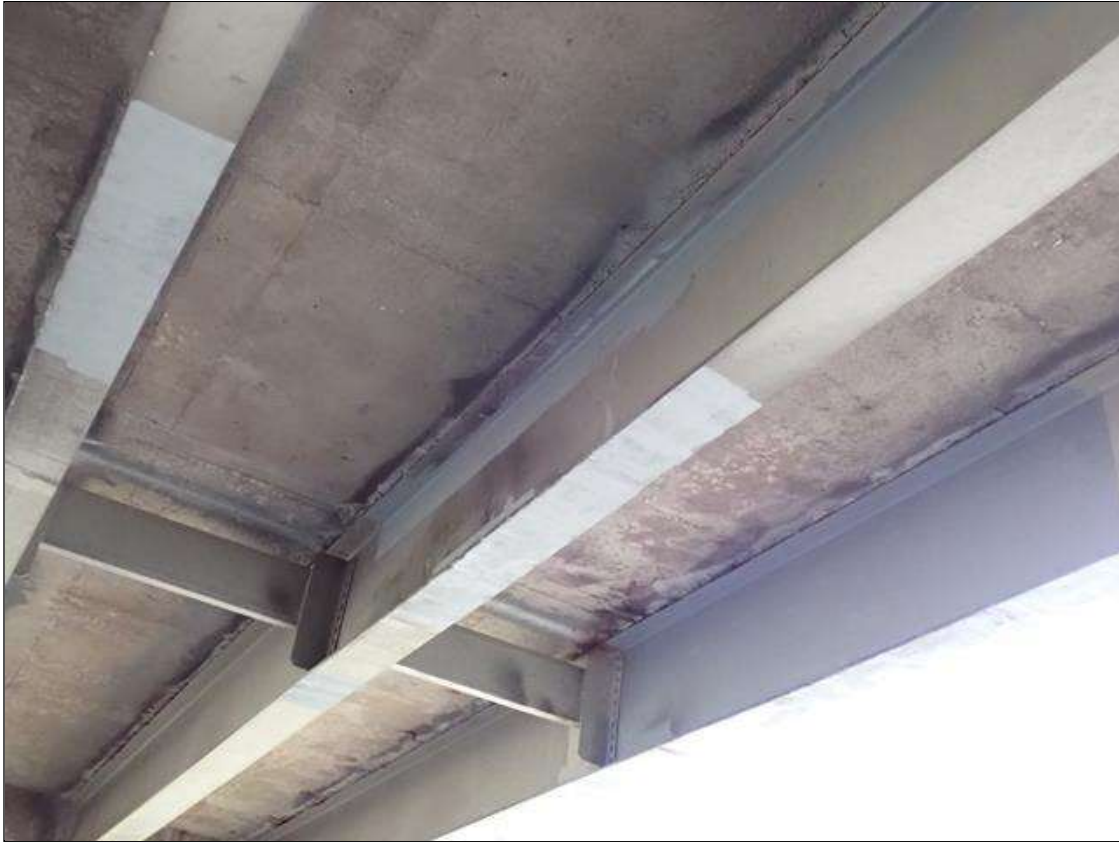
Span 2 Beam 4: (PAR) 2023 heat straightened and repainted with no apparent new damage; previously noted as: -----  
 -----2021 new impact damage to bottom flange, 2  
 feet wide with 3 inch upward deflection of West and 1 inch downward deflection of East side of bottom flange, request  
 supplemental damage inspection -----

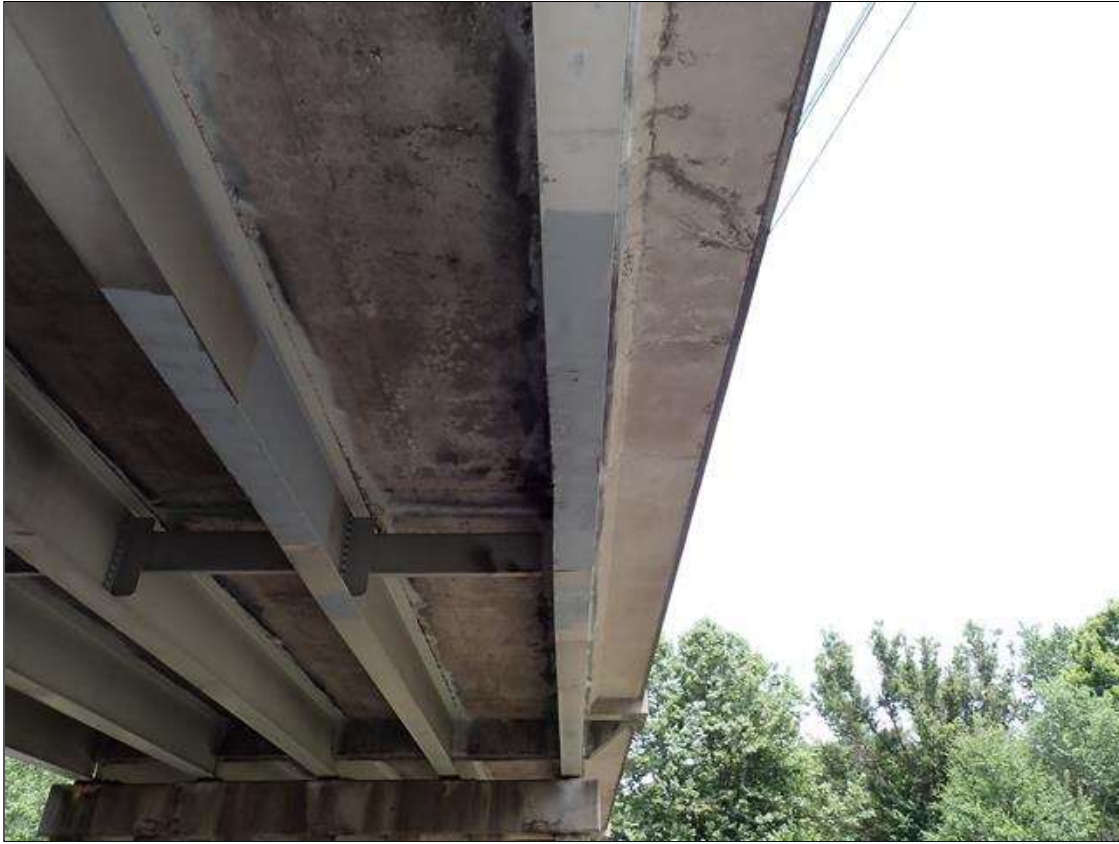
Span 2 Beam 5: (PAR) 2023 repainted with no apparent new damage; previously noted as: -----

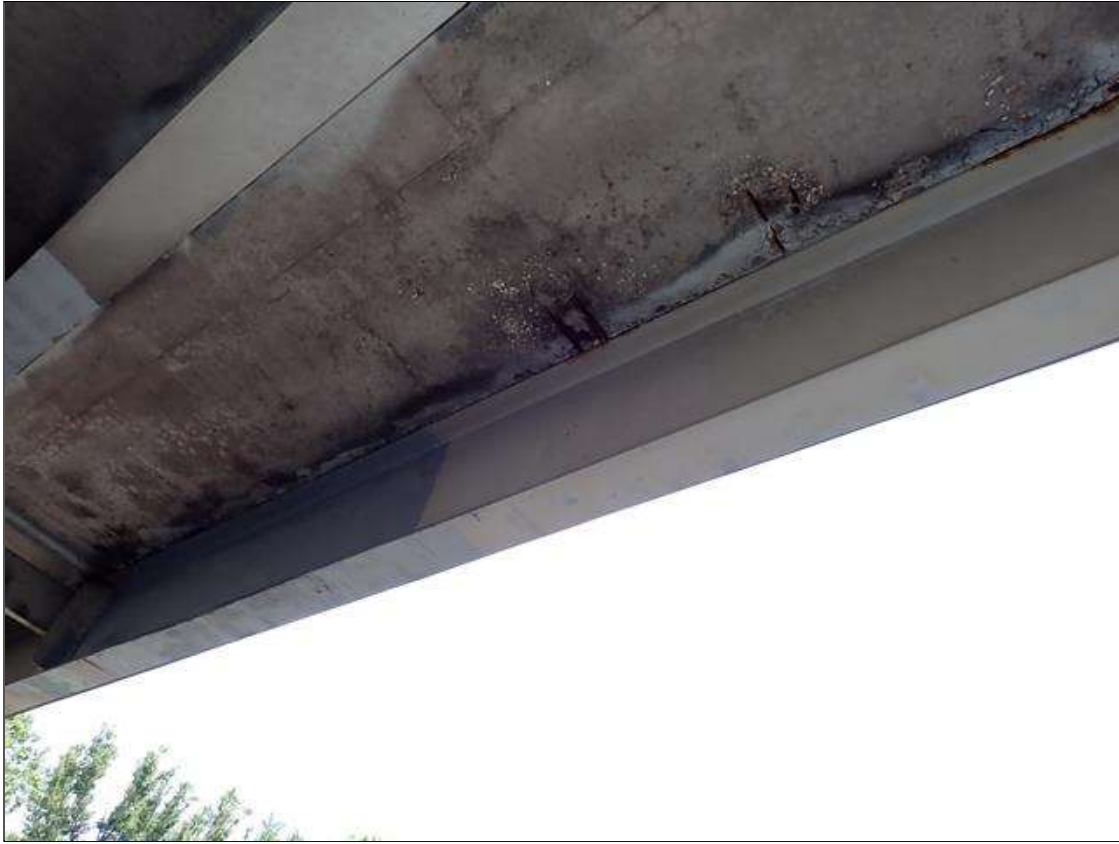
Span 2 Beam 5: (PAR) 2023 repainted with no apparent new damage; previously noted as: -----

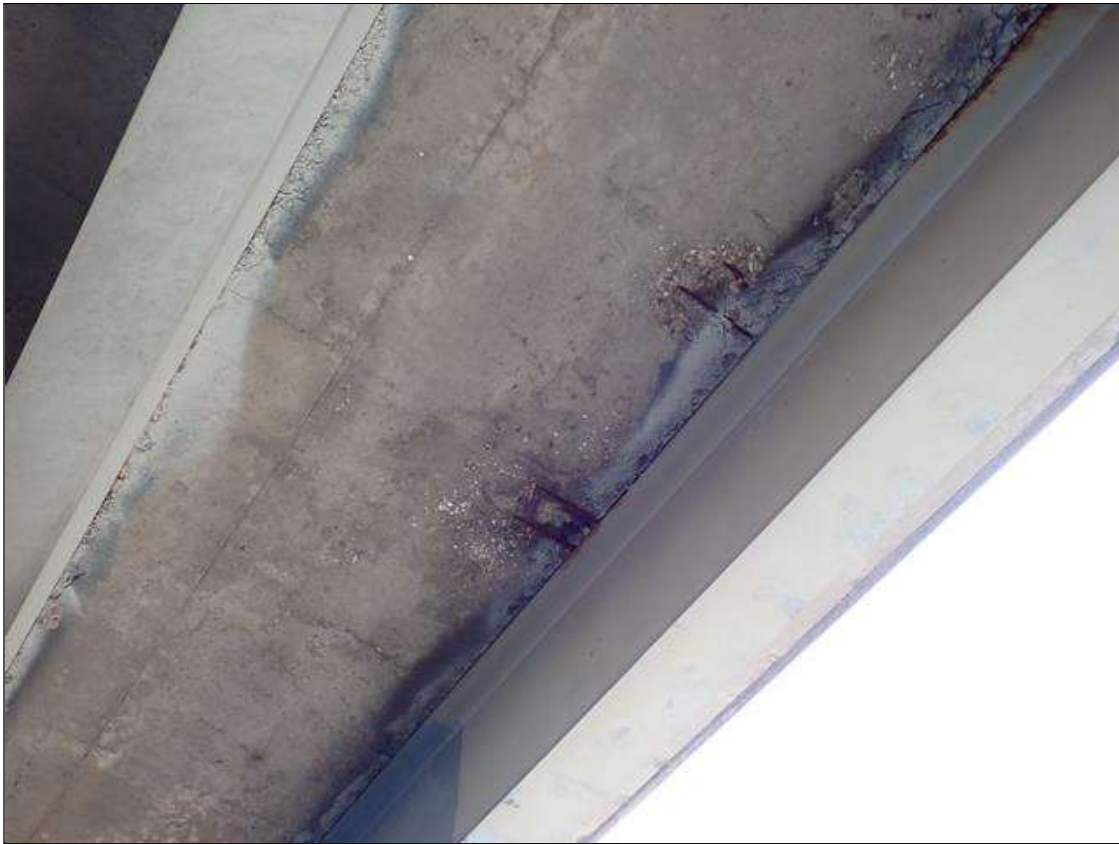
Span 2 Deck: (PAR) underside of bays 1 and 4, and left overhangs at bent 2, spalls/delaminations (up to 2.5 feet x 2 feet x 3 inches deep) with exposed rusted rebar; rebar has approximately 10 percent section loss
