NC DEPARTMENT OF TRANSPORTATION  
 DIVISION OF HIGHWAYS  
 STRUCTURE MANAGEMENT UNIT

ATTENTION: prompt action request, sketches revised, clearances revised; span 2 beams heat straightened and repainted since previous inspection

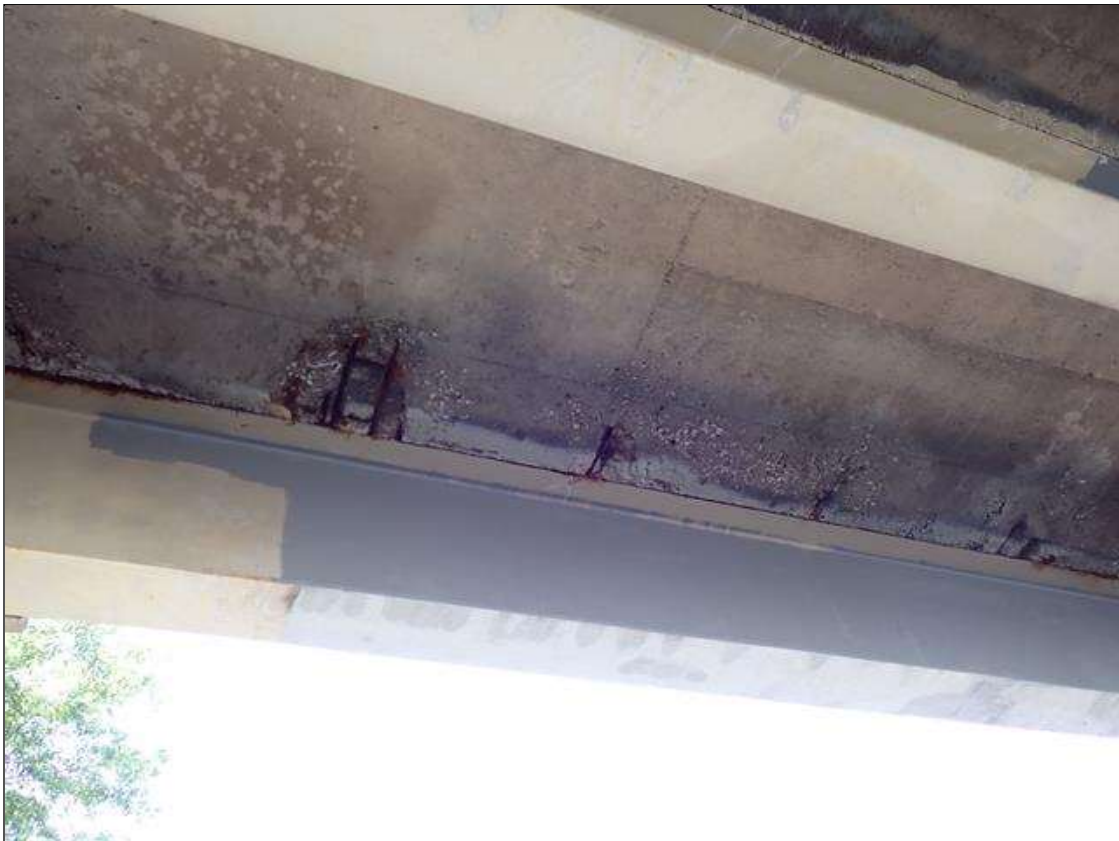
Span 2 Deck: (PAR) underside of bays 1 and 4, and left overhangs at bent 2, spalls/delaminations (up to 2.5 feet x 2 feet x 3 inches deep) with exposed rusted rebar; rebar has approximately 10 percent section loss

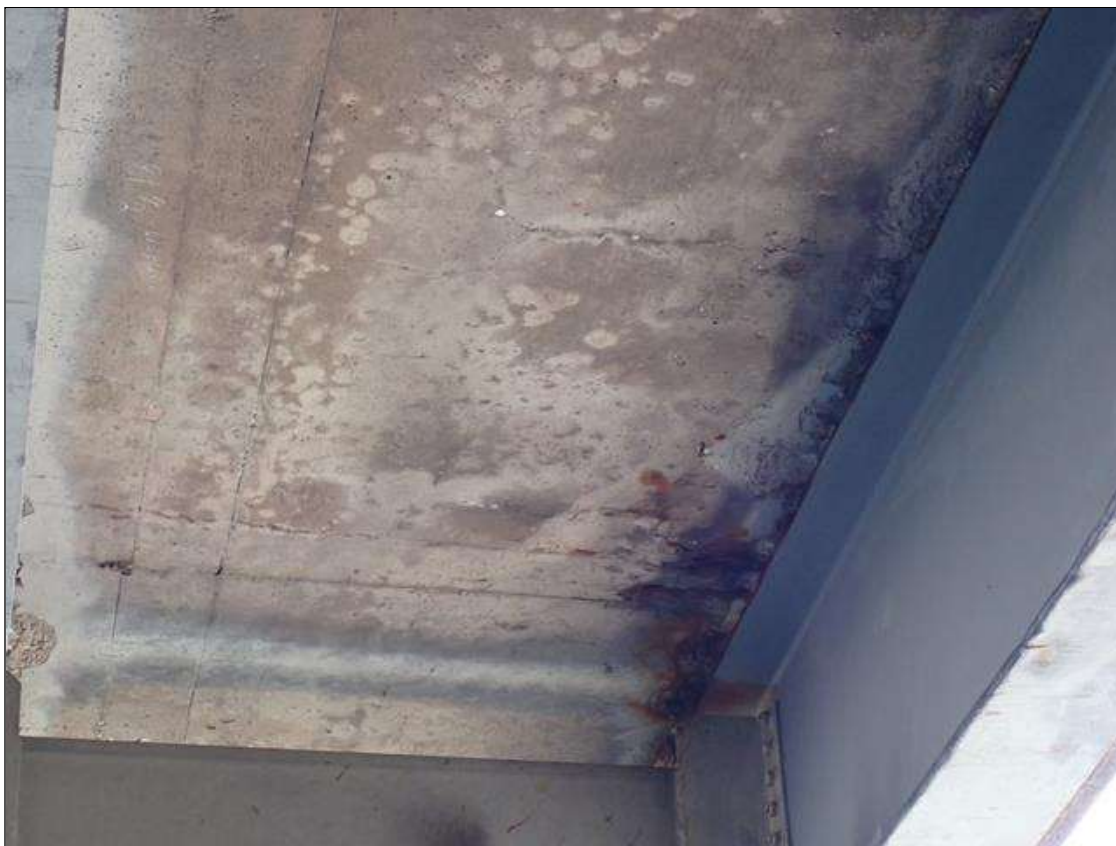
Span 2 Deck: (PAR) BOTTOM OF DECK HAIRLINE MAP CRACKING SOME WITH EFFLORESCENCE AND RUST STAINS.

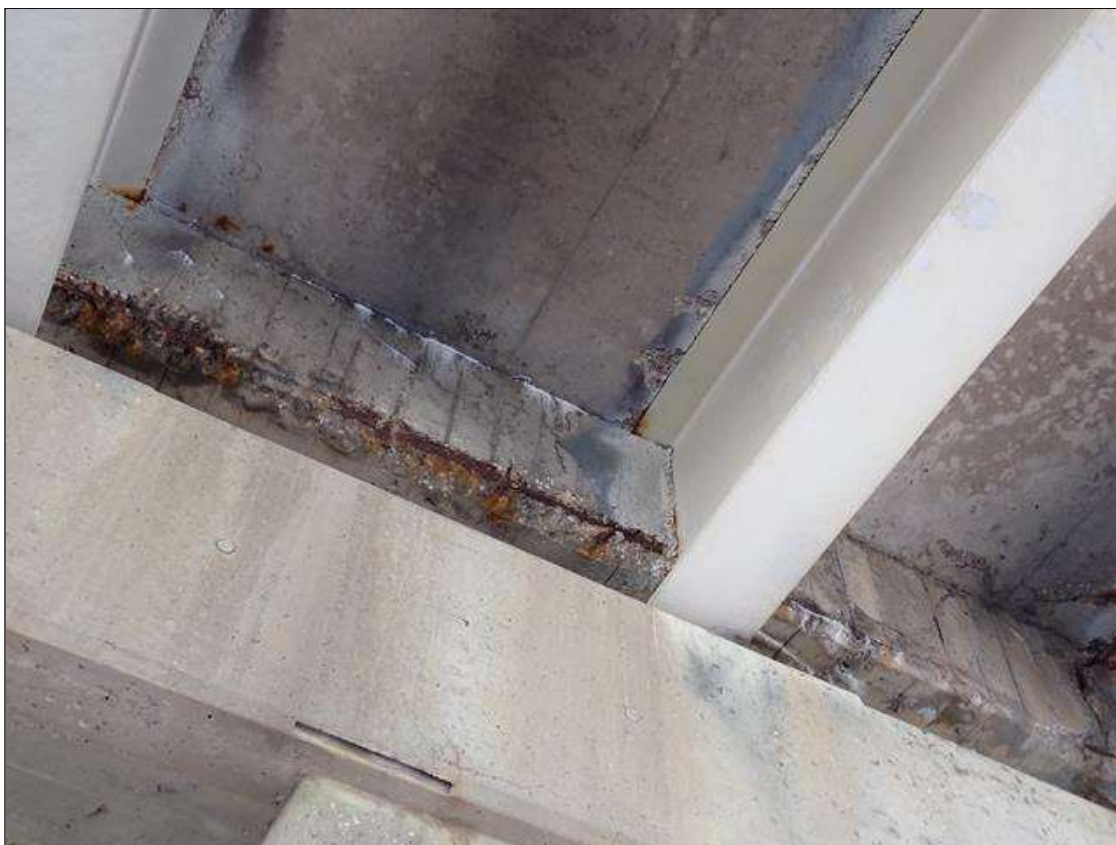
Span 2 Deck: at bent 1, end diaphragm in all bays, spalls/delaminations (up to full bay width x 8 inch wide x 2 inches deep) with exposed rusted rebar with cracks (up to 1/16 inch) with efflorescence

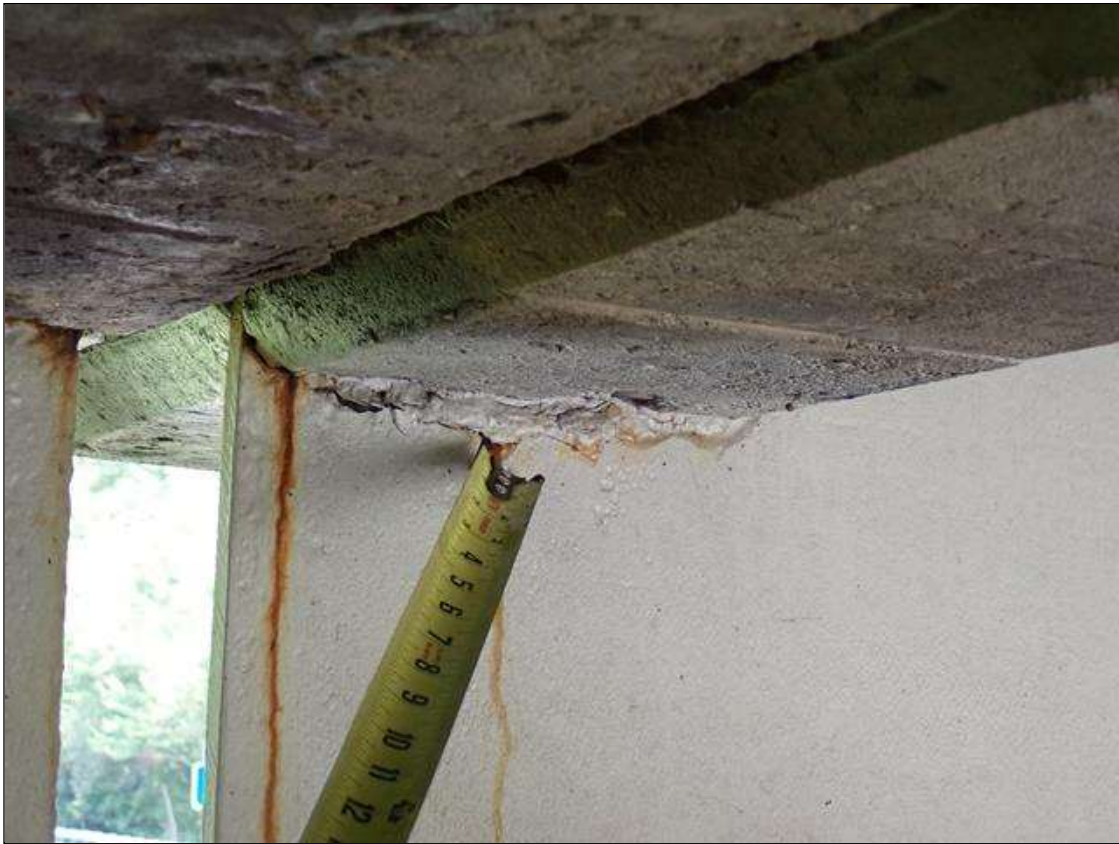
Span 3 Beam 5: (PAR) at bent 3, web adjacent to diaphragm, painted over section loss (7/16 inch average remaining x 10 inch x 2 inch) with corrosion reinitiated

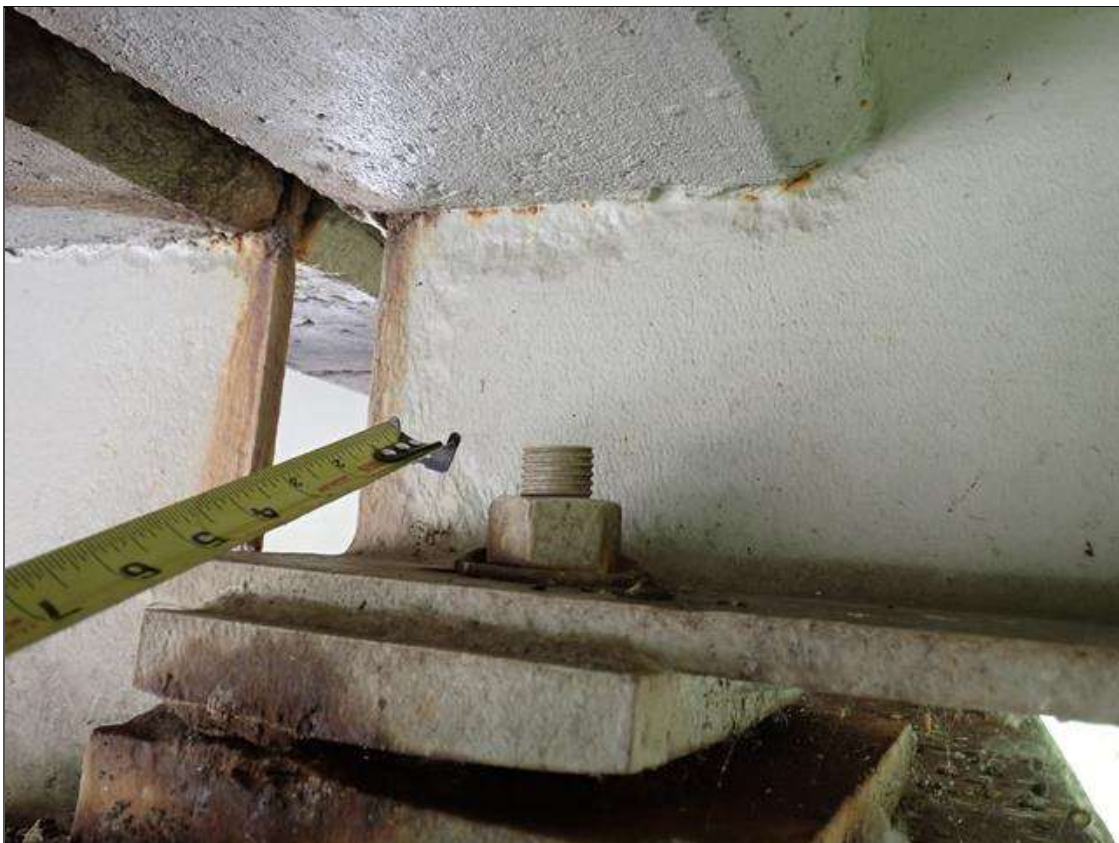
Span 4 Beam 4: (PAR) at bent 3, painted over section loss: web adjacent to diaphragm (3/8 inch average remaining x 9 inch x 1.5 inches); lower web (7/16 inch average remaining x 4 inch x 2 inch) with corrosion reinitiated

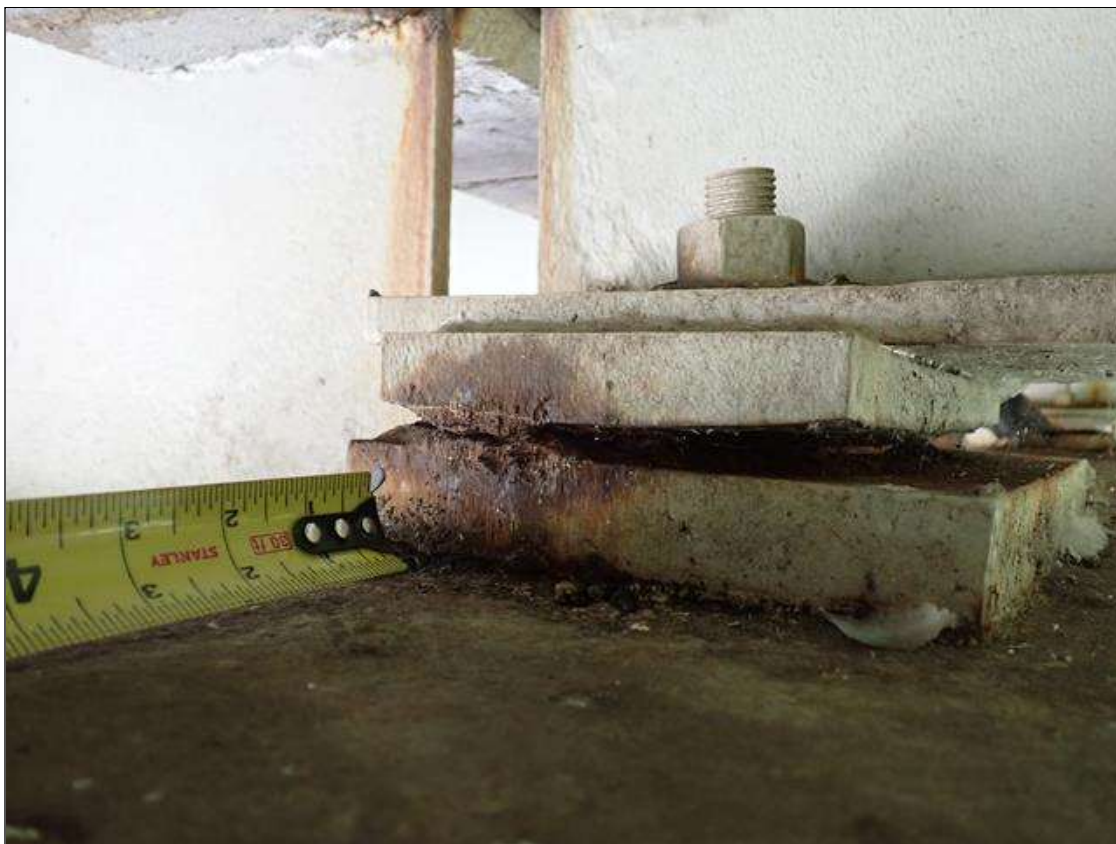
Span 4 Beam 4 - Near Bearing 4: SPAN 4 NEAR BEARING HAS PACK RUST.

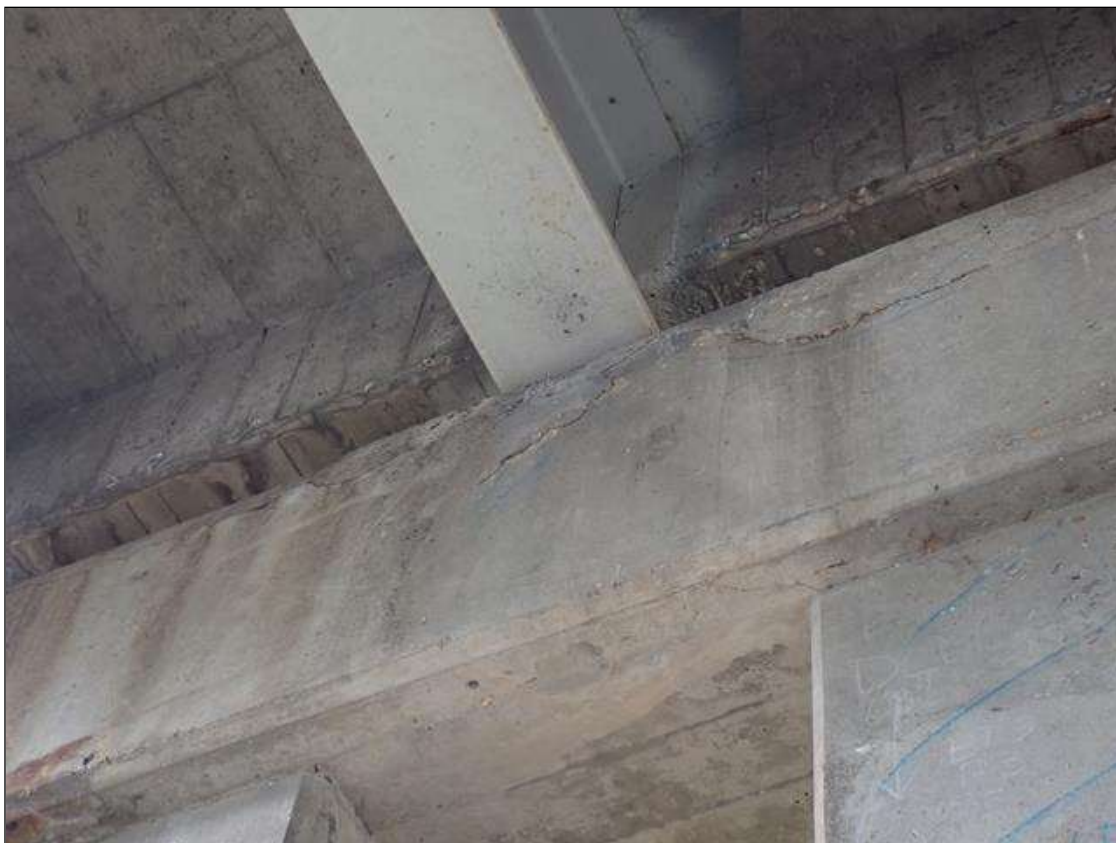
Bent 3 Cap 1: (PAR) south and north faces, below all bays, spalls/delaminations (up to 7 feet x 2 feet x 1/2 inch deep) with cracks (up to 1/16 inch) and rust stains

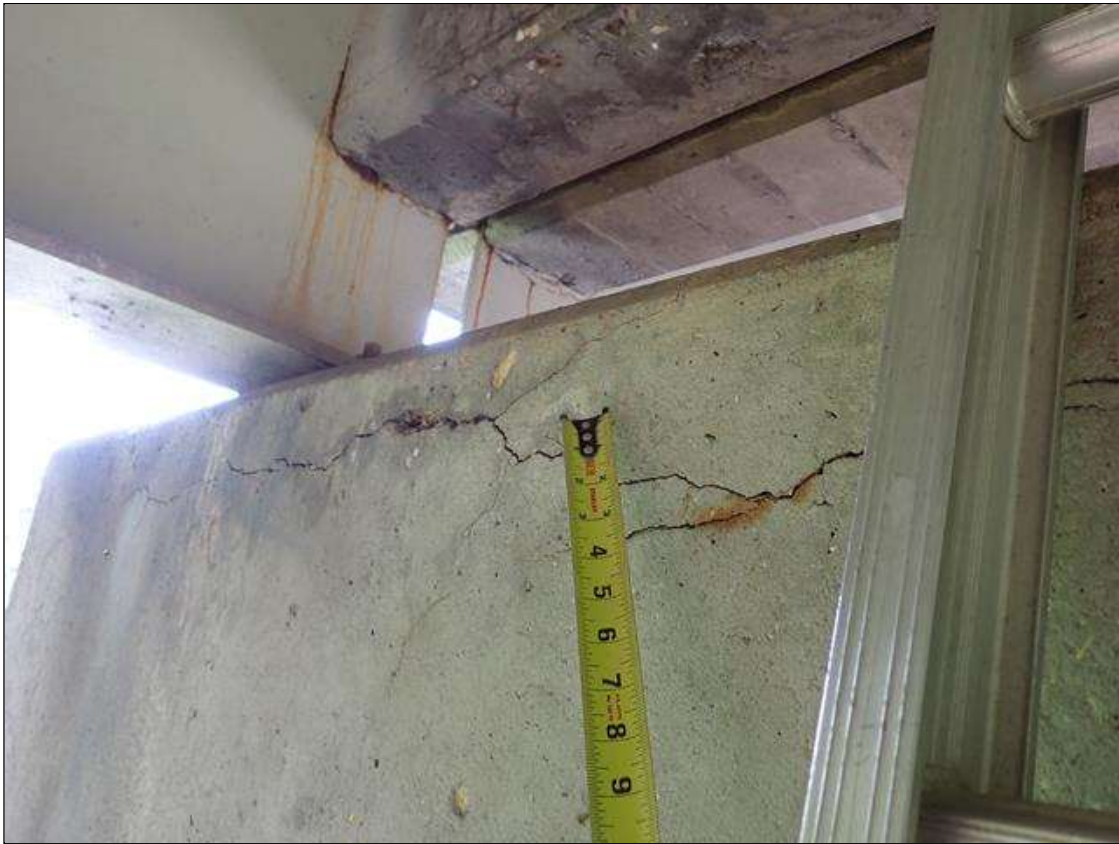
Bent 3 Cap 1: (PAR) south and north faces, below all bays, spalls/delaminations (up to 7 feet x 2 feet x 1/2 inch deep) with cracks (up to 1/16 inch) and rust stains

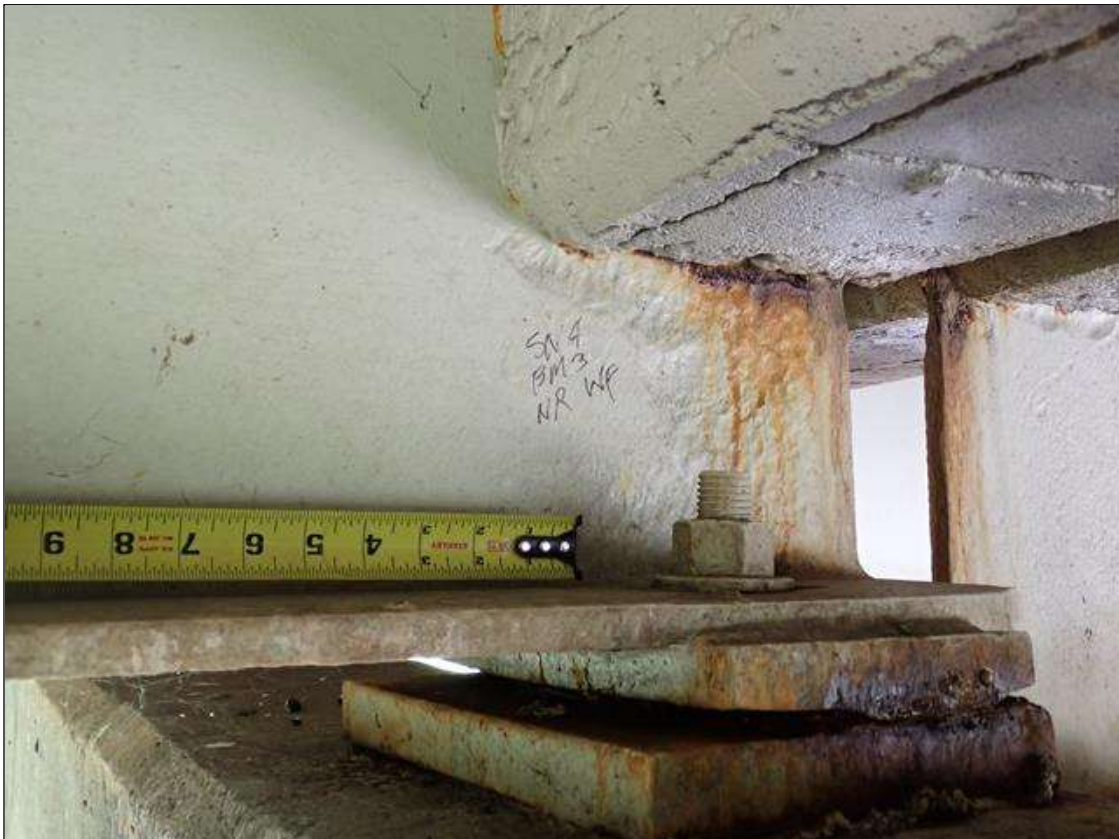
Span 4 Beam 3: (PAR) at bent 3, painted over section loss: web adjacent to diaphragm (5/16 inch average remaining x 9 inch x 2 inch), lower web (7/16 inch average remaining x 6 inch x 1 inch) with corrosion reinitiated

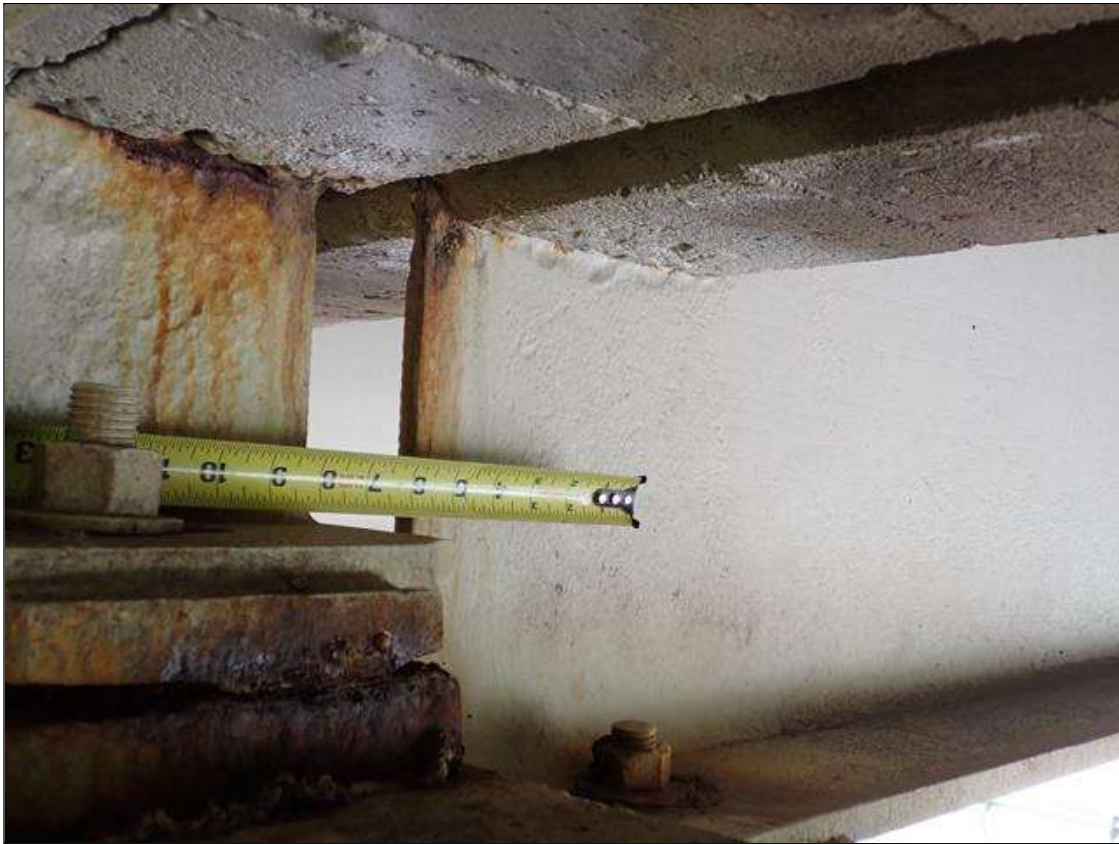
Span 3 Beam 3: (PAR) at bent 3, web adjacent to diaphragm, painted over section loss (7/16 inch average remaining x 10 inch x 2 inch) with corrosion reinitiated

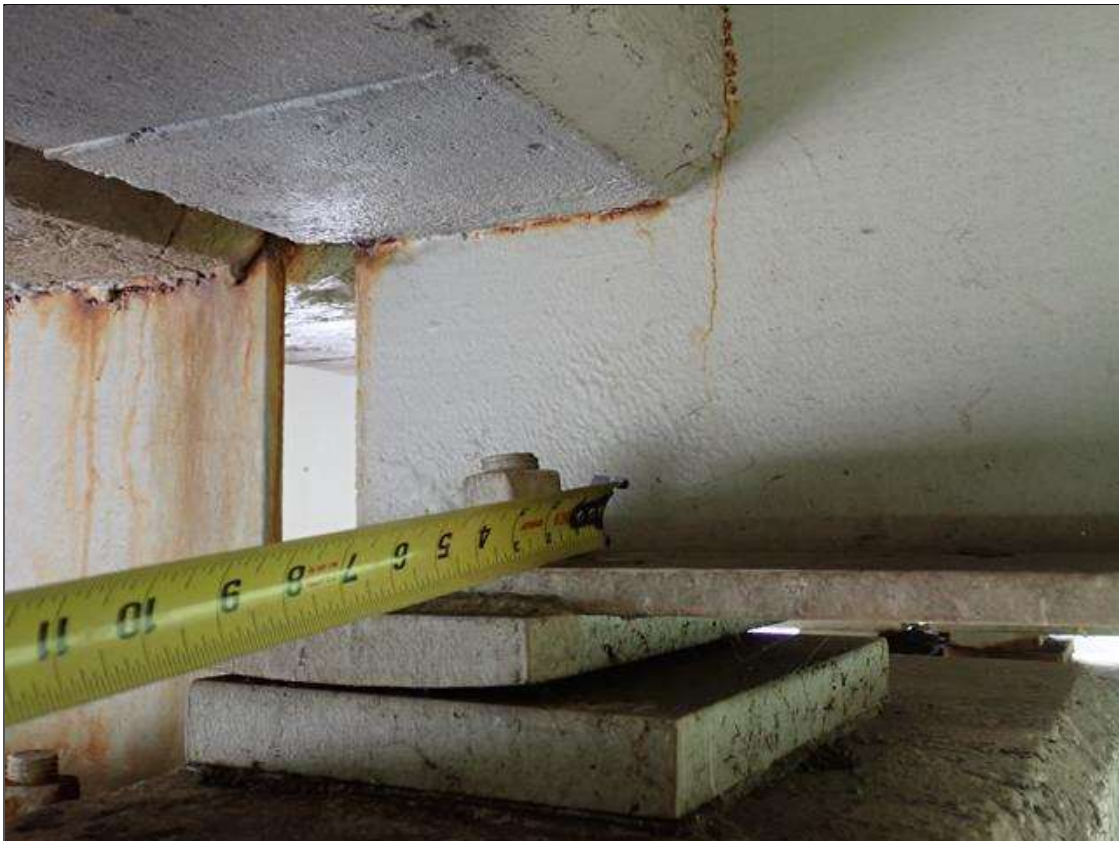
Span 4 Beam 2: (PAR) at bent 3, web adjacent to diaphragm, painted over section loss (3/8 inch average remaining x 3 inch x 1 inch) with corrosion reinitiated

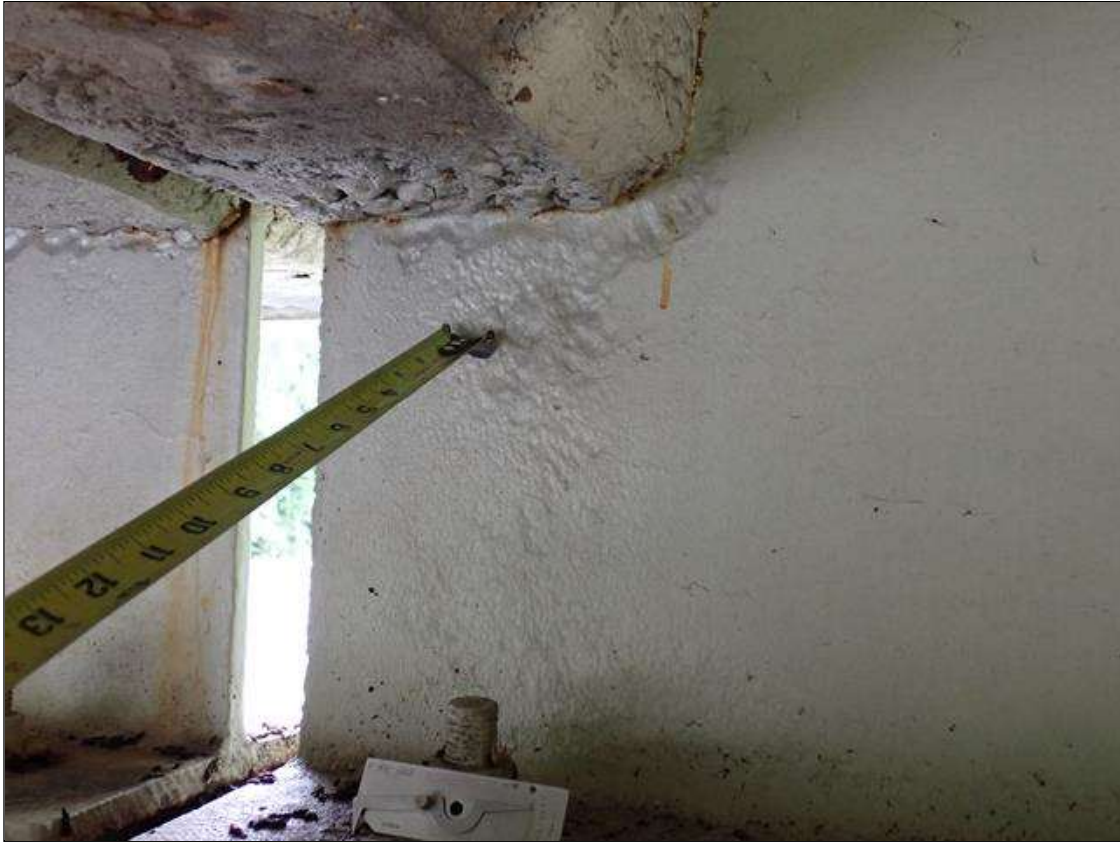
Span 4 Beam 1: (PAR) at bent 3, web adjacent to diaphragm, painted over section loss (7/16 inch average remaining x 8 inch x 4 inch)

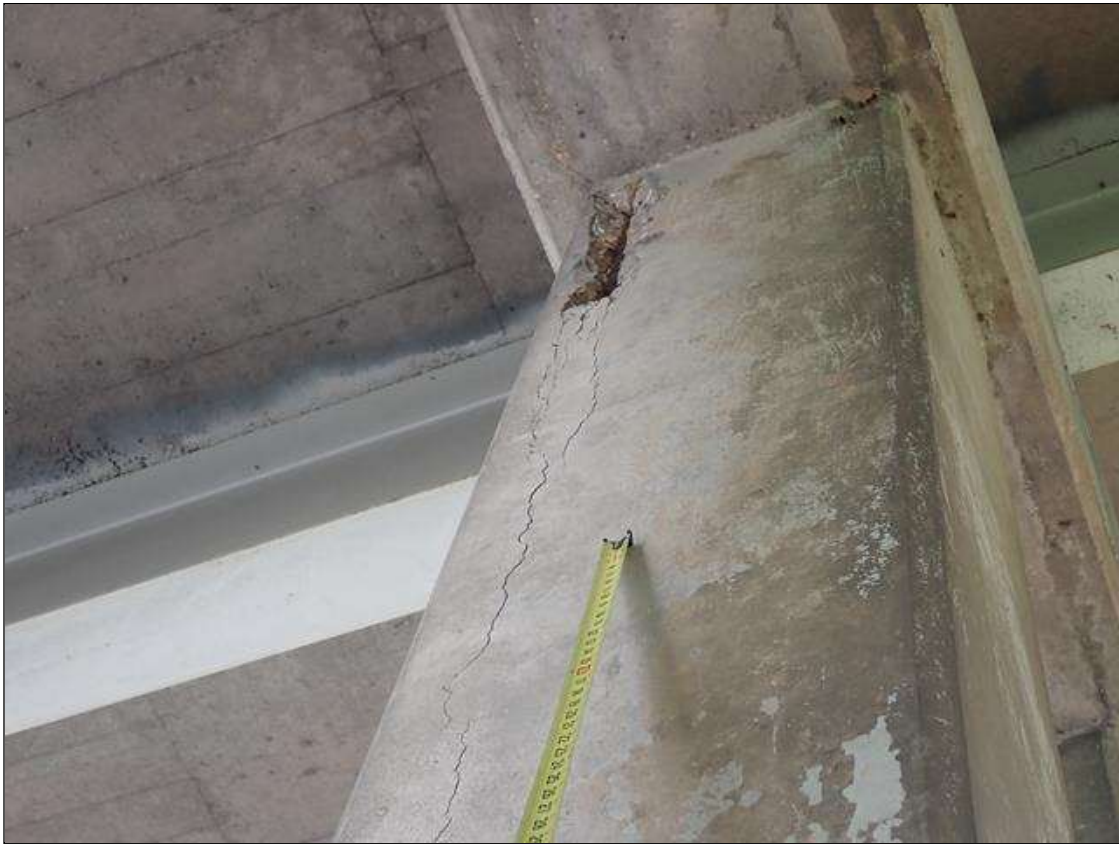
Bent 3 Pile 3: (PAR) southeast corner, near cap, spall/delamination (7 feet x 6 inch x 1.5 inch deep) with cracks (up to 1/16 inch) with east bottom flange exposed; flange has rust scale

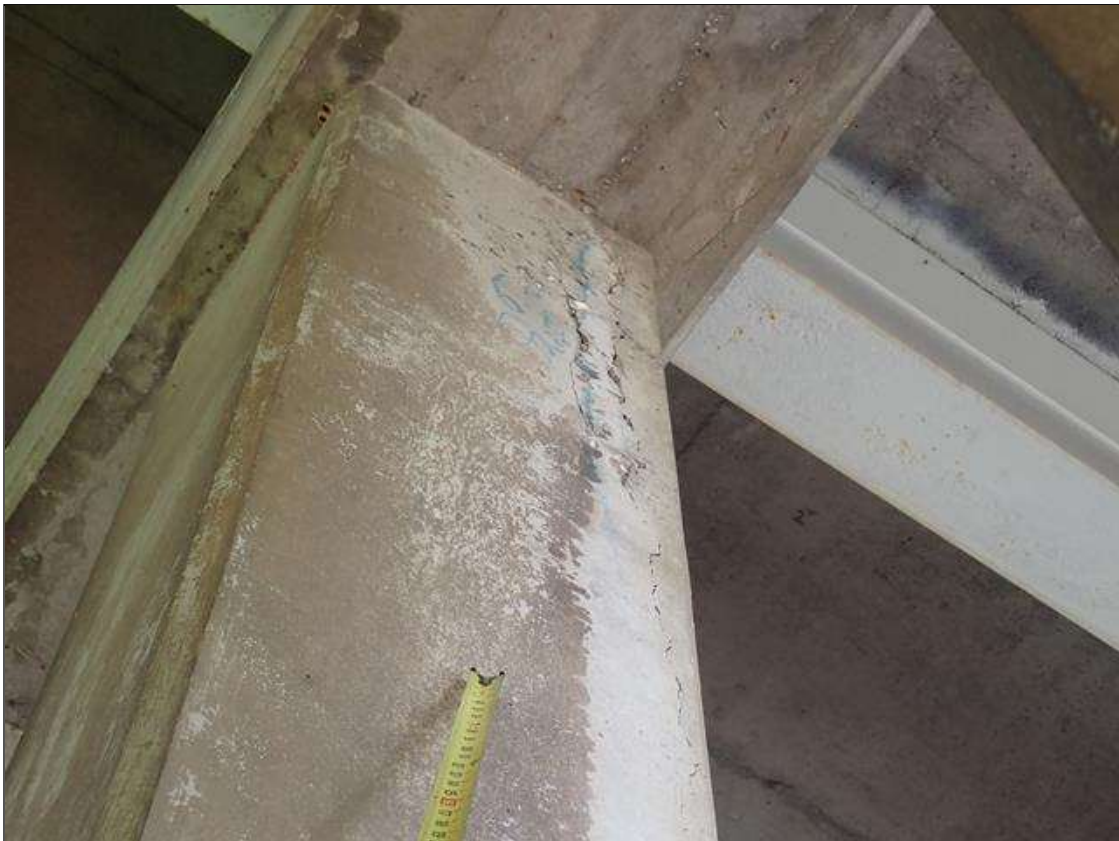
Bent 3 Pile 4: southwest and southeast corners, at cap, delaminations (up to 4.5 feet x 6 inch) with cracks (up to 1/16 inch)

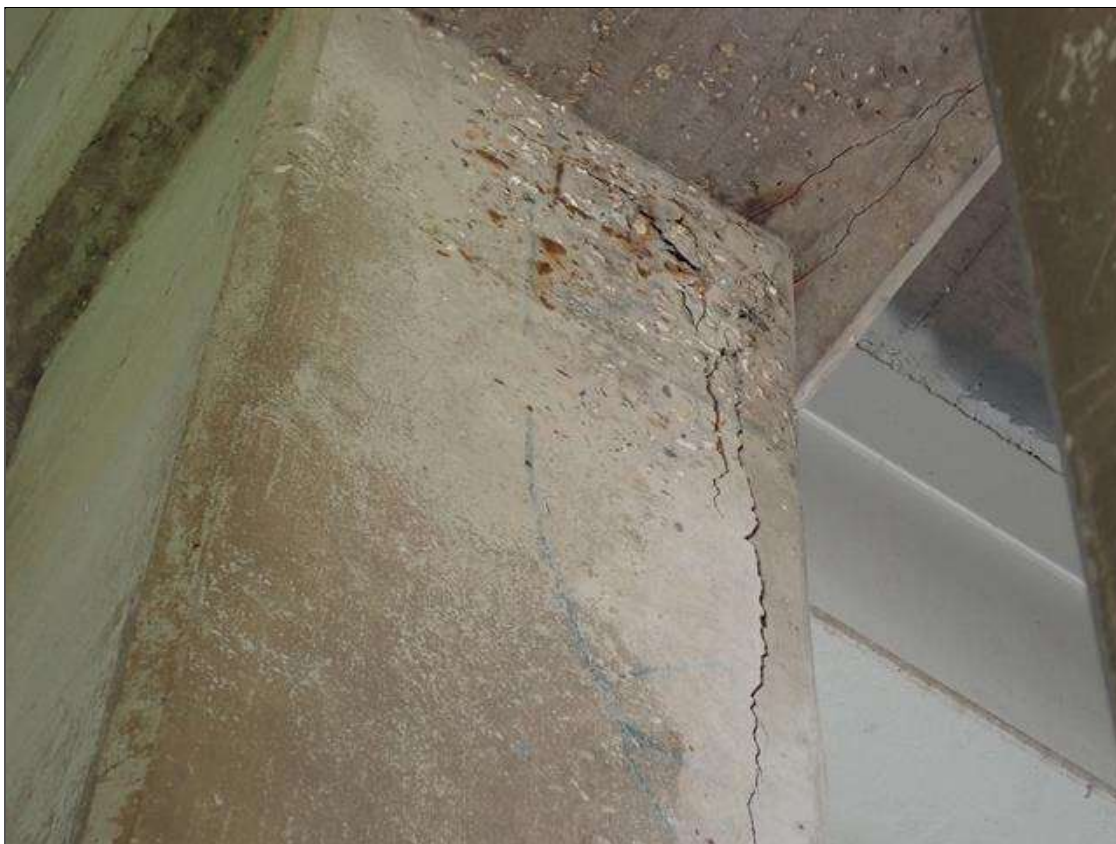
Bent 3 Pile 5: (PAR) southwest and southeast corners, at cap, delaminations (up to 3.5 feet x 1 foot) with cracks (up to 1/8 inch) and rust stains

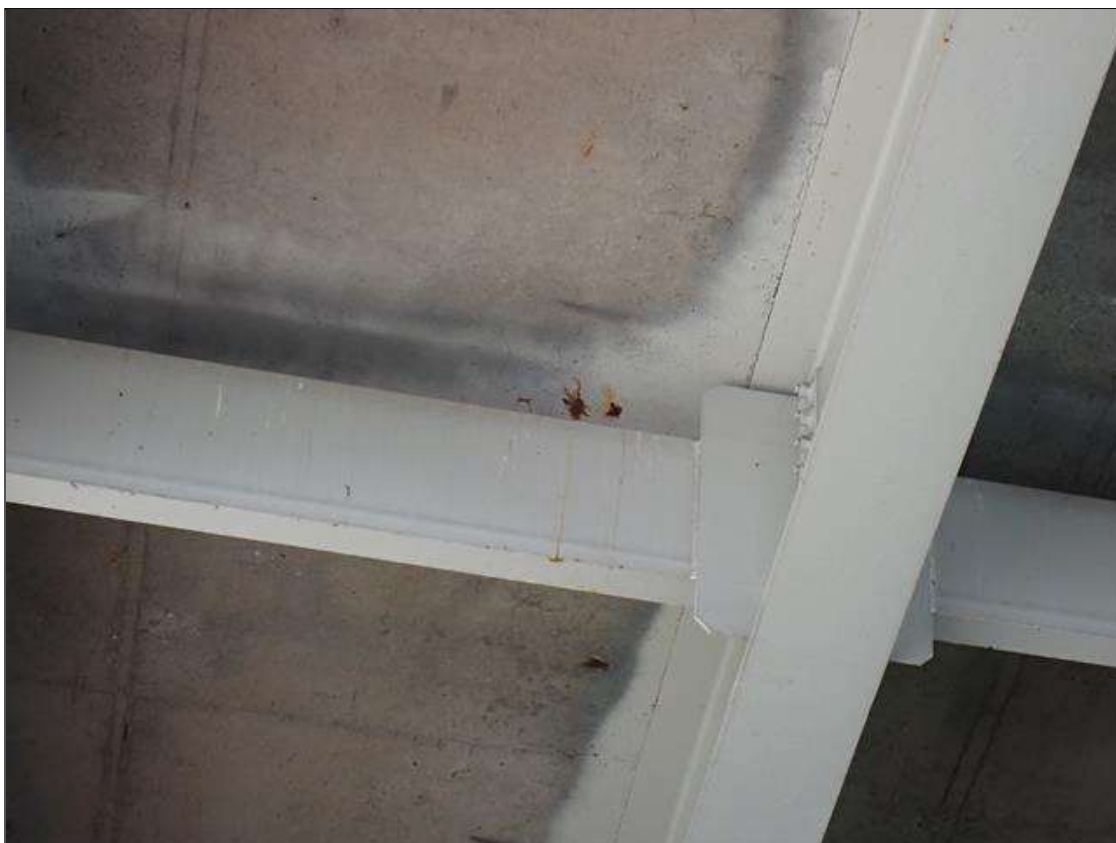
Span 4 Deck: (PAR) UP TO 1/32 INCH MAP CRACKING BOTTOM OF DECK some with efflorescence and rust stain

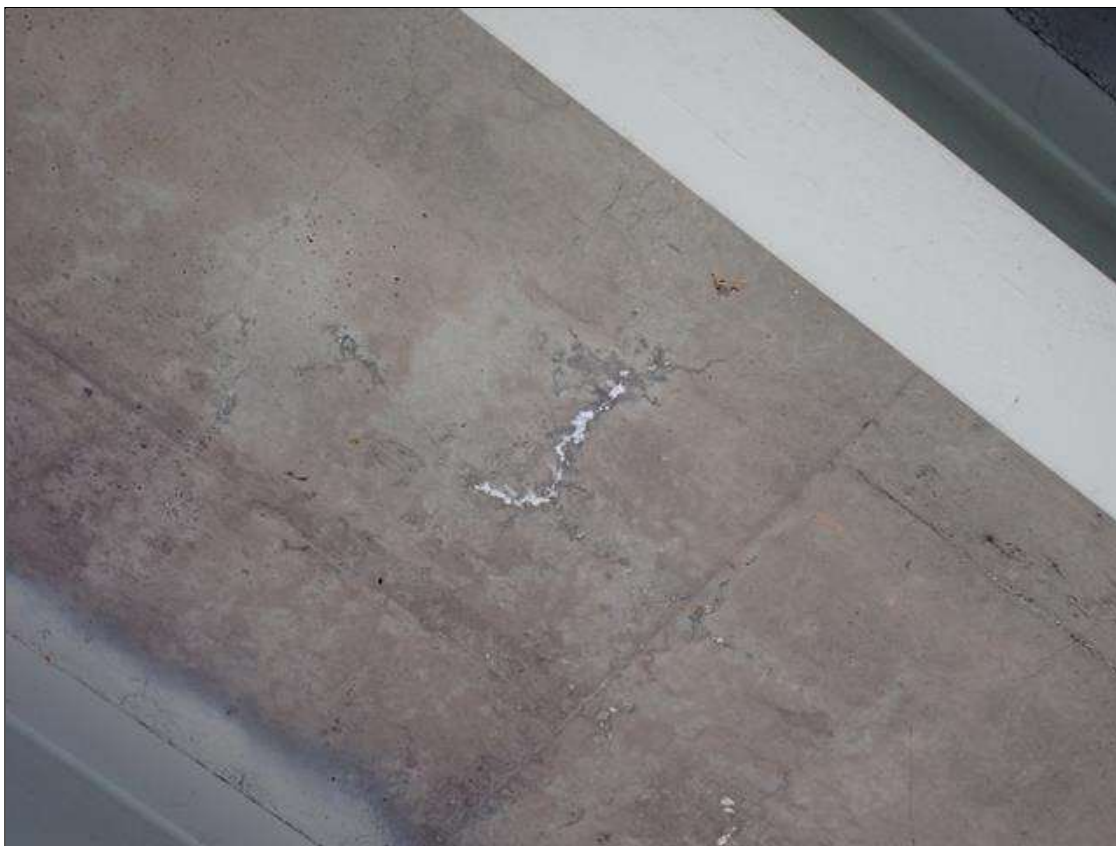
Span 4 Deck: (PAR) UP TO 1/32 INCH MAP CRACKING BOTTOM OF DECK some with efflorescence and rust stain

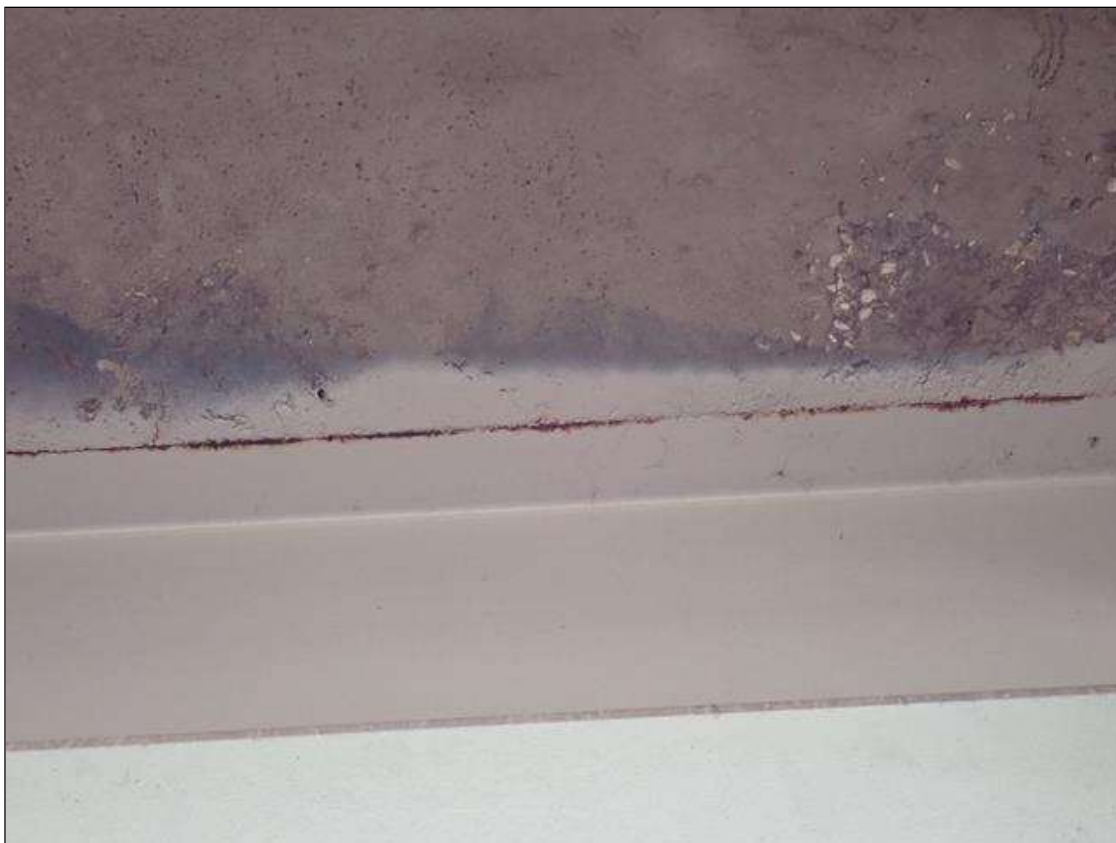
Span 4 Beam 5: along the top flange, surface rust at random

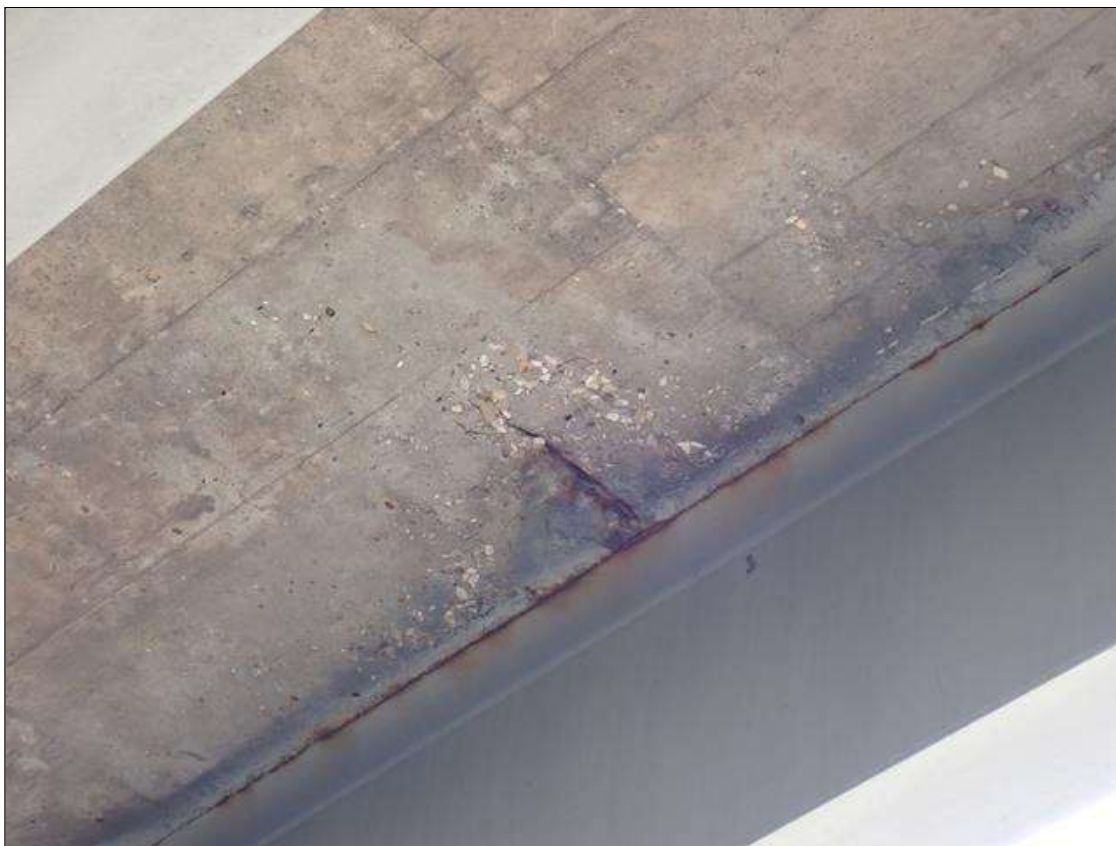
Span 3 Deck: (PAR) underside of bays 1 and 4, spalls/delaminations (up to 2 foot diameter x 2.5 inches deep) with exposed rusted rebar; rebar has approximately 5 percent section loss

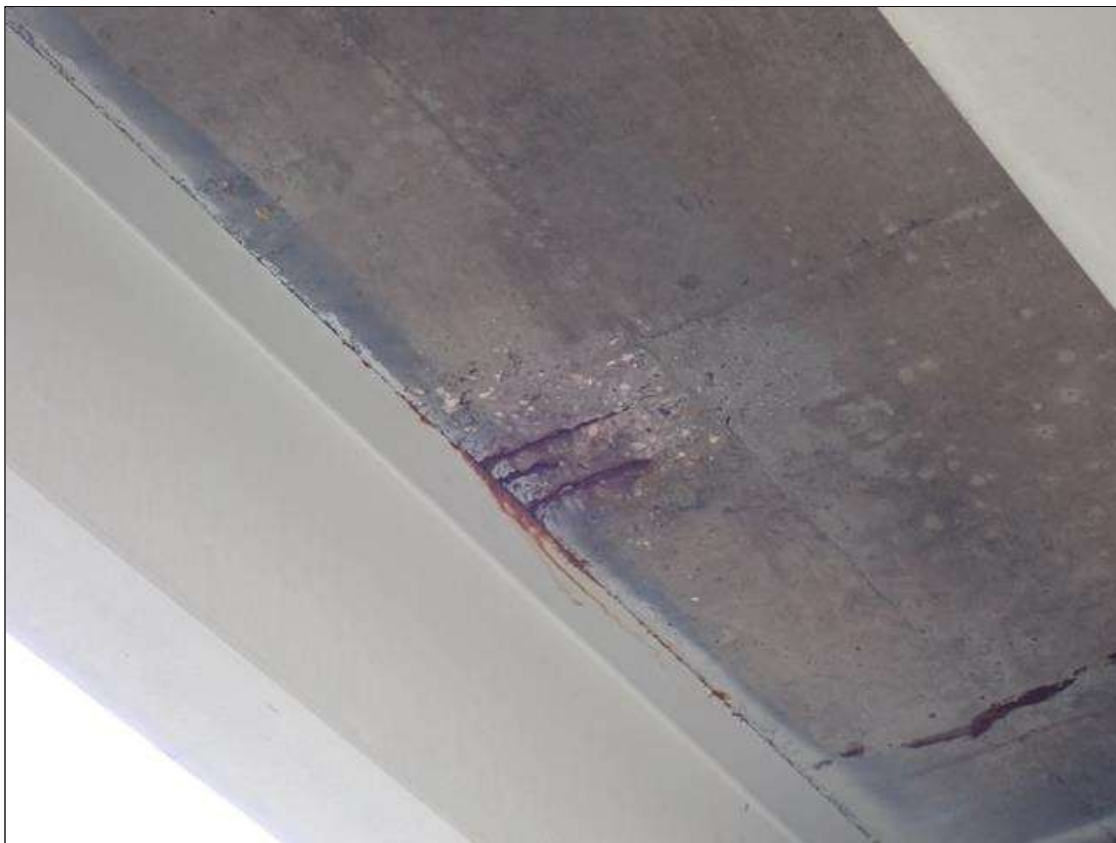
Span 3 Deck: (PAR) underside of bays 1 and 4, spalls/delaminations (up to 2 foot diameter x 2.5 inches deep) with exposed rusted rebar; rebar has approximately 5 percent section loss

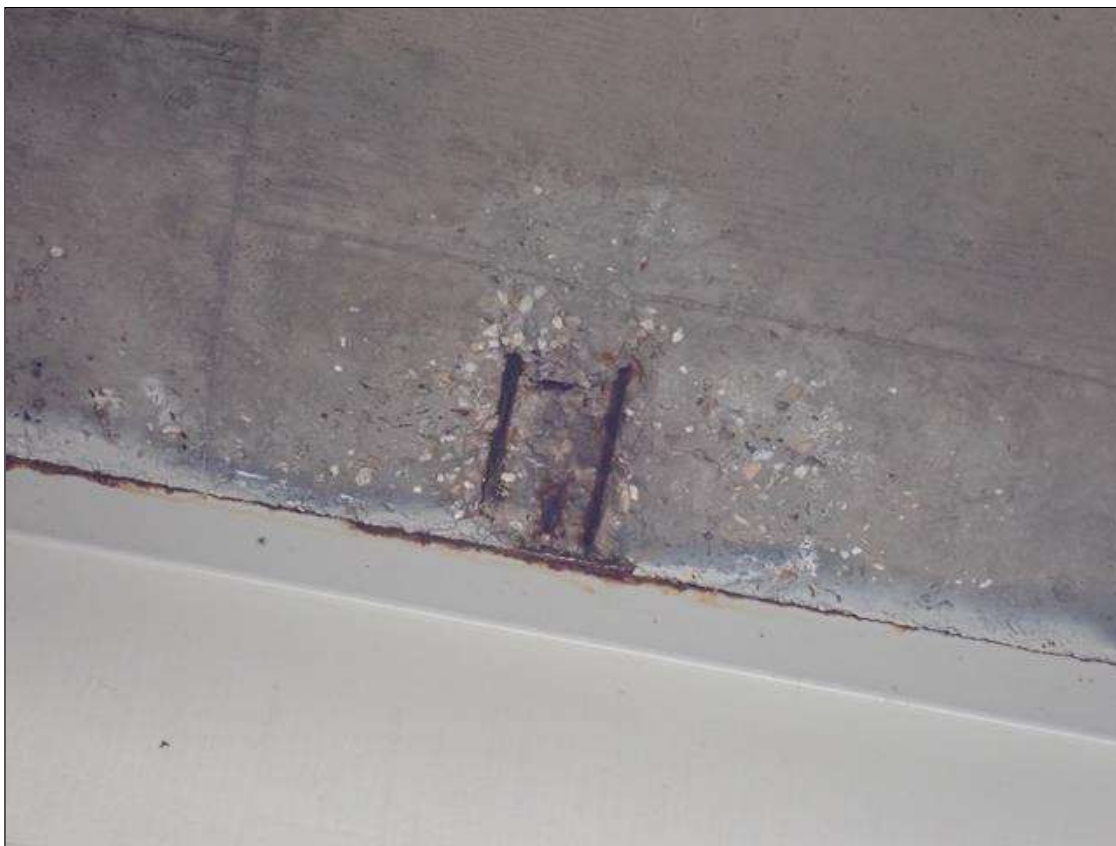
Span 3 Deck: (PAR) underside of bays 1 and 4, spalls/delaminations (up to 2 foot diameter x 2.5 inches deep) with exposed rusted rebar; rebar has approximately 5 percent section loss

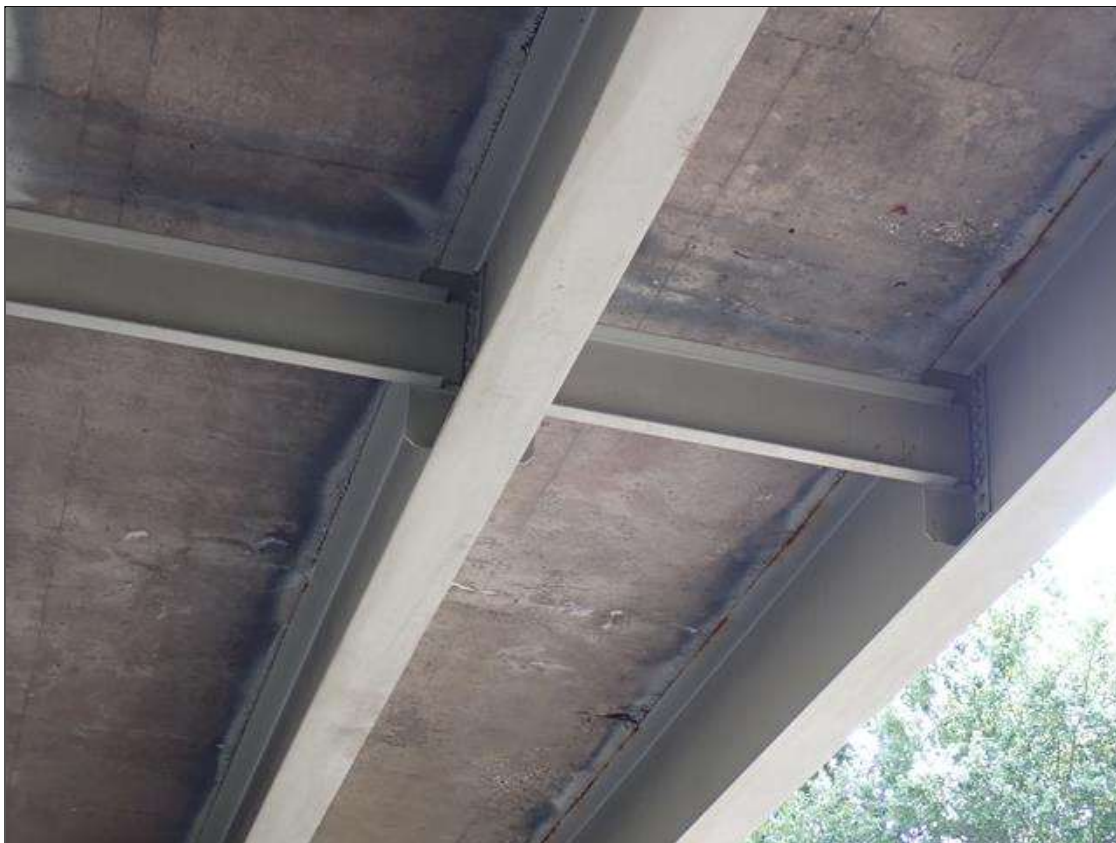
Span 3 Deck: (PAR) BOTTOM OF DECK UP TO 1/32 INCH MAP CRACKING AT RANDOM THROUGHOUT SOME WITH EFFLORESCENCE AND RUST STAINS

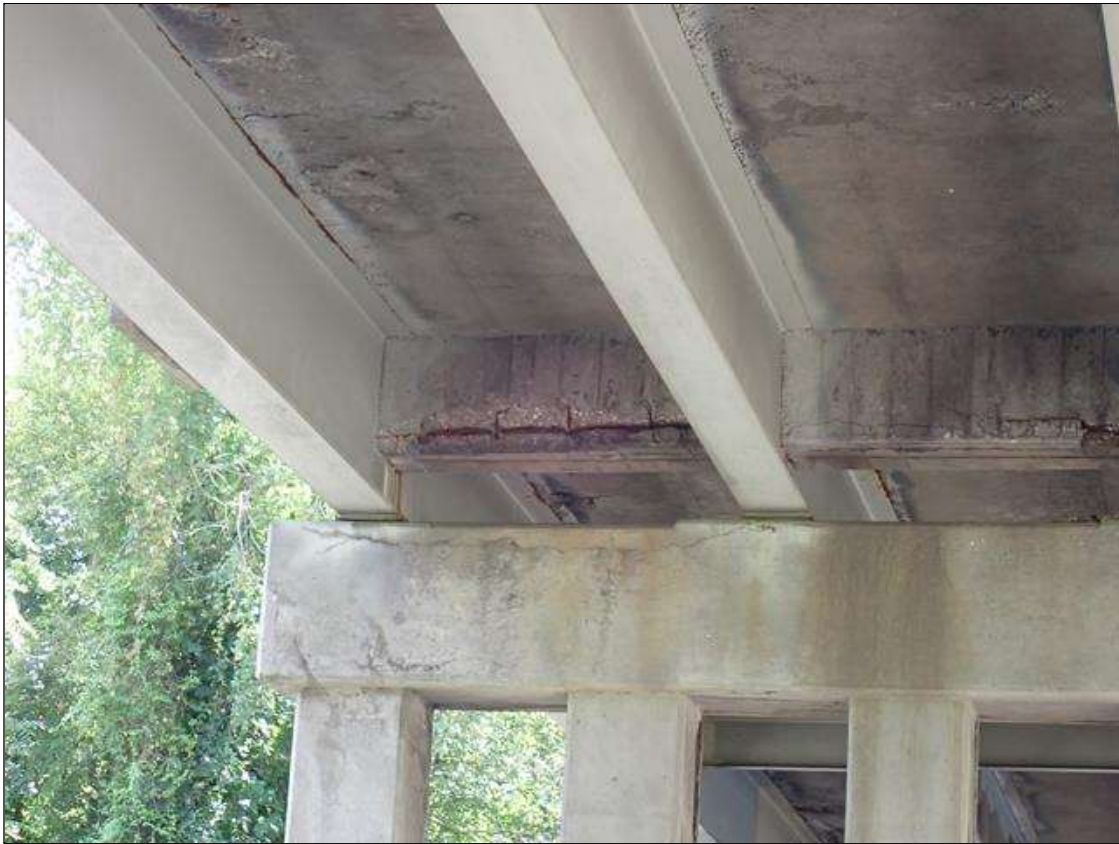
Span 3 Deck: at bent 2, end diaphragms in all bays and overhangs, spalls/delaminations (up to full bay width x 8 inch x 2 inches) with exposed rusted rebar and cracks (up to 1/16 inch)
