NC DEPARTMENT OF TRANSPORTATION  
 DIVISION OF HIGHWAYS  
 STRUCTURE MANAGEMENT UNIT

ATTENTION: prompt action request, sketches revised, clearances revised; span 2 beams heat straightened and repainted since previous inspection

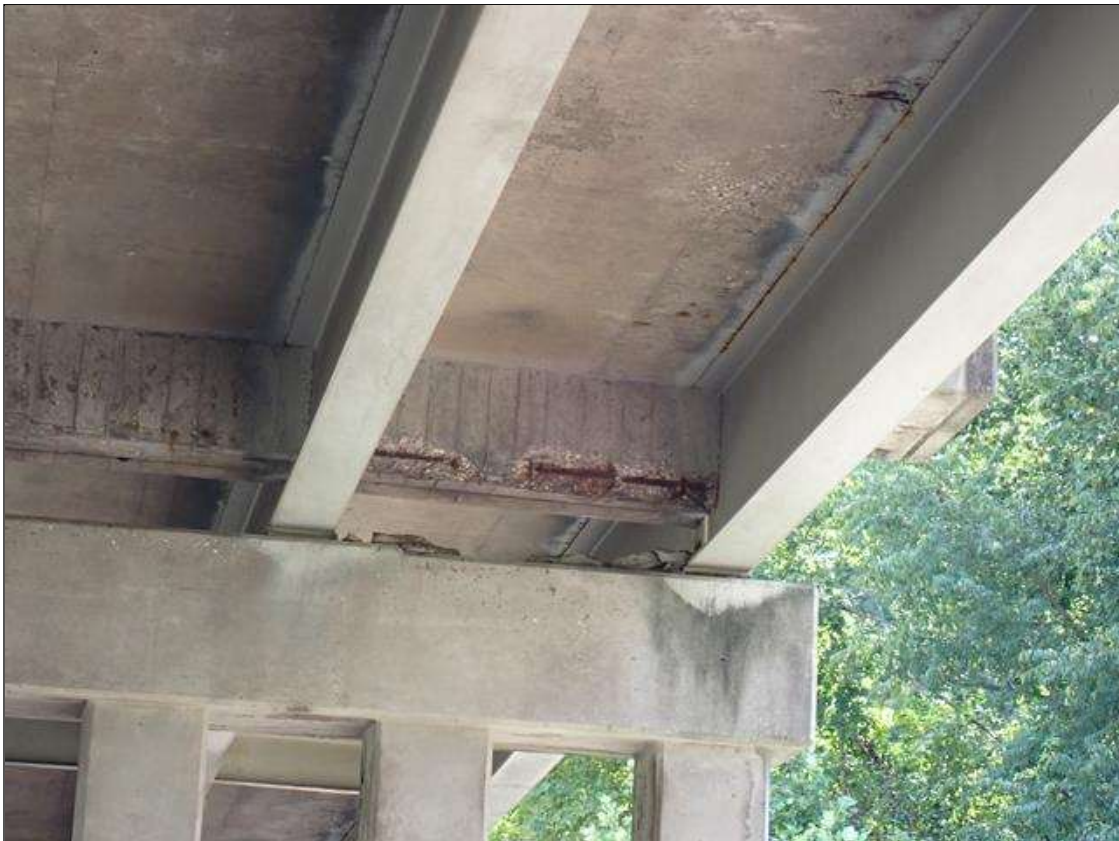
Span 3 Deck: at bent 2, end diaphragms in all bays and overhangs, spalls/delaminations (up to full bay width x 8 inch x 2 inches) with exposed rusted rebar and cracks (up to 1/16 inch)

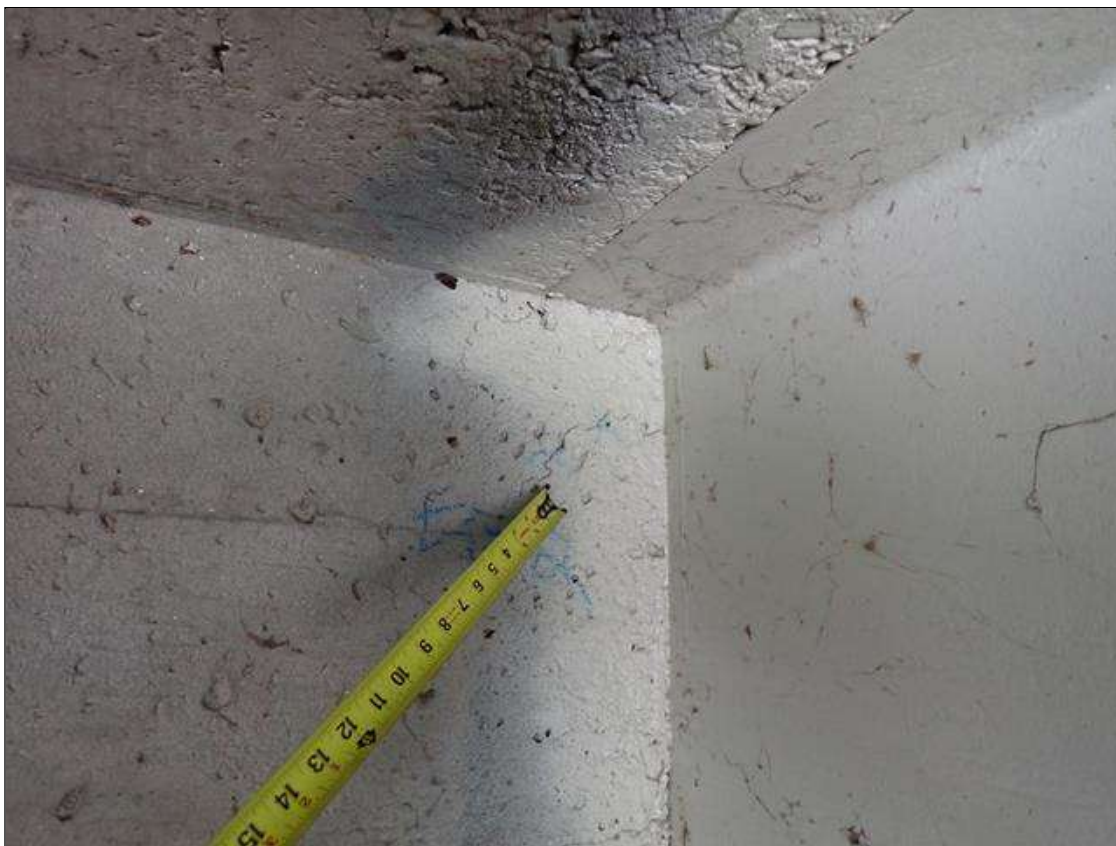
End Bent 2 Abutment: up to 8 INCH x UP TO 1/32 INCH VERTICAL AND DIAGONAL CRACKS AT BEAM ENDS

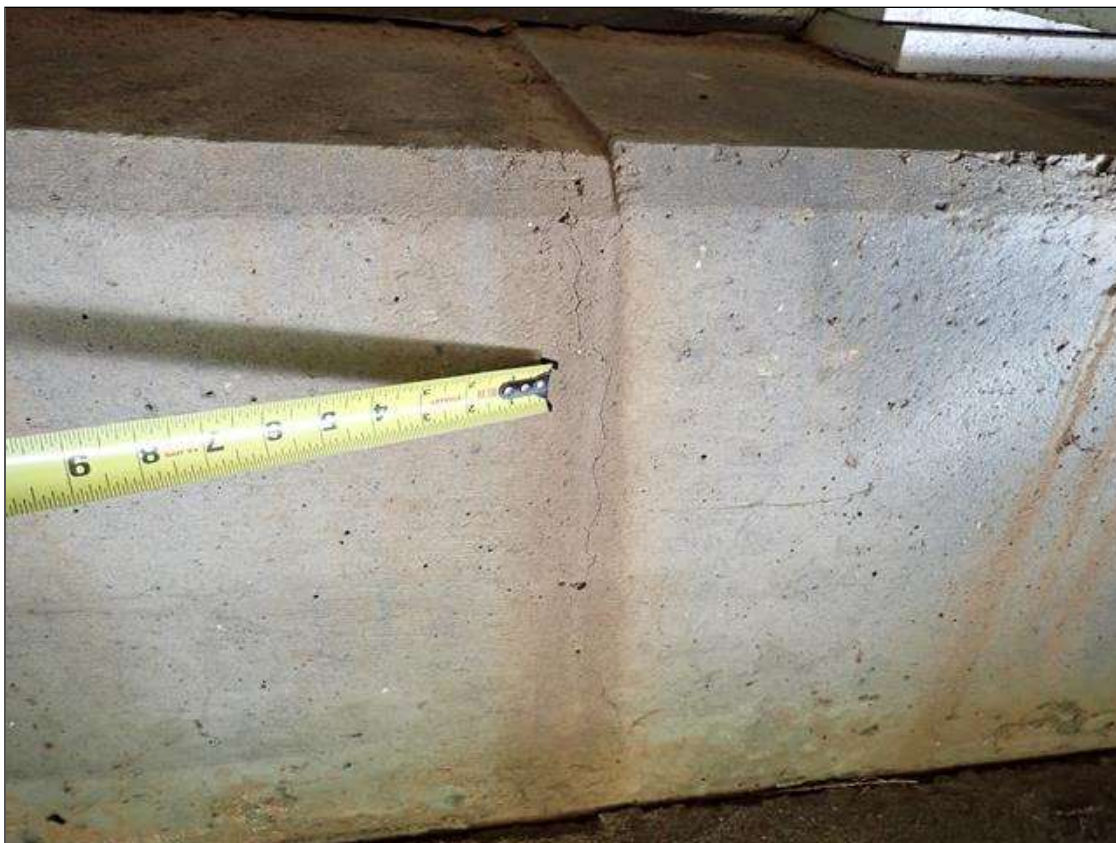
End Bent 2 Cap 1: up to full height x UP TO 1/64 INCH VERTICAL CRACKS, AT RANDOM, some wraparound

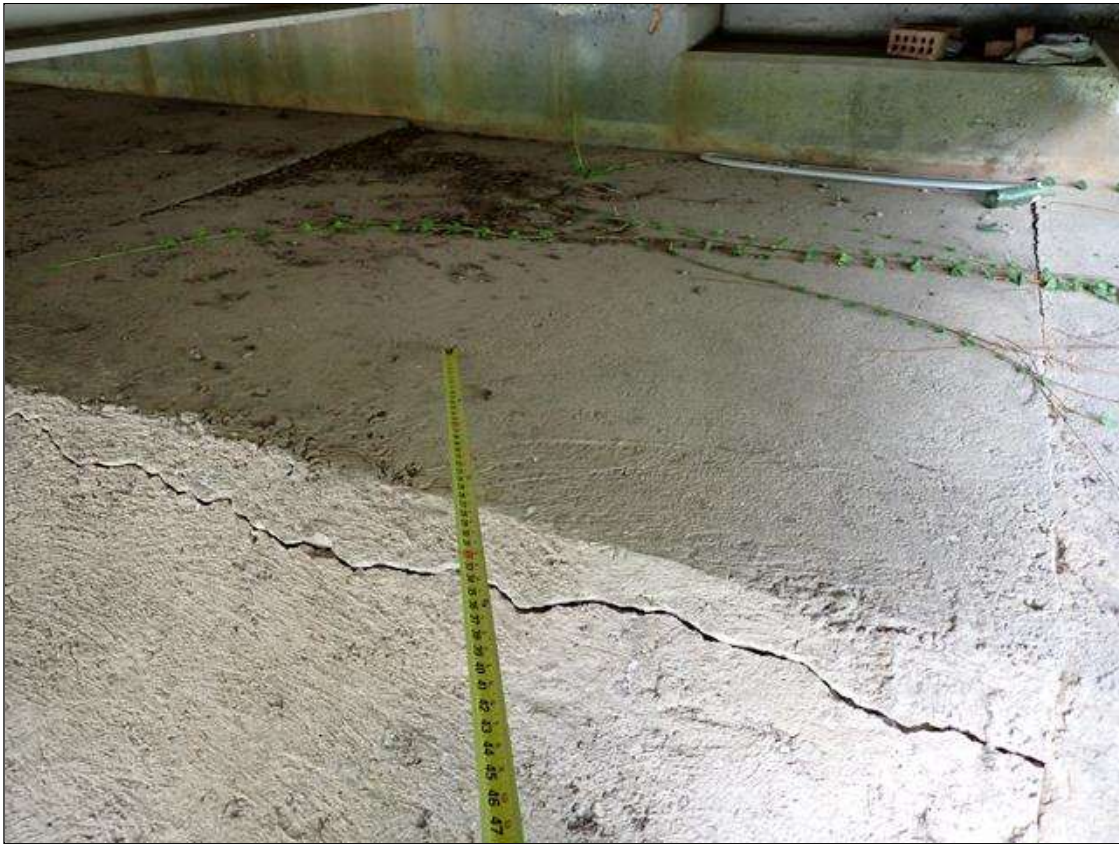
end bent 2 slope protection, below bays 3 and 4, adjacent to end bent, settlement (up to 1.5 inch deep) with transverse crack (1/4 inch x 8 feet)

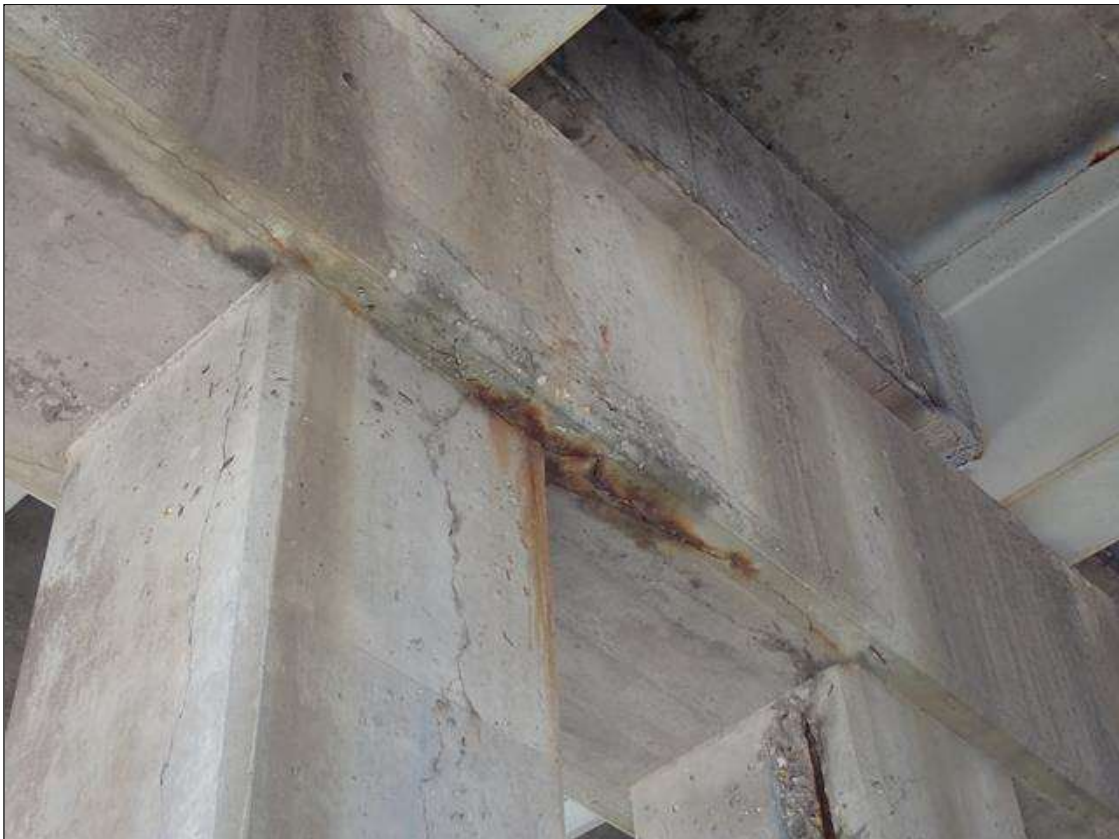
Bent 2 Cap 1: (PAR) south and north faces, spalls/delaminations (up to 6 feet x 8 inch x 1 inch deep) with cracks (up to 1/8 inch), some with rust stains

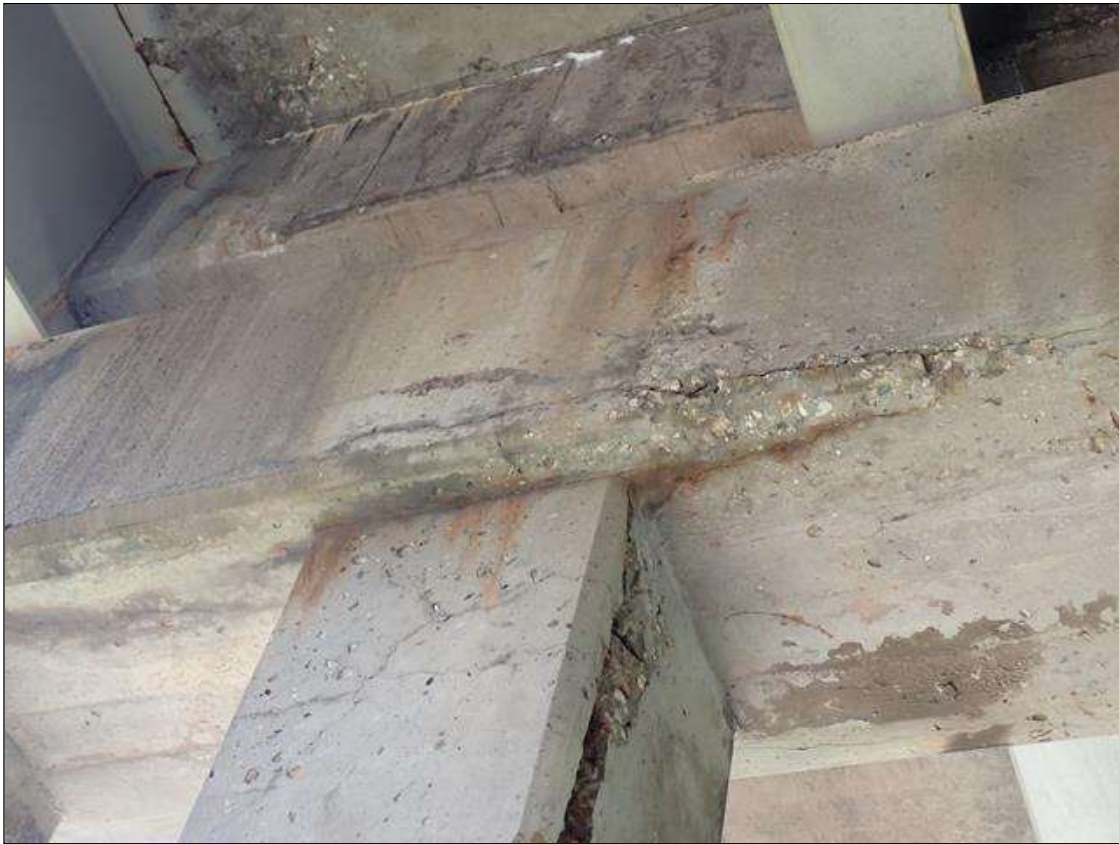
Bent 2 Cap 1: (PAR) south and north faces, spalls/delaminations (up to 6 feet x 8 inch x 1 inch deep) with cracks (up to 1/8 inch), some with rust stains

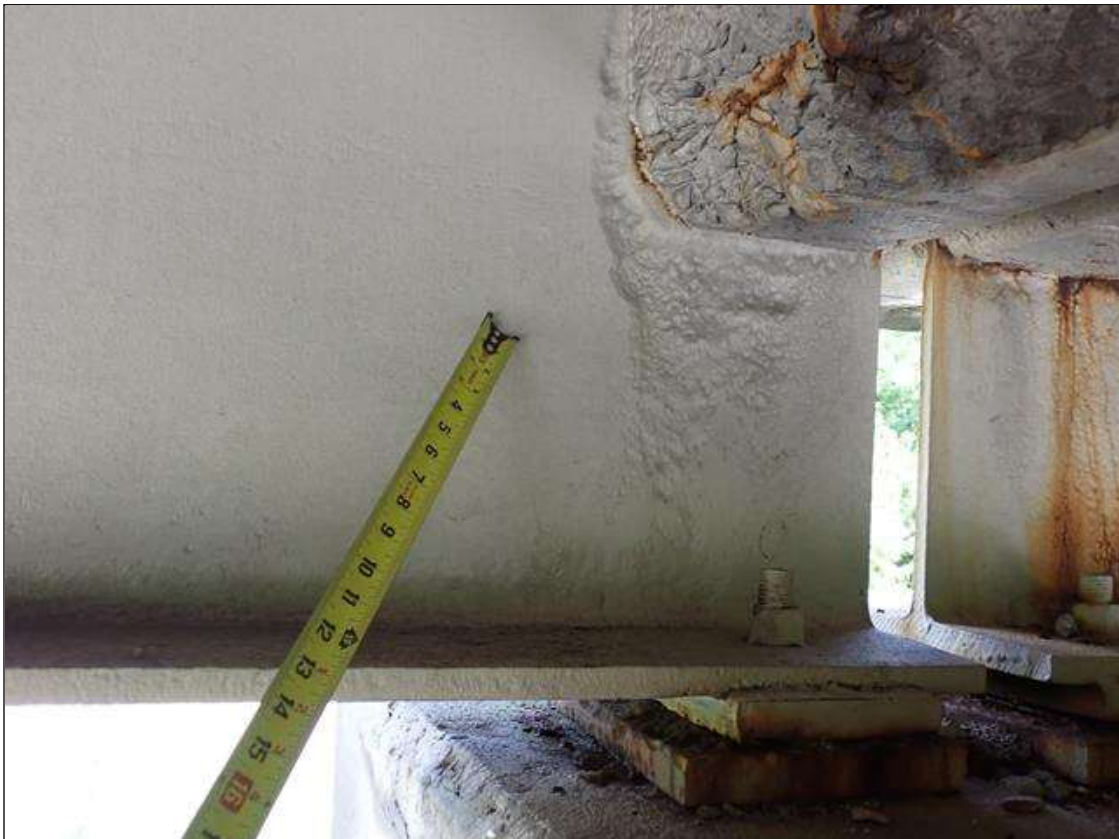
Span 3 Beam 5: (PAR) at bent 2, painted over section loss: web adjacent to diaphragm (7/16 inch average remaining x 9 inch x up to 15 inch); lower web (1/2 inch average remaining x 1 foot x 2 inch)

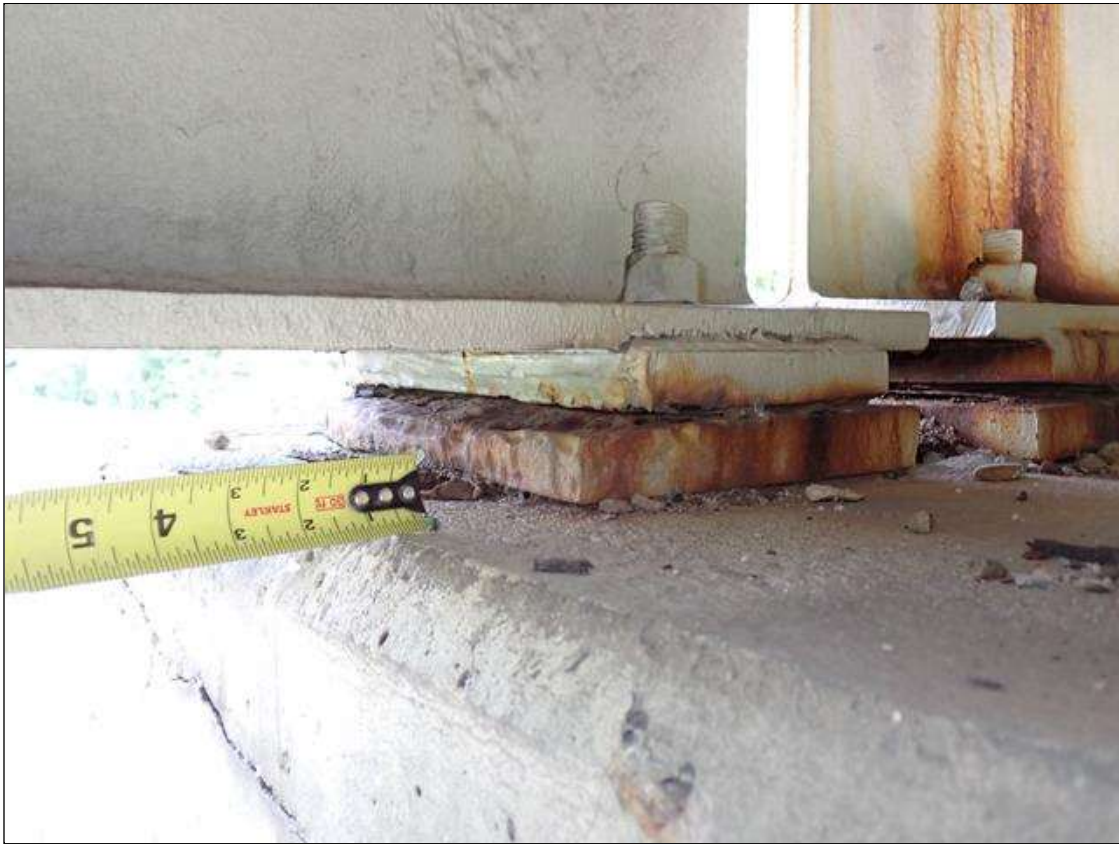
Span 3 Beam 5 - Near Bearing 5: painted over section loss (up to 3/16 inch deep) with corrosion reinitiated; pack rust

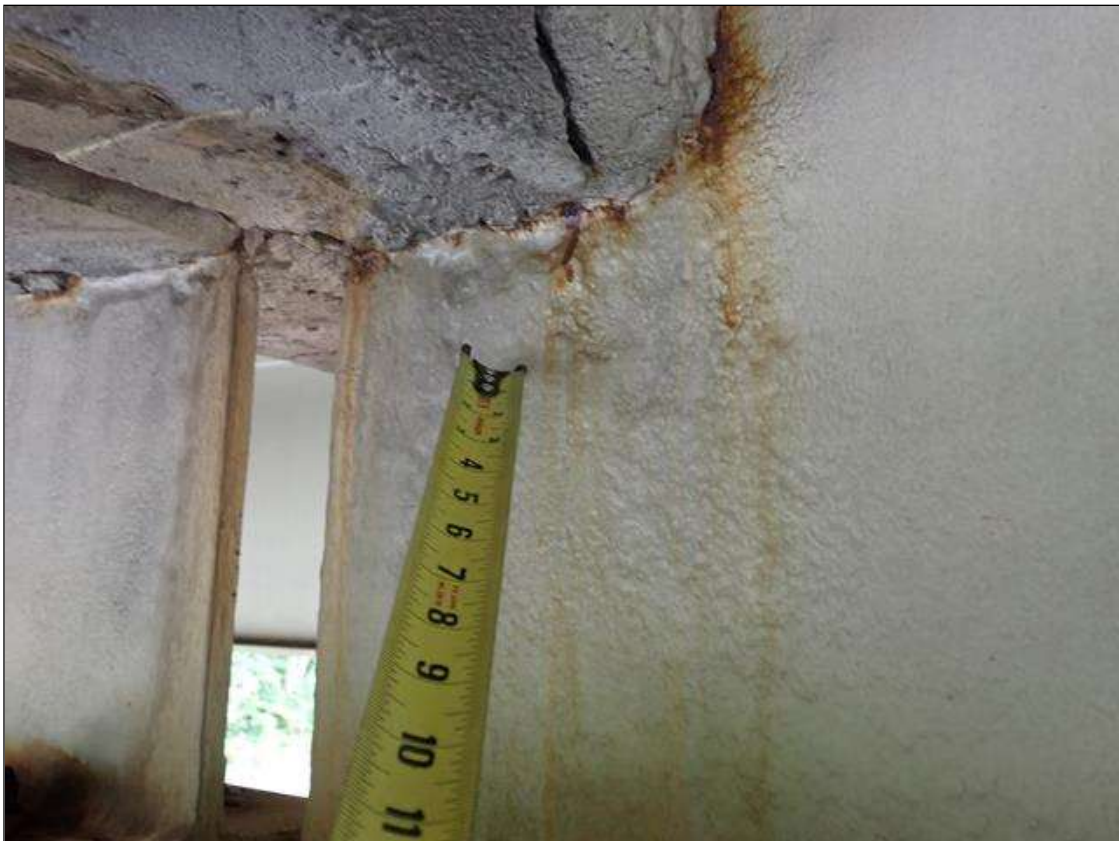
Span 3 Beam 4: (PAR) at bent 2, web adjacent to diaphragm, painted over section loss (3/8 inch average remaining x 9 inch x 2 inch), with adjacent pitting (up to 1/8 inch deep), with corrosion reinitiated

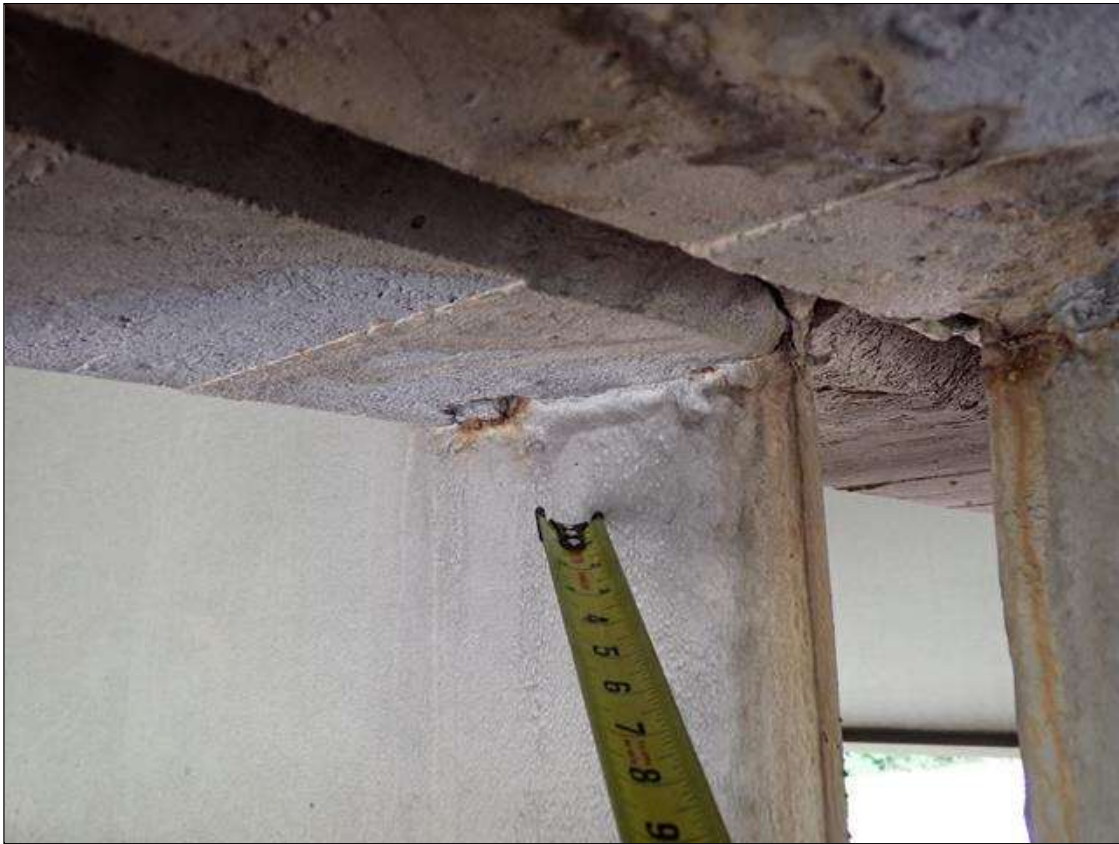
Span 2 Beam 4: (PAR) at bent 2, web adjacent to diaphragm, painted over section loss (3/8 inch average remaining x 8 inch x 2 inch), with adjacent pitting (up to 1/8 inch deep), with corrosion reinitiated

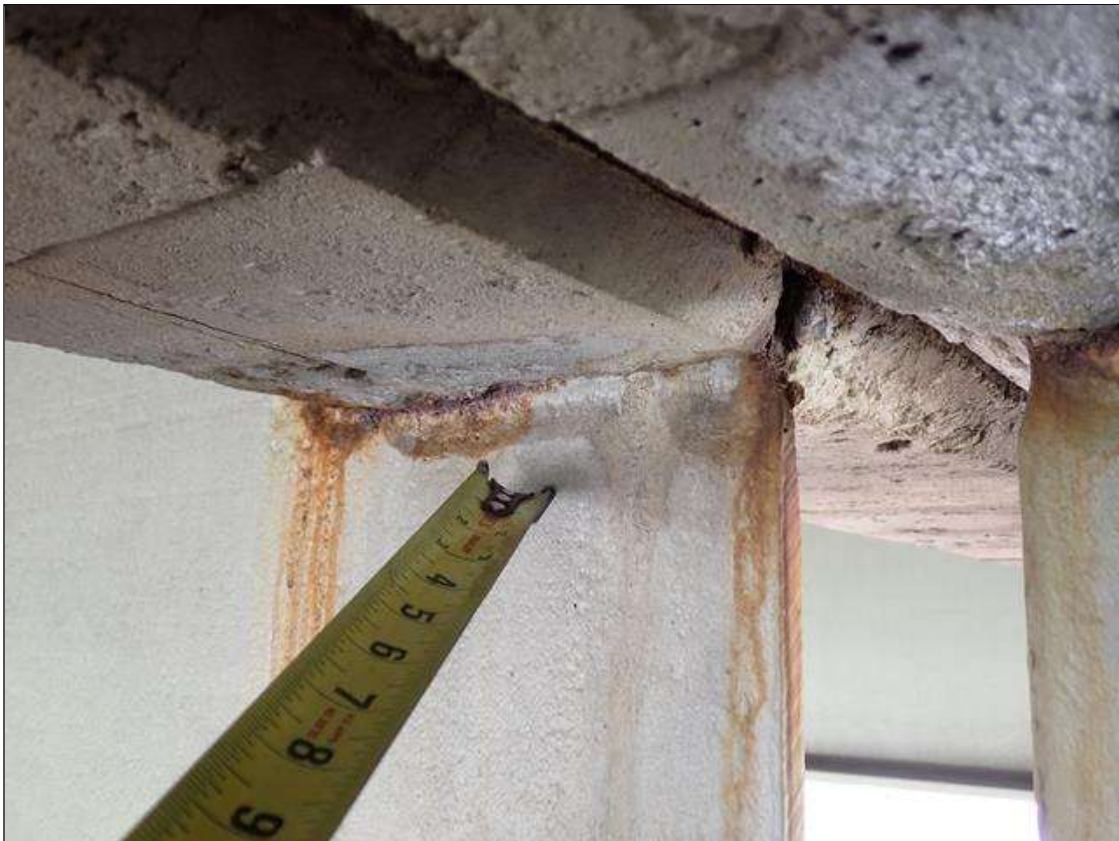
Span 2 Beam 3: (PAR) at bent 2, web adjacent to diaphragm, painted over section loss (3/8 inch average remaining x 9 inch x 2 inch), with adjacent pitting (up to 1/8 inch deep), with corrosion reinitiated

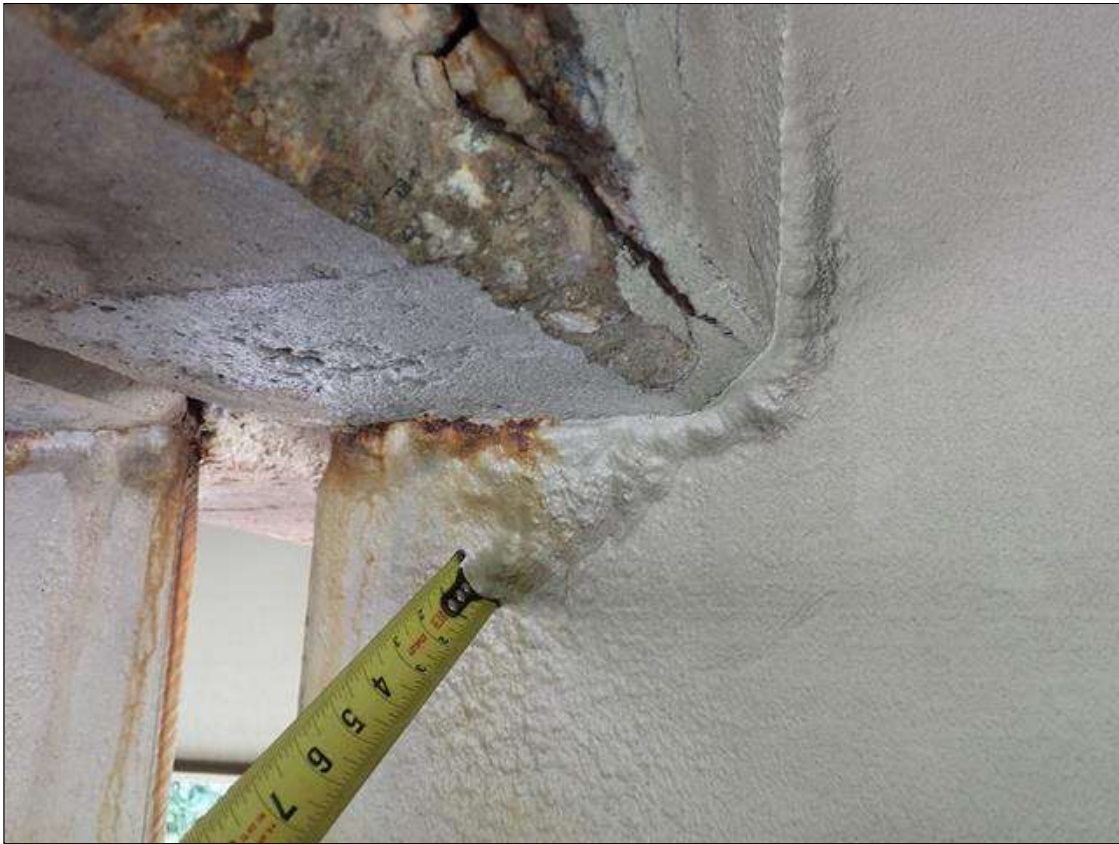
Span 3 Beam 3: (PAR) at bent 2, web adjacent to diaphragm, painted over section loss (3/8 inch average remaining x 10 inch x up to 10 inch), with adjacent pitting (up to 1/8 inch deep), with corrosion reinitiated

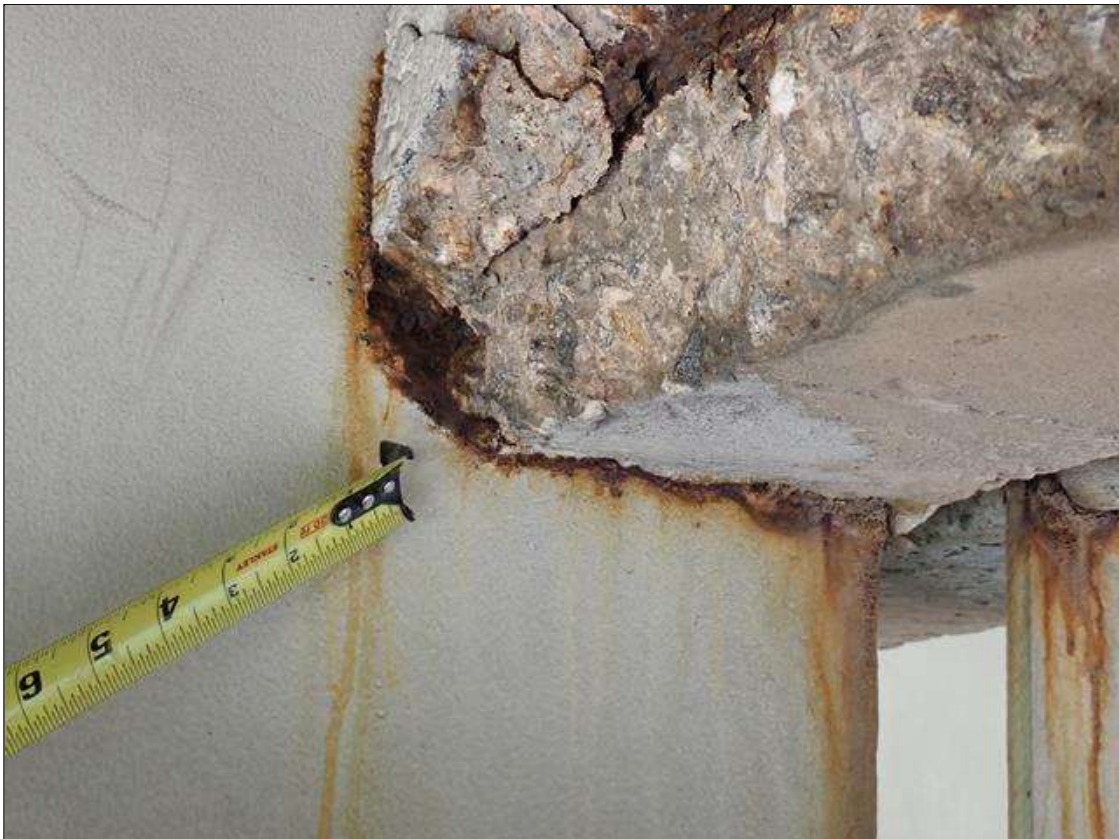
Span 3 Beam 2: at bent 2, web adjacent to diaphragm, corrosion with section loss (1/2 inch average remaining x 9 inch x 2 inch)

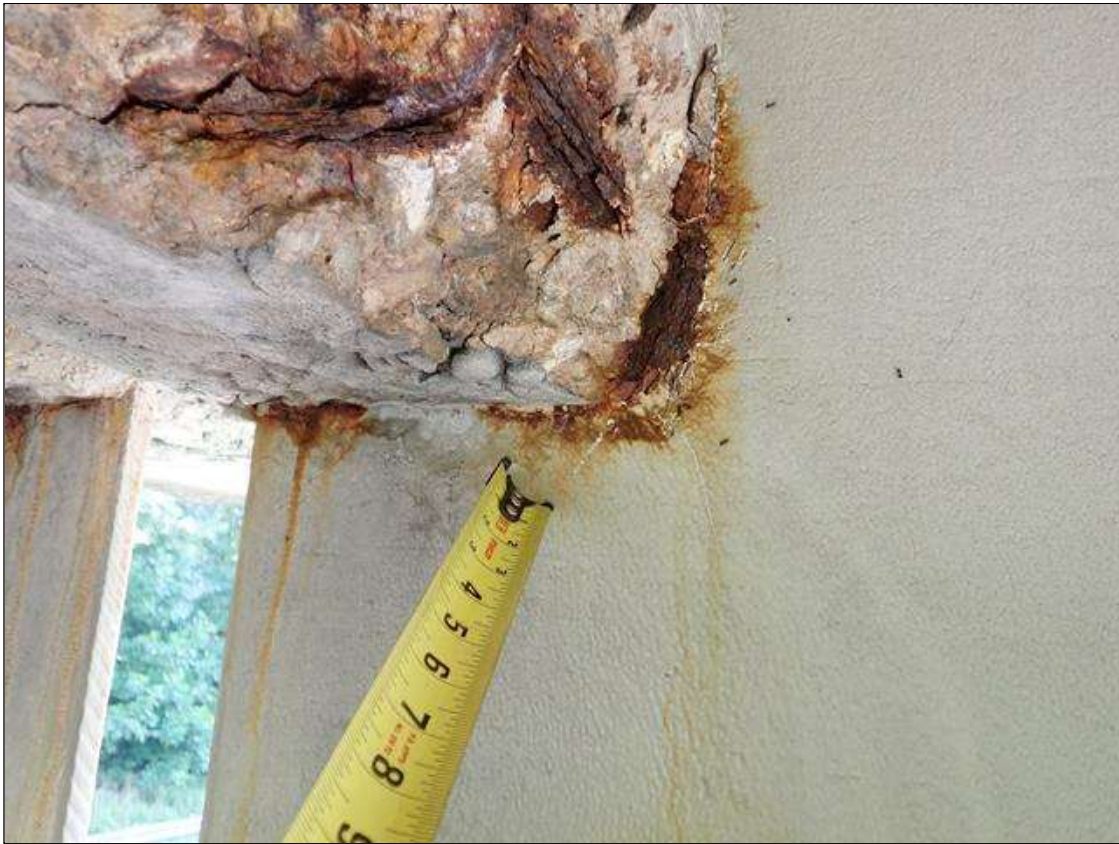
Span 3 Beam 1: at bent 2, web adjacent to diaphragm, painted over section loss (1/2 inch average remaining x 10 inch x 5 inch) with corrosion reinitiated

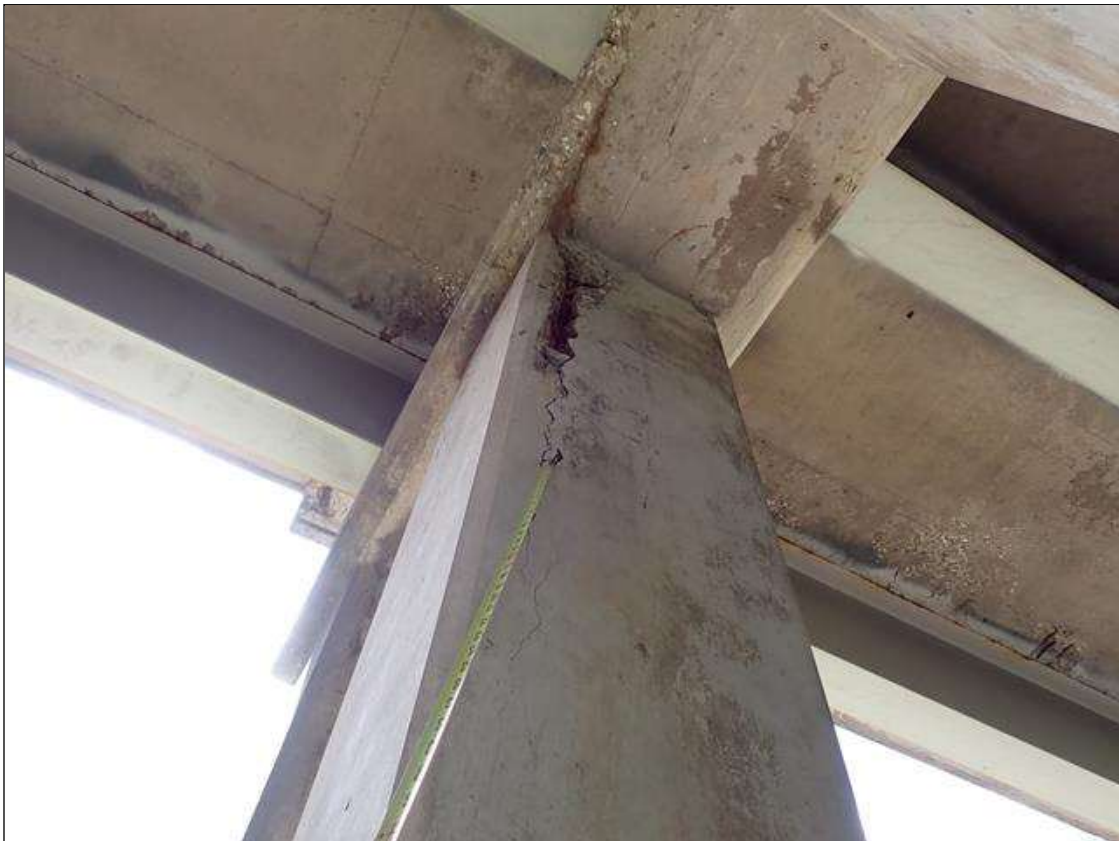
Bent 2 Pile 2: (PAR) west and east faces, near cap, spalls/delaminations (up to 5 feet x 6 inch x 2 inches deep) with cracks (up to 1/16 inch); H-pile flange exposed with rust scale

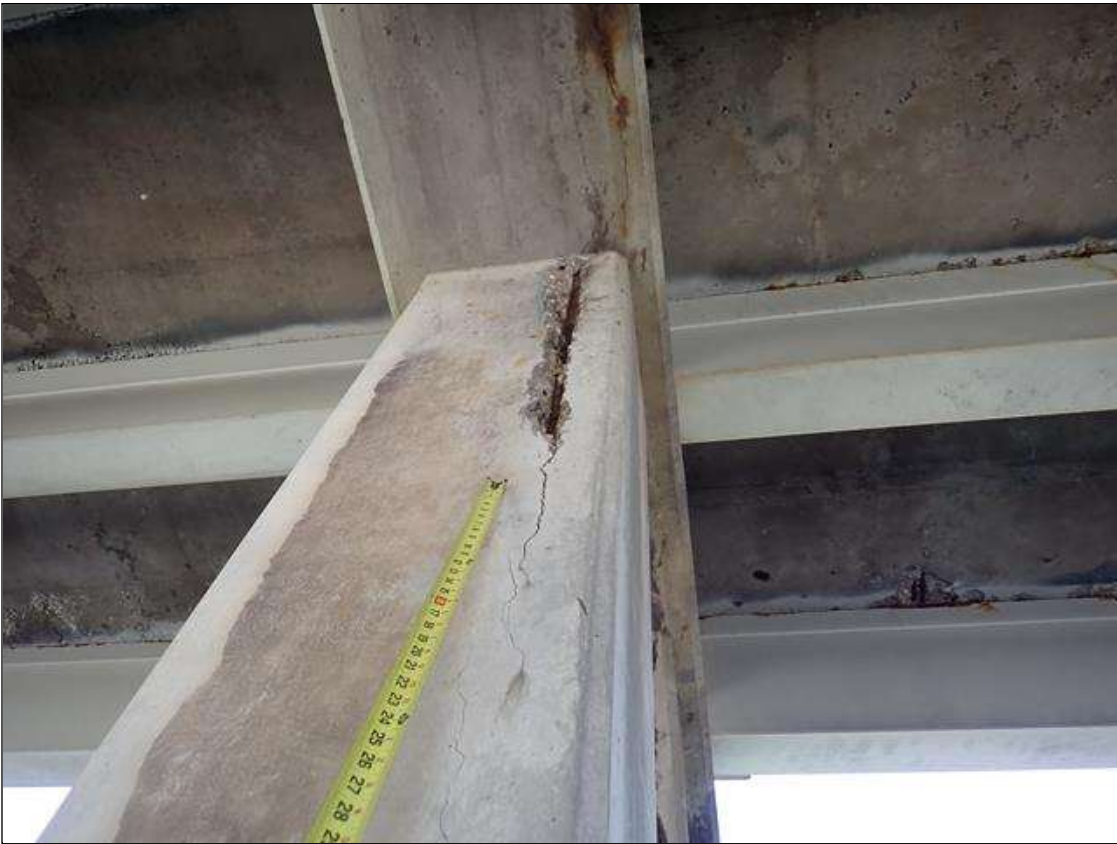
Bent 2 Pile 5: (PAR) west and east faces, near cap, spalls/delaminations (6 feet x 6 inch x 2 inches deep) with cracks (up to 1/8 inch); H-pile flange exposed with rust scale

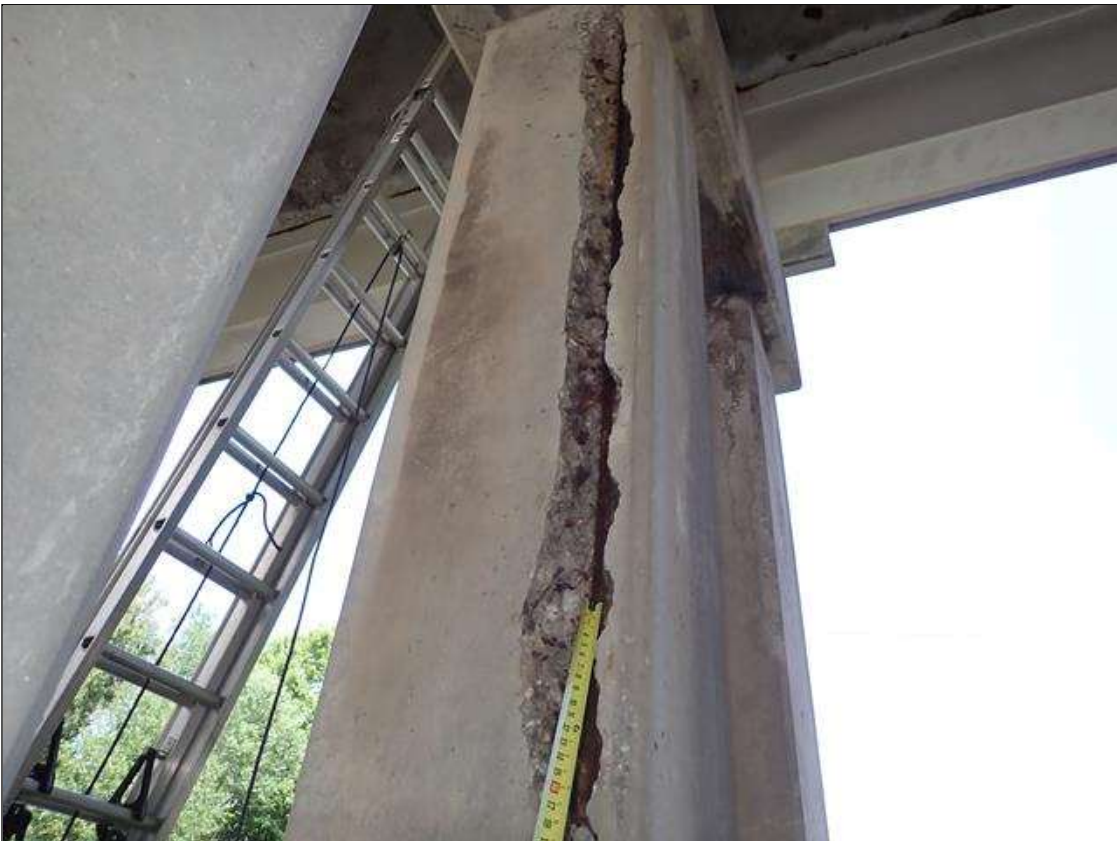
Bent 2 Pile 6: (PAR) west and east faces, spalls/delaminations (up to full height x 8 inch x 3 inches deep) with cracks (up to 1/4 inch) with efflorescence; H-pile flange exposed with rust scale

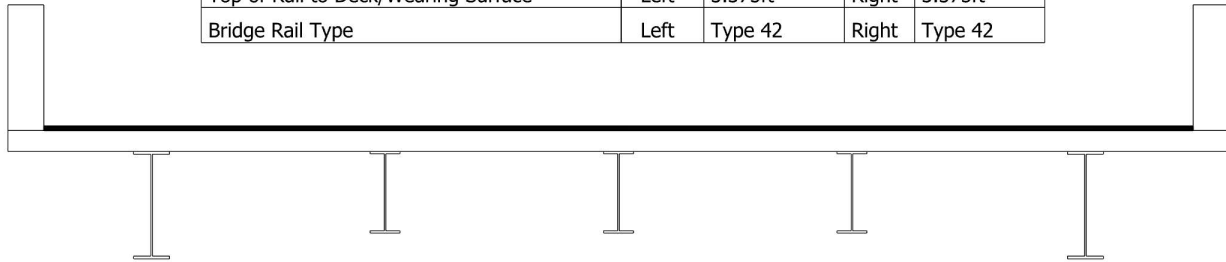
Measurements for Span #	1	Similar all spans	
Deck Thickness	7in	Left Overhang	4ft
Top of Rail to Bottom of Beam (Avg)	7.073ft	Right Overhang	4ft

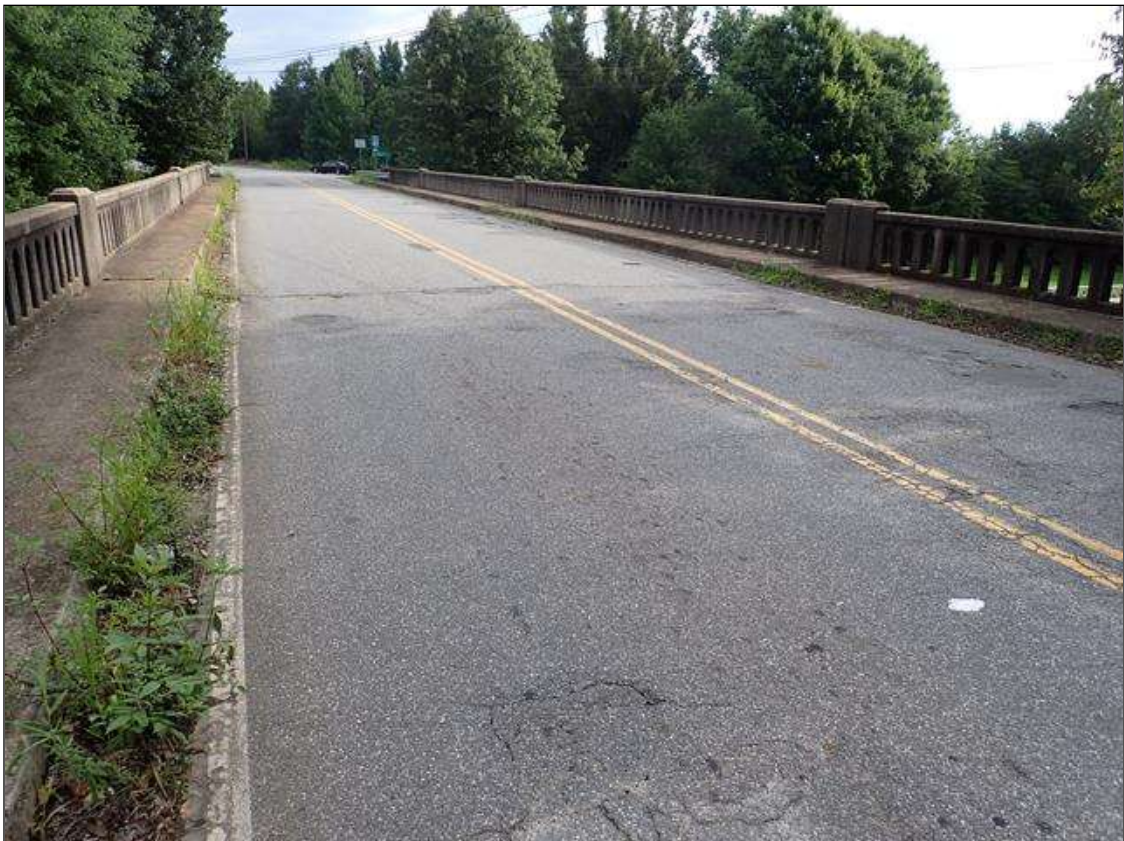
asphalt wearing surface

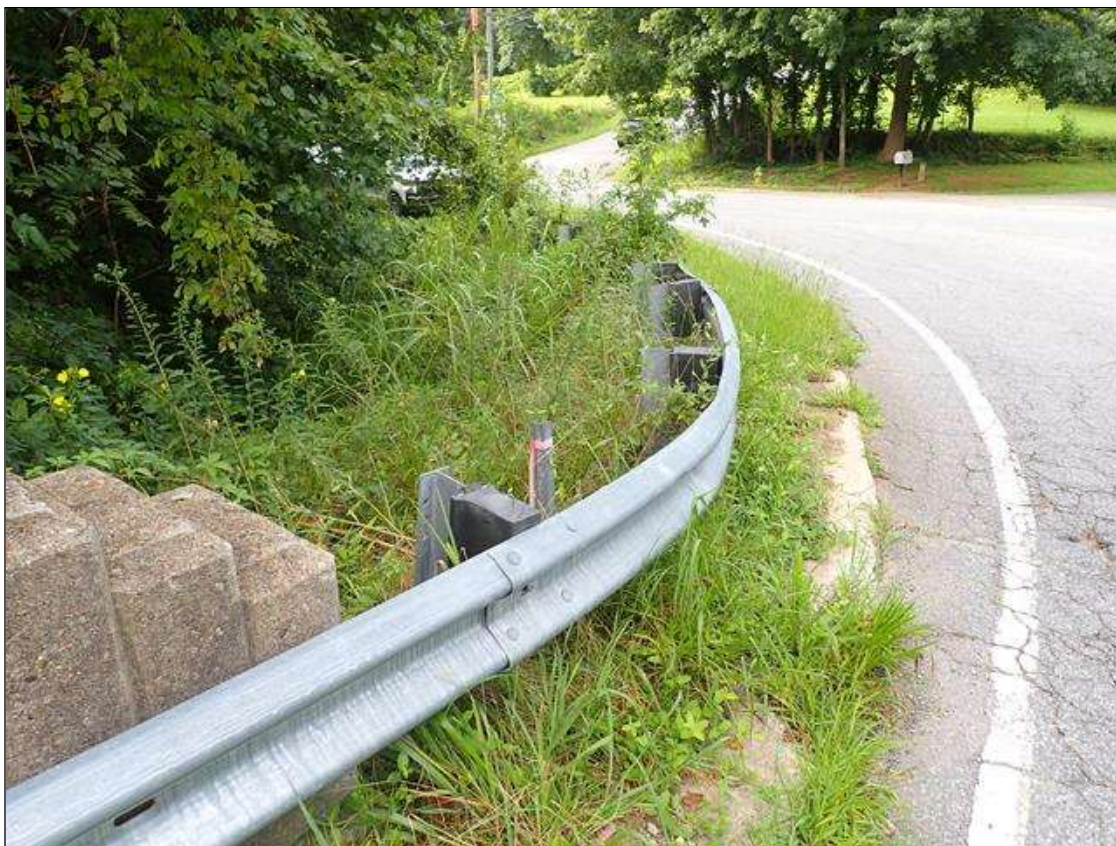
southeast guardrail transition
