NC DEPARTMENT OF TRANSPORTATION
 DIVISION OF HIGHWAYS
 STRUCTURE MANAGEMENT UNIT

ATTENTION: **prompt action request, sketches revised, clearances revised, newly structurally deficient**

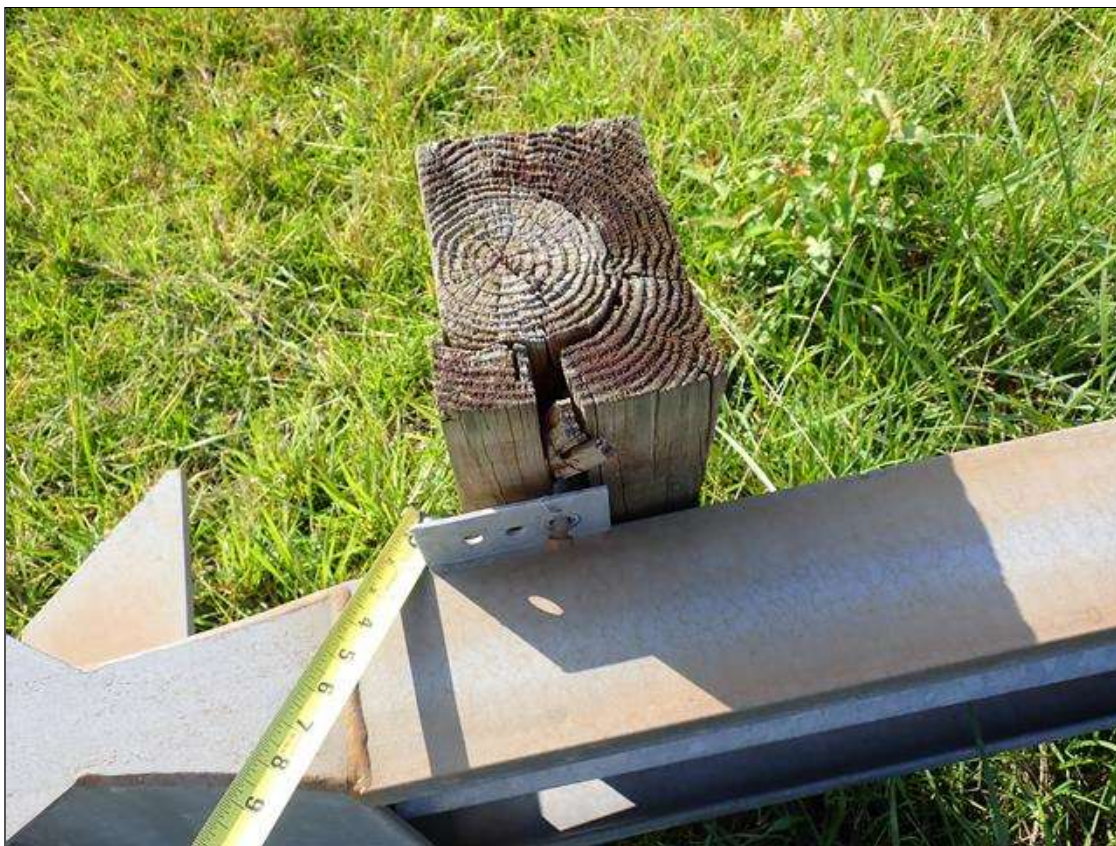
(PAR) northeast guardrail termination, end post split with disconnected termination block

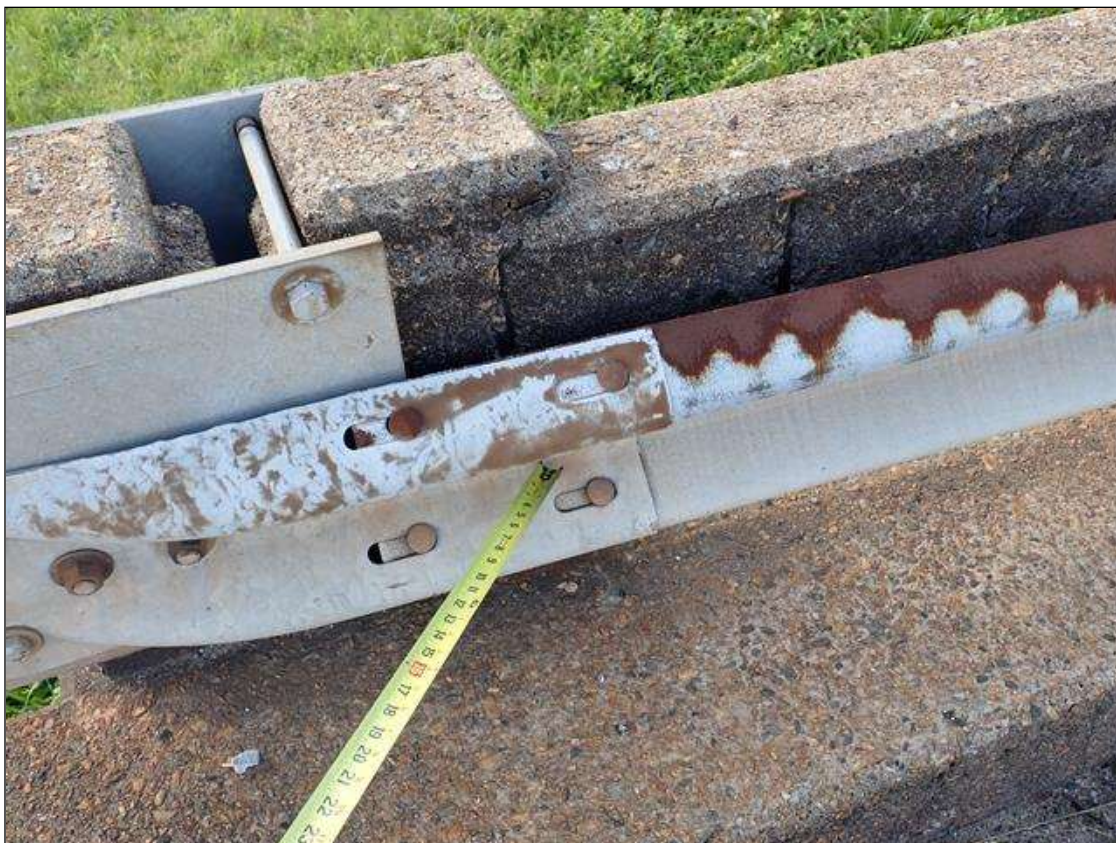
(PAR) southeast guardrail attachment, improper lap

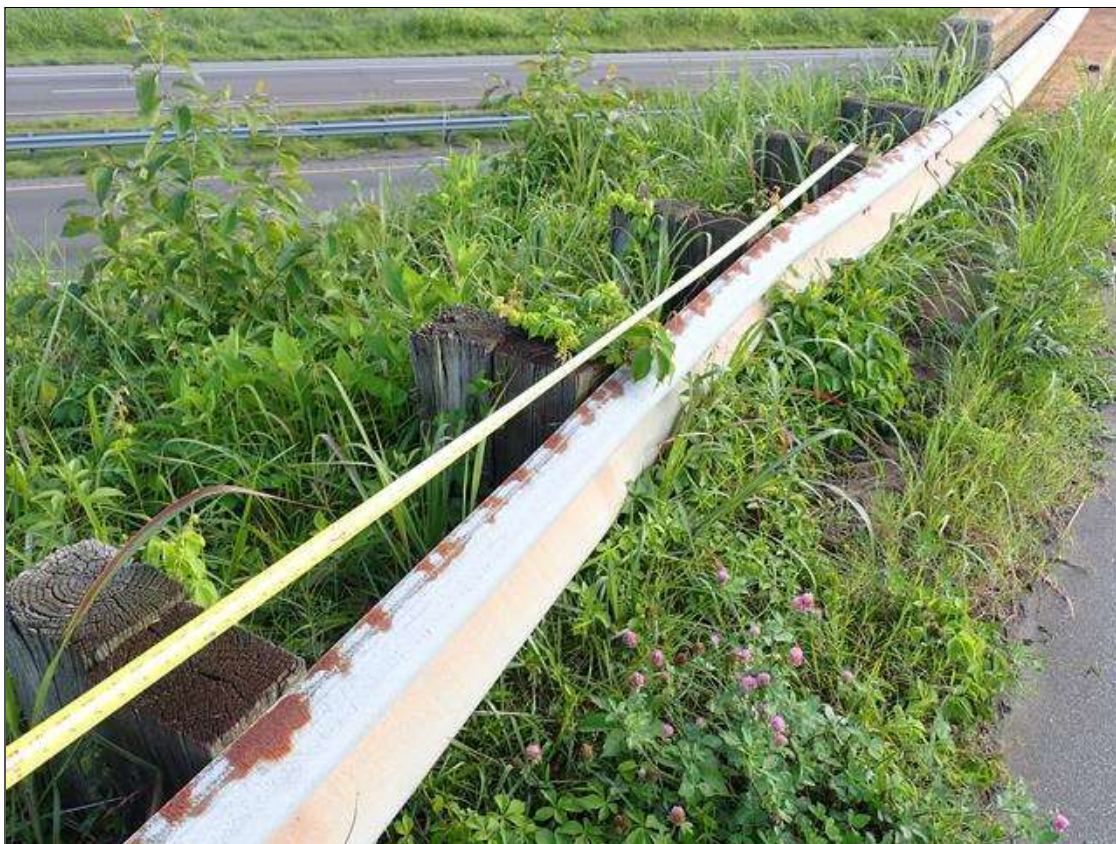
(PAR) southwest guardrail, 15 feet from bridge, impact damage (10 feet)

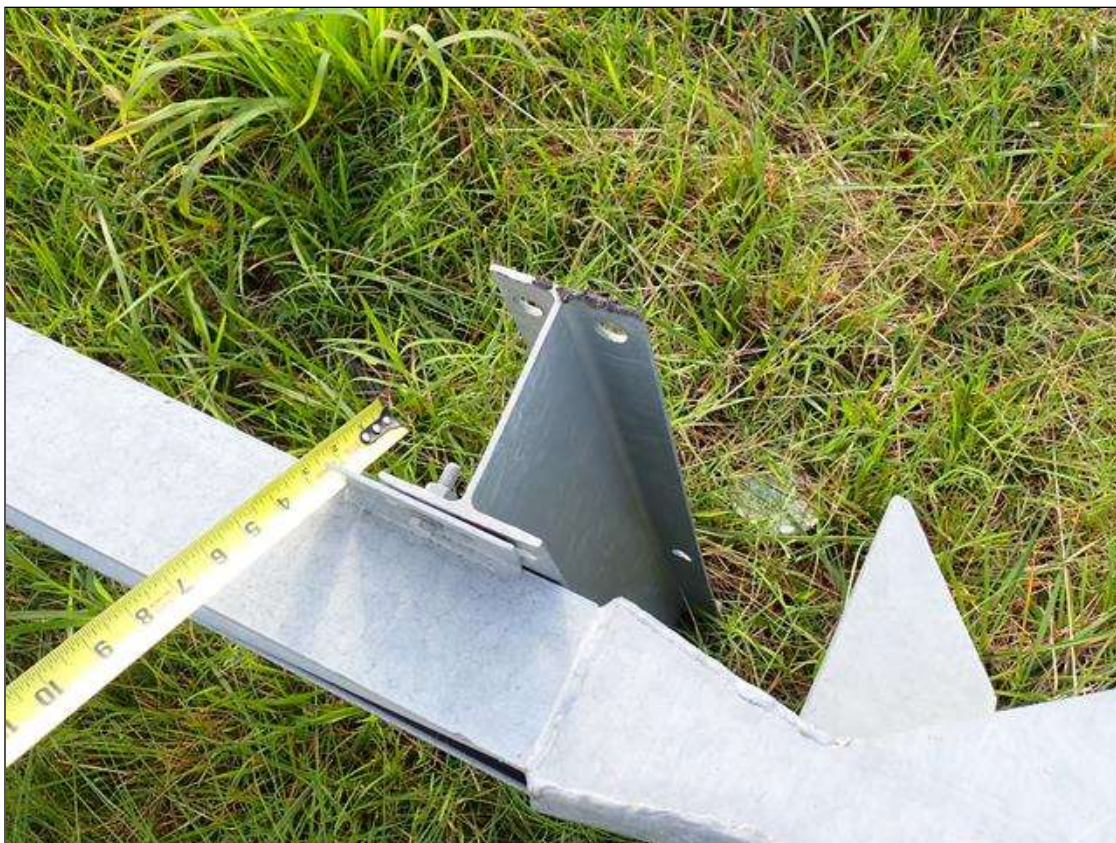
(PAR) southeast guardrail termination, impact damage with leaning end post

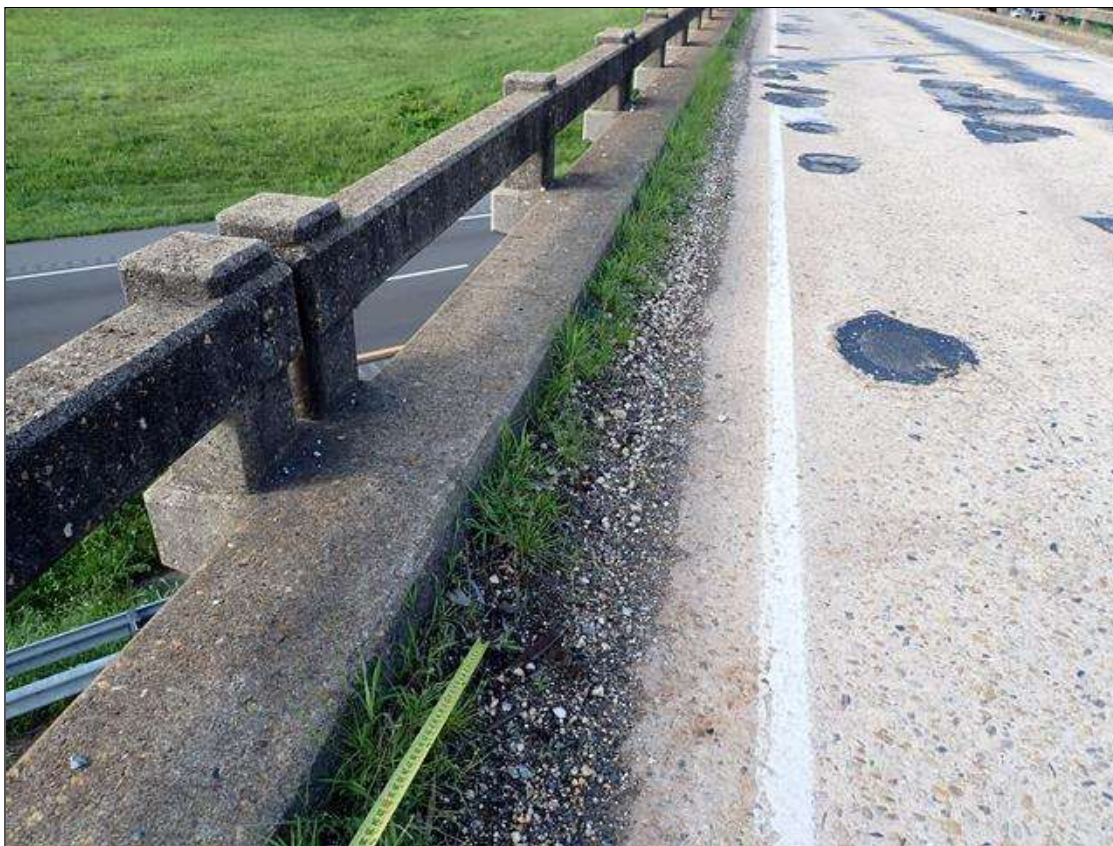
along the curblines, debris accumulation (up to 2 feet wide x 4 inches wide) with vegetation, with multiple clogged drains

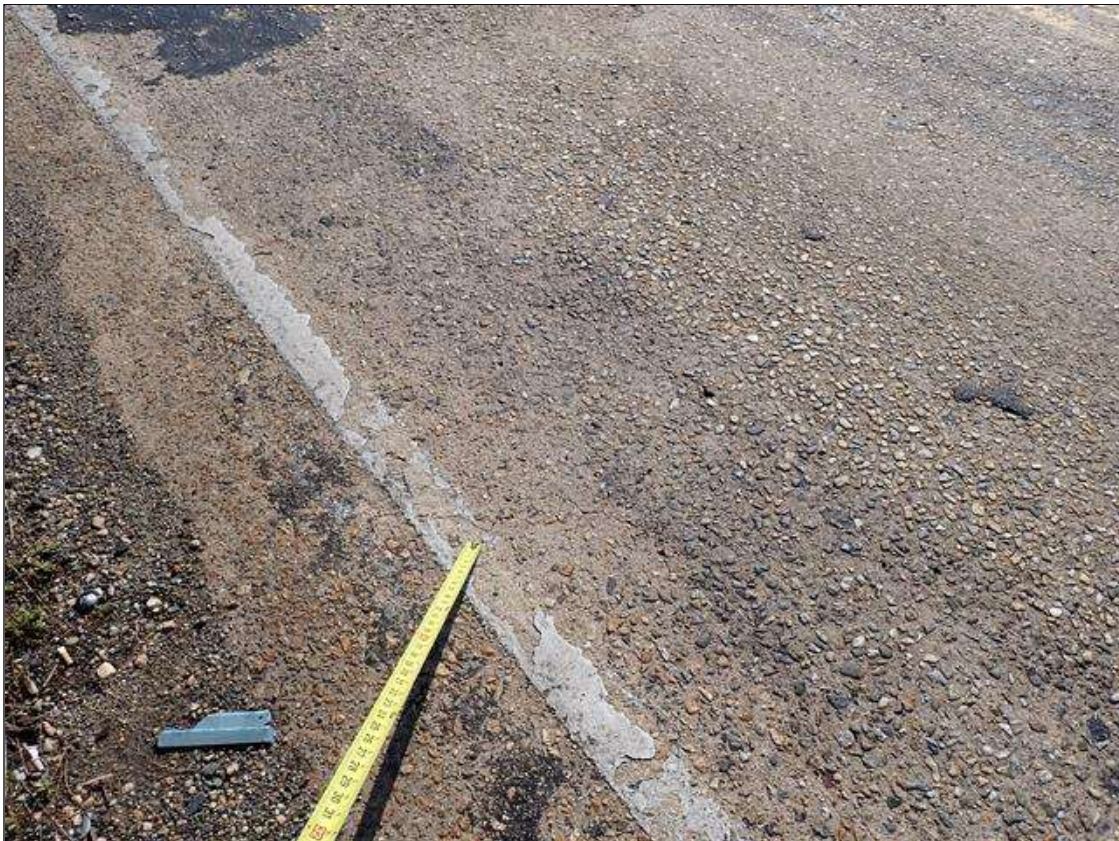
Span 4 Deck: SPAN 4 TOP OF DECK HAS MAP CRACKING UP TO 1/16 INCH AND COARSE AGGREGATE EXPOSED THROUGH OUT.

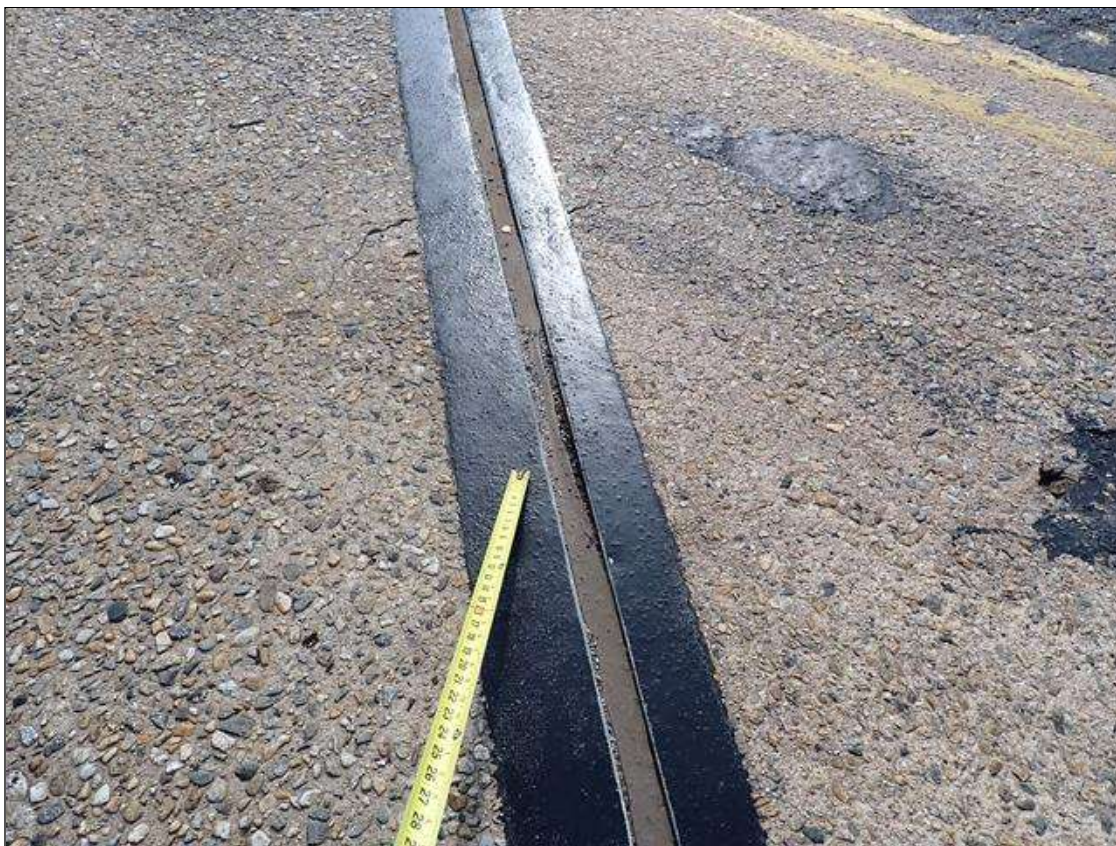
Span 4 Bent 3 Joint: along the length of the joint, areas of adhesion loss at random

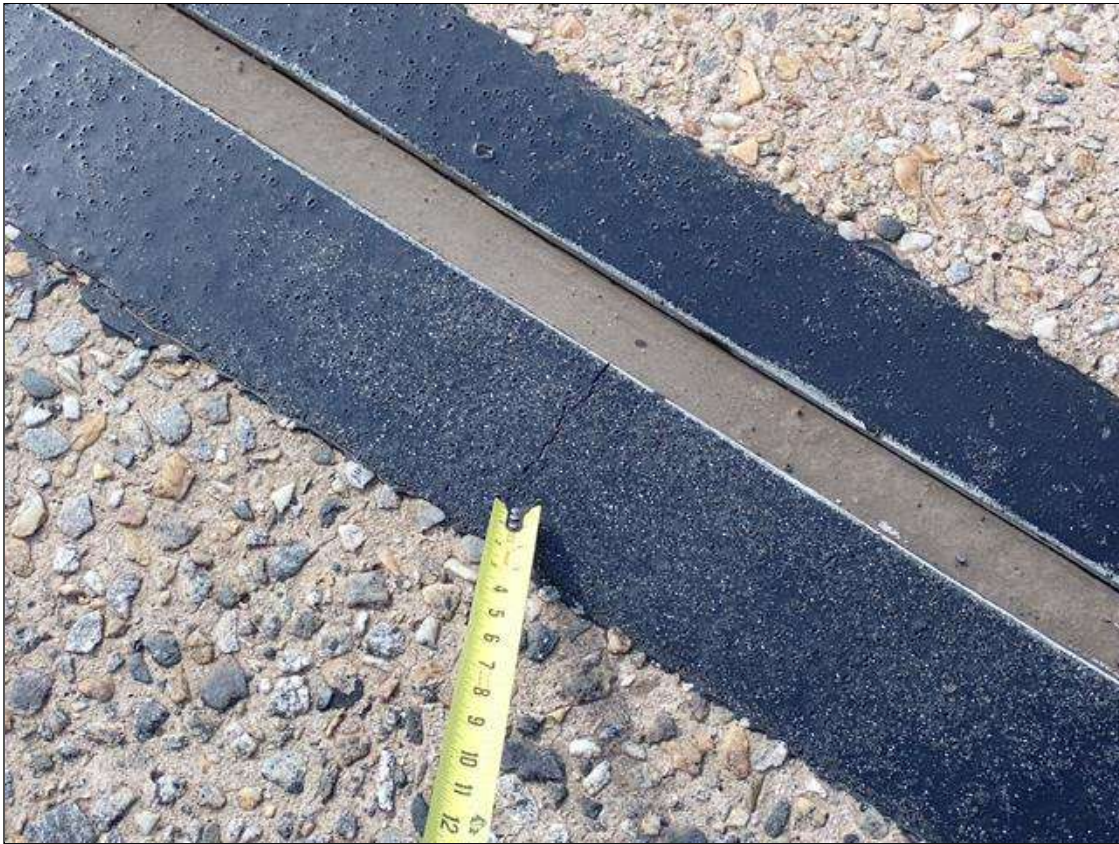
Span 4 Bent 3 Joint: along the headers, transverse cracks (up to 1/32 inch x 6 inches) at random

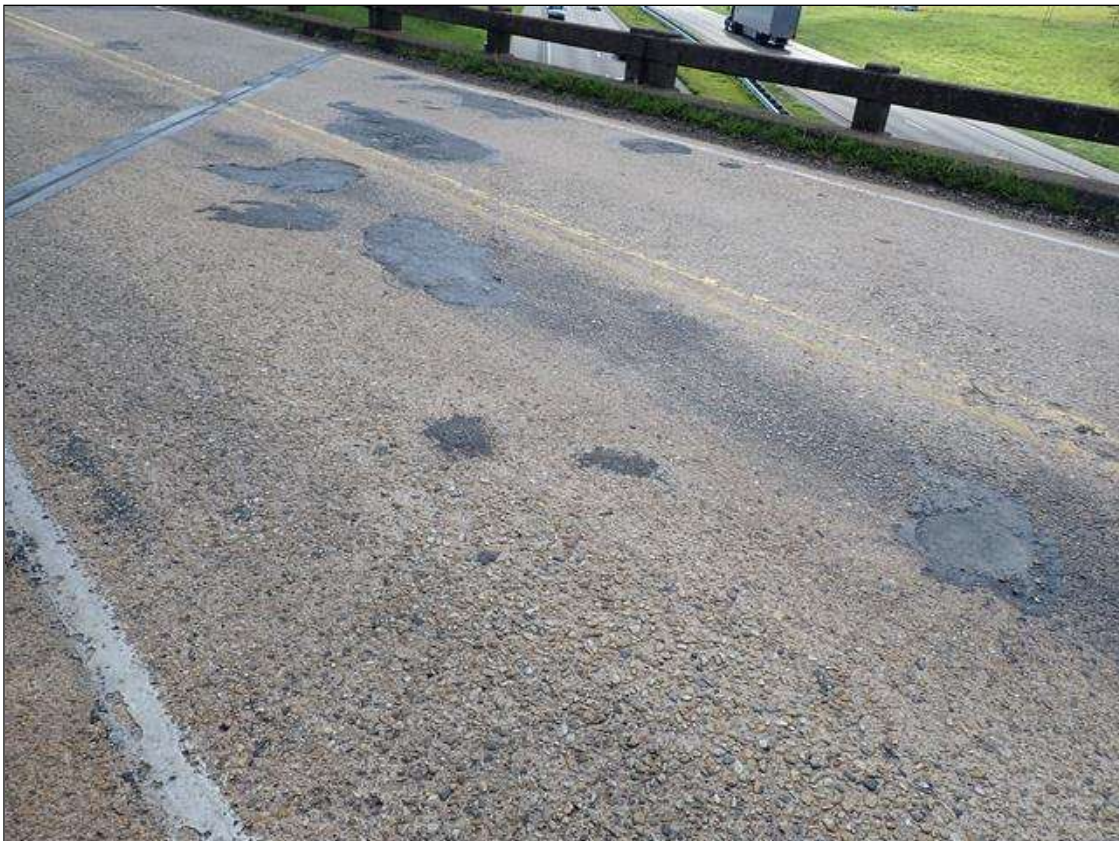
Span 3 Deck: 2023 previously repaired, previously noted as: in Southbound lane 10 feet from joint over bent 3, spall [up to 28 inch x up to 18 inch x up to 2 inch deep] with (1) exposed rusted reinforcing no section loss

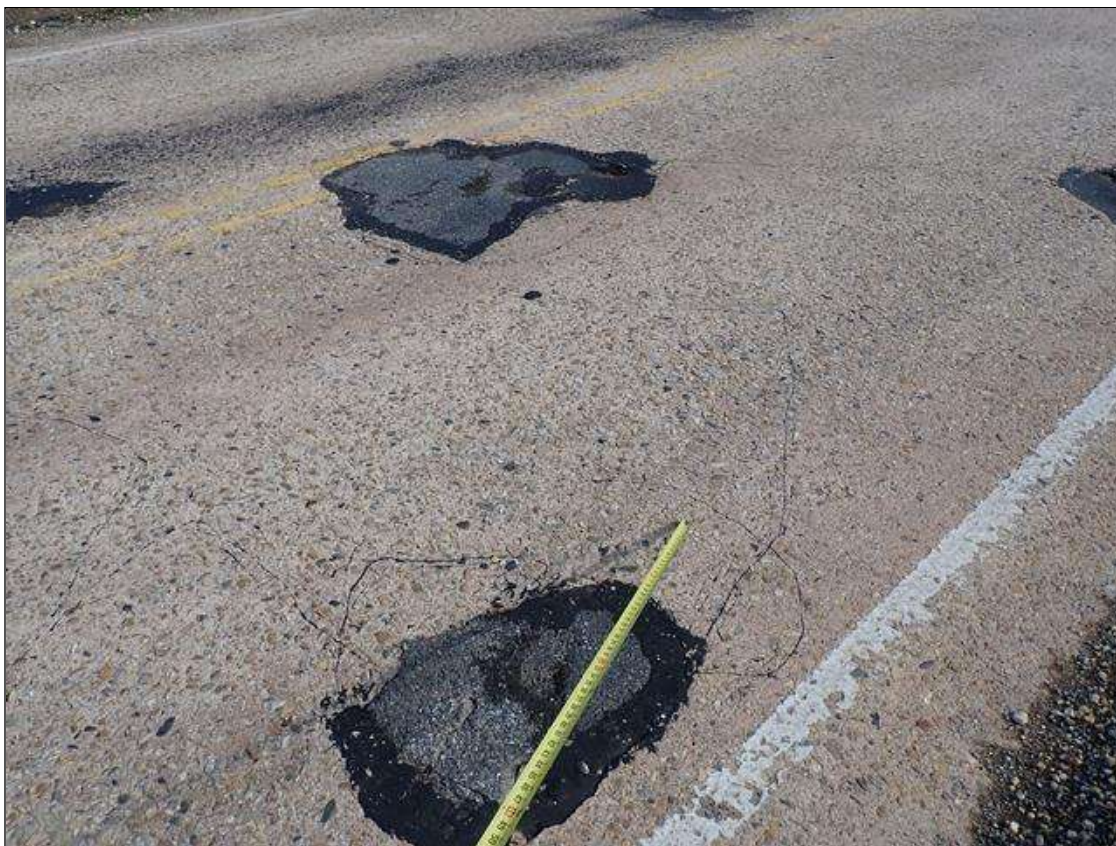
Span 3 Deck: (PAR) SPAN 3 TOP OF DECK HAS SCATTERED sound and unsound PATCHES [up to 8 feet x up to 4 feet x up to 1.5 inches deep] some with depressions; with adjacent spalls/delaminations (up to 1.5 foot diameter x 1.5 inches deep)

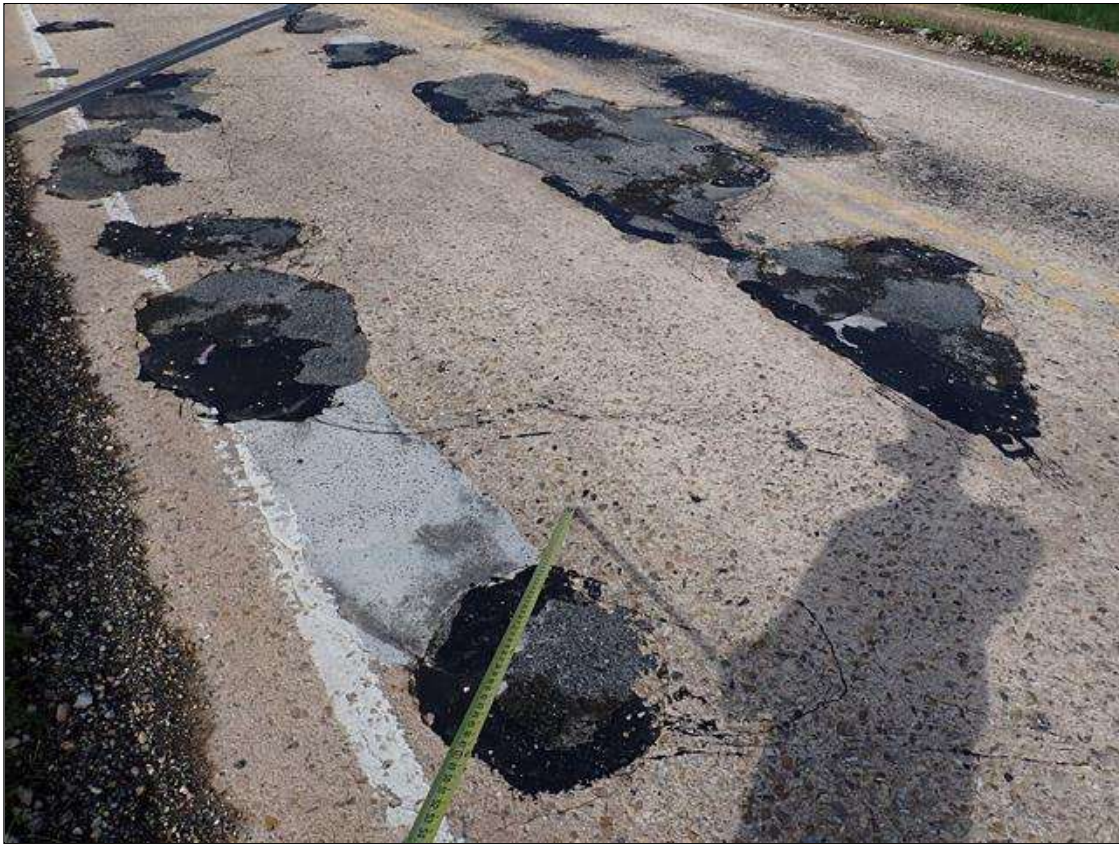
Span 3 Deck: (PAR) SPAN 3 TOP OF DECK HAS SCATTERED sound and unsound PATCHES [up to 8 feet x up to 4 feet x up to 1.5 inches deep] some with depressions; with adjacent spalls/delaminations (up to 1.5 foot diameter x 1.5 inches deep)

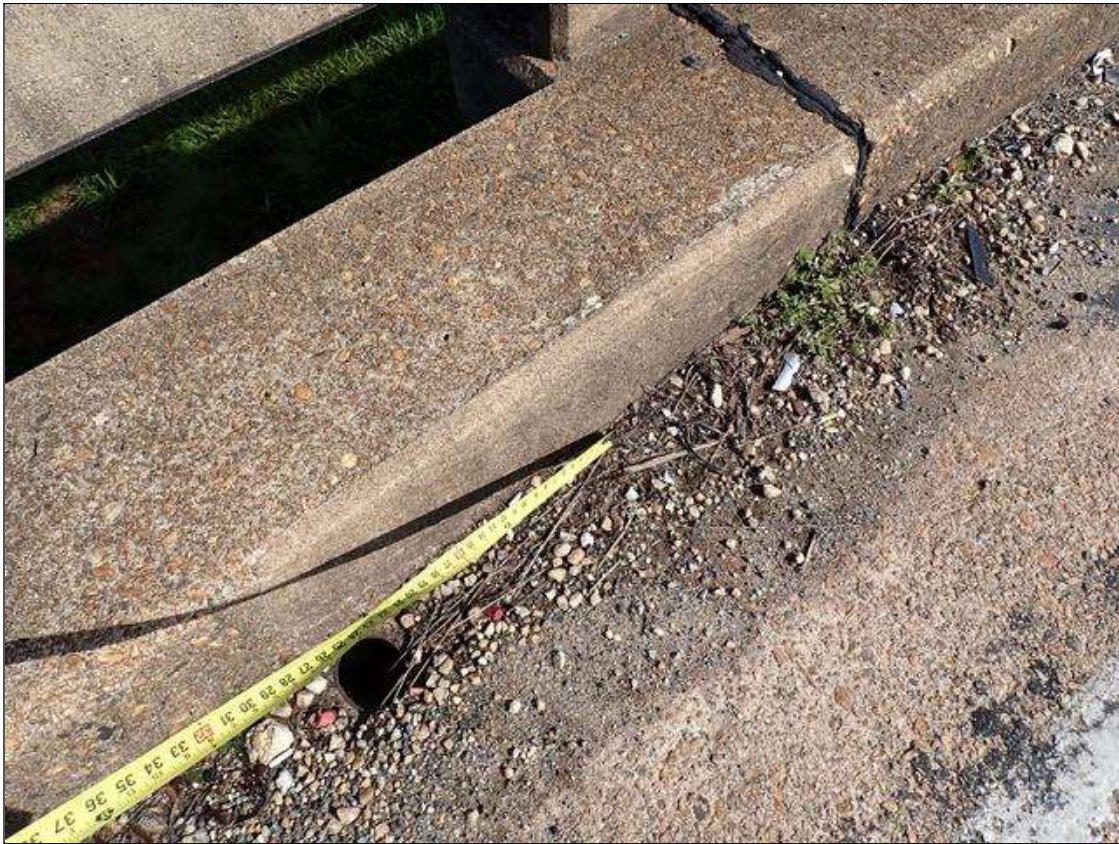
Span 3 Left Bridge Rail: adjacent to joint over bent 3, sound patched area [4 feet x 11 inches] with associated hairline map cracking

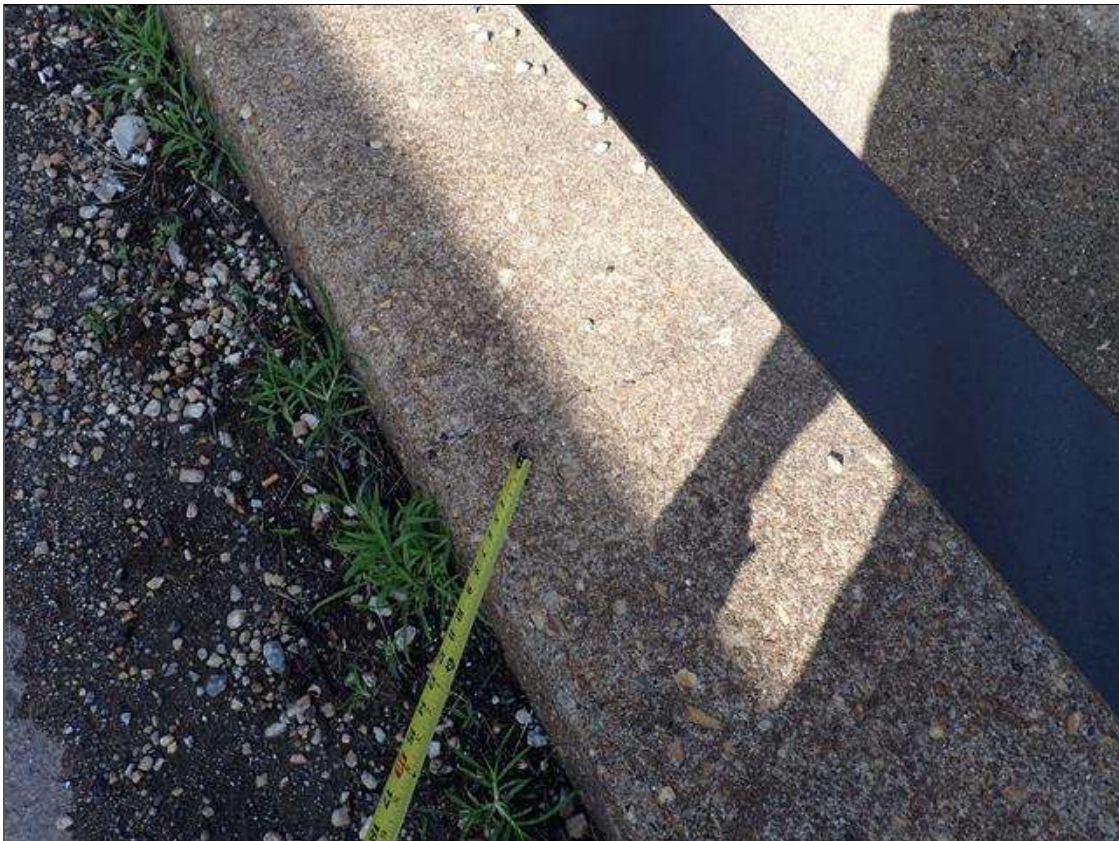
Span 3 Left Bridge Rail: along curb, wraparound vertical cracks [up to 1/32 inch]

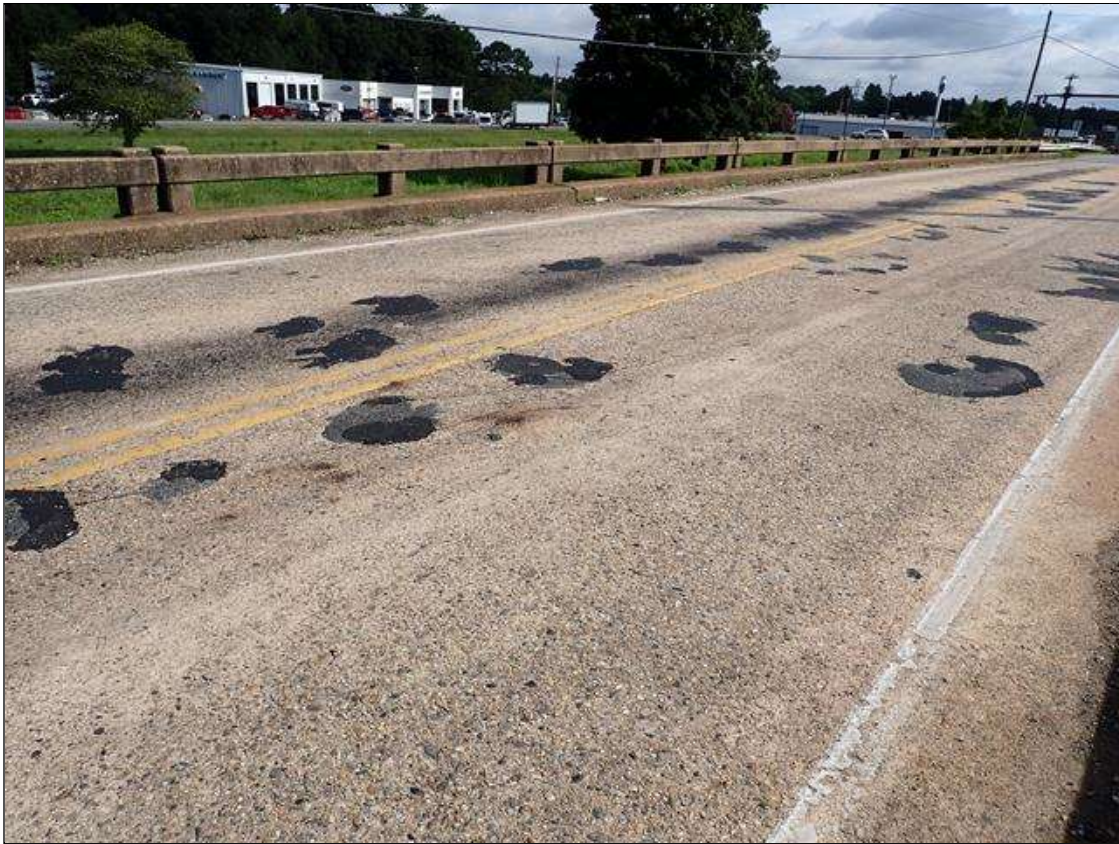
Span 2 Deck: 2023 previously repaired, previously noted as: in Northbound lane near midspan, (2) spalls [up to 16 inch x 21 inch x up to 2 inch deep] with (2) exposed rusted reinforcing no section loss

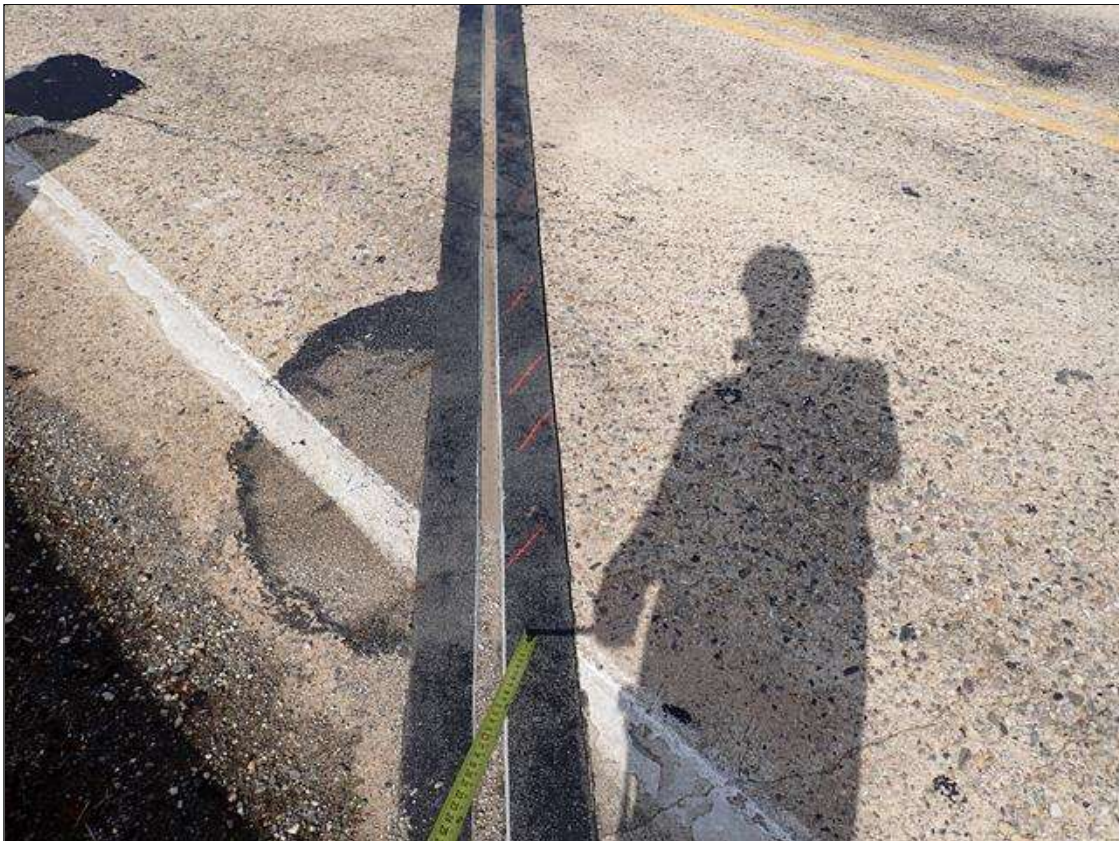
Span 2 Bent 1 Joint: (PAR) spans 1 and 2 header, in both travel lanes, delaminations (up to 12.5 feet x 6 inches) with cracks (up to 1/8 inch) and separated from adjacent deck (up to 1/2 inch)

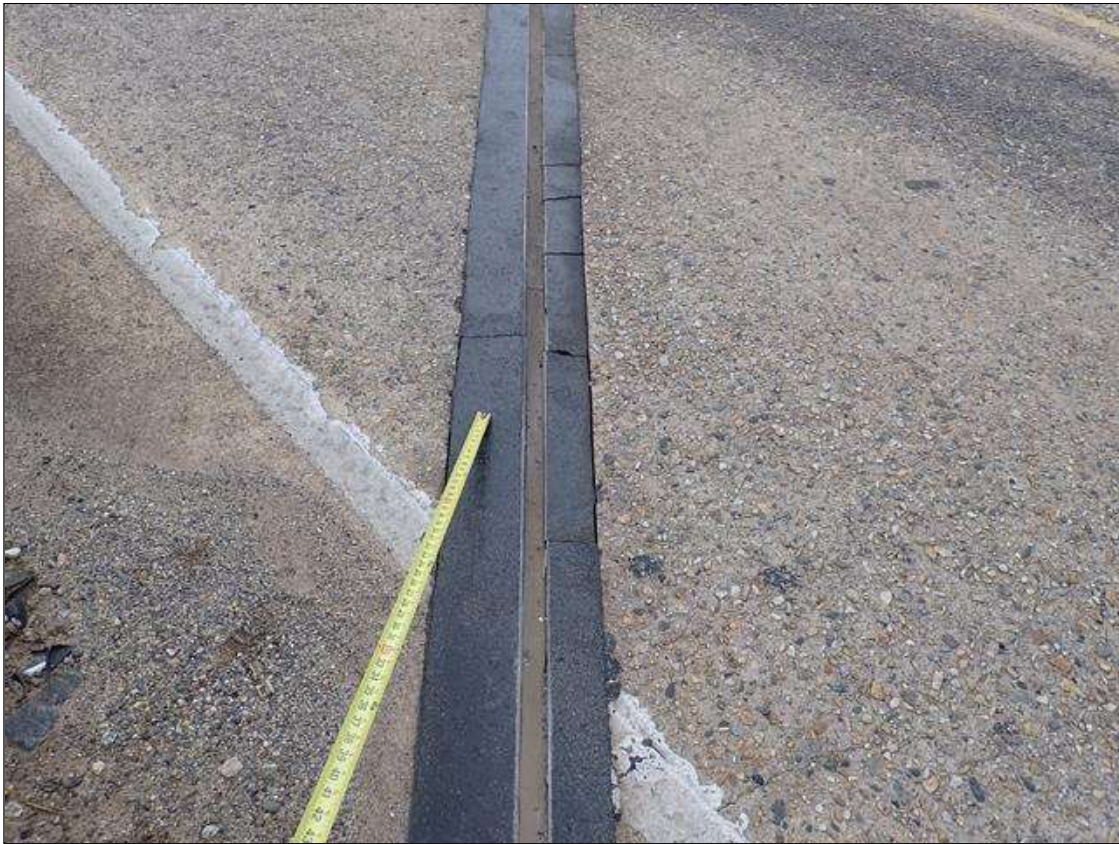
Span 2 Bent 1 Joint: (PAR) spans 1 and 2 header, in both travel lanes, delaminations (up to 12.5 feet x 6 inches) with cracks (up to 1/8 inch) and separated from adjacent deck (up to 1/2 inch)

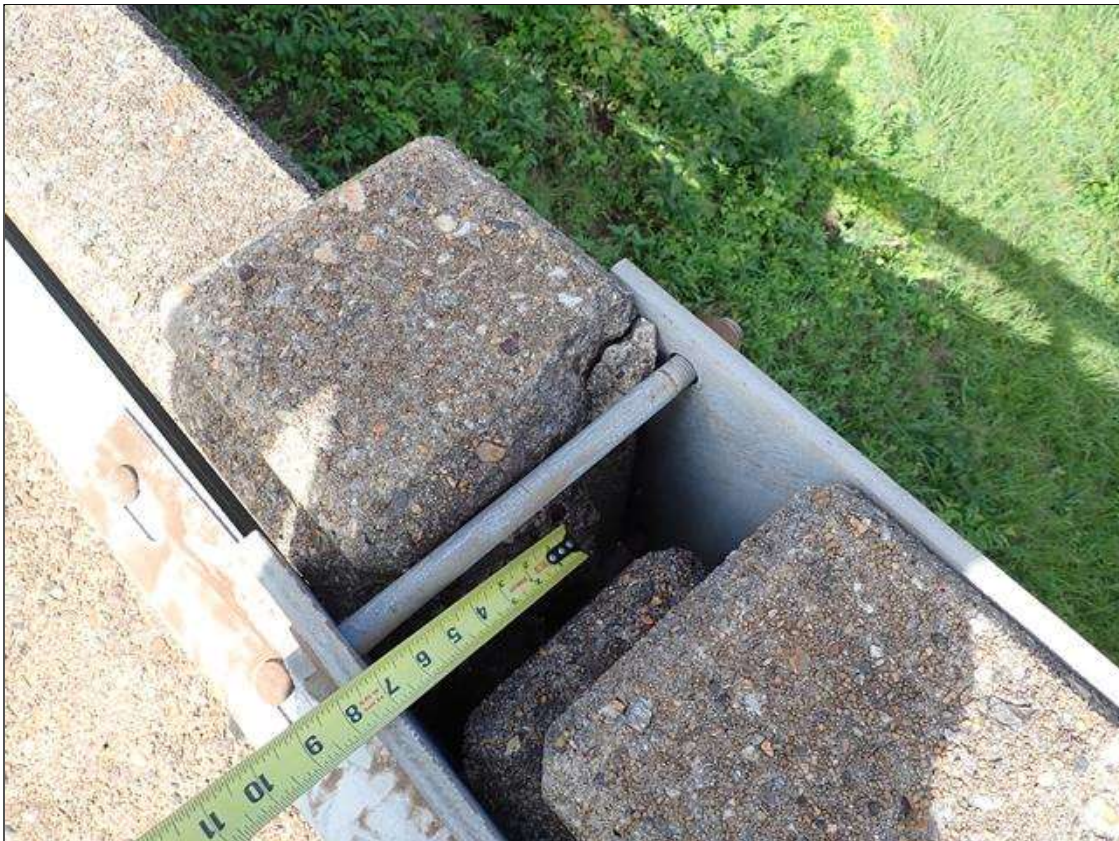
Span 1 Left Bridge Rail: at Southwest guardrail attachment in top of rail post, spall [10 inches x 10 inches x 1.5 inches deep] no exposed reinforcing

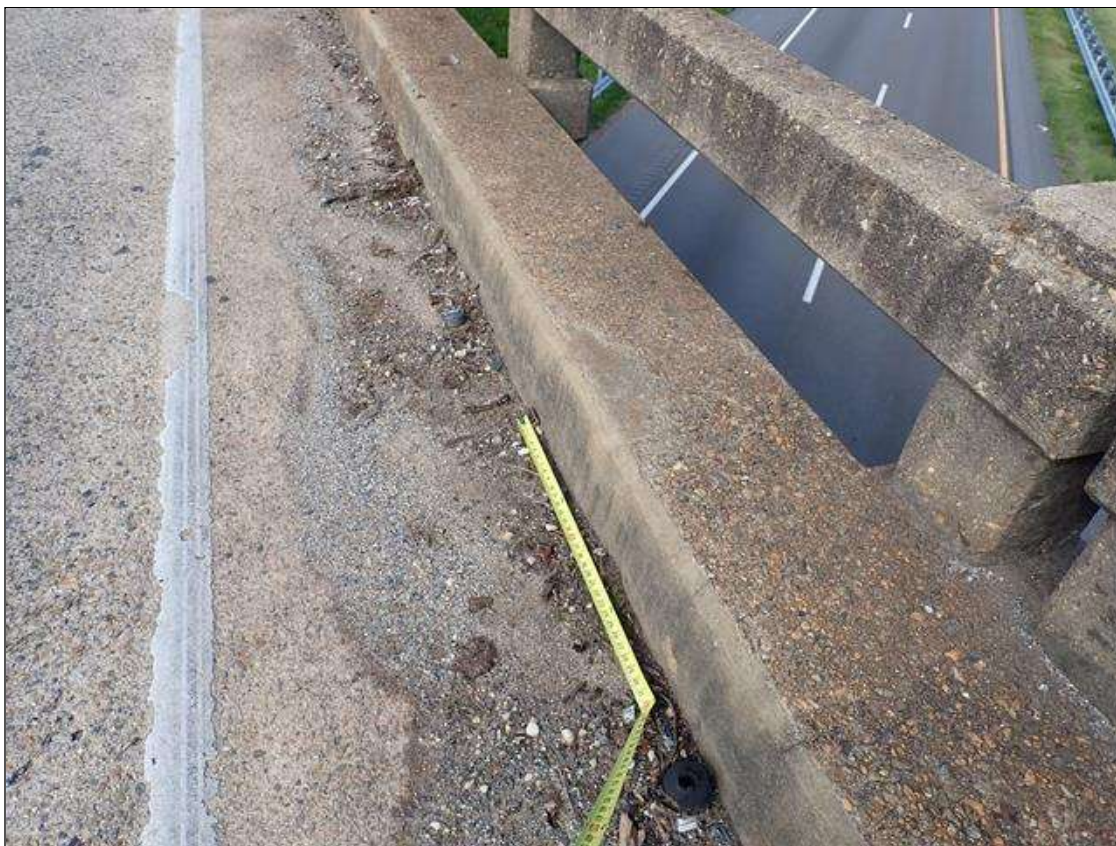
Span 2 Left Bridge Rail: face of curb, near bent 1, patched area (34 feet x 9 inch) with cracks (up to 1/32 inch)

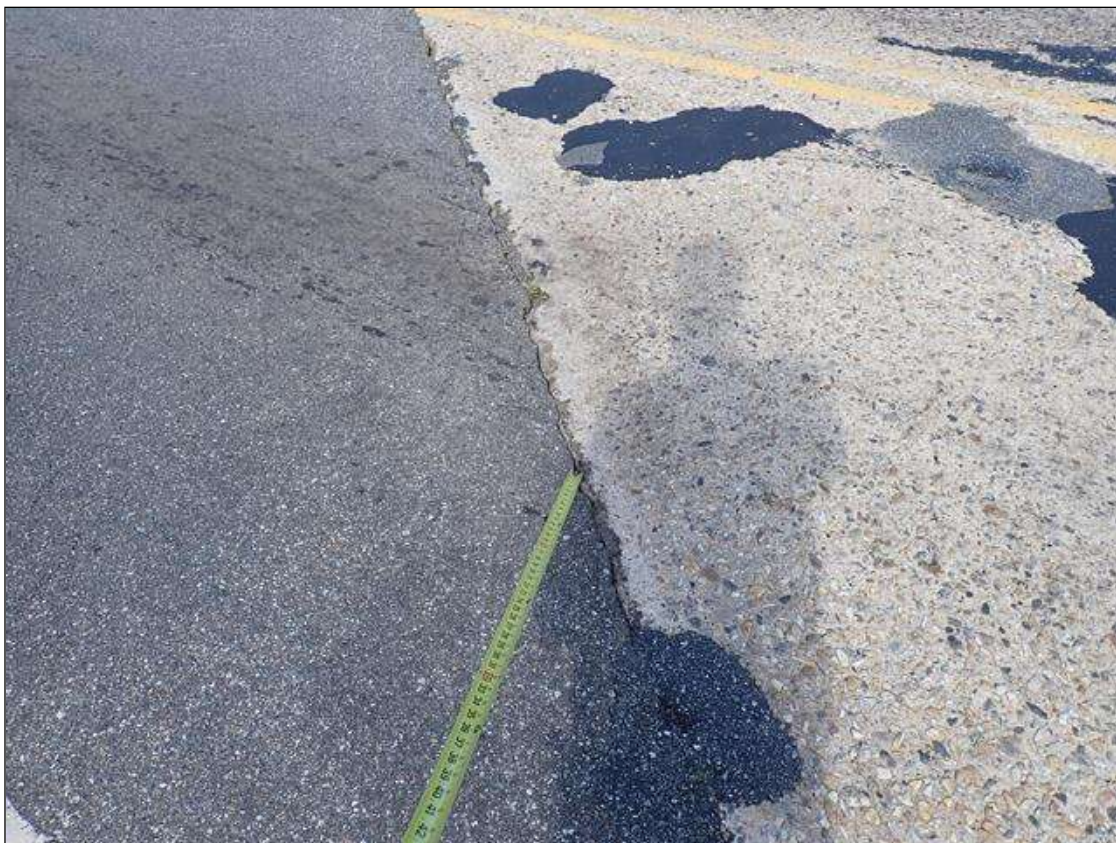
Span 1 Deck: along end bent 1, multiple edge spalls [up to 6 inches x 2 inches x 1 inch deep]

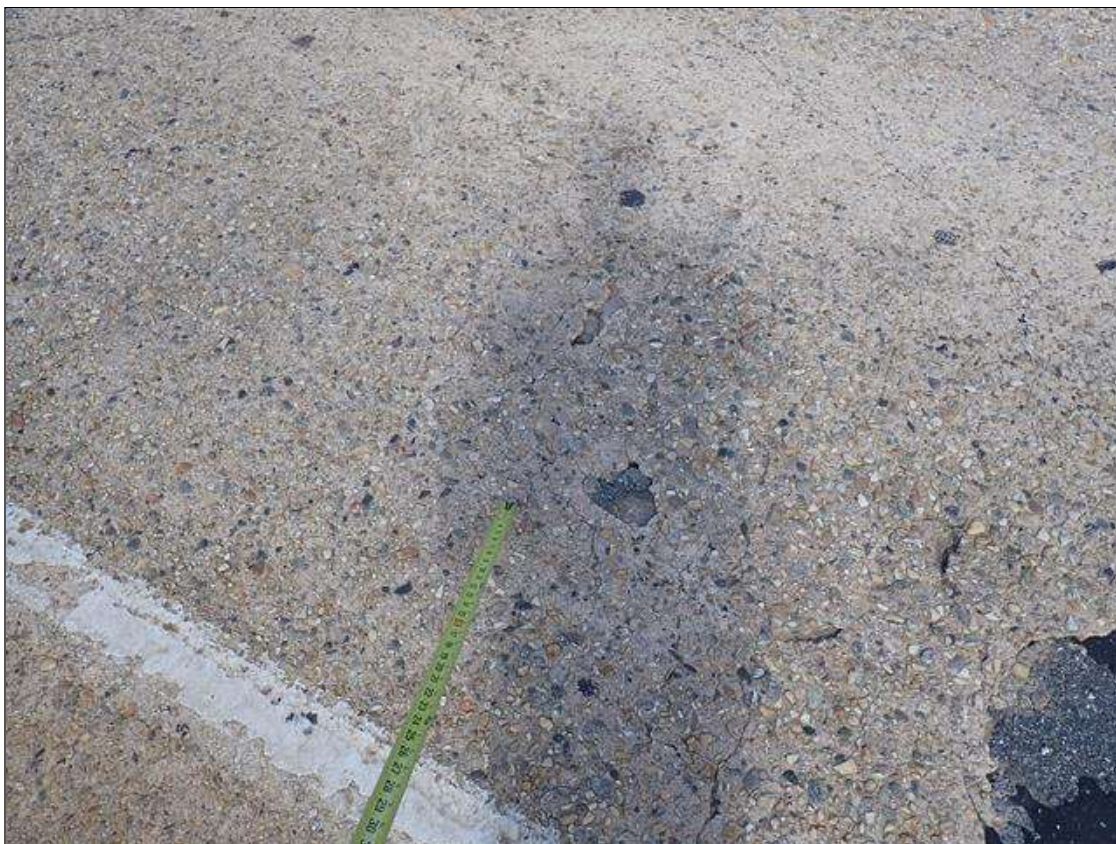
Span 1 Deck: scattered throughout top of deck, multiple spalls/delaminations [up to 18 inches x up to 20 inches x up to 1.5 inches deep] no exposed reinforcing

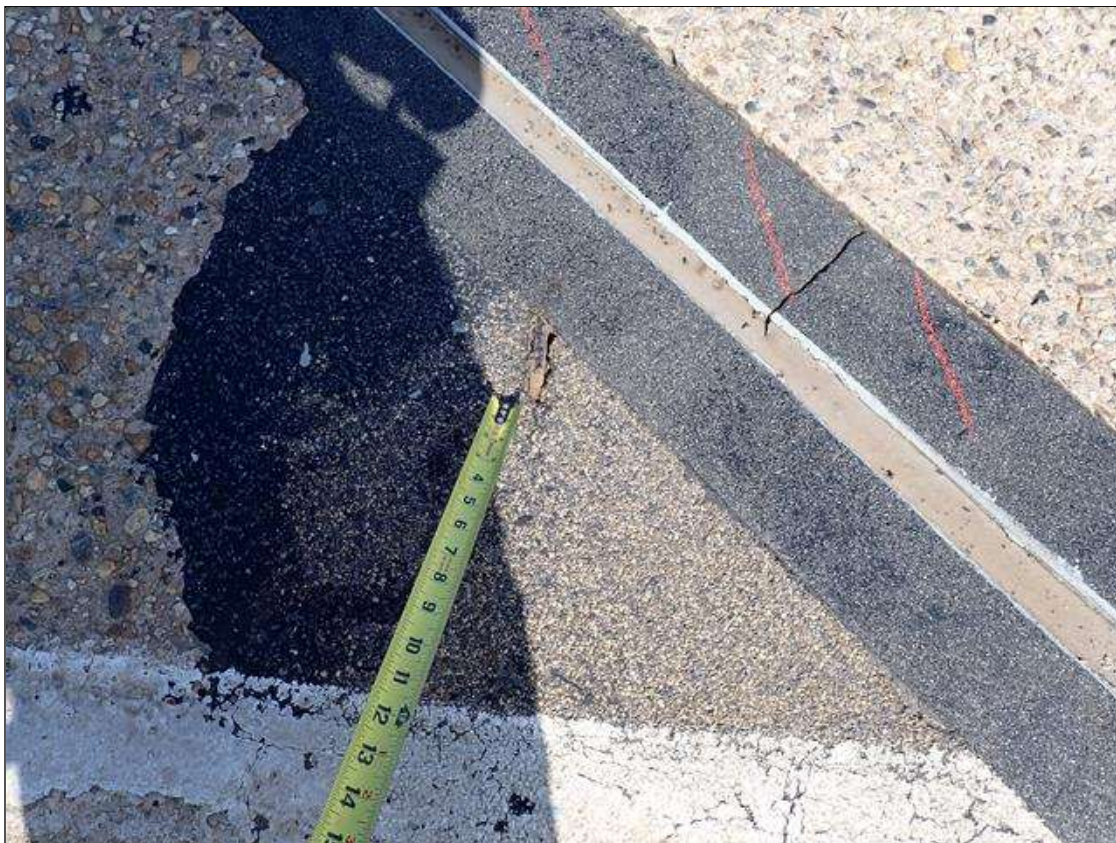
Span 1 Deck: (PAR) northbound lane, adjacent to bent 1 and right shoulder, shallow rebar; rebar has less than 5 percent section loss

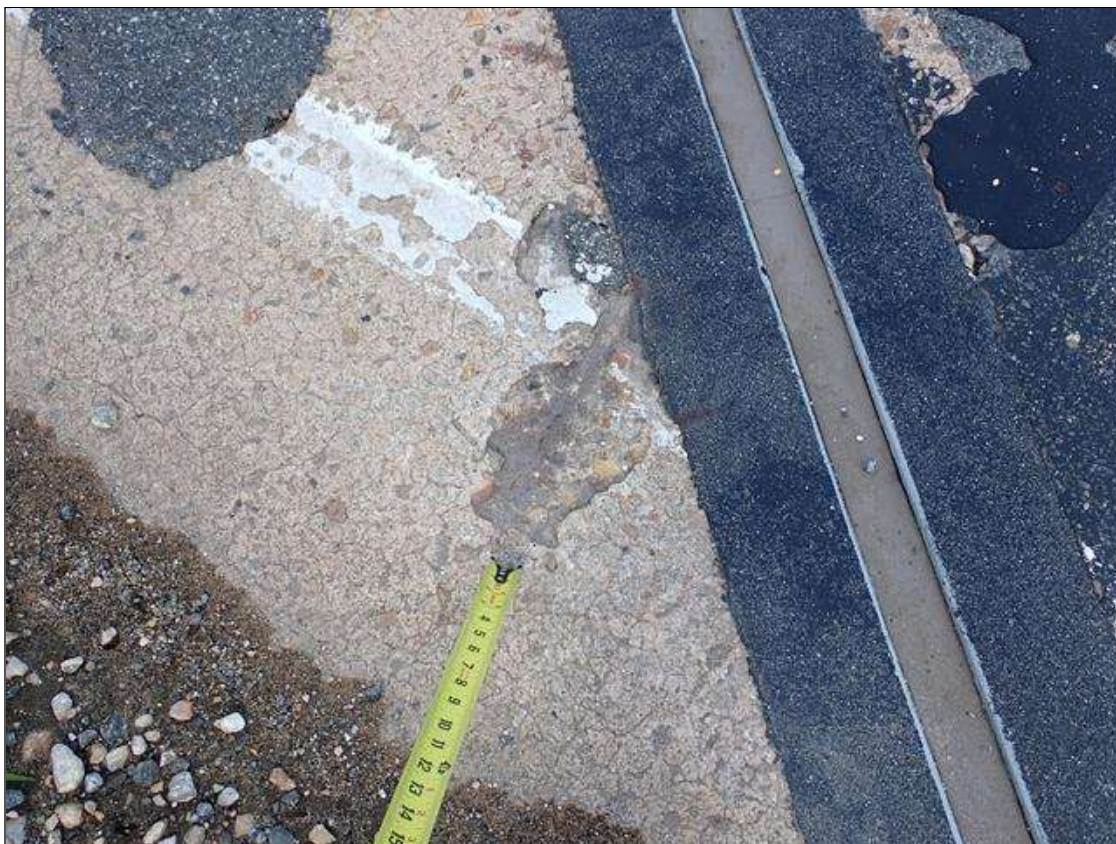
Span 2 Deck: (PAR) right shoulder, at bent 2, spall (1 foot x 6 inch x 1 inch deep) with exposed rusted rebar

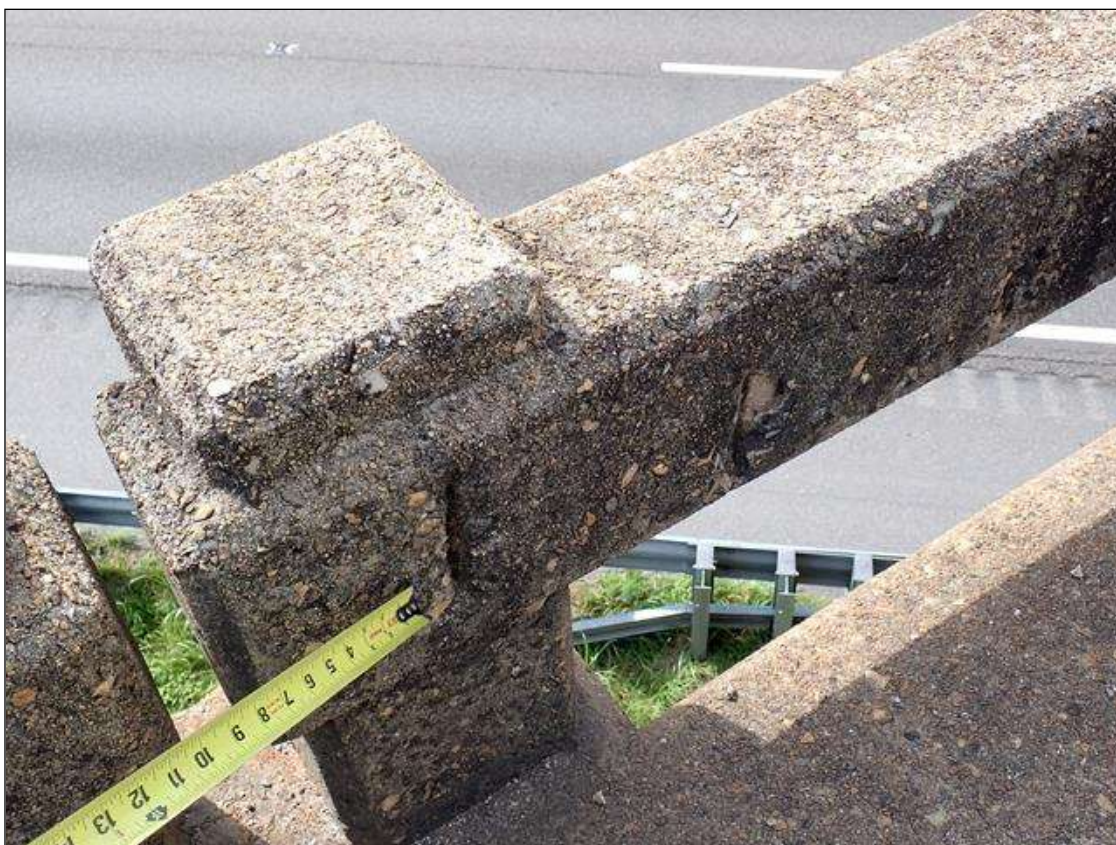
Span 4 Right Bridge Rail: rail, near midspan, spalls (up to 6 inch x 3 inch x 3/4 inch deep) with exposed rusted rebar
