NC DEPARTMENT OF TRANSPORTATION
 DIVISION OF HIGHWAYS
 STRUCTURE MANAGEMENT UNIT

ATTENTION: **prompt action request, sketches revised, clearances revised, newly structurally deficient**

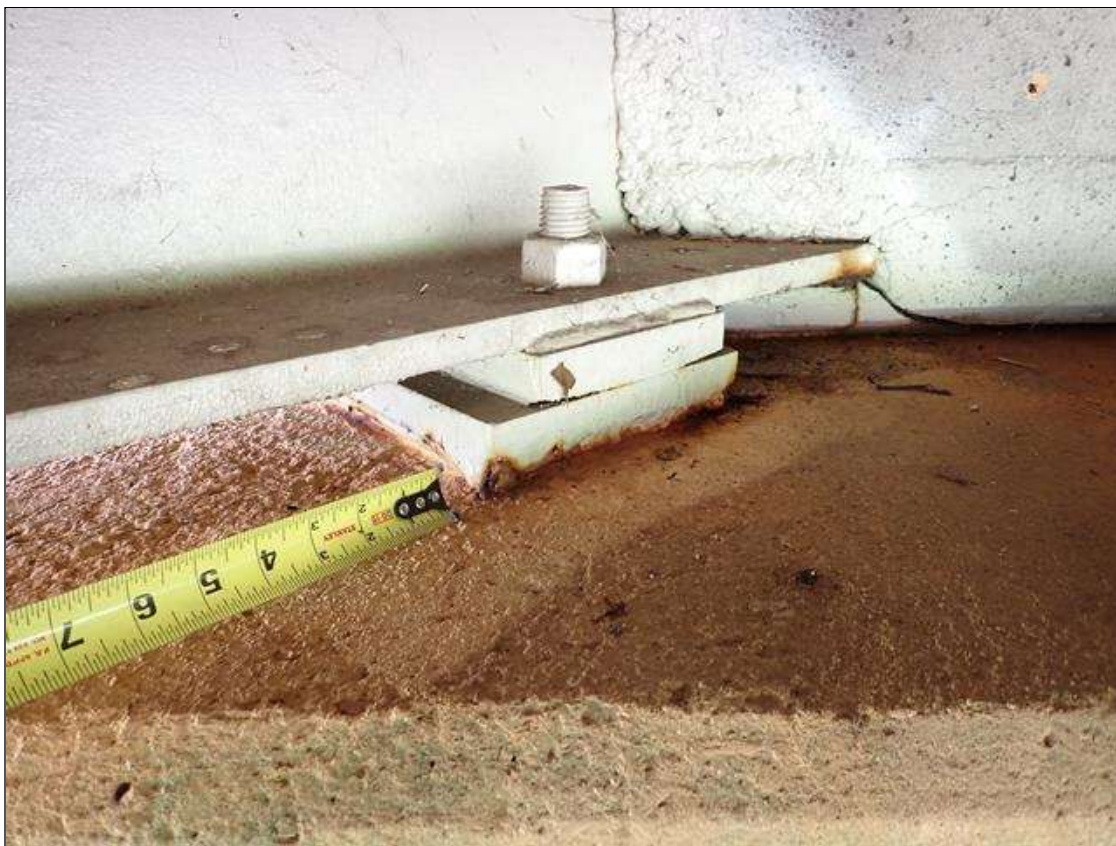
Span 1 Beam 4 - Near Bearing 4: painted over section loss (up to 1/8 inch deep) with corrosion reinitiated

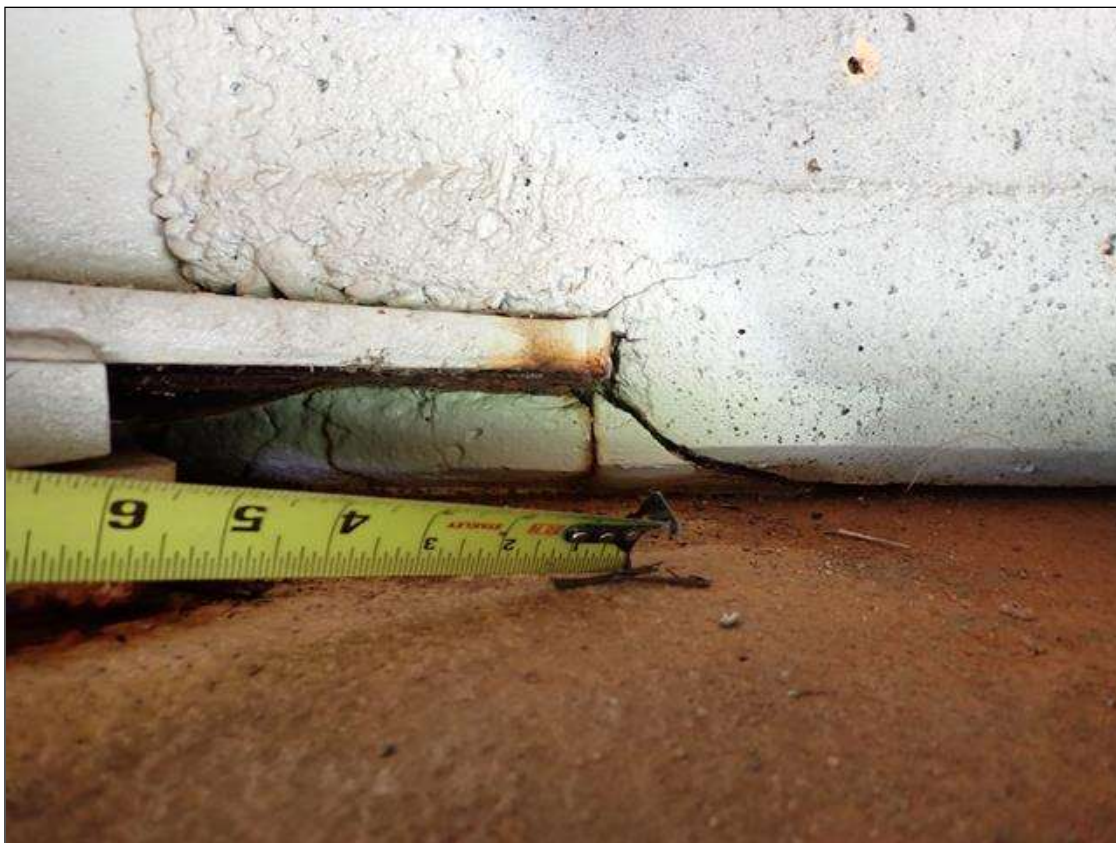
End Bent 1 Abutment: at beam penetrations, spall, up to 9 inch x 4 inch

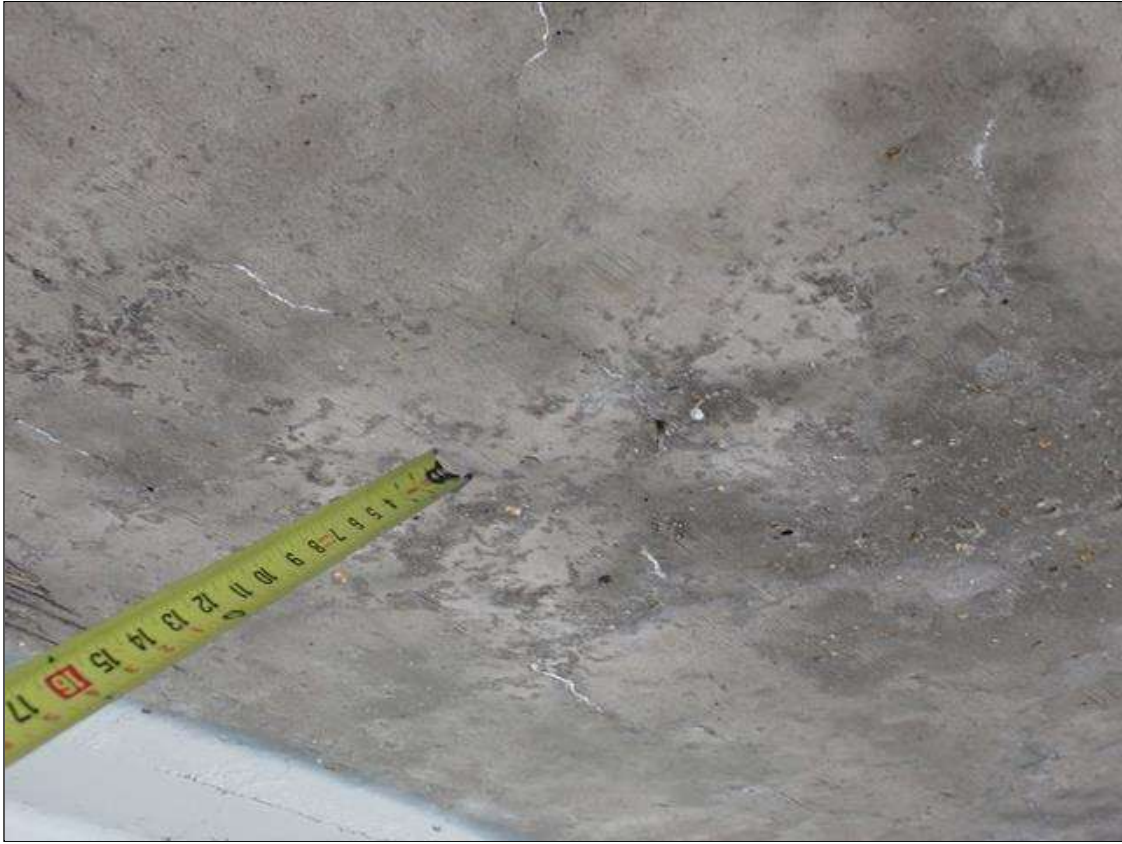
Span 1 Deck: throughout underside of deck, areas of map cracks (hairline), some with efflorescence at random

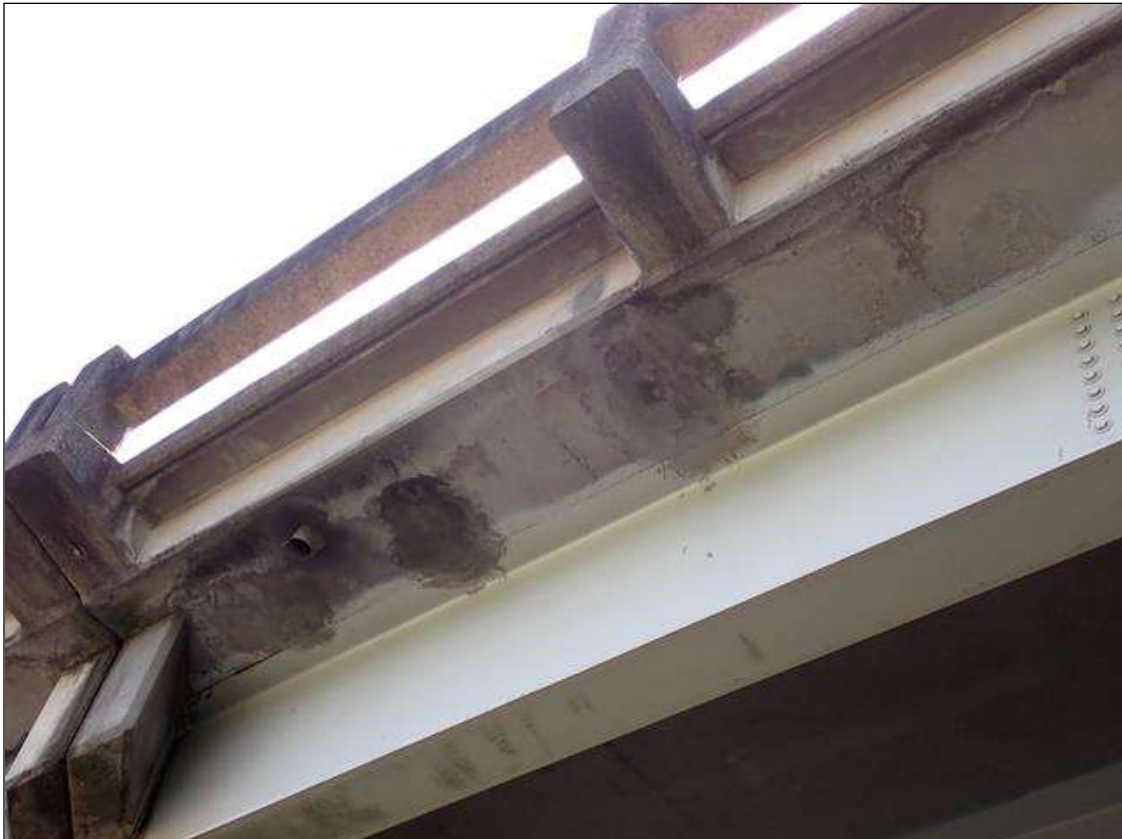
Span 1 Deck: SPAN 1 BOTTOM OF DECK IN WEST OVER HANG HAS SCATTERED PATCHED AREAS. APPROXIMATELY 20 SQUARE FEET.

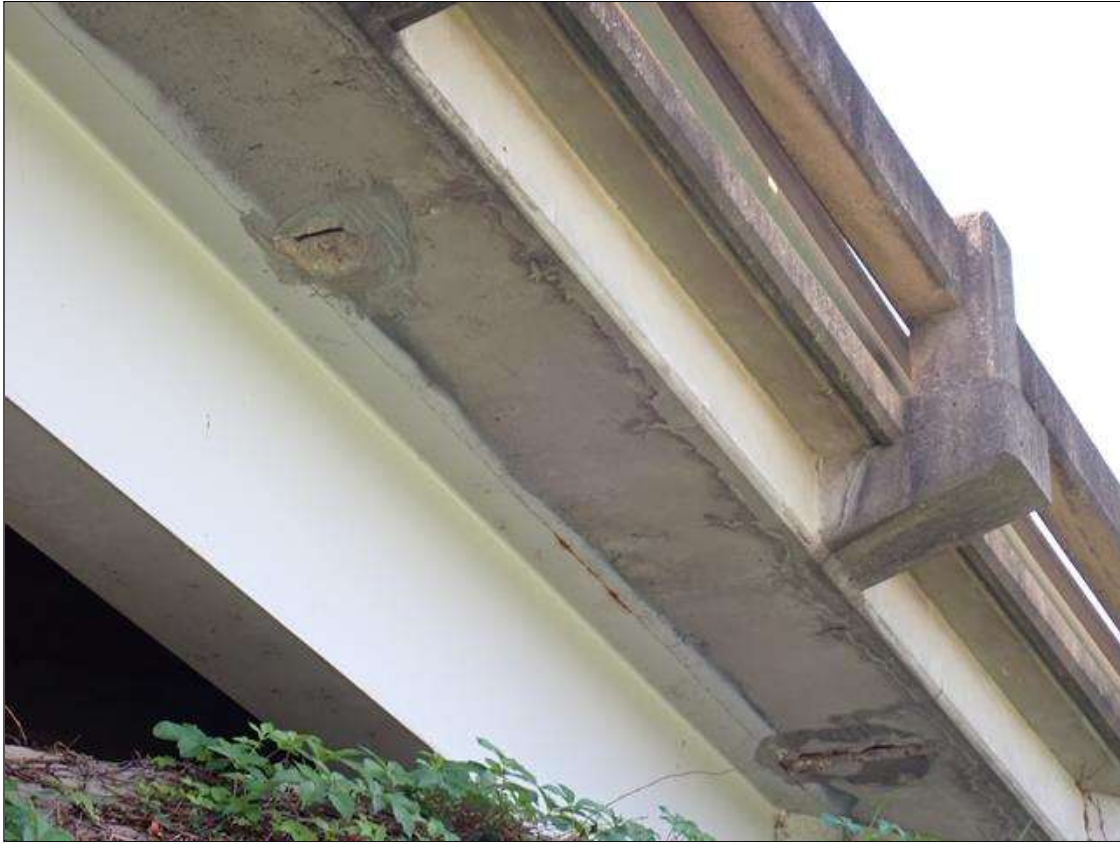
Span 1 Deck: (PAR) underside of deck on left overhang, multiple failed patches/spalls [up to 18 inches x 12 inches x up to 1 inch deep] with exposed rusted reinforcing [section loss up to 10 percent]

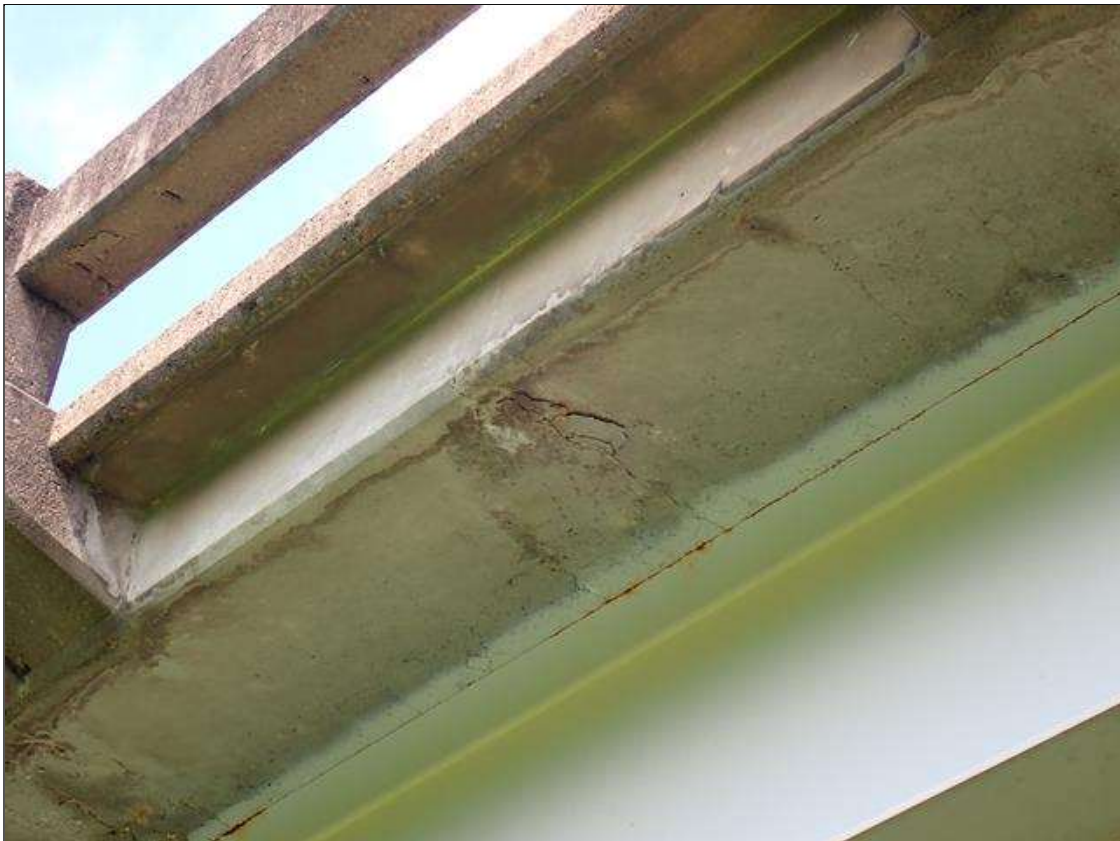
Span 1 Deck: SPAN 1 BOTTOM OF DECK IN RIGHT OVER HANG HAS SCATTERED unsound PATCHED AREAS with associated delaminations [up to 12 inch diameter]

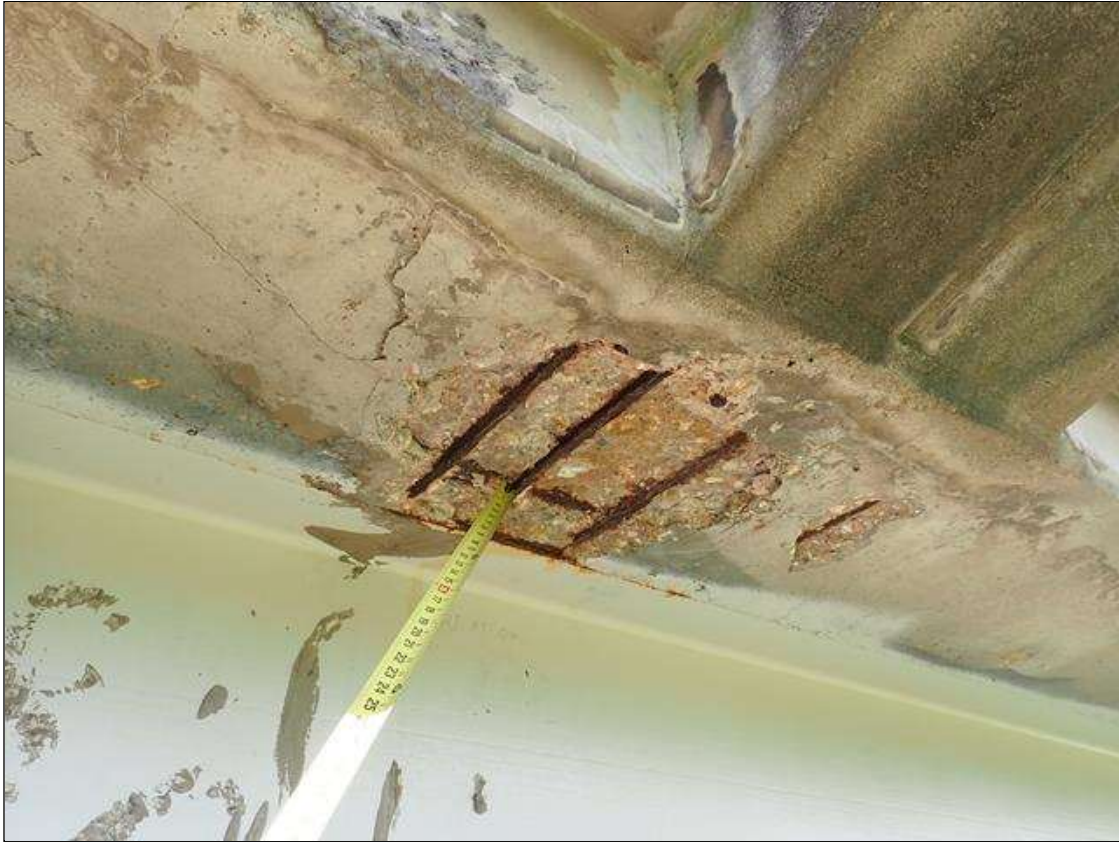
Span 1 Deck: (PAR) underside of deck on right overhang 20 feet from end bent 1, spall [2 feet x 3 feet x up to 2.5 inches deep] with multiple exposed rusted reinforcing [section loss up to 10 percent]

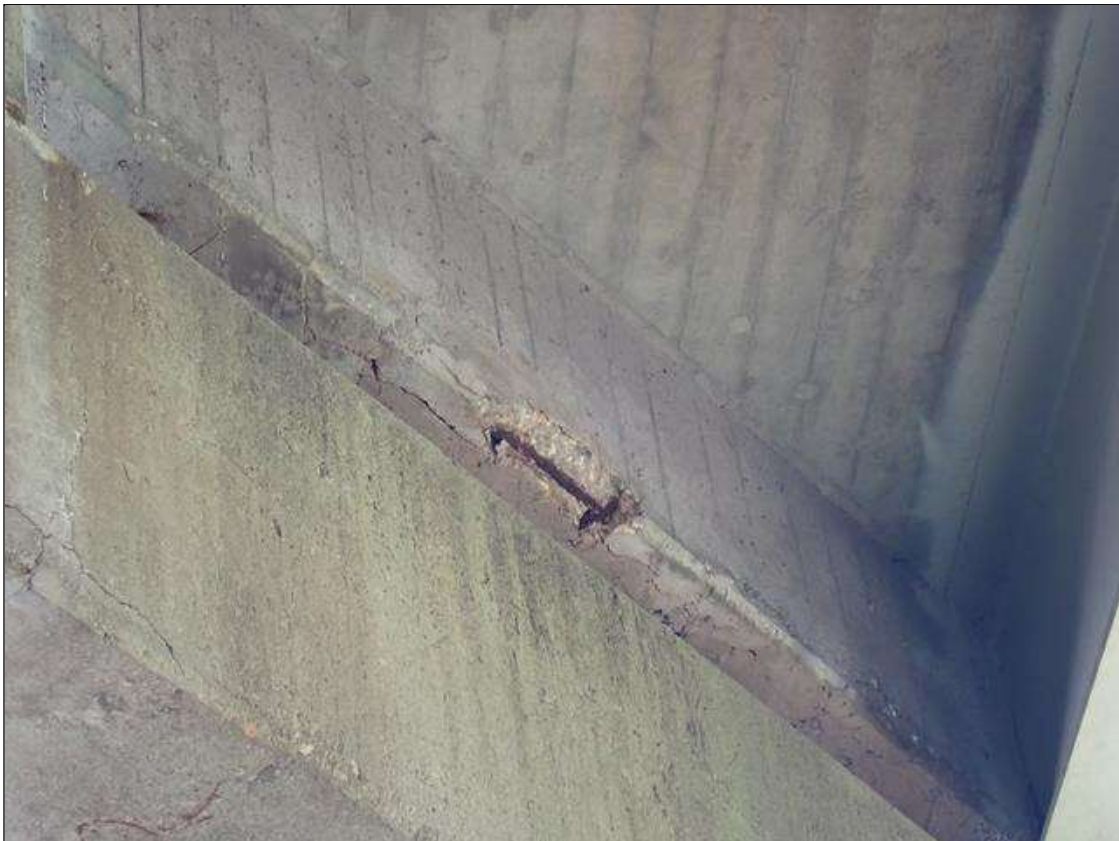
Span 1 Deck: at bent 1, bay 2 end diaphragm, spall/delamination (4 feet x 6 inch x 2 inch deep)

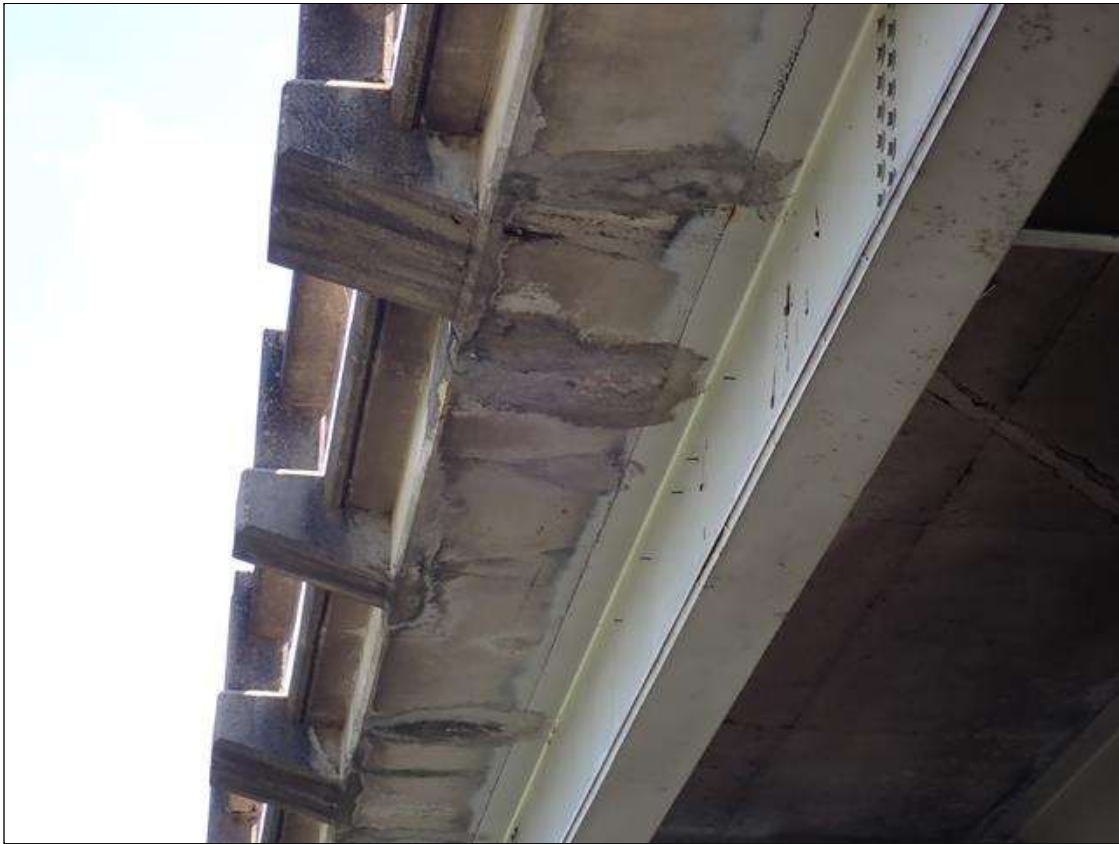
Span 2 Deck: (PAR) SPAN 2 BOTTOM OF DECK WEST OVERHANG HAS SCATTERED unsound PATCHED AREAS THROUGH OUT SPAN with some associated delaminations [up to 30 inch diameter] over traffic

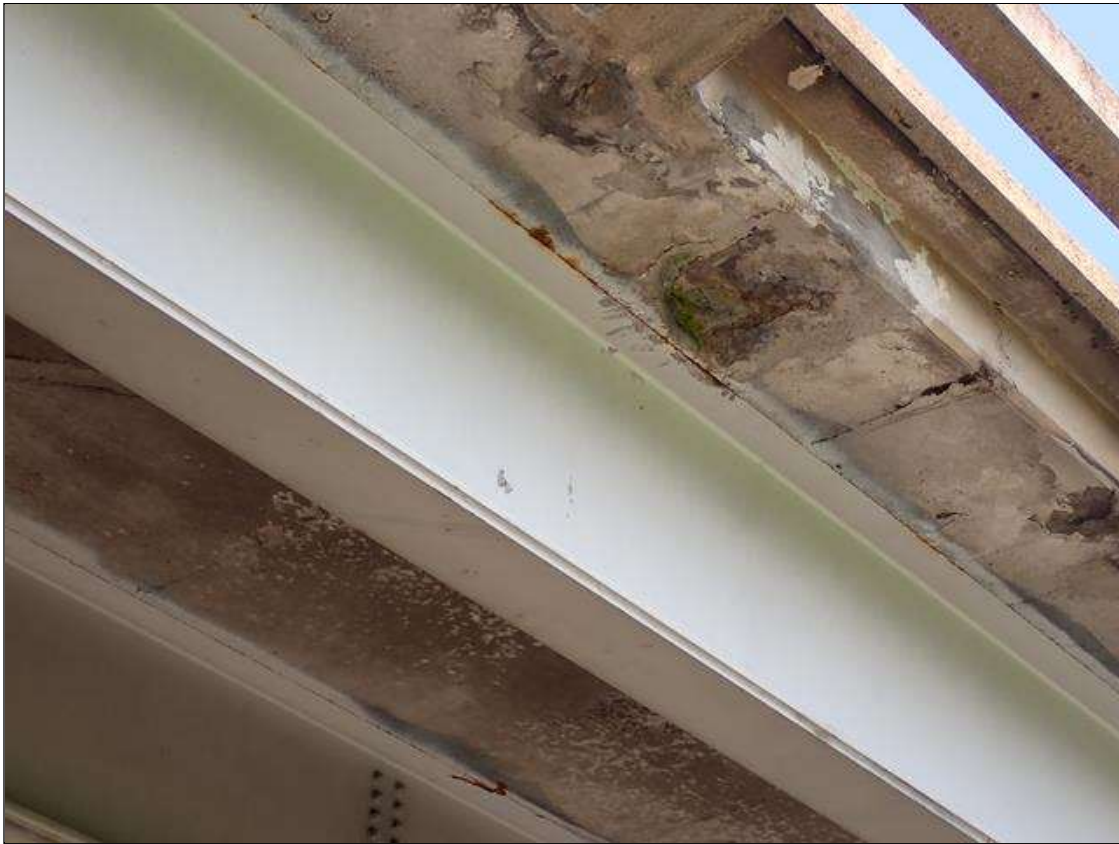
Span 2 Beam 4: along length, scattered spot rust

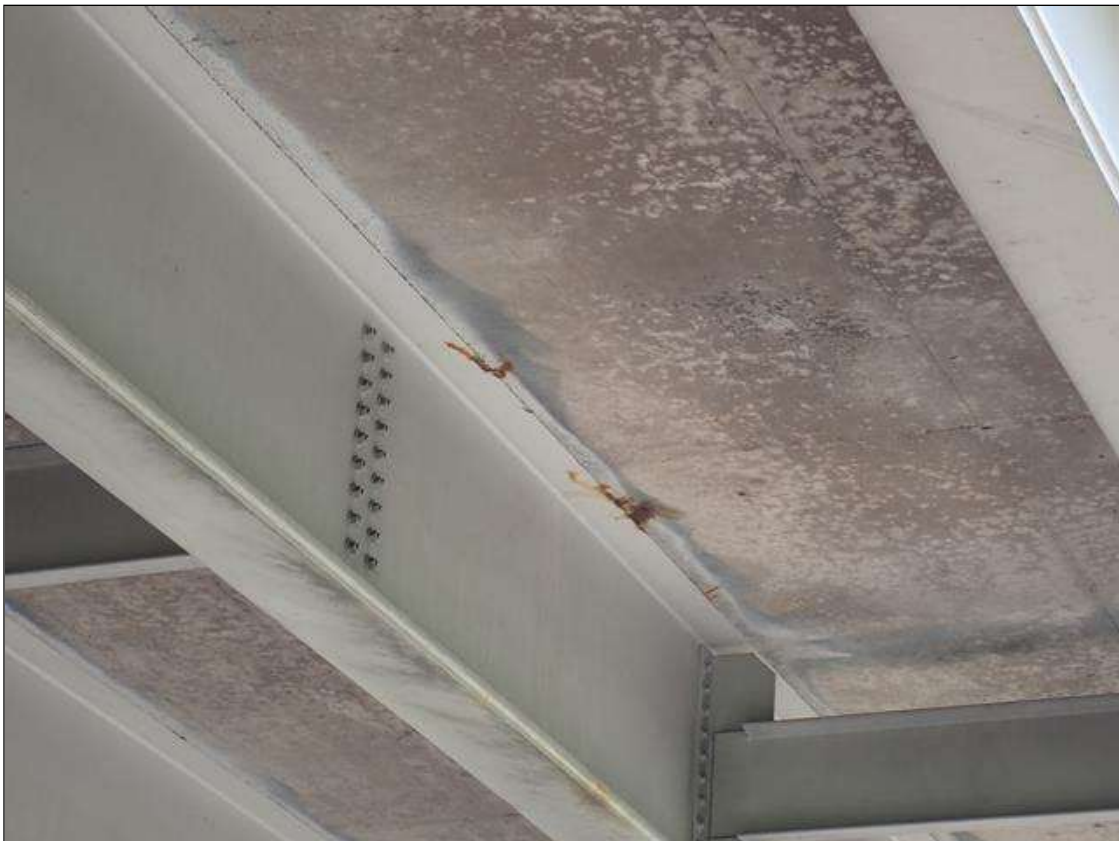
Span 2 Deck: (PAR) bay 3, adjacent to beam 3, near 2nd intermediate diaphragm, rust stains

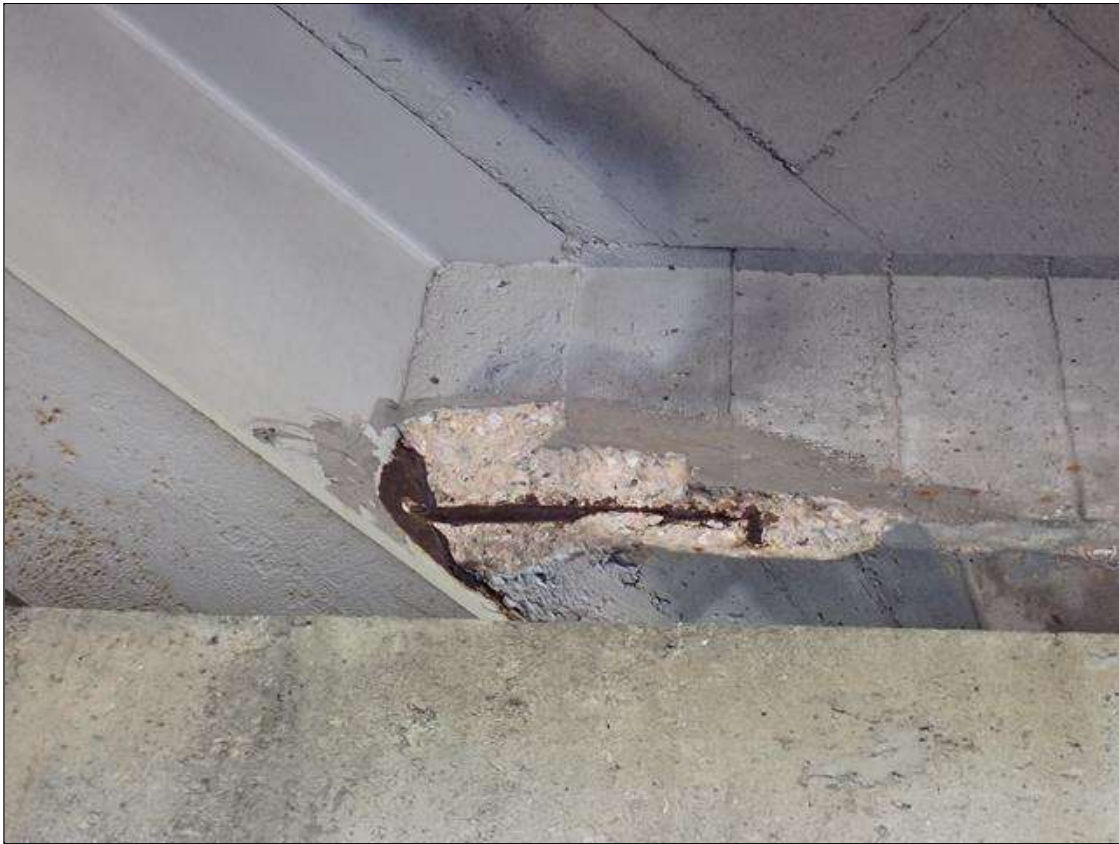
Span 2 Deck: at bents 1 and 2, end diaphragm, in all bays, spalls/delaminations/unsound patches (up to 2.5 feet x 10 inch x 3 inches deep) with exposed rusted rebar at random

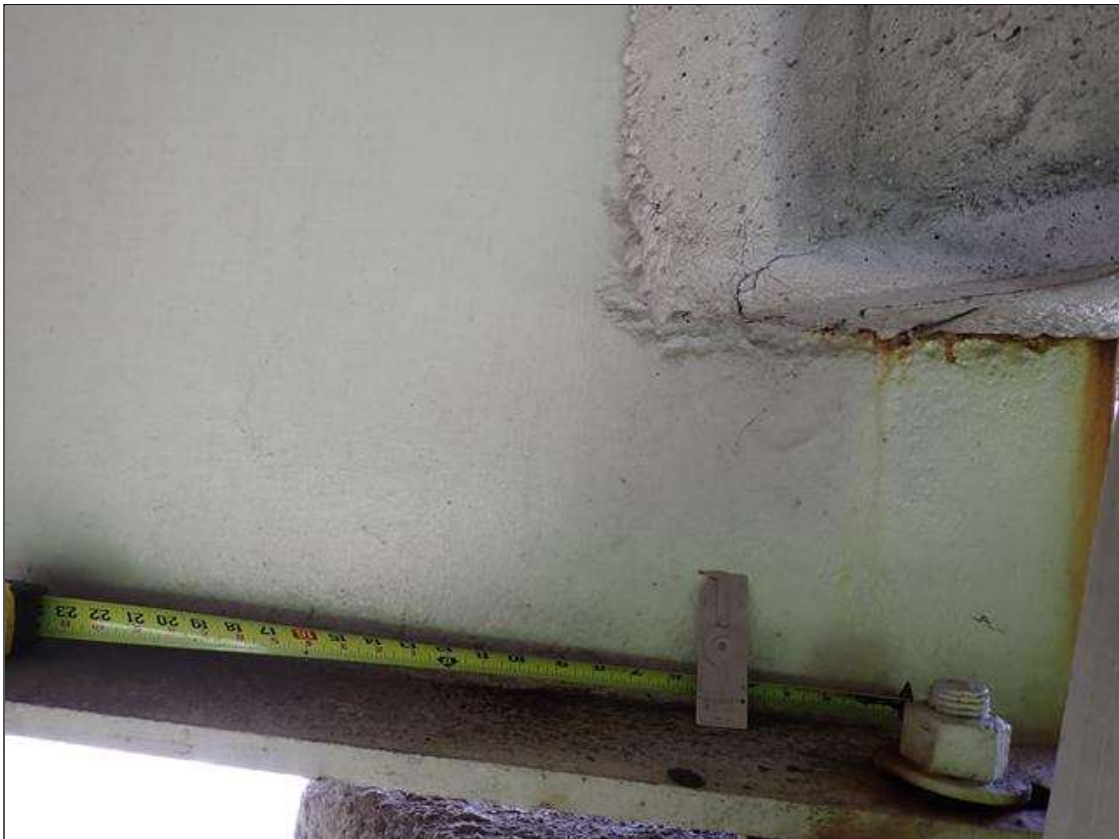
Span 1 Beam 1: (PAR) at bent 1, painted over section loss: web adjacent to diaphragm (5/16 inch average remaining x 12 inch x 5 inch); lower web (7/16 inch average remaining x 15 inches x 2 inches) with corrosion reinitiated

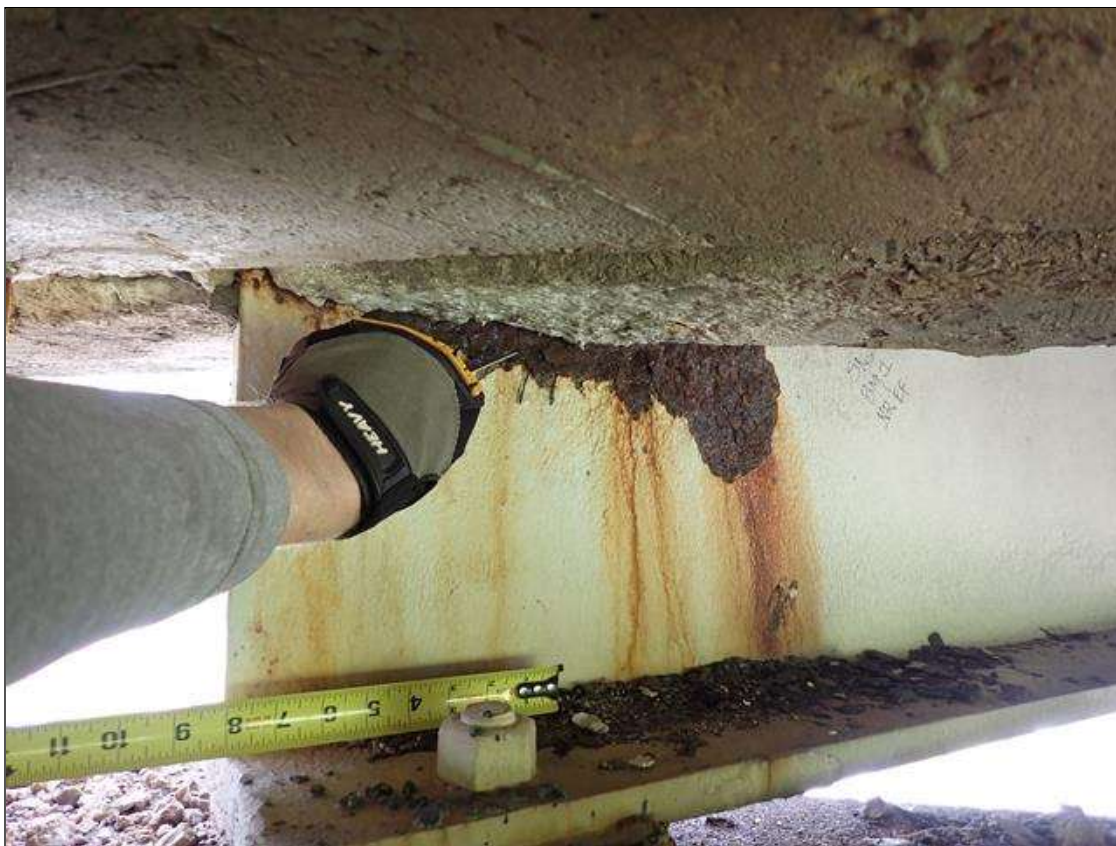
Span 2 Beam 1: (PAR) at bent 1, web adjacent to diaphragm, corrosion with section loss (1/4 inch average remaining x 15 inch x 7 inch); painted over pitting: lower web (up to 1/16 inch deep x 3 feet x 6 inches), bottom flange (1/8 inch deep x 2 feet)

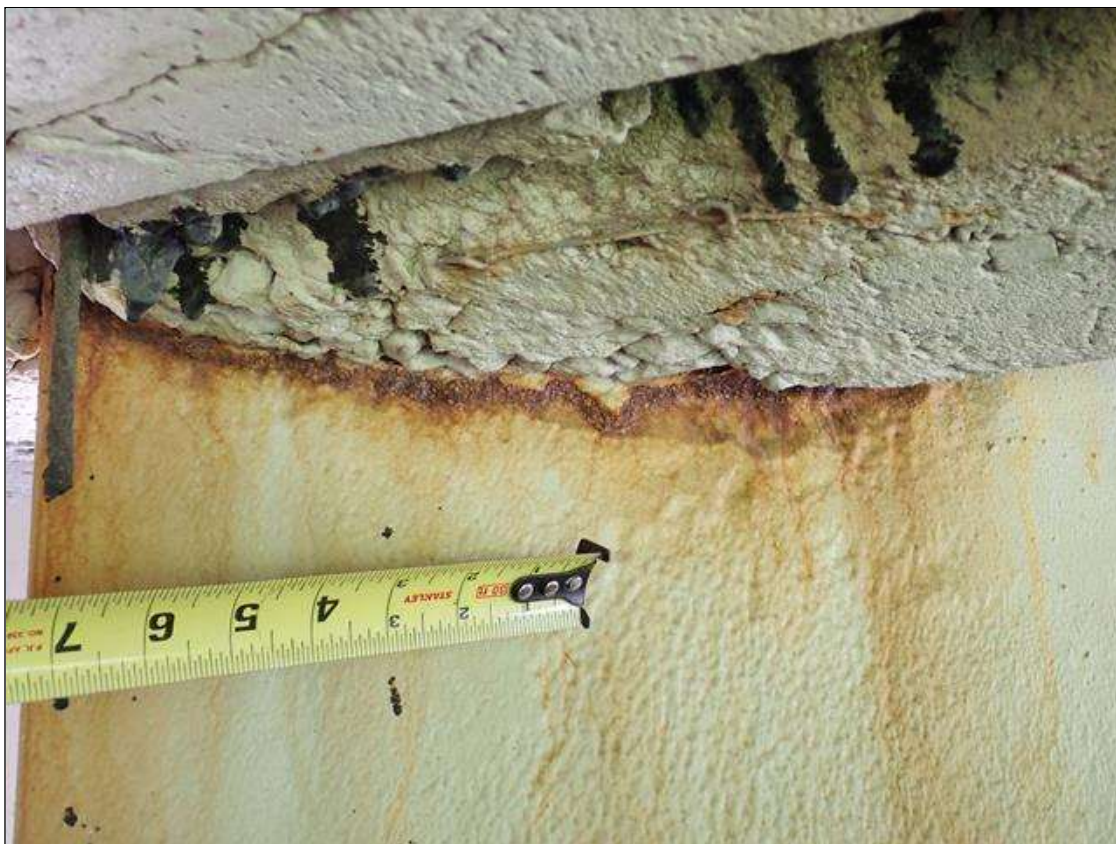
Span 2 Beam 2: (PAR) near end web at diaphragm, arrested metal loss/pitting, 12 inch long x up to 2 inch high x average remaining 5/16 inch with reactivated surface corrosion

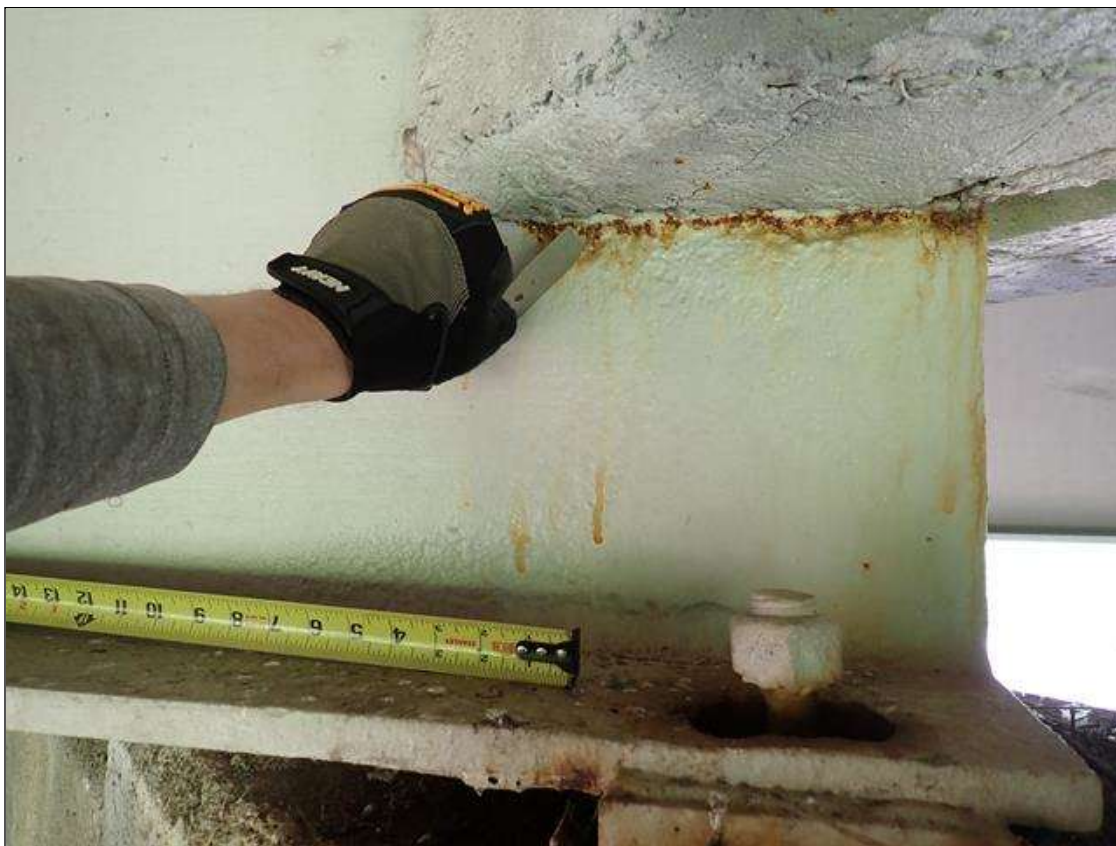
Span 1 Beam 2: (PAR) at bent 1, painted over section loss: web at end diaphragm (5/16 inch average remaining 12 inches long x up to 2 inches wide) with reactivated surface corrosion; lower web (3/8 inch average remaining x 15 inch x 3 inch)

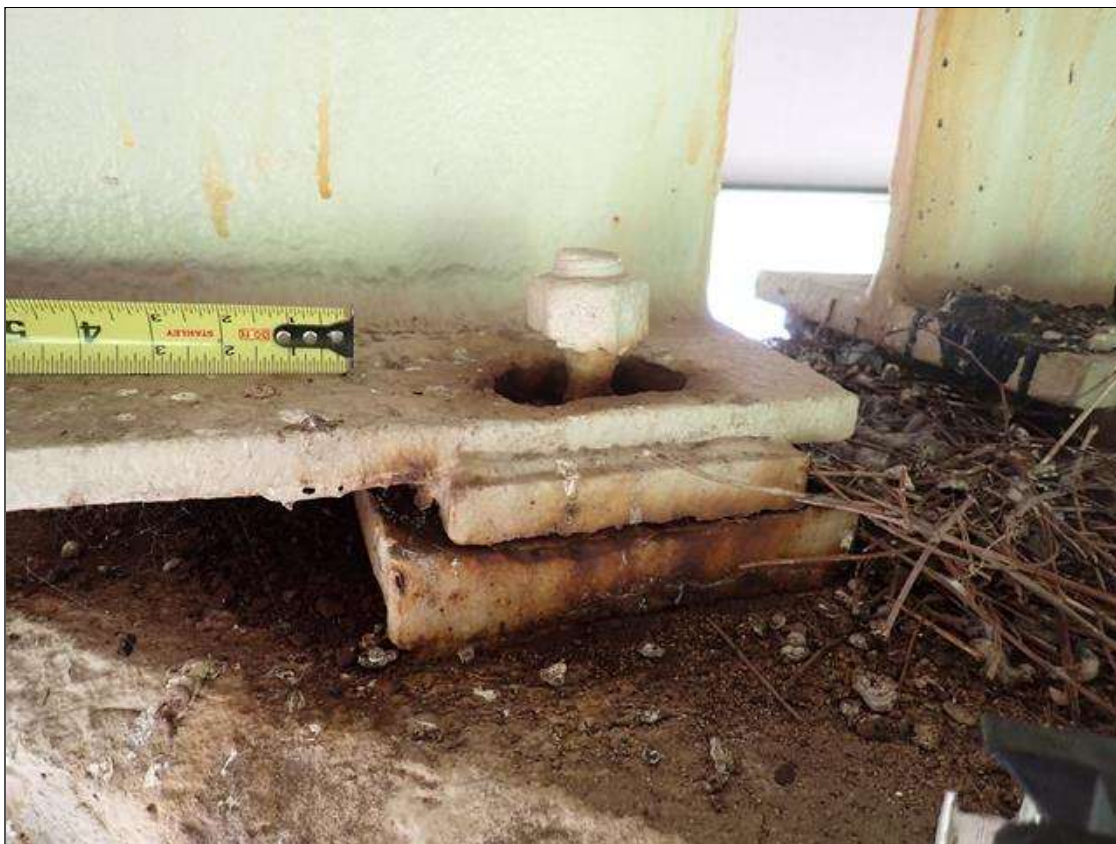
Span 1 Beam 2 - Far Bearing 2: (PAR) rust scale; right anchor bolt, painted over section loss (50 percent average remaining)

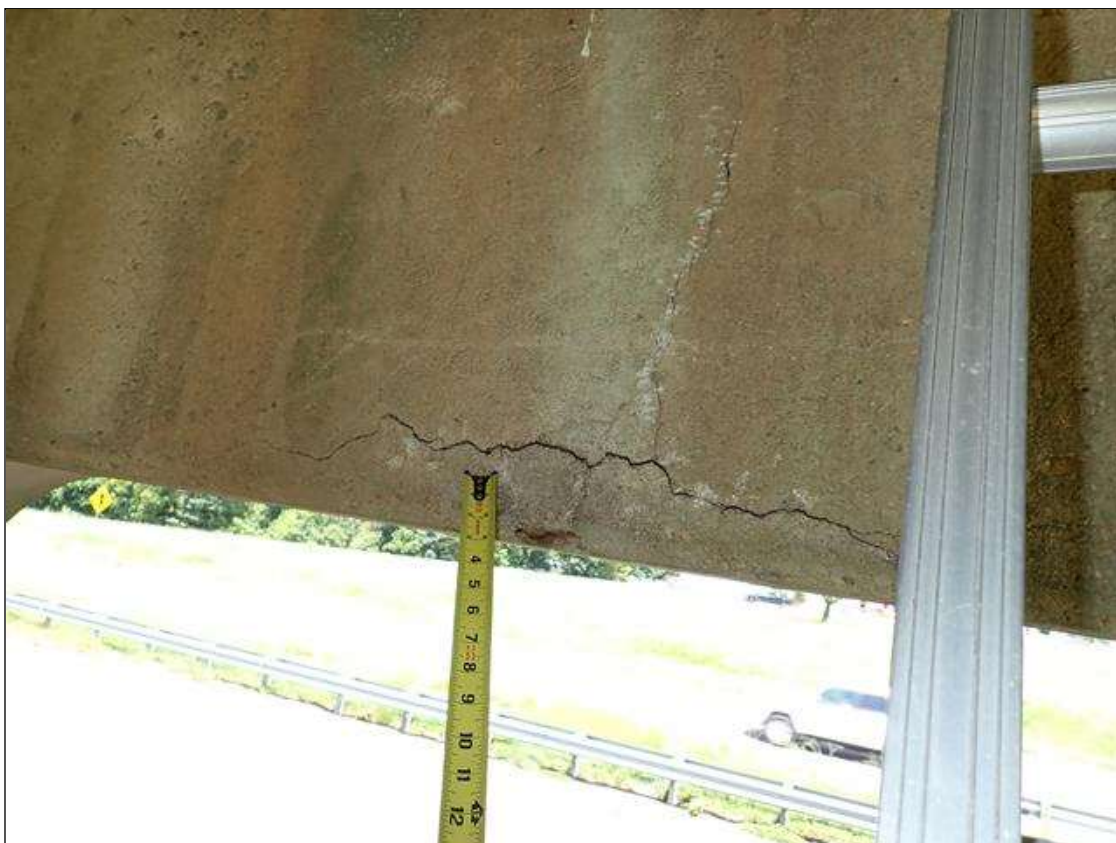
Bent 1 Cap 1: south face, below beams 2 and 3, vertical and longitudinal cracks (up to 1/8 inch x 5 feet)

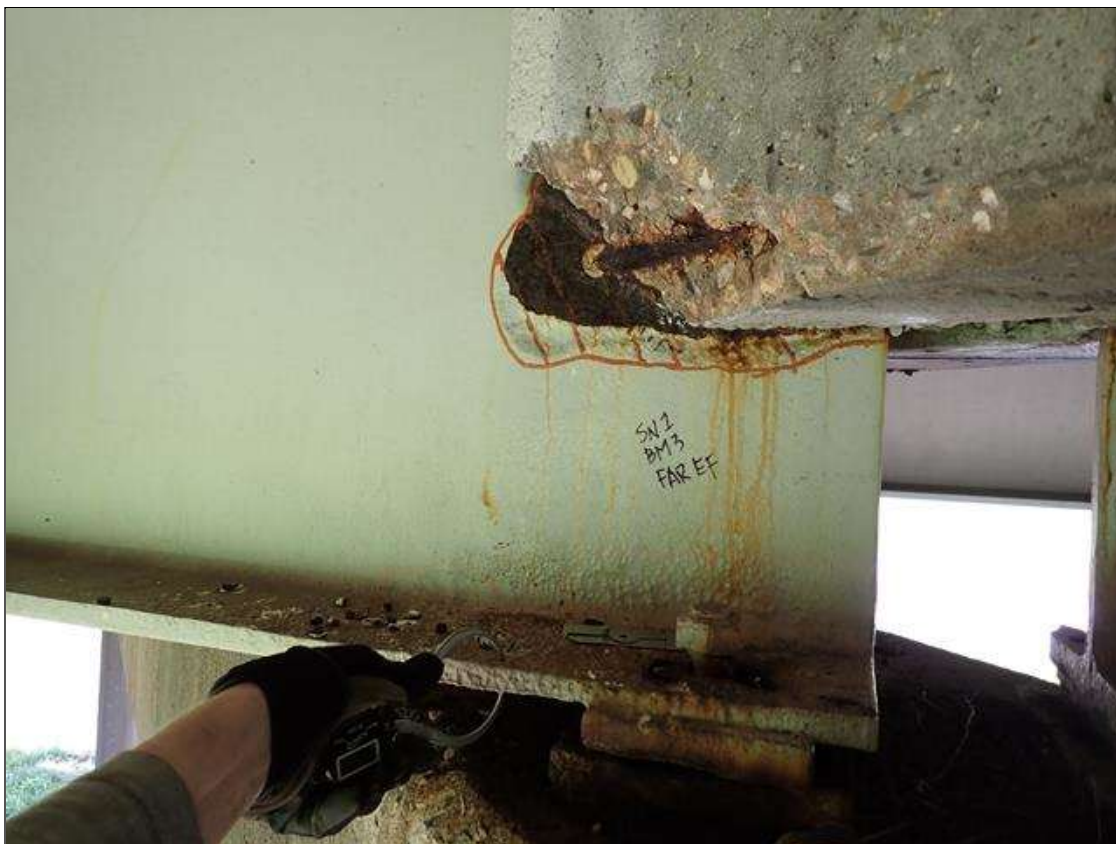
Span 1 Beam 3: (PAR) at bent 1, web adjacent to diaphragm, corrosion with section loss (1/4 inch average remaining x 12 inch x 6 inch); painted over section loss: lower web (5/16 inch average remaining x 16 inch x 3 inch), bottom flange (0.63 inch average remaining x 15 inches)

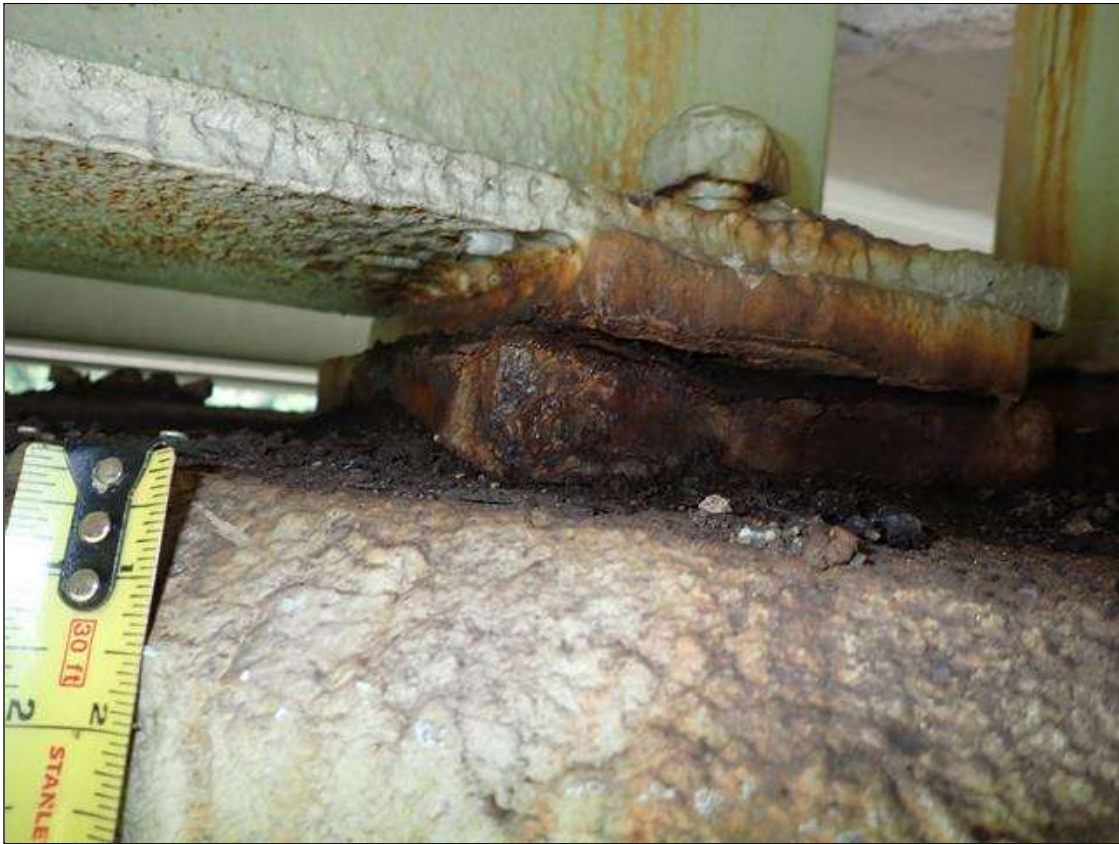
Span 1 Beam 3 - Far Bearing 3: rust scale/pack rust

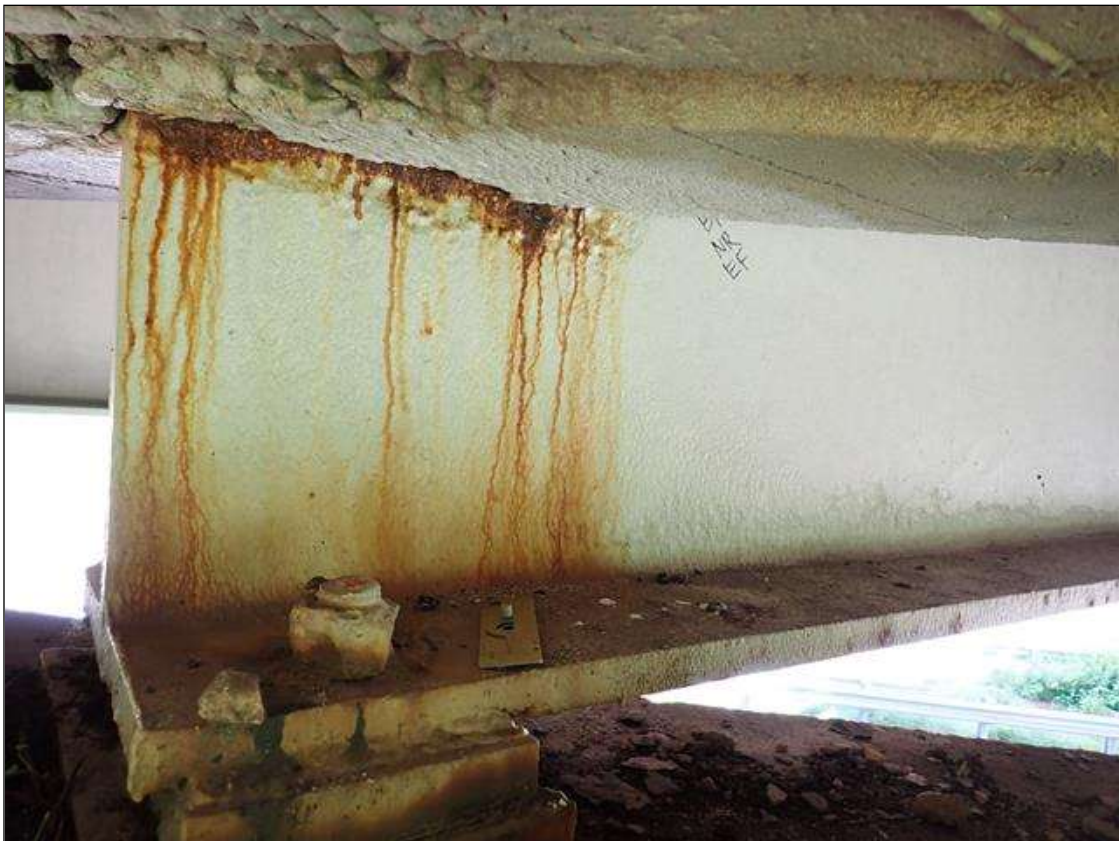
Span 2 Beam 3: (PAR) at bent 1, painted over section loss: web adjacent to diameter (5/16 inch average remaining x 14 inch x 3 inch); lower web (3/8 inch average remaining x 3 feet x 3 inches) with corrosion reinitiated

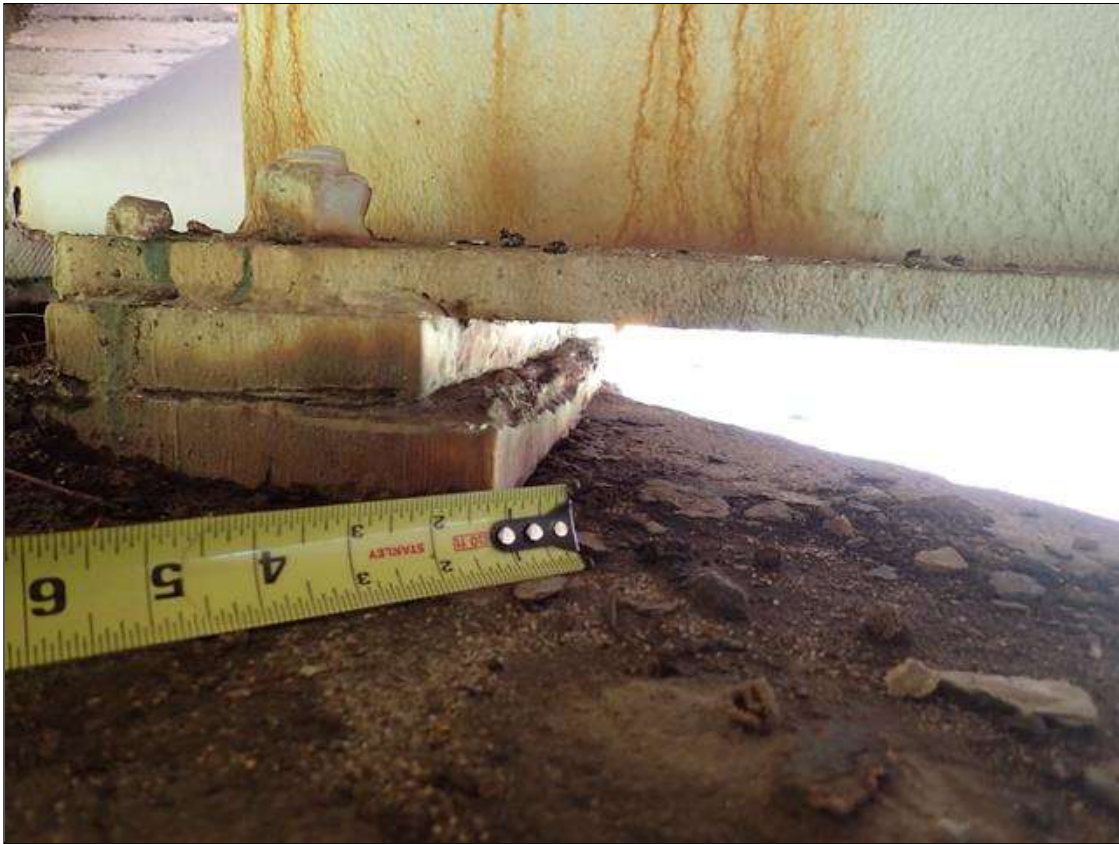
Span 2 Beam 3 - Near Bearing 3: painted over section loss (up to 1/4 inch deep); pack rust

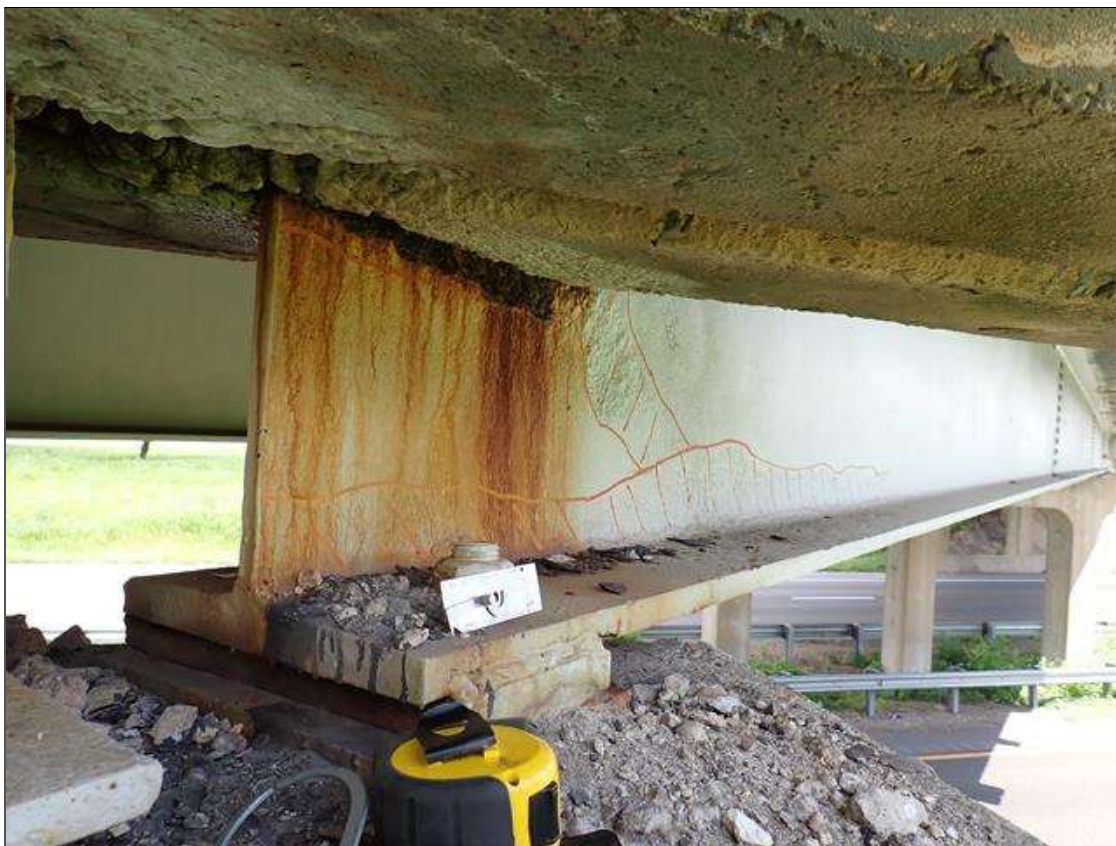
Span 2 Beam 4: (PAR) at bent 1, web adjacent to diaphragm, corrosion with section loss (3/16 inch average remaining x 18 inch x 5 inch); painted over section loss: lower web (5/16 inch average remaining x 5.5 feet x 4 inches); bottom flange, painted over pitting (up to 1/8 inch deep x 2.5 feet)
