NC DEPARTMENT OF TRANSPORTATION
 DIVISION OF HIGHWAYS
 STRUCTURE MANAGEMENT UNIT

ATTENTION: **prompt action request, sketches revised, clearances revised, newly structurally deficient**

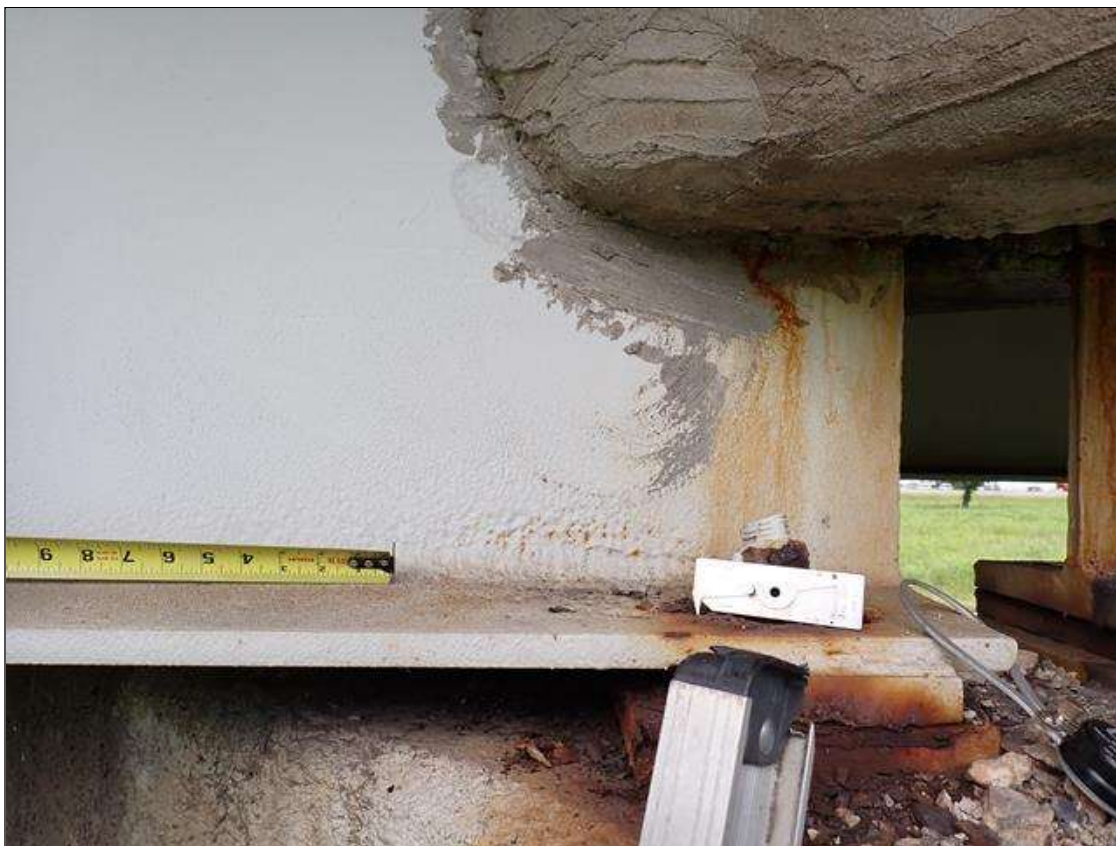
Span 1 Beam 4: (PAR) at bent 1, painted over section loss: web adjacent to diaphragm (5/16 inch average remaining x 12 inch x 3 inch) lower web (5/16 inch average remaining x 10 inch x 2 inch); bottom flange (0.63 inch average remaining x 6 inches) with corrosion reinitiated

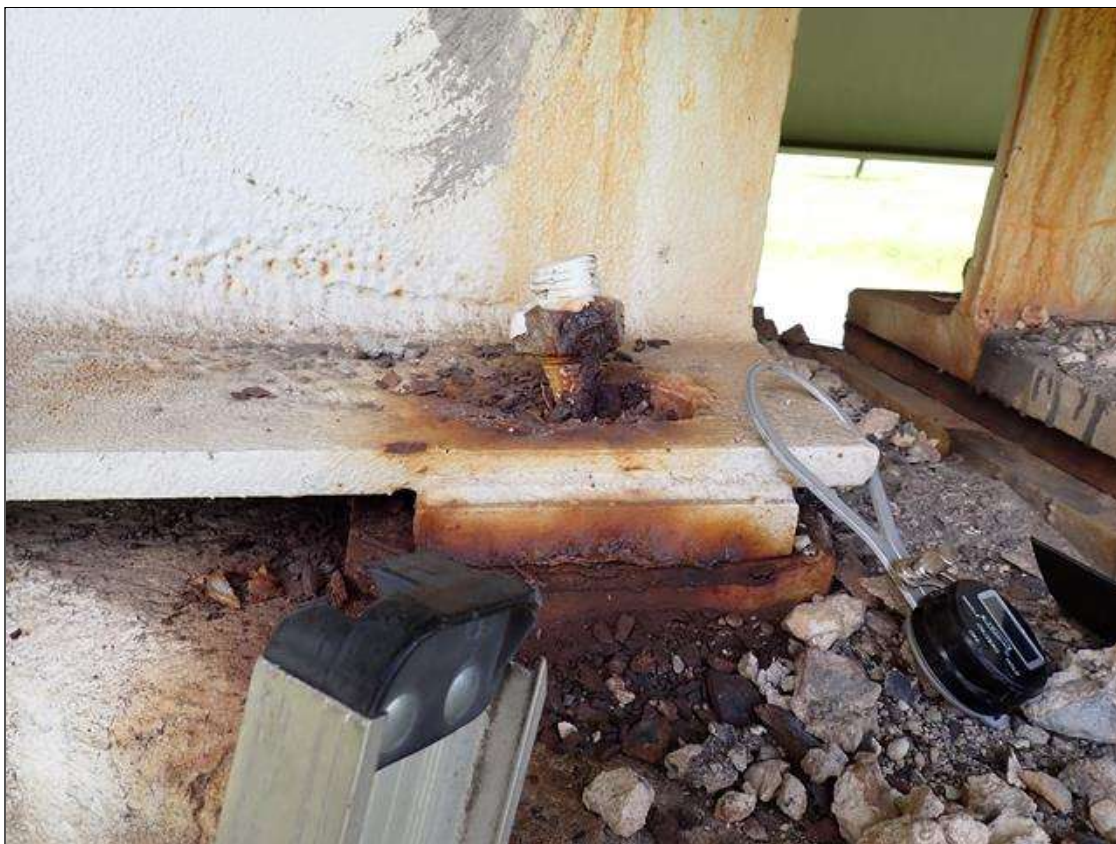
Span 1 Beam 4 - Far Bearing 4: (PAR) corrosion with section loss (up to 1/8 inch); right anchor bolt (50 percent average remaining)

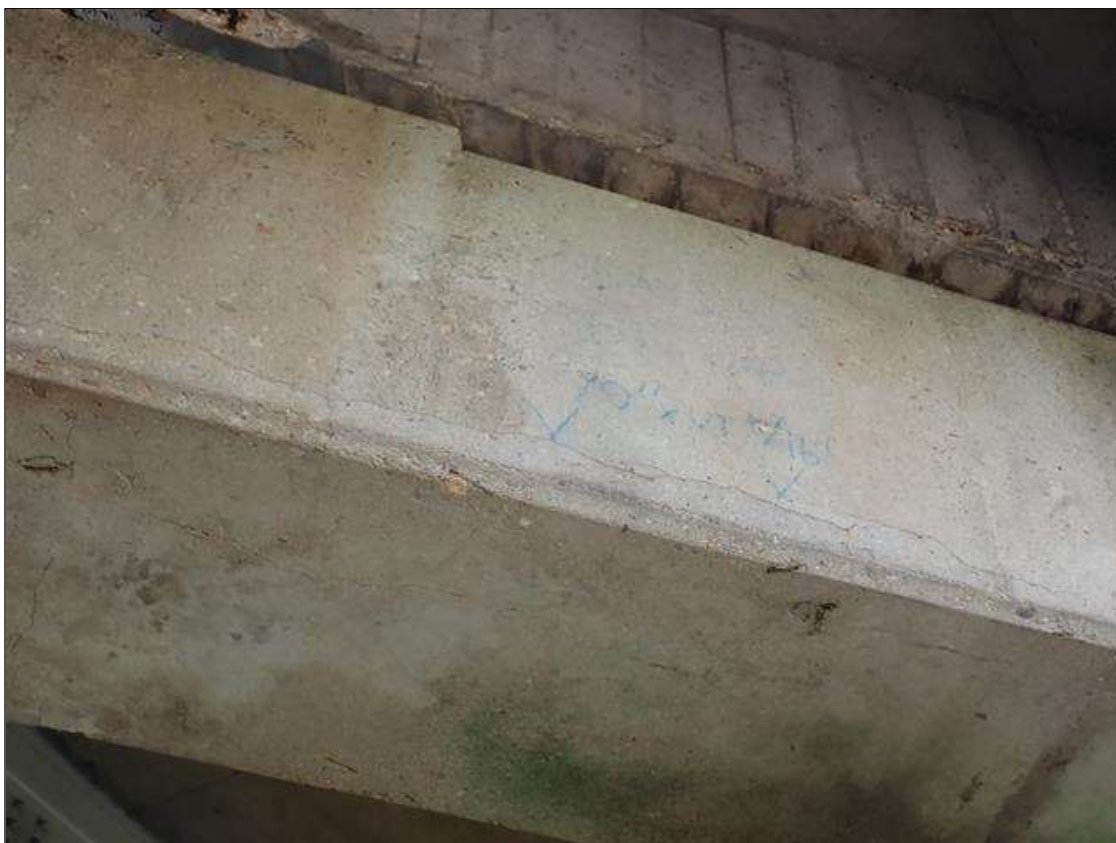
Bent 1 Cap 1: south, and north face, and underside of cap, longitudinal and vertical cracks (up to 1/8 wide x 7 feet) at random

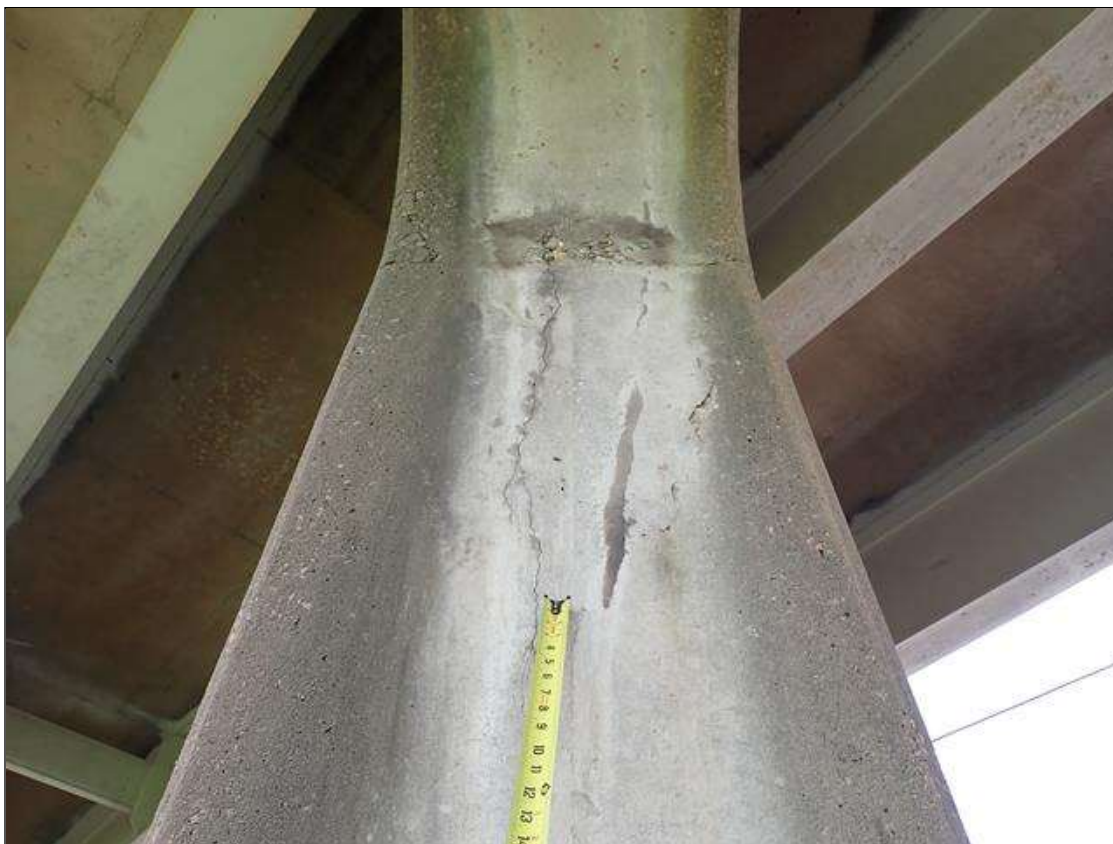
Bent 1 Pile 2: East face under cap, delamination [5 feet x 19 inches]

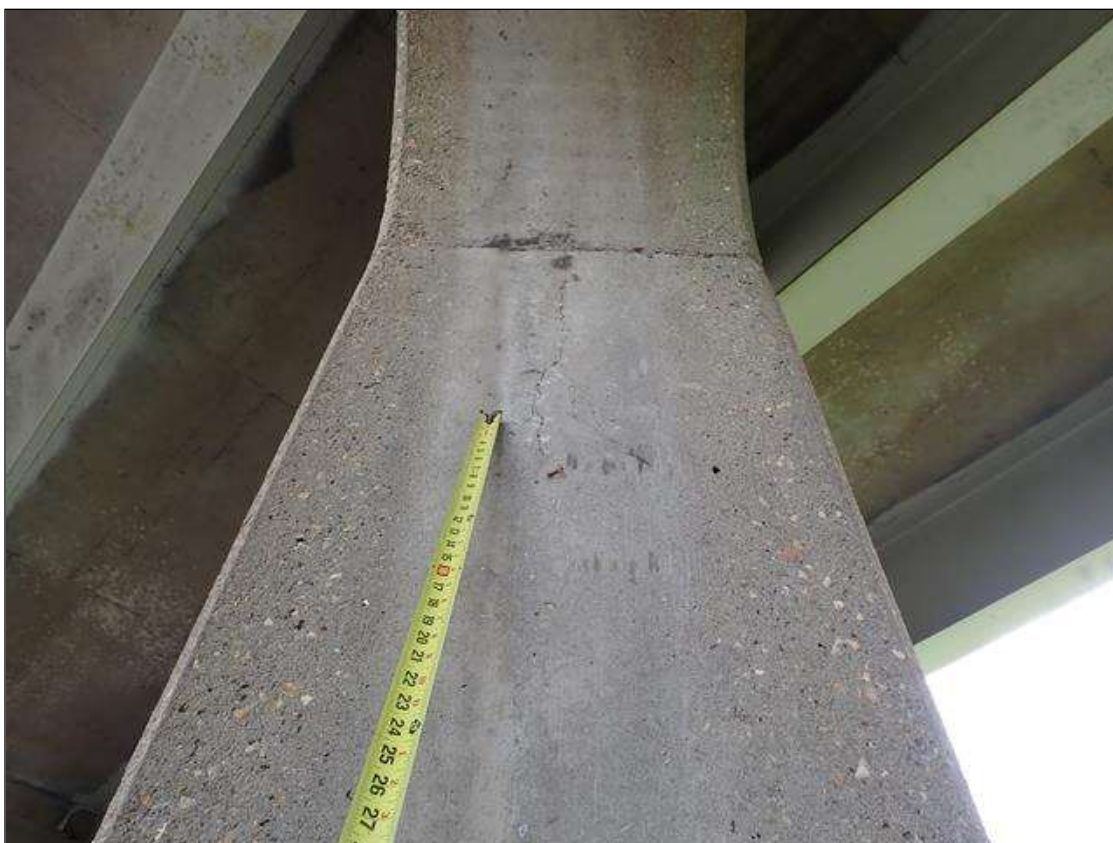
Bent 1 Pile 2: UP TO 3 FOOT X 1/32 VERTICAL CRACK WEST FACE AT BOTTOM OF CAP

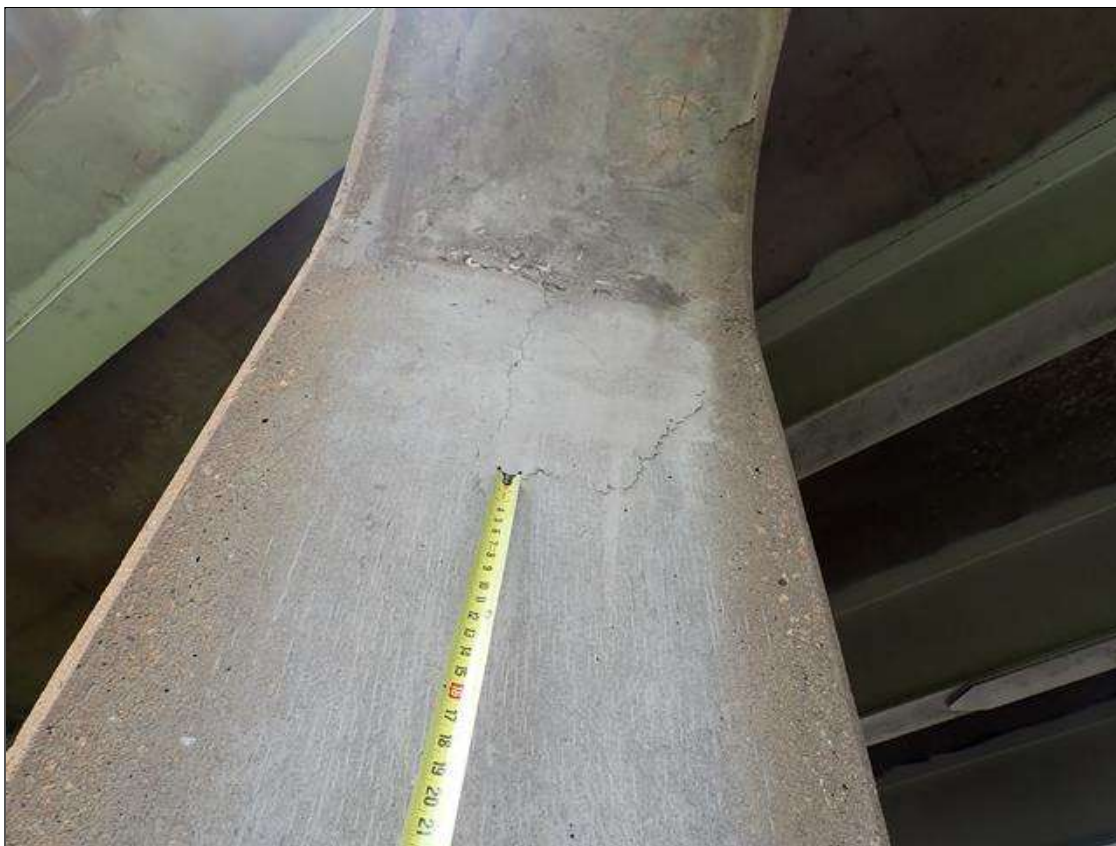
Bent 1 Pile 3: on East and West faces of pile, delaminations [up to 18 inch x 1 foot]

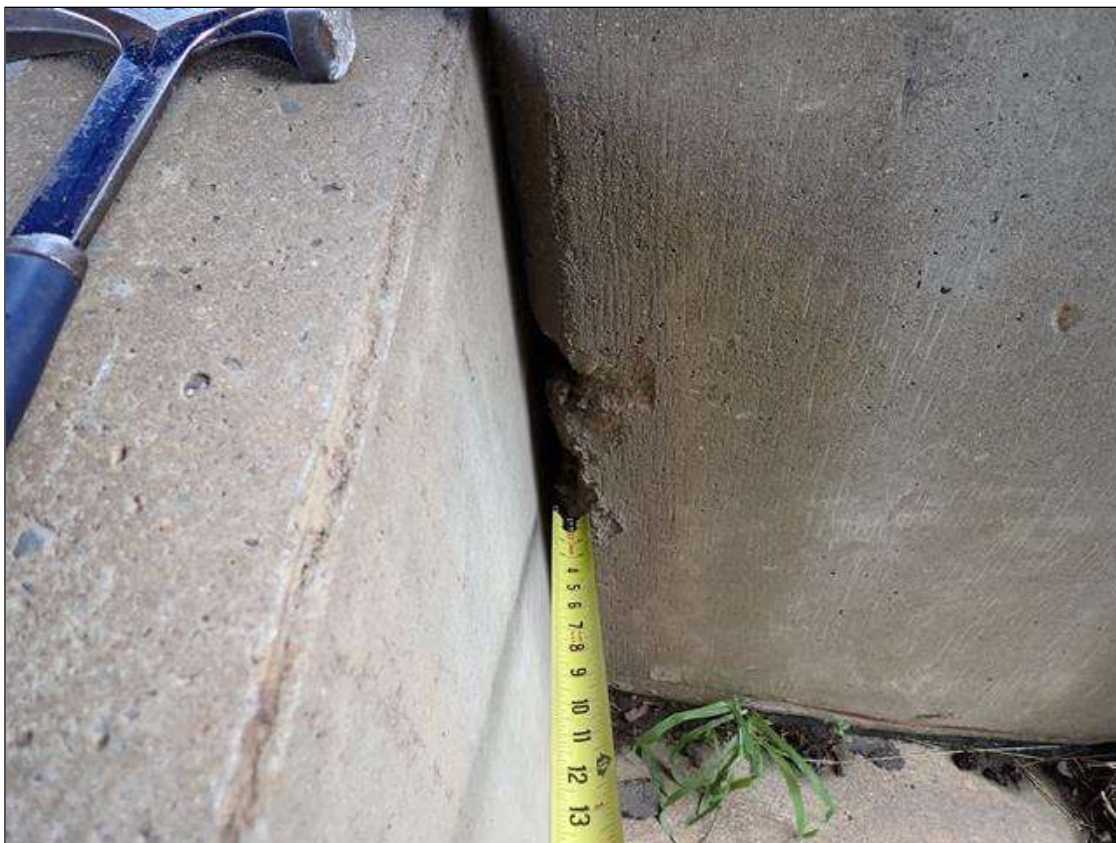
Bent 1 Pile 3: northwest corner, near ground, spall (10 inch x 4 inch x 1.5 inch deep)

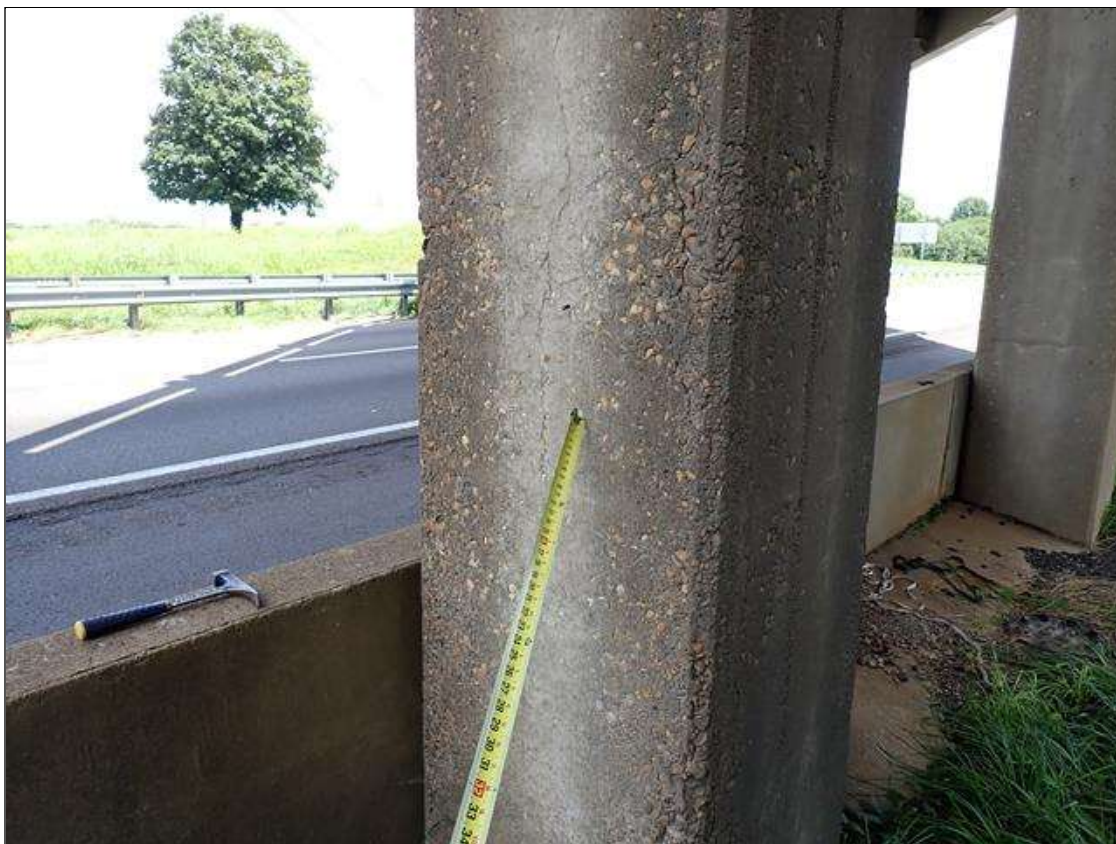
Bent 1 Pile 1: west face, near ground, poor consolidation (up to 5 feet x 1 foot x 1 inch deep) with associated vertical cracks (up to 1/8 inch wide x 3.5 feet)

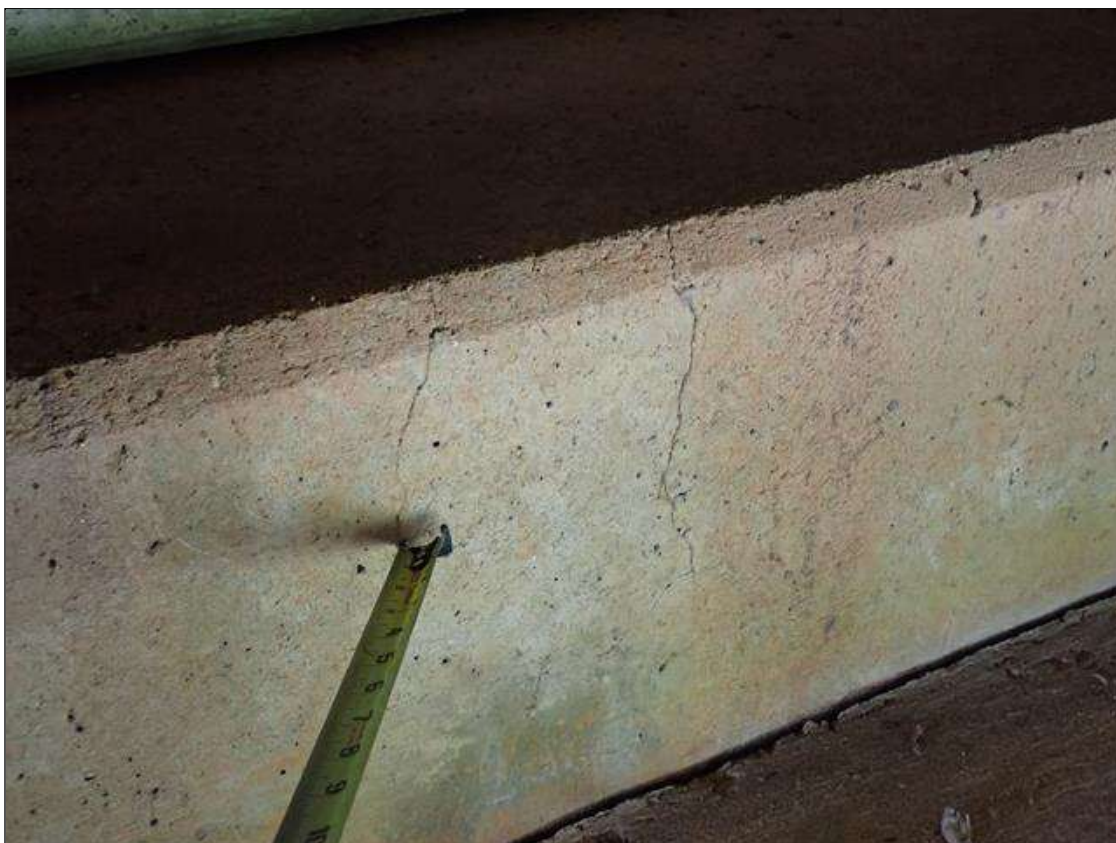
End Bent 2 Cap 1: along length, multiple vertical crack, up to full height x 1/64 inch, some extend across top face

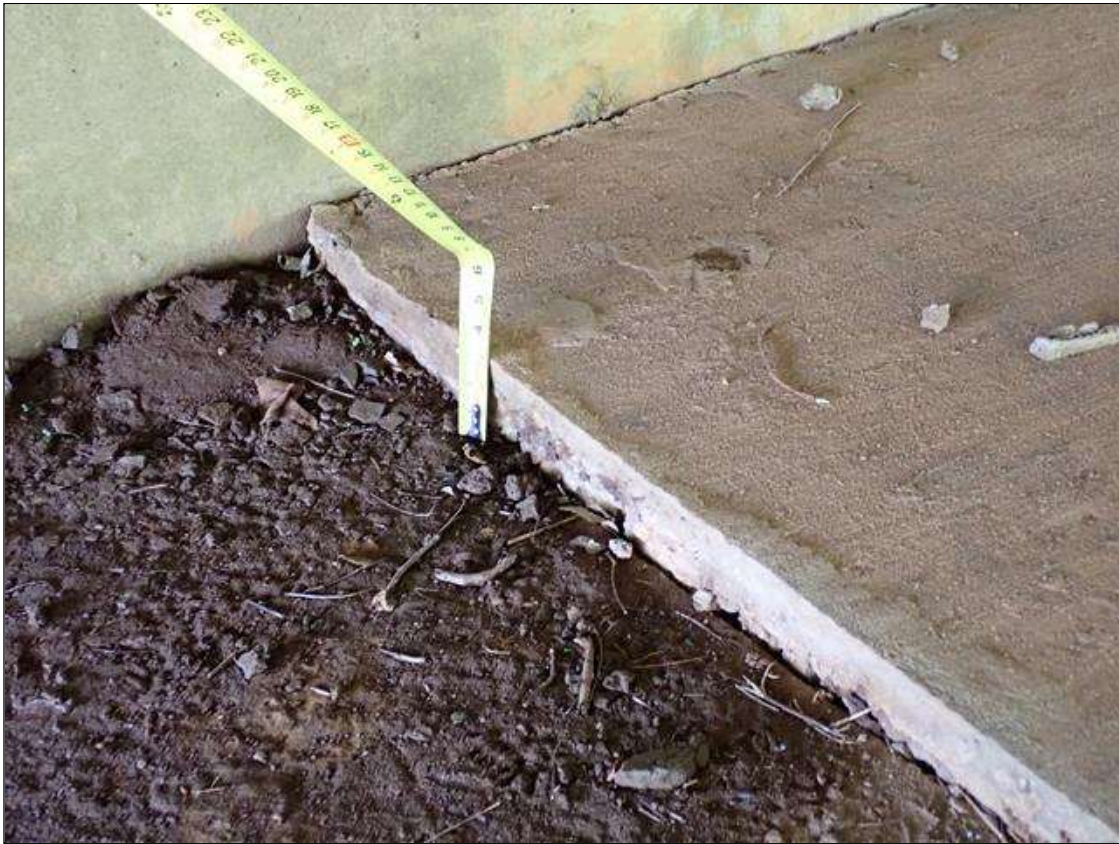
end bent 2 slope protection, in bay 1, near cap, settlement (up to 3 inches) with adjacent longitudinal crack (up to 1/8 inch x 10 feet)

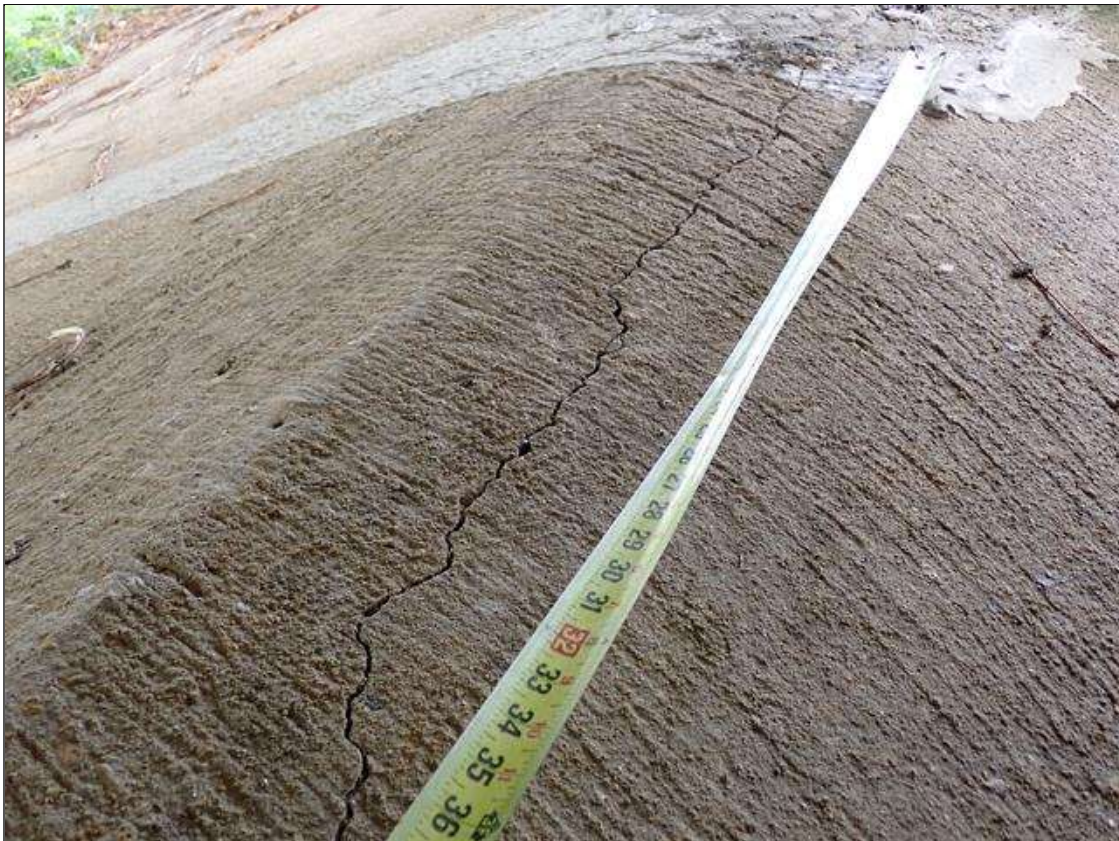
end bent 2 slope protection, in bay 1, near cap, settlement (up to 3 inches) with adjacent longitudinal crack (up to 1/8 inch x 10 feet)

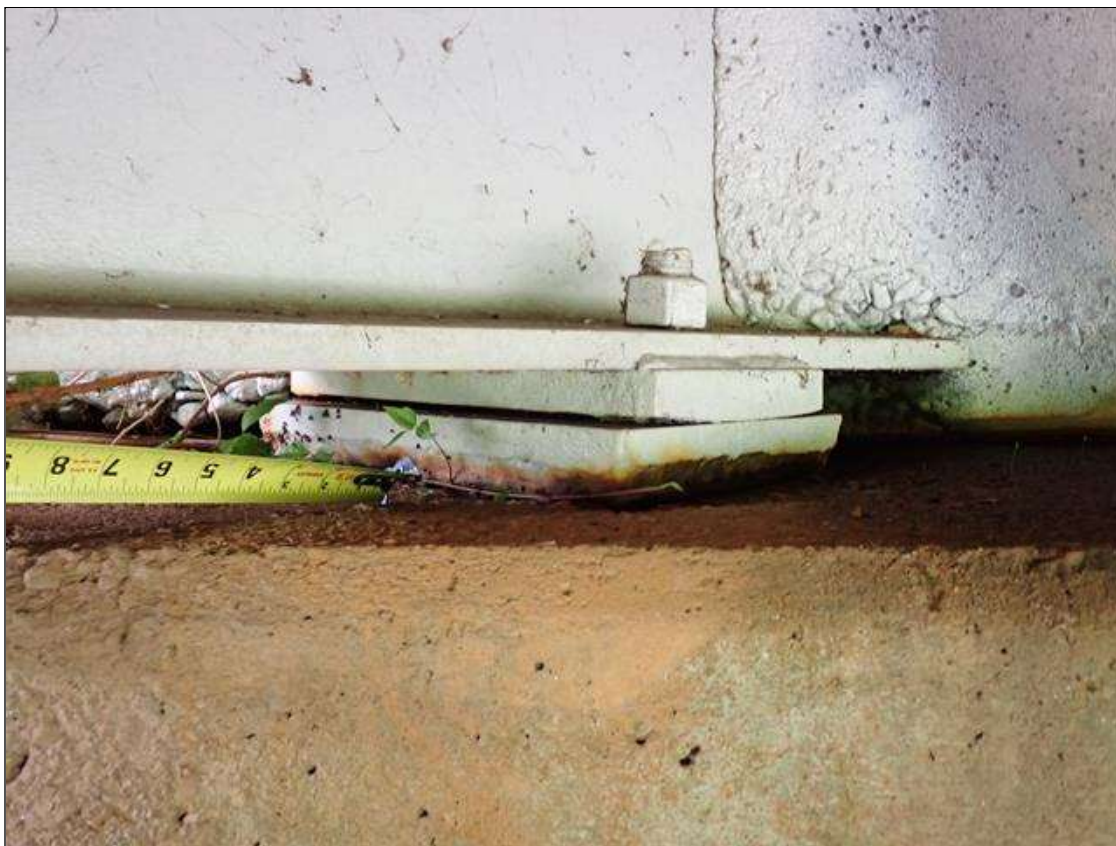
Span 4 Beam 1 - Far Bearing 1: painted over section loss (up to 3/16 inch deep) with corrosion reinitiated

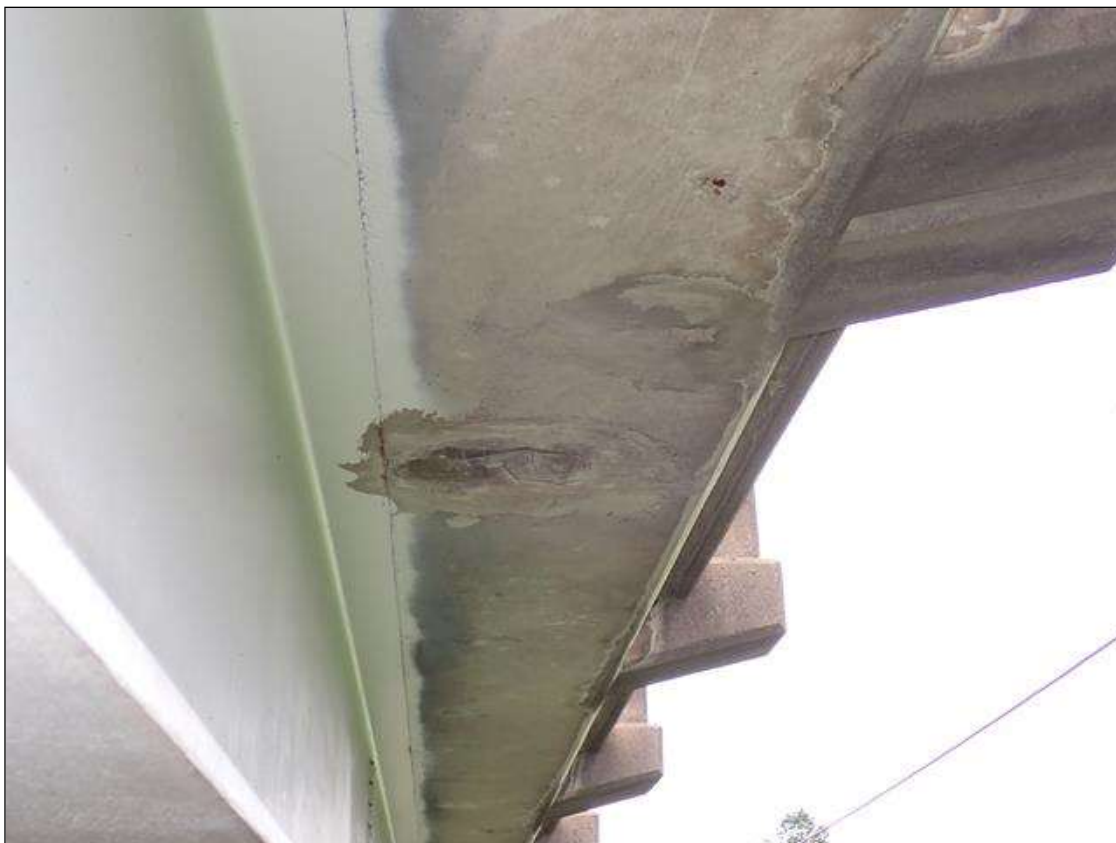
Span 4 Deck: SPAN 4 BOTTOM OF LEFT OVERHANG HAS multiple failed PATCH AREAS/DELAMINATIONS (up to 2 feet x 15 inch) THROUGH OUT THE SPAN

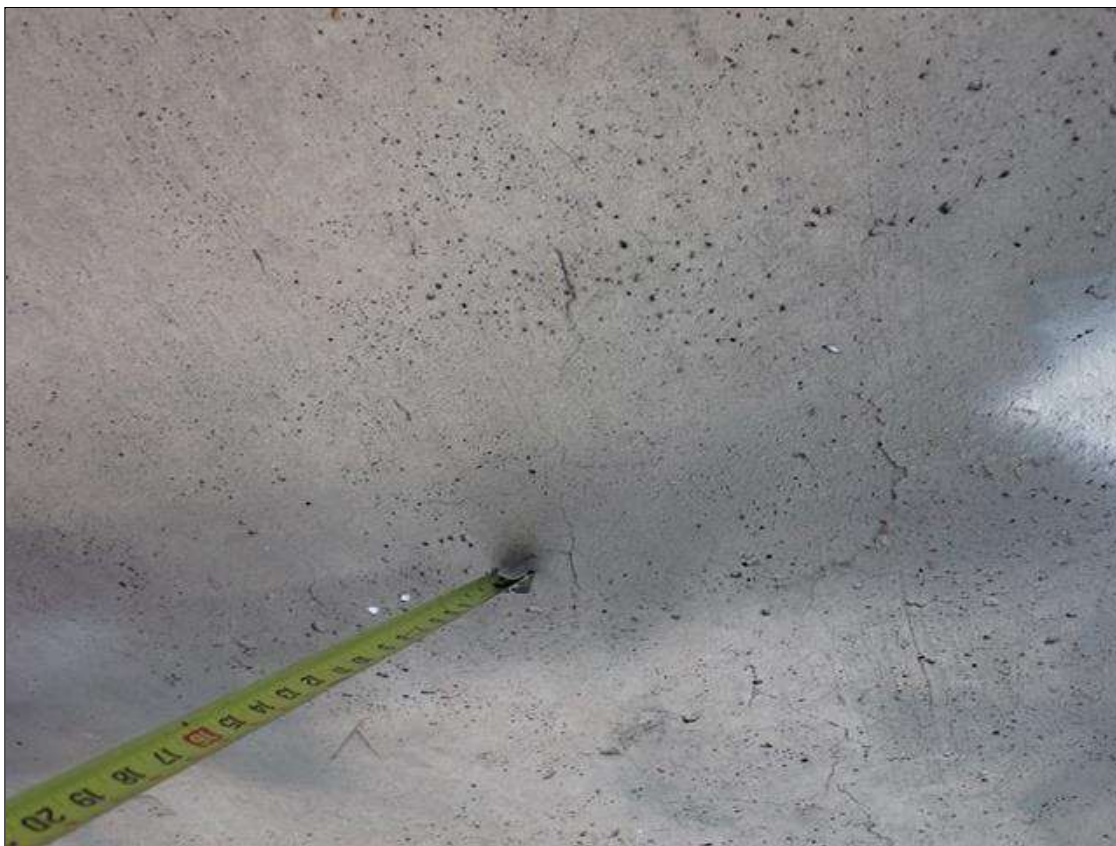
Span 4 Deck: throughout underside of deck, areas of map cracks (hairline) at random

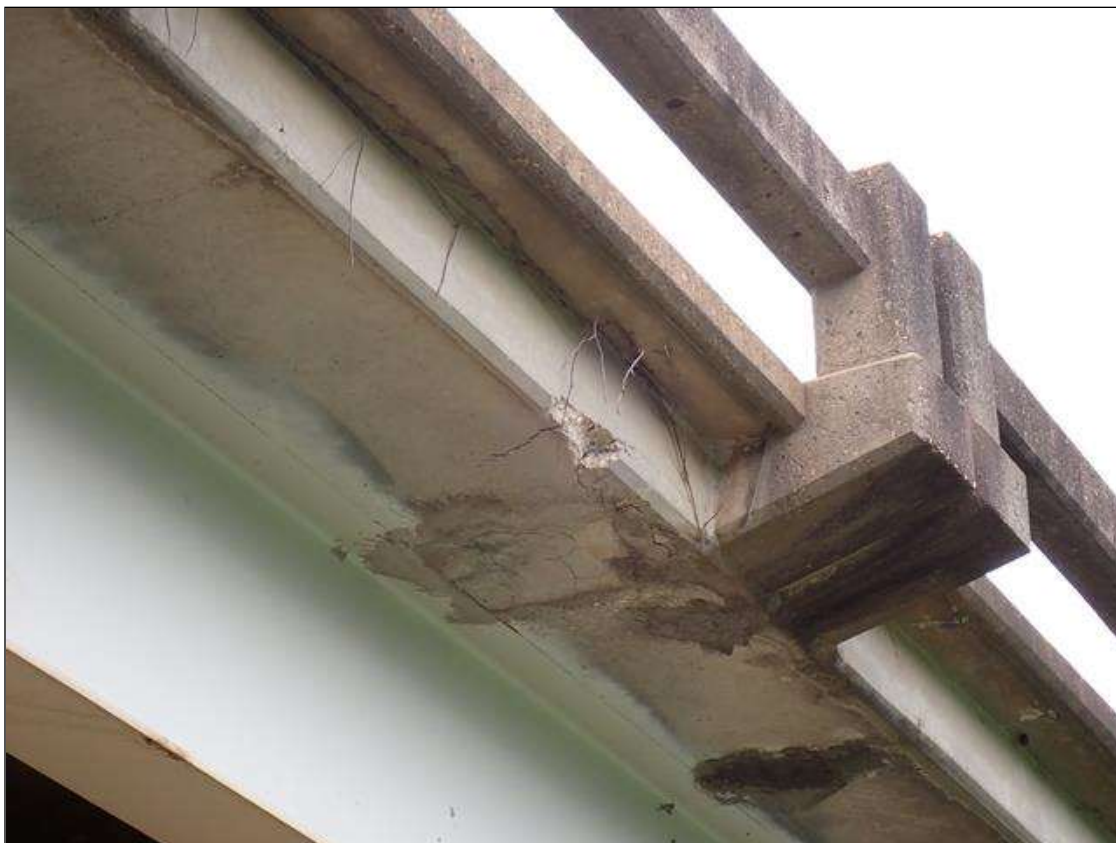
Span 4 Deck: underside right overhang at midspan, spall with adjacent delamination, 34 inch x 18 inch x 2 inch deep

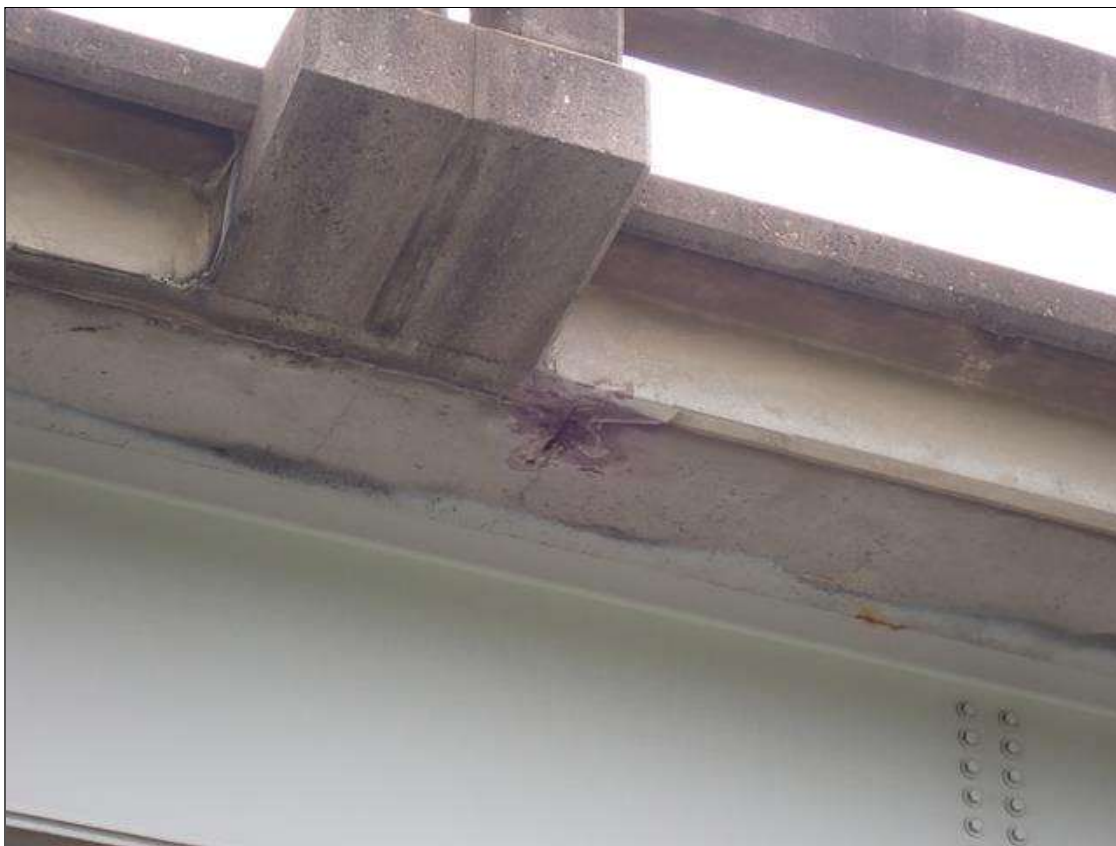
Span 3 Deck: (PAR) left overhang near mid span, spall [8 inch x 4 inch x 1 inch deep] with exposed rusted reinforcing [no measurable loss]

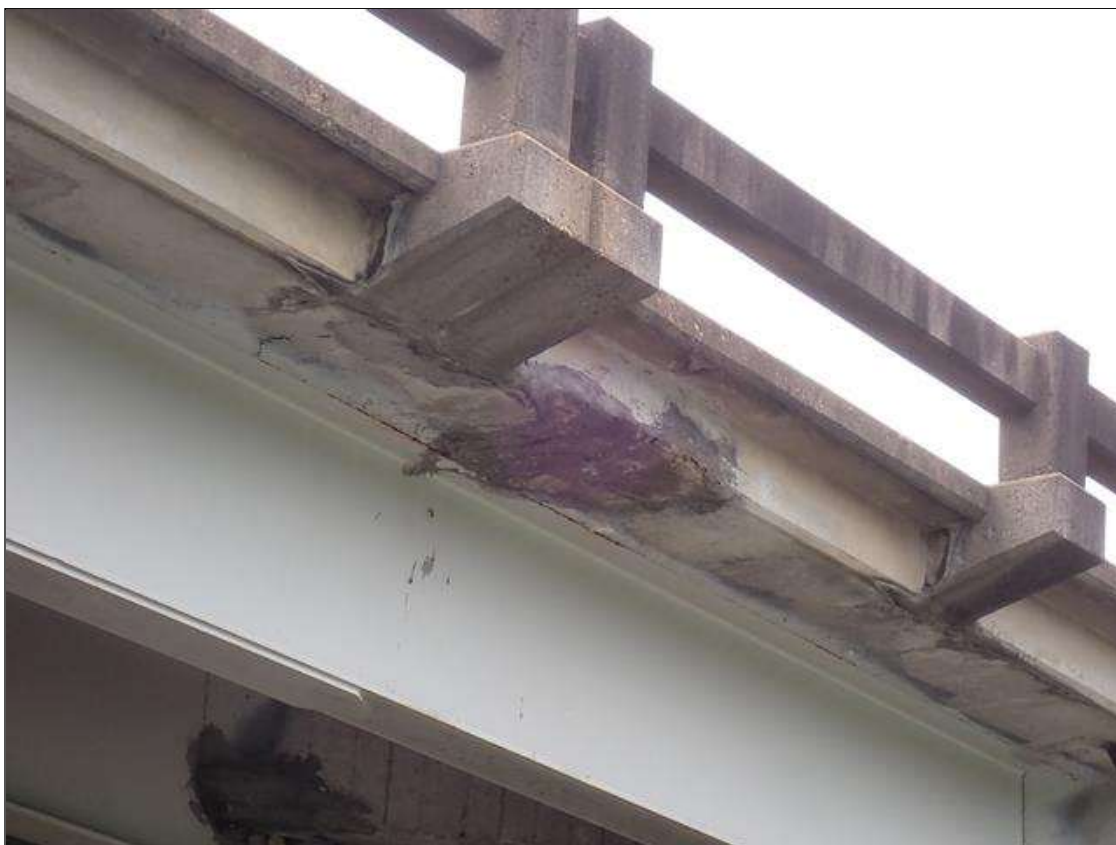
Span 3 Deck: [PAR] along left overhang, multiple failed patches with associated delaminations [up to 30 inch diameter] over traffic

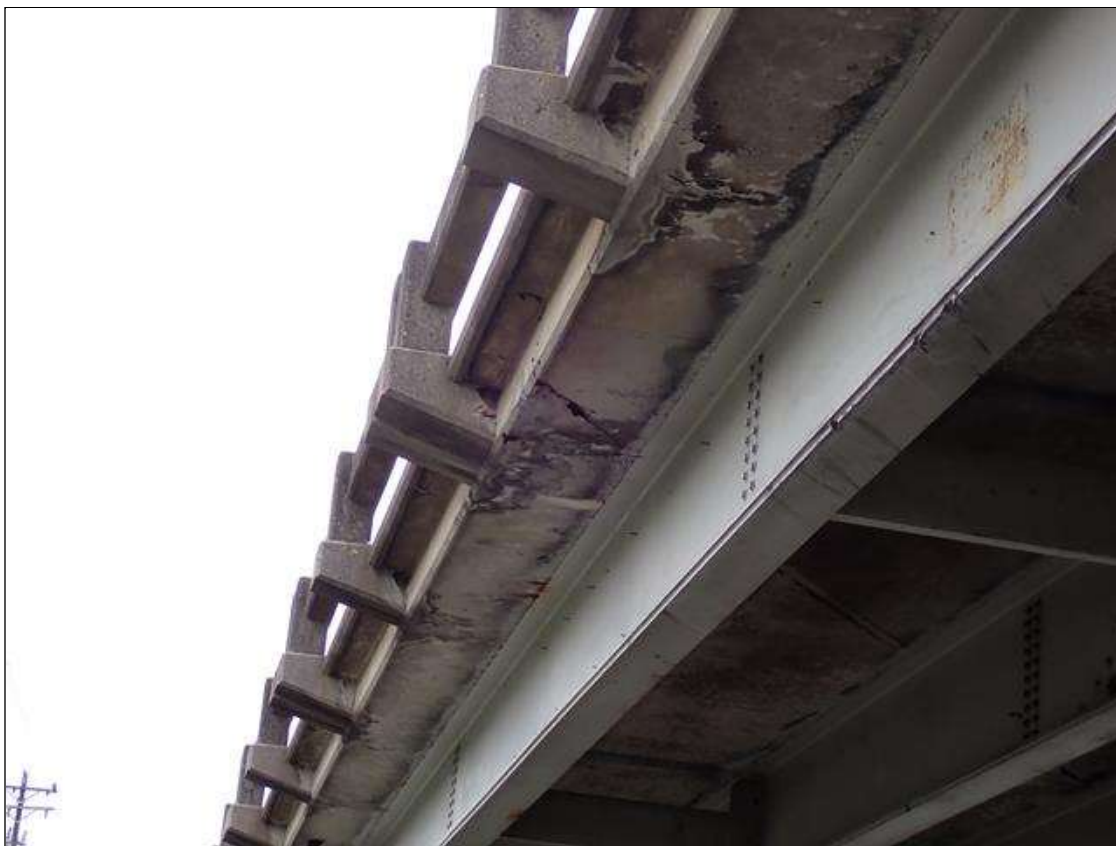
Span 3 Deck: [PAR] SPAN 3 BOTTOM OF DECK RIGHT OVER HANG HAS SCATTERED UNSOUND PATCHED AREAS THROUGH OUT THE SPAN WITH ASSOCIATED DELAMINATIONS [UP TO 18 INCH X UP TO 3 FEET] OVER TRAFFIC

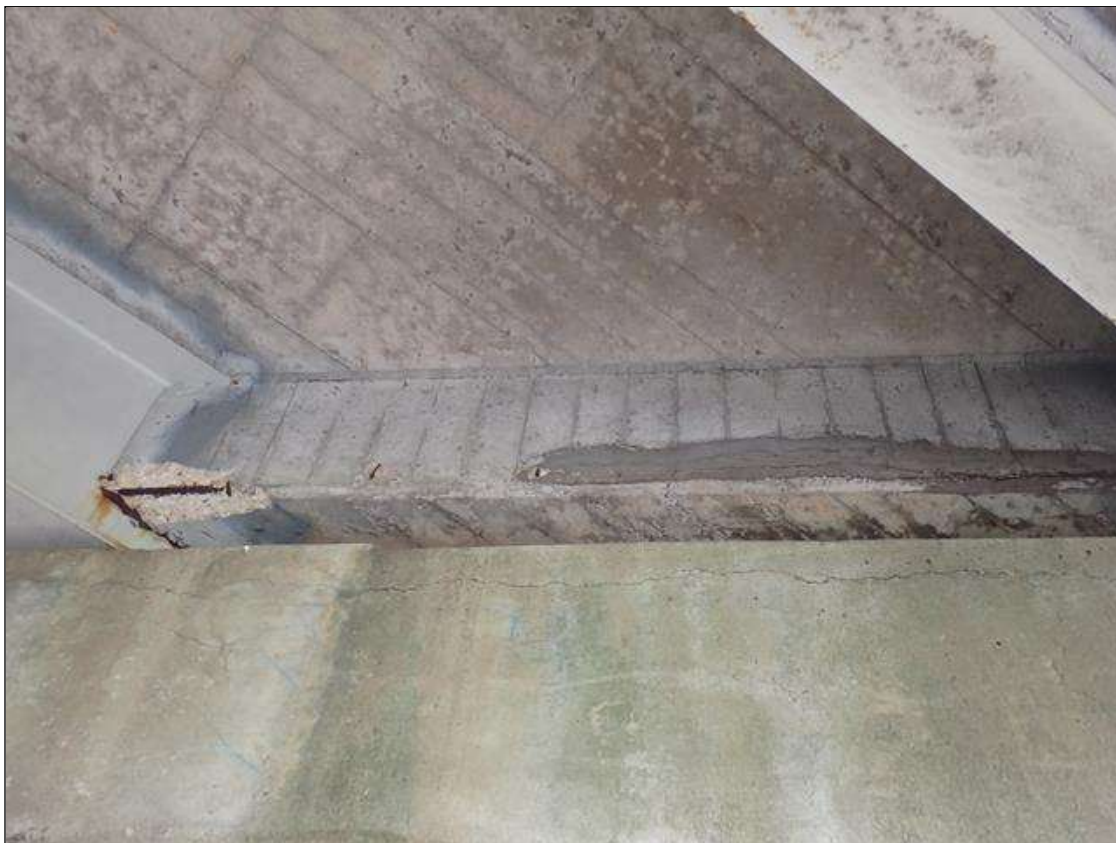
Span 3 Deck: at bents 2 and 3, end diaphragm, in all bays, spalls/delaminations/unsound patches (up to 5 feet x 6 inch x 2 inches deep) with exposed rusted rebar

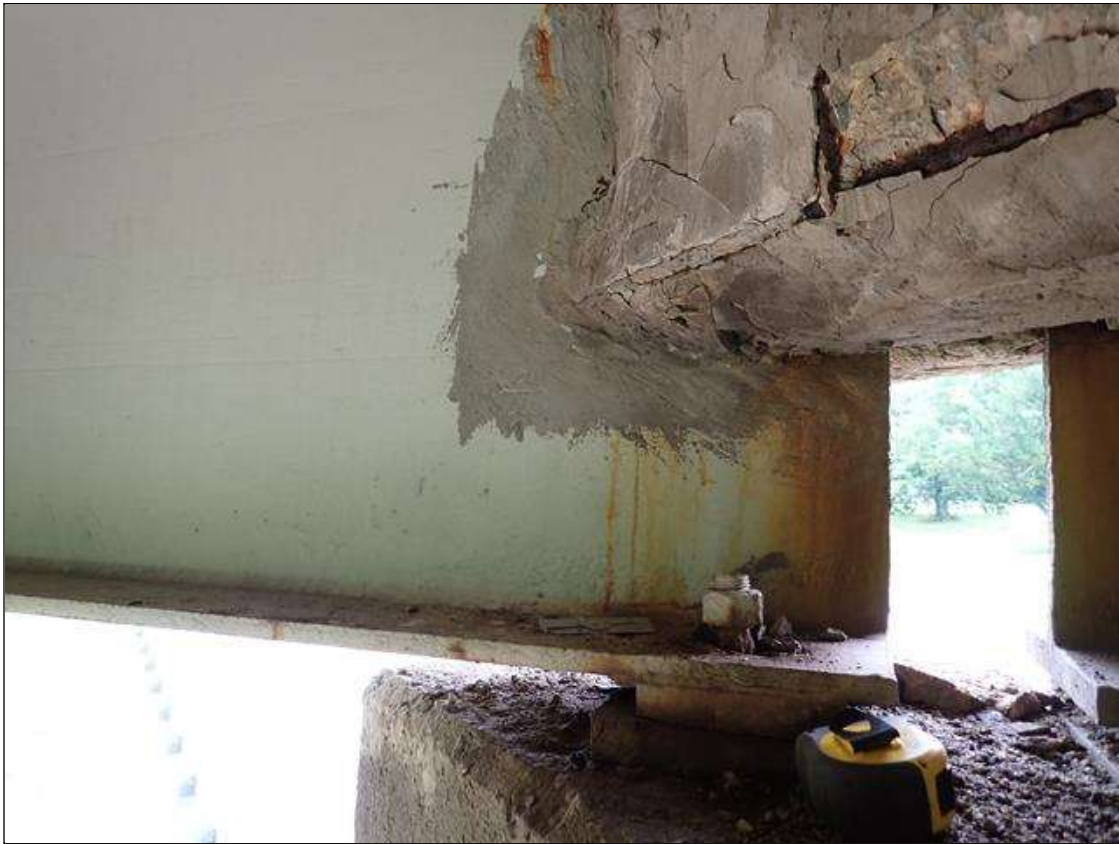
Span 4 Beam 4: (PAR) at bent 3, painted over section loss: web adjacent to diaphragm (5/16 inch average remaining x 9 inch x 2 inch); lower web (7/16 inch average remaining x 1 foot x 3 inch); bottom flange (0.75 inch average remaining x 6 inches) with corrosion reinitiated

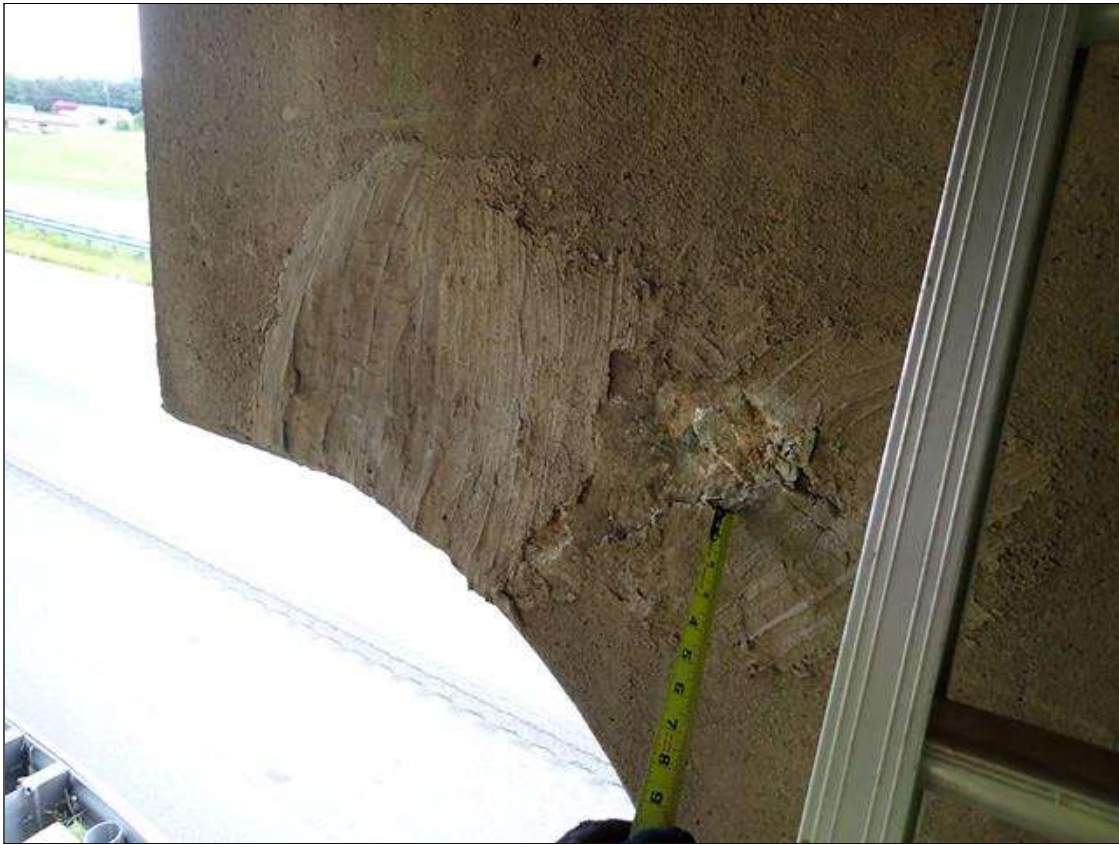
Bent 3 Cap 1: north face of cap, bay 3 to right end, delamination/unsound patches/spalls (up to 7.5 feet x 1 foot x 1/2 inch deep) with associated cracks (up to 1/16 inch)

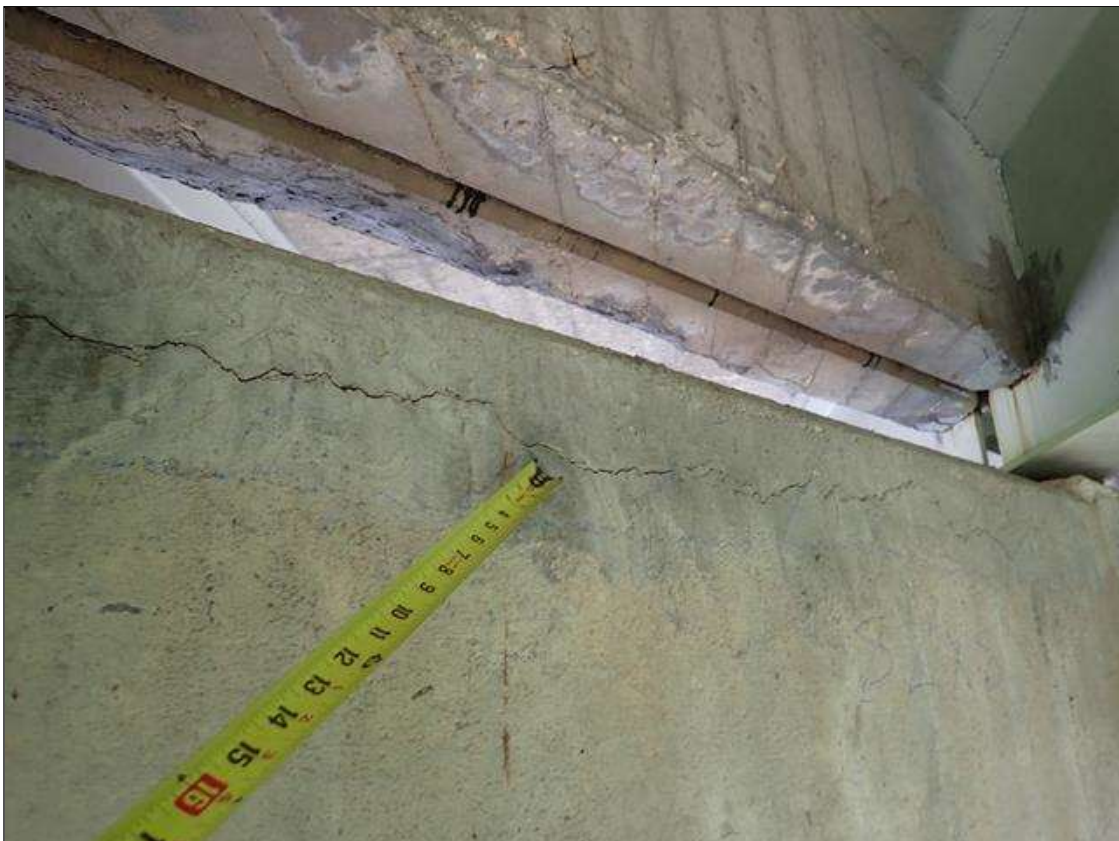
Bent 3 Cap 1: north face of cap, bay 3 to right end, delamination/unsound patches/spalls (up to 7.5 feet x 1 foot x 1/2 inch deep) with associated cracks (up to 1/16 inch)

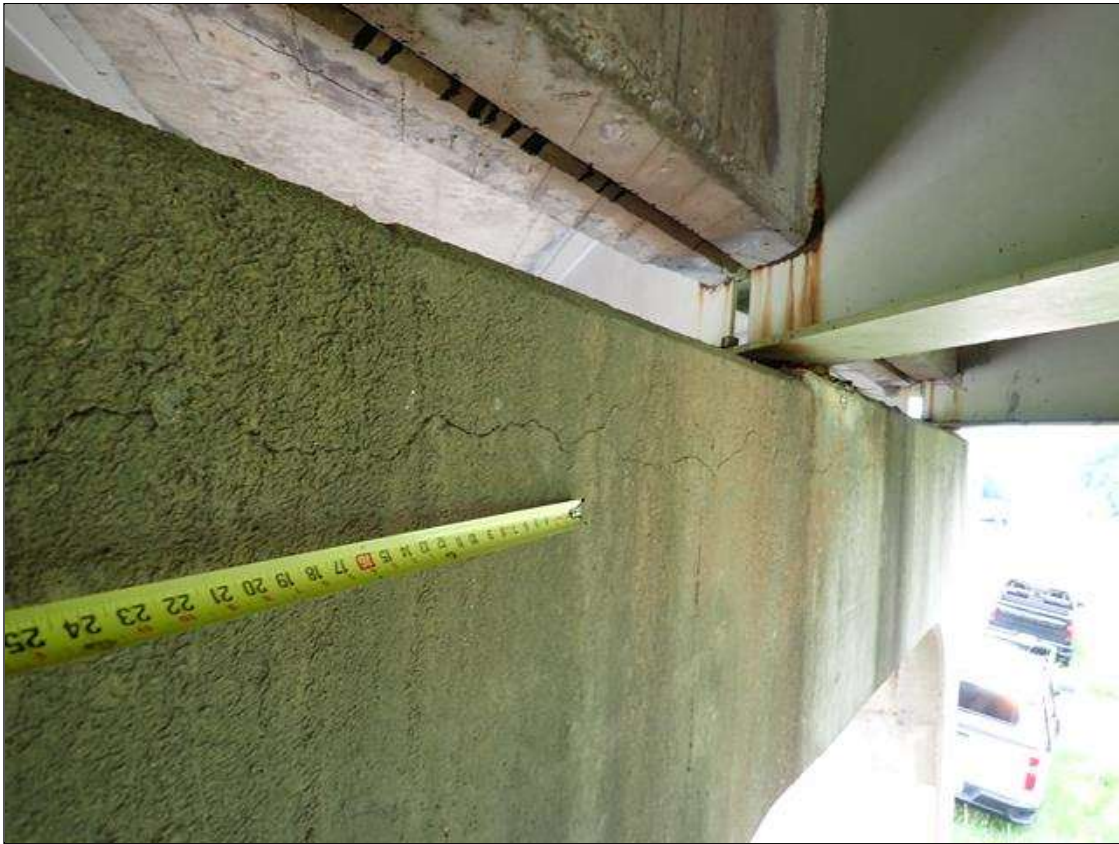
Bent 3 Cap 1: north face, below bays 1 and 2, longitudinal crack (up to 1/16 inch x 20 feet)
