NC DEPARTMENT OF TRANSPORTATION
 DIVISION OF HIGHWAYS
 STRUCTURE MANAGEMENT UNIT

ATTENTION: **prompt action request, sketches revised, clearances revised, newly structurally deficient**

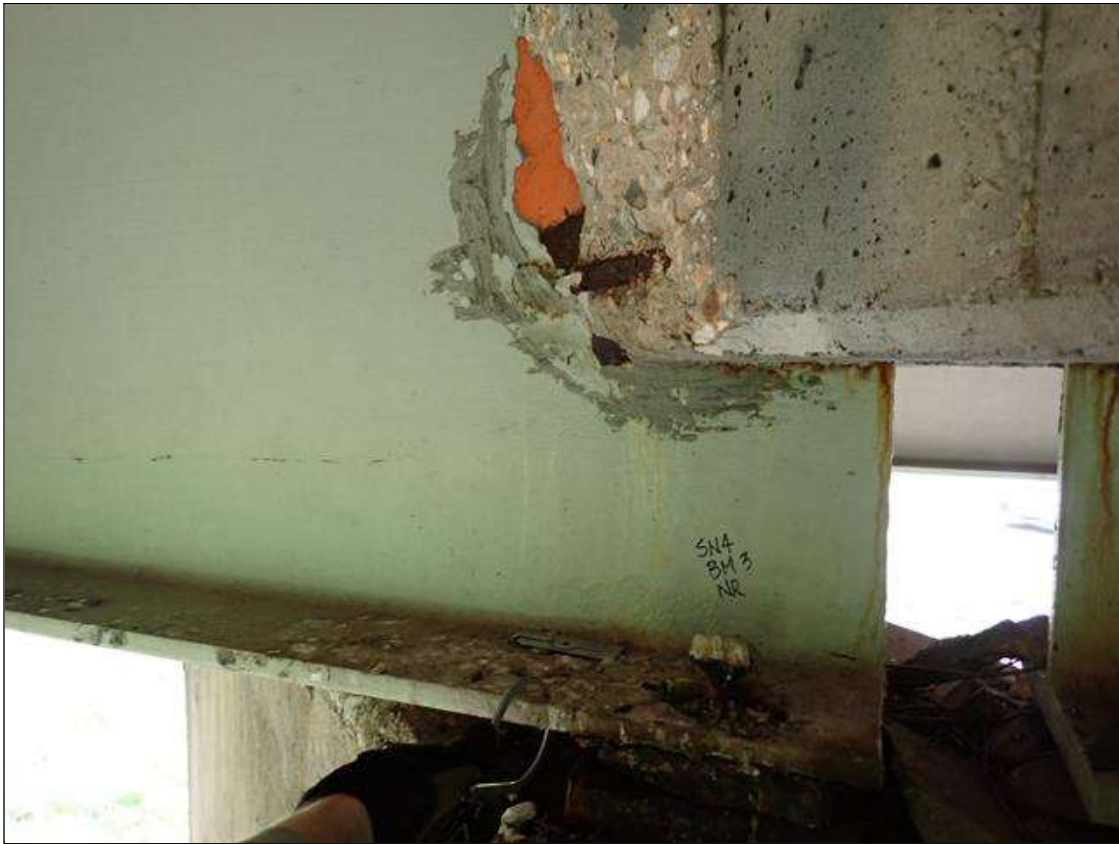
Span 4 Beam 3: (PAR) at bent 3, web adjacent to diaphragm, corrosion with section loss (5/16 inch average remaining x 14 inch x 6 inch); painted over section loss: lower web (3/8 inch average remaining x 1 foot x 2 inches), bottom flange (0.65 inch average remaining x 1 foot)

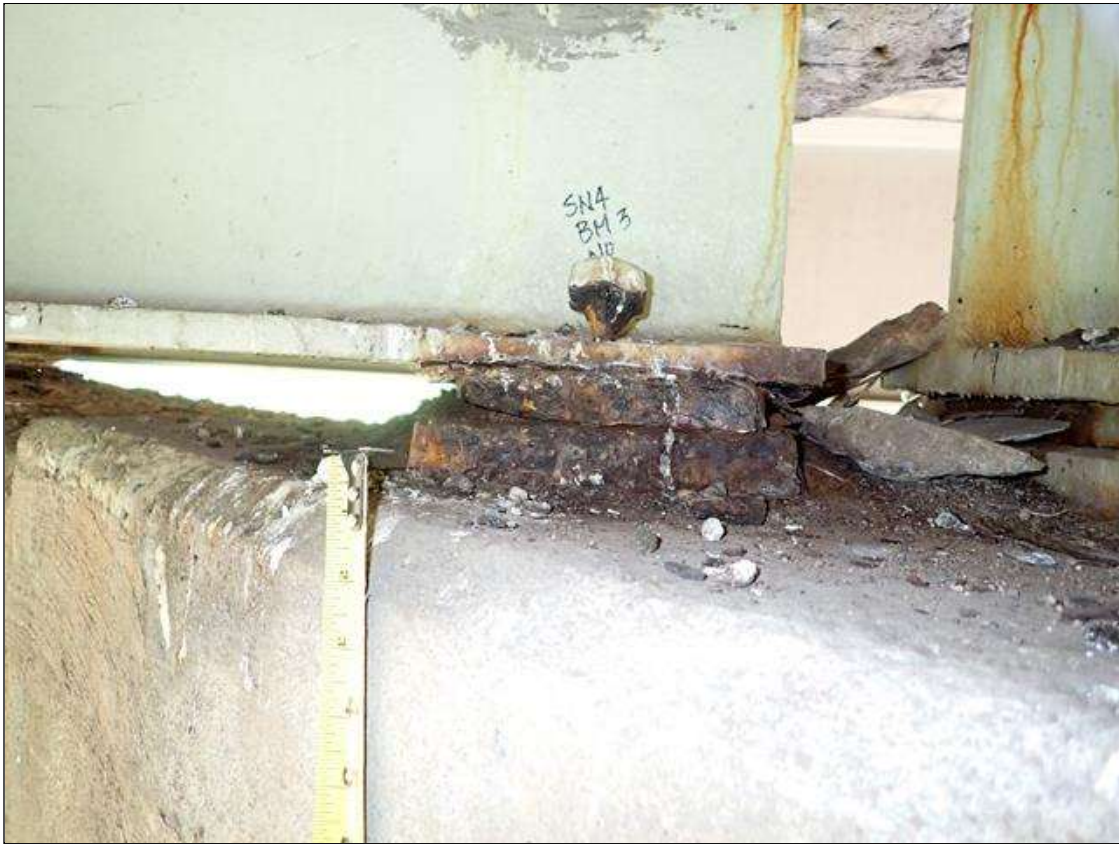
Span 4 Beam 3 - Near Bearing 3: (PAR) corrosion with section loss (up to 1/4 inch deep); left anchor bolt (75 percent section loss)

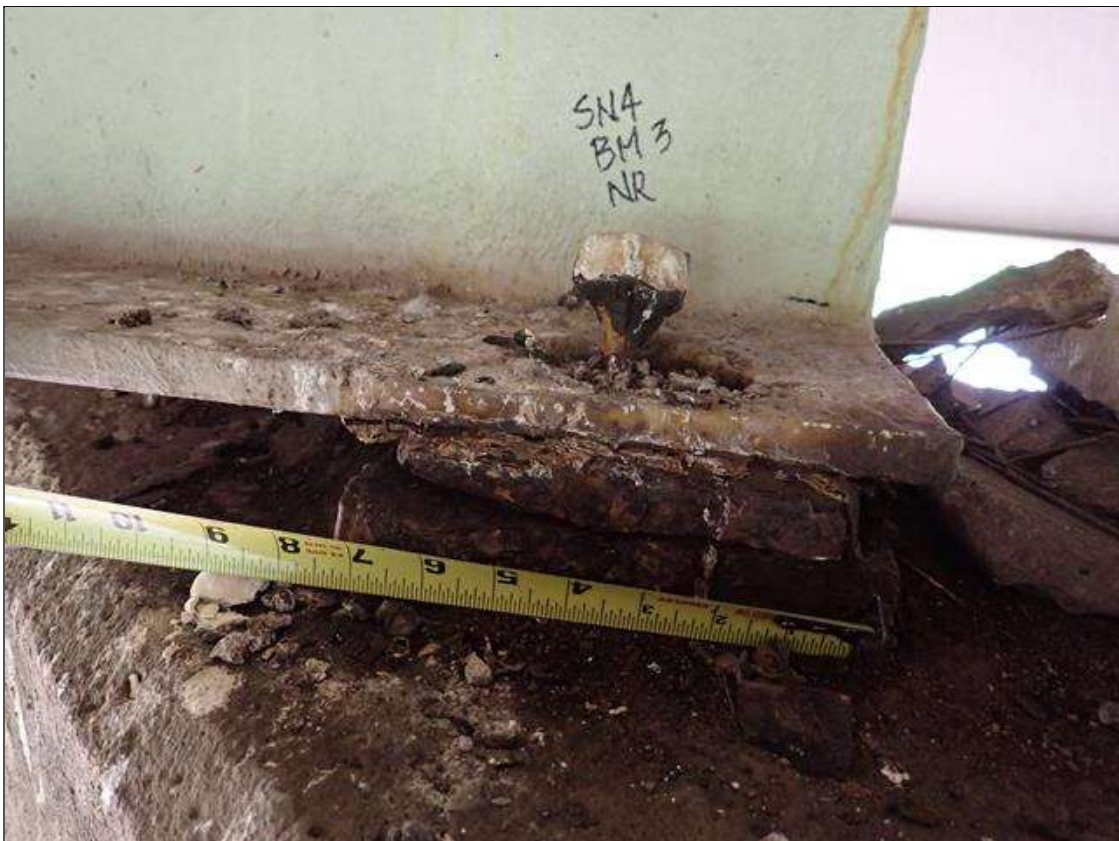
Span 4 Beam 3 - Near Bearing 3: (PAR) west side of bearing, between sole and beam bottom flange, broken weld

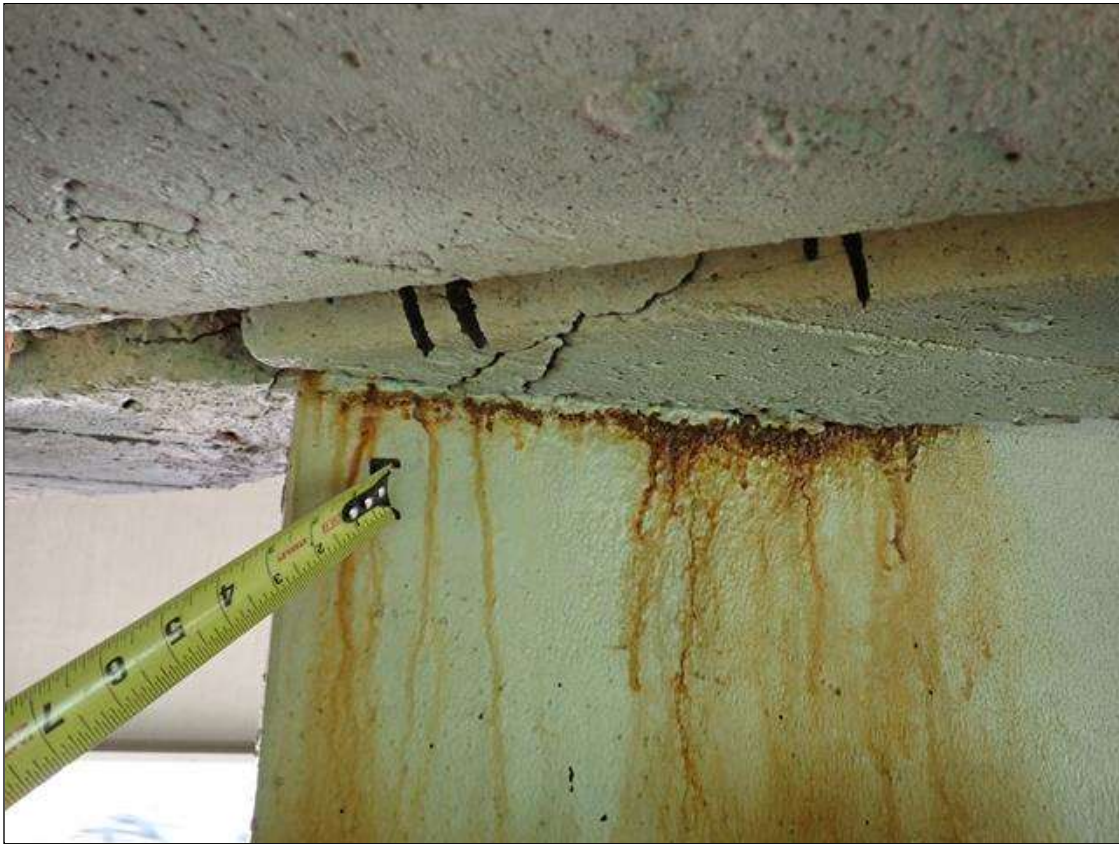
Span 3 Beam 3: (PAR) at bent 3, web adjacent to diaphragm, corrosion with section loss (3/8 inch average remaining x 13 inch x 1.5 inch)

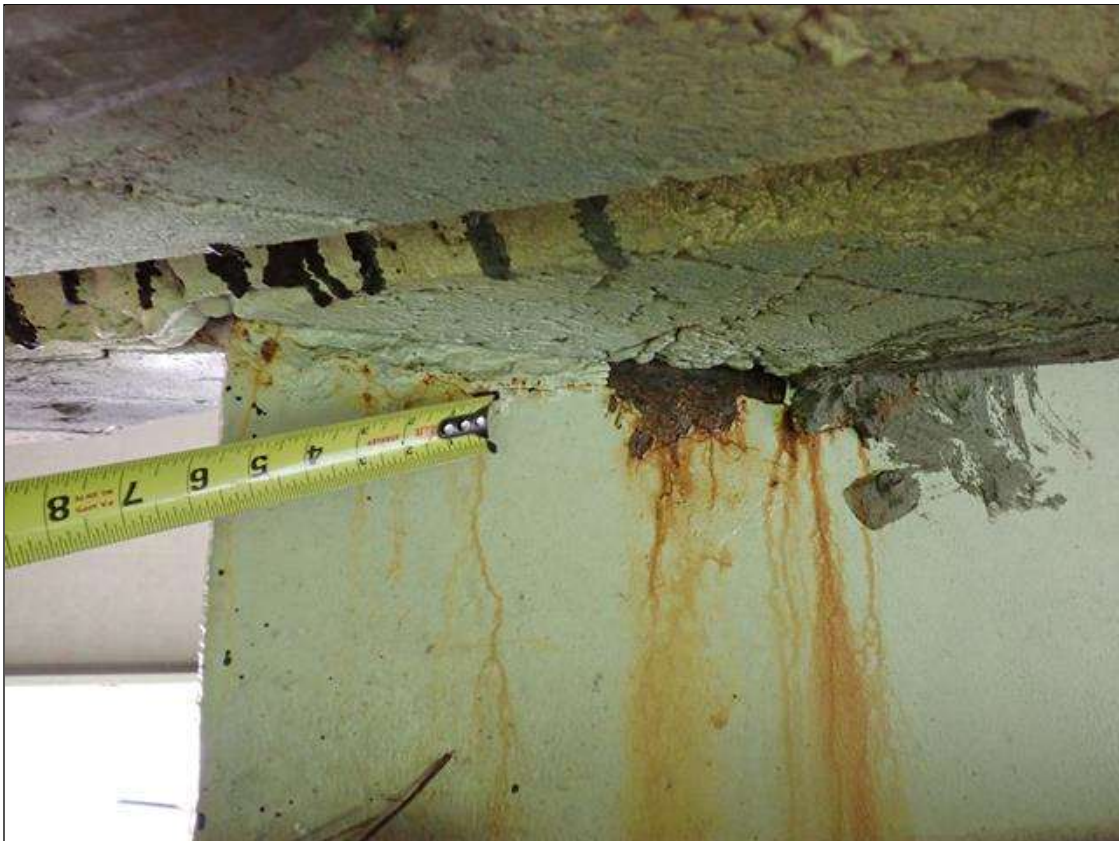
Span 3 Beam 2: (PAR) at bent 3, web adjacent to diaphragm, corrosion with section loss (3/8 inch average remaining x 14 inch x 2 inch)

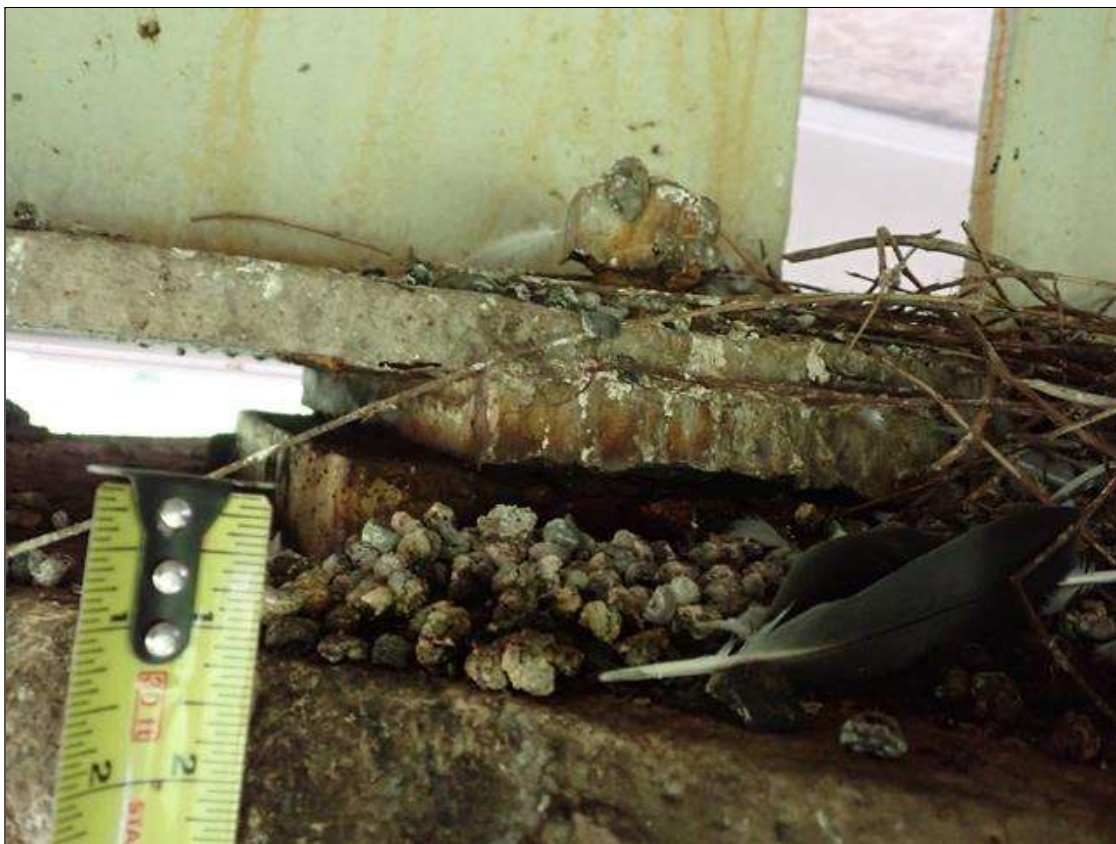
Span 4 Beam 2 - Near Bearing 2: SURFACE RUST/PACK RUST ON THE BEARING PLATES.

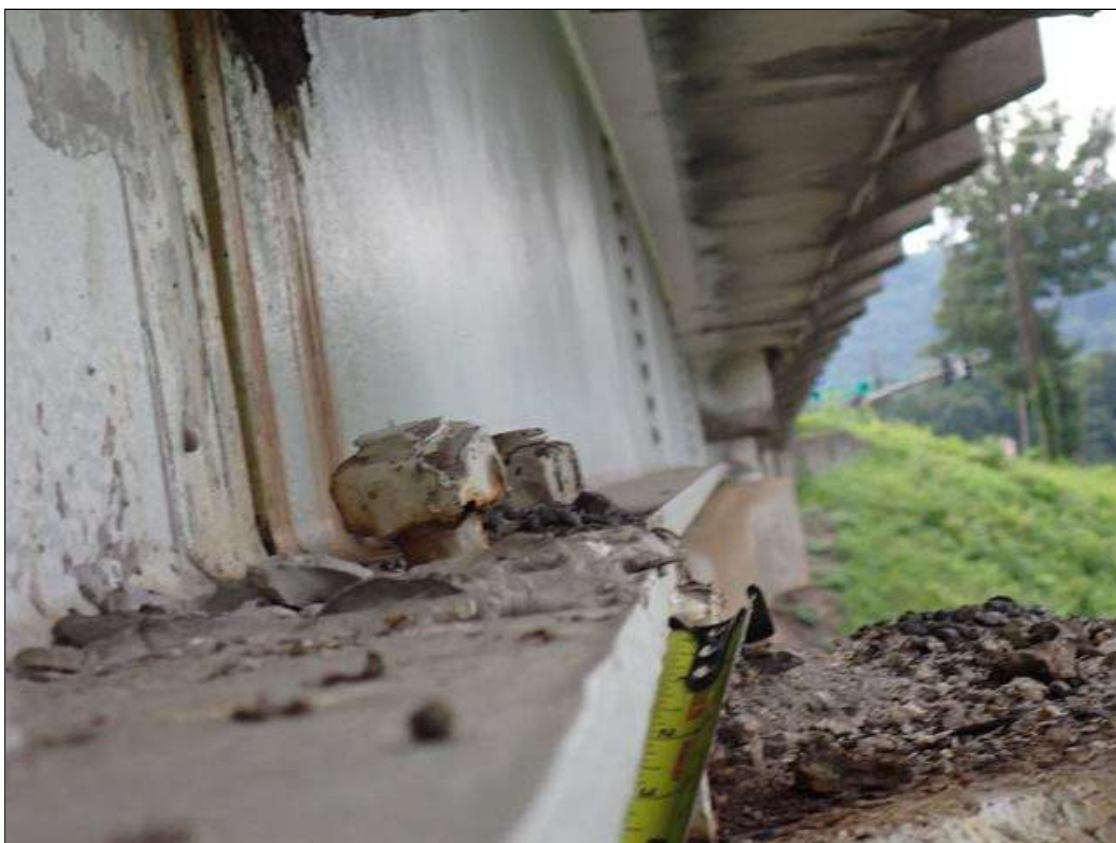
Span 4 Beam 1 - Near Bearing 1: rust scale; both anchor bolts (approximately 10 percent section loss)

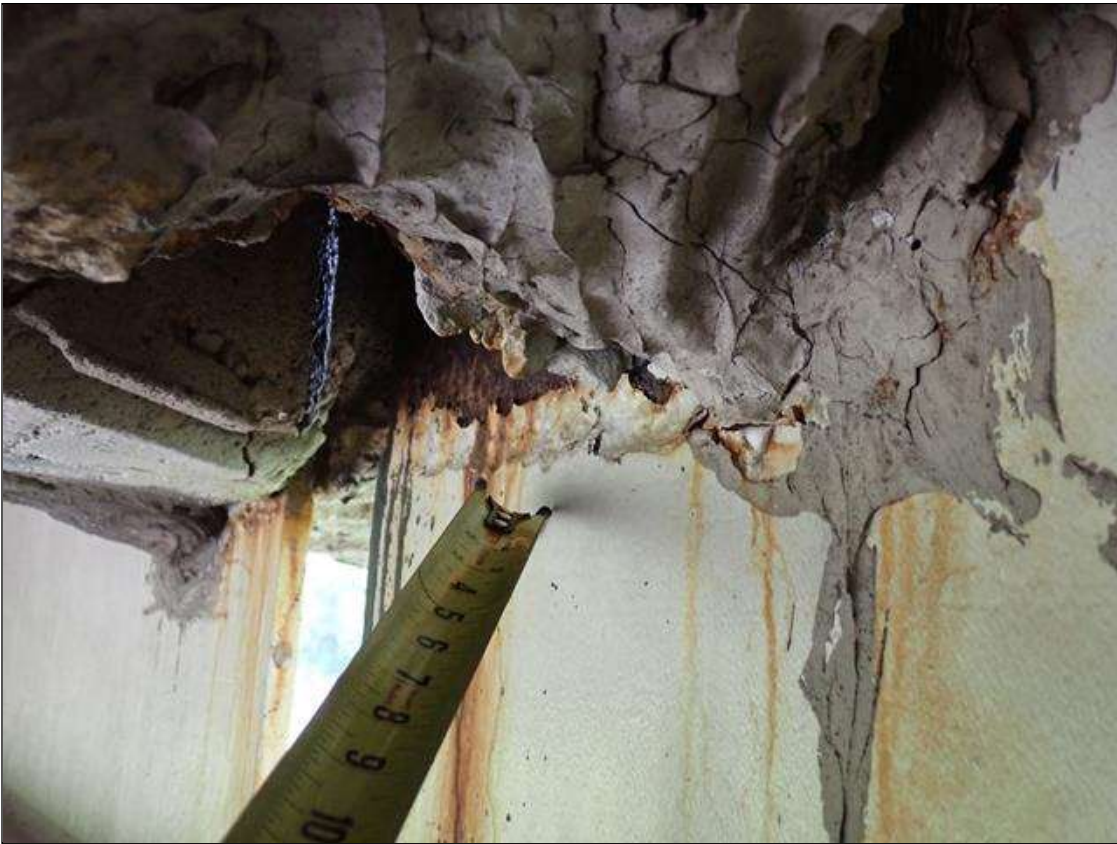
Span 4 Beam 1: (PAR) at bent 3, web adjacent to diaphragm, corrosion with section loss (1/4 inch average remaining x 15 inch x 4 inch)

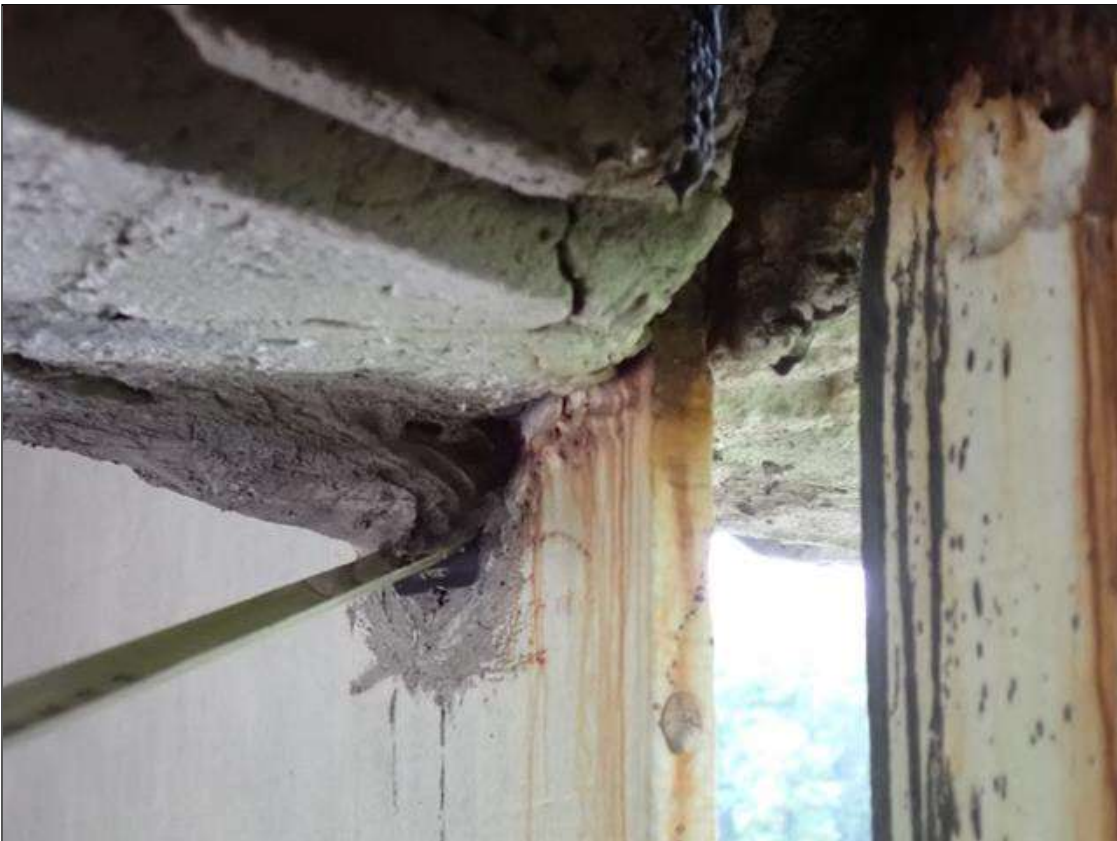
Span 3 Beam 1: (PAR) at bent 3, web adjacent to diaphragm, corrosion with section loss (5/16 inch average remaining x 1 foot x 3 inch)

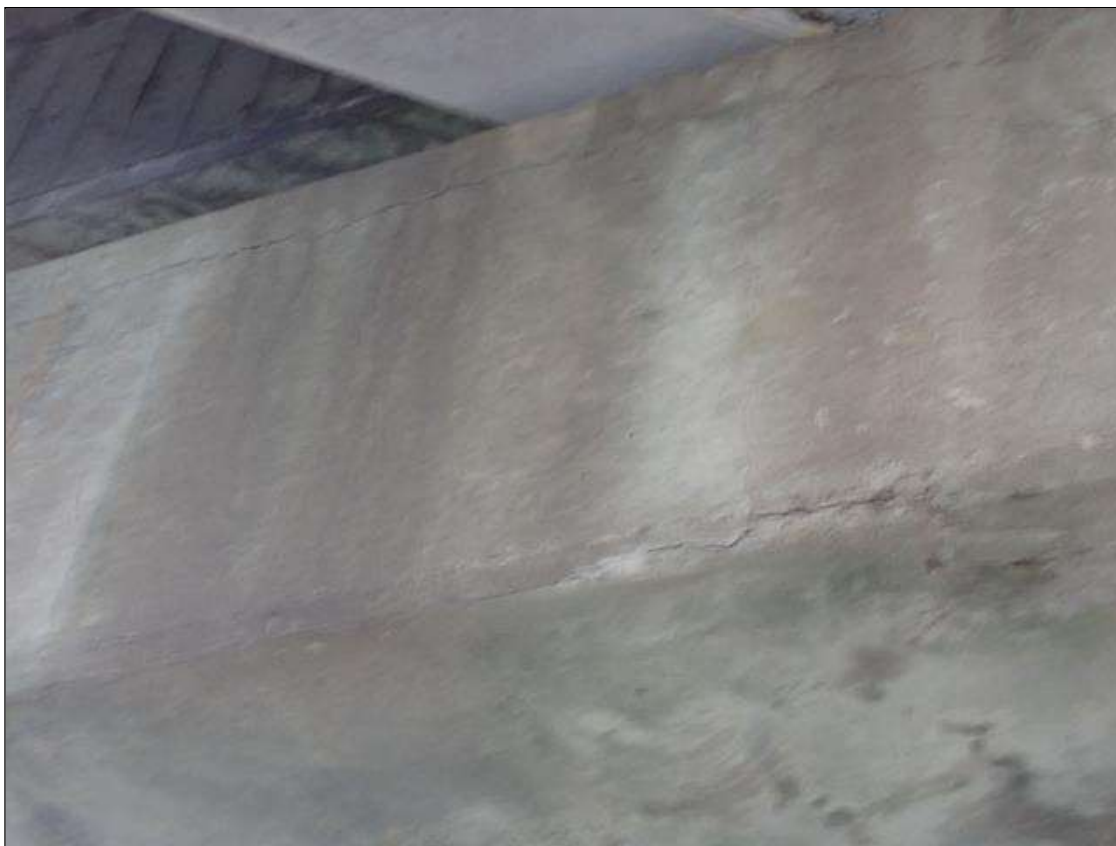
Bent 3 Cap 1: south face, upper and lower edges, longitudinal cracks (up to 1/8 inch x full length) with adjacent delaminations (up to 8 feet x 8 inch)

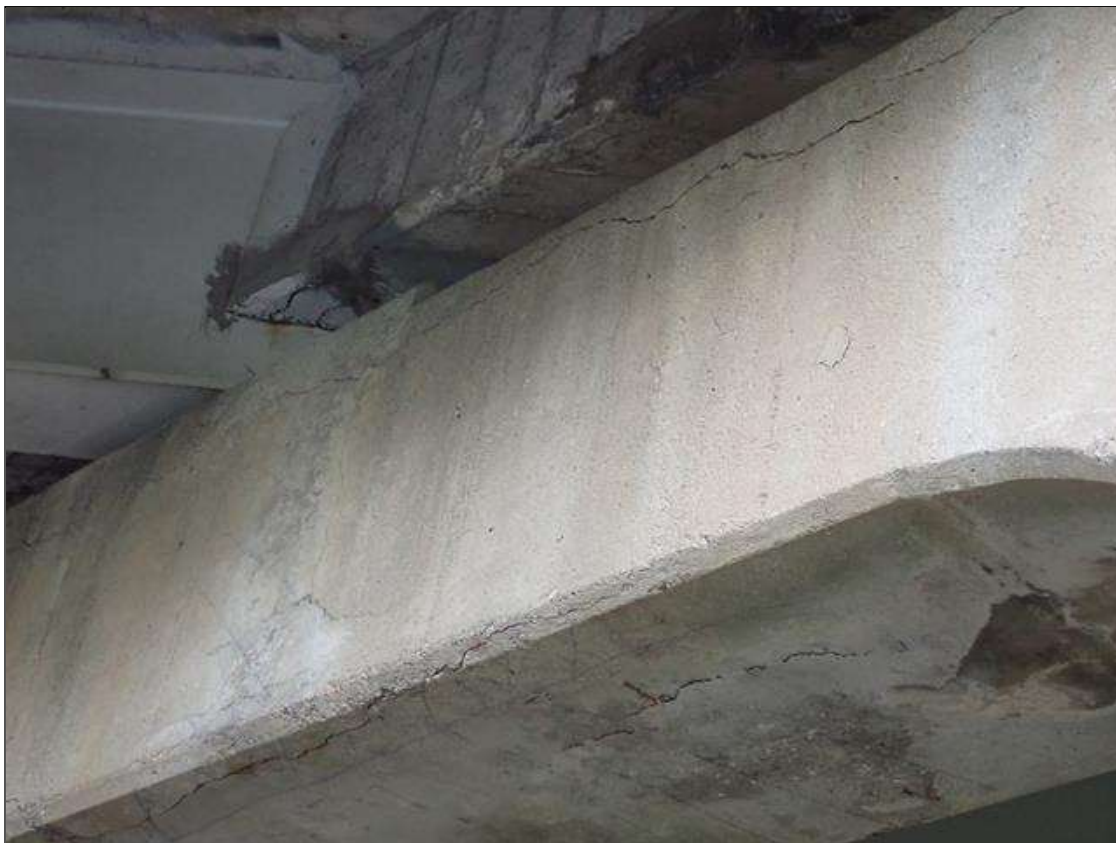
Bent 3 Cap 1: south face, upper and lower edges, longitudinal cracks (up to 1/8 inch x full length) with adjacent delaminations (up to 8 feet x 8 inch)

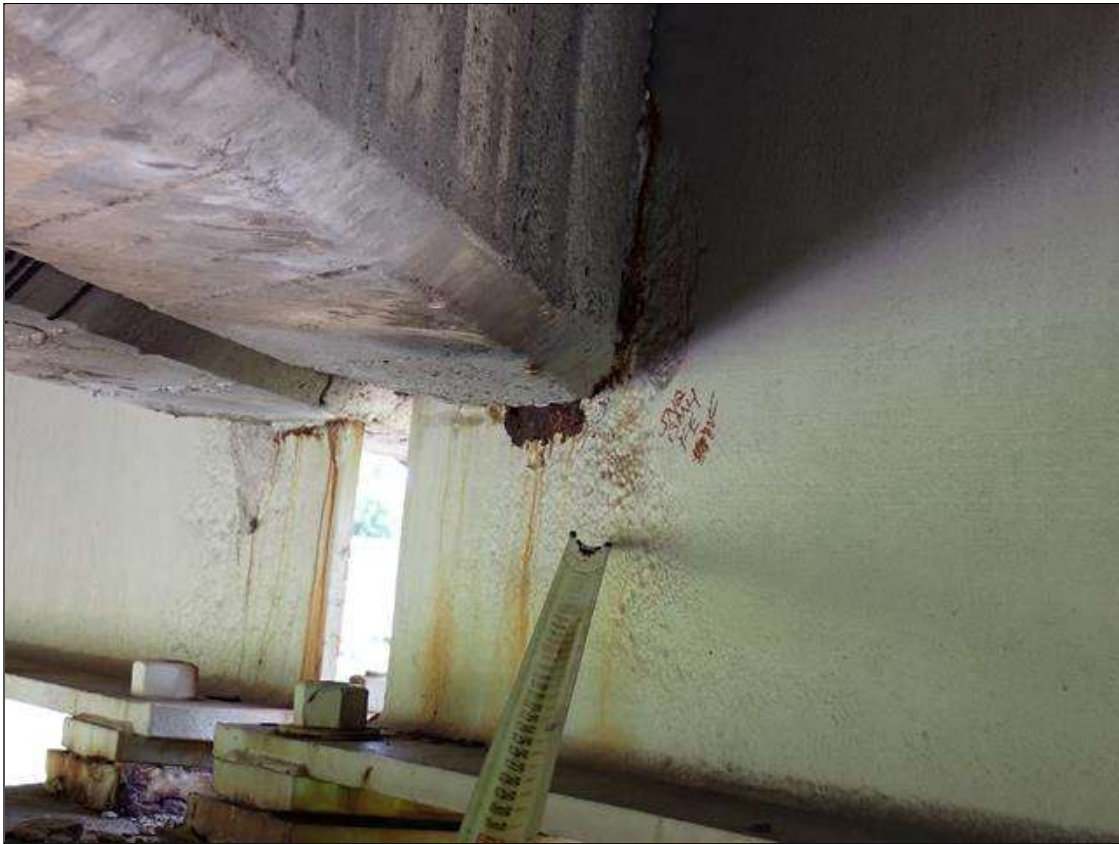
Span 2 Beam 4: (PAR) at bent 2, web adjacent to diaphragm, painted over section loss (1/4 inch average remaining x 14 inch x 8 inch) with adjacent pitting (up to 1/8 inch deep) with corrosion reinitiated

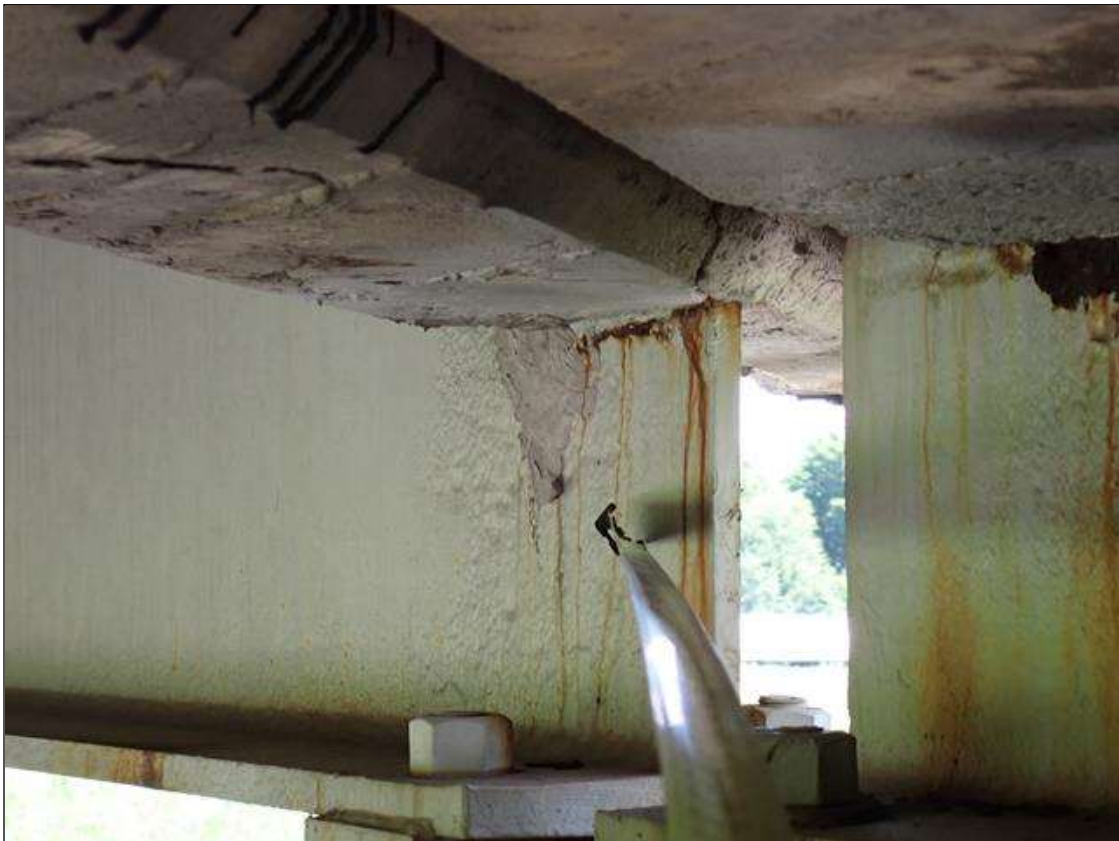
Span 3 Beam 4: (PAR) at bent 2, web adjacent to diaphragm, painted over section loss (5/16 inch average remaining x 12 inch x 6 inch); lower web, painted over pitting (up to 1/8 inch deep x 1 foot x 3 inches) with corrosion reinitiated

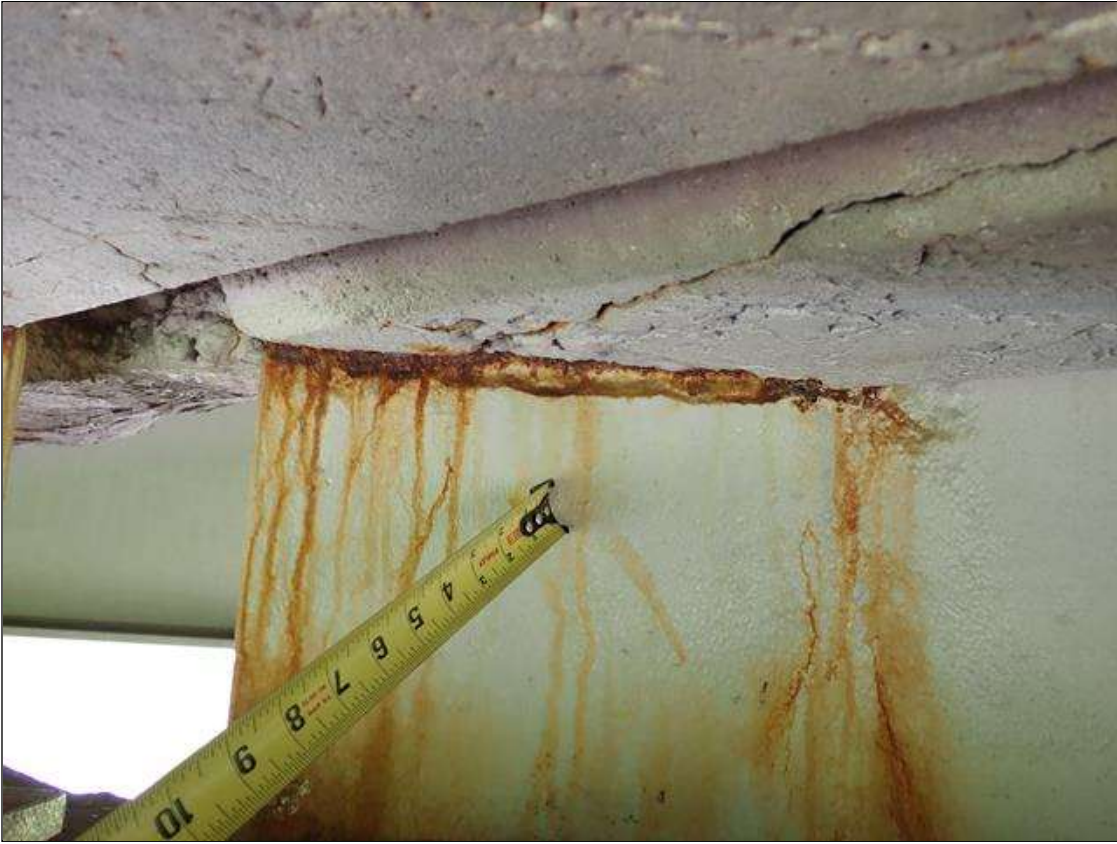
Span 3 Beam 3: (PAR) at bent 2, web adjacent to diaphragm, painted over section loss (1/4 inch average remaining x 14 inch x 3 inch) with adjacent painted over pitting (up to 1/8 inch deep) with corrosion reinitiated

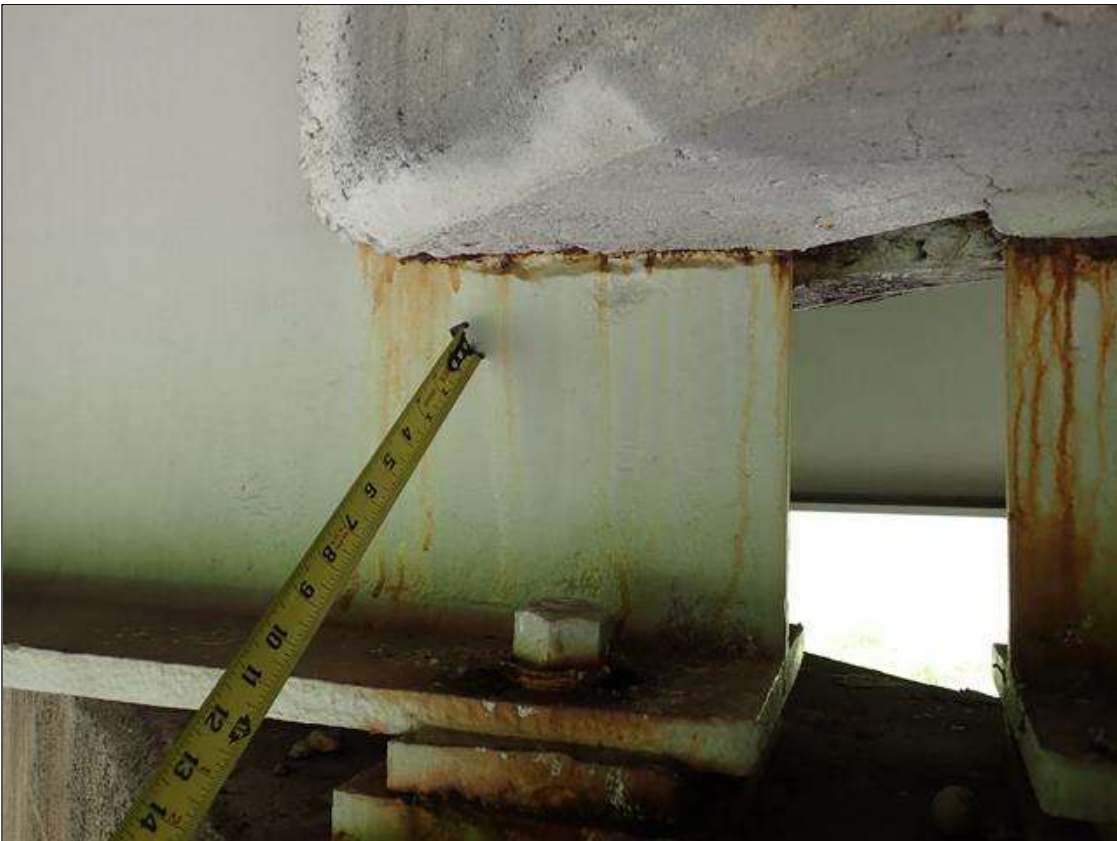
Span 2 Beam 3: (PAR) at bent 2, web adjacent to diaphragm, painted over section loss (5/16 inch average remaining x 9 inch x 1 inch); lower web, painted over pitting (up to 1/8 inch deep x 3 inch x 3 inch) with corrosion reinitiated

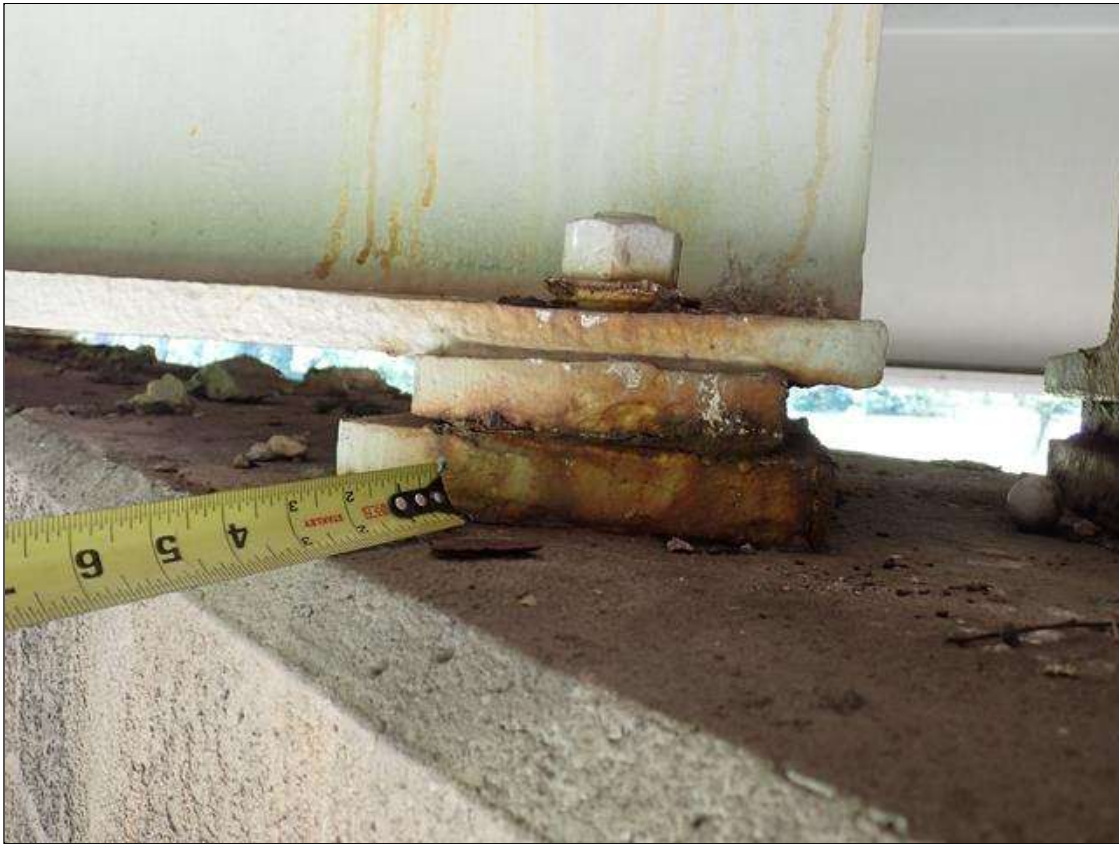
Span 2 Beam 3 - Far Bearing 3: painted over section loss (up to 1/8 inch deep) with corrosion reinitiated; pack rust

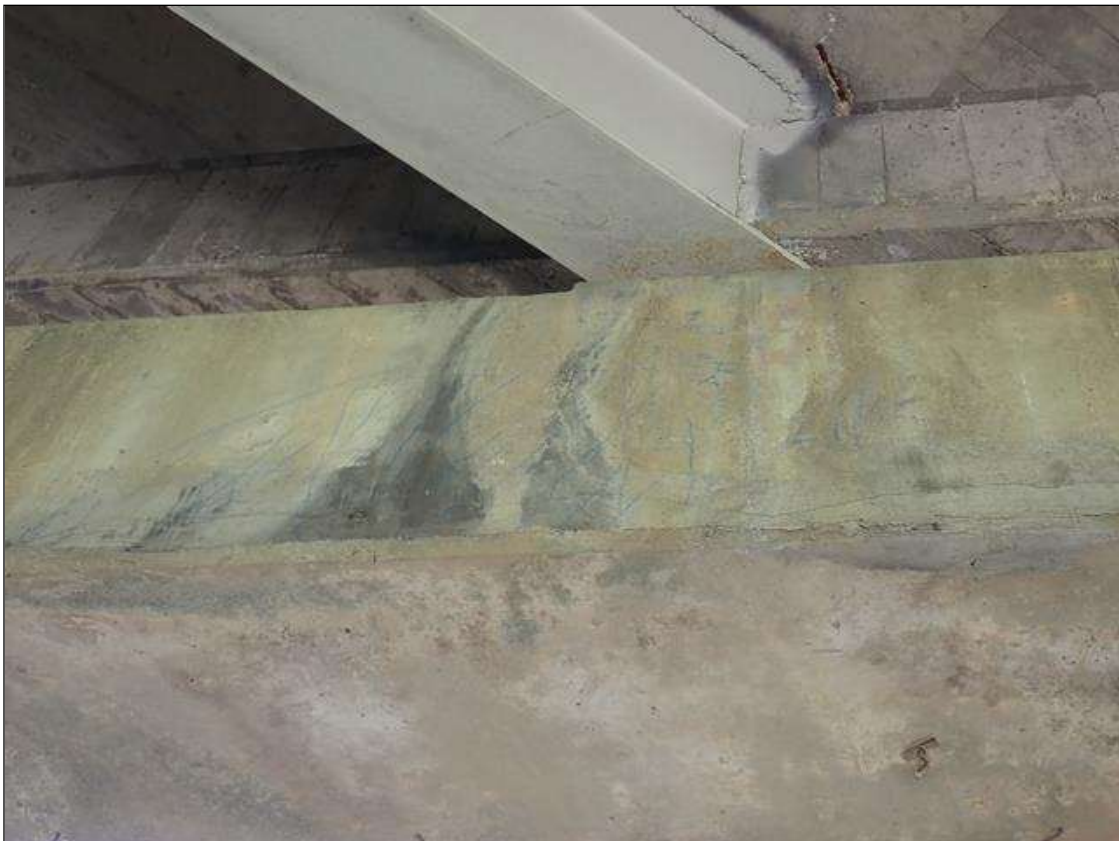
Bent 2 Cap 1: south and north faces of cap, multiple delaminations/spalls (up to 8 feet x 2 feet x 1.5 inch deep), some with exposed rusted rebar and associated cracks (up to 1/8 inch wide)

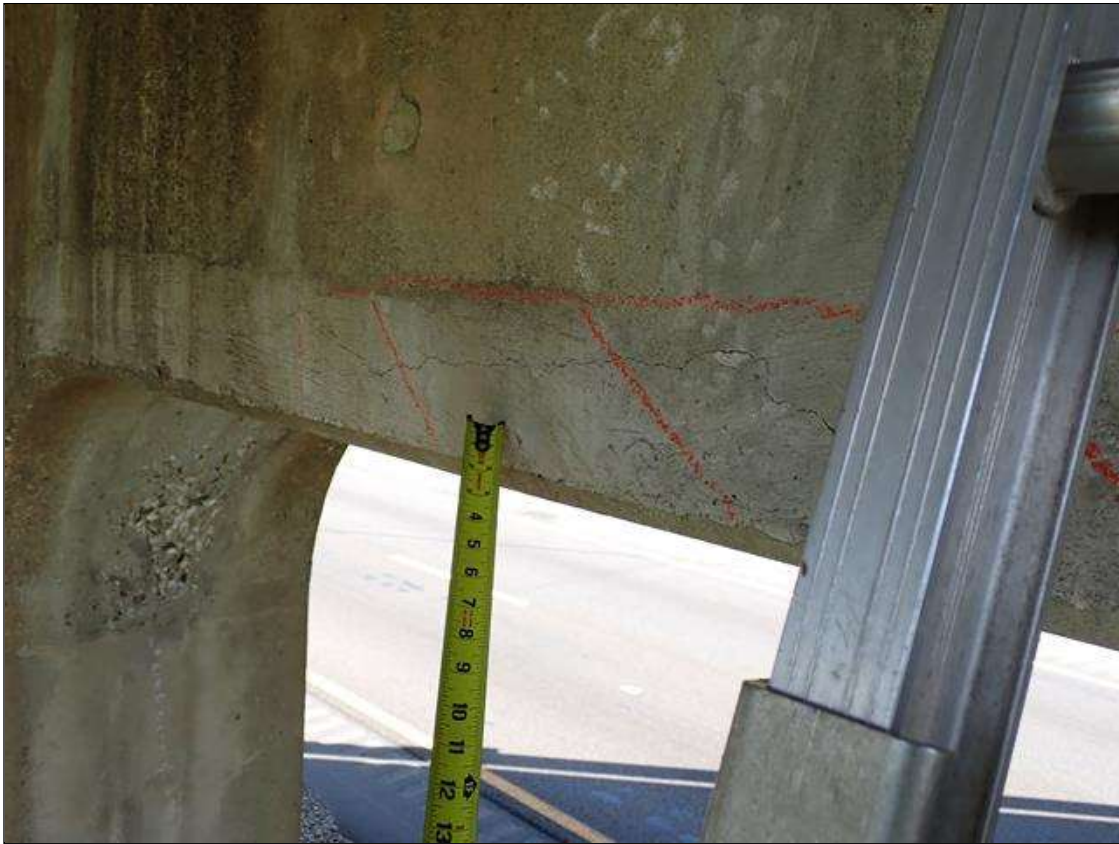
Bent 2 Cap 1: south and north faces of cap, multiple delaminations/spalls (up to 8 feet x 2 feet x 1.5 inch deep), some with exposed rusted rebar and associated cracks (up to 1/8 inch wide)

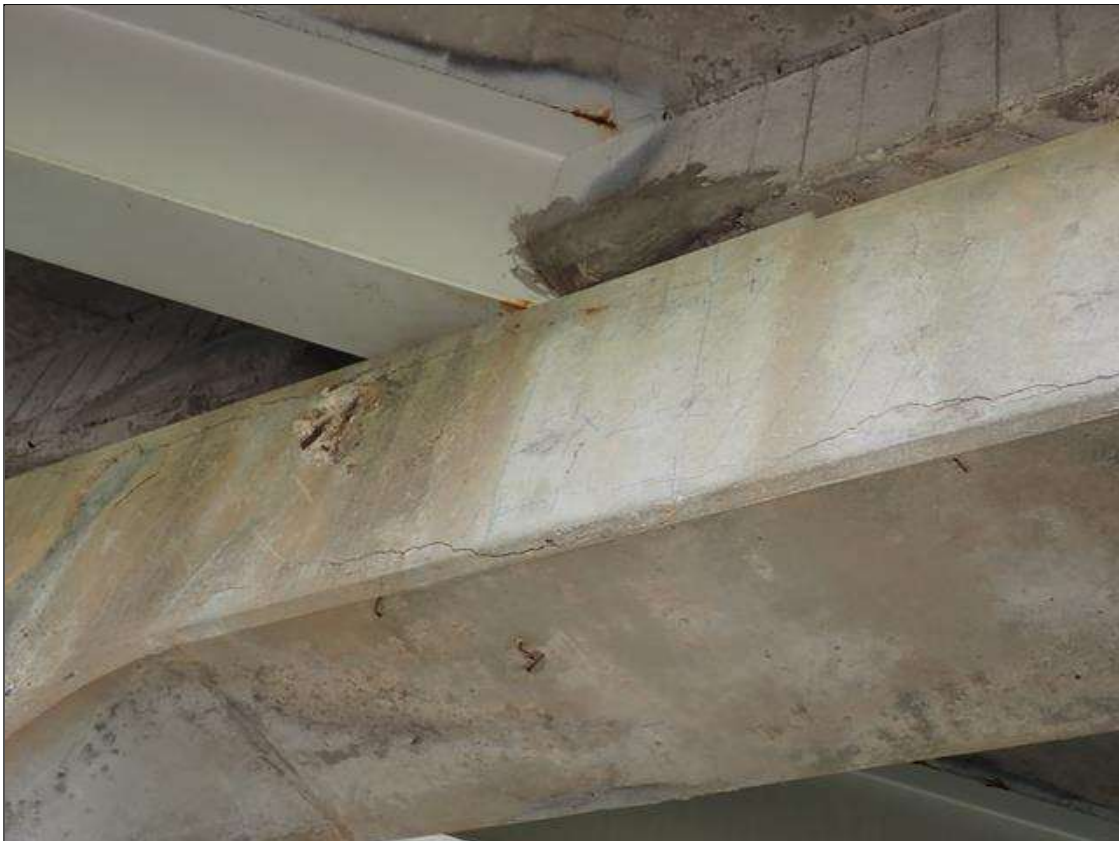
Bent 2 Cap 1: south and north faces of cap, multiple delaminations/spalls (up to 8 feet x 2 feet x 1.5 inch deep), some with exposed rusted rebar and associated cracks (up to 1/8 inch wide)

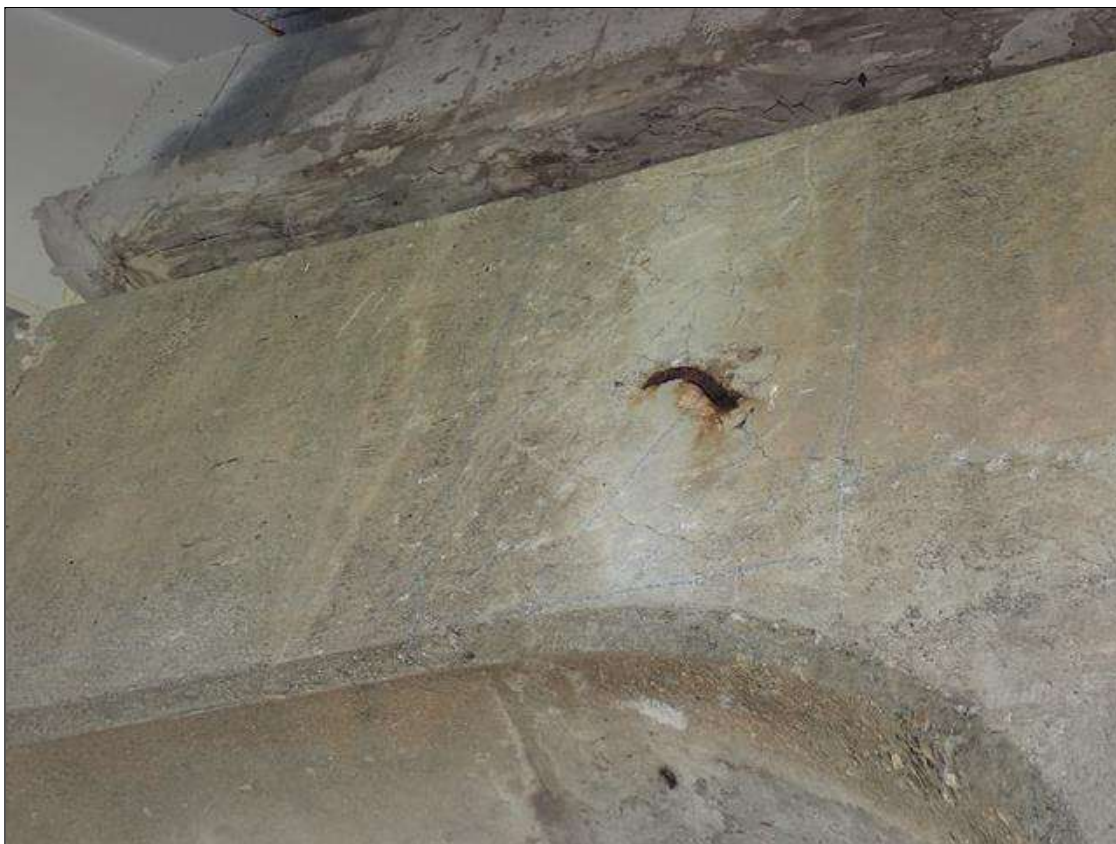
Bent 2 Cap 1: south and north faces of cap, multiple delaminations/spalls (up to 8 feet x 2 feet x 1.5 inch deep), some with exposed rusted rebar and associated cracks (up to 1/8 inch wide)

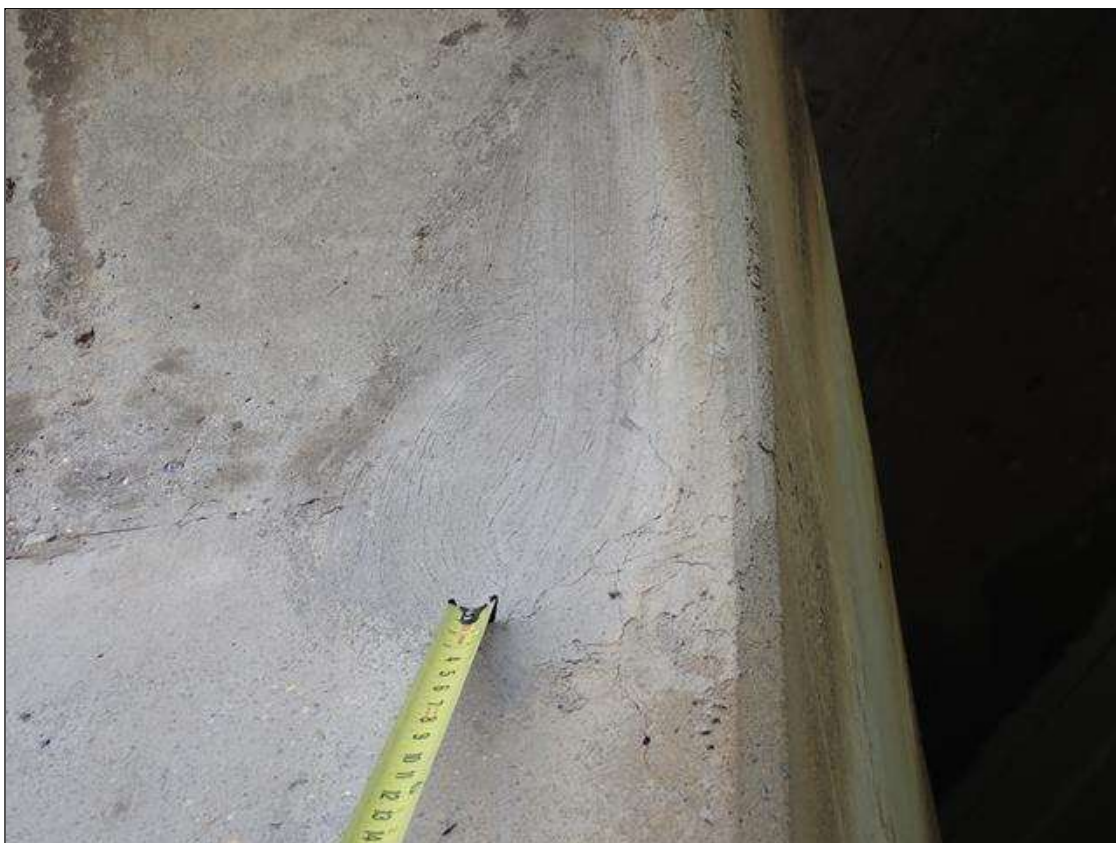
Bent 2 Pile 1: West face below cap, sound patch [8 inch x 2 feet] with cracks [up to 1/32 inch]

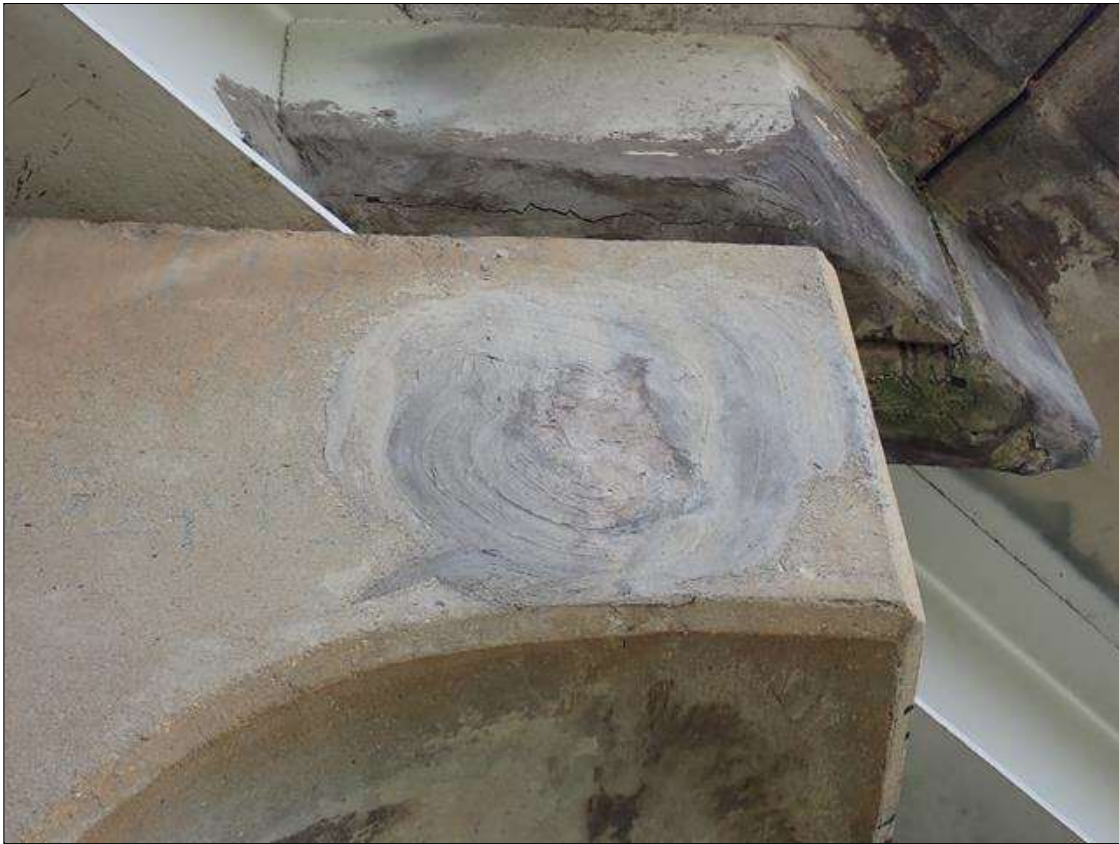
Bent 2 Cap 1: BENT 2 NORTH FACE OF CAP HAS AN UNSOUND PATCHED AREA (2 FEET X 15 INCH) WEST SIDE OF BEAM 1.

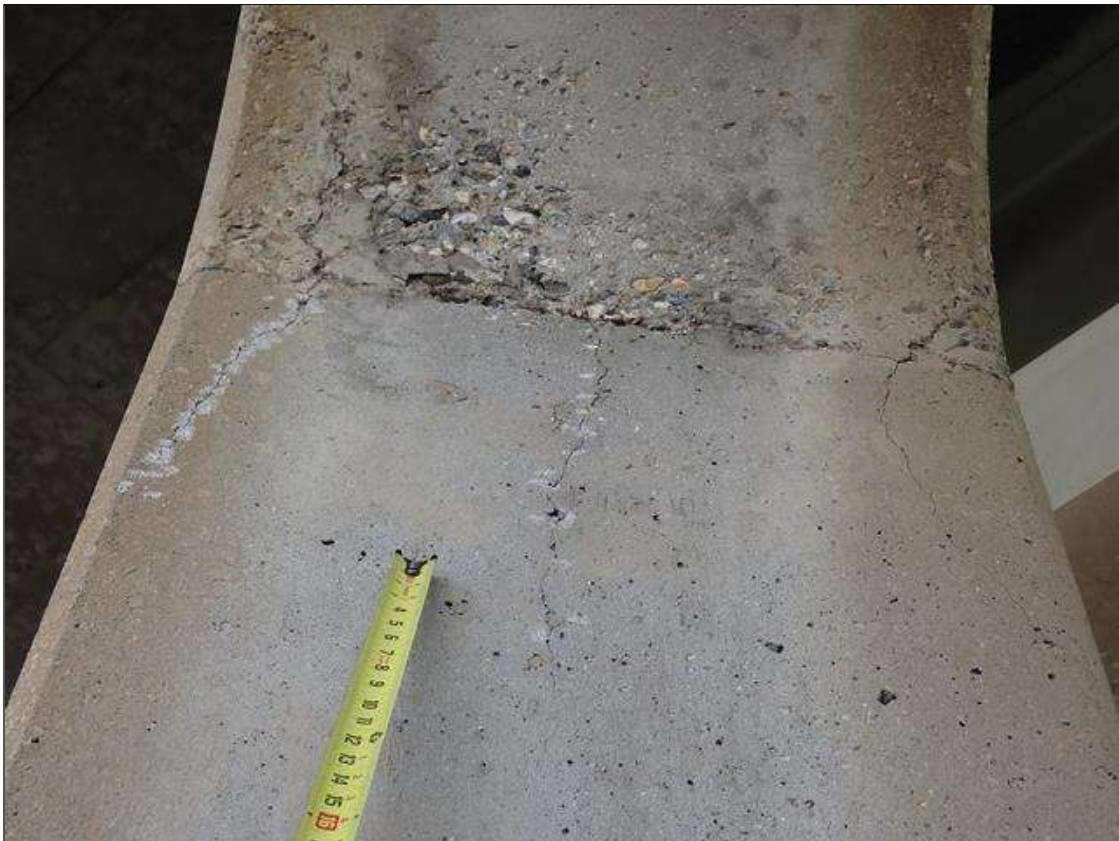
Bent 2 Pile 2: West and East faces, delamination [up to 14 inch x 11 inch] with associated map cracking up to 1/32 inch with efflorescence
