NC DEPARTMENT OF TRANSPORTATION
 DIVISION OF HIGHWAYS
 STRUCTURE MANAGEMENT UNIT

ATTENTION: **prompt action request, sketches revised, clearances revised, newly structurally deficient**

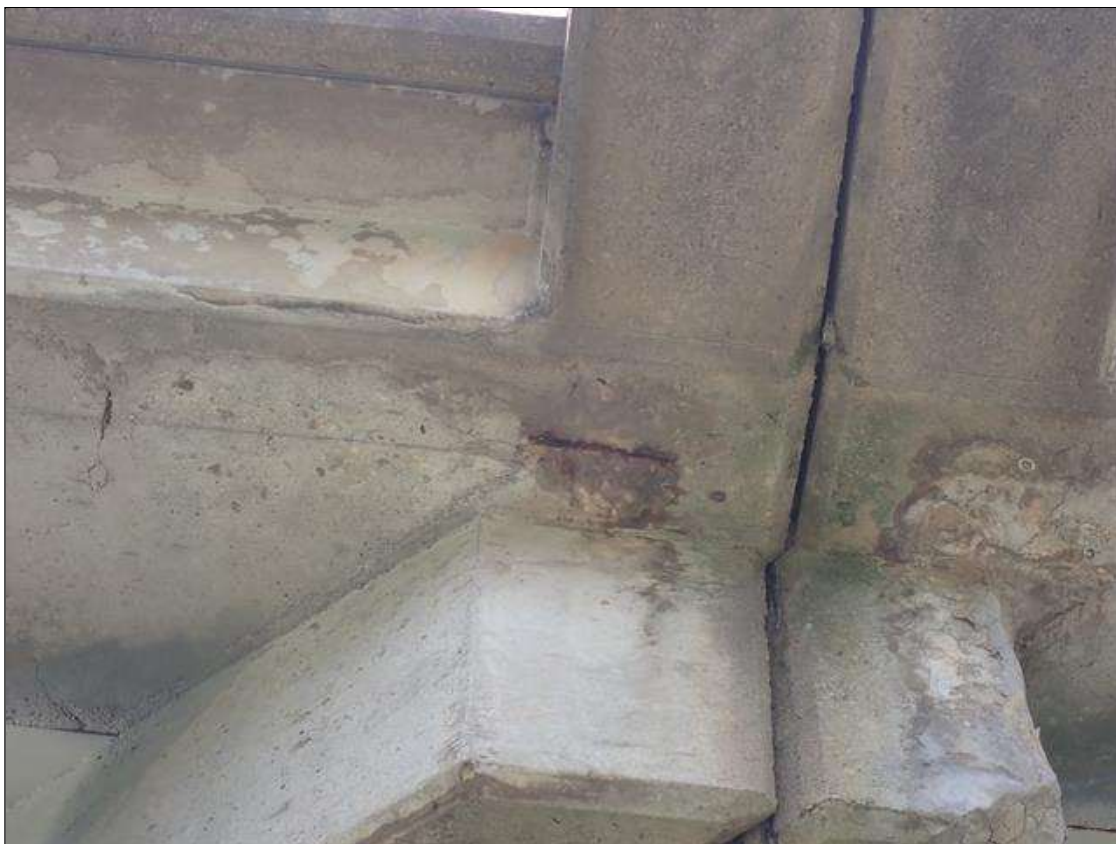
Span 2 Deck: (PAR) on right overhang at bent 2, spall [7 inch x 1 inch x 1/2 inch deep] with exposed rusted reinforcing

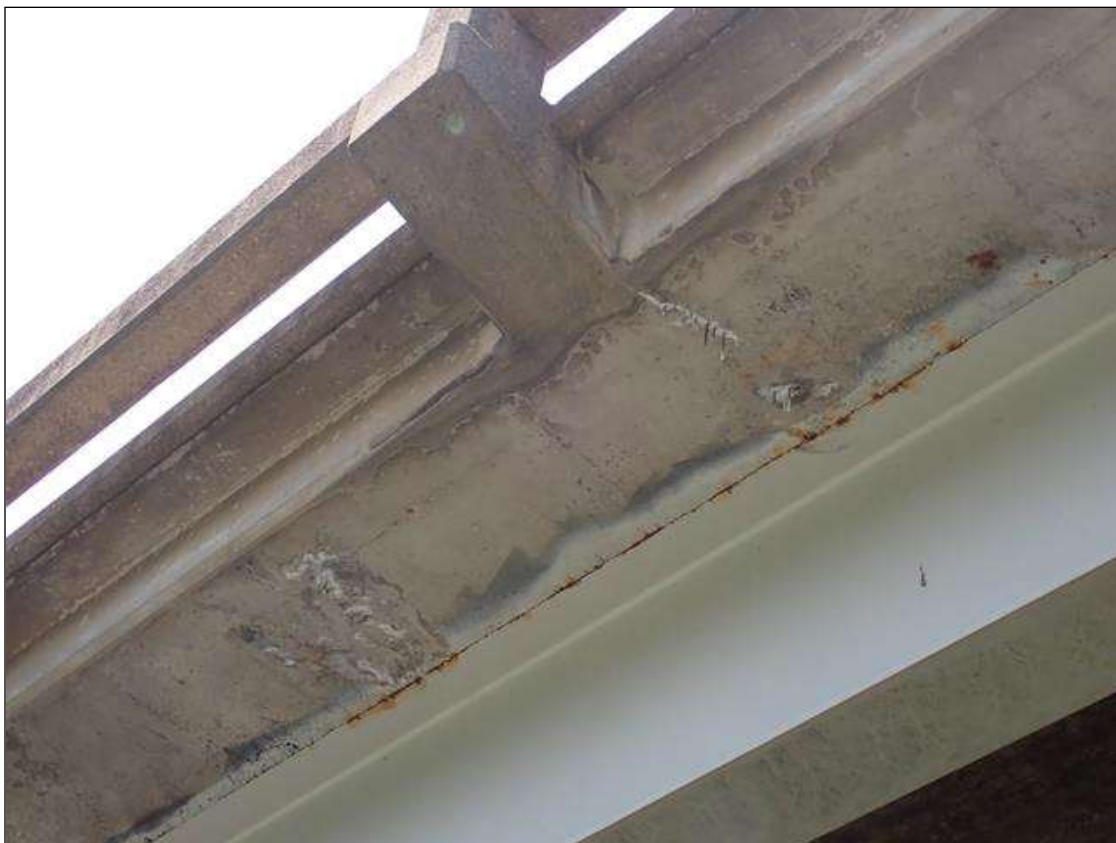
Span 2 Deck: (PAR) underside of right overhang near bent 2, multiple transverse cracks [up to 1/64 inch] with some efflorescence buildup

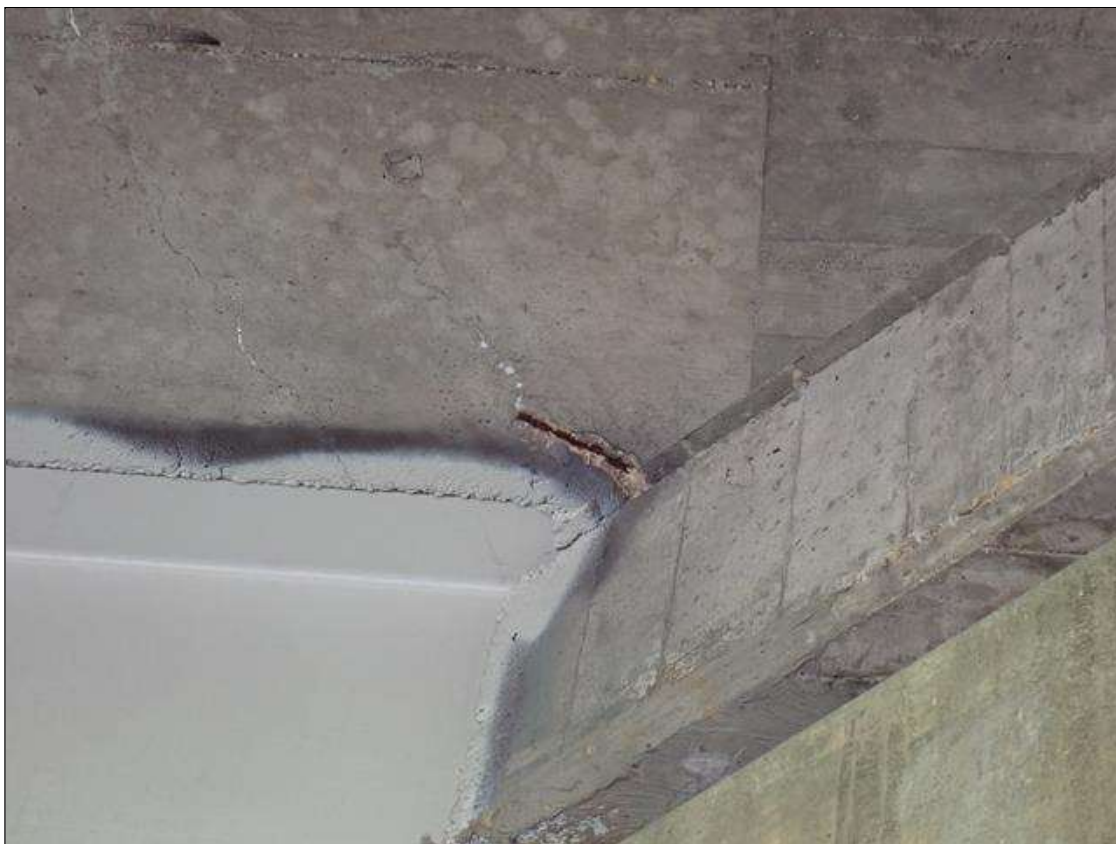
Span 2 Deck: (PAR) underside of bay 2, at bent 2, shallow rusted rebar

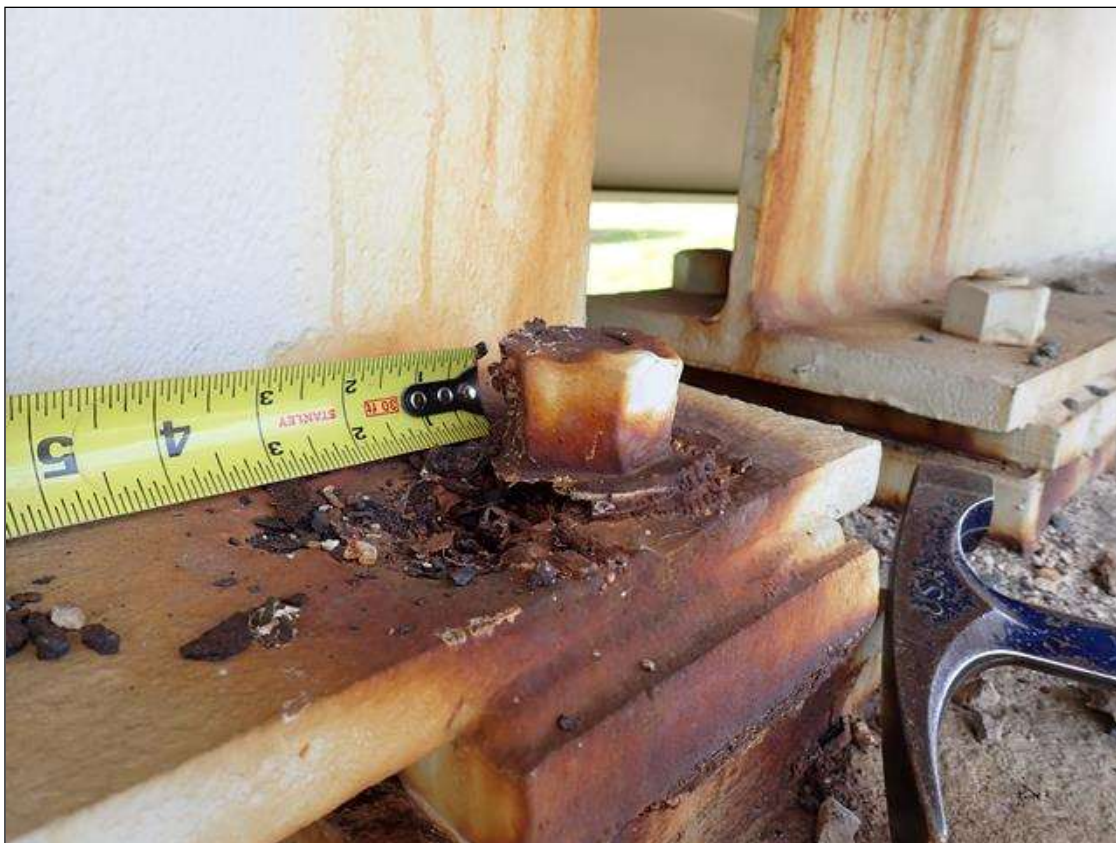
Span 2 Beam 4 - Far Bearing 4: right anchor bolt nut, painted over section loss up to 10 percent with corrosion reinitiated

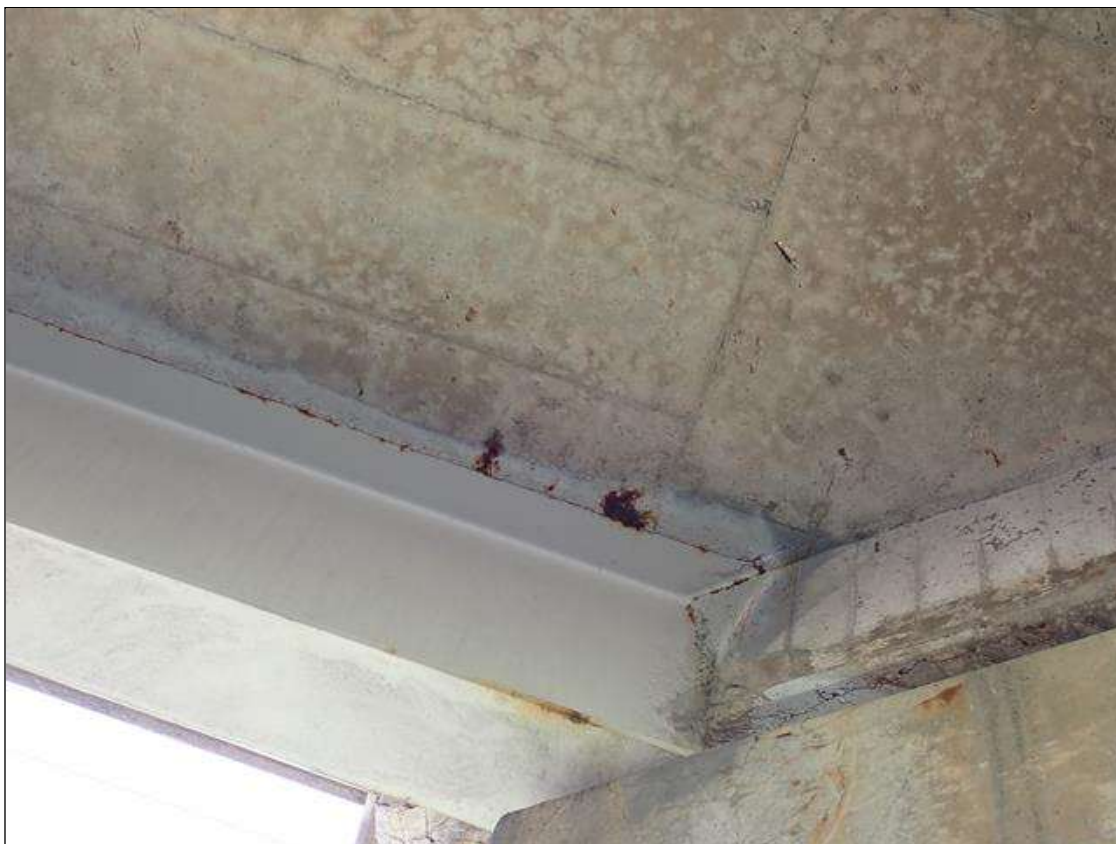
Span 3 Deck: (PAR) underside of bays 1 and 3, adjacent to beams, areas of rust stains at random

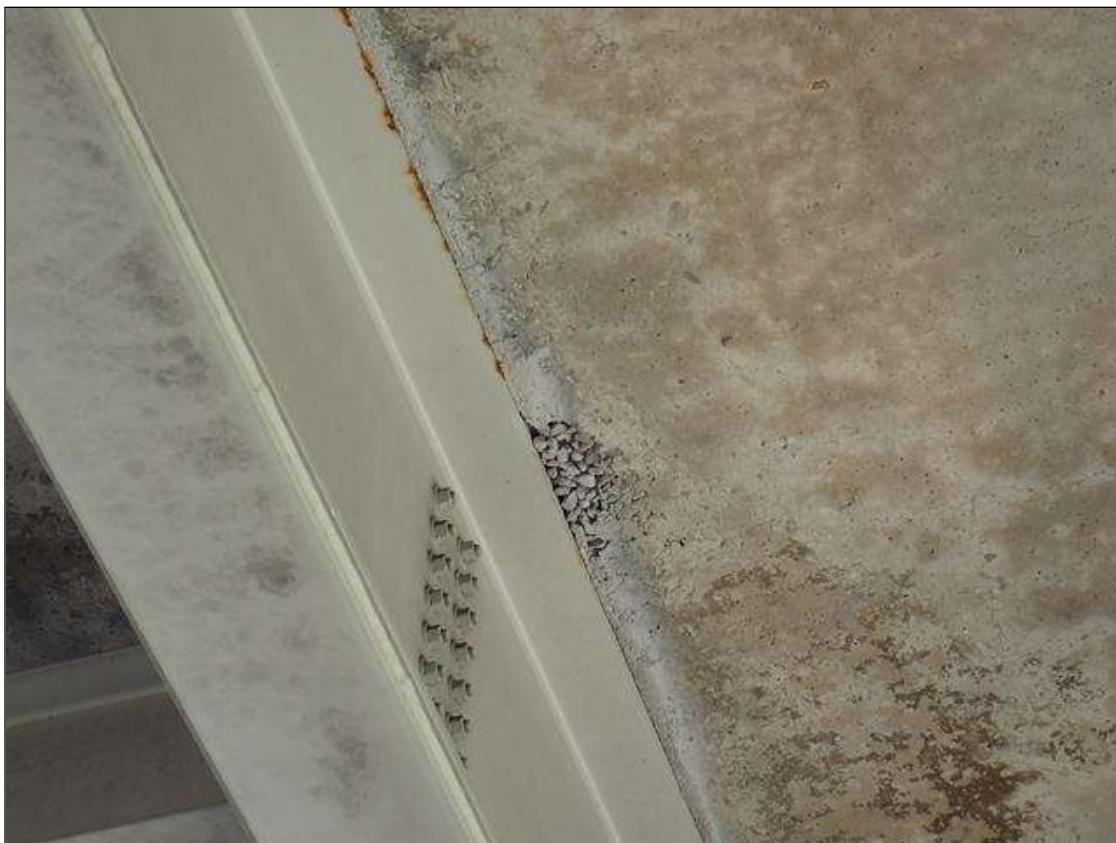
Span 3 Deck: underside of bays 2 and 3, near half of span, areas of poor consolidation (up to 3.5 feet x 15 inch x 1 inch deep)

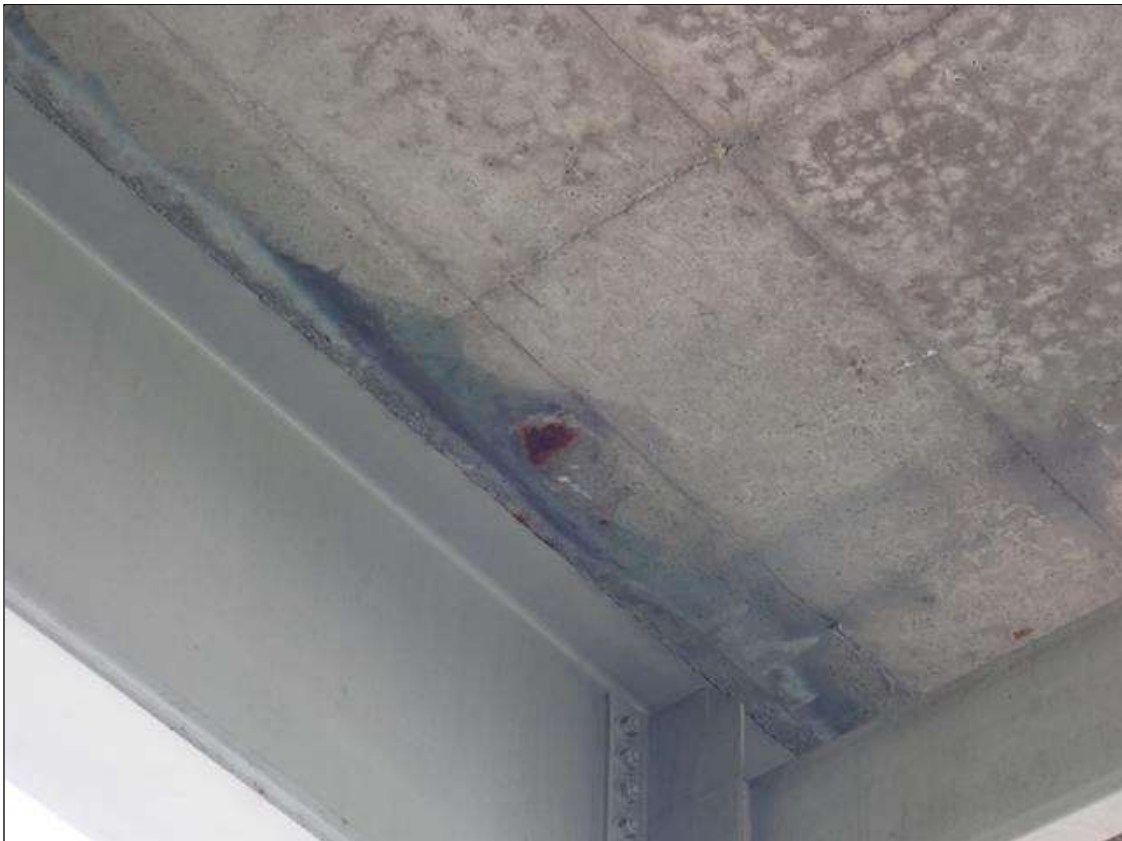
Span 2 Deck: (PAR) bays 2 and 3, adjacent to beams, areas of rust stains at random

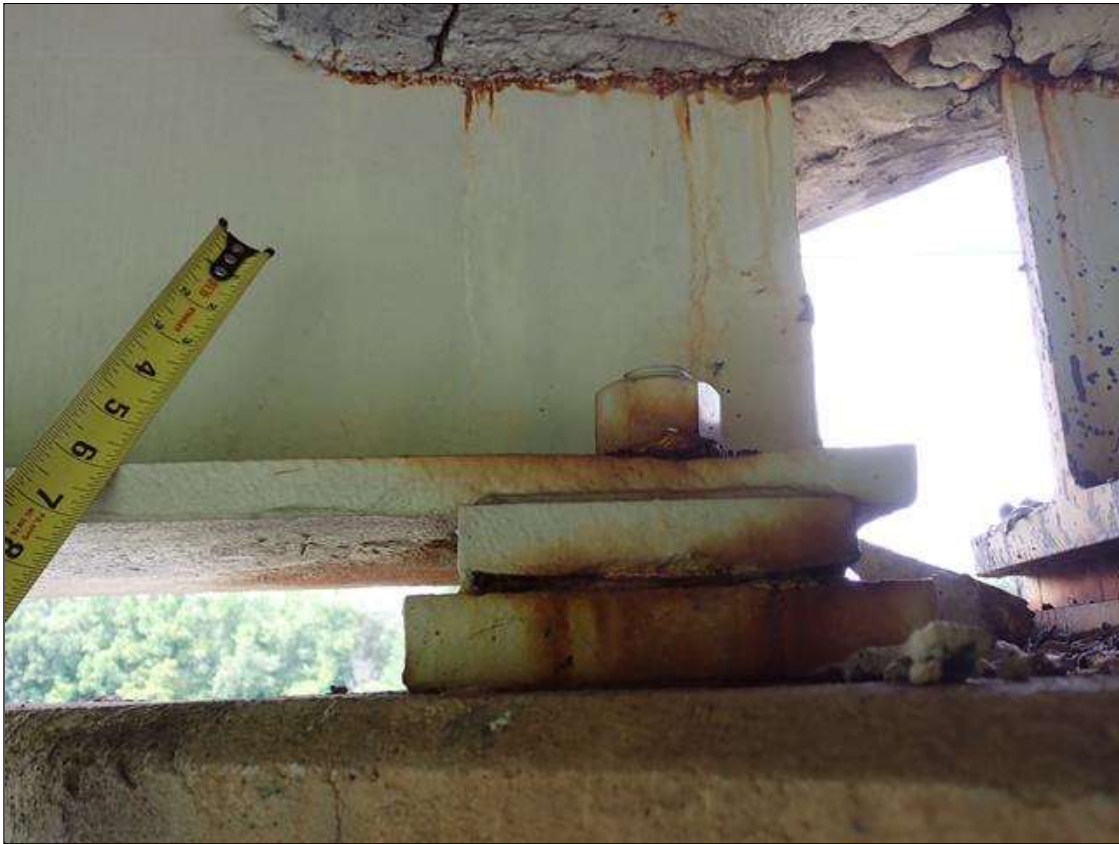
Span 2 Beam 1: (PAR) at bent 2, web adjacent to diaphragm, painted over section loss (3/8 inch average remaining x 6 inch x 1 inch); underside of bottom flange, painted over pitting (up to 1/8 inch deep x 6 inches) with corrosion reinitiated

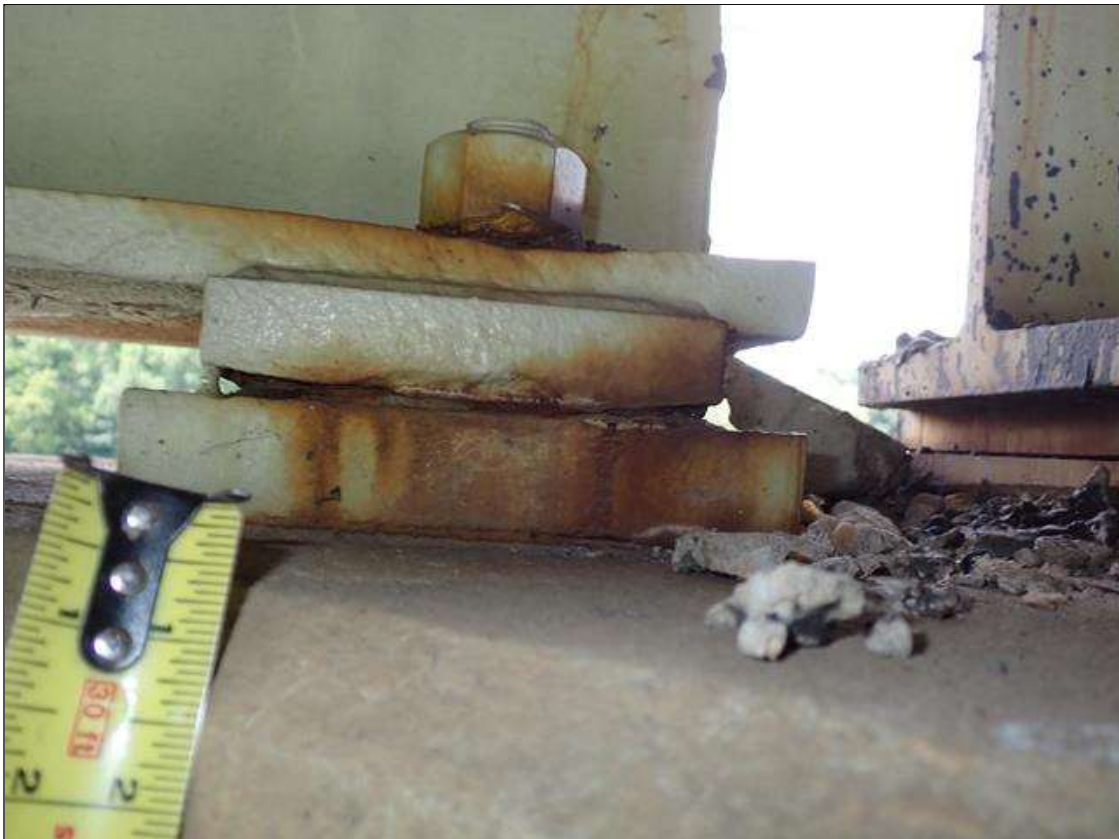
Span 2 Beam 1 - Far Bearing 1: FRECKLED RUST/PACK RUST ON ON THE BEARING PLATES.

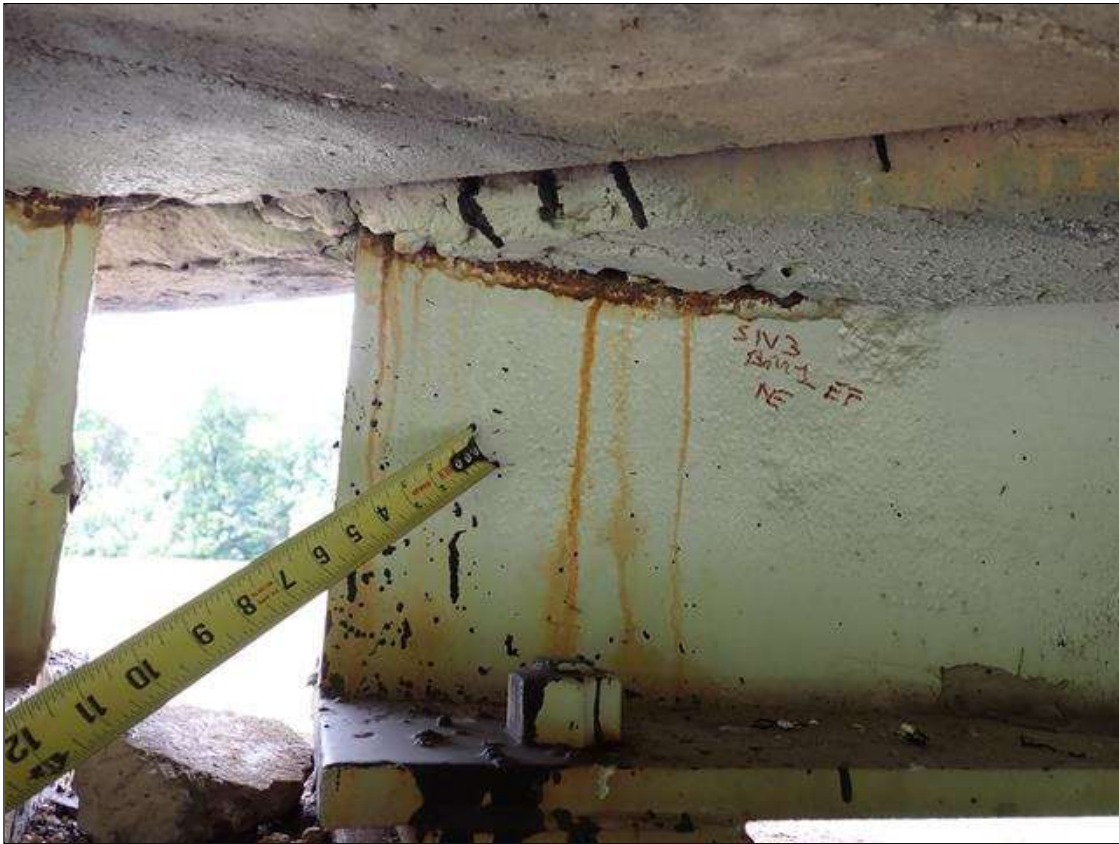
Span 3 Beam 1: (PAR) at bent 2, web adjacent to diaphragm, painted over section loss (5/16 inch average remaining x 14 inch x 4 inch); lower web, painted over pitting (up to 1/8 inch deep x 17 inch x 6 inch) with corrosion reinitiated

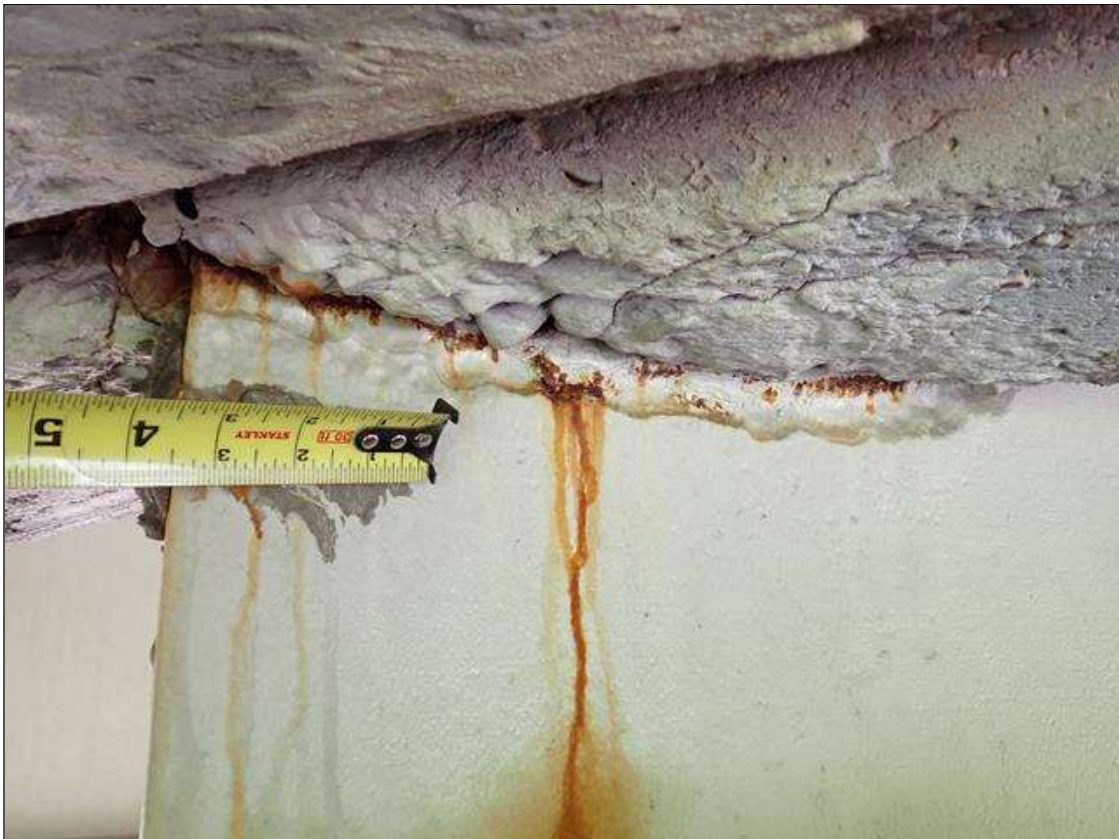
Span 3 Beam 2: (PAR) at bent 2, web adjacent to diaphragm, painted over section loss (1/4 inch average remaining x 15 inch x 2 inch) with corrosion reinitiated

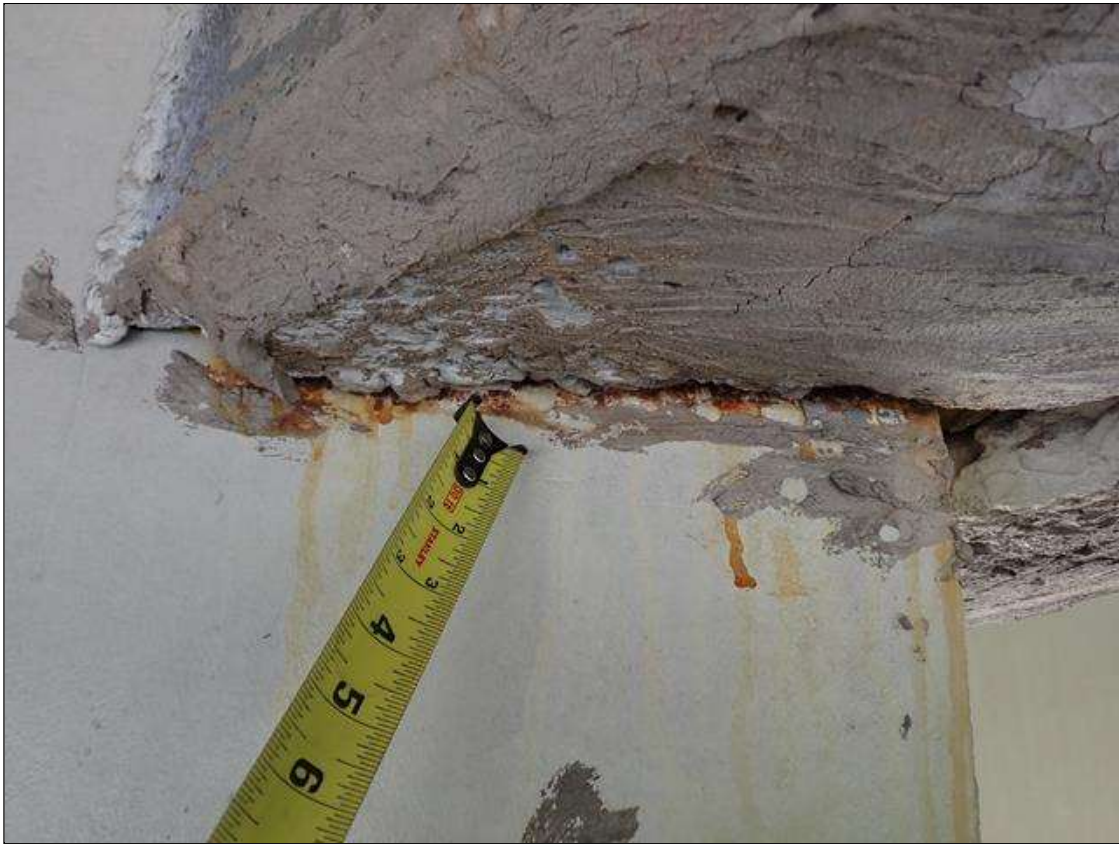
Span 2 Beam 2: (PAR) at bent 2, web adjacent to diaphragm, painted over section loss (5/16 inch average remaining x 9 inch x 1 inch) with corrosion reinitiated

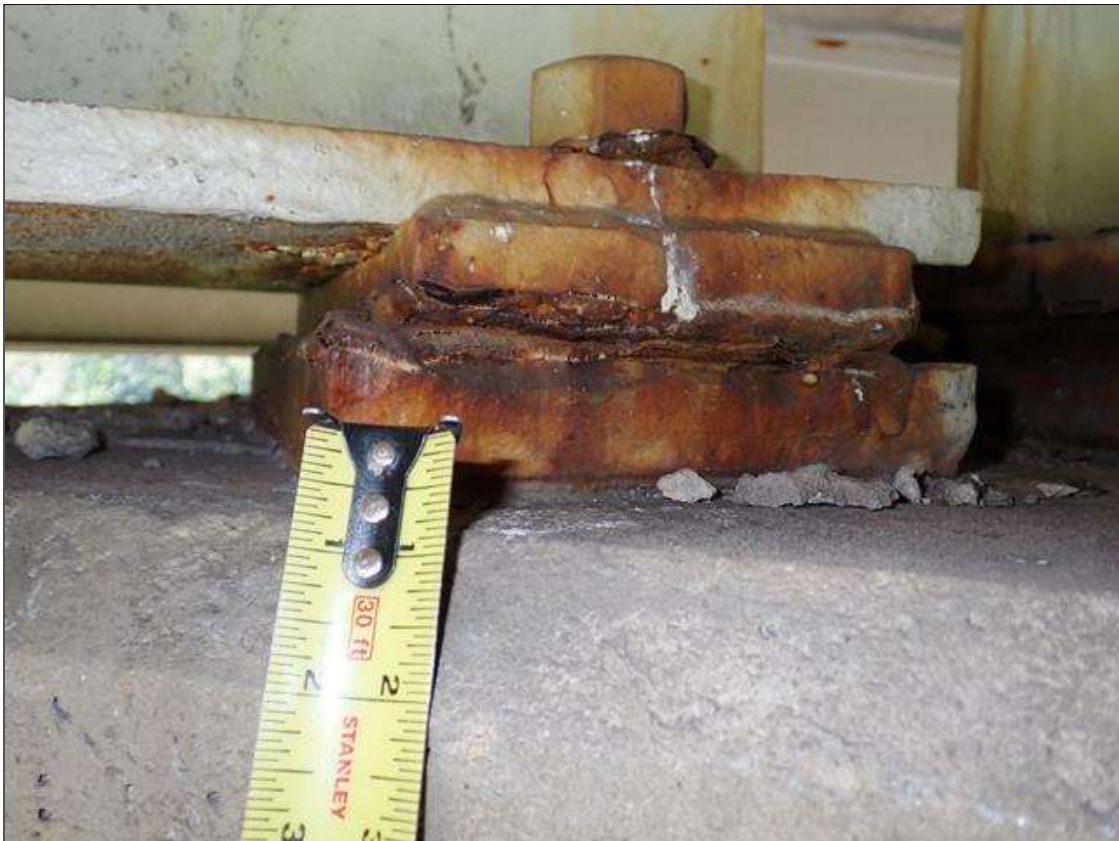
Span 2 Beam 2 - Far Bearing 2: painted over section loss (up to 1/8 inch deep) with corrosion reinitiated; pack rust

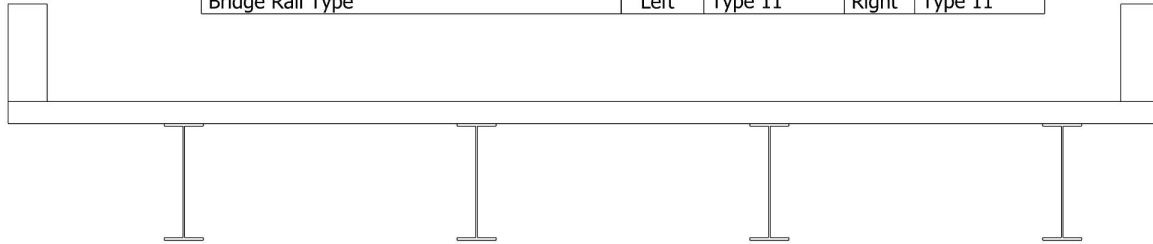
Measurements for Span #	1-4		
Deck Thickness	6.75in	Left Overhang	4.5ft
Top of Rail to Bottom of Beam (Avg)	6.052ft	Right Overhang	4.5ft
