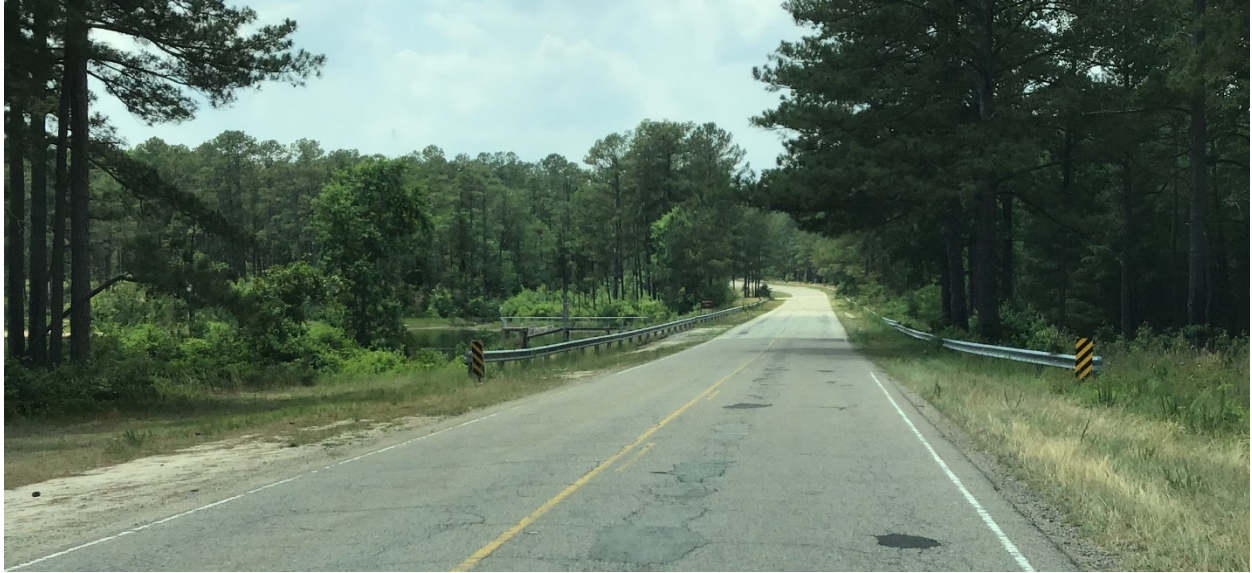
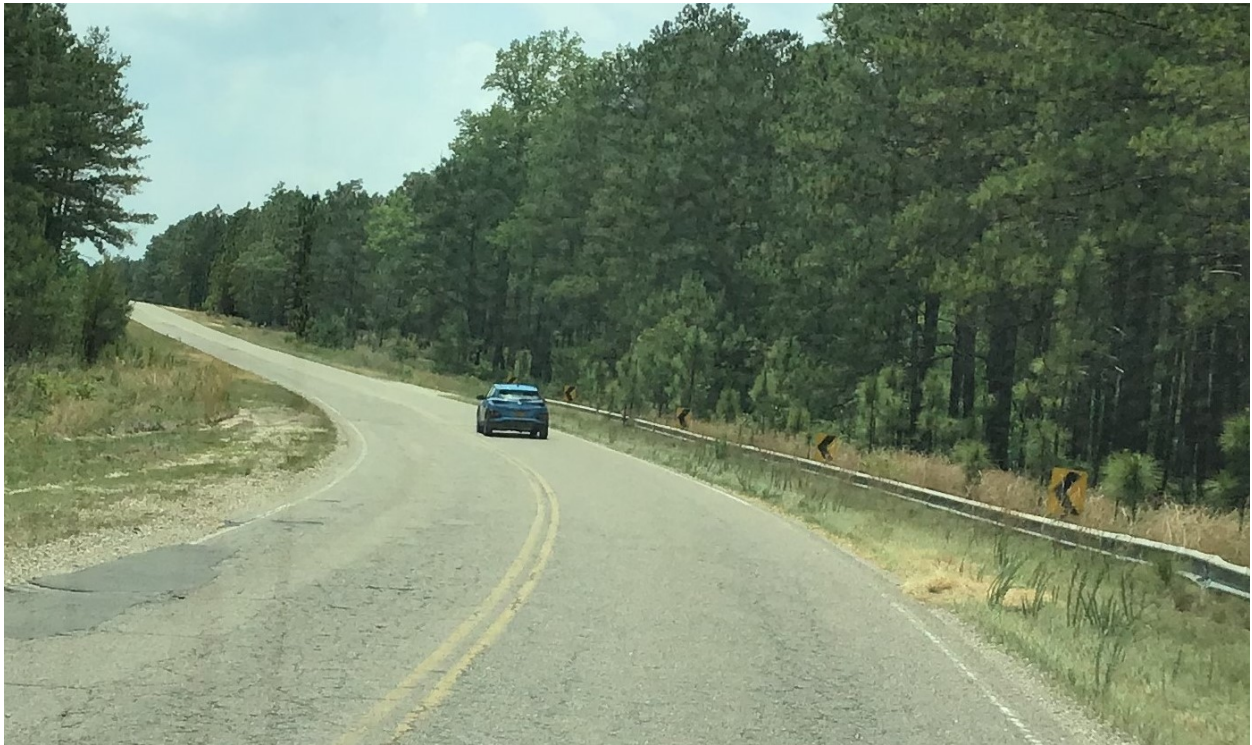
Guardrail proposed to be upgraded to current standard. Note terminal ends, and lack of blocks, and substandard height.
