COLINGTON CREEK AND CUT INSPECTION REPORT

MITIGATION SITE NAME Colington Creek and Cut		TIP# B-2024		WBS # N/A		INSPECTION DATE 9/16/2015	
COUNTY # Dare		# ACRE 0.08	# ACRES 0.08		ONEID 028-015		
MONITORING ORGANIZATION INSPEC Kimley-Horn JRH/I							
INSPECTION ACTIVITIES: Complete all that apply.							
Walked boundaries YES NO N/A			Walked trails / roads				
Walked road frontage			Walked interior				
Monitored from air YES NO N/A							
Condition of boundaries Sood Fair Poor Condition Condition							
COMMENTS: Site boundary remains in good condition. No trespass or disturbance was observed at the time of inspection. Phragmites is dominating the site. The "Control Plot" sign observed during the 2014 site visit was not observed due to dense vegetation. Some trash was observed in the site.							
WHICH NATURAL ACTIVITIES / CHANGES HAVE TAKEN PLACE SINCE LAST MONITORING INSPECTION? Check all that apply. Note location and extent. Wherever possible, note species of concern. Document with photos.

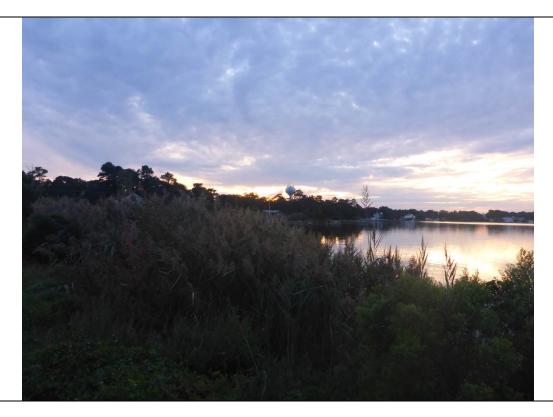
Photo 1 – View of site as seen from between the two mitigation areas facing west.

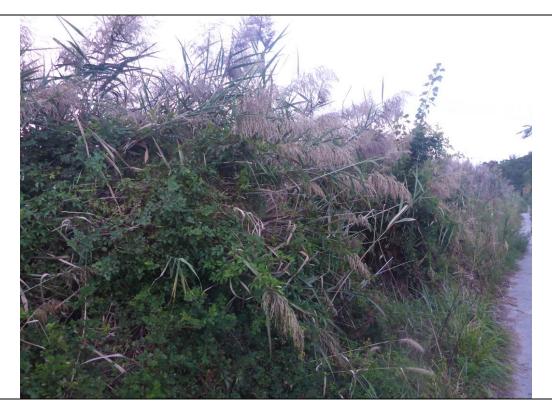
Photo 2 – View of site looking east from the adjacent footpath.
