WHALEBONE JUNCTION INSPECTION REPORT

MITIGATION SITE NAME Whalebone Junction	TIP # B-2301 & R-2304	WBS # N/A	INSPECTION DATE 10/27/2014
--	--------------------------	--------------	-------------------------------

Division 1 - Whalebone Junction
NCDOT Site Inspection Program
Dare County, North Carolina
November 2014

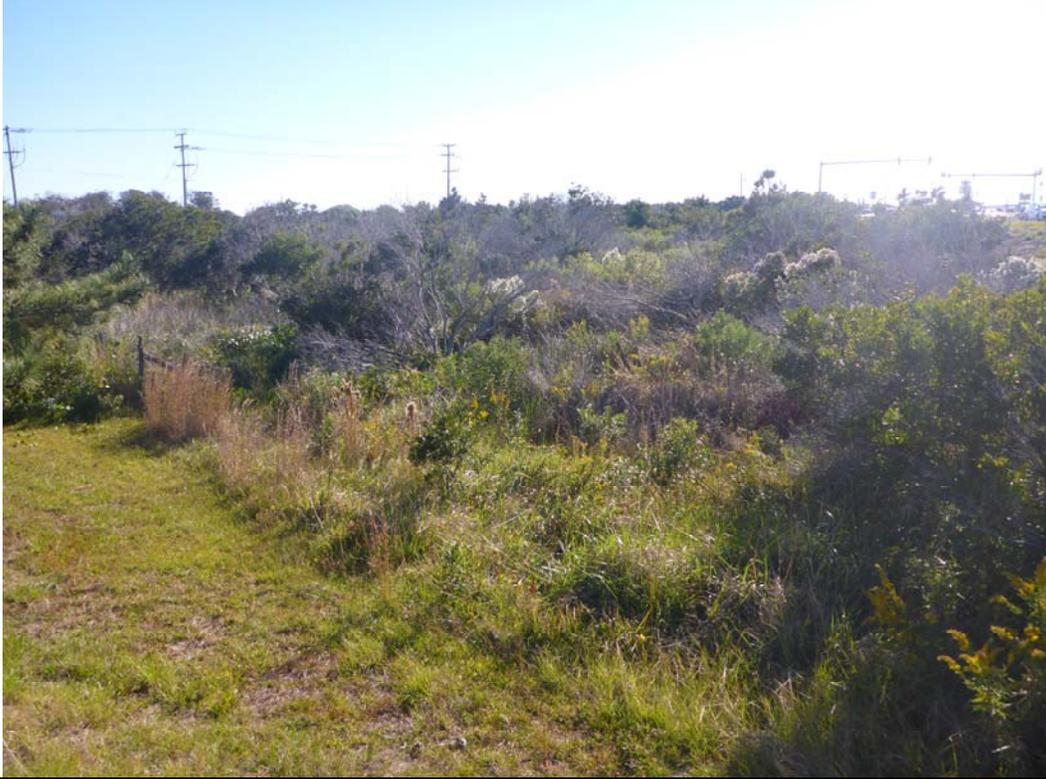
Photo 1 – View of the interior of the Site as seen from the northern boundary, facing southwest.

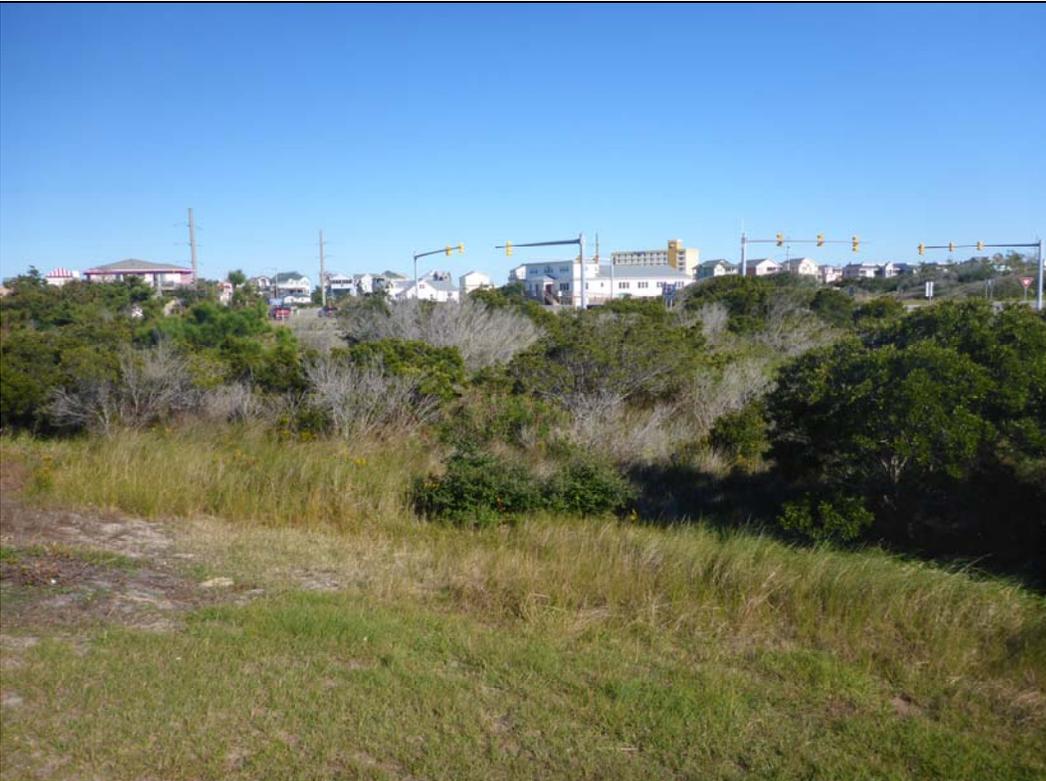
Photo 2 – View of the mitigation site as seen from US 158, facing east.

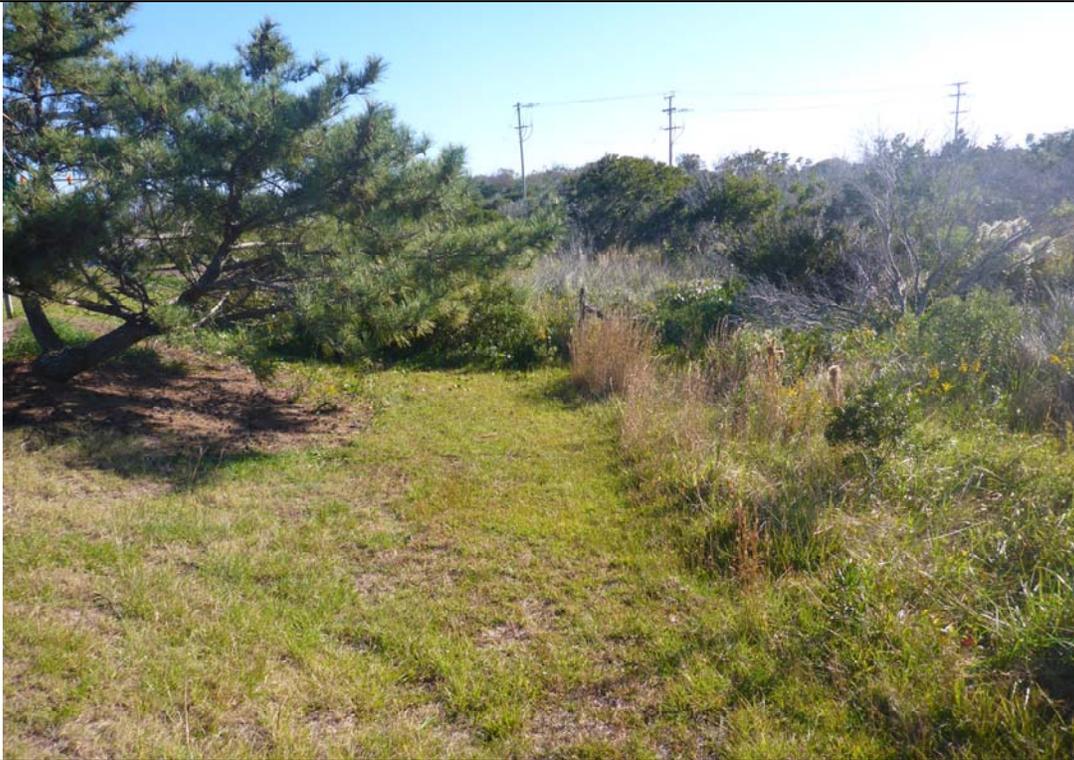
Explain: No manmade activities were observed within the site, however the boundaries are being encroached upon by mowing activities due to lack of signage (Photo 3). Interior trails were walked and confirmed as deer or other animal activity, not human trespass.

Photo 3 – Mowing is occurring within the site boundary due to lack of signage/identification, but appears to be unintentional and resulting from the landscapers attempting to avoid the pines located outside the site boundary. Photo location is along the northeastern

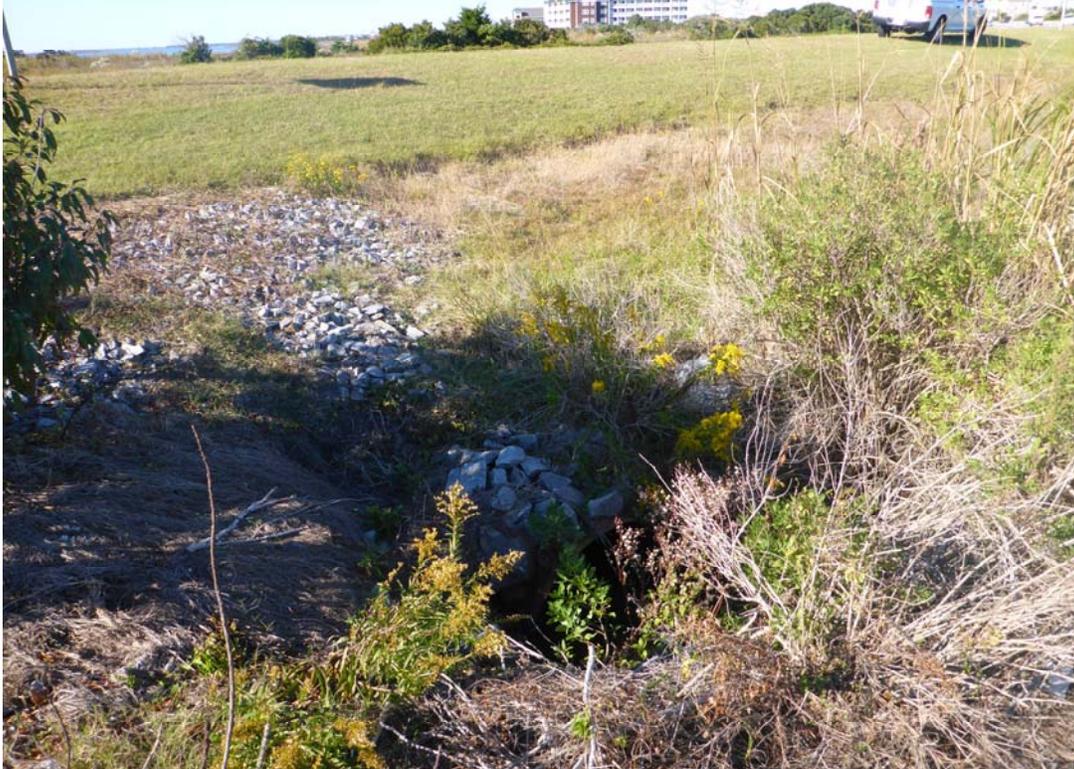
COMMENTS:
 Site continues to function properly, evidence of flow exiting the site was observed at the outlet culvert. Mowing is encroaching into the site due to lack of signage and completely unmarked boundaries.

Photo 4 – Outlet structure from the Site shows evidence of flow and indicates recent inundation within the mitigation site.
