BROCK SITE INSPECTION REPORT

MITIGATION SITE NAME Brock Site	TIP # R-2539WM	WBS #	INSPECTION DATE 8/10/2015
------------------------------------	-------------------	-------	------------------------------

COUNTY Jones	# ACRES 59.3	ONEID 052-001
-----------------	-----------------	------------------

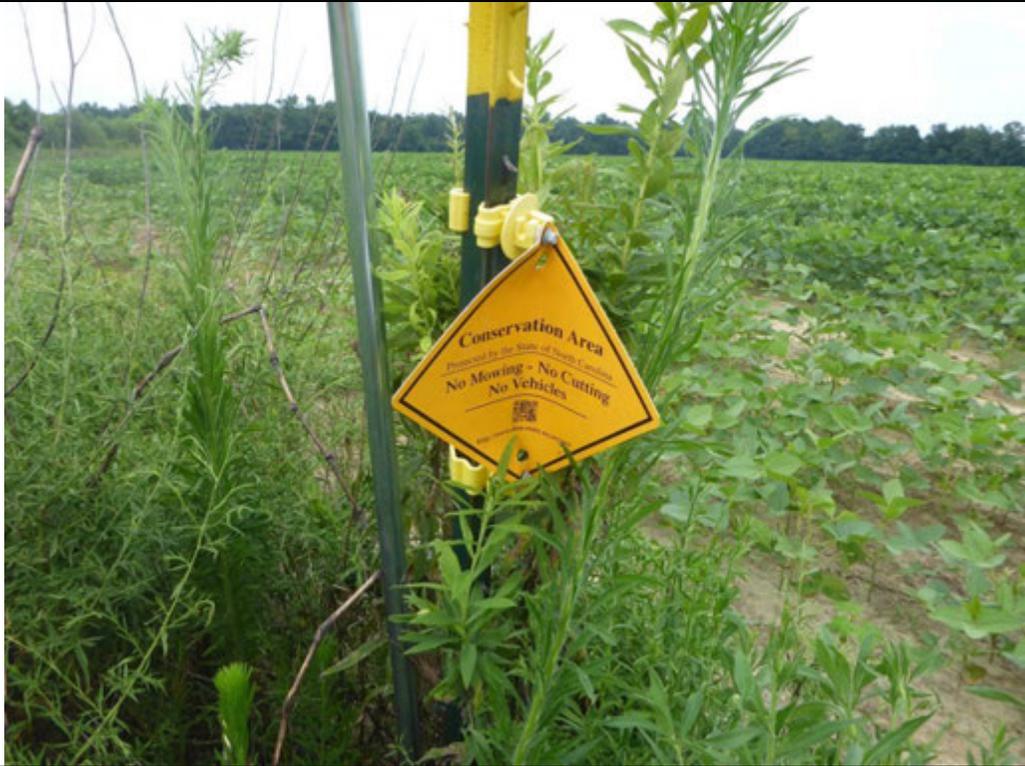
Photo 1 – One of the “Conservation Area” signs observed around the stream restoration area.

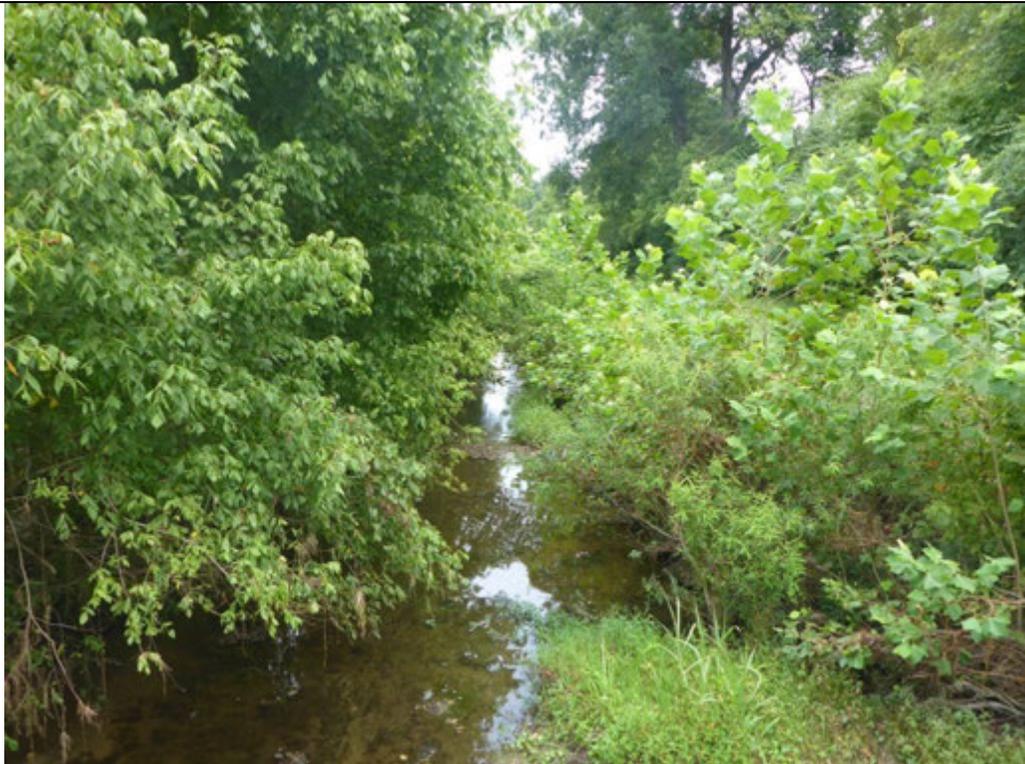
Photo 2 – View of the stream flowing through the middle of the site.

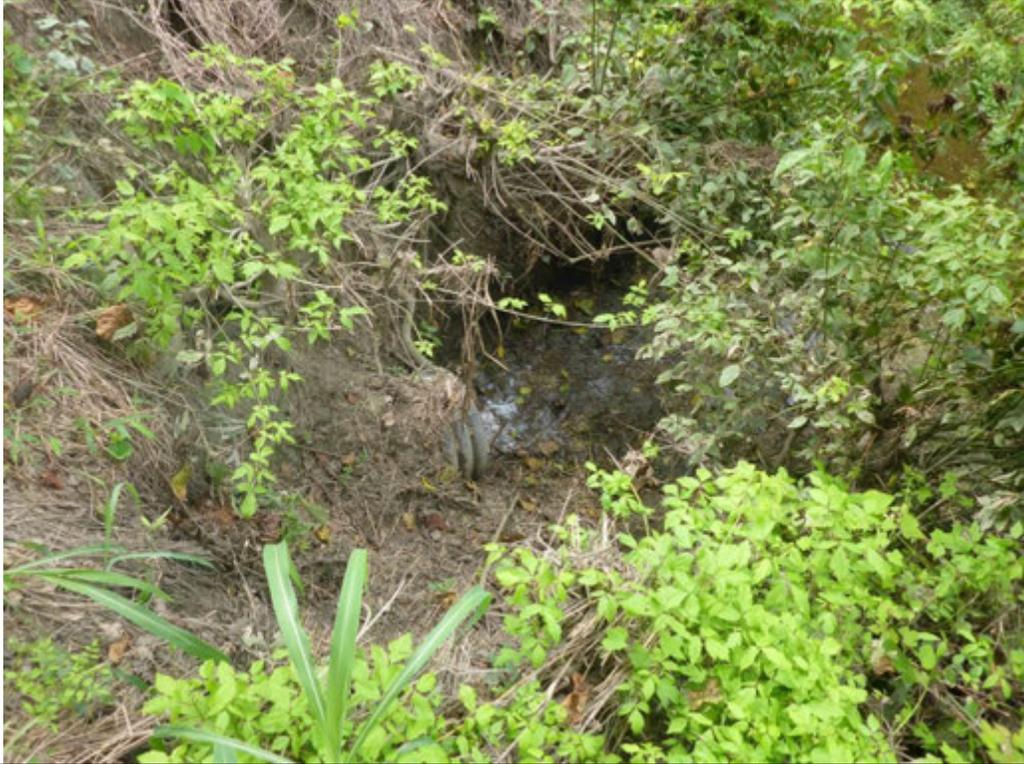
EXPLAIN: ATVs are accessing the site from the northern property boundary along an existing road adjacent to the offsite stream. ATV traffic has damaged the culvert crossing for the main outlet from the site. Recommend NCDOT place a gate with lock at this road to prevent access.

Photo 3 – View of CMP with erosion from ATV traffic.

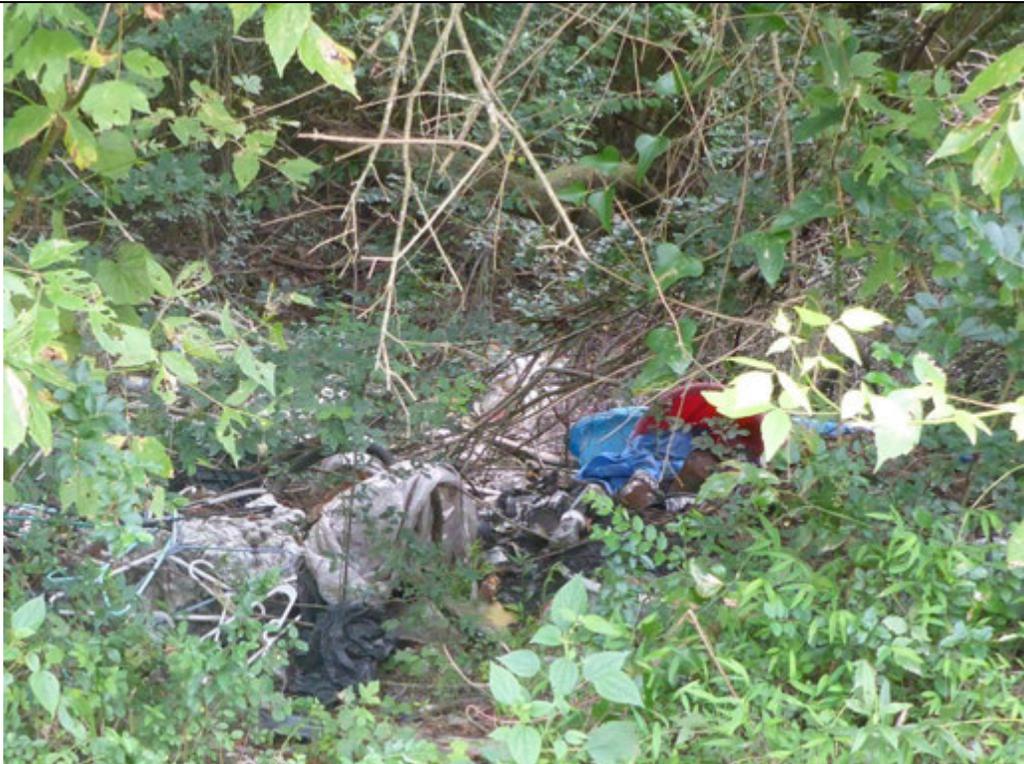
Photo 4 – Trash dumping that was observed within the site.
