DISMAL SWAMP SITE INSPECTION REPORT

MITIGATION SITE NAME Dismal Swamp	TIP # R-2204WM	WBS # N/A	INSPECTION DATE 10/28/2014
--------------------------------------	-------------------	--------------	-------------------------------

COUNTY Gates/Perquimans	# ACRES 611.6
----------------------------	------------------

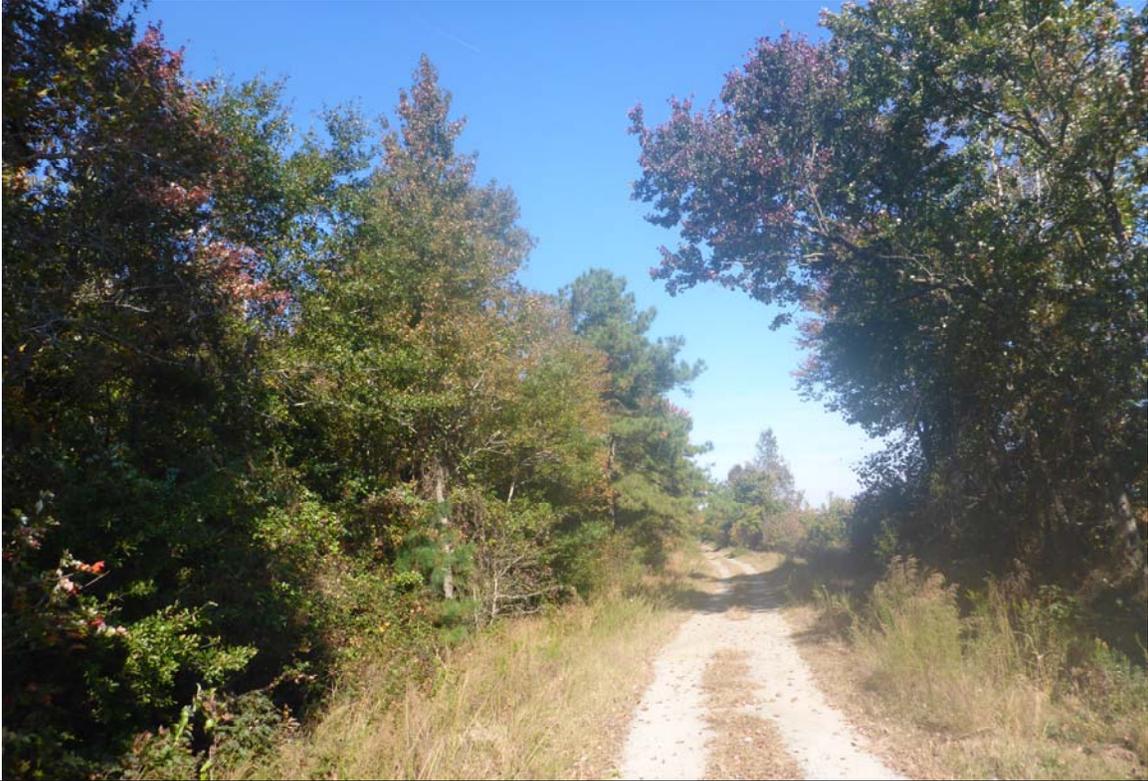
Photo 1 – Site access road along eastern border. Dismal Swamp Site is along left side of the road.

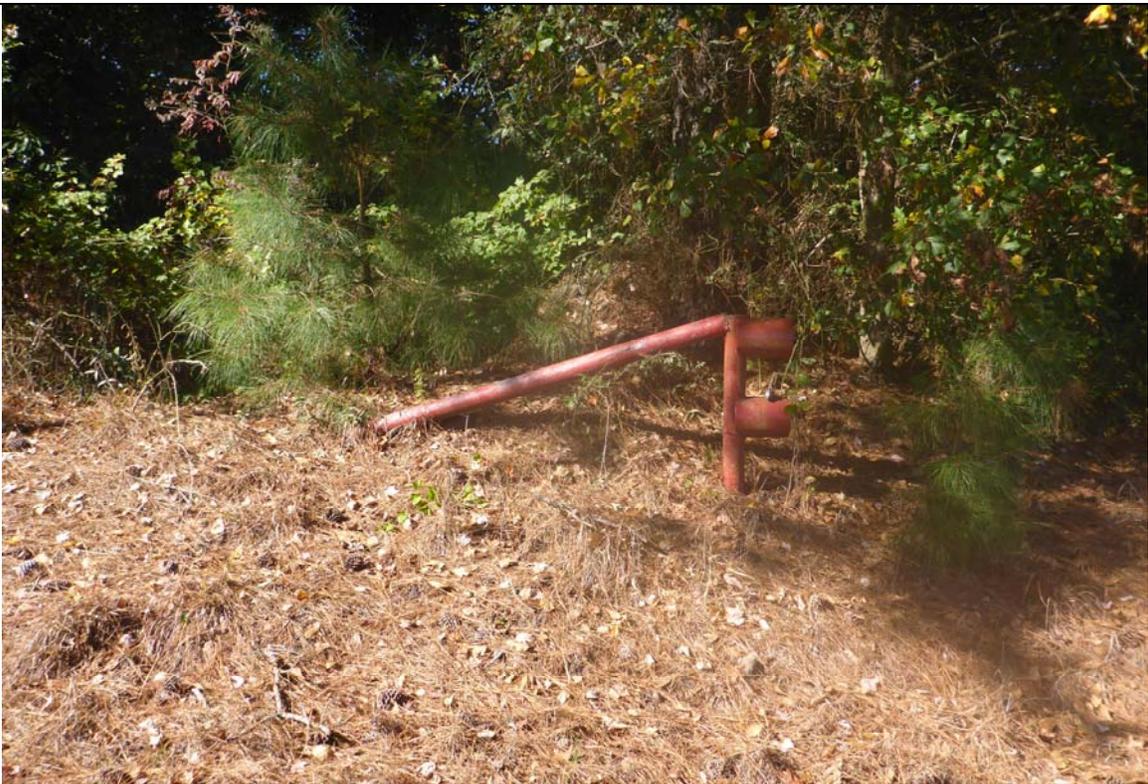
Photo 2 – Open and unsecured gate along eastern boundary of site.

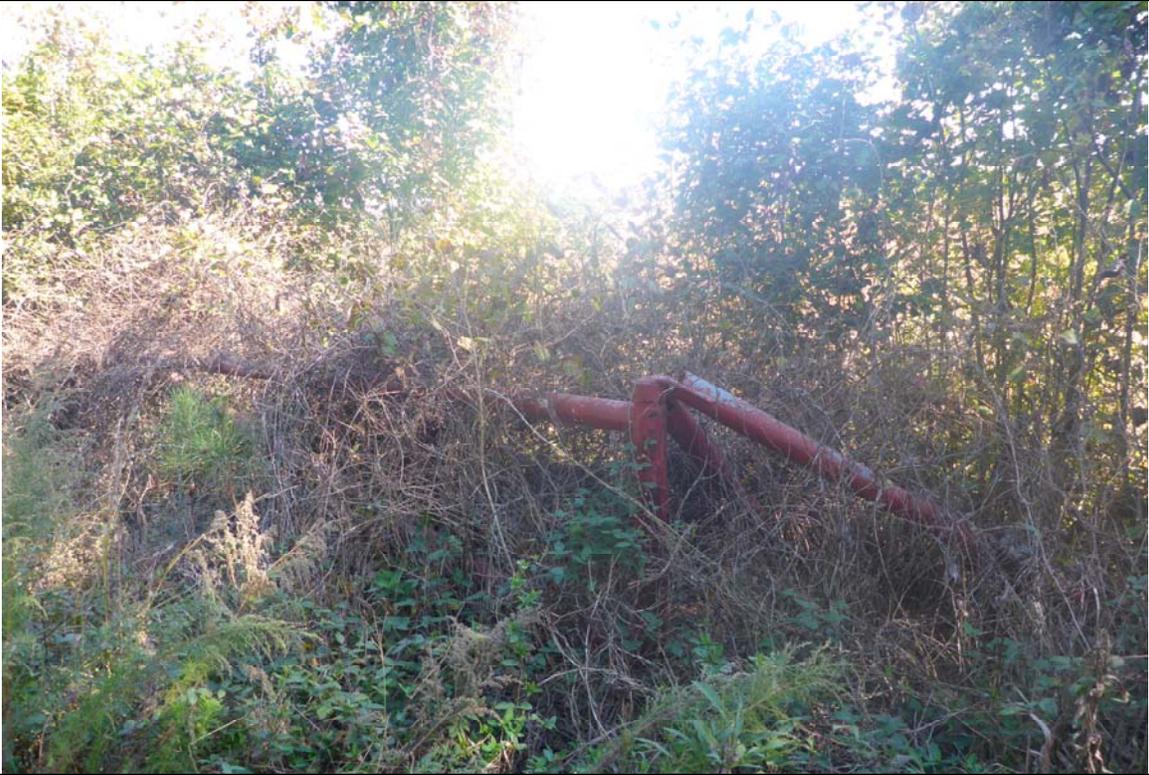
Photo 3 – Open and unsecured gate along eastern boundary of site.

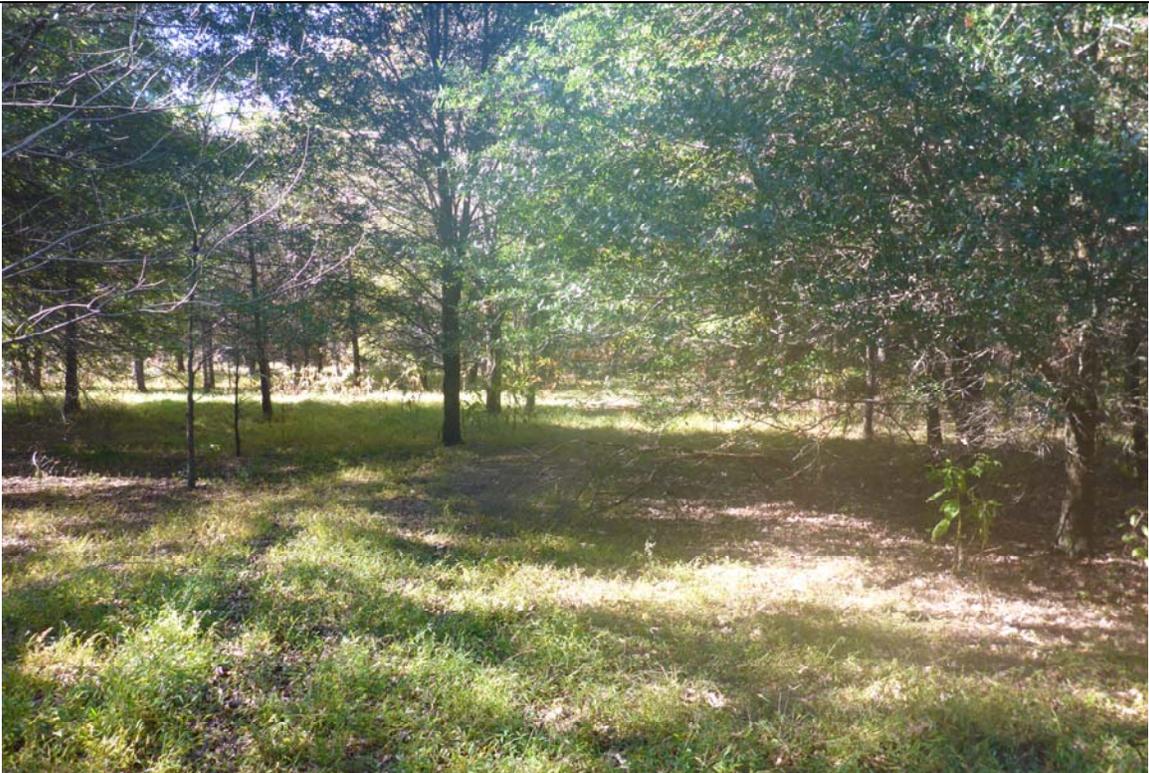
EXPLAIN: Minor trails/paths were again located leading into the site, but no damage was noted along these trails (Photo 4). Trails appear to be too narrow to be truck/vehicle access, and are likely ATV routes. Site is not marked with signage of any sort and currently has unrestricted access via Craney Island Road.

Photo 4 – Evidence of light ATV traffic noted within southeastern quadrant of site. No damage was found, and no destination was found.

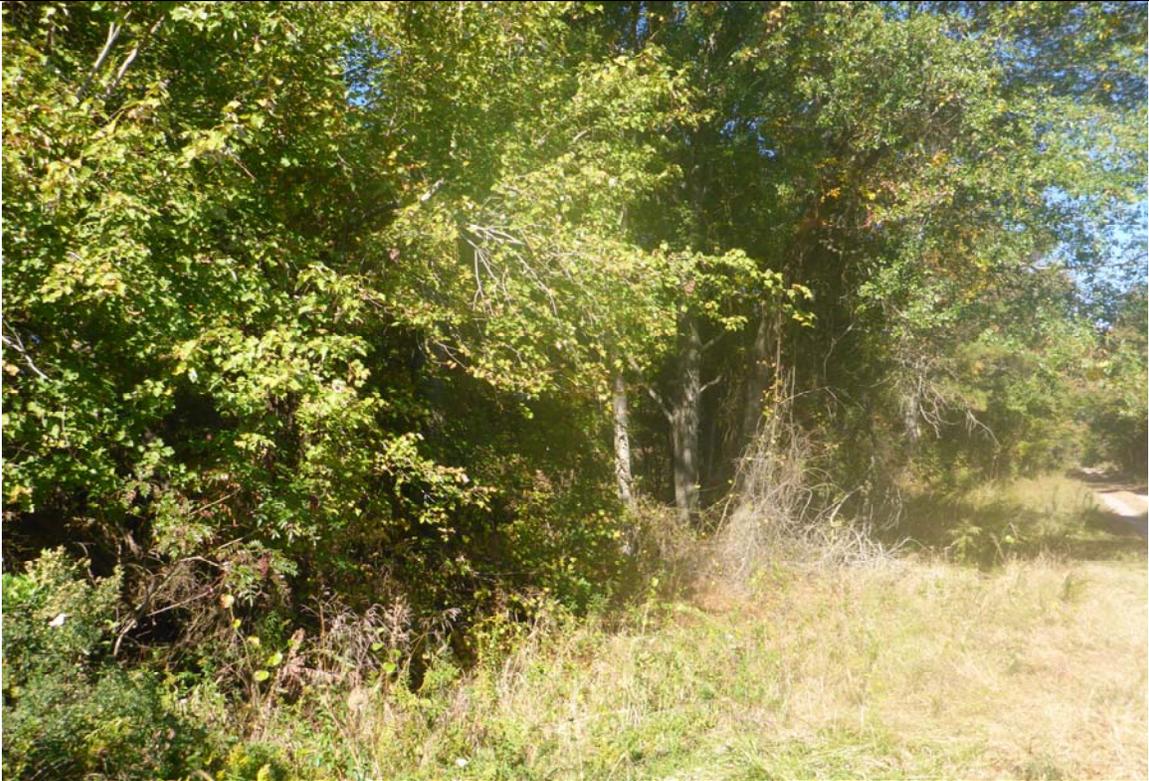
Photo 5 – Site observed from road near northern boundary.

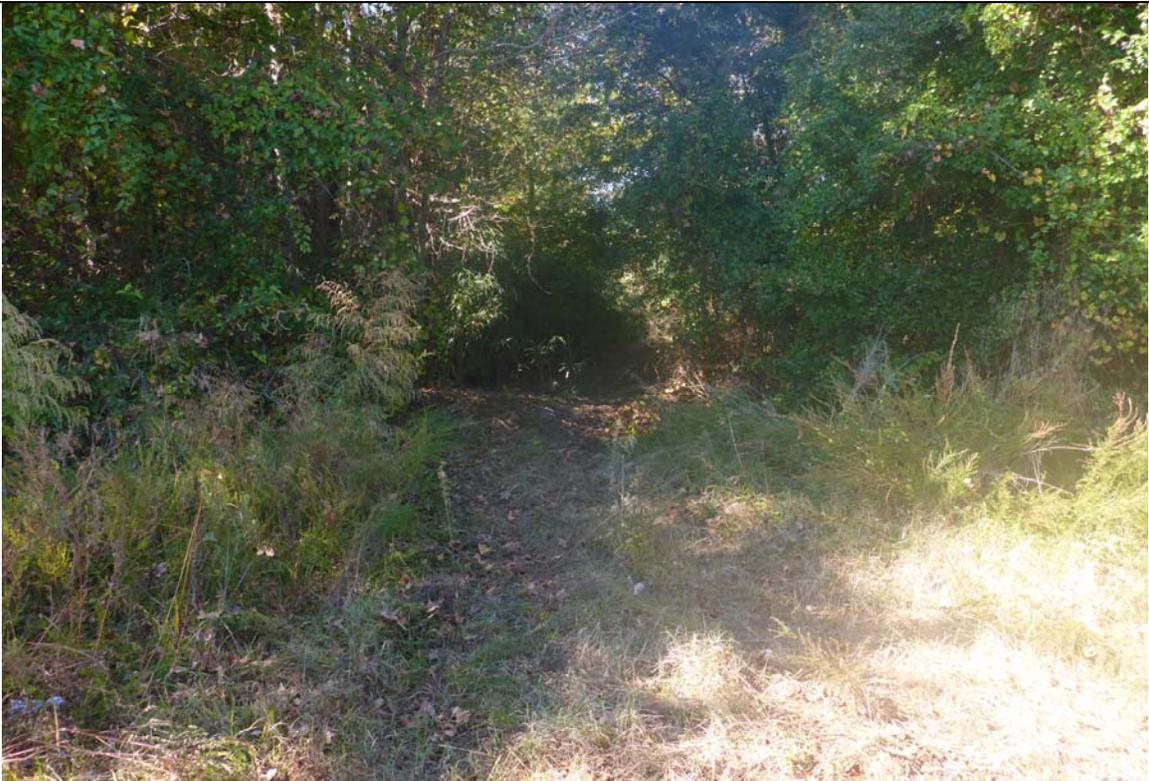
Photo 6 – A second access road with evidence of light ATV traffic was observed in the middle of the site.

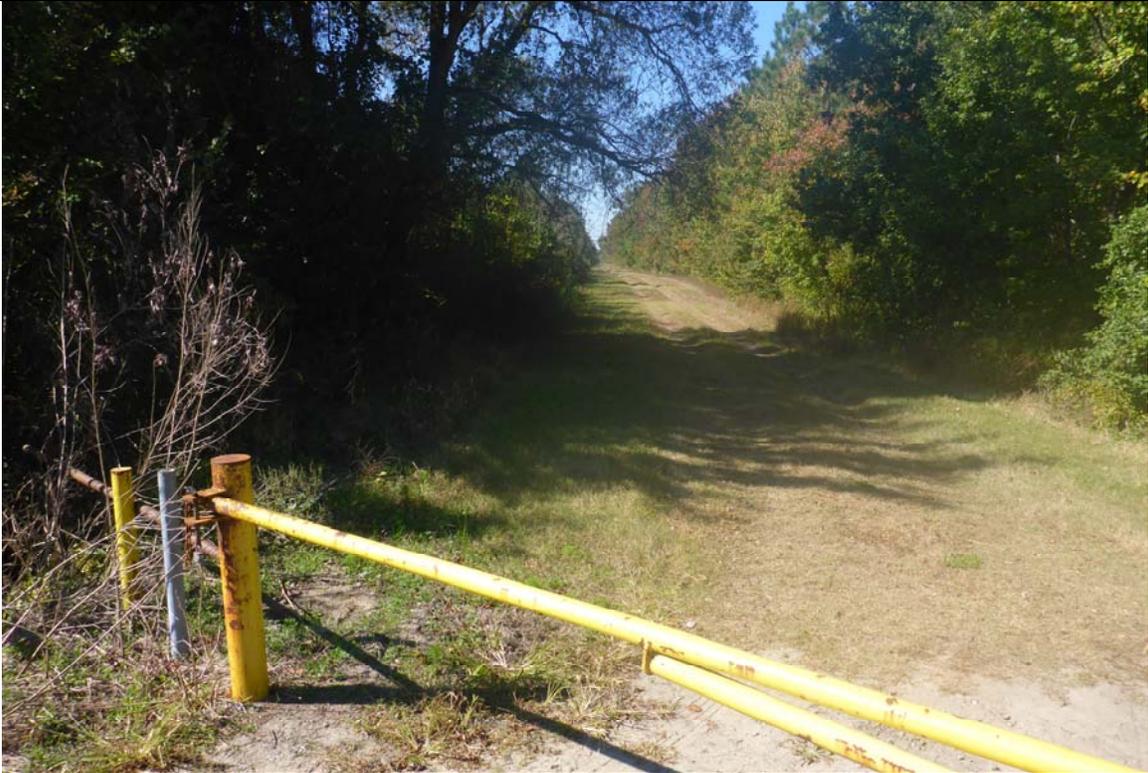
Photo 7 – Closed and secured gate at northeastern property boundary. Road in photo travels east/west along the northern boundary of the Site.

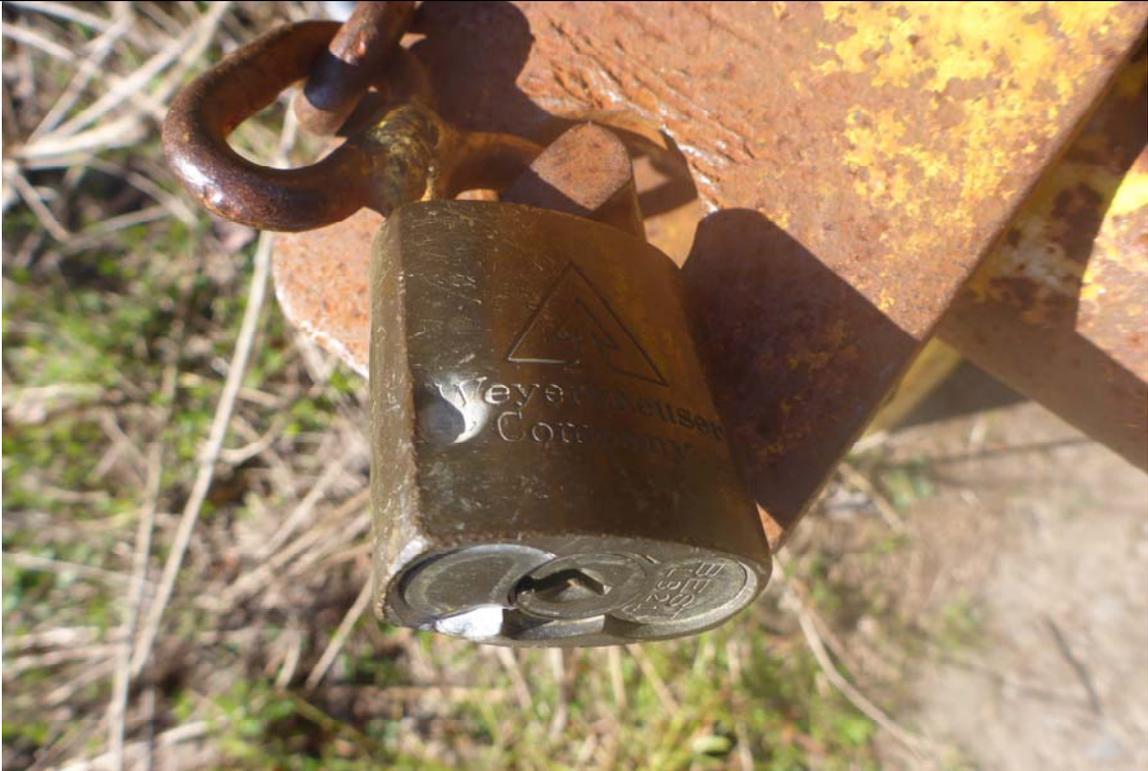
Photo 8 – The lock at the northeastern property corner had been tampered with but the gate was still secured.
