RACCOON CREEK INSPECTION REPORT

MITIGATION SITE NAME Raccoon Creek	TIP # R-2210A	WBS # 34634.2.14	INSPECTION DATE 8/22/14
---------------------------------------	------------------	---------------------	----------------------------

COUNTY Haywood	# ACRES 2.25
-------------------	-----------------

MONITORING ORGANIZATION HDR for NCDOT	INSPECTOR SE / VM	PHONE (919) 785-1118	EMAIL ADDRESS vickie.miller@hdrinc.com
--	----------------------	-------------------------	---

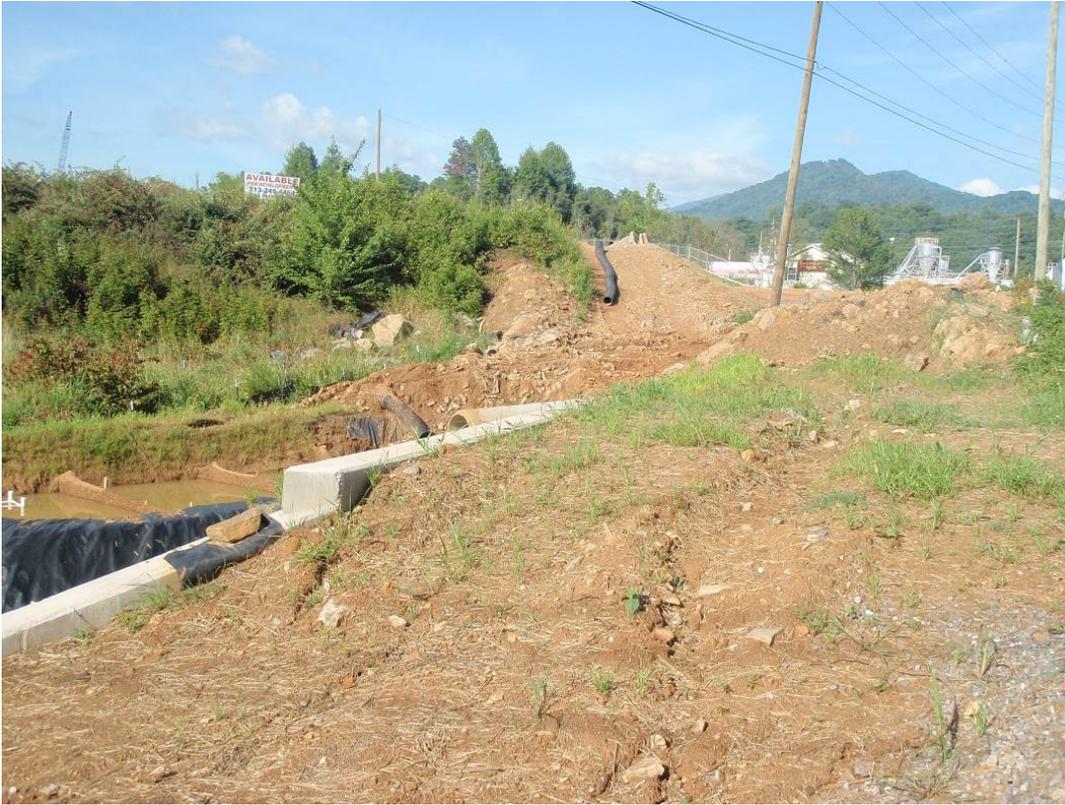
Potential grading/stormwater basin encroachment near Howell Mill Rd.

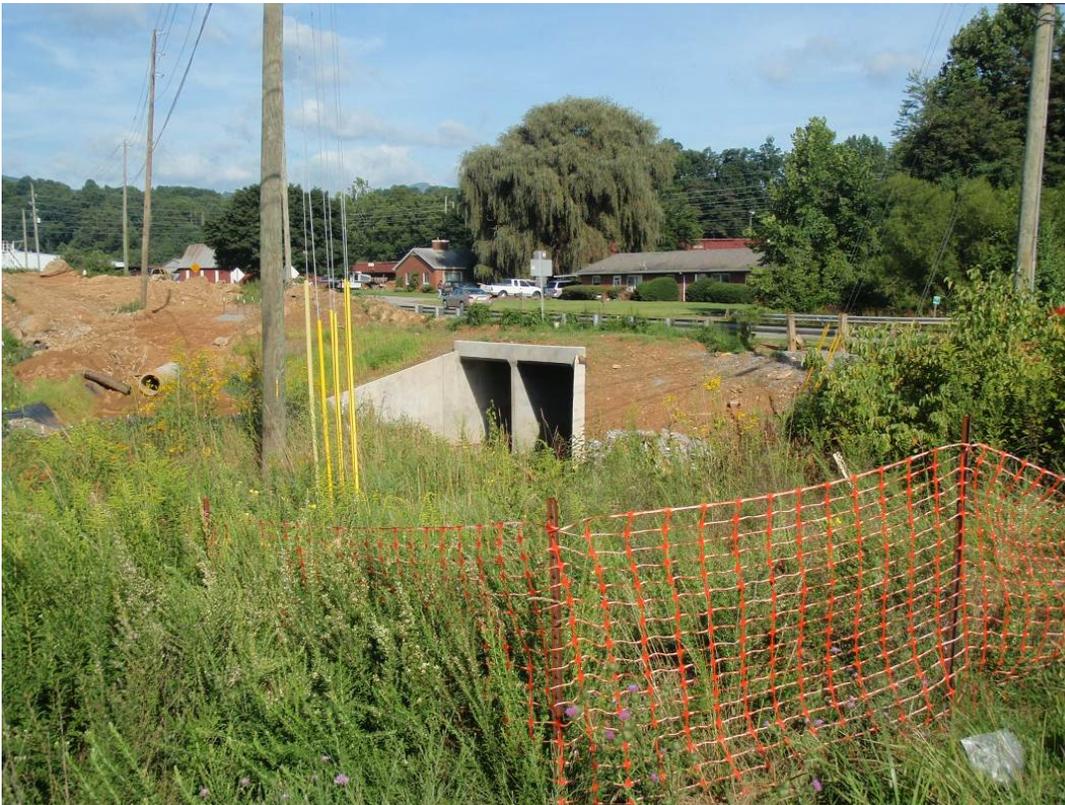
Potential grading/stormwater basin encroachment near Howell Mill Rd.

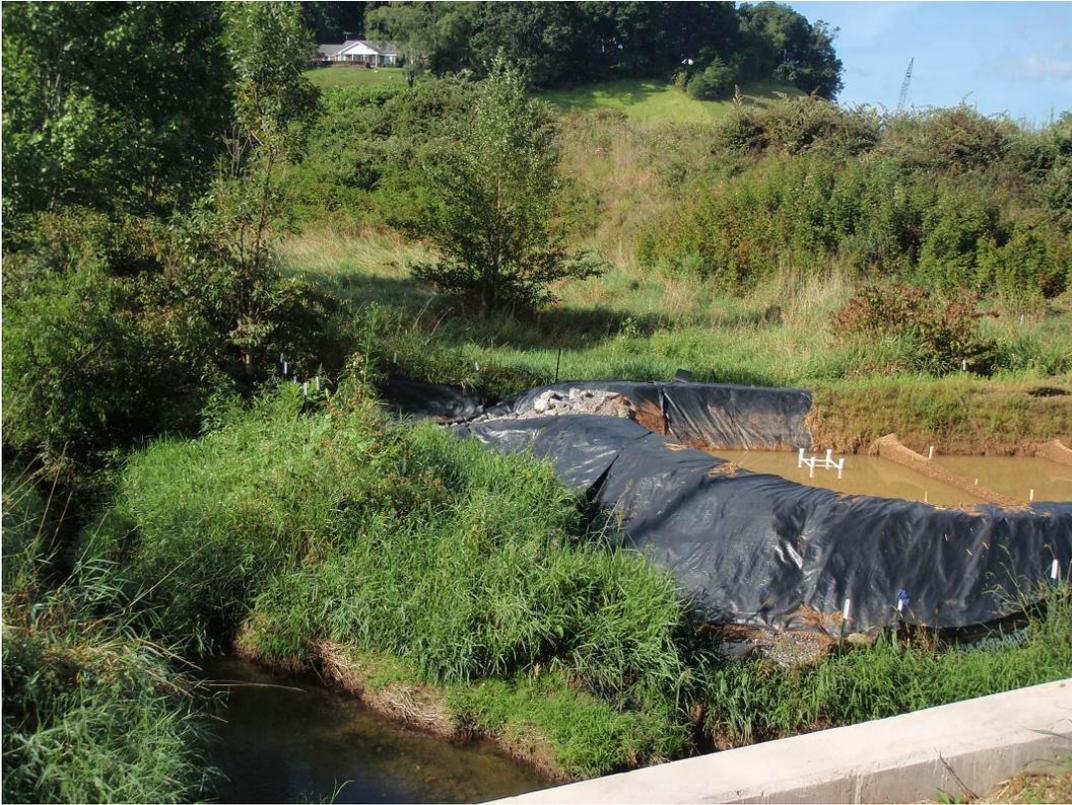
Potential stormwater basin encroachment at the northern site boundary near Howell Mill Rd.

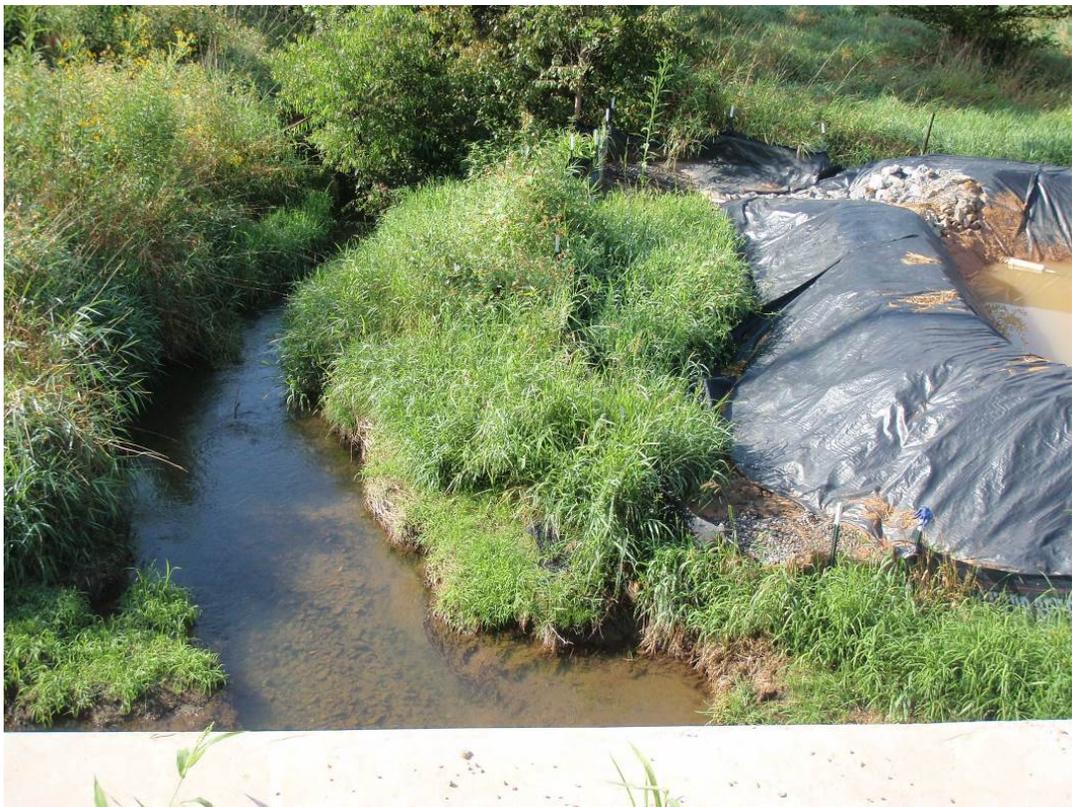
View of stormwater basin from culvert at Howell Mill Road.

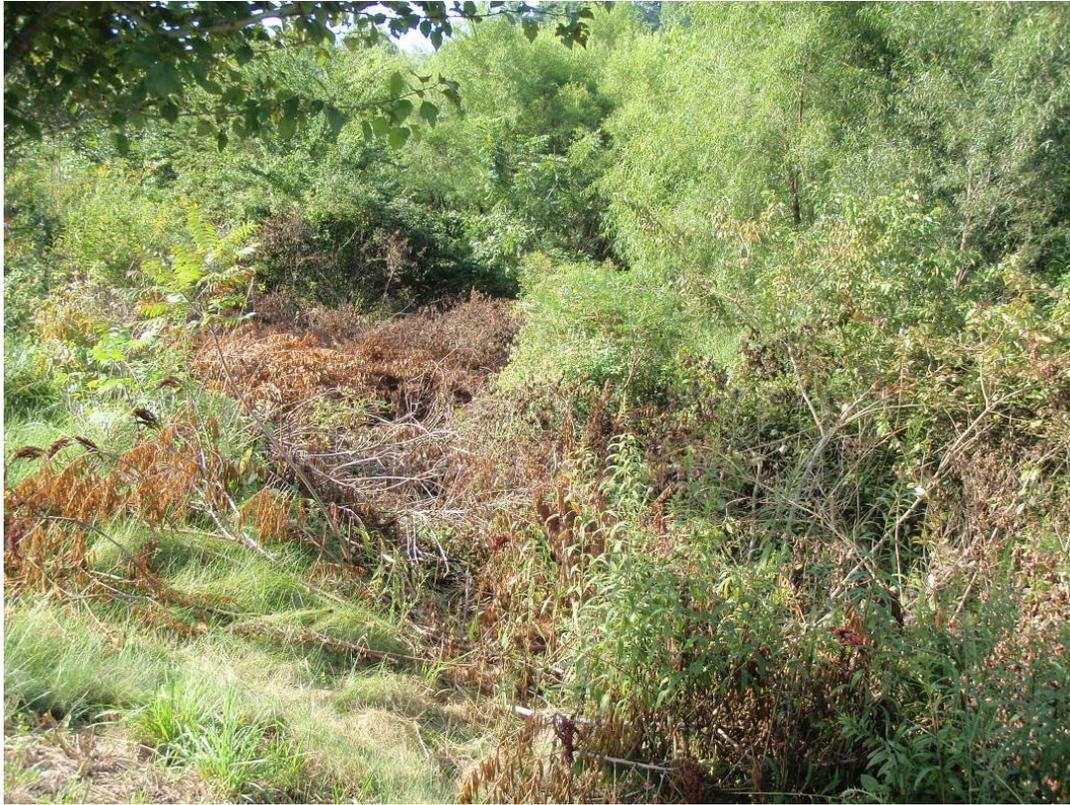
Trees have been cut along the power line adjacent to Bus. 23 for utility line maintenance. There was nearby excavation along the northern extent of the site at the stormwater basin encroachment and clearing around the bridge with some grading. See photos.

Woody vegetation cutting along utility line adjacent to Bus. 23.

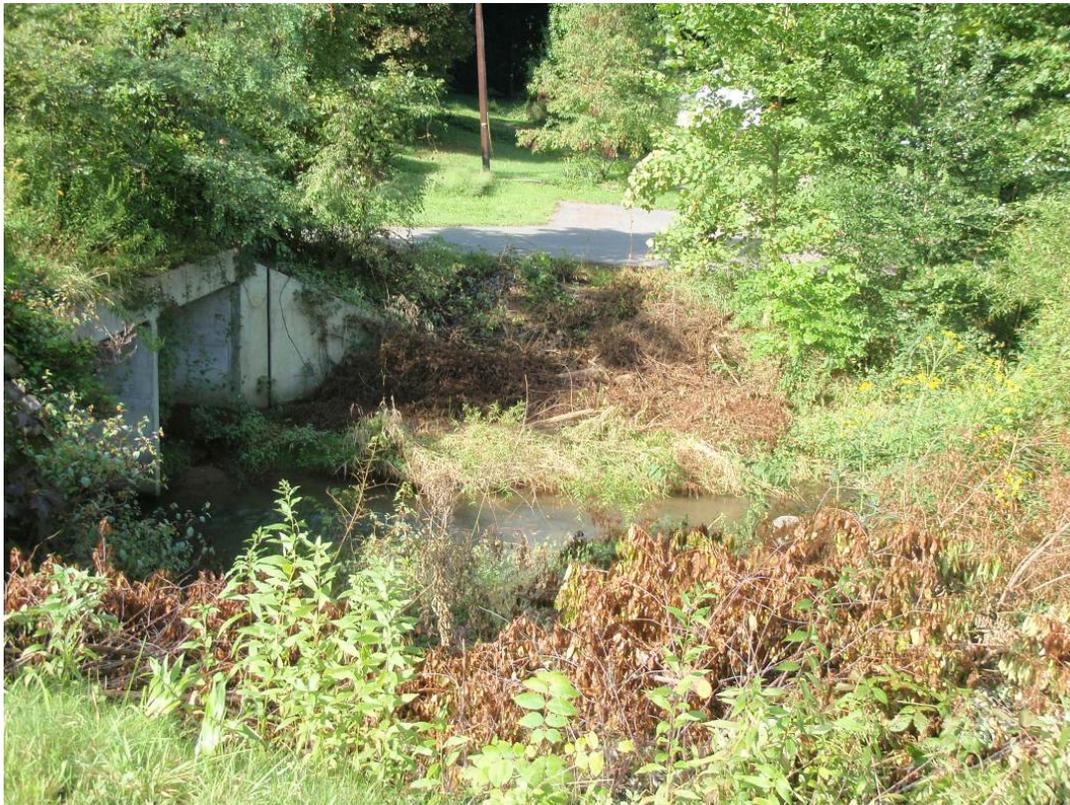
The site is not fenced but has NCDOT markers along the road frontage boundary. There appears to be potential encroachments at this site. Points were taken on a stormwater basin that has been installed for the adjacent parcel. There was also vegetative clearing along the utility line near the roadway and at the utility crossing at the southern extent of the site.

Woody vegetation cutting along utility at southern extent of the site.
