## BALLANCE FARM INSPECTION REPORT

MITIGATION SITE NAME Ballance Farm	TIP # R-2228WM	WBS # N/A	INSPECTION DATE 10/27/2014
---------------------------------------	-------------------	--------------	-------------------------------

**Division 1 - Ballance Farm**  
NCDOT Site Inspection Program  
Currituck County, North Carolina  
November 2014

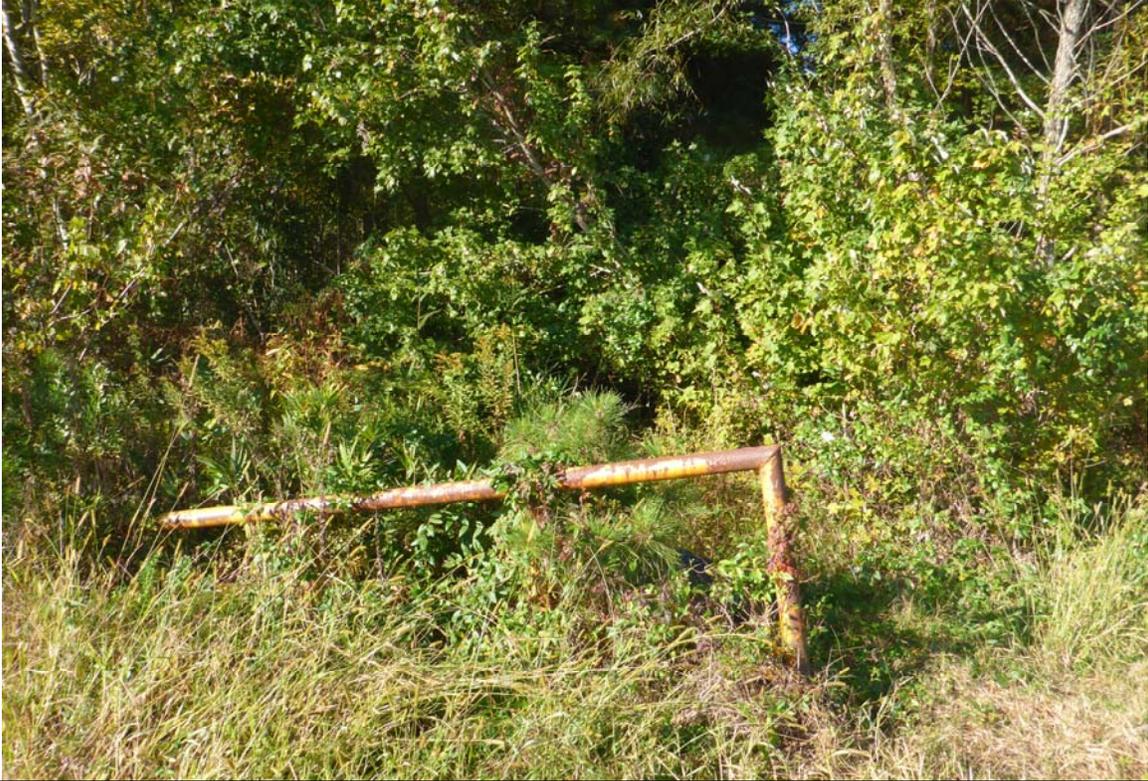
**Explain:**  
 A tree has fallen next to the gate and is blocking access into the site.

Photo 1 – Locked gate overgrown with natural vegetation. Access into the site around the right side of the gate has been blocked by a fallen tree.

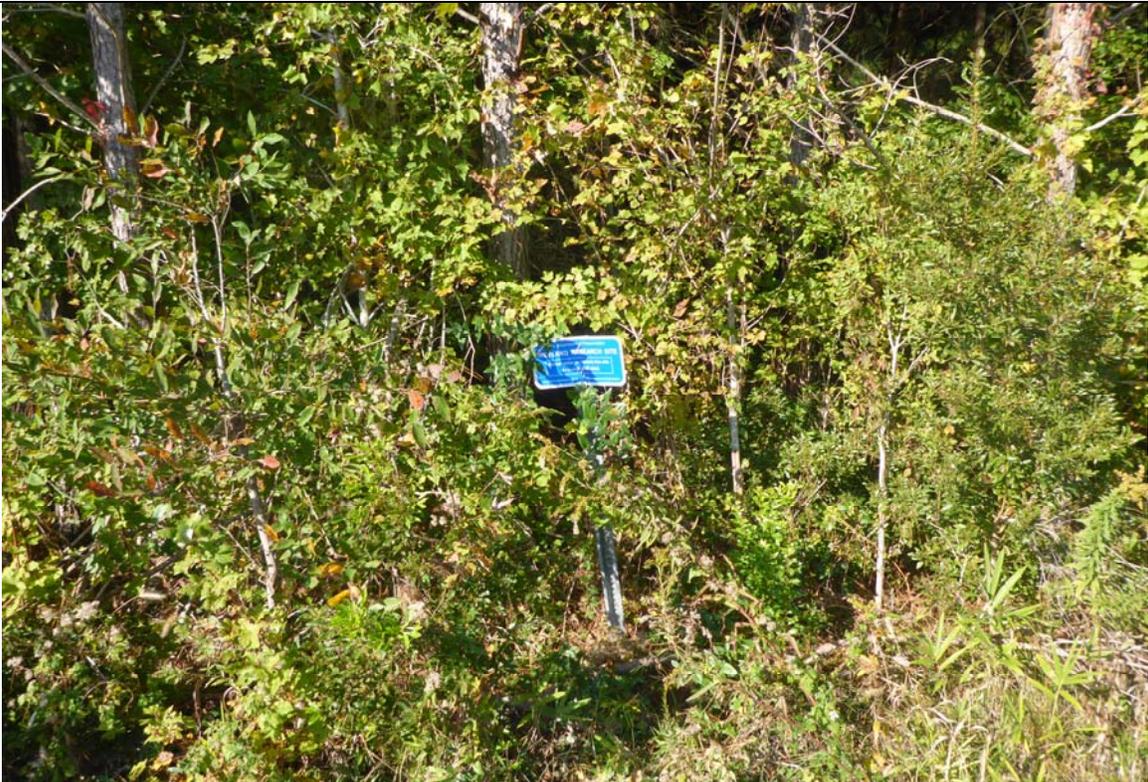
Photo 2 – NCDOT boundary signage was found to be in place and readily identifiable.

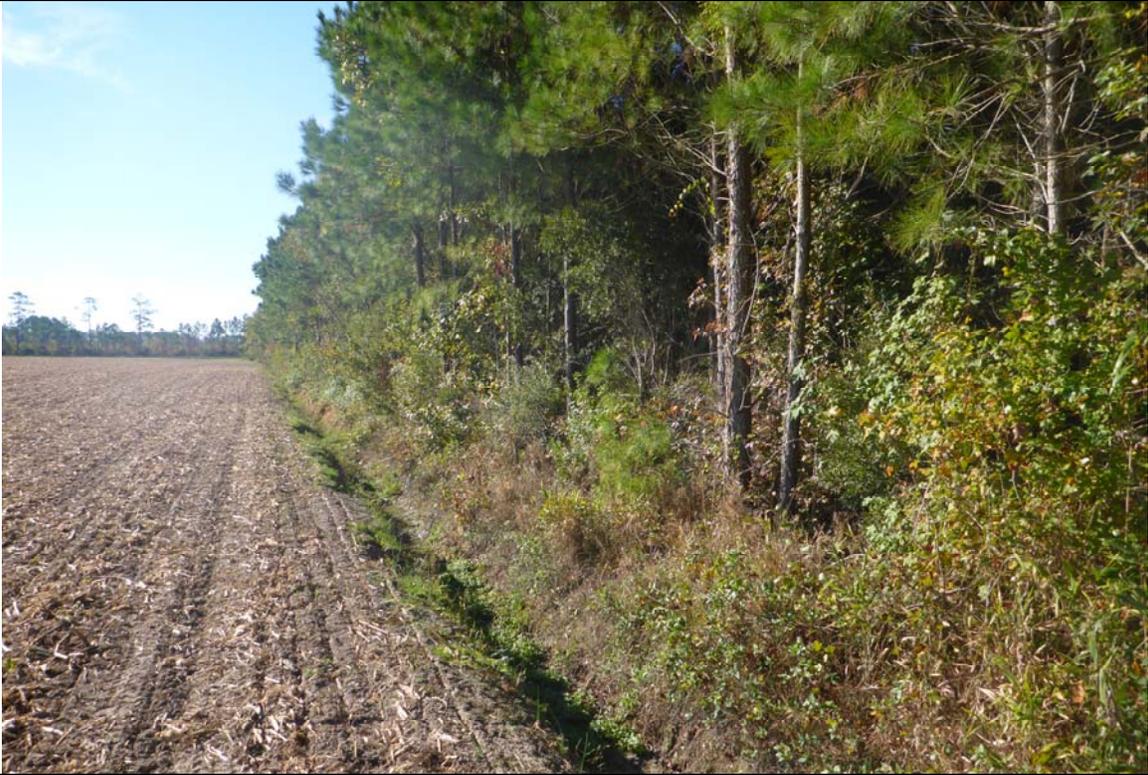
Photo 3 – Eastern property boundary at agricultural field edge.

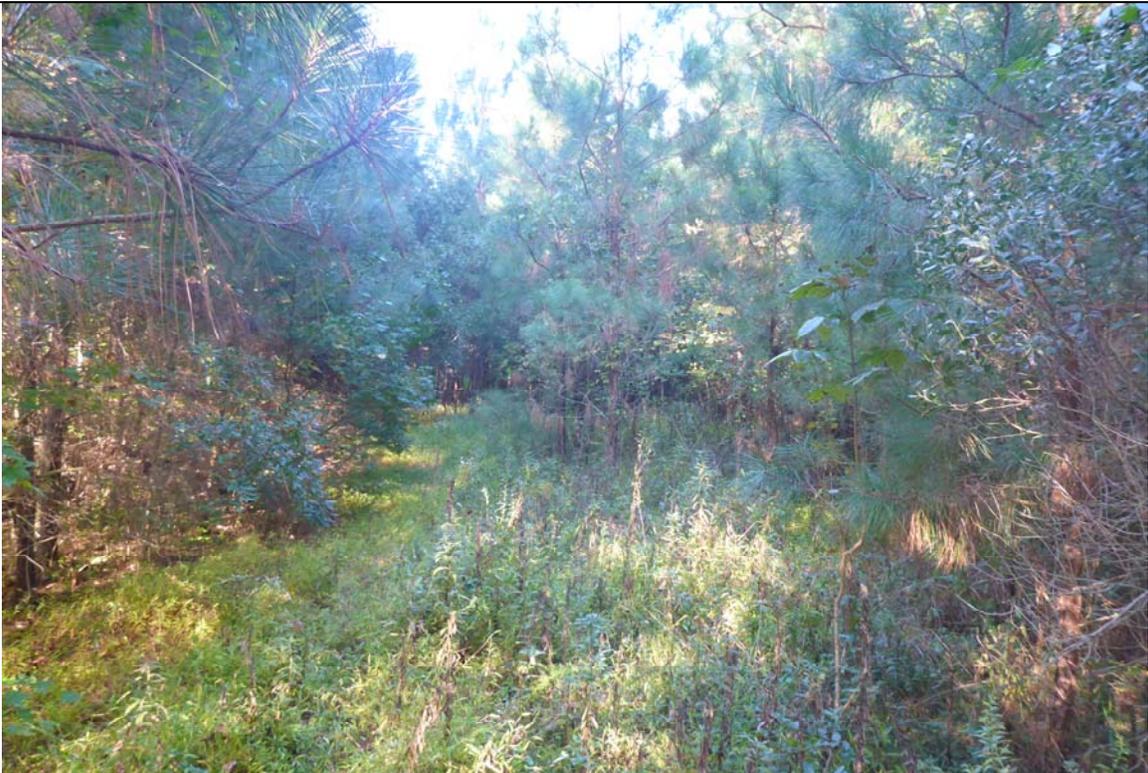
Evidence of ATV access into the site was observed, entering around the right side of the locked but overgrown gate and continuing down the access road into the site. However, activity along the access road appears to be light and has not damaged the site. The road is becoming overgrown so access into the site is limited, and the fallen tree at the locked gate further limits site access.

Photo 4 – Access road leading into the site from the locked gate. Evidence of ATV traffic noted, but no damage was noted and the tracks were only faintly visible.
