## TUCKER FARM INSPECTION REPORT

| MITIGATION SITE NAME<br>Tucker Farm | TIP #<br>R-2228WM | WBS #<br>N/A | INSPECTION DATE<br>10/28/2014 |

| COUNTY<br>Currituck | # ACRES<br>68.8 |

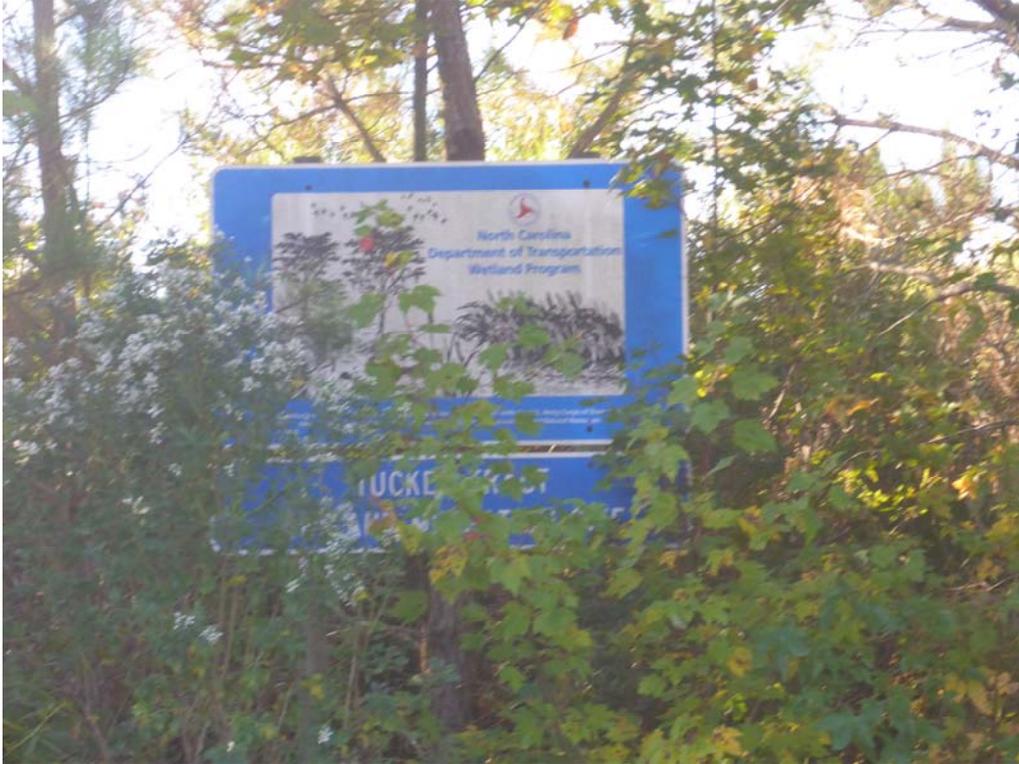
Photo 1 – NCDOT Mitigation Site signage visible from NC 168, but vegetation is growing in front of the sign and will continue to obscure the signage in the future.

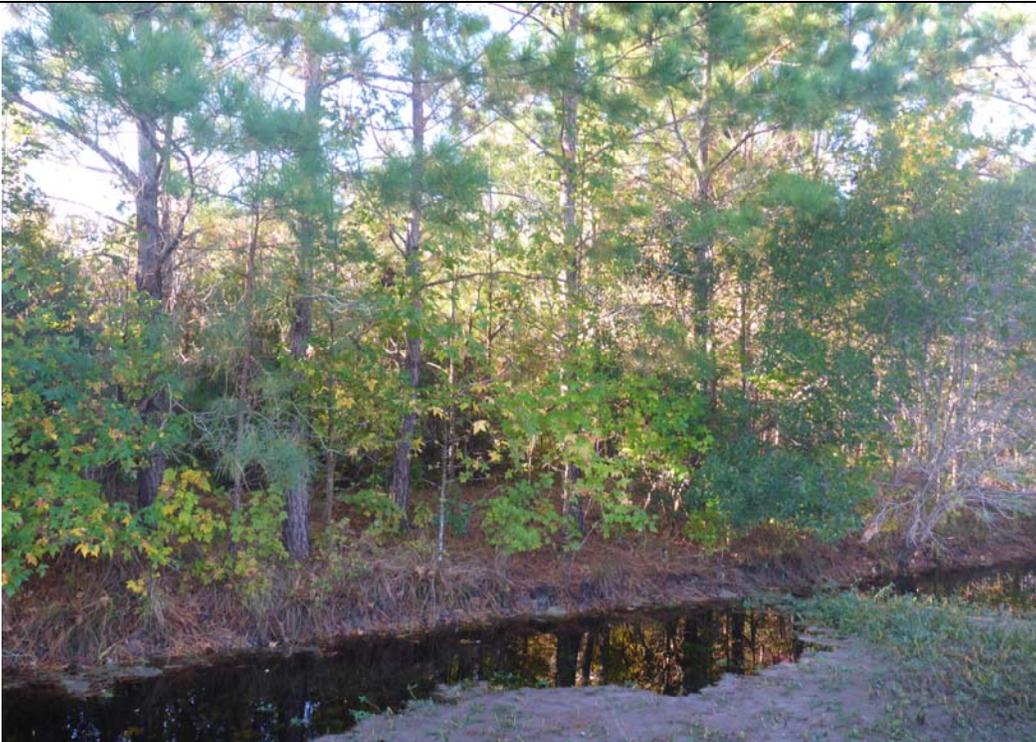
| <p><b>COMMENTS:</b> Site continues to function well. As shown in Photo 4, the gate was locked and access road was secured with no evidence of activity on the single road into the site (overgrown with vegetation). No trespass issues were noted, and site is protected from road frontage by wide canal contributing to boundary identification (Photos 2, 3).</p> | | | |

Photo 2 – Interior view of the Site as visible from NC 168.

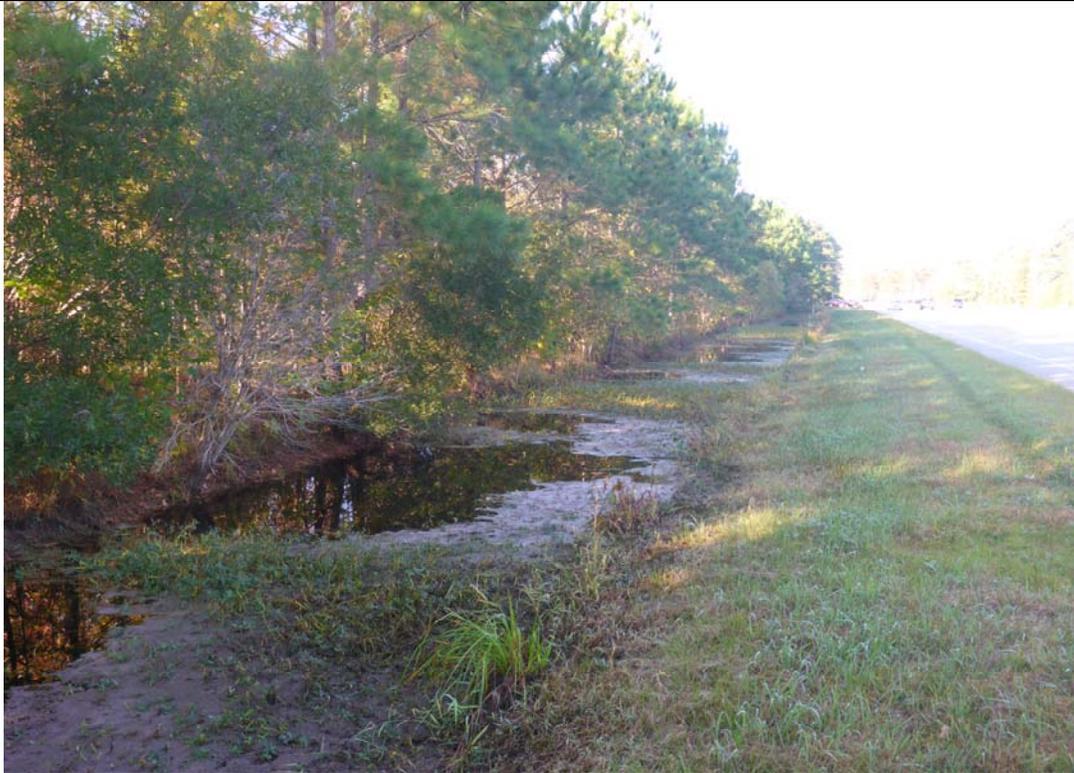
Photo 3 – Roadside canal along NC 168 adjacent to the Site. Photo is facing west from the eastern boundary.

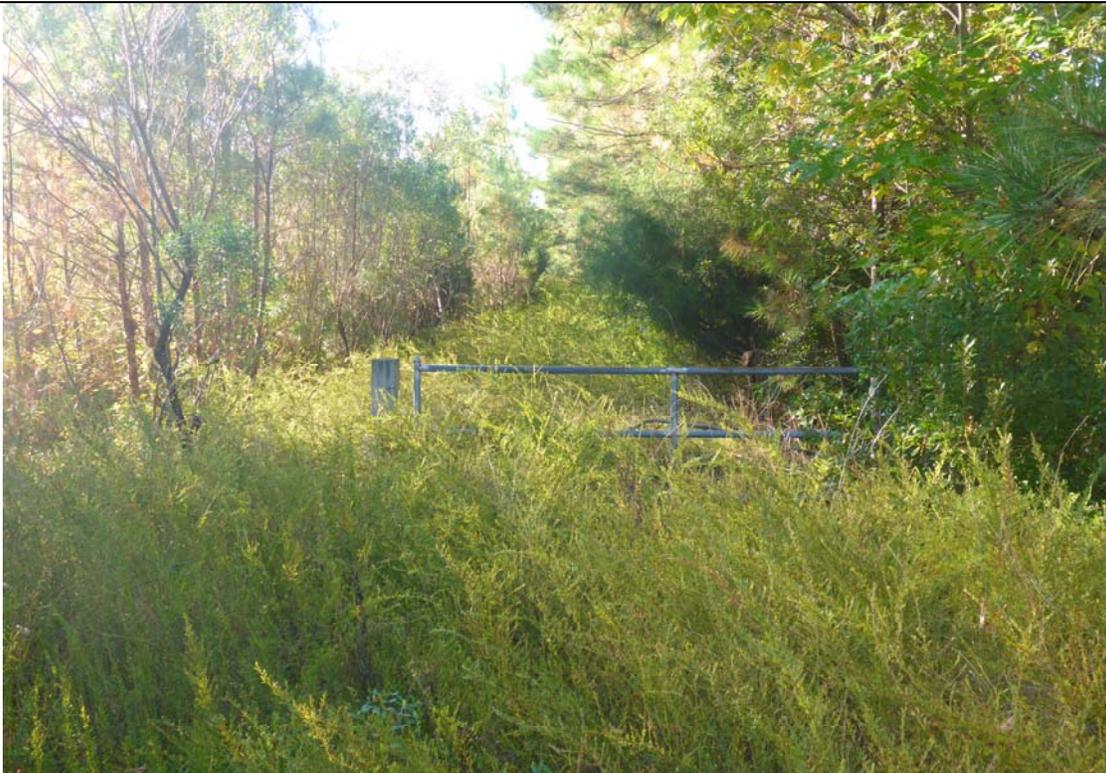
No manmade activity was observed in the site. The single access route into the site is undisturbed, and remains gated and locked. Signed was visible from road frontage and adjacent to the site access gate.

Photo 4 – Closed and secured gate leading into the Site. No evidence of activity was noted on the road leading into the Site.
