## HANGING ROCK INSPECTION REPORT

| MITIGATION SITE NAME<br>Hanging Rock Creek | TIP #<br>R-2237WM | WBS #<br>34634.2.11 | INSPECTION DATE<br>10/11/2013 |

| COUNTY<br>Avery | # ACRES<br>9.80 |

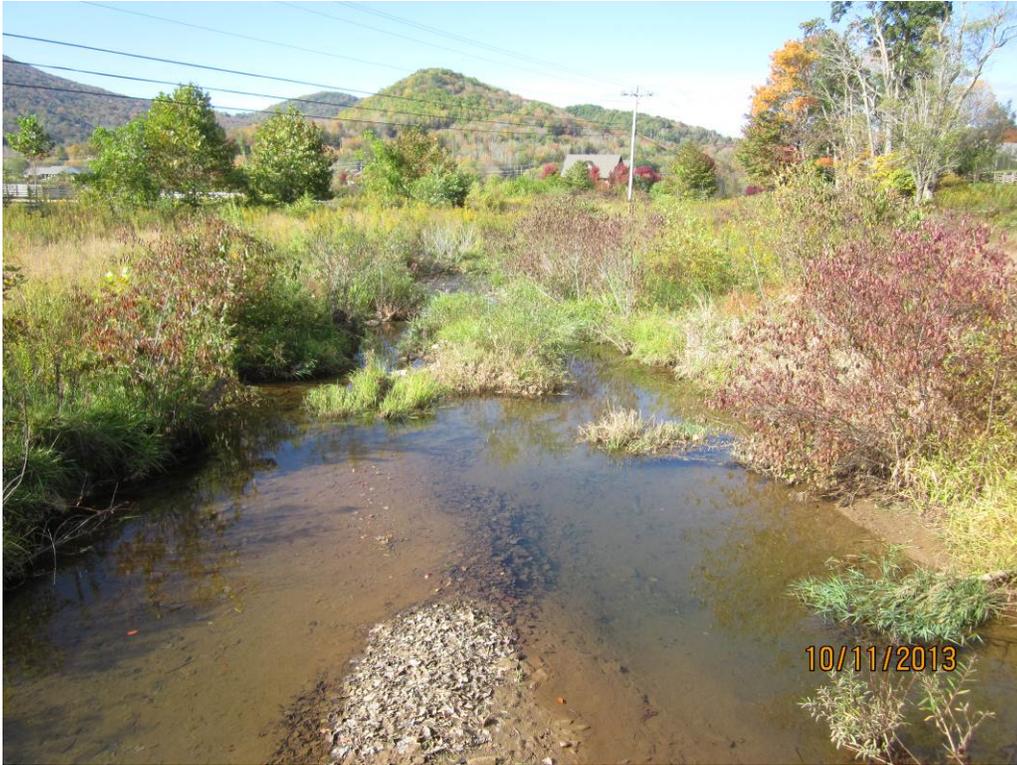
View of stream in the upper portion of the reach along Dobbins Road

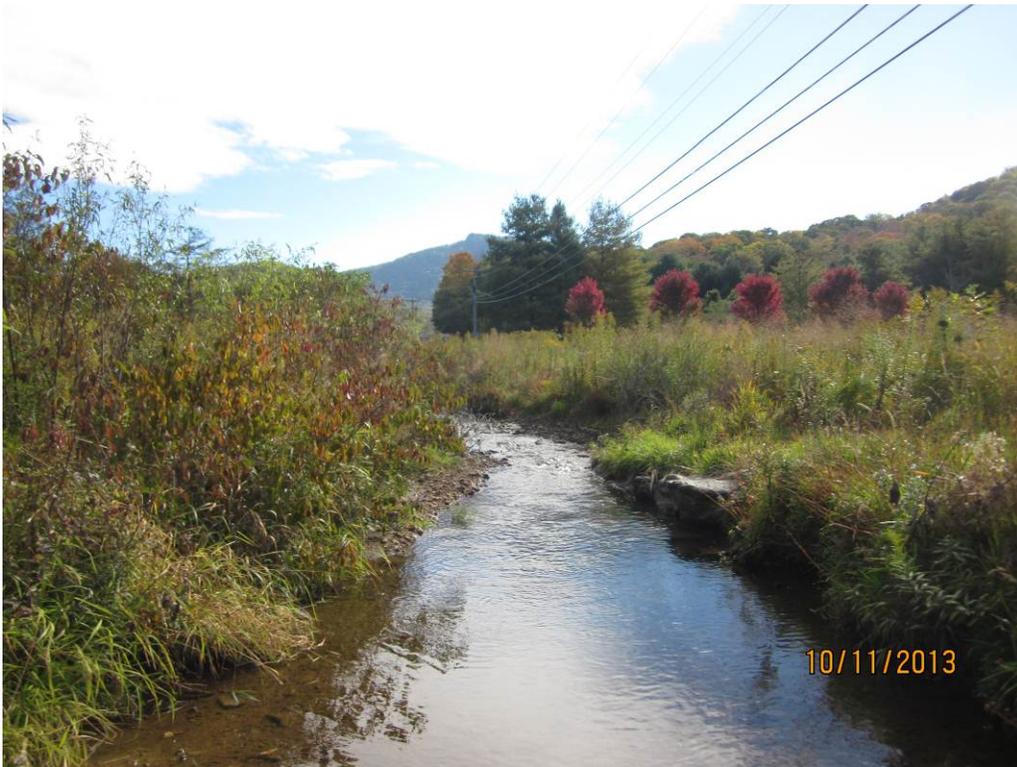
View of stream in the upper portion of the reach with nearby utility easement

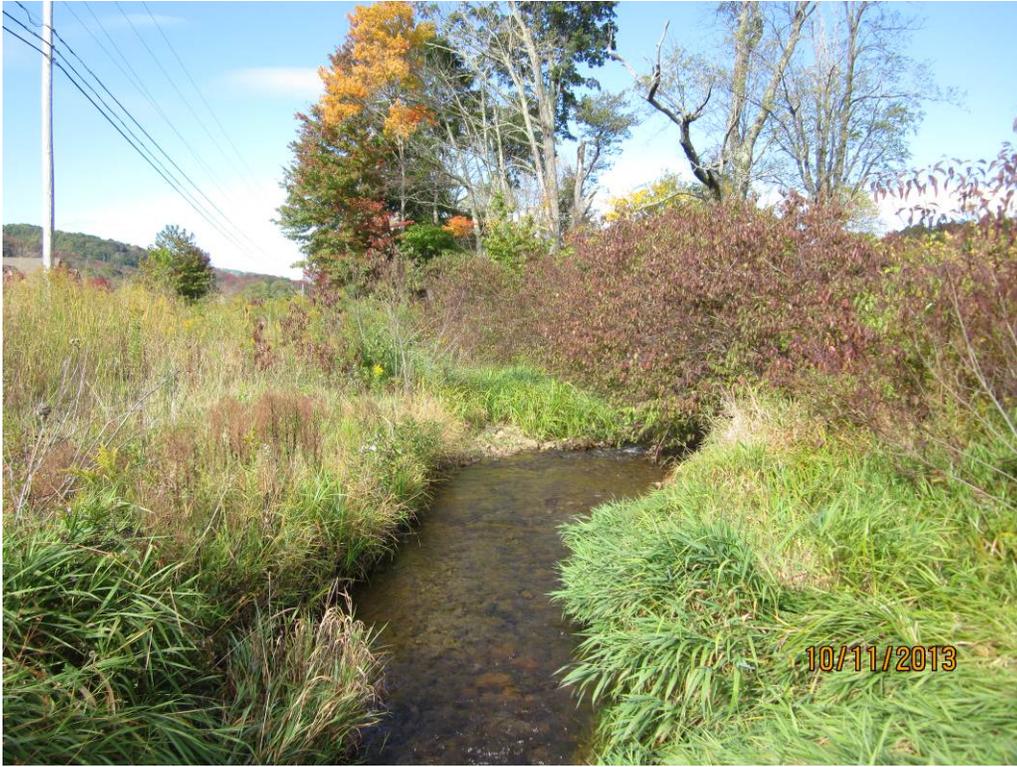
View of stream in the upper portion of the reach

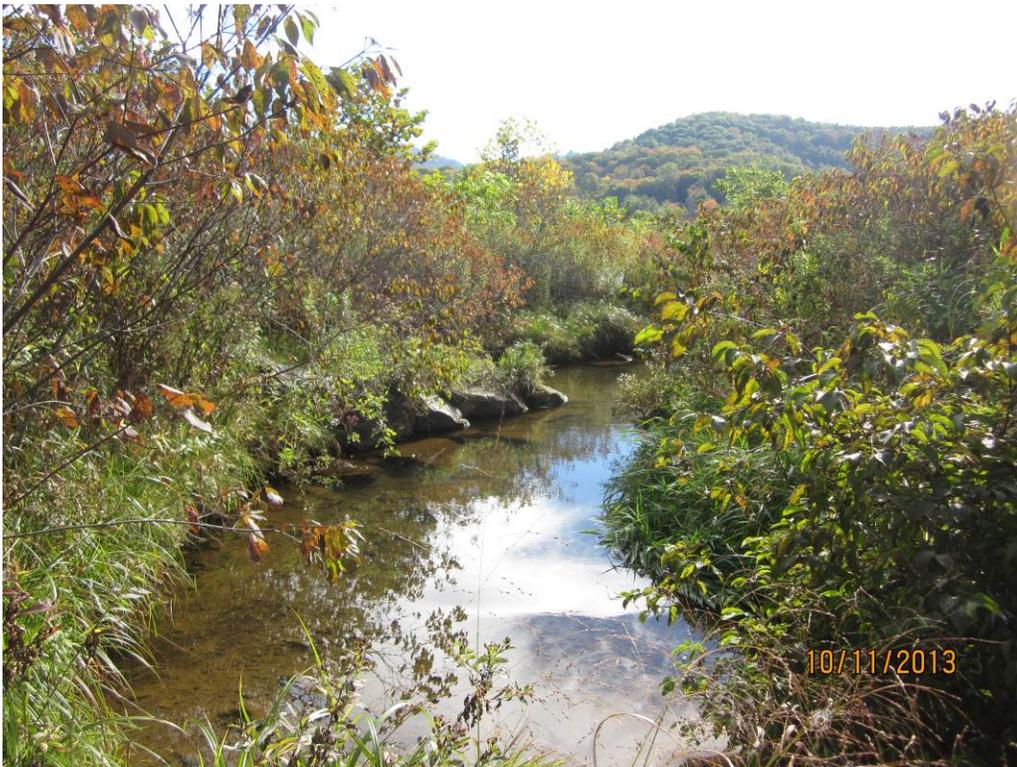
View of stream in the upper portion of the reach

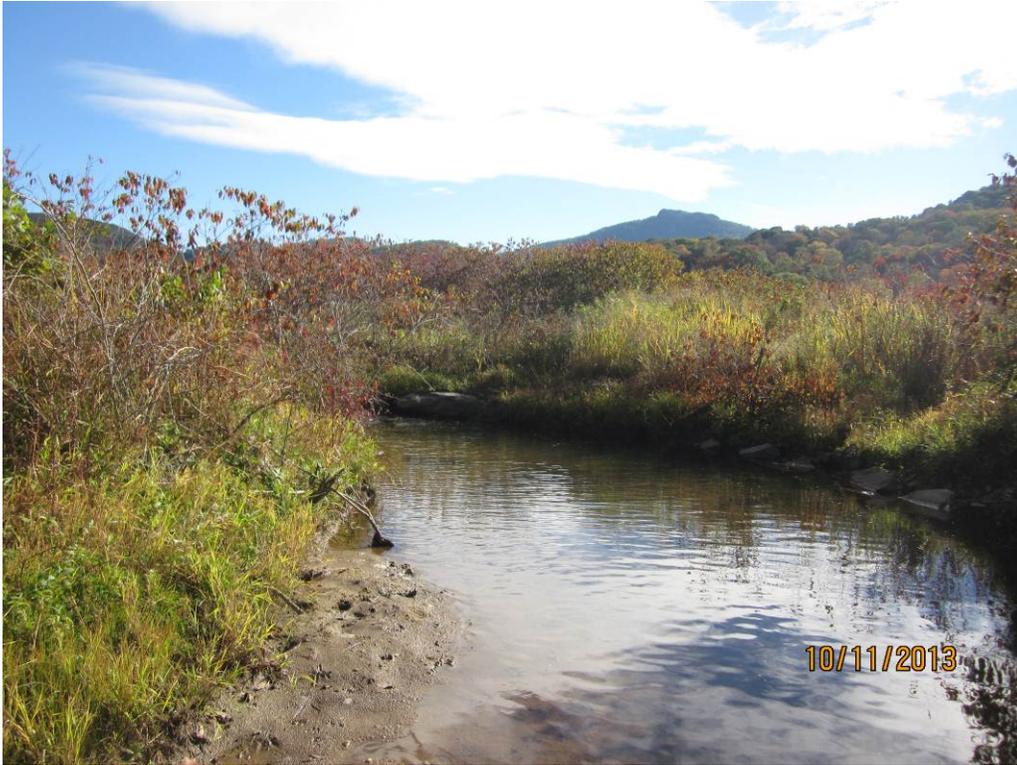
View of stream in the upper portion of the reach

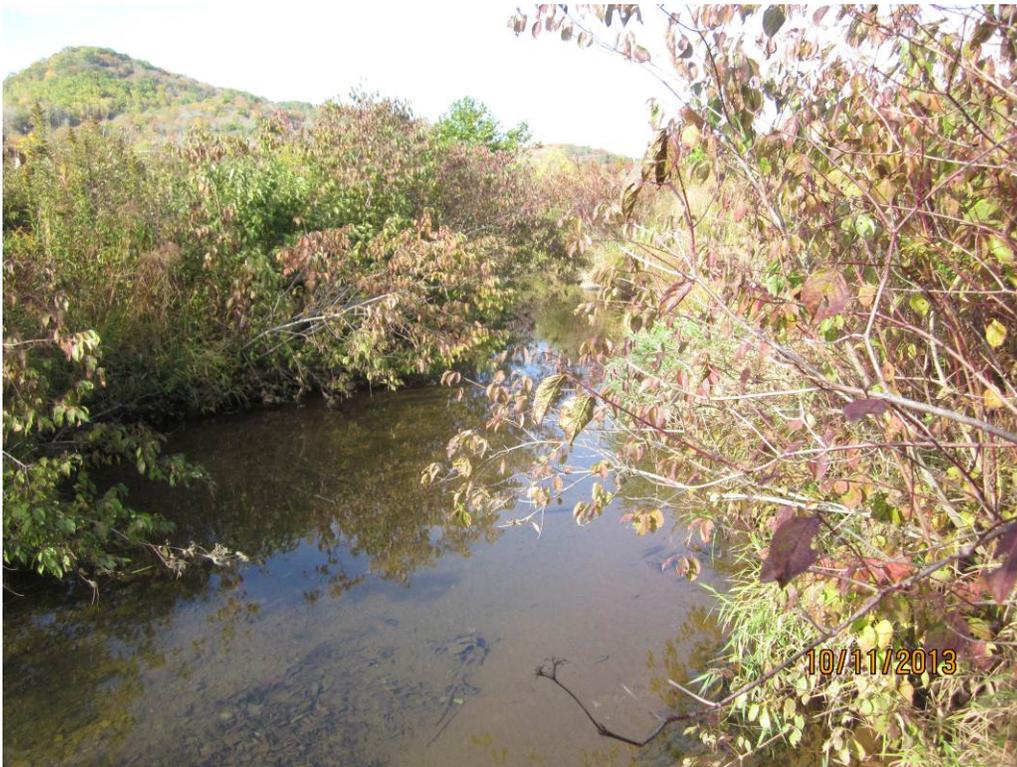
View of stream and vegetation along upper portion of the reach

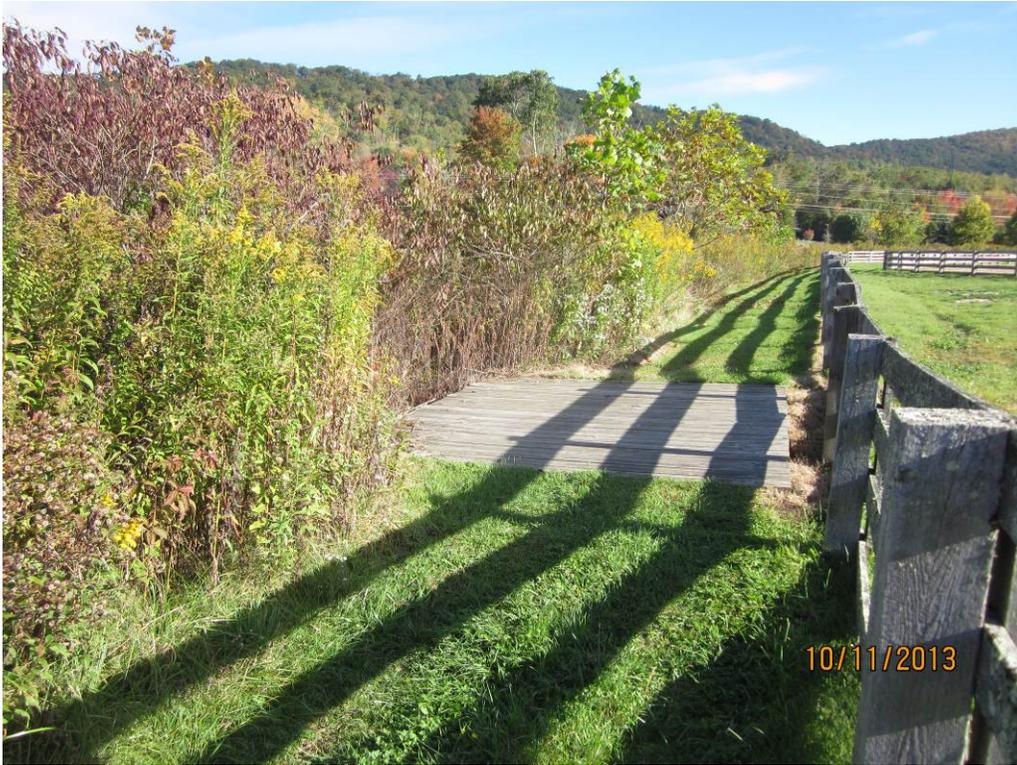
Wooden crossing and mowed path along the horse farm

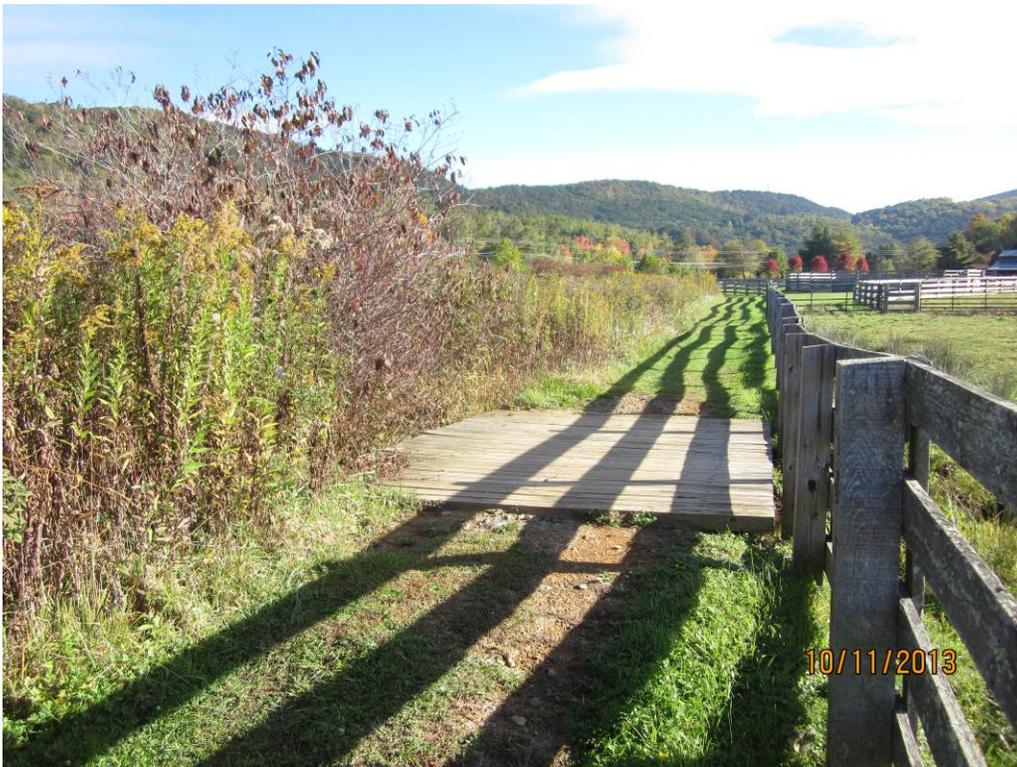
2<sup>nd</sup> wooden crossing and mowed path along the horse farm

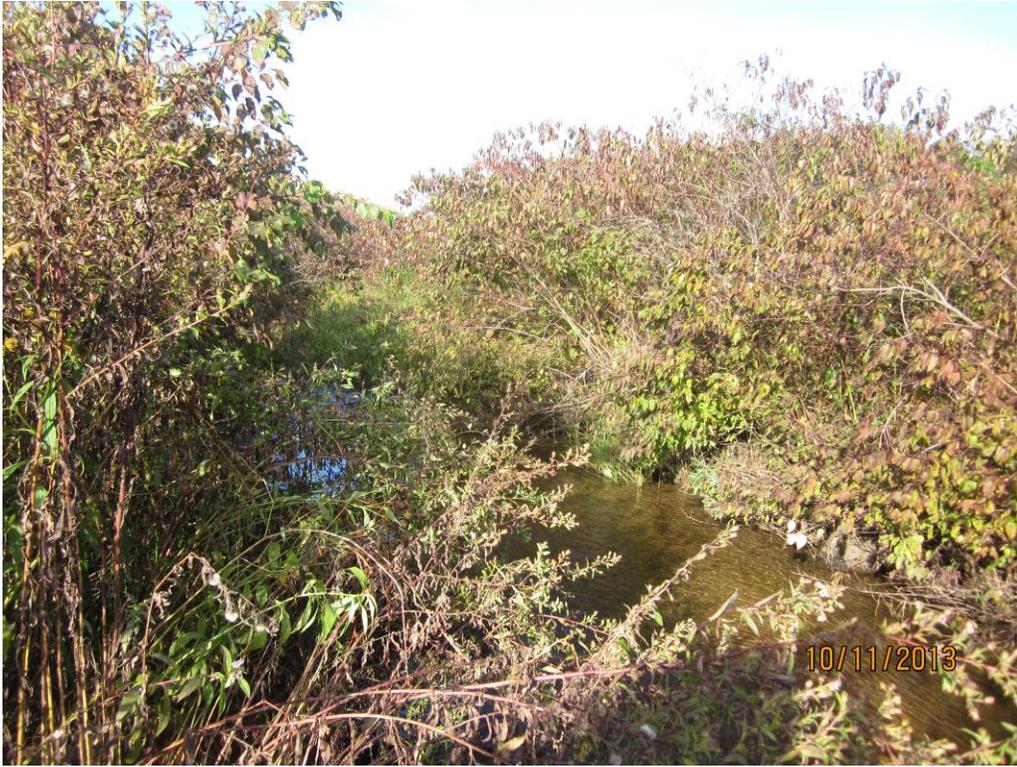
Stream and vegetation near middle portion of the reach

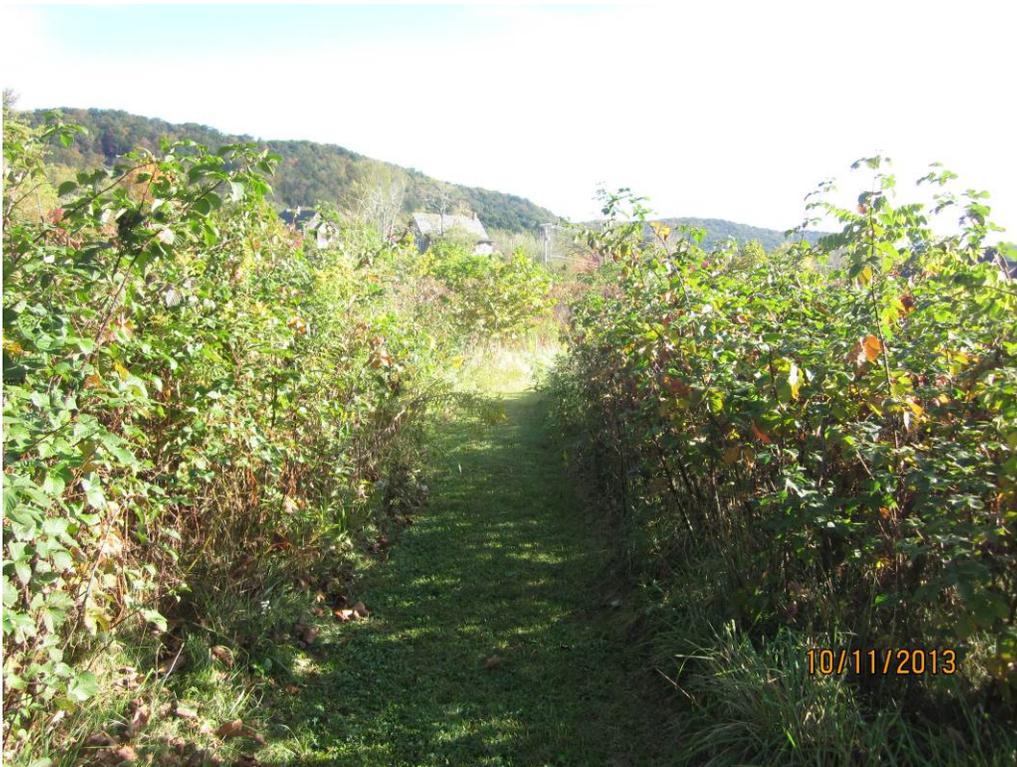
**EXPLAIN:** Mowing of interior paths was noted during the inspection but it allowed within the easement.

Mowed interior pathways

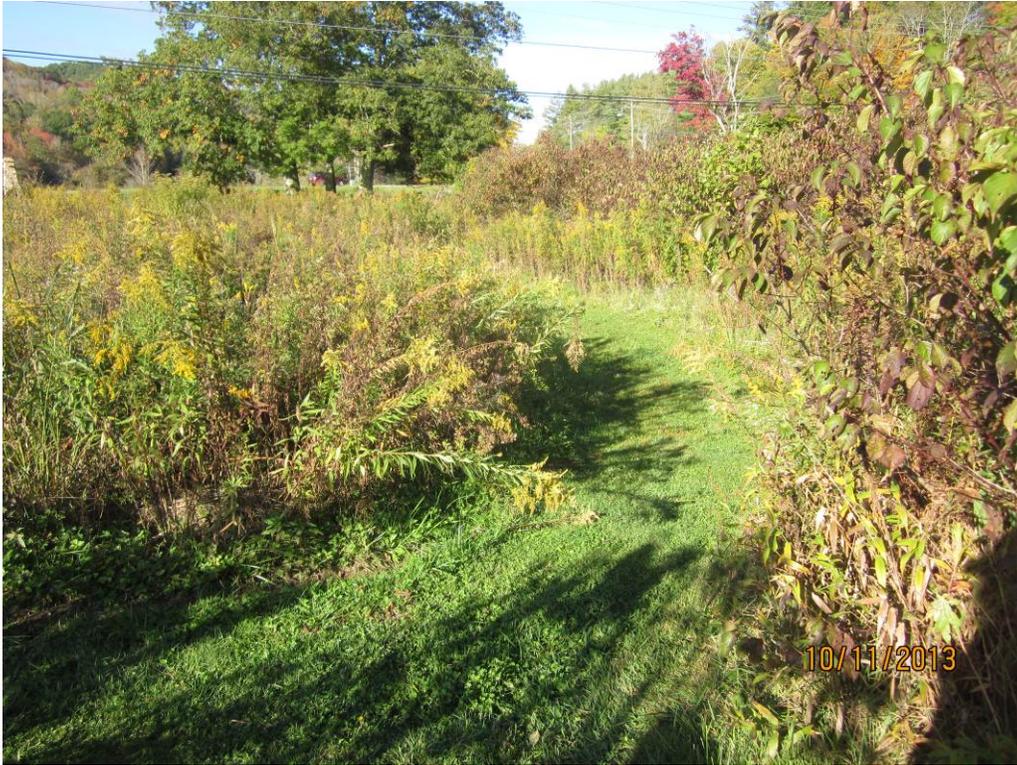
Mowed interior pathways

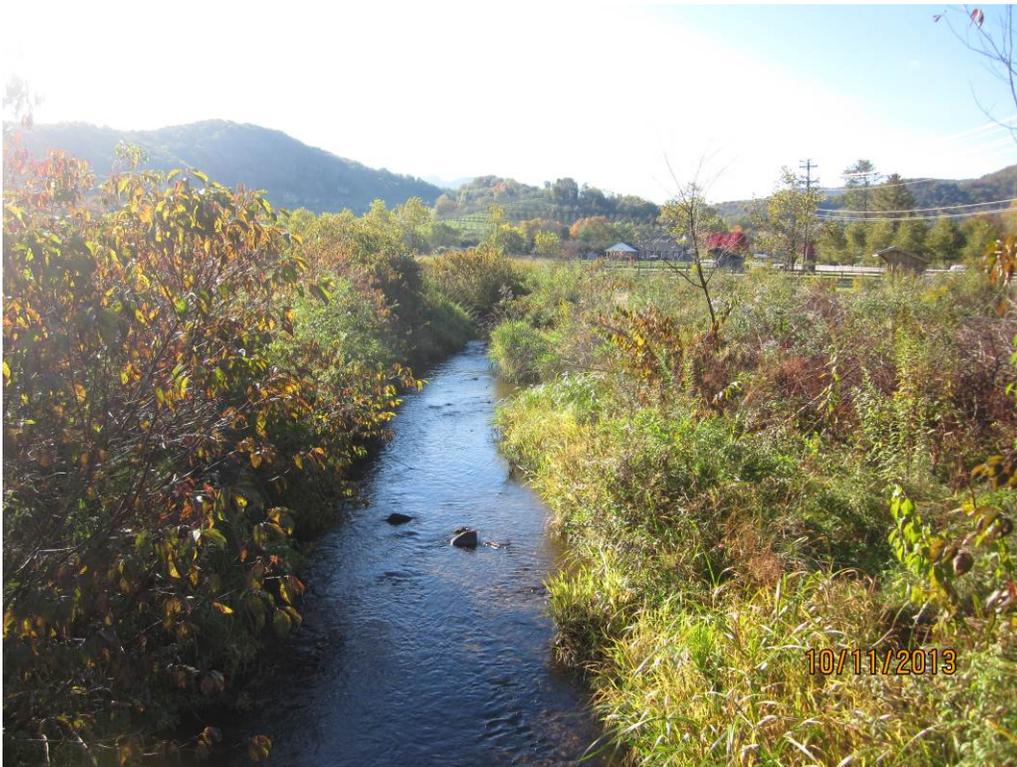
View of stream and vegetation near middle of the reach

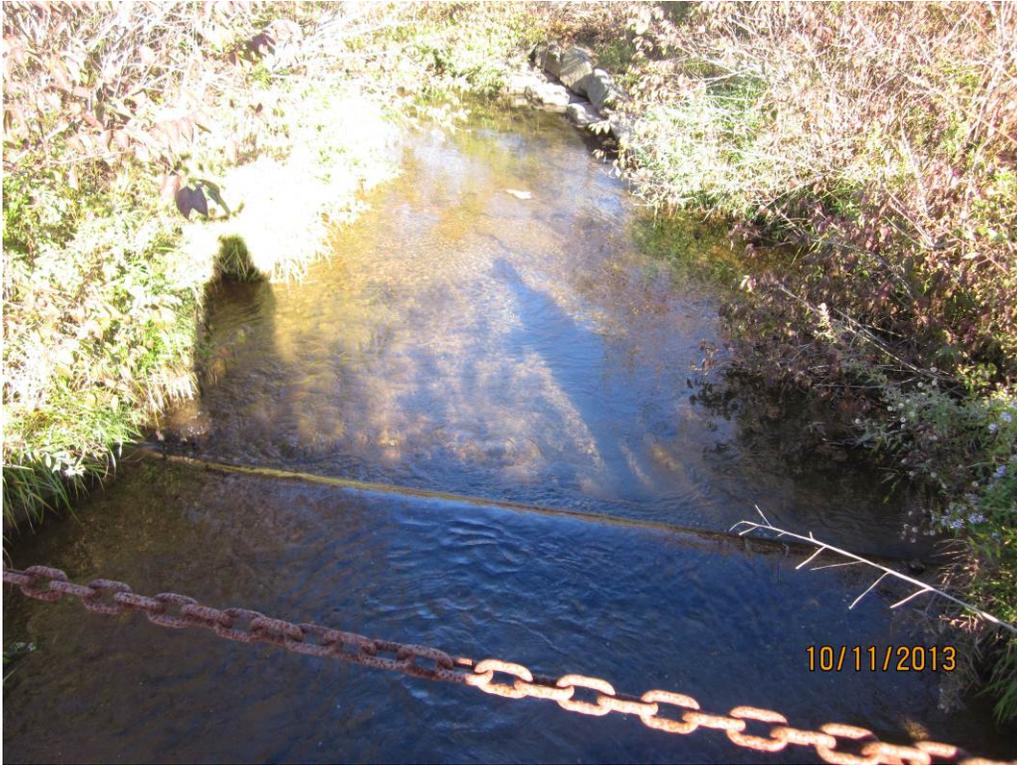
Pipe crossing downstream of a mowed path/stream crossing

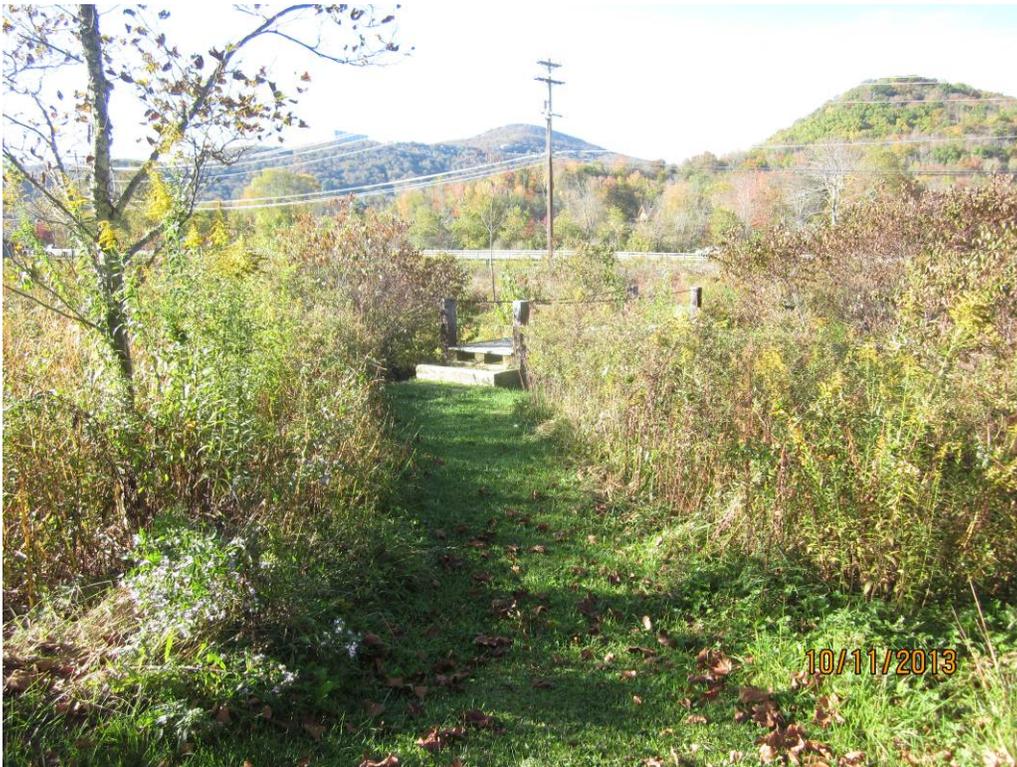
Mowed path to stream crossing closest to US 184

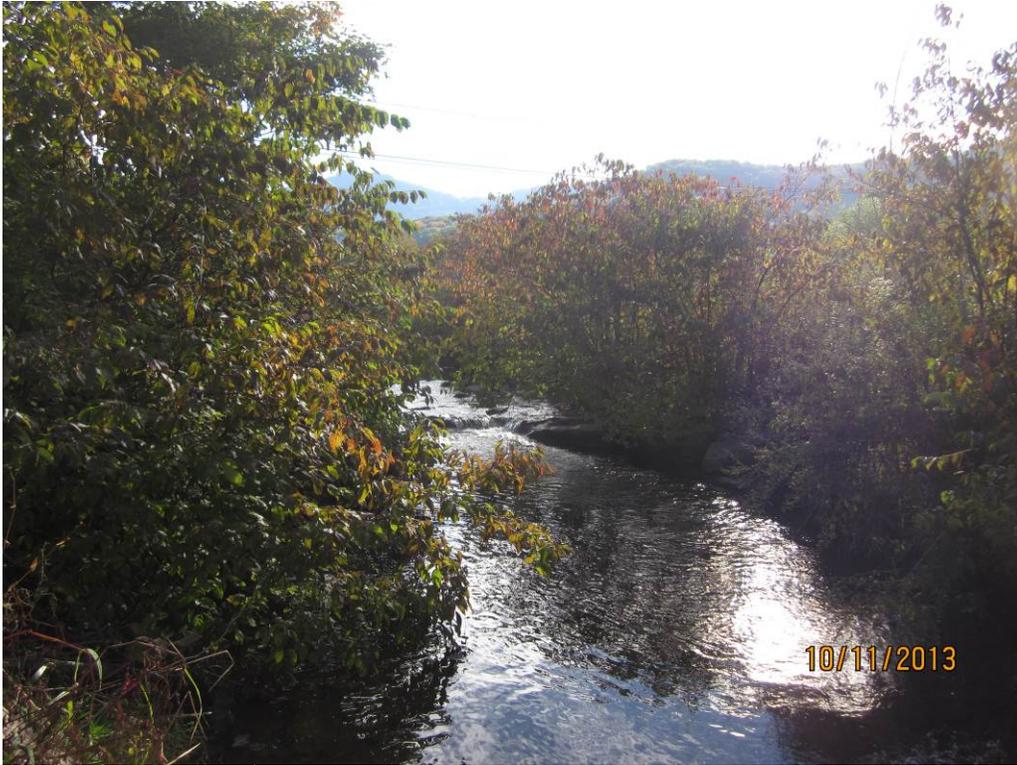
View of cross vane in the lower reach

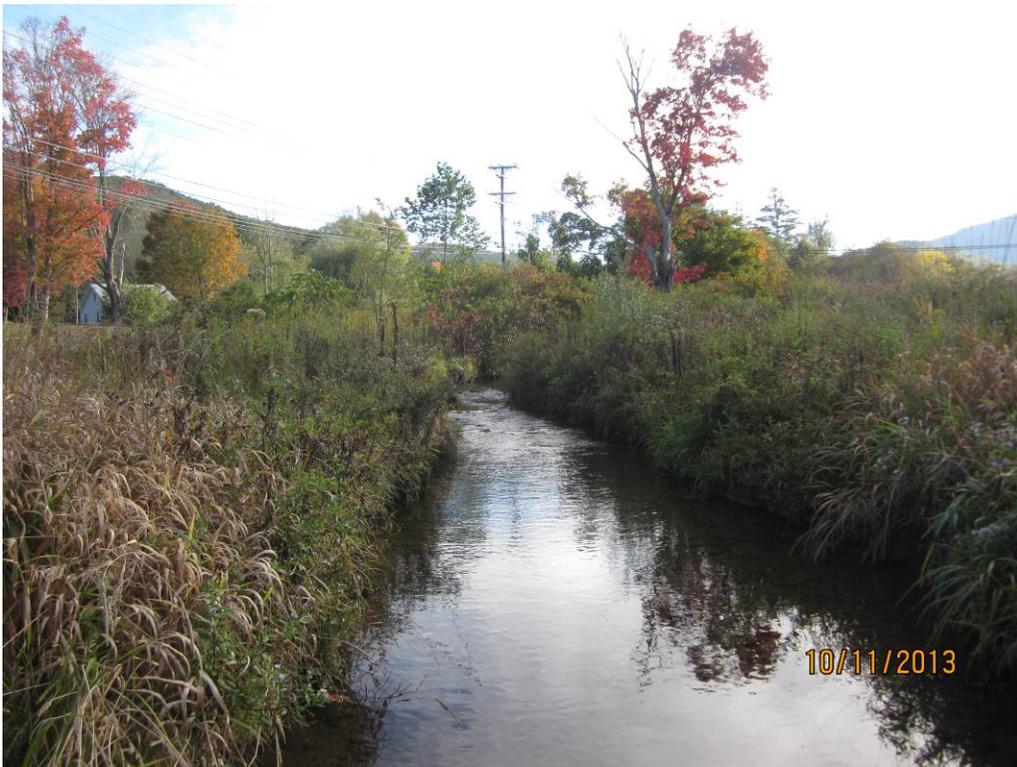
Upstream of culvert under US 184

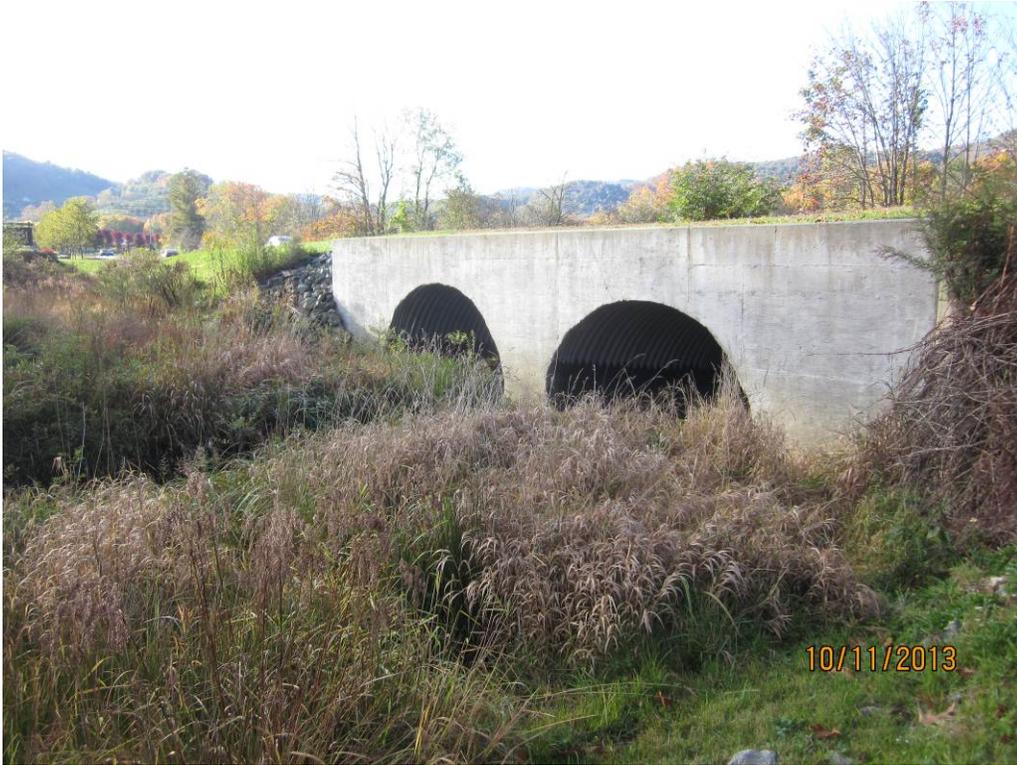
Culvert at US 184

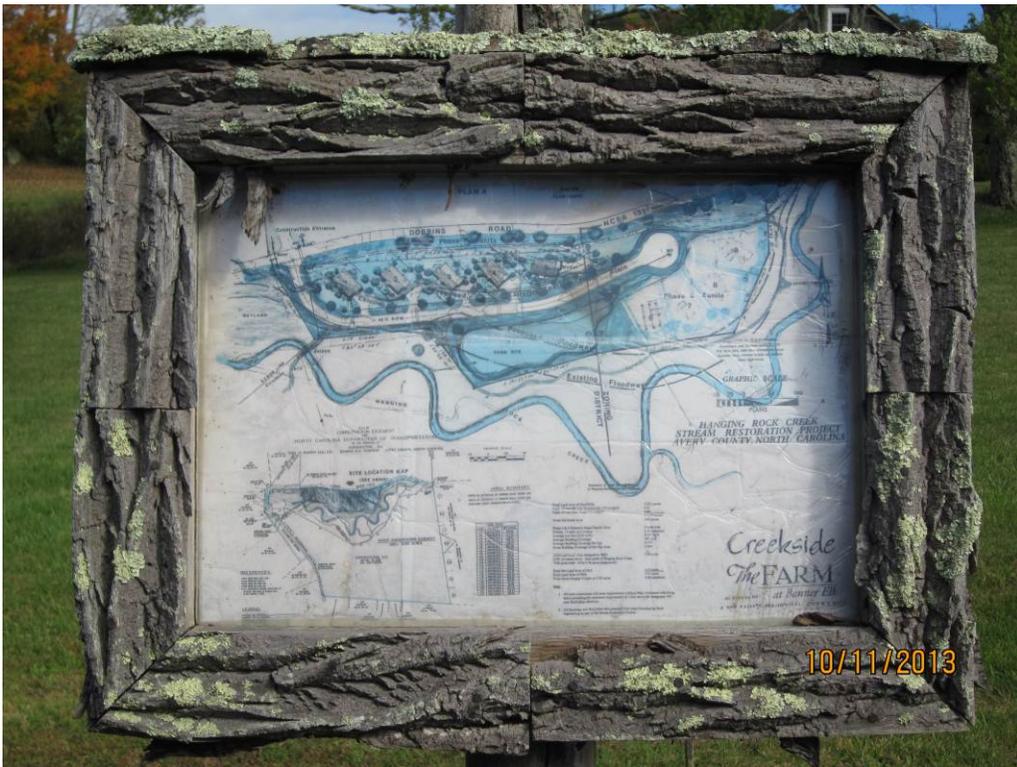
Visual of project area located within adjacent subdivision
