CORBETT TRACT SITE INSPECTION REPORT

MITIGATION SITE NAME Corbett Tract	TIP # U-4751/R-3300	WBS # N/A	INSPECTION DATE 10/28/2014
---------------------------------------	------------------------	--------------	-------------------------------

COUNTY New Hanover	# ACRES 617.5
-----------------------	------------------

MONITORING ORGANIZATION Kimley-Horn	INSPECTOR RLS/JLY	PHONE (919) 677-2104	EMAIL ADDRESS Ross.sullivan@kimley-horn.com
--	----------------------	-------------------------	--

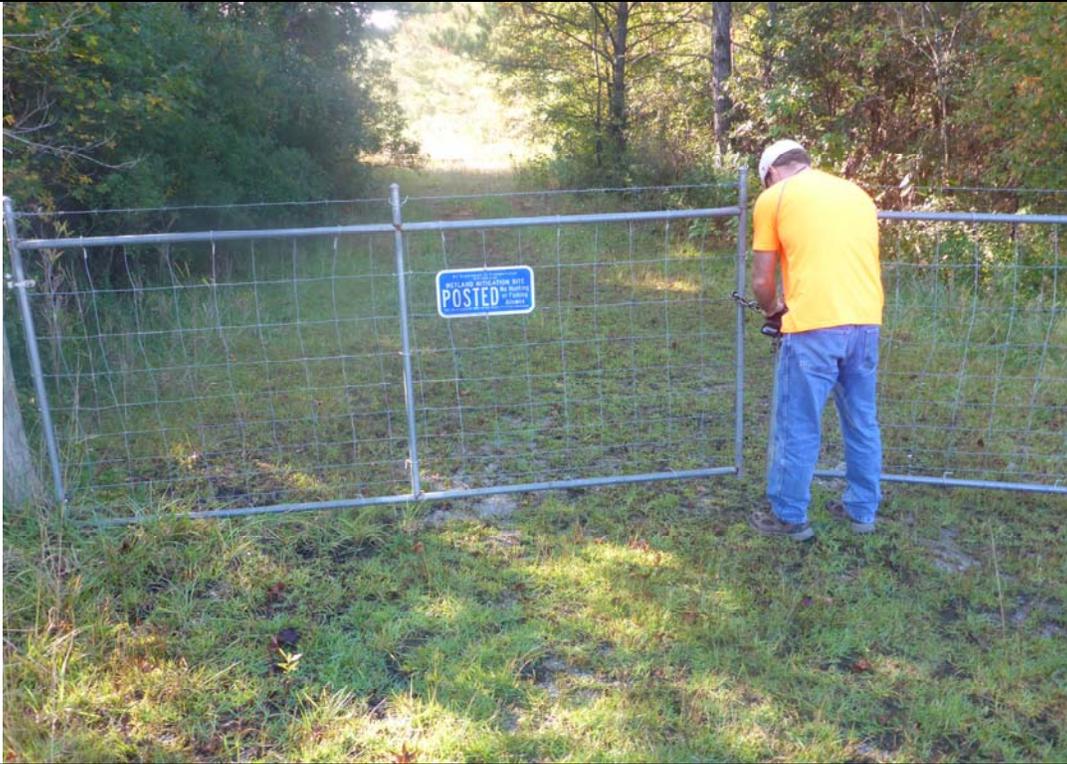
Photo 1 – Site entrance into the southern portion of the Corbett Tract that is accessible from US 17.

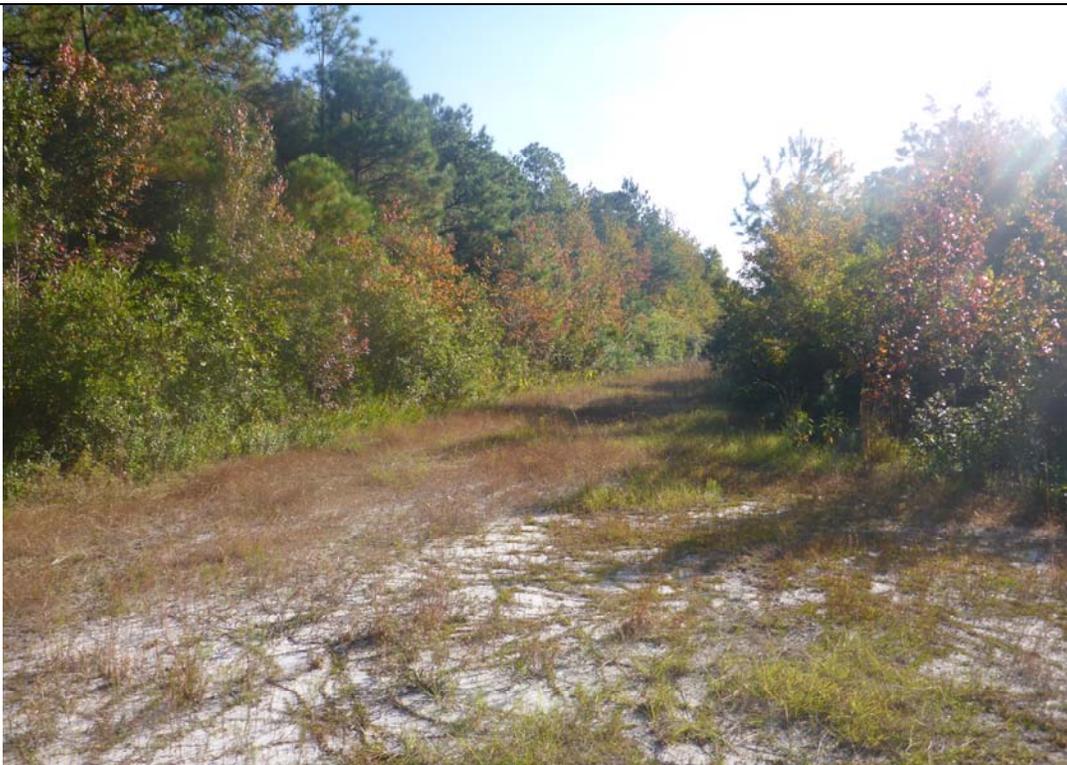
Photo 2 – Large maintained road within the interior of the property.

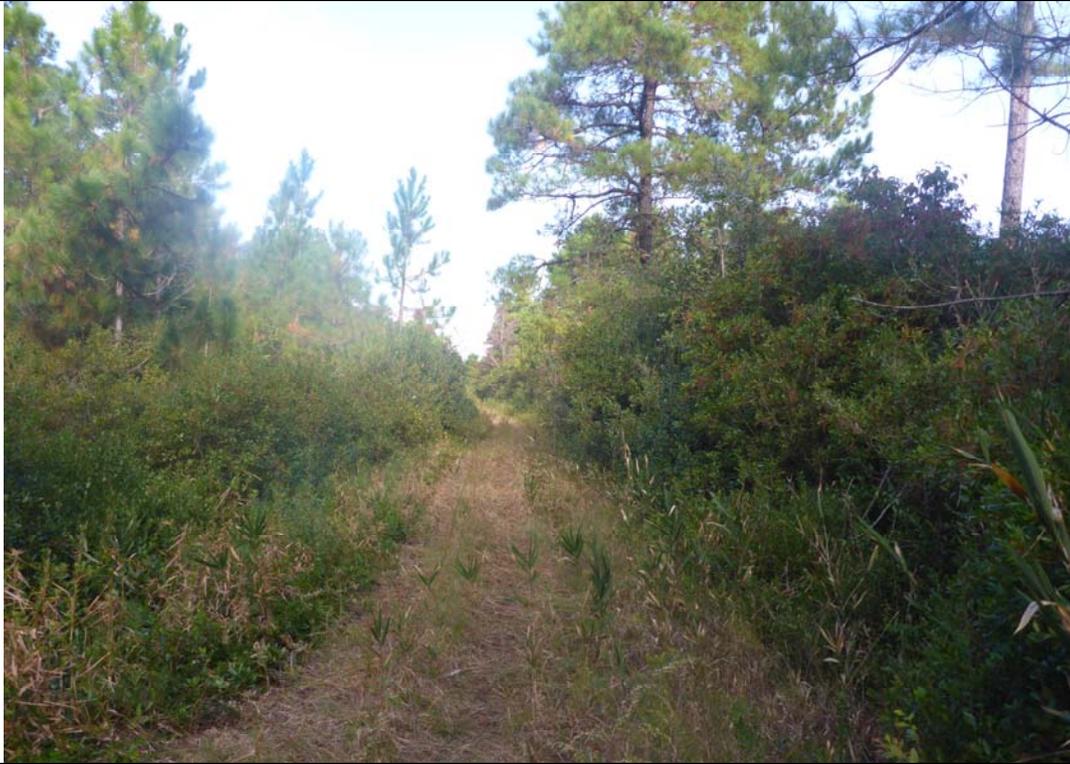
Photo 3 – One of the smaller ATV trails observed on the southern portion of the Corbett Tract.

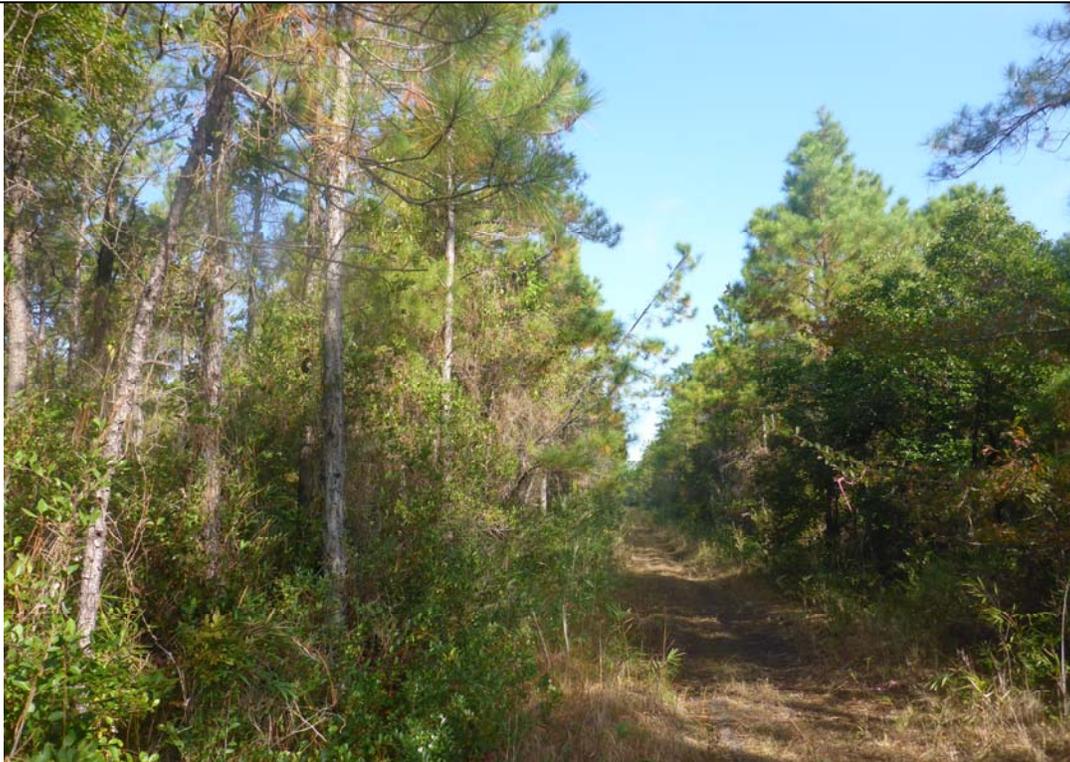
Photo 4 – Another view of the ATV trail.
