DOT SITE INSPECTION REPORT

UT TO BLACK CREEK (HARRISON AVE.) SITE

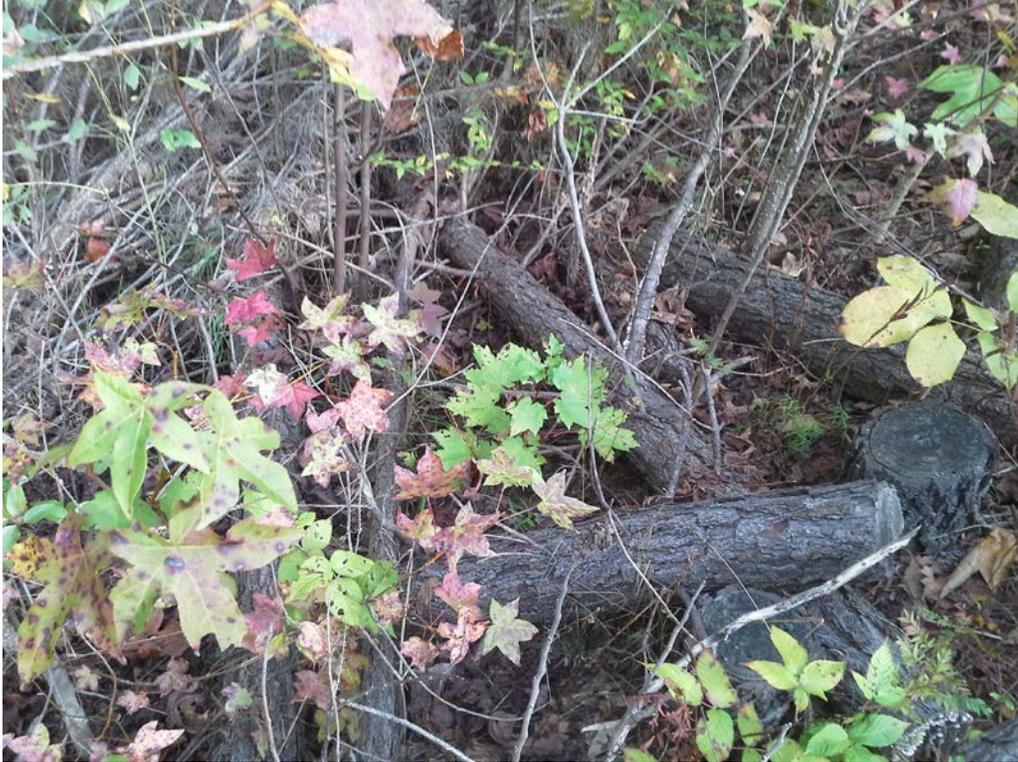
Tree cutting in the power line easement on the north site

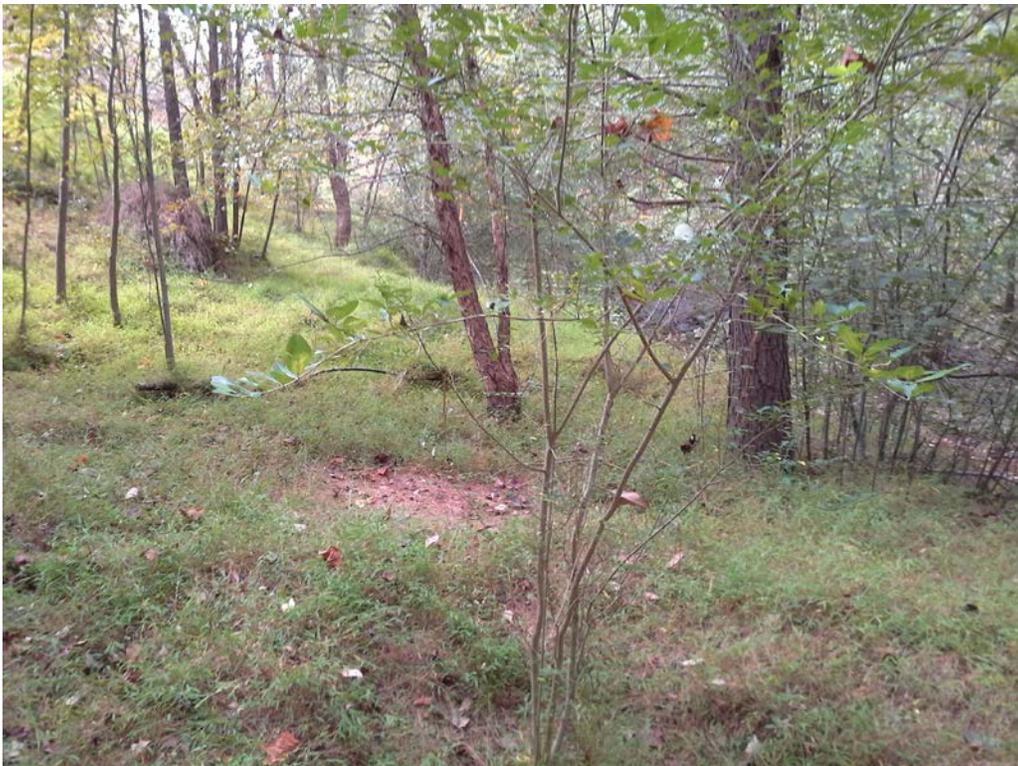
Southern portion of site looking south

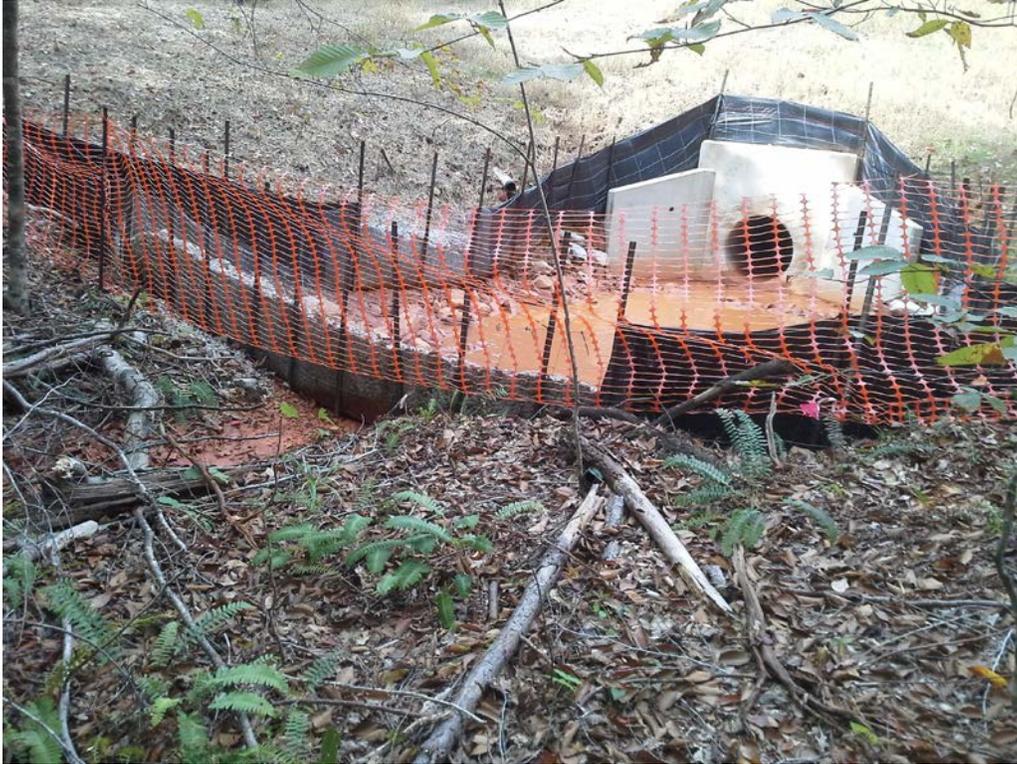
The southern site; stormwater basin on adjoining property to the west

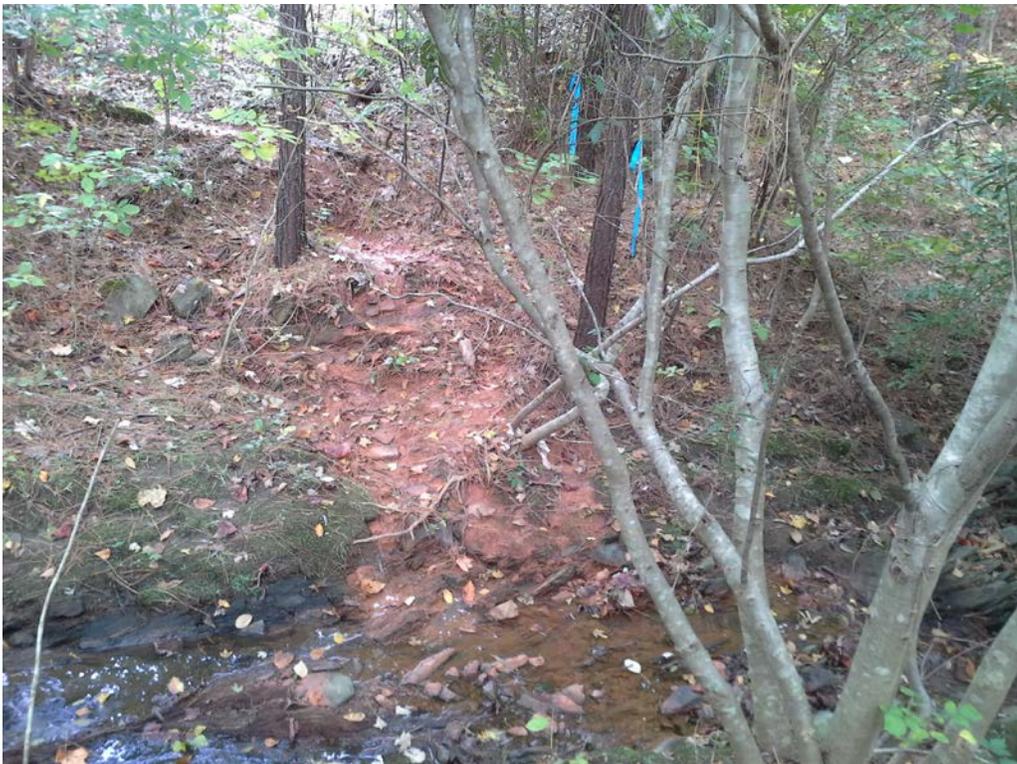
EXPLAIN: New development was observed adjacent to the southern portion of the site. Grading was taking place on this property at the time of the site inspection. A storm water feature was observed just outside of the mitigating area. It appears that a small amount of sediment is escaping the stormwater feature and flowing through the buffer area into the creek. See enclosed map for location of sediment fence and runoff location. The site buffer remained in good condition.

Area of sediment escaping the stormwater basin and entering creek
