‘CORBETT TRACT’ INSPECTION REPORT

MITIGATION SITE NAME Corbett Tract	TIP # U-4751/R-3300	WBS # N/A	INSPECTION DATE Nov-2015
---------------------------------------	------------------------	--------------	-----------------------------

COUNTY New Hanover	# ACRES 617.5
-----------------------	------------------

MONITORING ORGANIZATION KCI for NCDOT	INSPECTOR AF/TS	PHONE (919)783-9214	EMAIL ADDRESS alex.french@kci.com
--	--------------------	------------------------	--------------------------------------

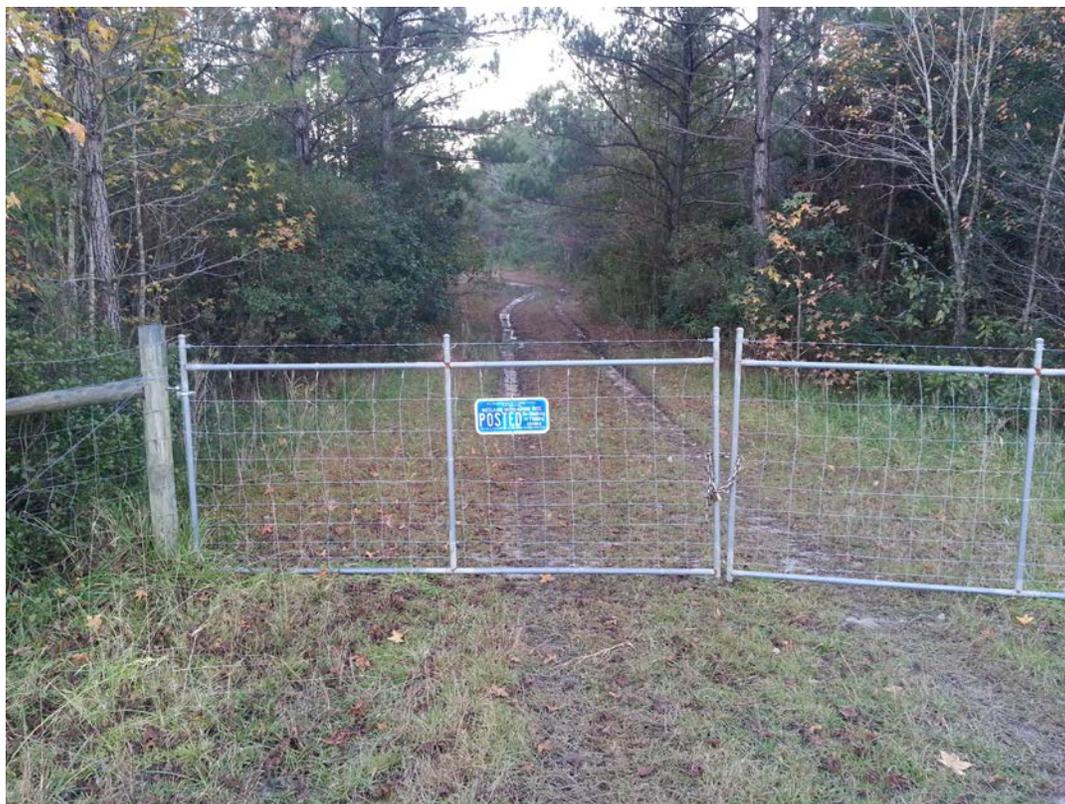
Photo 4 - Access gate along US-17 closed and locked. Signs of vehicles accessing site.
