Channel Mitigation Monitoring Sheets I, II, III, AND IV
Monitoring Data Record

Project Title: R-5206 COE Action ID: 2015-00451
Stream Name: UT to Blanton Branch – Permit Site 5 DWR Number: 2015-0216
City, County and other Location Information: The project is located on Cope Creek Rd, SR 1449 just off of US 74 in Jackson County, NC.
Date Construction Completed: _____ Final Planting: April 10, 2018
Monitoring Year: (1) of 3
Ecoregion: Southern Crystalline Ridges and Mountains 8 digit HUC unit 06010203
USGS Quad Name and Coordinates: Sylva North 35.390942°, -83.185654°
Rosgen Classification: _____
Length of Project: 277 linear feet
Urban or Rural: Rural Watershed Size: 0.65 sq. miles
Monitoring DATA collected by: M. Green Date: 7-9-18
Applicant Information:
Name: NCDOT Roadside Environmental Unit
Address: 1425 Rock Quarry Road Raleigh, NC 27610
Telephone Number: (919) 615-6733 Email address: mlgreen@ncdot.gov
Consultant Information:
Name: _____
Address: _____
Telephone Number: _____ Email address: _____

UT to Blanton Branch Mitigation Site

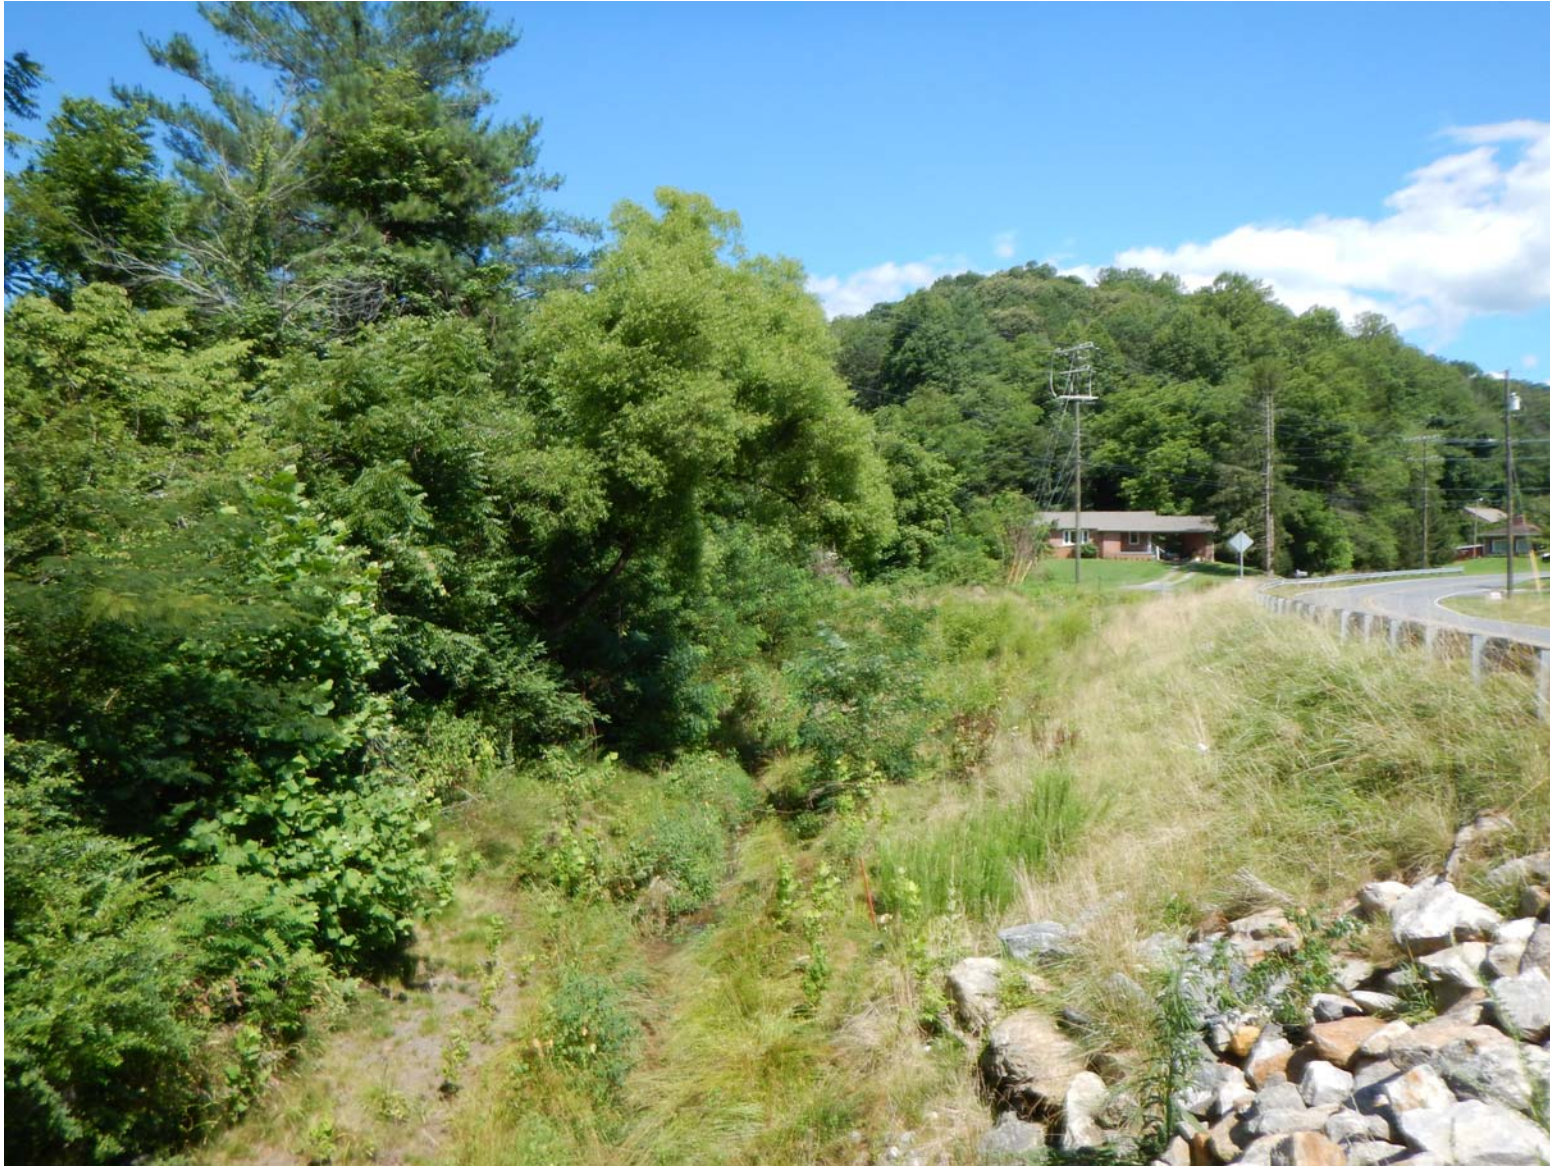
Overview photo looking upstream

The UT to Blanton Branch onsite stream mitigation is stable for the Year 1 evaluation. No instability was noted along the stream and all structures were functioning properly. NCDOT will continue to monitor channel stability at the UT to Blanton Branch Mitigation Site in 2019.
