# ANNUAL REPORT FOR 2016

**R-2635C UT to Reedy Branch**  
**Wake County**  
**USACE Action ID: 2007-02903-292**  
**NCDWR Project #: 20071470**

Prepared By:  
Natural Environment Unit & Roadside Environmental Unit  
North Carolina Department of Transportation  
December 2016

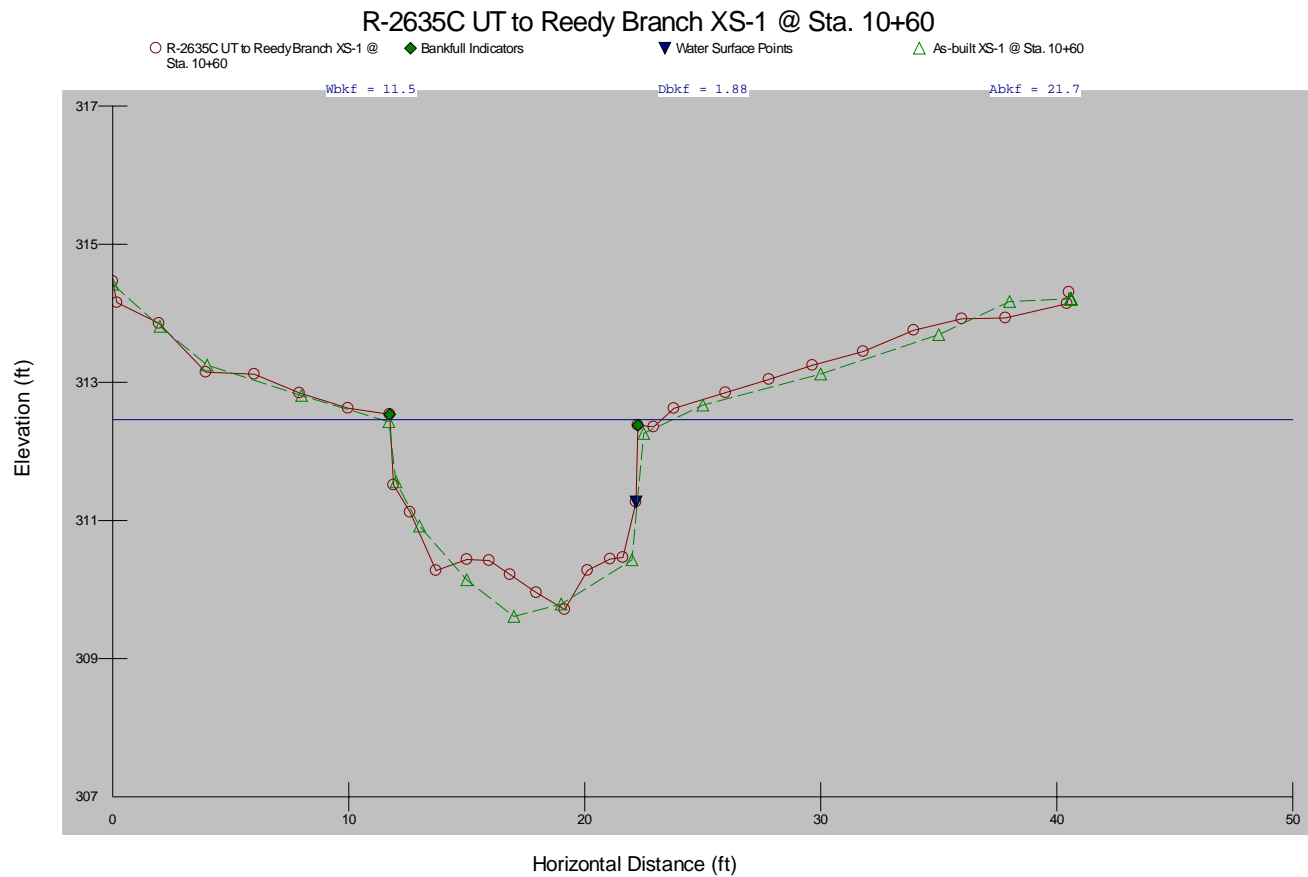
Cross-Section #1 (Pool) Abbreviated Morphological Summary				
	As-built	2016	2017	2018
Bankfull Width (ft)	10.8	11.5		
Bankfull Mean Depth (ft)	2.53	1.88		
Bankfull Cross Sectional Area (ft <sup>2</sup> )	27.3	21.67		
Maximum Bankfull Depth (ft)	3.2	2.75

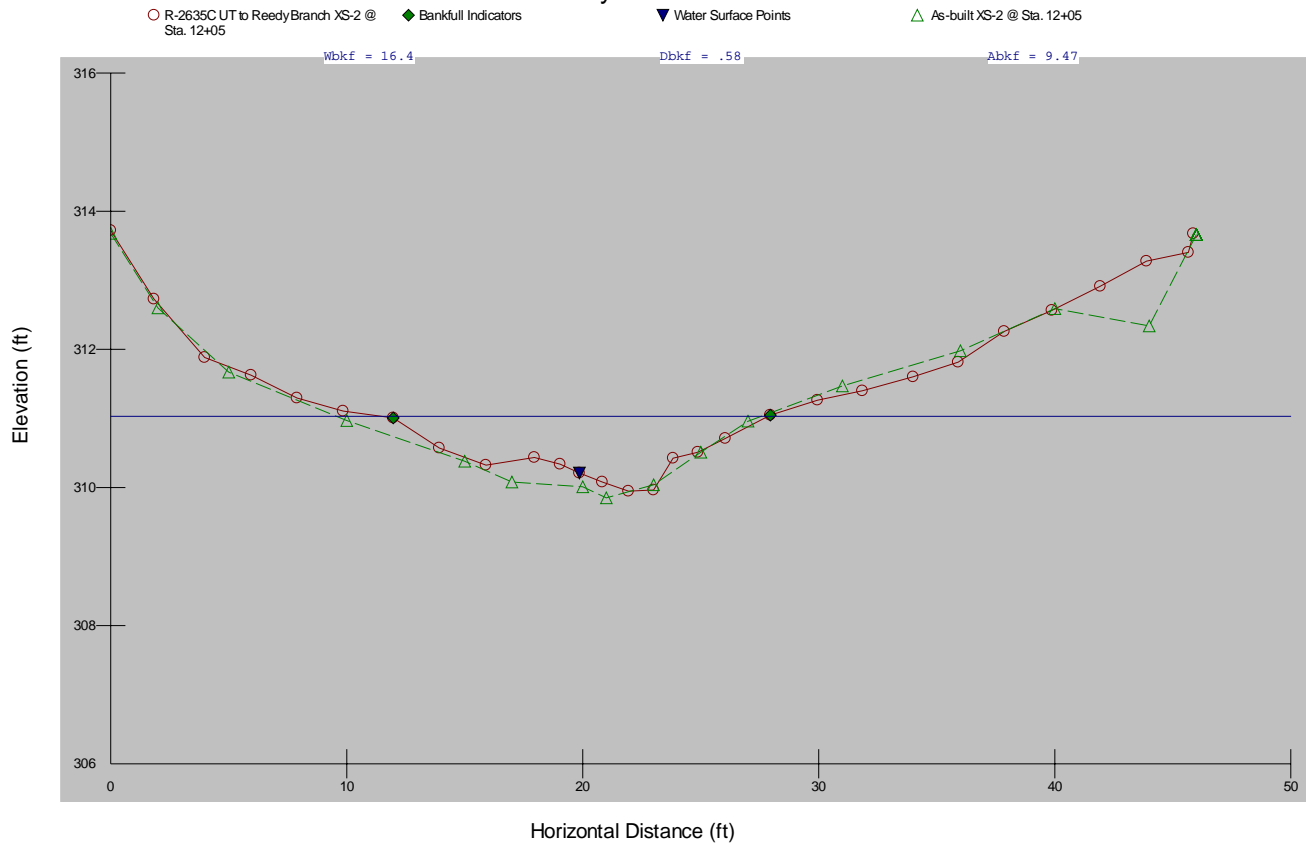
### R-2635C UT to Reedy Branch XS-2 @ Sta. 12+05

Cross-Section #2 (Riffle) Abbreviated Morphological Summary				
	As-built	2016	2017	2018
Bankfull Width (ft)	16.92	16.38		
Bankfull Mean Depth (ft)	0.62	0.58		
Width/Depth Ratio	27.29	28.24		
Bankfull Cross Sectional Area (ft <sup>2</sup> )	10.51	9.47		
Maximum Bankfull Depth (ft)	1.11	1.08		
Width of the Floodprone Area (ft)	32.88	33.82		
Entrenchment Ratio	1.94	2.07

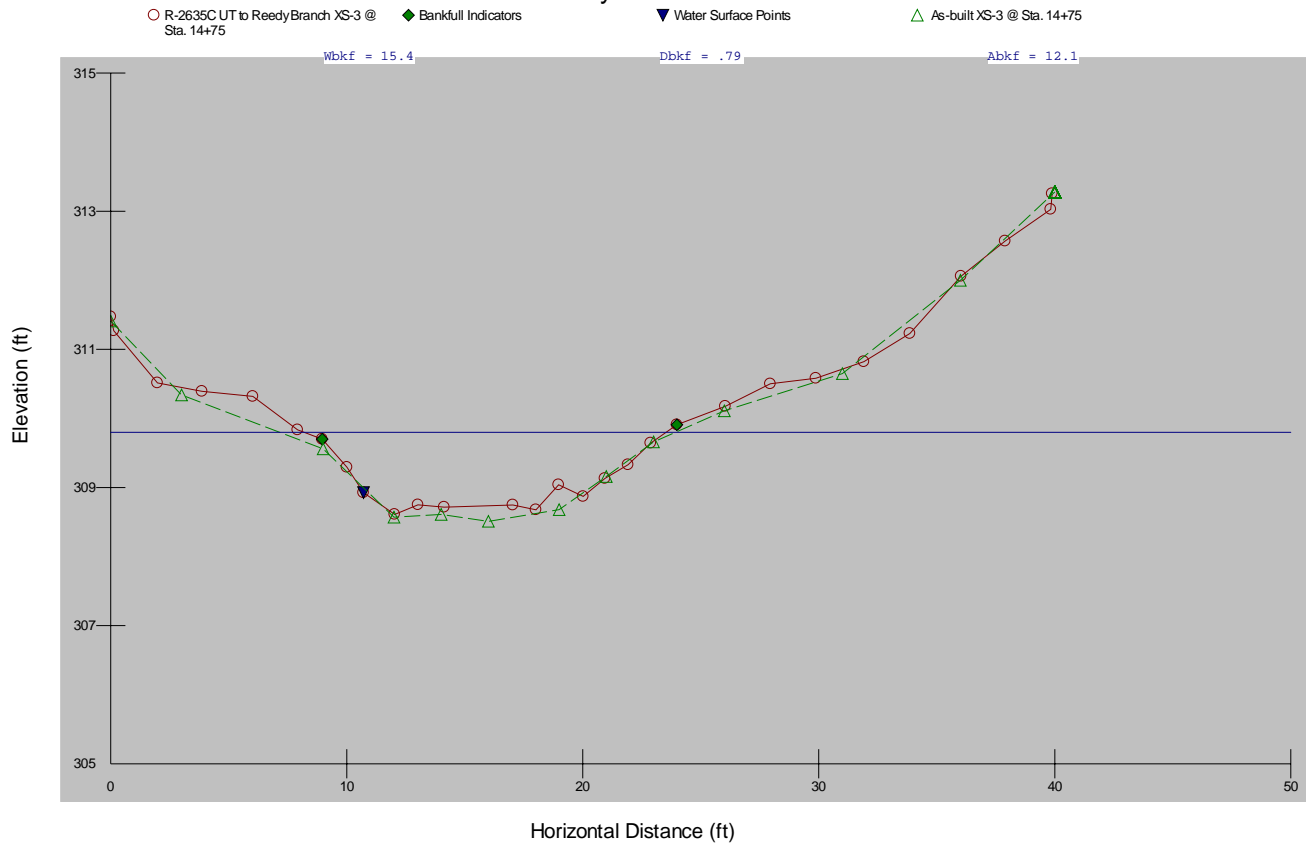
### R-2635C UT to Reedy Branch XS-3 @ Sta. 14+75

Cross-Section #3 (Riffle) Abbreviated Morphological Summary				
	As-built	2016	2017	2018
Bankfull Width (ft)	14.77	15.35		
Bankfull Mean Depth (ft)	0.77	0.79		
Width/Depth Ratio	19.18	19.43		
Bankfull Cross Sectional Area (ft <sup>2</sup> )	11.34	12.1		
Maximum Bankfull Depth (ft)	1.15	1.19		
Width of the Floodprone Area (ft)	29.91	31.89		
Entrenchment Ratio	2.03	2.08

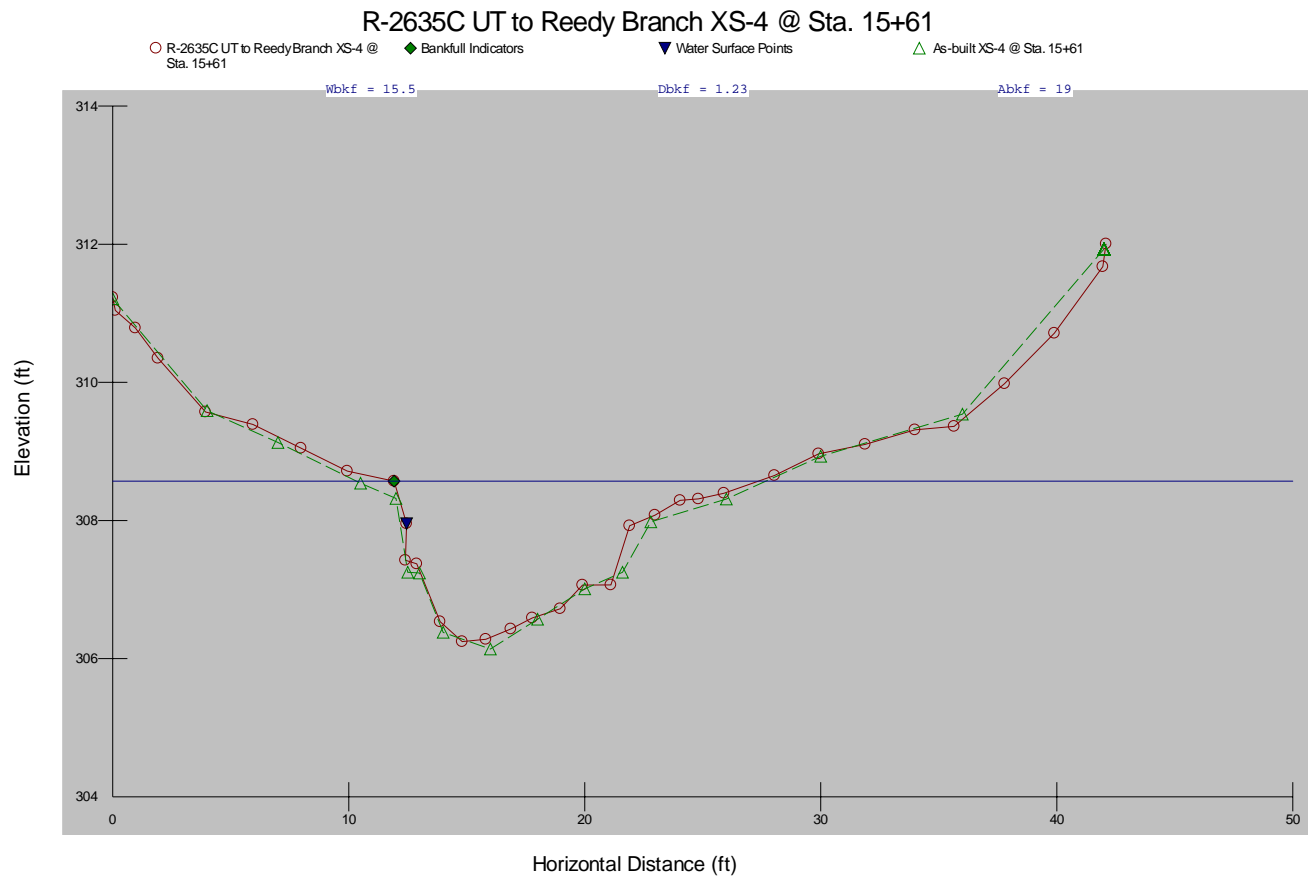
Cross-Section #4 (Pool) Abbreviated Morphological Summary				
	As-built	2016	2017	2018
Bankfull Width (ft)	16.98	15.45		
Bankfull Mean Depth (ft)	1.19	1.23		
Bankfull Cross Sectional Area (ft <sup>2</sup> )	20.15	18.96		
Maximum Bankfull Depth (ft)	2.4	2.32

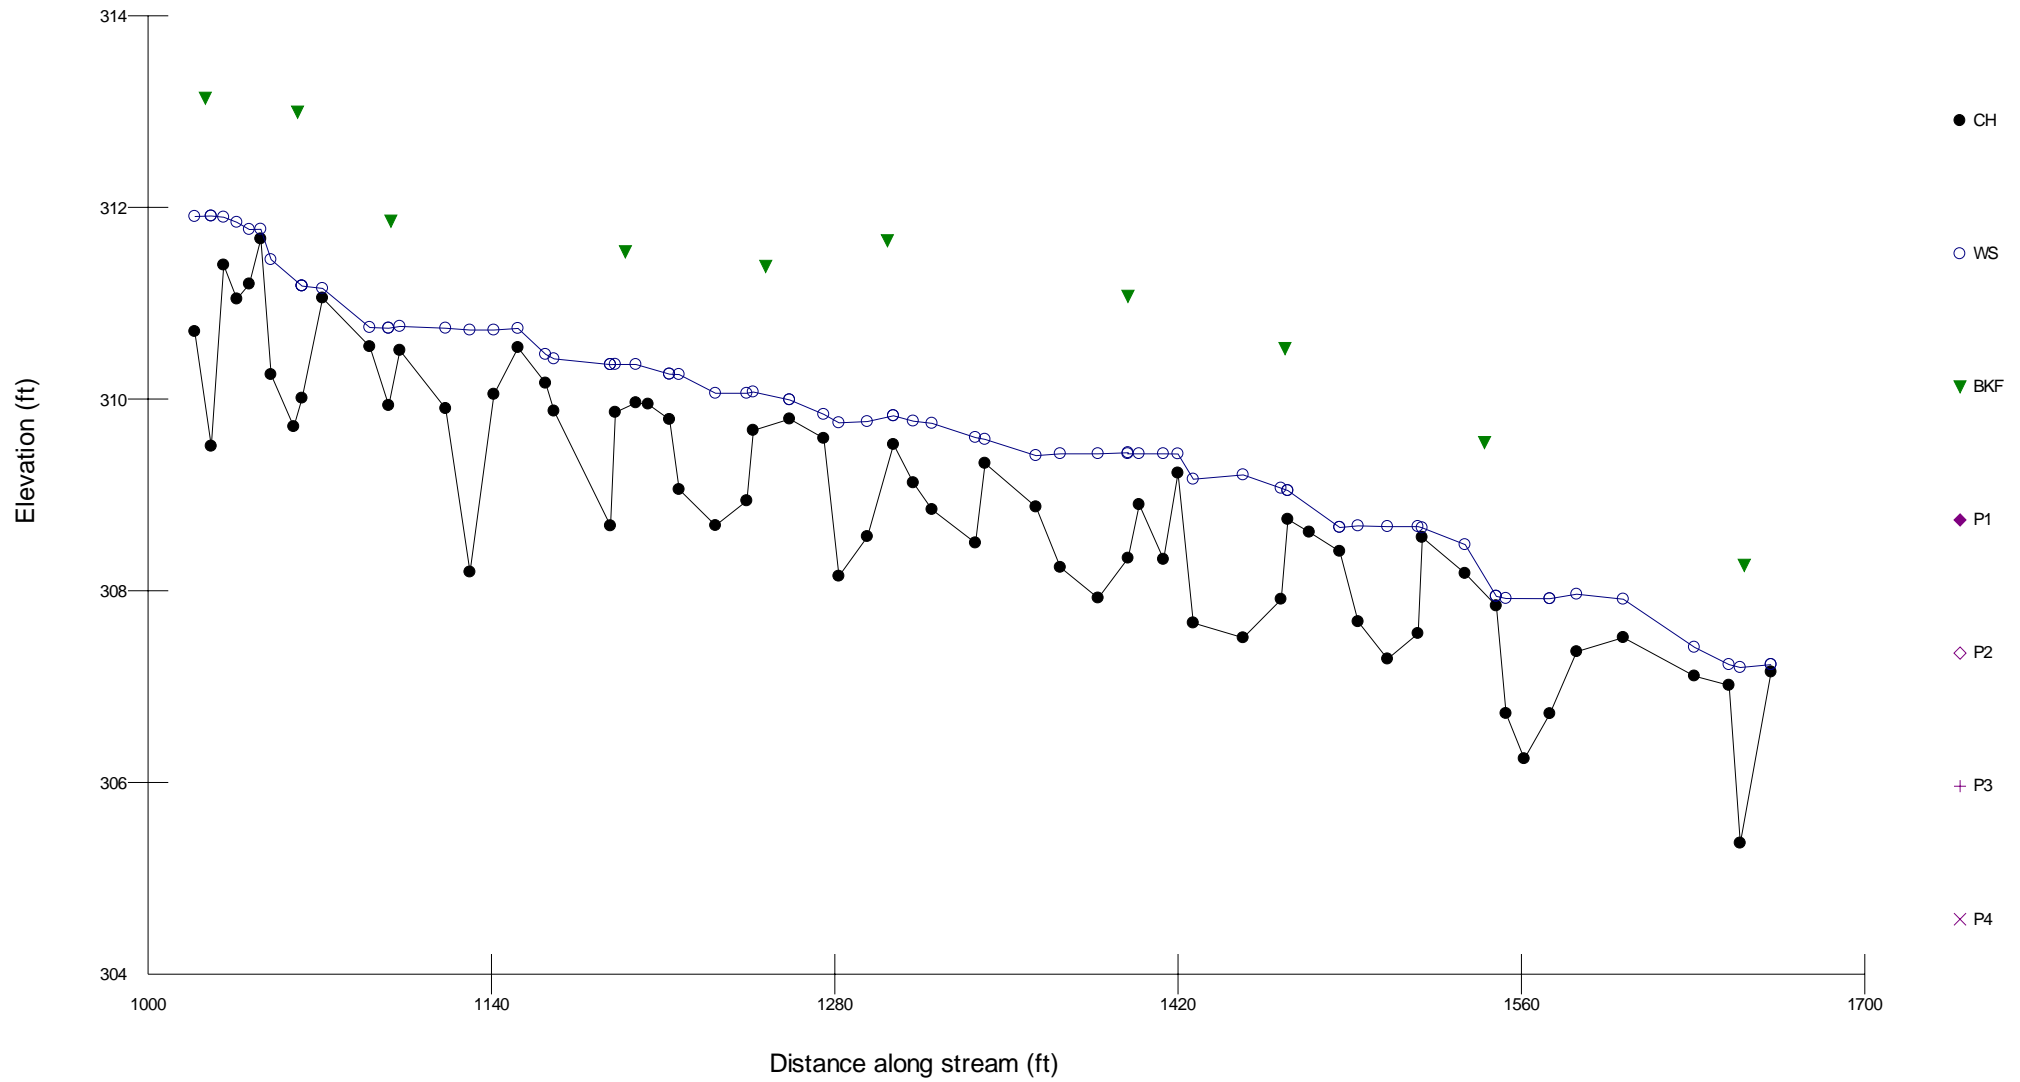
2016 Year 1 R-2635C Longitudinal Profile

Based on visual assessment and comparisons of the as-built to MY1 monitoring data, the channel and all four cross sections appear stable with little or no active bank erosion. Graphs of the cross sections are presented in Appendix A. The longitudinal profile showed that the channel was stable for the 2016 MY1 monitoring evaluation. Photo points 1 through 4 presented in Appendix B show steady growth of herbaceous and woody vegetation. Based on field observations (sand deposits and wrack lines) at least one bankfull event has occurred since construction was completed on this site. Pebble counts were not required per the permit conditions and therefore were not completed. All other monitoring activities will continue to be completed by NCDOT throughout the five-year monitoring period.
