MITIGATION SITE NAME Tulula		TIP # A-0009WM			ID # -001	INSPECTION DATE AUGUST 19, 2020	
COUNTY Graham		# ACRES 242.30					
MONITORING ORGANIZATION KCI for NCDOT TS/KOB		-	PHONE (919) 783-9214		EMAIL ADDRESS tommy.seelinger@kci.com		
INSPECTION ACTIVITIES: Complete all that apply. Describe location of visited areas if <100%.							
Walked boundaries	Yes 🗌 No 🗌]N/A	Walked tr	ails / roads	YES YES	NO N/A	
Walked road frontage	Kes 🗌 No 🗌] N/A	Walked in	terior	YES YES	NO N/A	
Monitored from air	Kes 🗌 No 🗵	N/A					
Condition of boundaries			Good	FAIR P	OOR		
COMMENTS: Lock on gate leading into site from northeast corner has been broken. Spoke to WRC Ranger

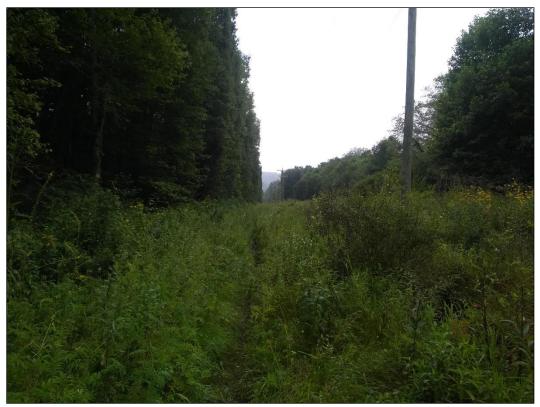
who said that haven't noticed any other signs of trespass. Main road through site shows signs of WRC access, but most roads through site are overgrown. There are also several large beaver dams backing up the stream on site. Land clearing/storage mentioned in last year's report is an allowed use.

Photo 1 - Interior of site. Road shows access by WRC.

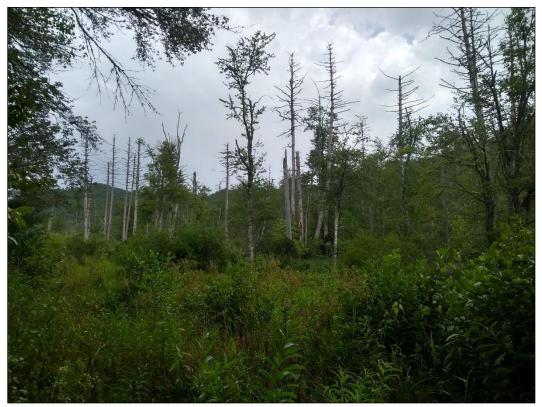
Photo 2 – View of site interior.

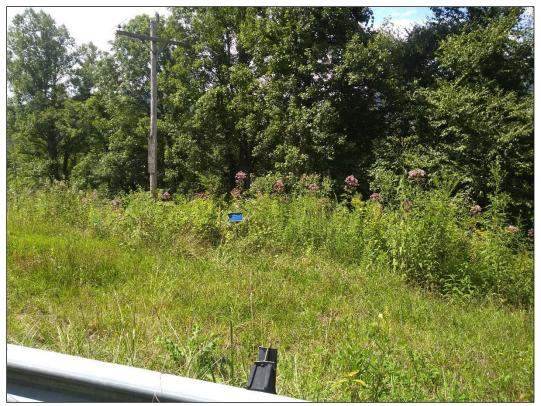
Photo 3 – Site boundary with signage visible and present.

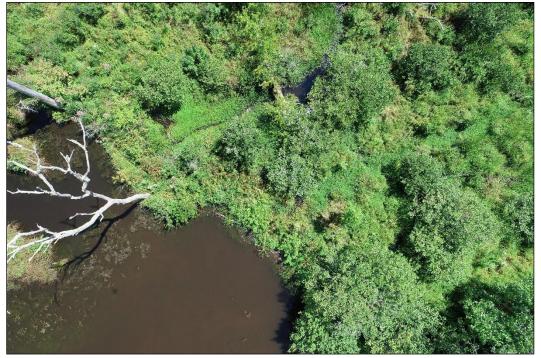
FLOODING	FIRE	STORM	EARTH MOVEMENT					
∑Invasive Exotic Vegetation	INSECT INFESTATION	Animal Activity	OTHER ACTIVITIES/ CHANGES? (Please Explain)					
COMMENTS: Lots of Kudzu was observed along site perimeter. Several large beaver dams are blocking up the stream on site.

Photo 4 – One of the large beaver dams on site.

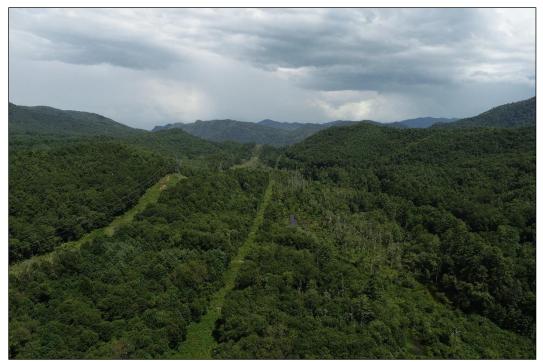
Photo 5 – Aerial view of the site looking east
