TULULA INSPECTION REPORT

MITIGATION SITE NAME Tulula	TIP # A-0009WM	ONE ID # 038-001	INSPECTION DATE OCTOBER 5, 2022
--------------------------------	-------------------	---------------------	------------------------------------

COUNTY Graham	# ACRES 242.30
------------------	-------------------

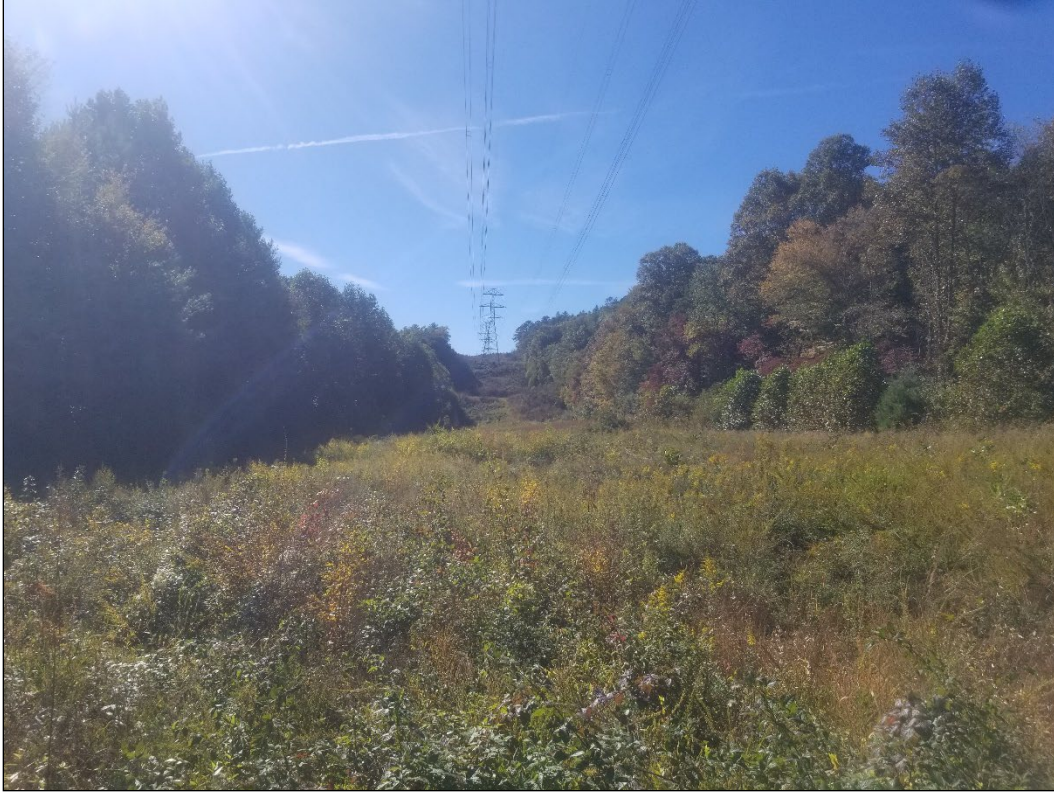
Photo 1 – Interior view of site along northern boundary under powerline easement.

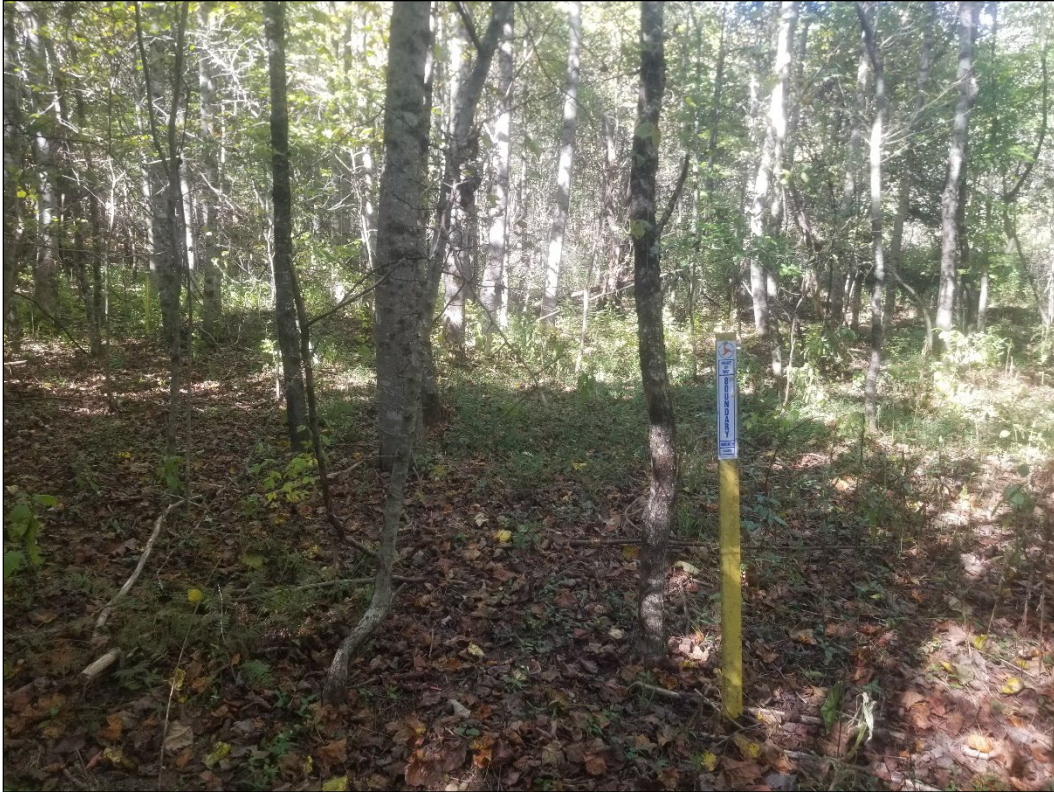
Photo 2 – View of site interior with NCDOT boundary markers present.

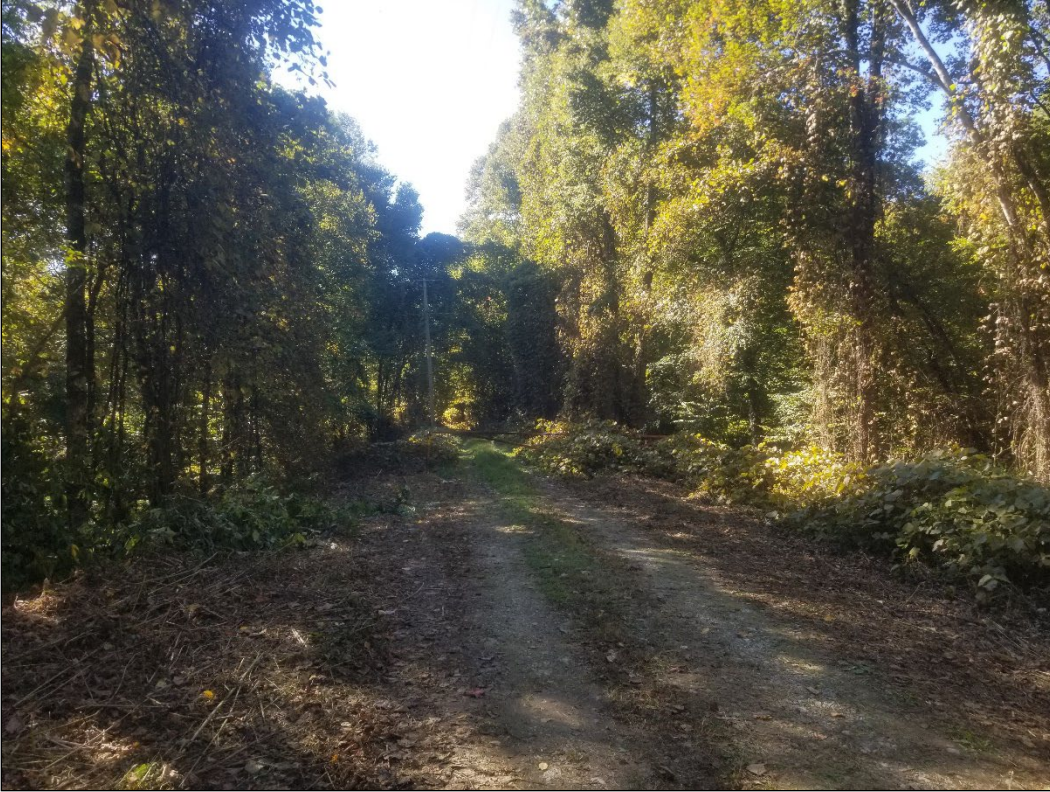
Photo 3 – Northeastern gate entrance to site, locked at time of visit.

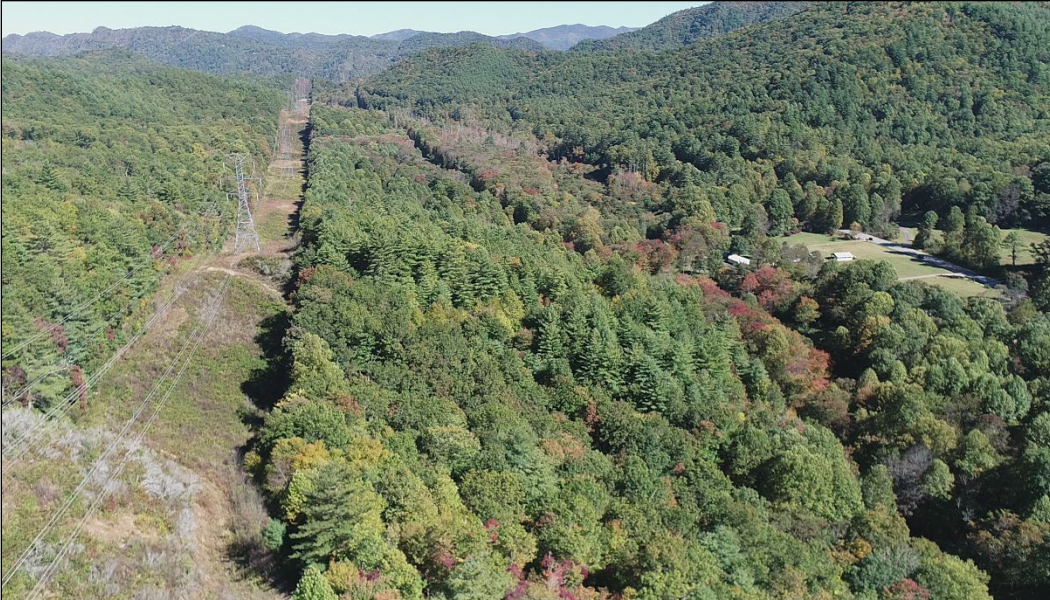
Photo 4 – Aerial view of the interior of the site looking east.

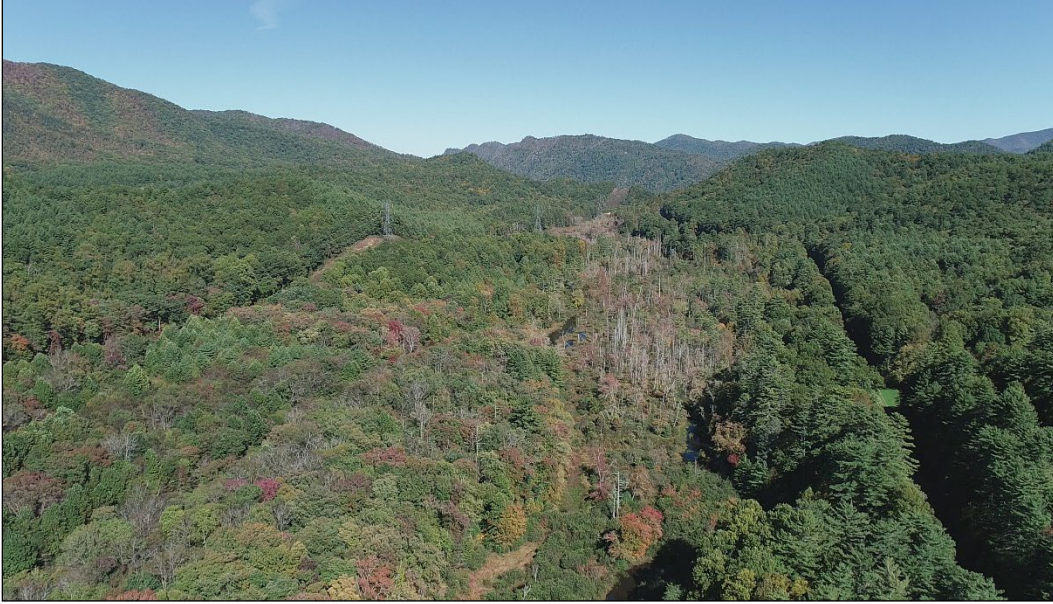
Photo 5 – Aerial view of the interior of the site looking west.
