DOT SITE INSPECTION REPORT

MITIGATION SITE NAME Tulula	TIP # A-0009WM	ONEID 038-001	INSPECTION DATE October 25, 2023
--------------------------------	-------------------	------------------	-------------------------------------

COUNTY Graham	# ACRES 242.3
------------------	------------------

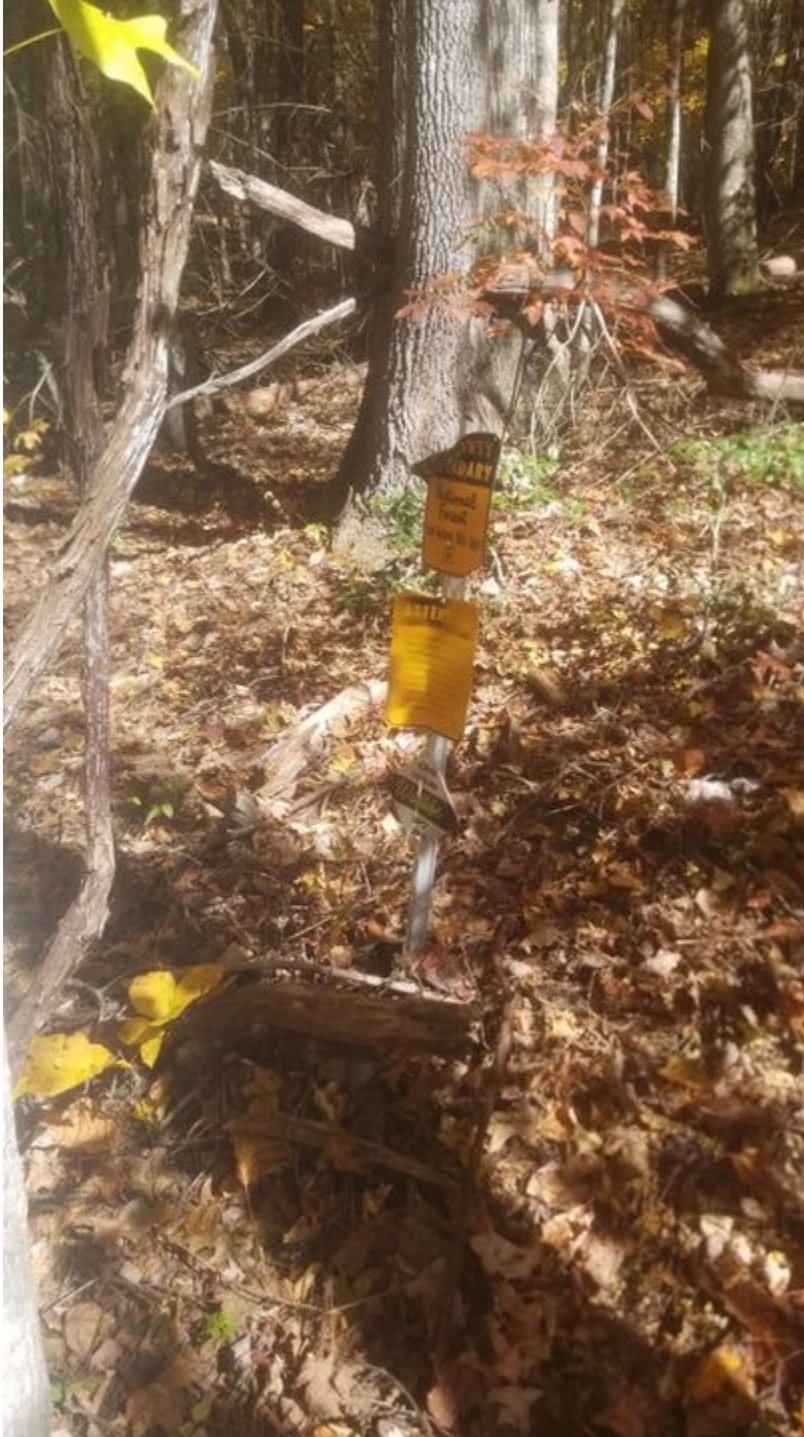
Image #1: Property boundary marker near the northern end of the site

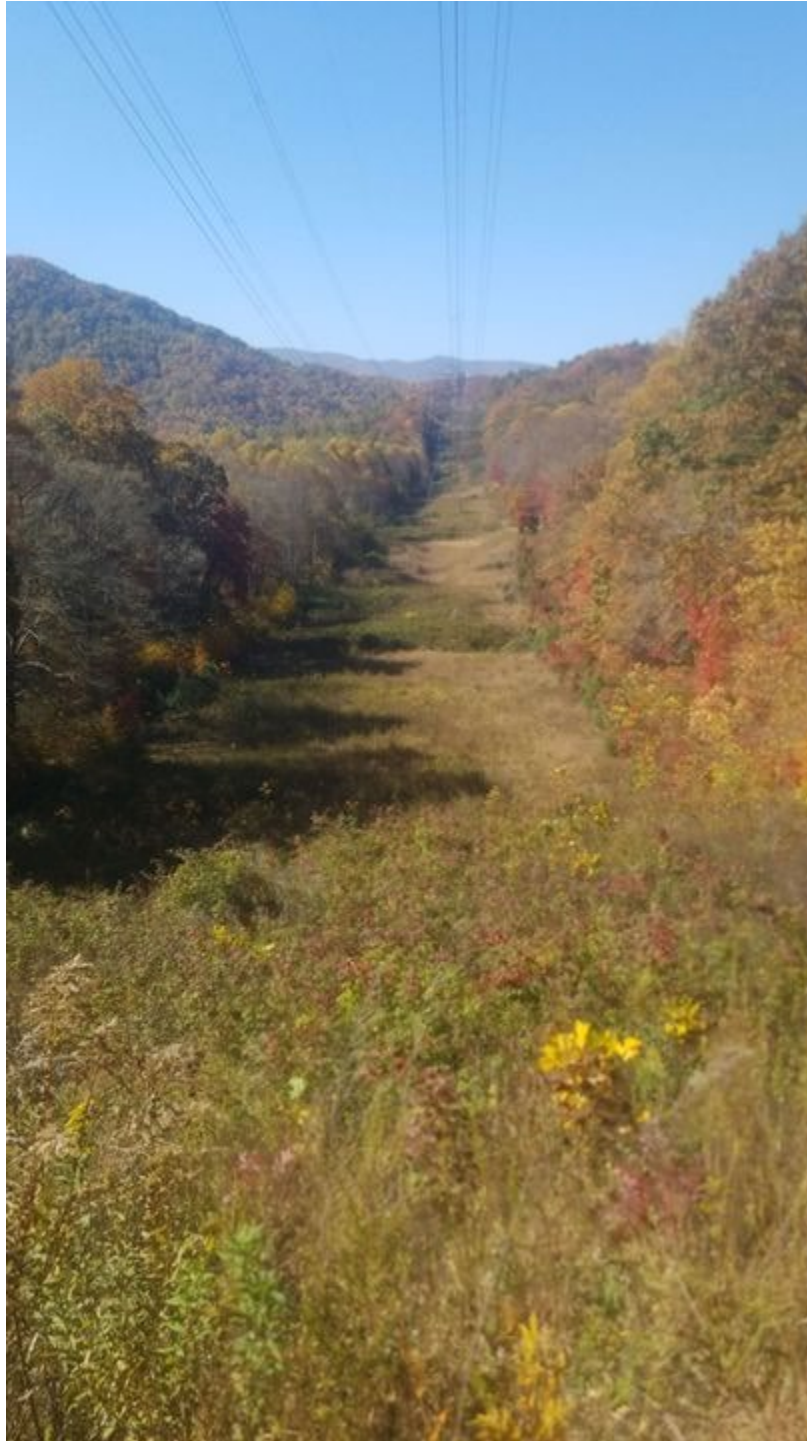
Image #2: Powerline easement through site

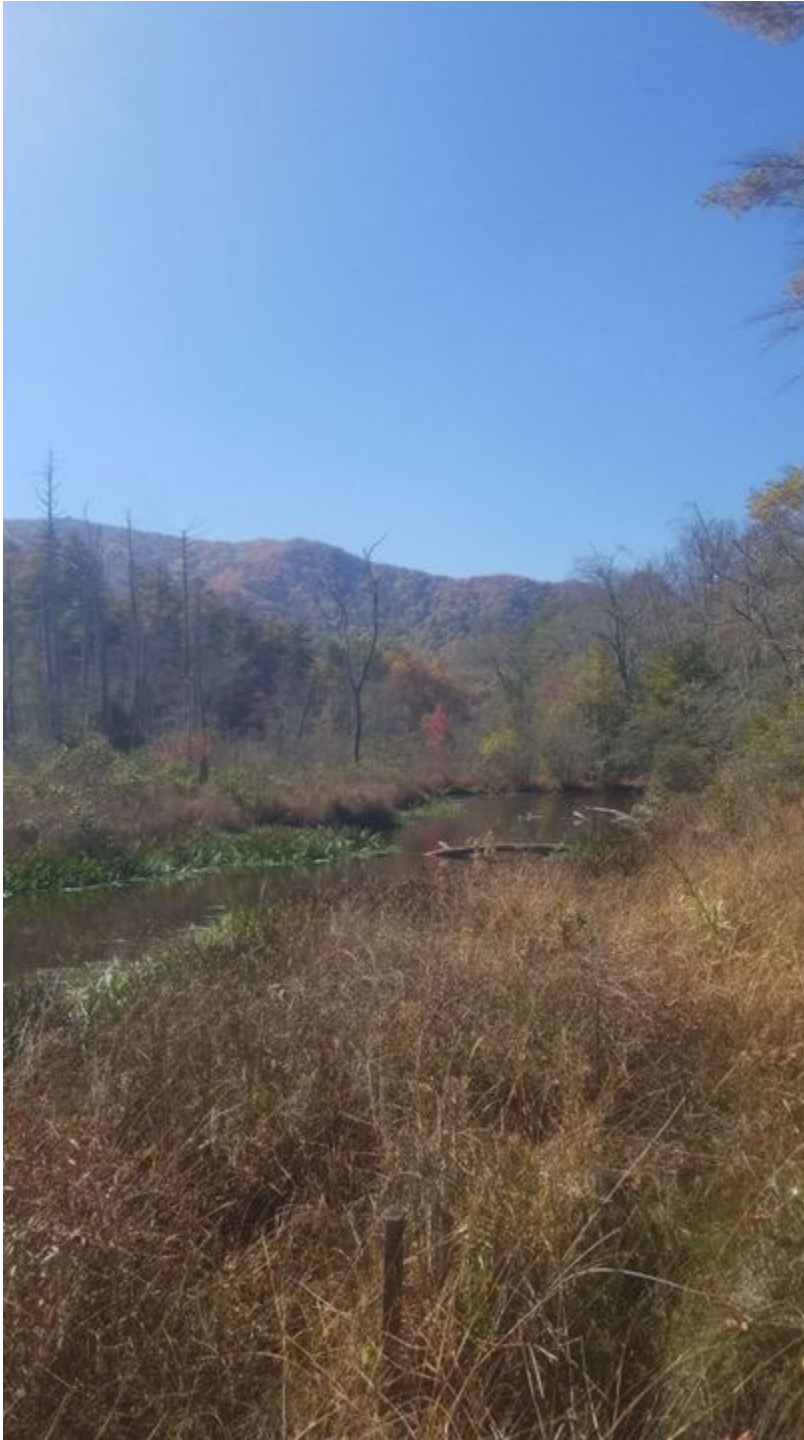
Image #3: Project stream

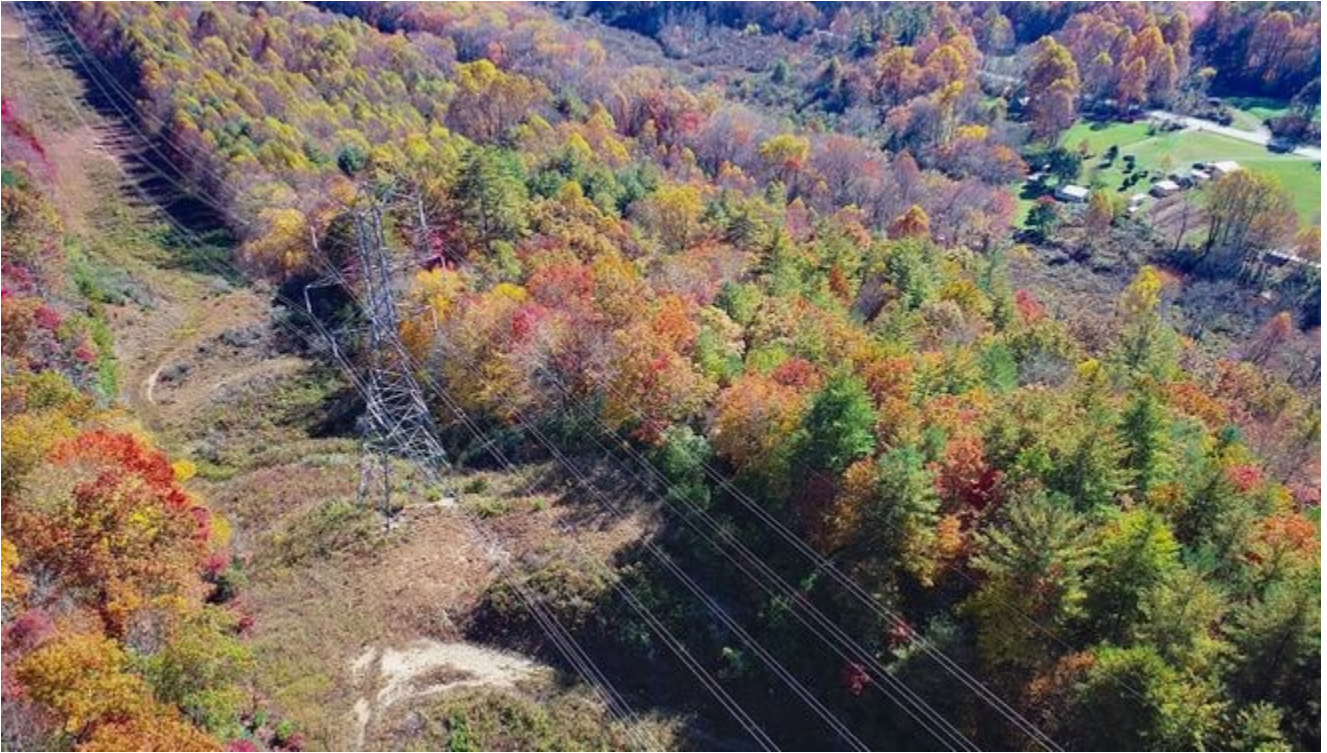
Image #4: Powerline easement through the site

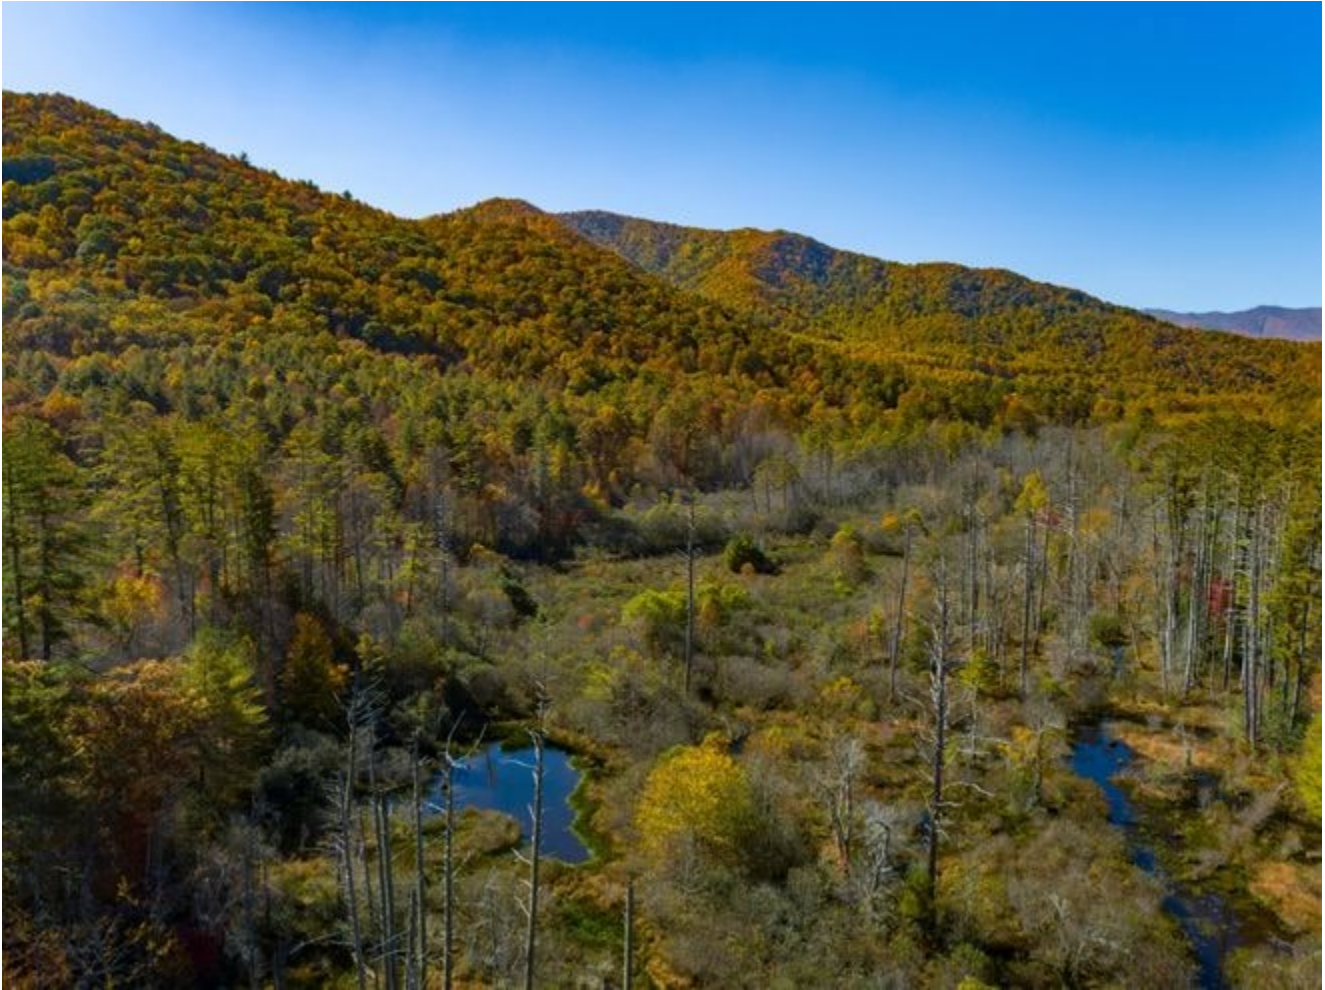
Image #5: Project stream
