TULULA INSPECTION REPORT

MITIGATION SITE NAME Tulula	TIP # A-0009WM	WBS # 34634.2.14	INSPECTION DATE 8/22/14
--------------------------------	-------------------	---------------------	----------------------------

COUNTY Graham	# ACRES 234.4
------------------	------------------

MONITORING ORGANIZATION NCDOT	INSPECTOR SE / VM	PHONE (919) 785-1118	EMAIL ADDRESS vickie.miller@hdrinc.com
----------------------------------	----------------------	-------------------------	---

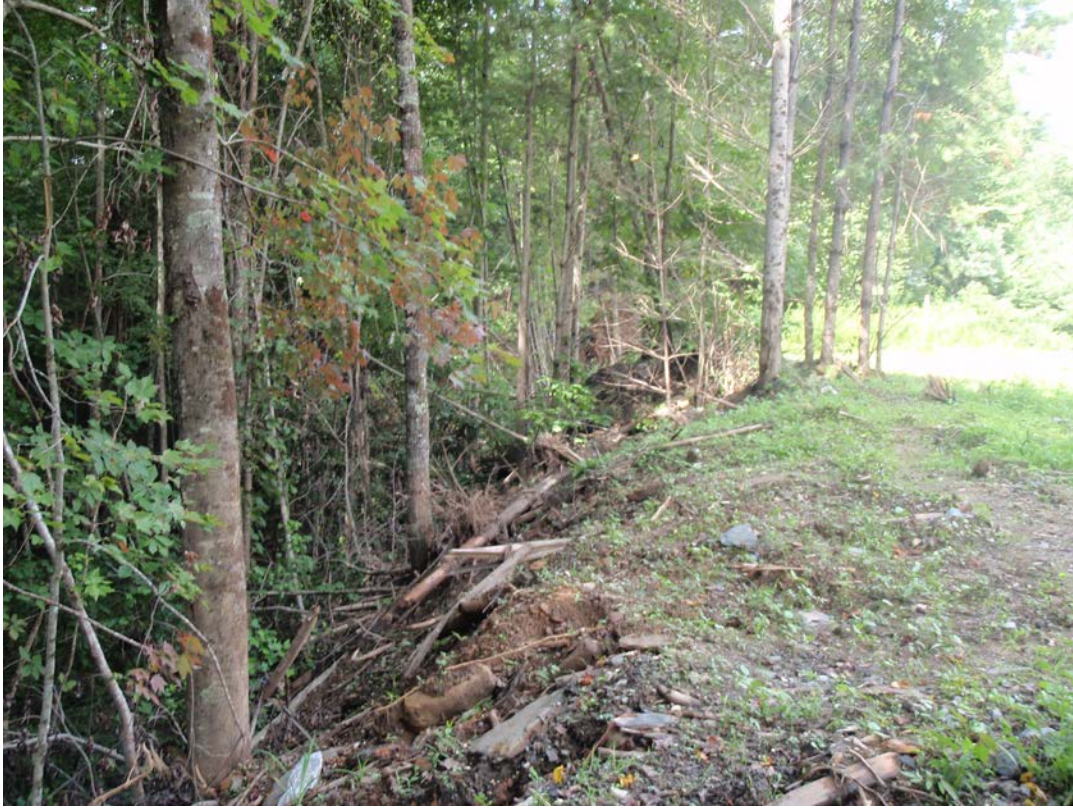
EXPLAIN: Some dumping continues to occur along a gated pull in site off of Tallulah Road. It is comprised mainly of woody debris. A second debris area is also noted beyond the newly cut barricade. See photos of the two debris piles located off of Tallulah Road.

Dumping site looking toward Tallulah Road appears to be leveled and graded

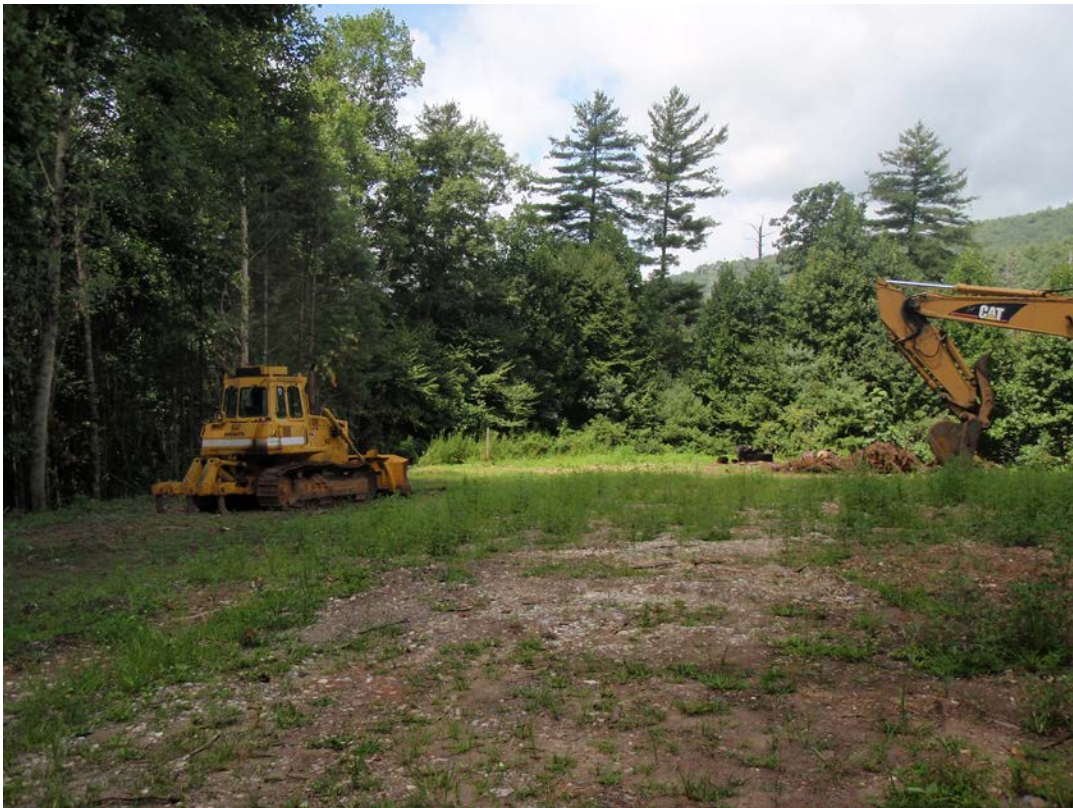
Dumping site looking from access gate north toward site

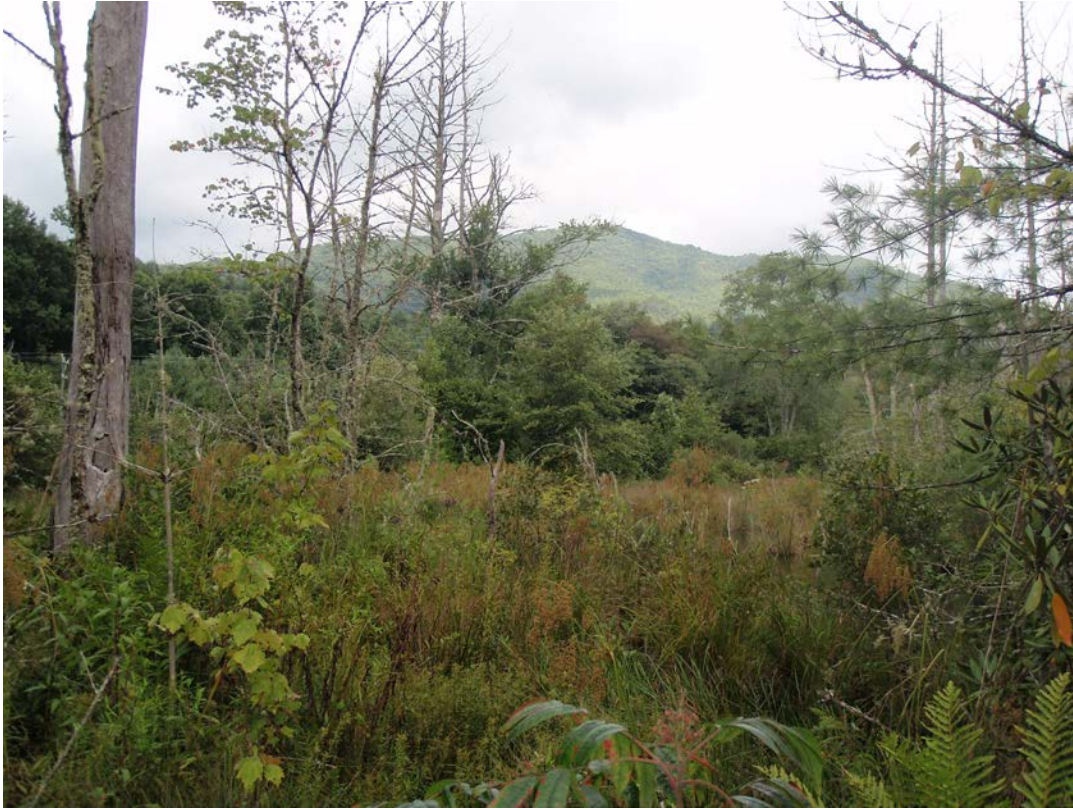
Tulula bog area nearby dumping site

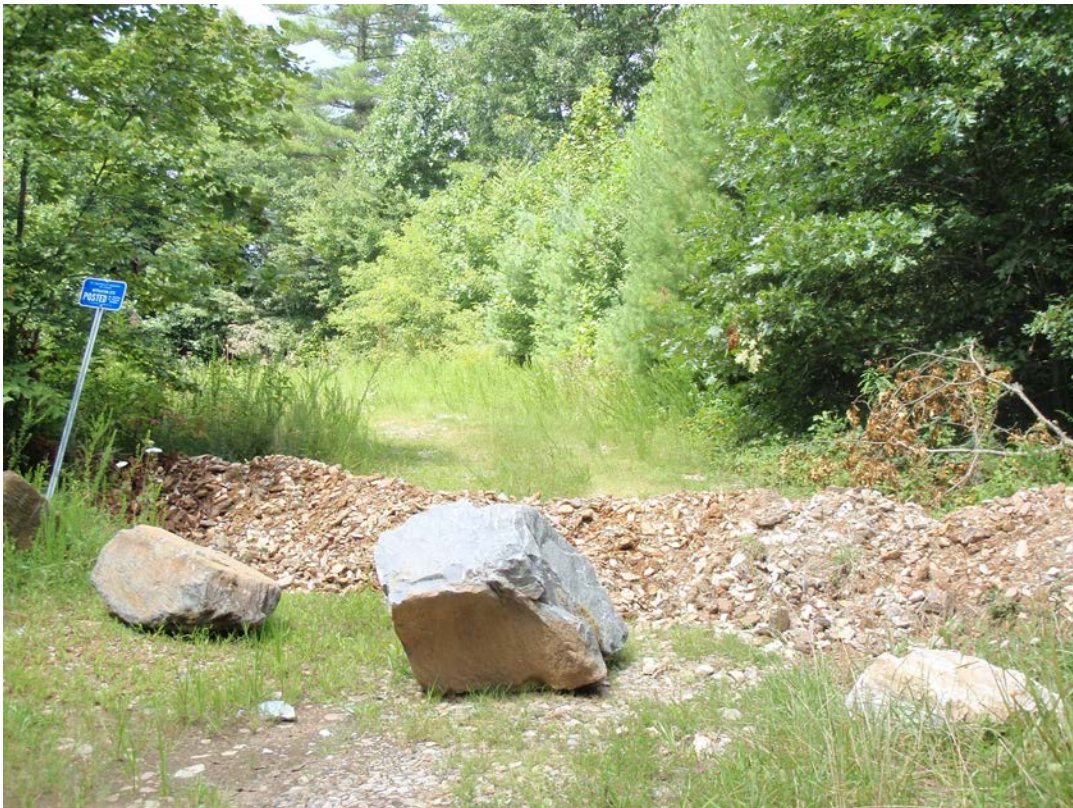
Newly cut barricade

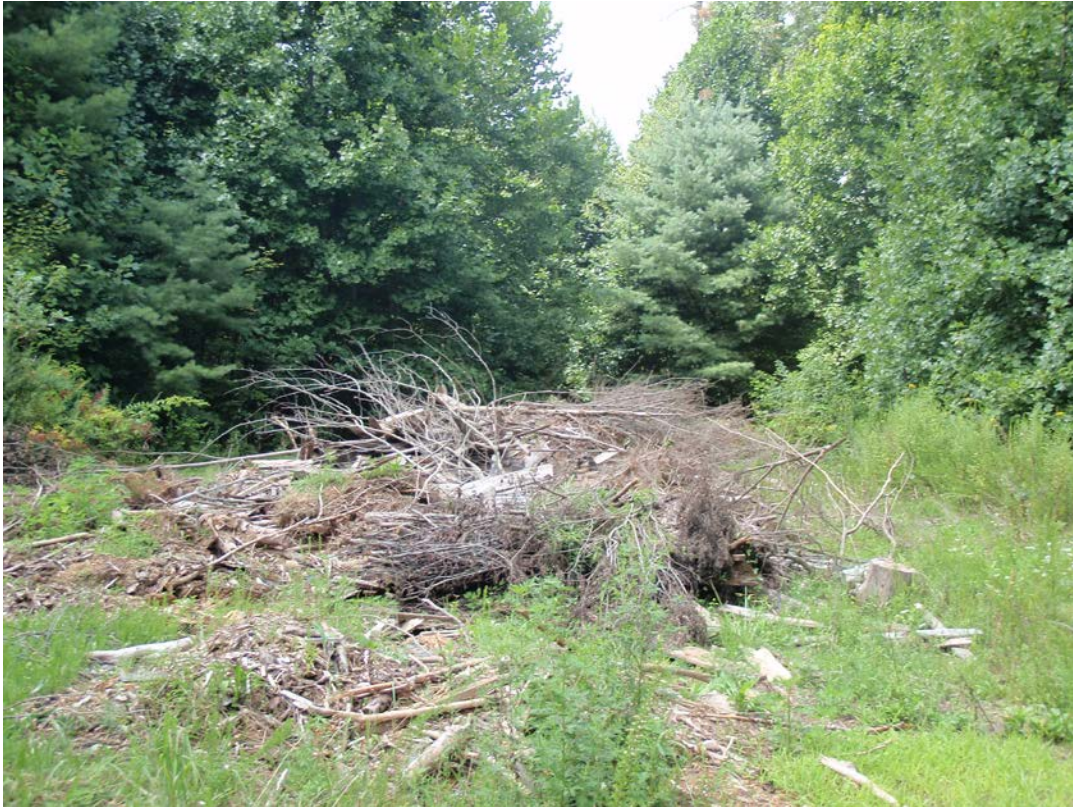
Second dumping site just beyond blocked access at newly cut barricade

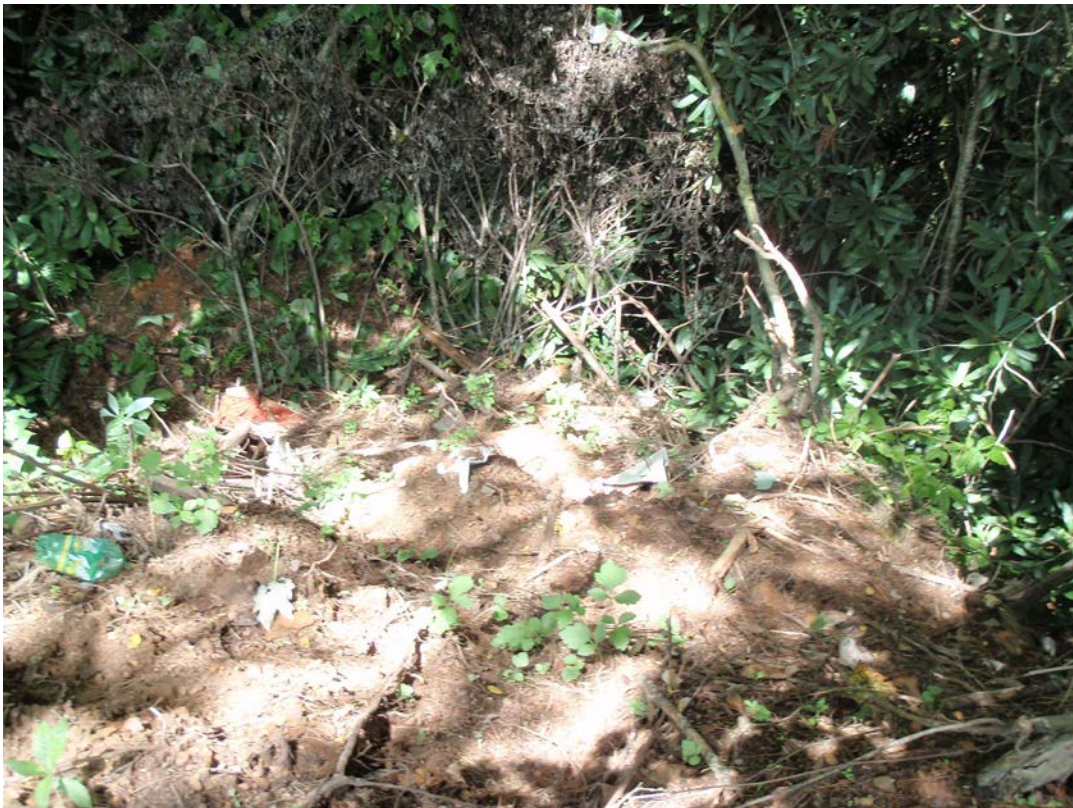
Debris migrating toward the bog at the second dumping site noted above

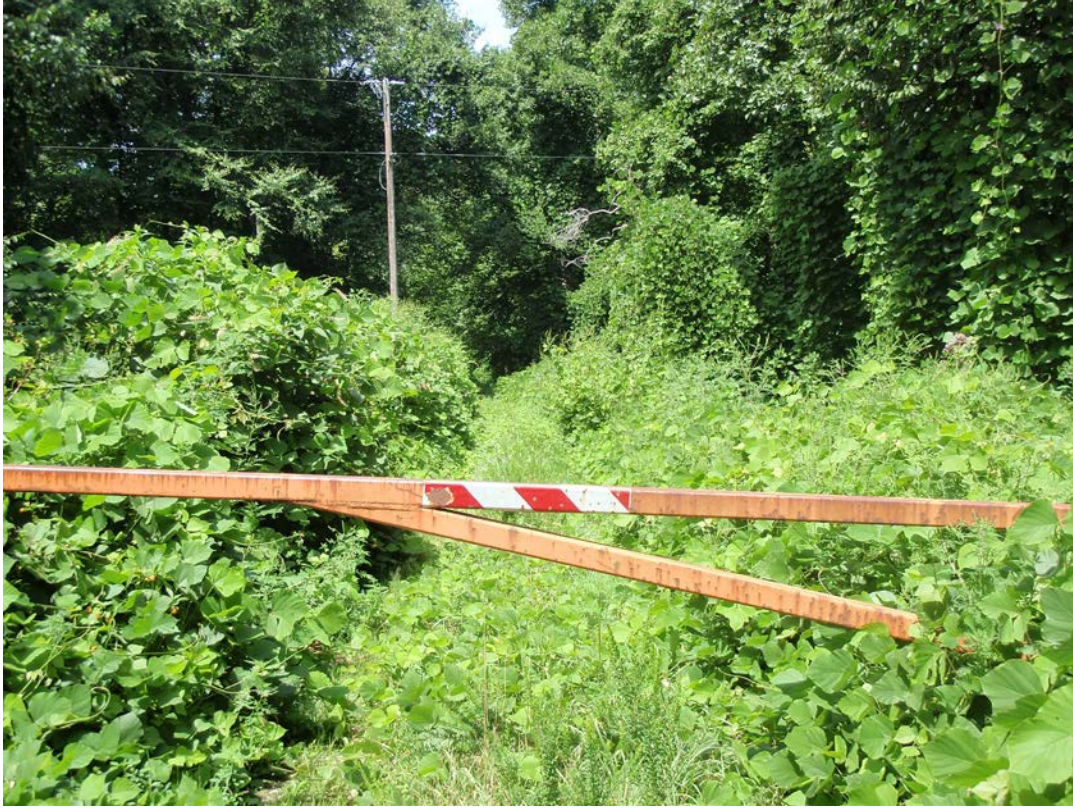
Northern trail site boundary looking west

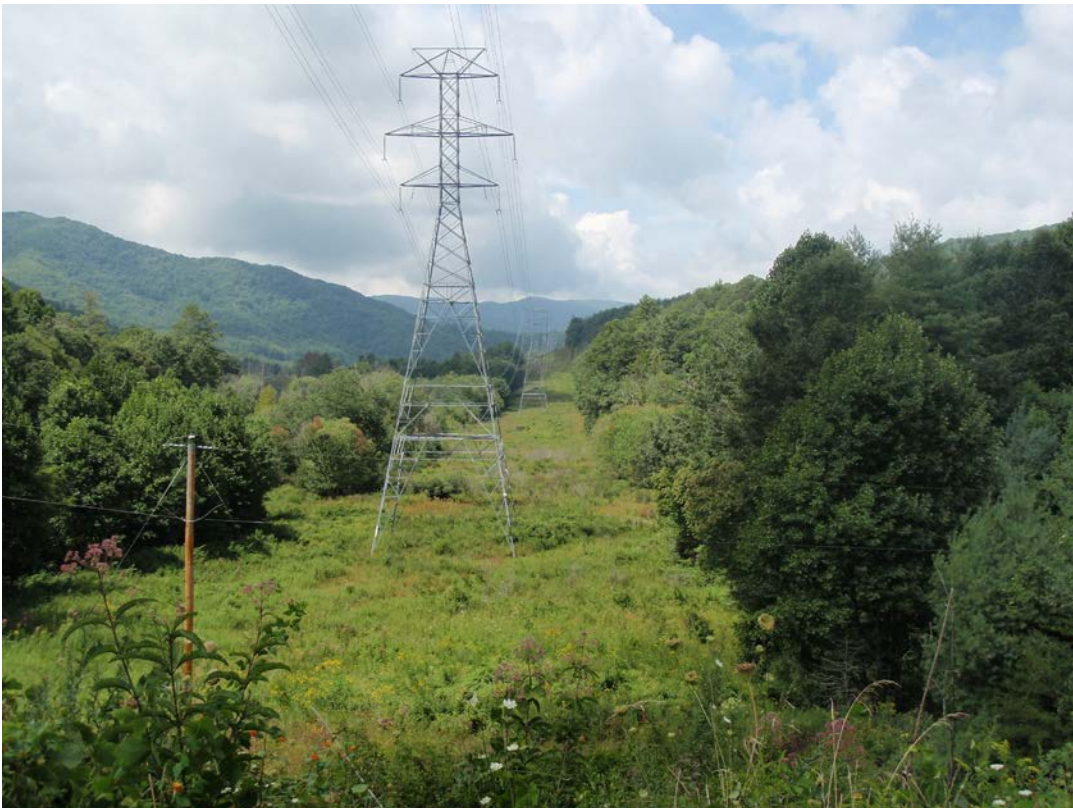
View toward site along utility line corridor
