## DOT MITIGATION STEWARDSHIP INSPECTION REPORT

| MITIGATION SITE NAME<br>A10 Charles McGinnis | TIP #<br>A-0010 | ONEID<br>057-004 | INSPECTION DATE<br>November 6, 2025 |

| COUNTY<br>Madison | Division<br>13 | # ACRES<br>1.1 |

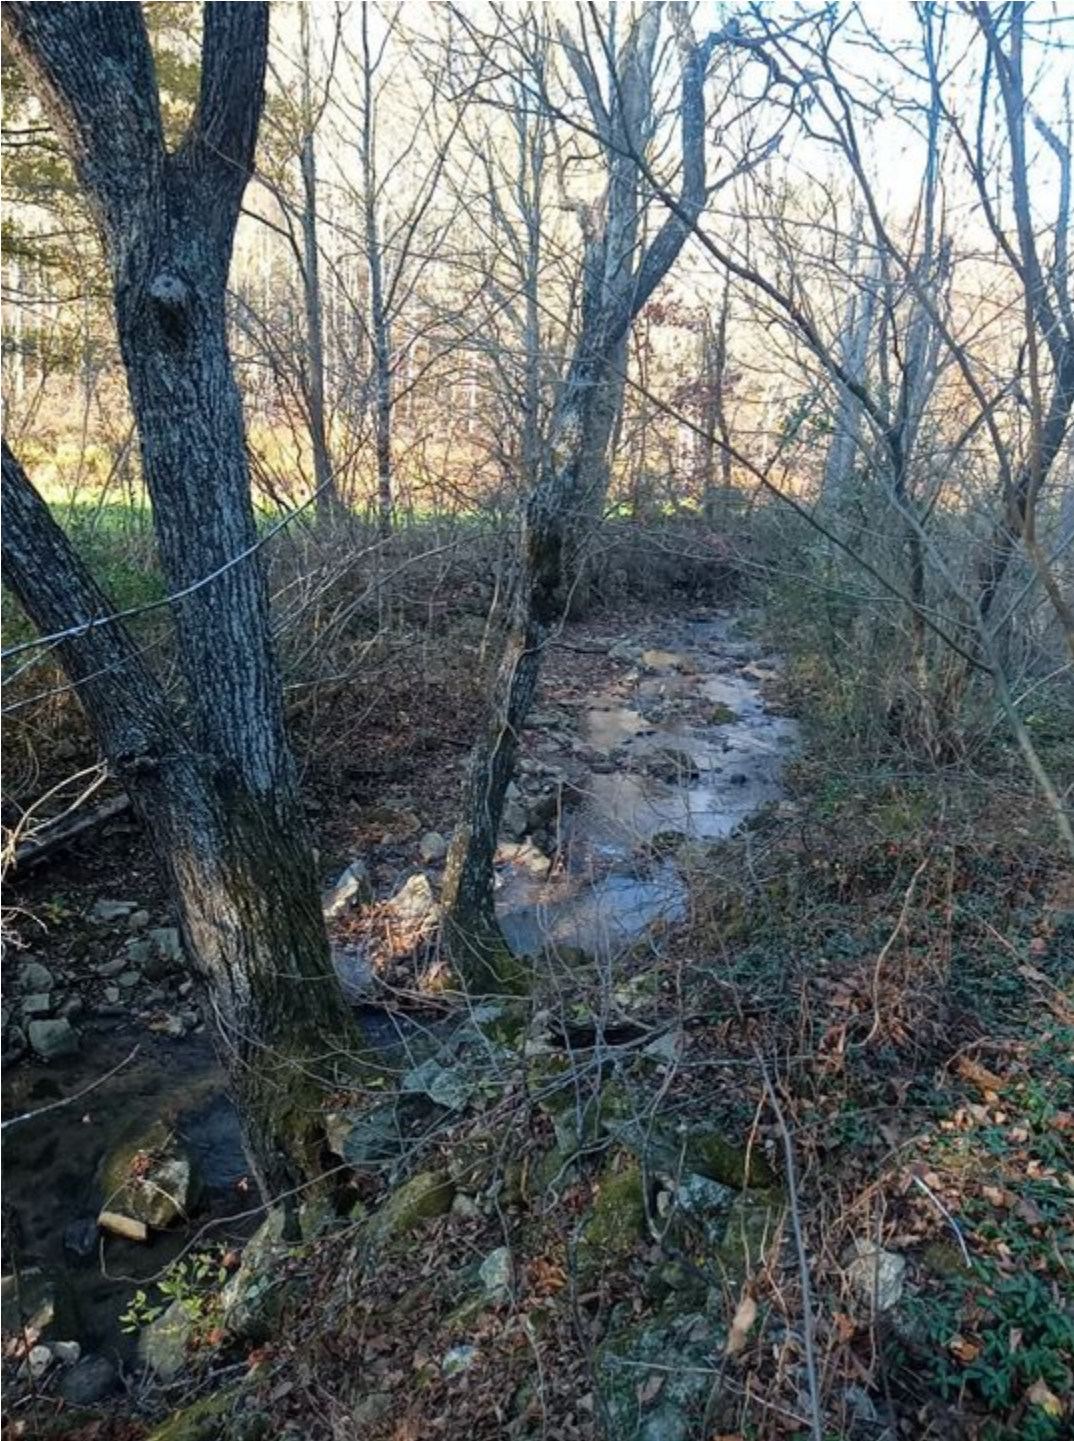
Image #1 Text: Site interior.

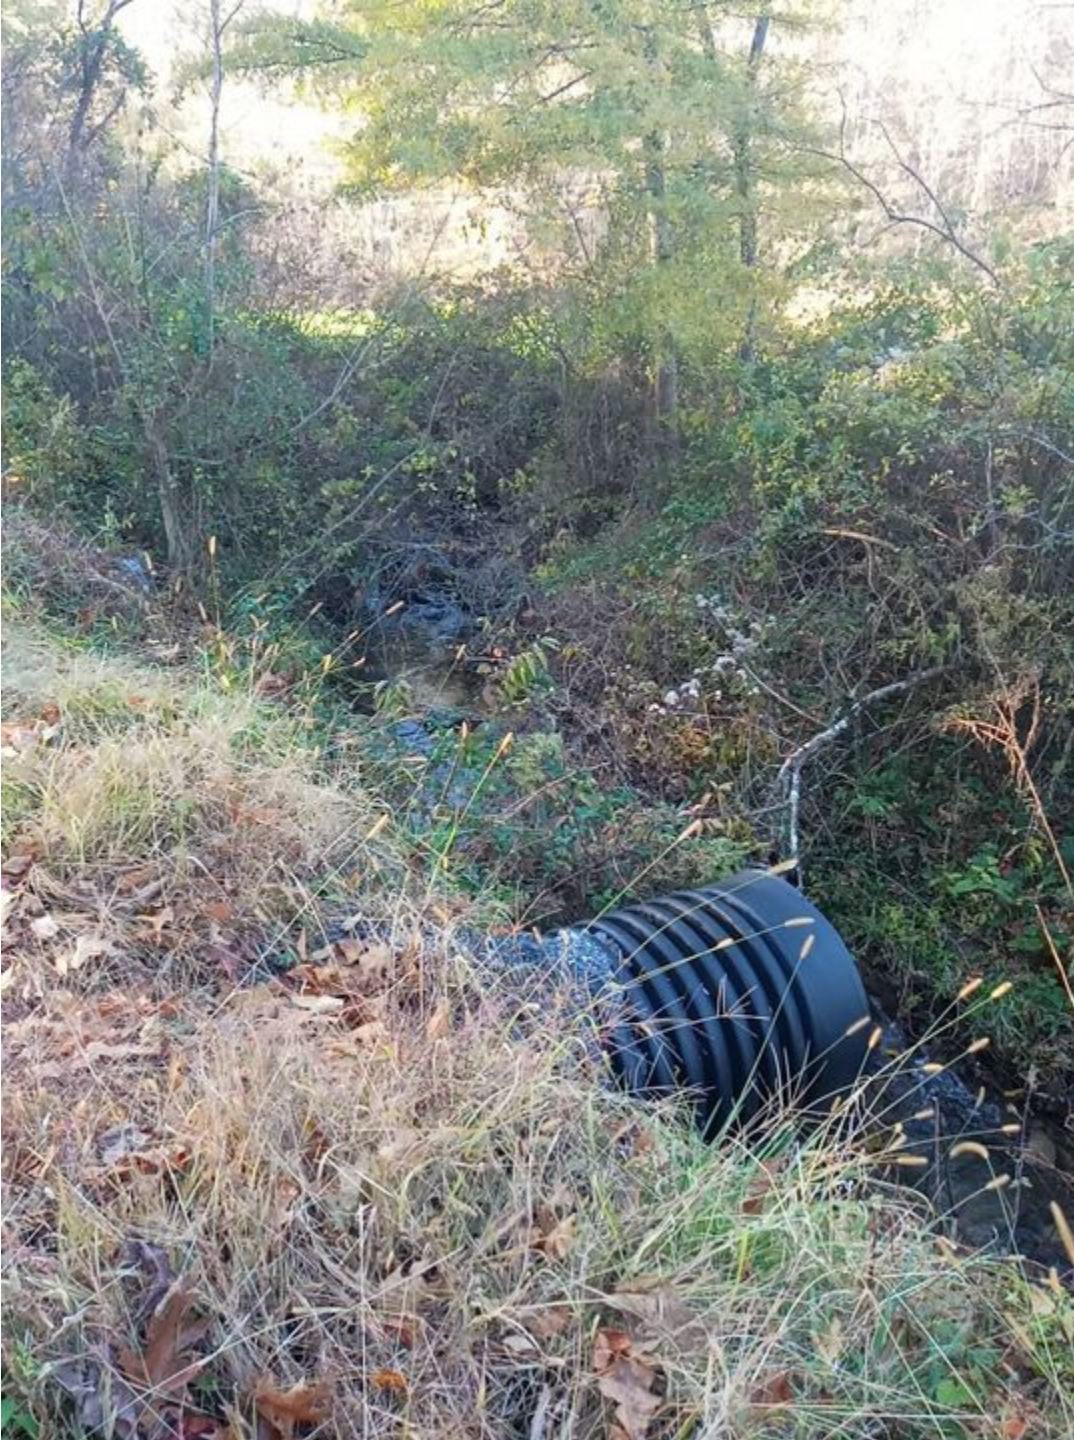
| <b>COMMENTS:</b> Boundary in good condition at time of inspection. Evidence of pedestrian use and potential trespassing (Image 6). New Pipe entering site (Image 2). | | | |

**EXPLAIN:** Potential pedestrian trespassing (Image 6). New pipe addition (Image 2).

Image #2 Text:  
New pipe entering site.

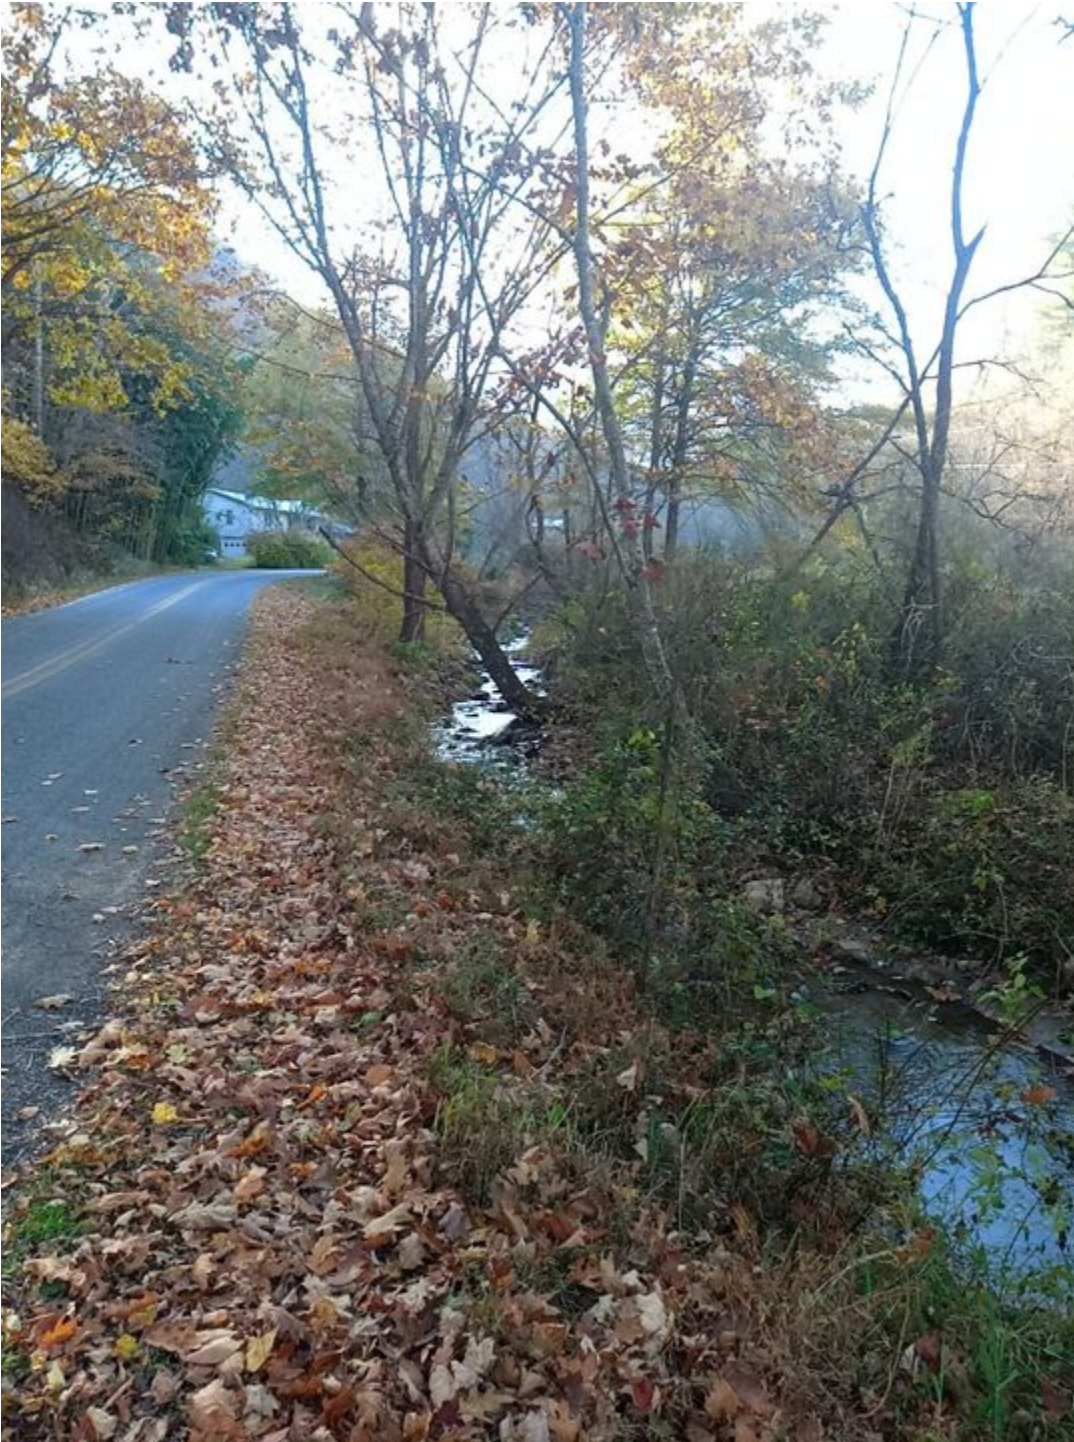
Image #3 Text: Site overview.

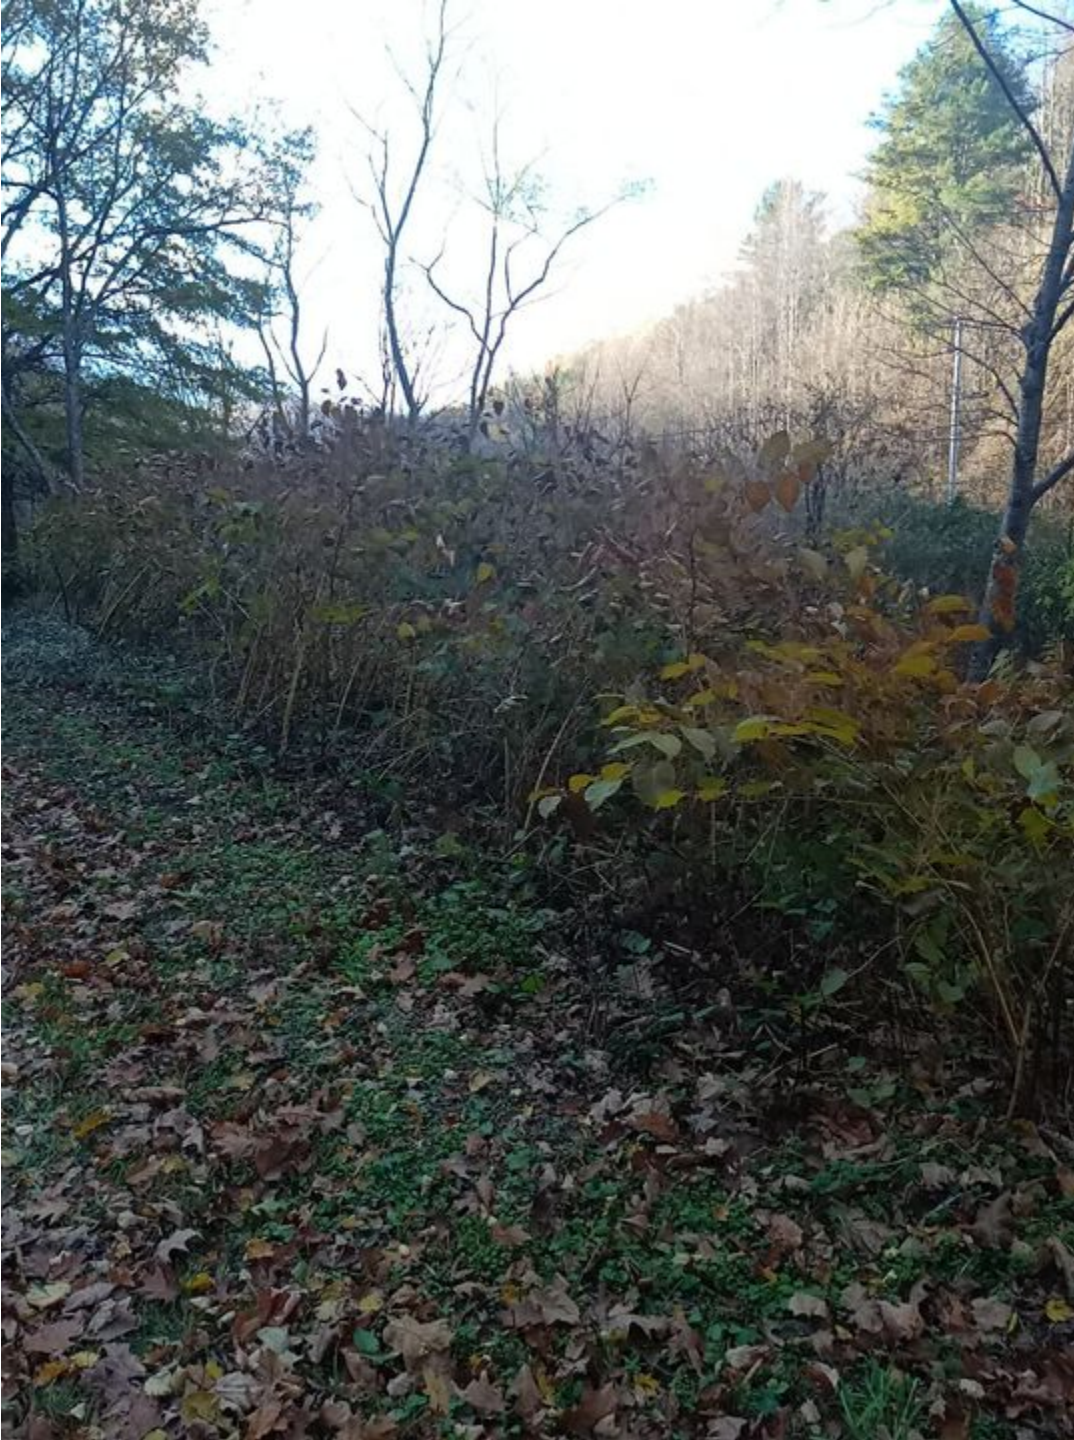
| <b>EXPLAIN:</b> Japanese knotweed (Image 4). |

Image #4 Text:  
Japanese knotweed

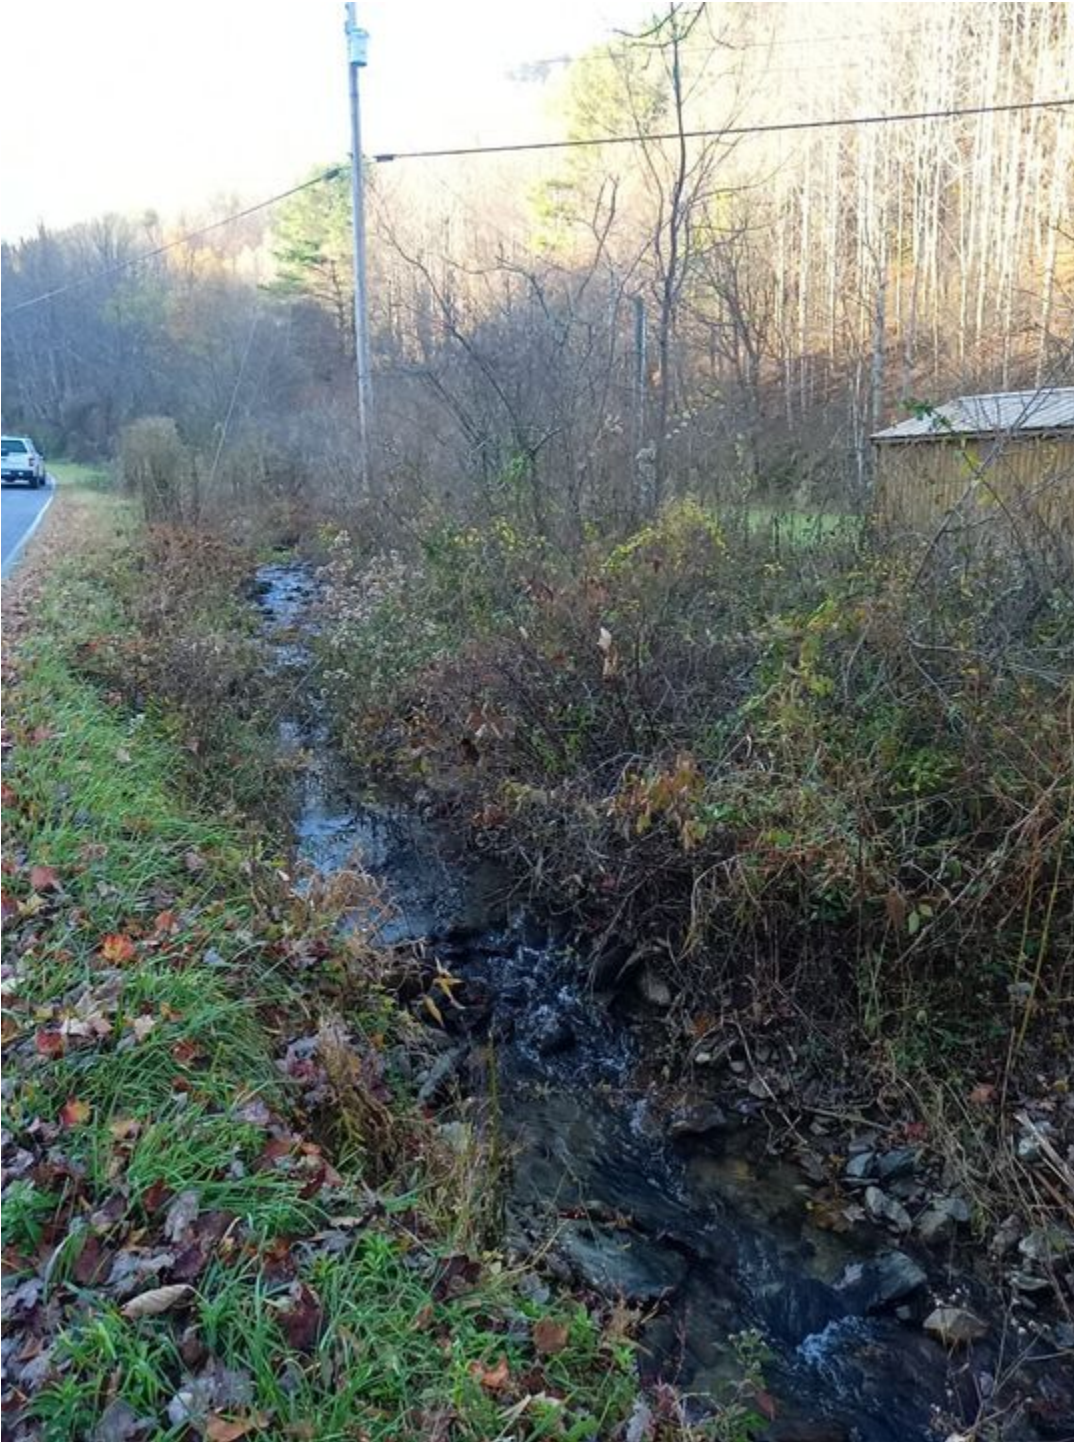
Image #5 Text: Site overview.

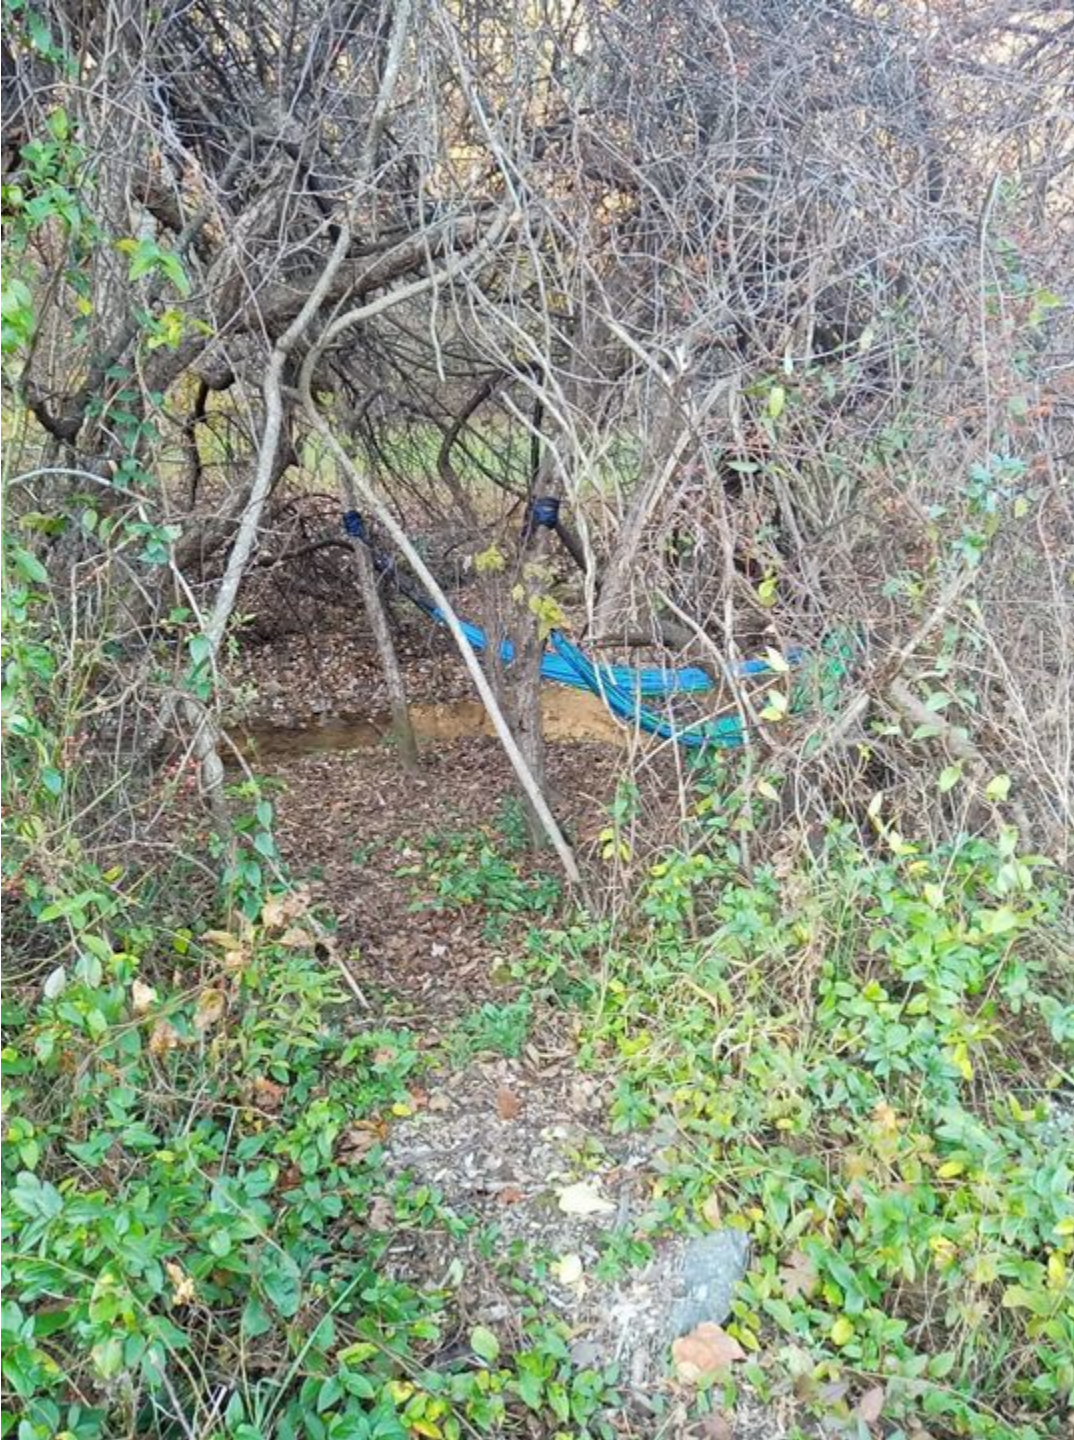
Image #6 Text:  
Potential Trespassing.
