THOROFARE BAY INSPECTION REPORT

MITIGATION SITE NAME THOROFARE BAY	TIP # B-1098	WBS #	INSPECTION DATE 10/8/2015
---------------------------------------	-----------------	-------	------------------------------

COUNTY Carteret	# ACRES 3.35	ONEID 016-005
--------------------	-----------------	------------------

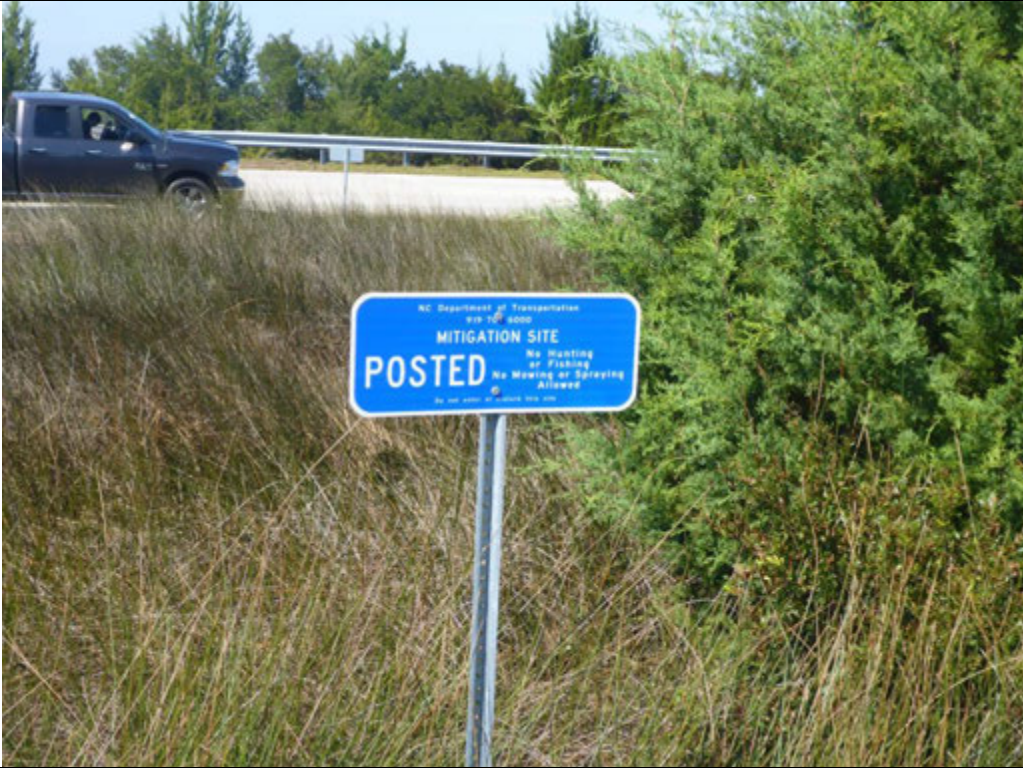
Photo 1 – NCDOT “Mitigation Site” signage was observed around the site.

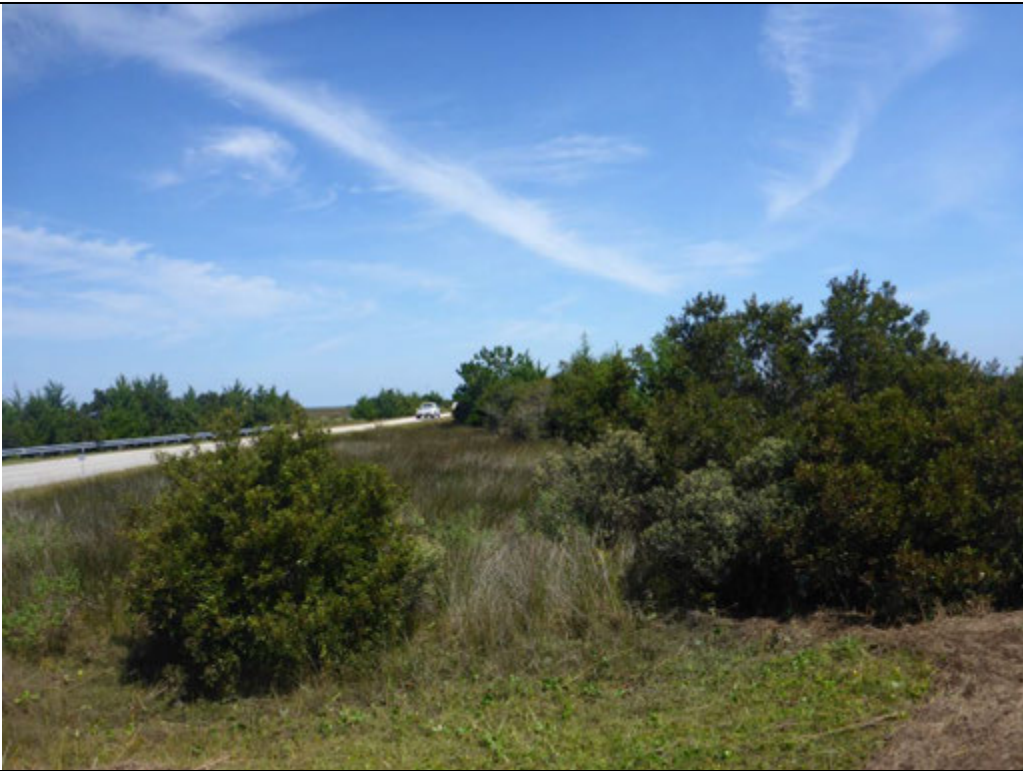
Photo 2 – View of the mitigation area north of the dock entrance road.

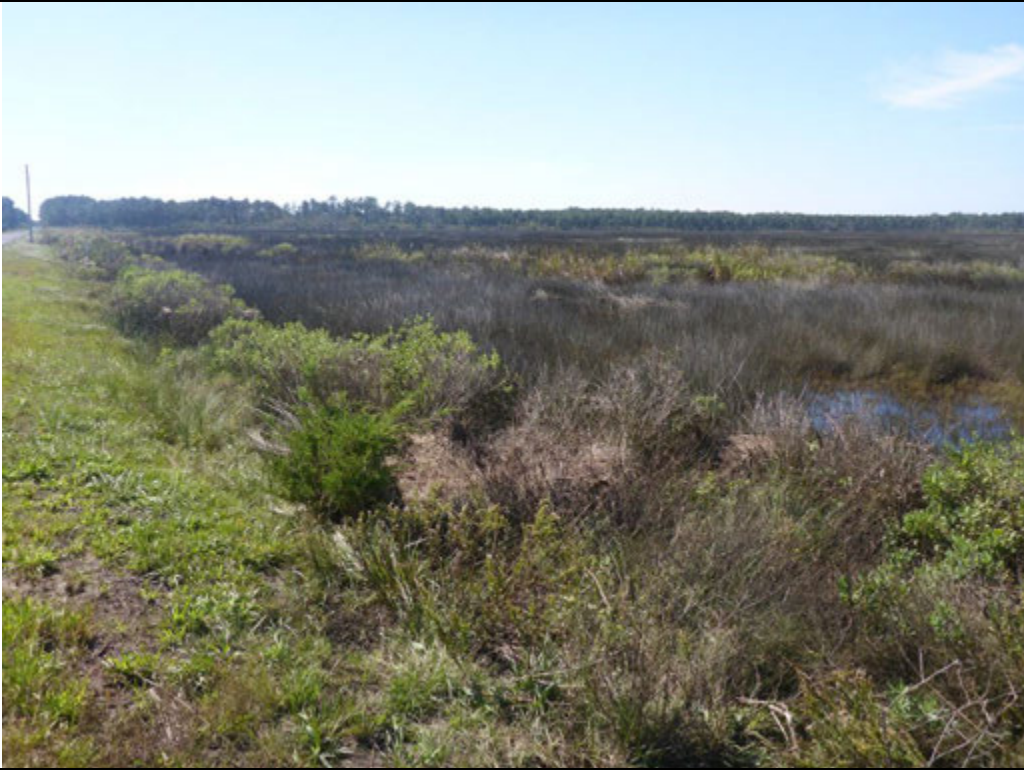
Photo 3 – View of the mitigation area south of the dock entrance road.

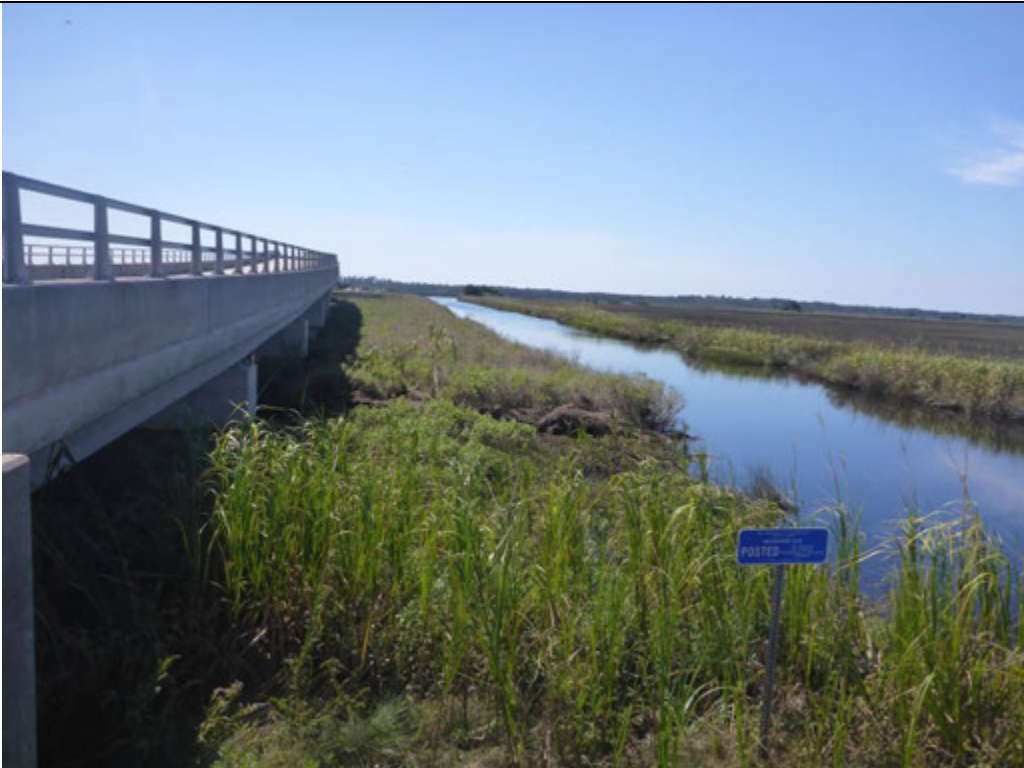
Photo 4 – View of the mitigation area north of Thorofare Bay and west of the bridge.
