DOT SITE INSPECTION REPORT

MITIGATION SITE NAME Spring Branch Bridge	TIP # B-2059	ONEID 065-008	INSPECTION DATE September 16, 2021
--	-----------------	------------------	--

COUNTY New Hanover	# ACRES 0.12
-----------------------	-----------------

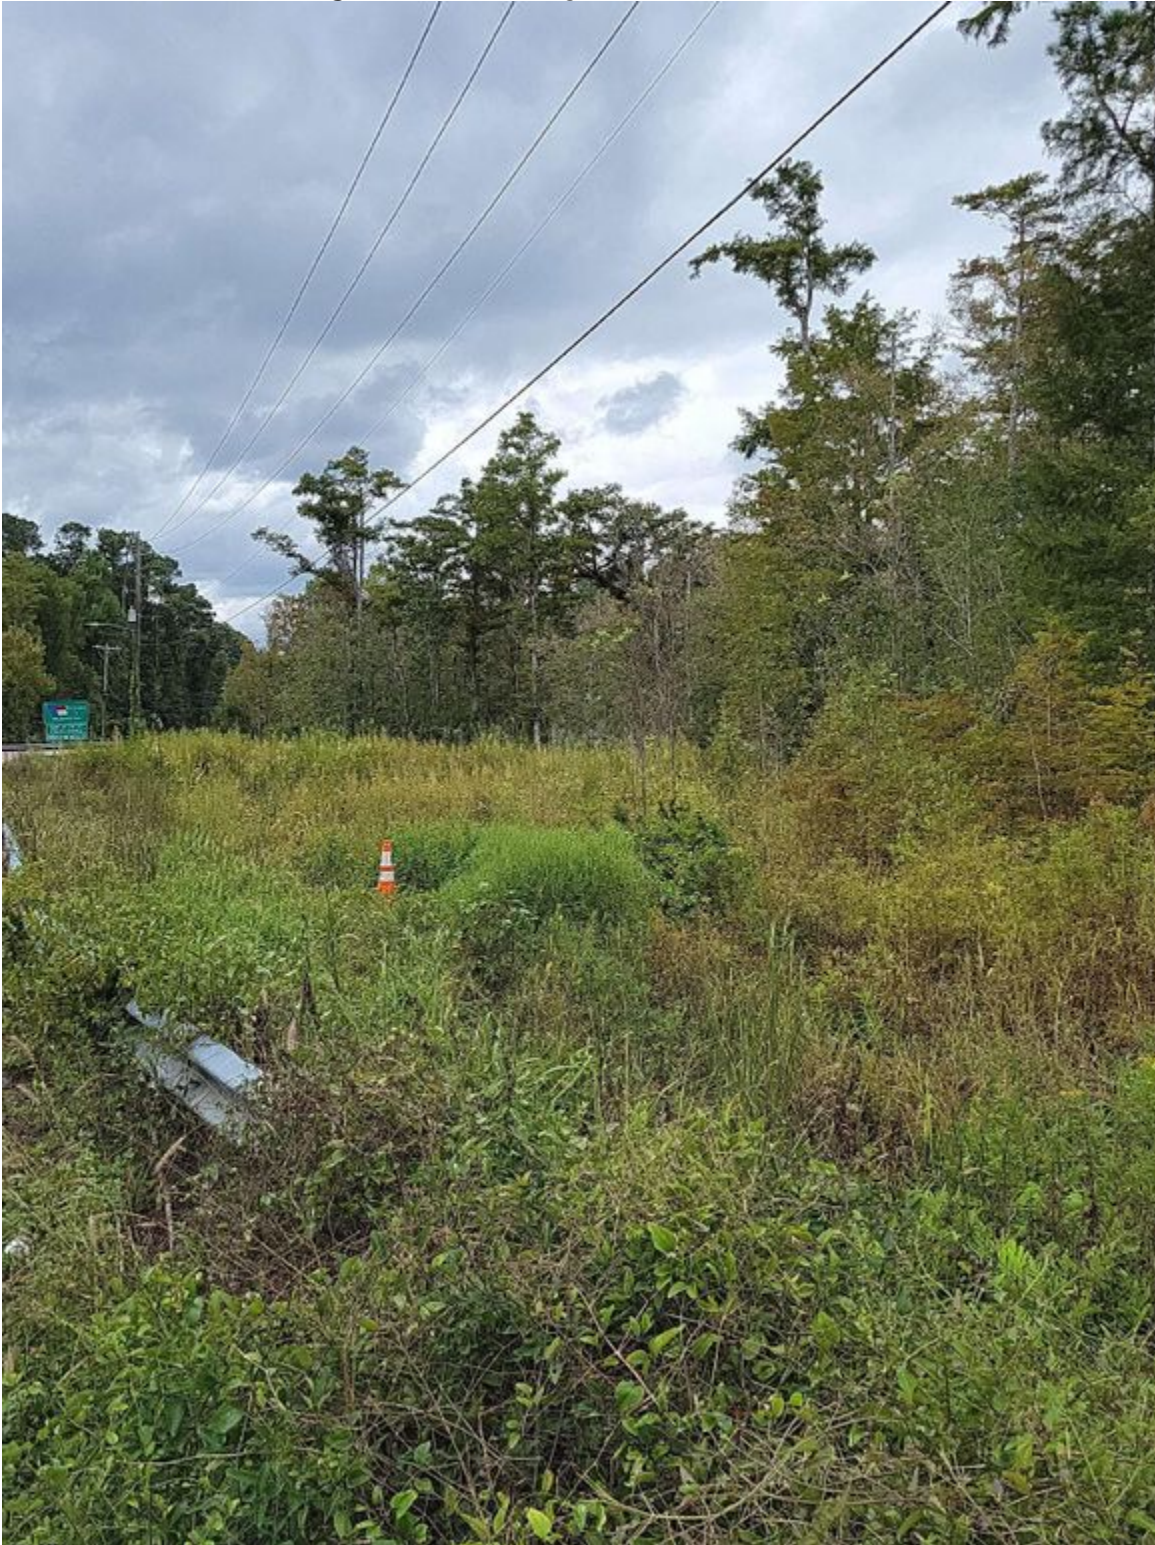
Image #1: View looking South from Kerr Avenue
