ANNUAL REPORT 2025
Year 7 Report for
Horse Creek Stream Relocation Monitoring Plan – Photo Documentation

TIP Project No. I-4729A – Interchange Improvements at I-26 and US 74
USACE Action ID No. **SAW-2017-01737**
NCDWR Project No. **2017-01737**
Polk County, NC

Date: January 2026

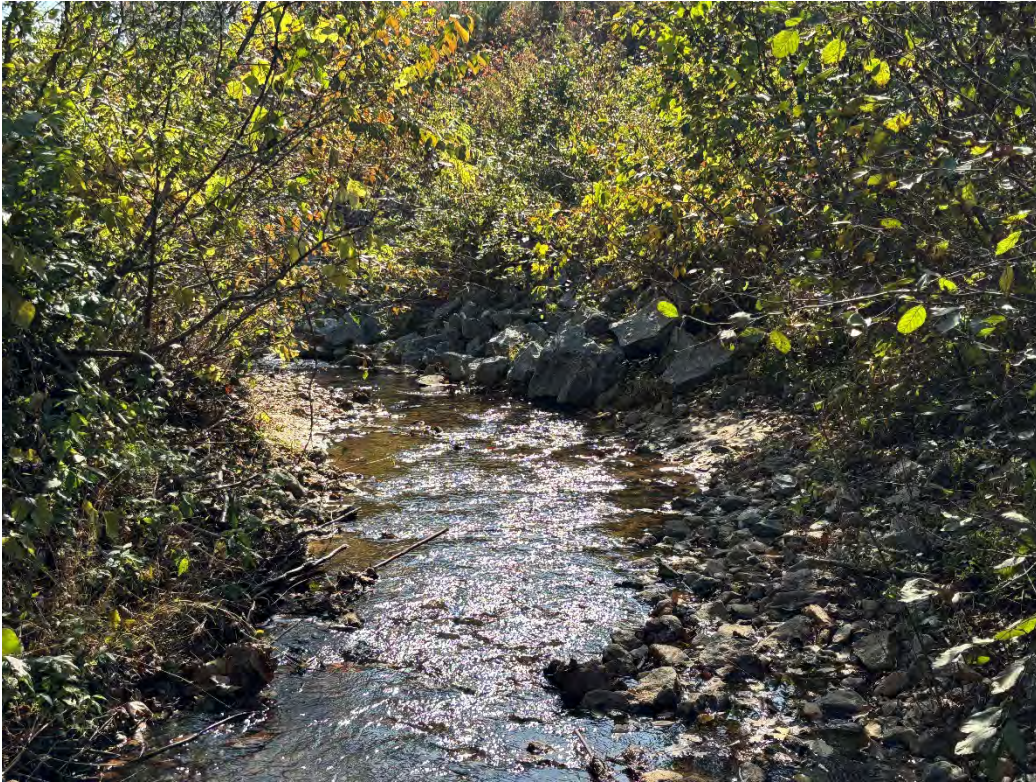
Looking Downstream from X-Section 3 into Transition Zone – New to Old Channel

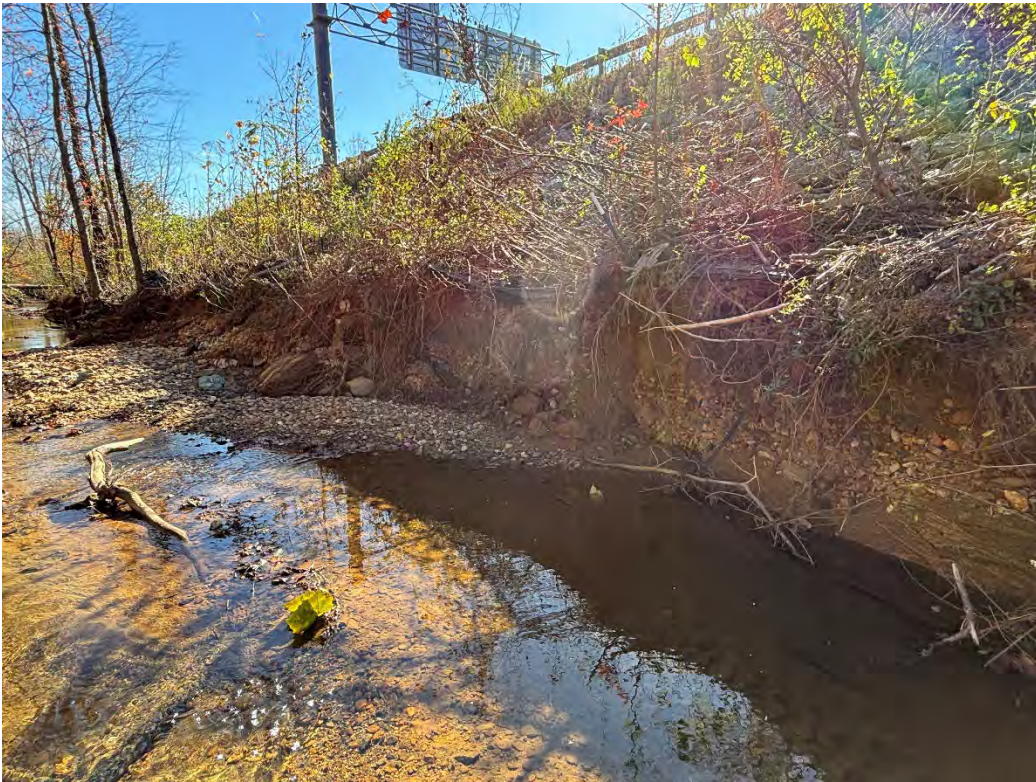
The streambank destabilization near the transition zone at the end of the channel change was exasperated by flooding associated with Hurricane Helene and documented in the 2024 FMR. This streambank failure was beginning to undercut the rock plated fill slope along I-26. The eroded streambank was repaired in February 2025 by NCDOT maintenance forces using FEMA funding associated with Hurricane Helene storm repairs.

Looking Downstream into Transition Zone Streambank Erosion – November 2024

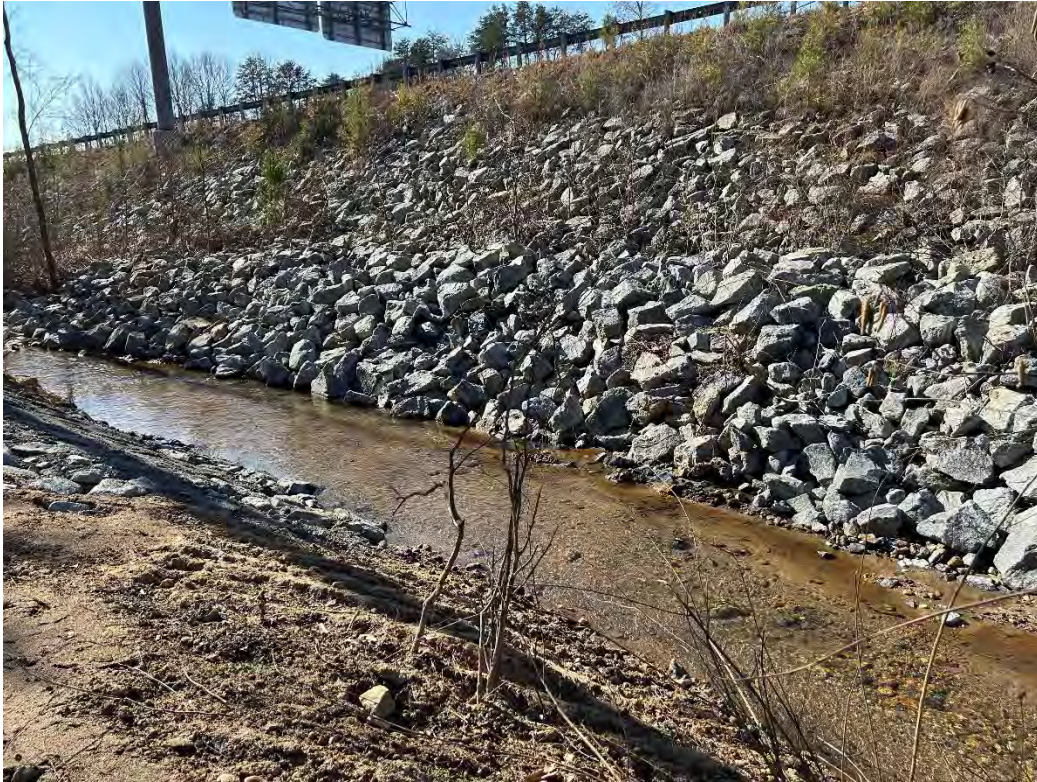
Transition Zone Streambank Repairs Completed February 2025

The streambank destabilization near the transition zone along the southern end of the channel change was exasperated by flooding associated with Hurricane Helene and documented in the 2024 FMR. This streambank failure was beginning to undercut the rock plated fill slope along I-26. The streambank was repaired in February 2025 by NCDOT maintenance forces using FEMA funding associated with Hurricane Helene.

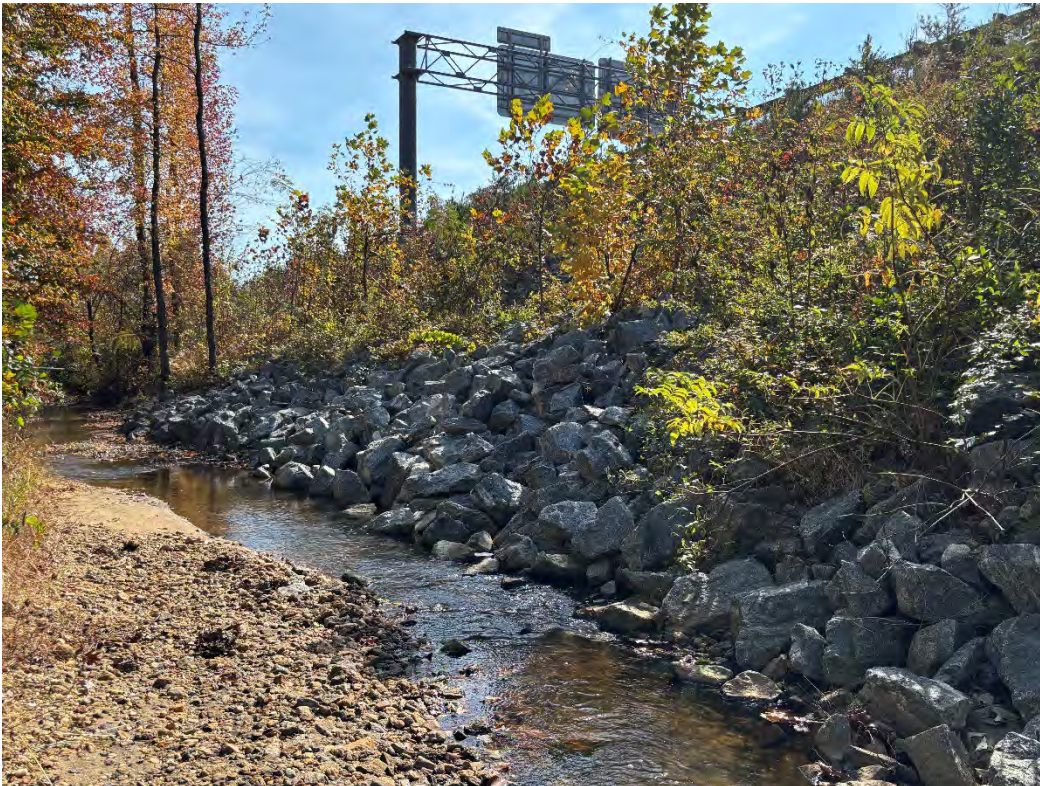
Looking Downstream at Transition Zone Streambank Repairs – November 2025

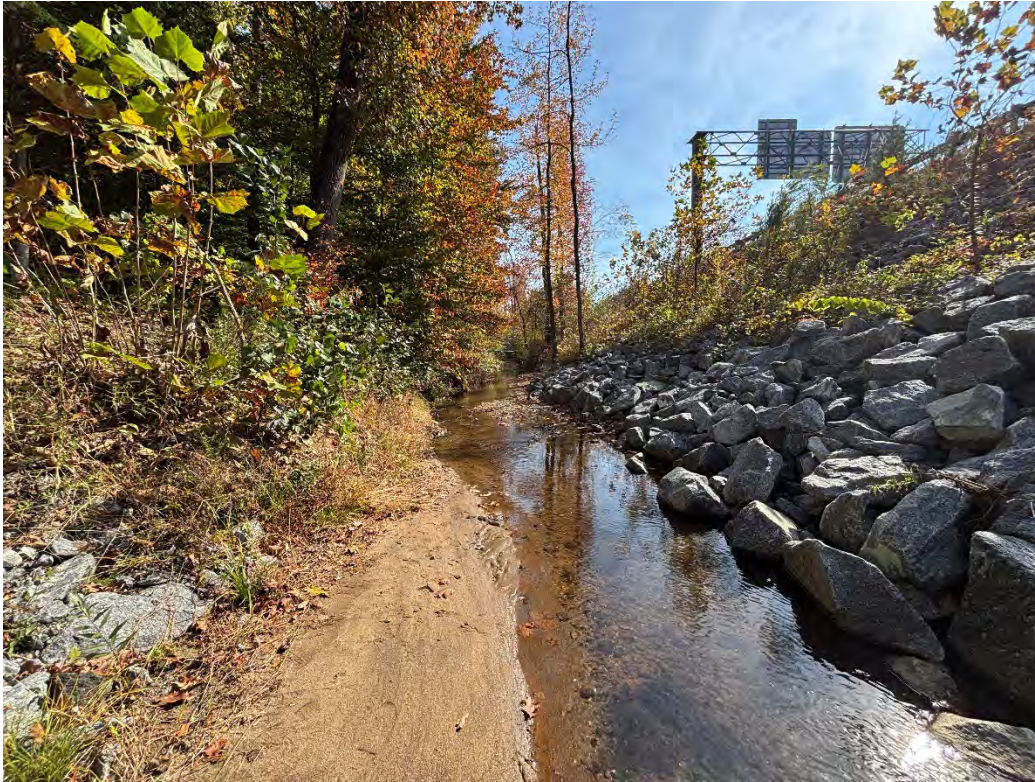
Looking Downstream at Transition Zone Streambank Repairs – November 2025

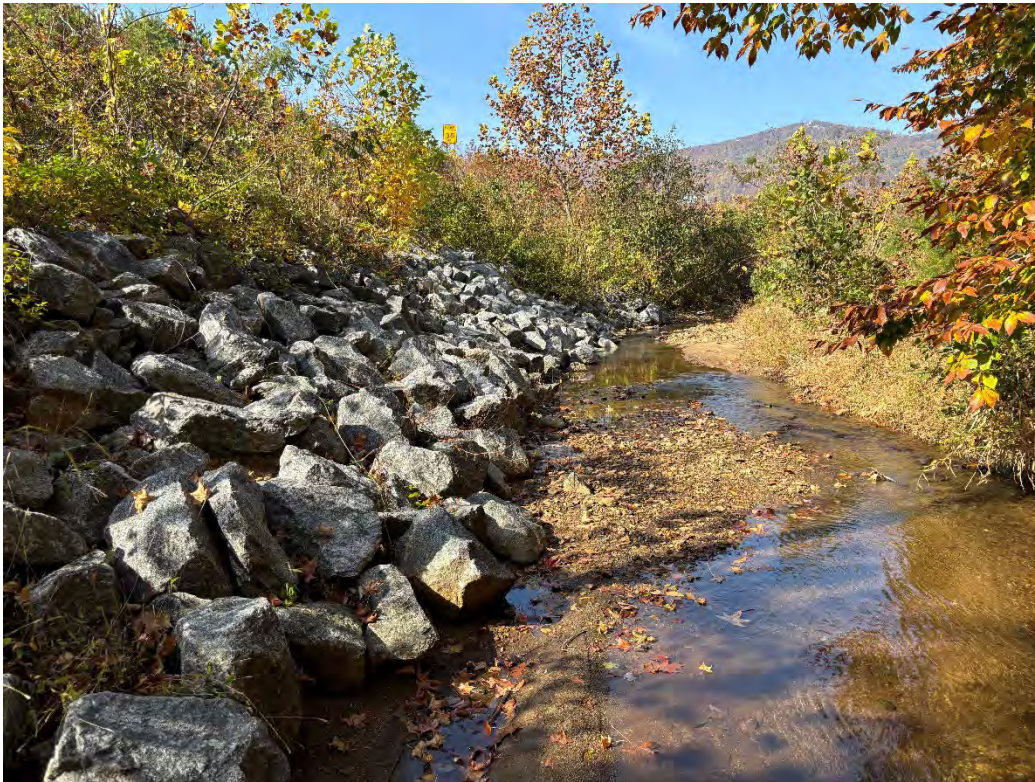
Looking Upstream at Transition Zone Streambank Repairs – November 2025

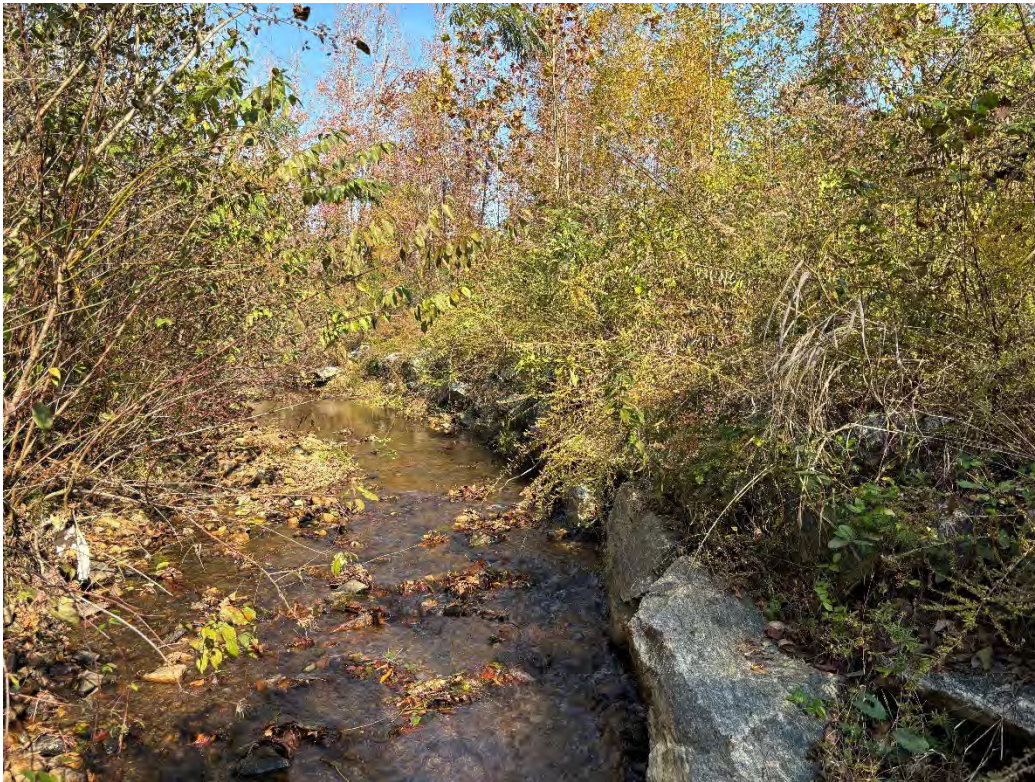
Looking Upstream at Shot Rock Bank Stabilization Repairs from 2020

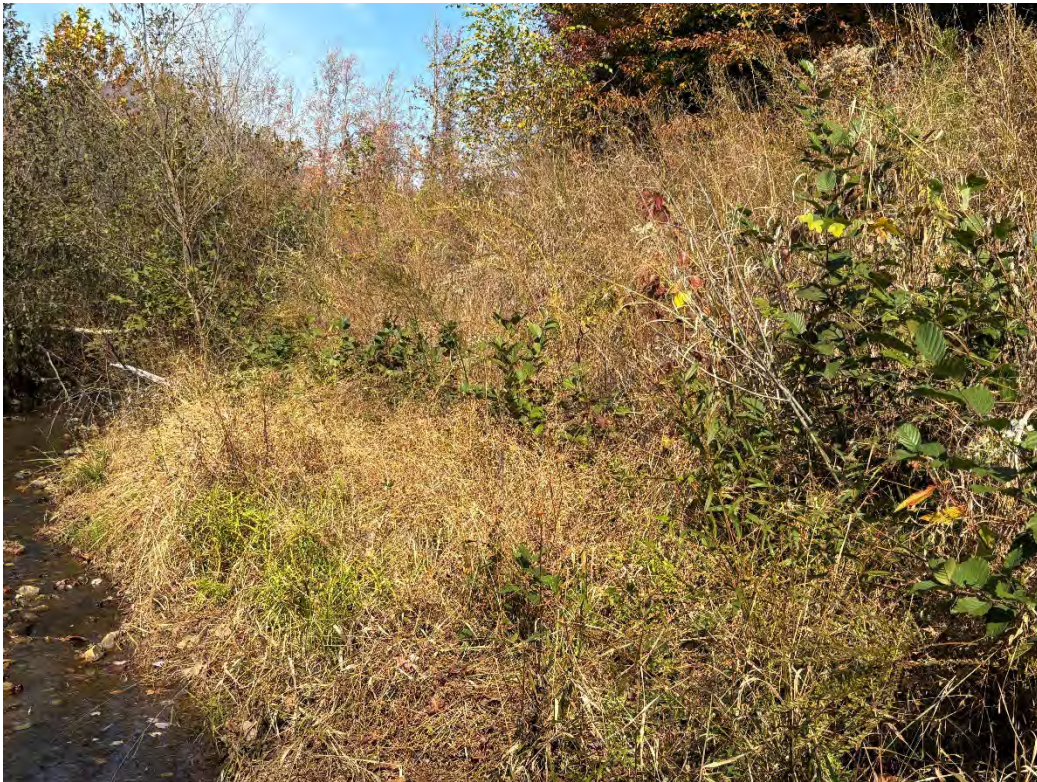
Based on Year 7 (2025) visual/photo assessment and comparisons to the Year 6 (2024) Final Monitoring Report (FMR) the stream channel is well vegetated and stable. The two beaver dams that were documented in the 2024 FMR were removed in the spring of 2025 by USDA Wildlife Services and showed no signs of reconstruction in the 2025 field review conducted on November 7, 2025. Beaver dams are no longer causing any channel stability issues along the stream reach noted in the past two stream monitoring reports (2023/2024). All accumulated sediments associated with beaver dams in the past have been flushed downstream and returned the stream profile to a basic riffle pool complex. The streamside vegetation affected by beaver activity is regenerating and recovering nicely along these impacted reaches.

Looking at Regeneration of Streamside Vegetation Impacted by Beavers
