ANNUAL REPORT FOR 2025

**Middle Fork California Creek Site I Mitigation Site
Madison County
TIP No. R-2518A
COE Action ID: SAW-2007-2197-357/300
DWR #: 20071134**

Prepared By:
Environmental Analysis Unit & Roadside Environmental Unit
North Carolina Department of Transportation
December 2025

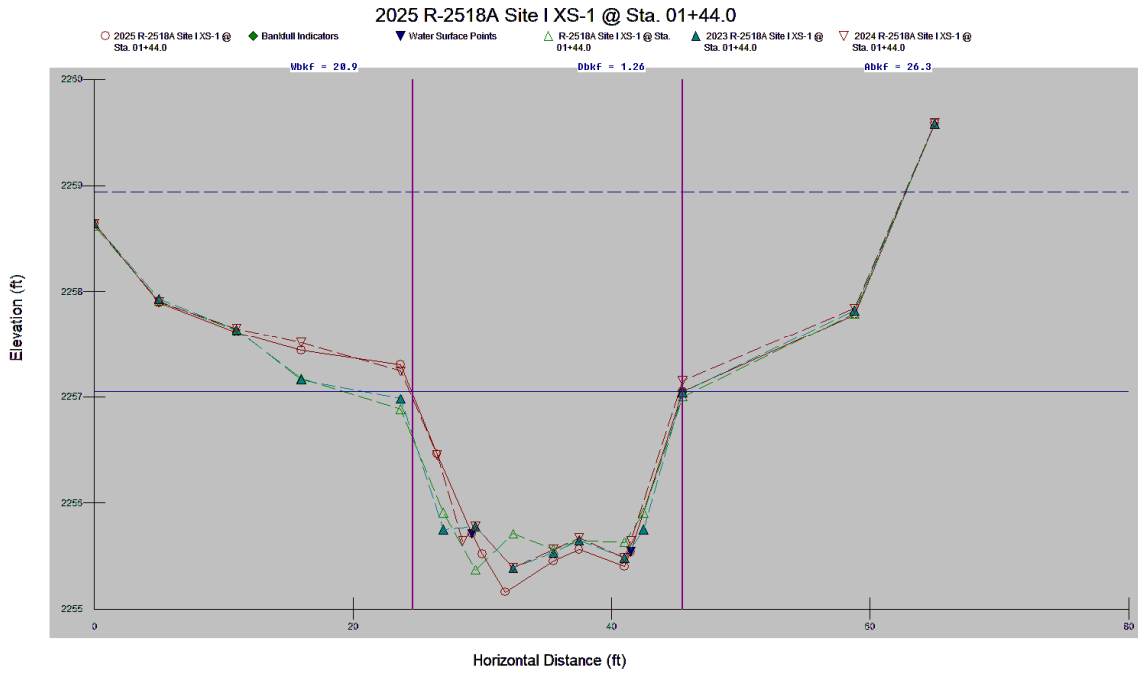
R-2518A Middle California Creek (Site I): Cross-Section #1 (Riffle) Abbreviated Morphological Summary

Based on comparisons of the Remediation As-Built and prior years monitoring data to the Year 3 monitoring data, all cross sections appear stable. The riffle sections demonstrate morphological characteristics of a C3 type stream according to Rosgen's Stream Classification method. Graphs and morphological data of the cross sections are presented in Appendix A. Future survey data will vary depending on the actual location of rod placement and alignment; however, this information should remain similar in appearance. The longitudinal profile showed that the channel bed was stable for the 2025 monitoring evaluation. An area of instability noted during the 2024 monitoring period along the right bank downstream of cross section #5 has stabilized and is now well vegetated (see photo in Appendix B). Hydrologic monitoring was not required per the permit conditions. There was evidence of at least one bankfull event having occurred during the 2025 monitoring year by presence of matted vegetation and wrack lines. NCDOT will continue stream monitoring in 2026.

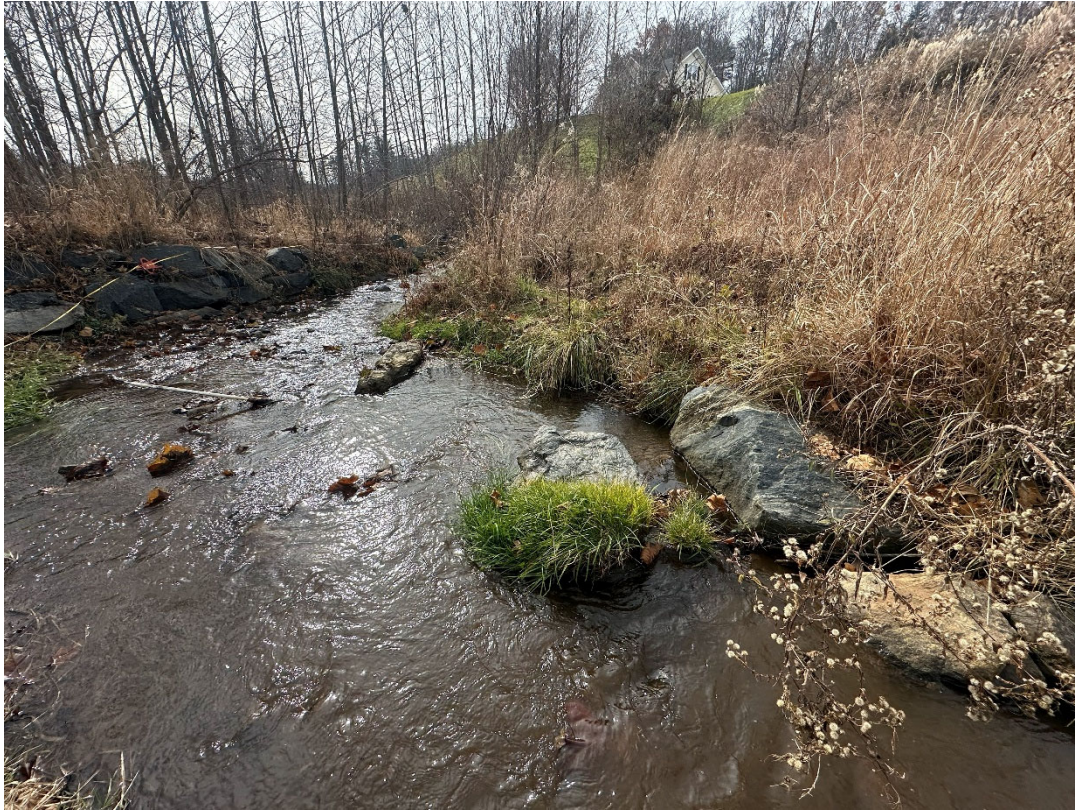
Minor Bank Erosion downstream of XS-5 Improved Since 2024 Monitoring

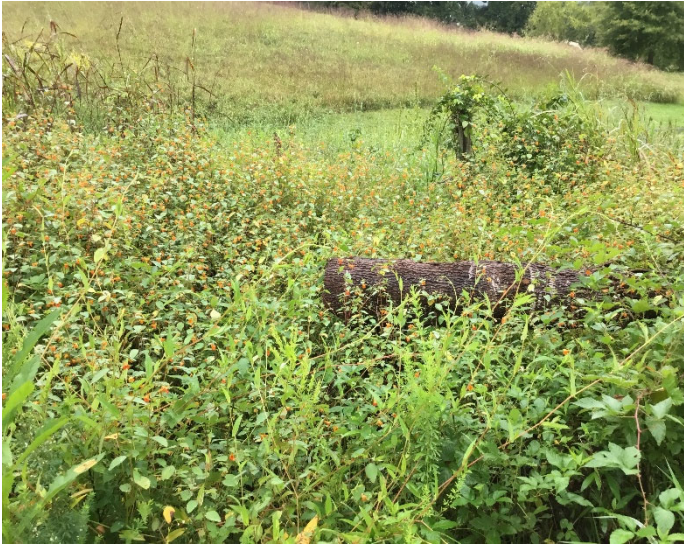
Cut trees along CA fence at Shake Rag Road

Brief description of incident Four sycamore trees cut at mitigation site.

Remarks (attach additional remarks if needed): Violators were not seen. Trees were cut between December 2024 and September 2025.

NCDOT plans to treat the Japanese Knotweed and will continue to monitor the planted vegetation in 2026 at Middle Fork Creek Site I.

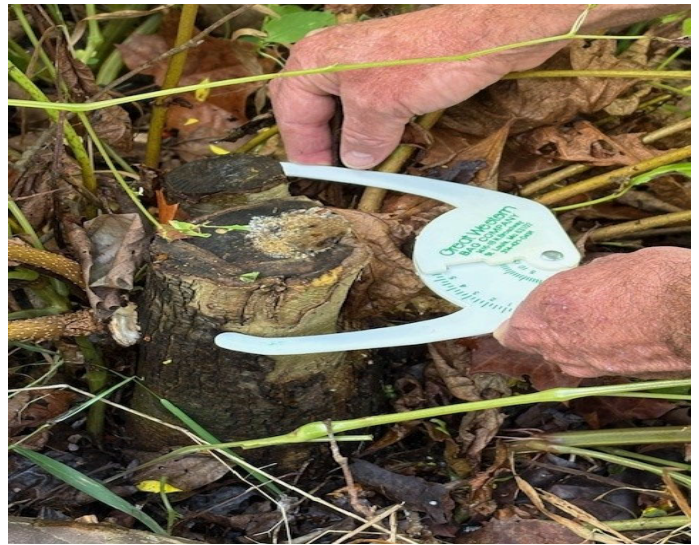
Sycamore Tree #1 Cut

| Tree # | Species | Caliper Inches | Zone | Comments |
|---|---|---|---|---|
| 2 | Sycamore | 14' | | |

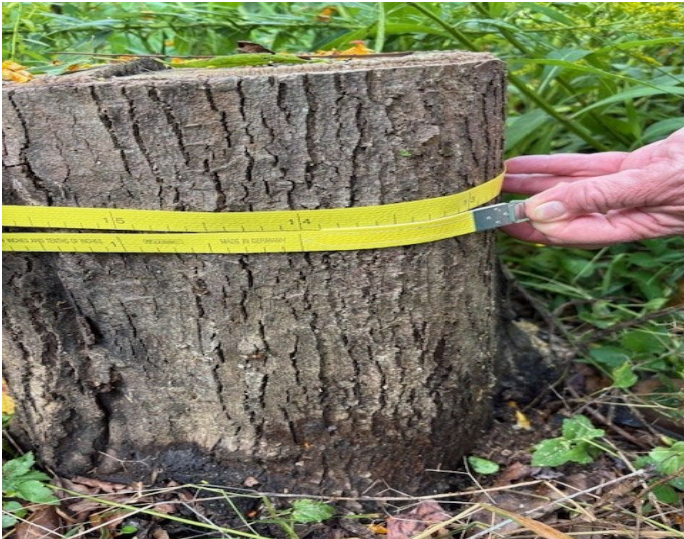
Sycamore Tree #2 Cut

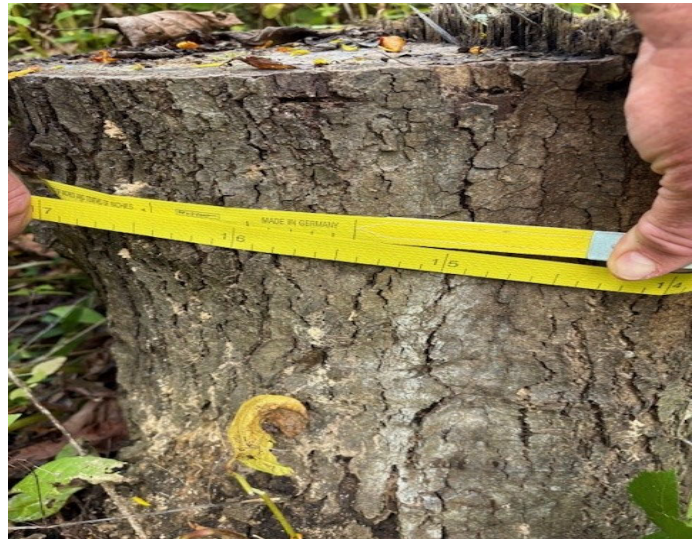
Sycamore Tree #3 Cut

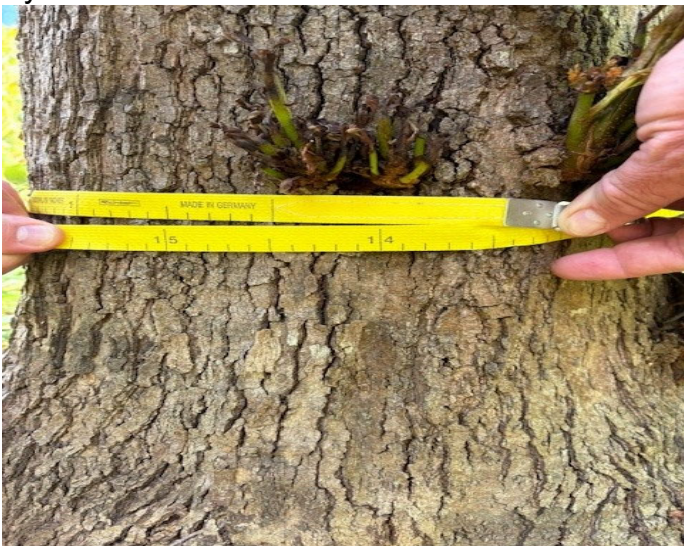
Sycamore Tree #4 Cut

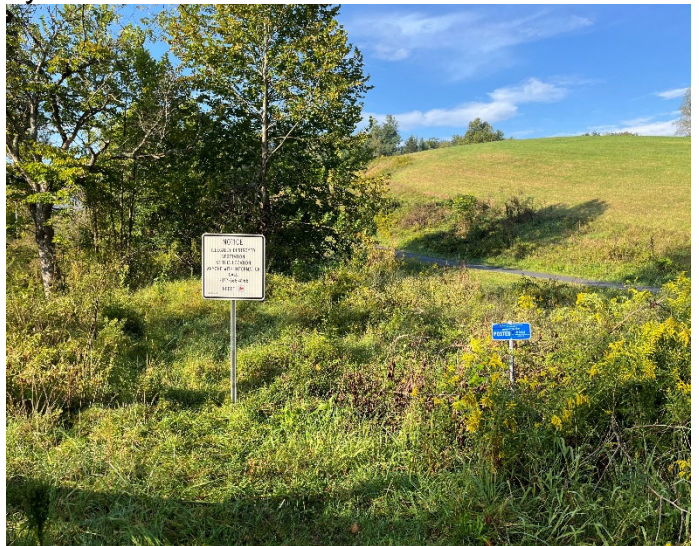
Illegal Cutting of Vegetation Sign Installed
