ANNUAL REPORT 2020
Year 2 Report for
Horse Creek Stream Relocation Monitoring Plan

TIP Project No. I-4729A – Interchange Improvements at I-26 and US 74
USACE Action ID No. **SAW-2017-01737**
NCDWR Project No. **2017-01737**
Polk County, NC

Vaughn & Melton Consulting Engineers, Inc.
40 Colonial Square
Sylva, NC 28779
(828) 477-4993

Date: April 2020

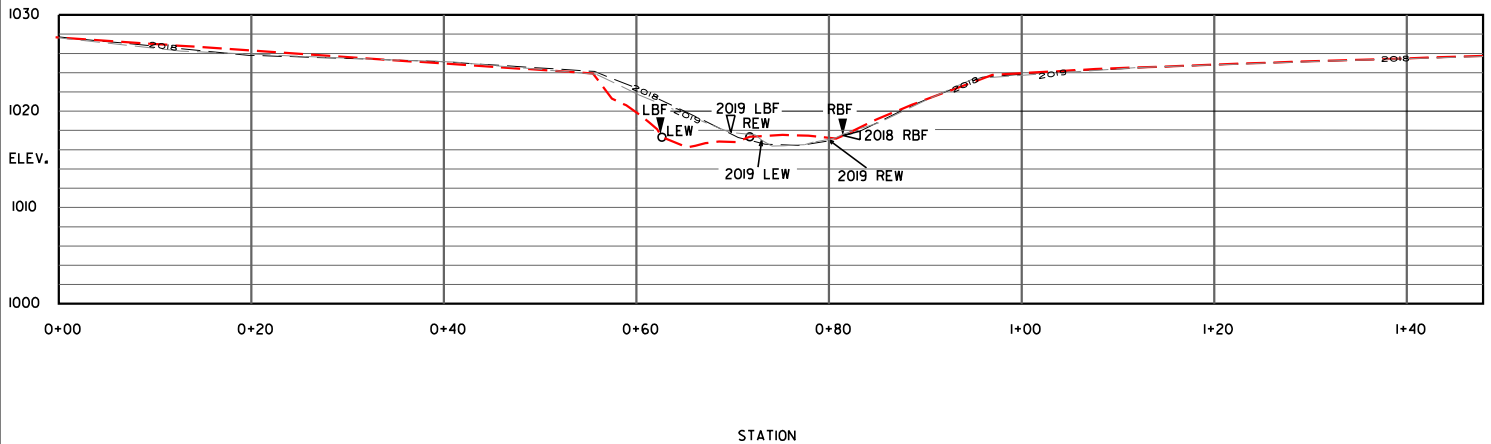
RIFFLE CROSS-SECTION - STA. 12+05

Based on visual assessment and comparisons of the As-Built to Year 2 monitoring data, the channel is showing some stability issues in the form of excessive streambank erosion, especially in the vicinity of XS-1 (riffle), in the upper reaches of the channel below the reinforced concrete box culvert. The channel is also showing signs of degradation (downcutting) in the pool areas. XS-1 shows an increase in bankfull width of approximately 7.5 feet (see photos) and a decrease in mean bankfull depth of 0.40 feet due to aggradation associated with the streambank erosion and widening of the stream channel. XS-2 (pool) shows an increase in bankfull width of approximately 1-foot and mean bankfull depth of 1-foot. The channel shows signs of widening and degradation (downcutting) of the pool at this site. XS-3 (riffle) shows an increase in bankfull width of approximately 1-foot. All other parameters at this site appear to be stable.

NCDOT recommends that the streambank instability issues below the reinforced concrete box culvert (RCBC) be addressed and repaired as soon as possible (see photos). Other issues such as degradation (downcutting) of the stream channel in the pool areas and another area of potential streambank failure in the lower reaches of the channel may also need to be addressed. Methods of repair could entail the addition of additional toe protection (riprap and/or boulders), rebuilding and/or re-sloping of the eroded streambanks in the areas of extreme scour and the installation of additional vanes and/or cross vanes at strategic locations along the channel reach. NCDOT will develop reconstruction/restoration plans for the channel repairs and these plans will be forwarded to the resource agencies for review before any corrective measures are implemented.

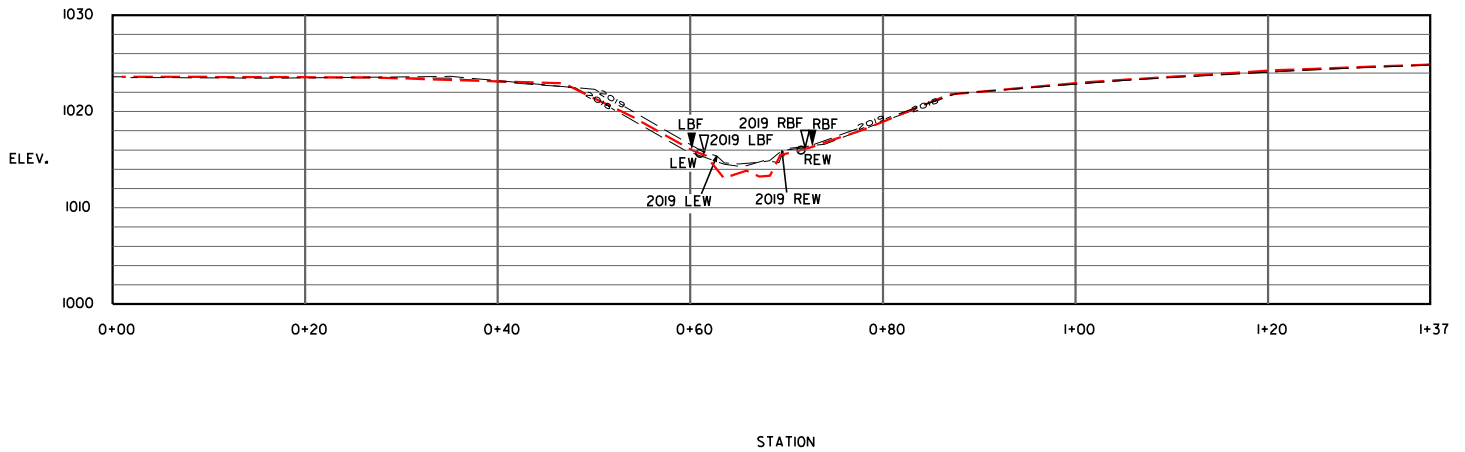
POOL CROSS-SECTION - STA. 13+56

The longitudinal profile appears to be relatively stable, except in the pool areas. The pool areas have degraded (downcut) approximately 3-4 feet and have also extended longitudinally from the 2019 profile.

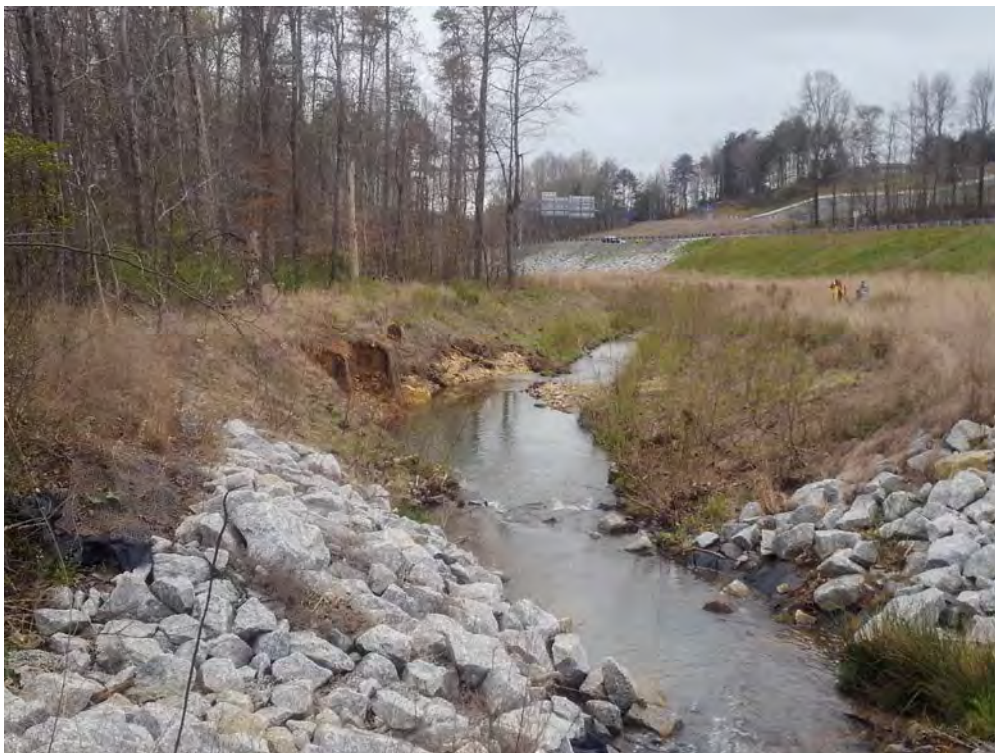
Looking South at Streambank Destabilization below Cross Vane 1 – 3/26/20

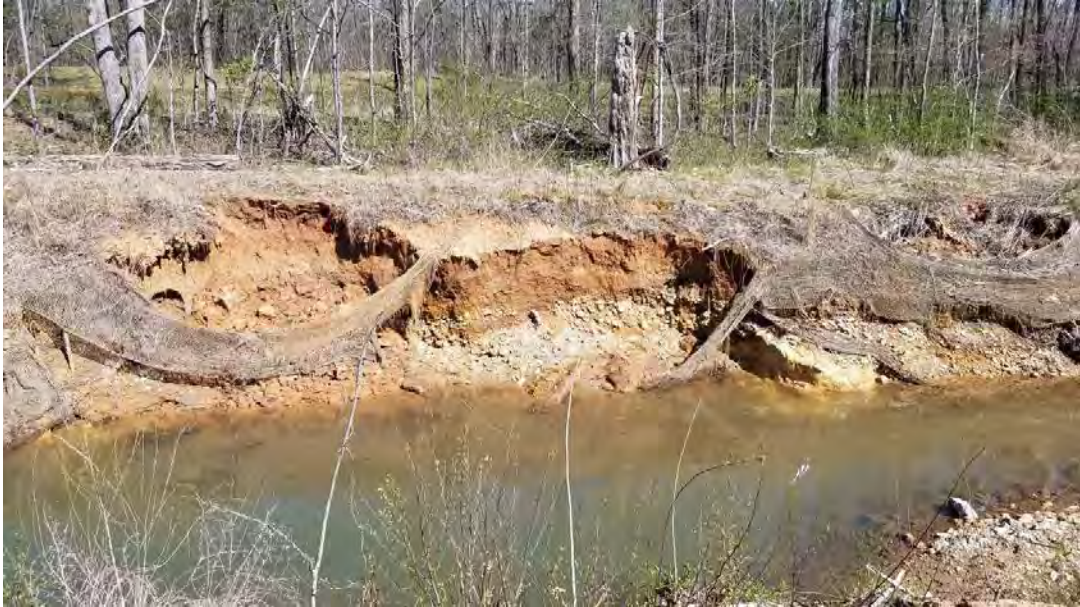
Looking East at Streambank Destabilization below Cross Vane 1 – 3/26/20

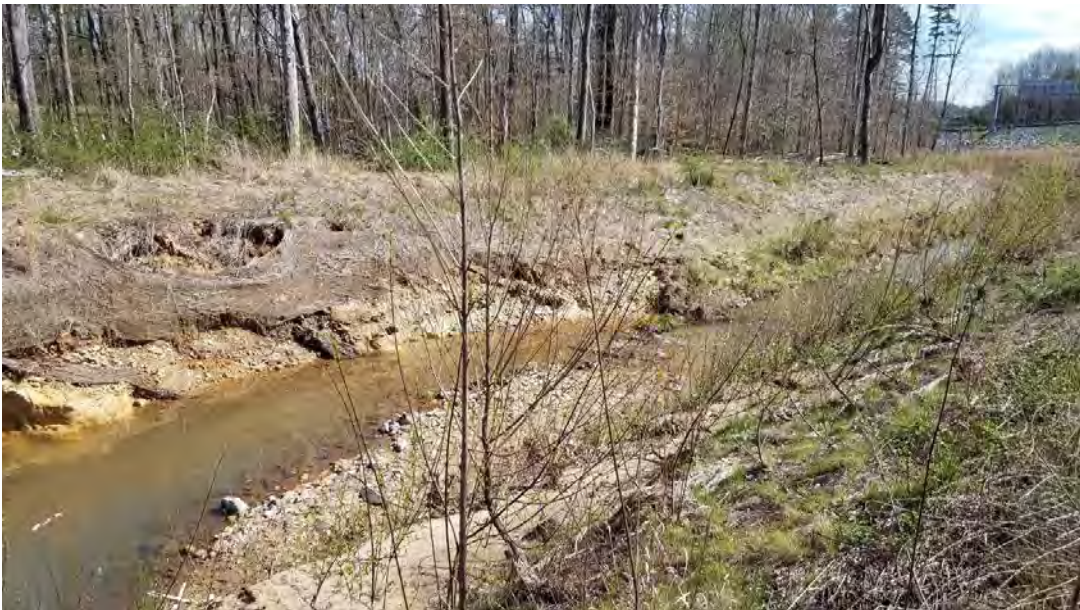
Looking East at Streambank Destabilization below Cross Vane 1 – 3/26/20

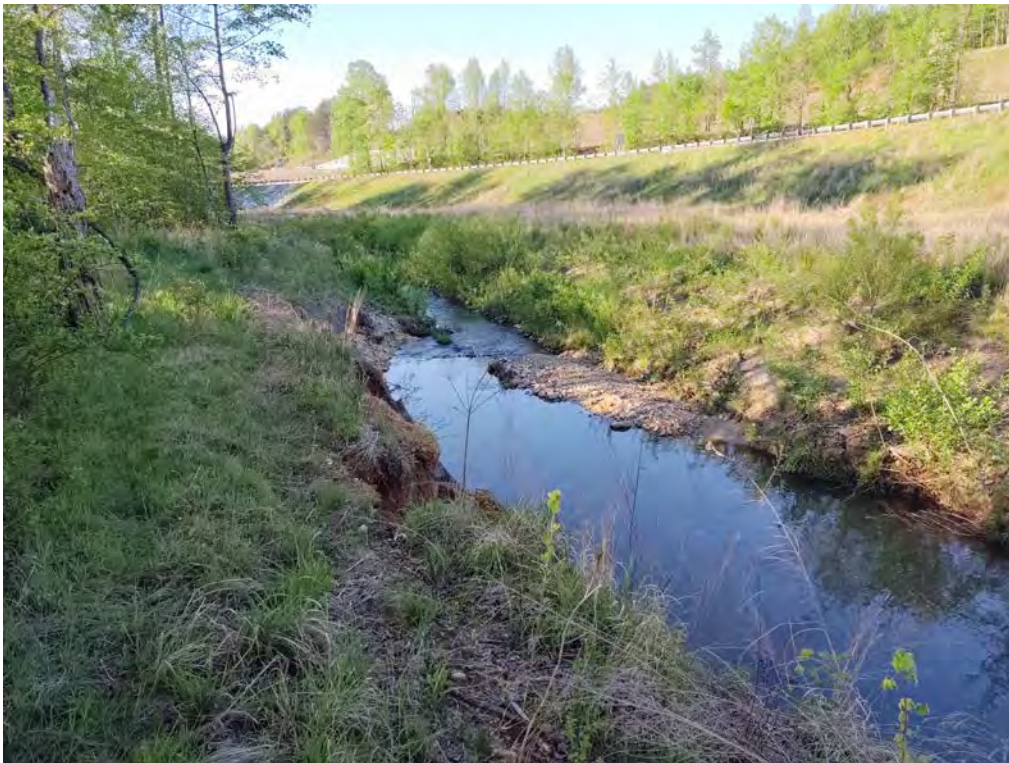
Looking South Downstream through End of Destabilized Streambank

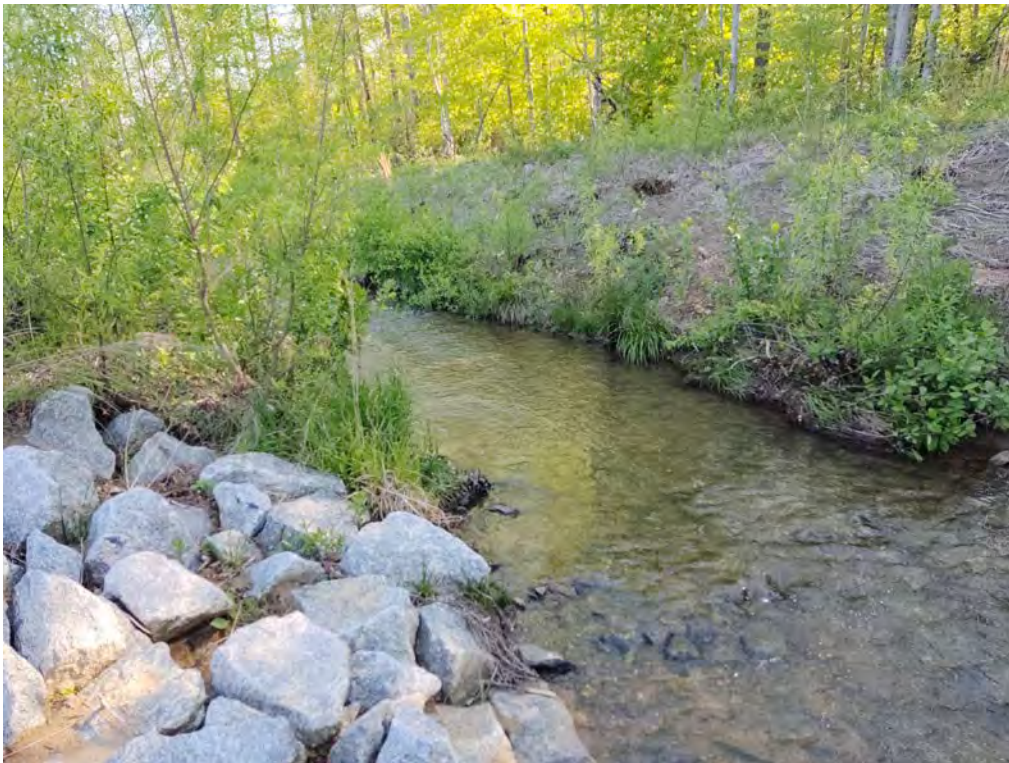
**Looking North (Upstream) from End of Channel Relocation
Rip Rap on Left is “Plug” of Old Stream Channel**
