**ANNUAL REPORT 2021**  
**Year 3 Report for**  
**Horse Creek Stream Relocation Monitoring Plan**

TIP Project No. I-4729A – Interchange Improvements at I-26 and US 74  
USACE Action ID No. **SAW-2017-01737**  
NCDWR Project No. **2017-01737**  
Polk County, NC

**Vaughn & Melton Consulting Engineers, Inc.**

**Date:** May 2021

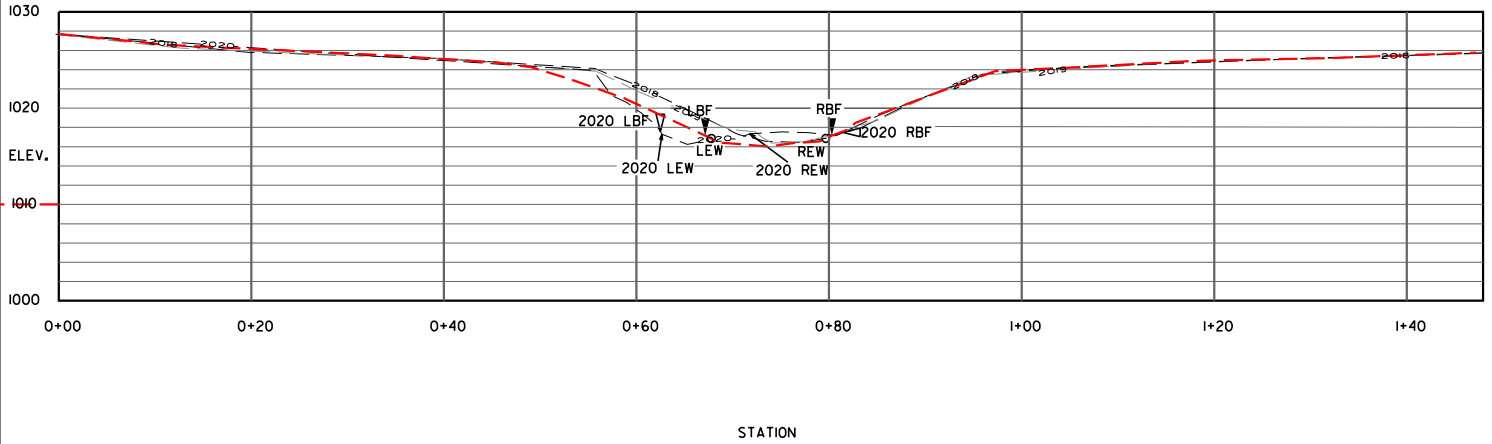
**RIFFLE CROSS-SECTION - STA. 12+05**  
 I-4729A  
 I-26 AND US 74 INTERCHANGE IMPROVEMENTS  
 STREAM RELOCATION  
 POLK CO., NORTH CAROLINA

Based on the review of the 2020 monitoring data, the channel was showing signs of widening, downcutting and scouring of pools, and considerable streambank erosion in the area of cross-section 1 (XS-1) mainly due to extreme weather conditions (excessive rainfall and flooding) that continues to occur in Polk County since the inception of this project. Stream channel modifications and/or repairs were designed and implemented by NCDOT personnel and were completed in October 2020. Methods of repair included boulder toe protection and the construction of a 150-foot long boulder wall along the eroded streambank, slight adjustment of the cross-vane below the RCBC, hardening and shallowing up of the deeply scoured pools and the removal of a beaver dam on the southern reach of the stream channel. The reconstructed areas were reseeded with appropriated vegetation and stabilized with coir fiber matting. These disturbed areas were replanted with live stakes and bare root seedlings in March 2021, to provide long-term stabilization.

CROSS SECTION #1 - STA. 12+05				
	AS BUILT	2019	2020	2021
BANKFULL WIDTH (FT.)	10.87	11.61	19.20	13.14
BANKFULL MEAN DEPTH (FT.)	0.62	0.86	0.47	0.76
BANK HEIGHT (FT.)	7.70	7.41	7.64	7.84
WIDTH/DEPTH RATIO	17.53	13.50	40.85	17.29
BANKFULL CROSS SECTIONAL AREA (SQ. FT.)	6.71	8.45	9.01	9.97
MAXIMUM BANKFULL DEPTH (FT.)	0.95	1.27	1.33	1.14
FLOODPRONE AREA (SQ. FT.)	19.62	27.78	36.99	27.83
ENTRENCHMENT RATIO	2.92	1.61	1.21	1.36
BANK HEIGHT RATIO (FT./FT.)	8.11	5.83	5.74	6.88

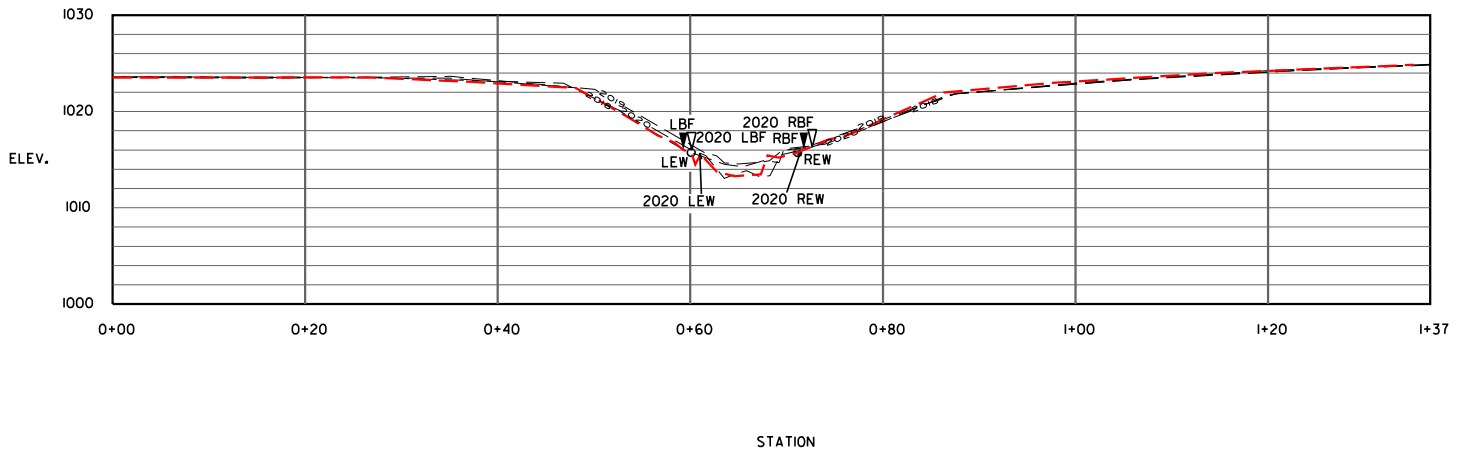
**POOL CROSS-SECTION - STA. 13+56**

CROSS SECTION #2 - STA. 13+56				
	AS BUILT	2019	2020	2021
BANKFULL WIDTH (FT.)	10.35	10.91	11.43	12.52
BANKFULL MEAN DEPTH (FT.)	1.16	1.07	1.60	1.46
BANK HEIGHT (FT.)	8.21	7.74	9.39	8.69
WIDTH/DEPTH RATIO	8.92	10.20	7.14	8.57
BANKFULL CROSS SECTIONAL AREA (SQ. FT.)	12.07	11.72	18.29	18.26
MAXIMUM BANKFULL DEPTH (FT.)	1.79	1.70	2.96	2.75
FLOODPRONE AREA (SQ. FT.)	42.43	38.89	73.24	69.25
ENTRENCHMENT RATIO	3.51	1.82	2.21	1.96
BANK HEIGHT RATIO (FT./FT.)	4.59	4.55	3.17	3.16

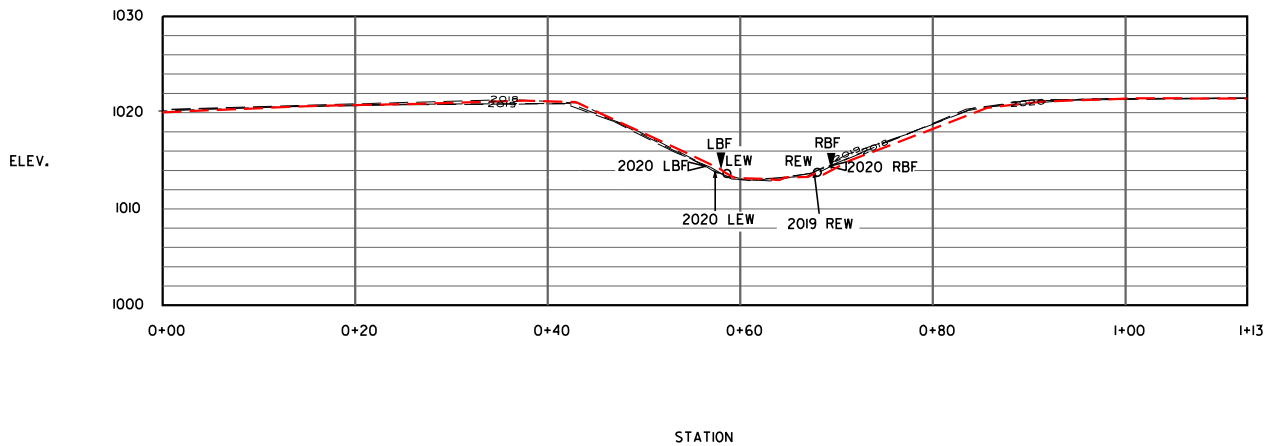
**RIFFLE CROSS-SECTION - STA. 16+37**

CROSS SECTION #3 - STA. 16+37				
	AS BUILT	2019	2020	2021
BANKFULL WIDTH (FT.)	11.83	11.75	12.79	11.60
BANKFULL MEAN DEPTH (FT.)	0.71	0.91	1.04	0.73
BANK HEIGHT (FT.)	7.94	7.98	7.80	8.09
WIDTH/DEPTH RATIO	16.66	12.91	12.30	15.89
BANKFULL CROSS SECTIONAL AREA (SQ. FT.)	8.41	10.70	13.36	8.43
MAXIMUM BANKFULL DEPTH (FT.)	1.12	1.40	1.52	1.09
FLOODPRONE AREA (SQ. FT.)	24.09	31.28	37.65	23.31
ENTRENCHMENT RATIO	1.37	1.51	1.50	1.36
BANK HEIGHT RATIO (FT./FT.)	7.09	5.70	5.13	7.43

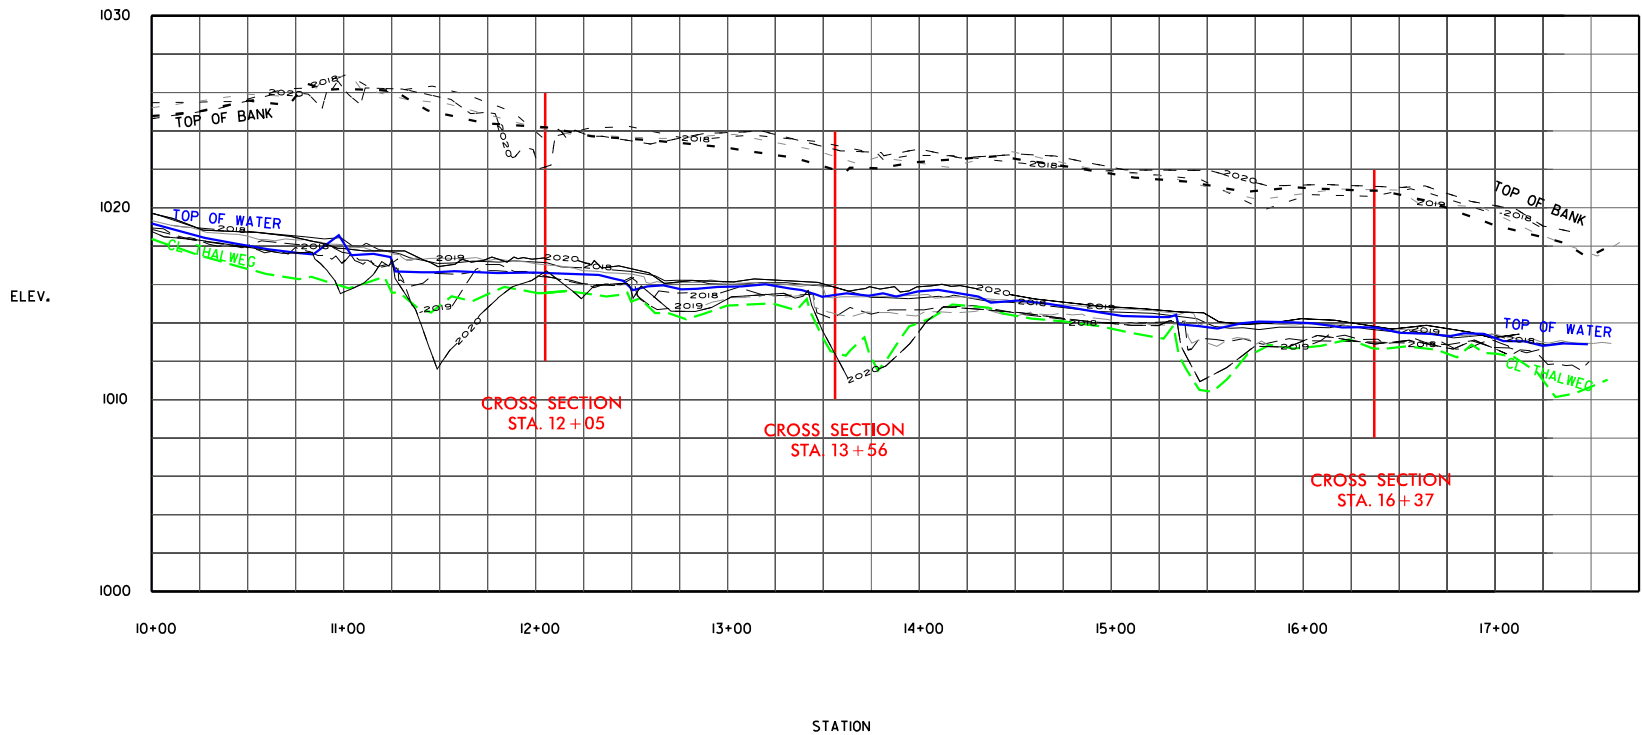
**STREAM LONGITUDINAL PROFILE**  
I-4729A  
1-26 AND US 74 INTERCHANGE IMPROVEMENTS  
STREAM RELOCATION  
POLK CO., NORTH CAROLINA

Following the October 2020 repairs, the longitudinal profile shows some degradation (downcutting) along the thalweg, especially in the upper reaches of the stream channel near XS-1. The deeply scoured pool areas near XS-1 and XS-2 were filled-in to some degree and hardened to prevent further scouring and deepening of the pools. The installation of the 150 linear foot boulder wall along the eastern streambank probably attributed to the establishment of the new deeper thalweg in 2021. Additional survey data will be required to fully assess the stream channel repairs made in October 2020.

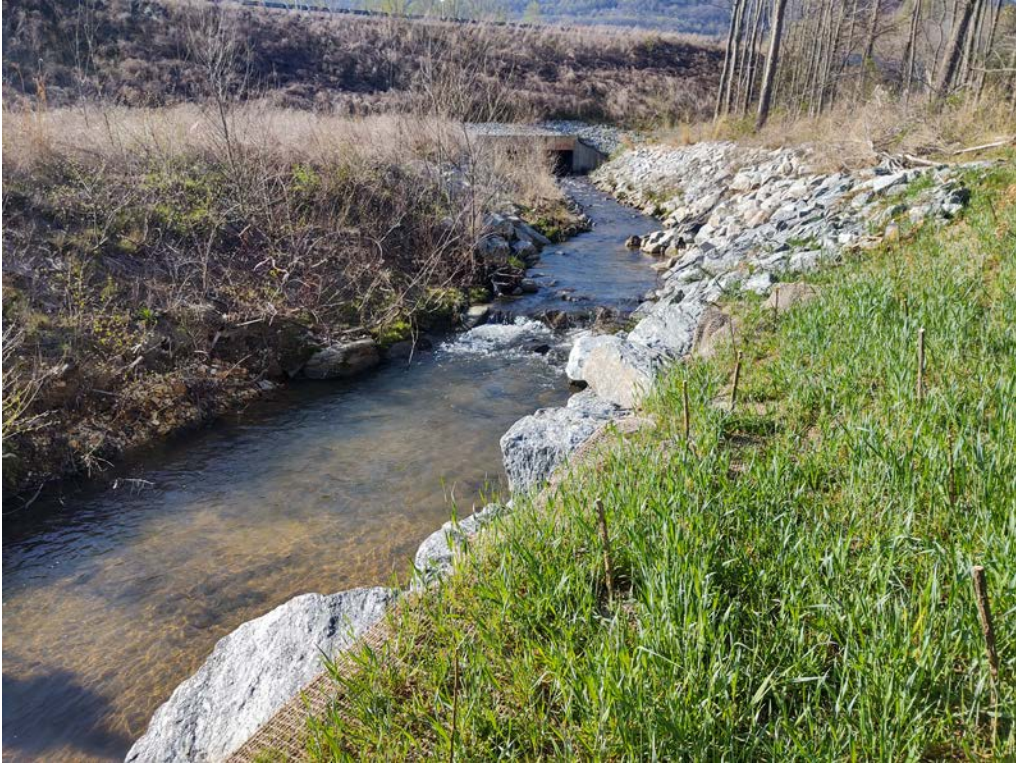
**I-4729A – Horse Creek Mitigation Site – Polk County  
Photo Point 1A – 2021**

**Looking Upstream After Repairs – 4-2-2021**

The live stakes that were planted along the streambank and noted in the monitoring evaluation are surviving and becoming well established. The area of extensive streambank erosion below the RCBC in the vicinity of XS-1 was repaired by NCDOT in October 2020 and replanted with live stakes and bare root seedlings in March 2021 (see attached photos Appendix C).

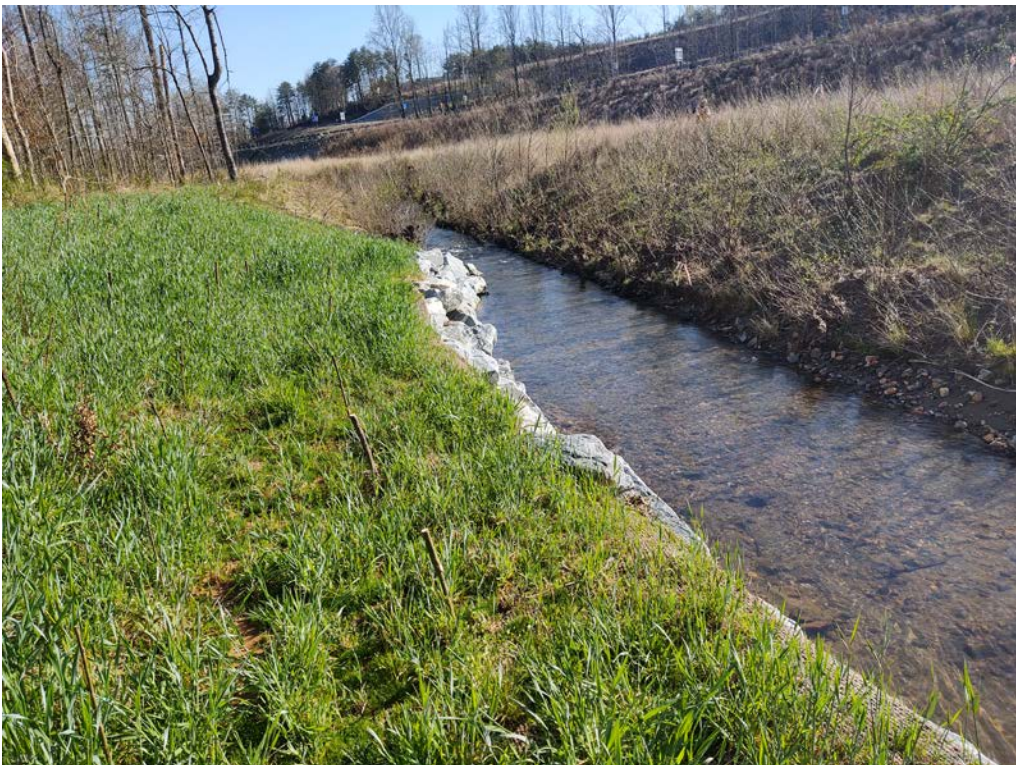
**Looking Downstream After Repairs – 4-2-2021**

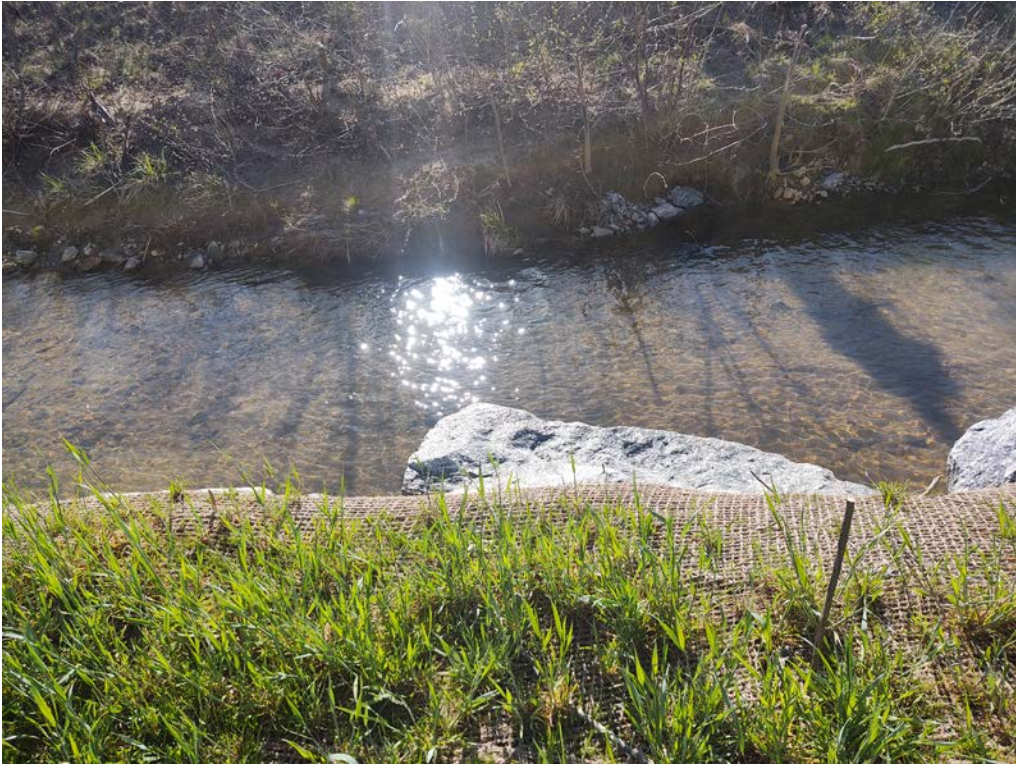
**I-4729A – Horse Creek Mitigation Site – Polk County  
Photo Point 1A – 2021**

**Looking Across Stream from Point 1A After Repairs – 4-2-2021**

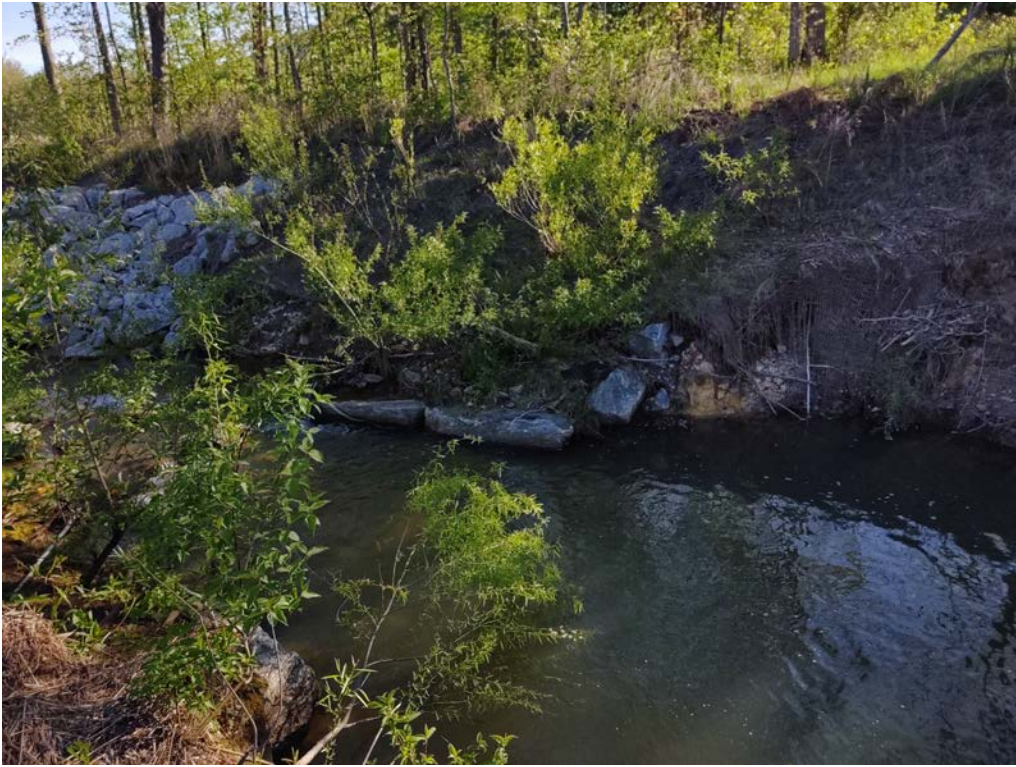
**Looking East at Upper End of Streambank Destabilization April 2020**

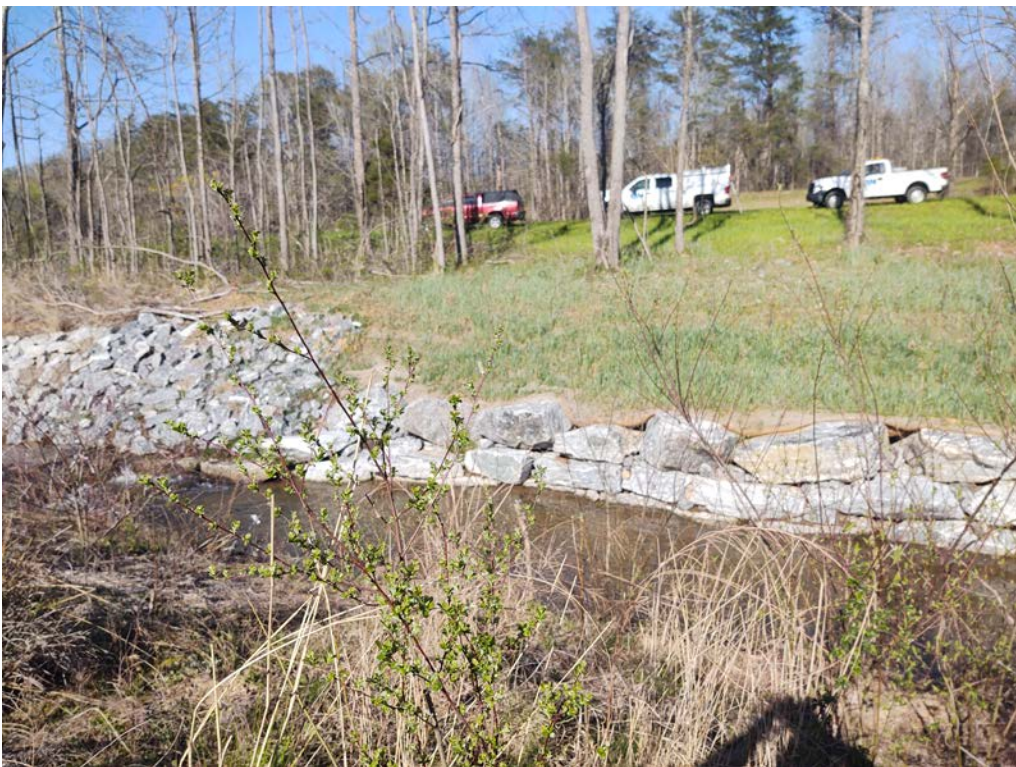
**Looking East at Upper End of Streambank Repairs April 2021**

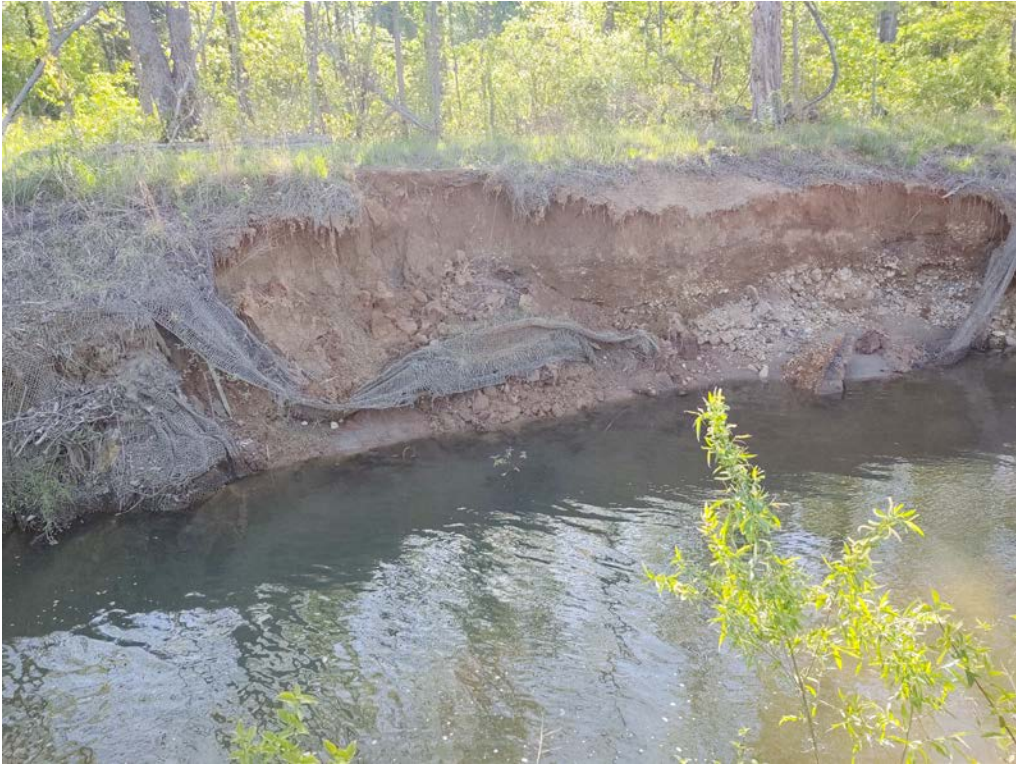
**Looking East at Middle of Streambank Destabilization April 2020**

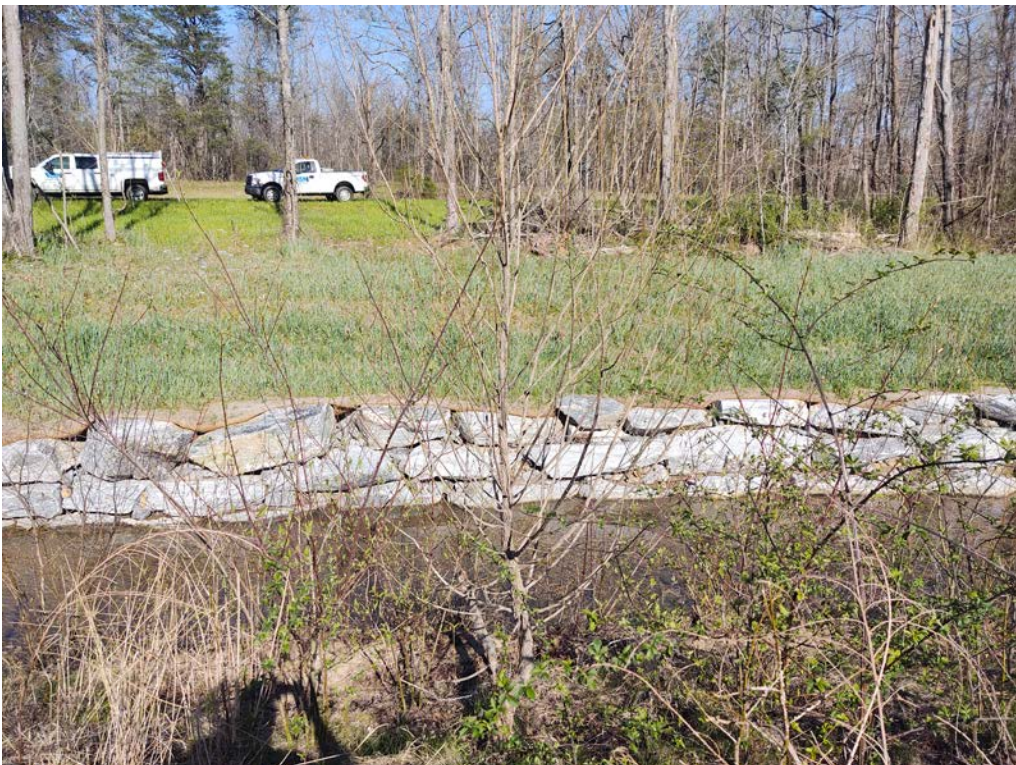
**Looking East at Middle of Streambank Repairs April 2021**

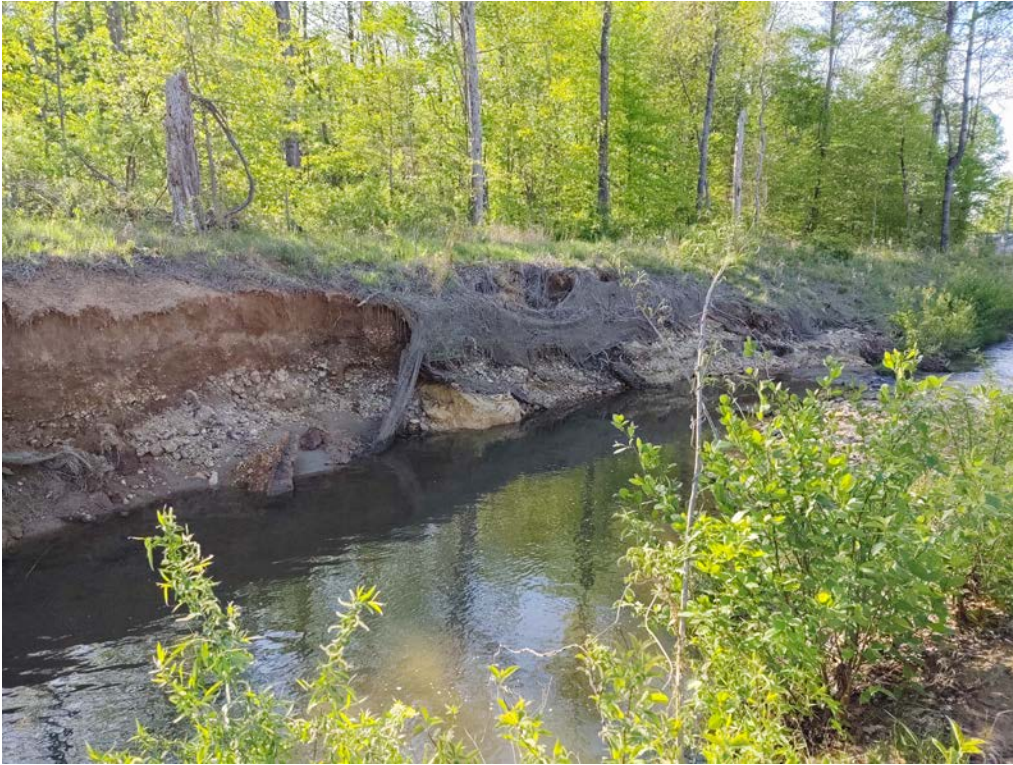
**Looking East at Lower End of Streambank Destabilization April 2020**

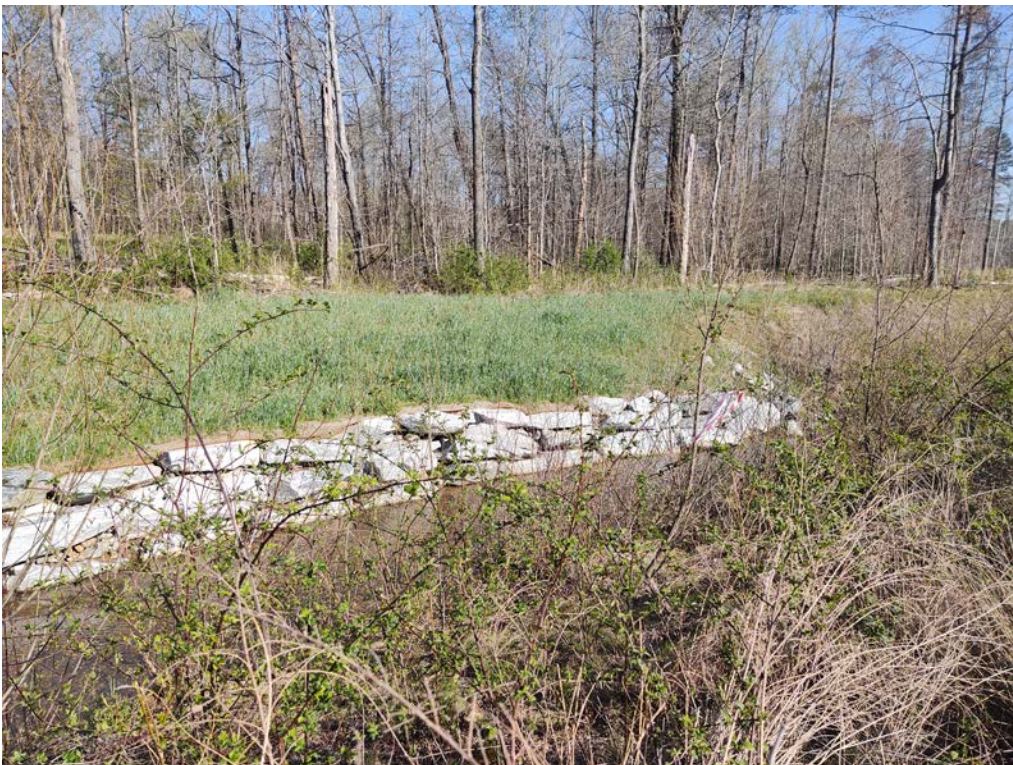
**Looking East at Lower End of Streambank Repairs April 2021**

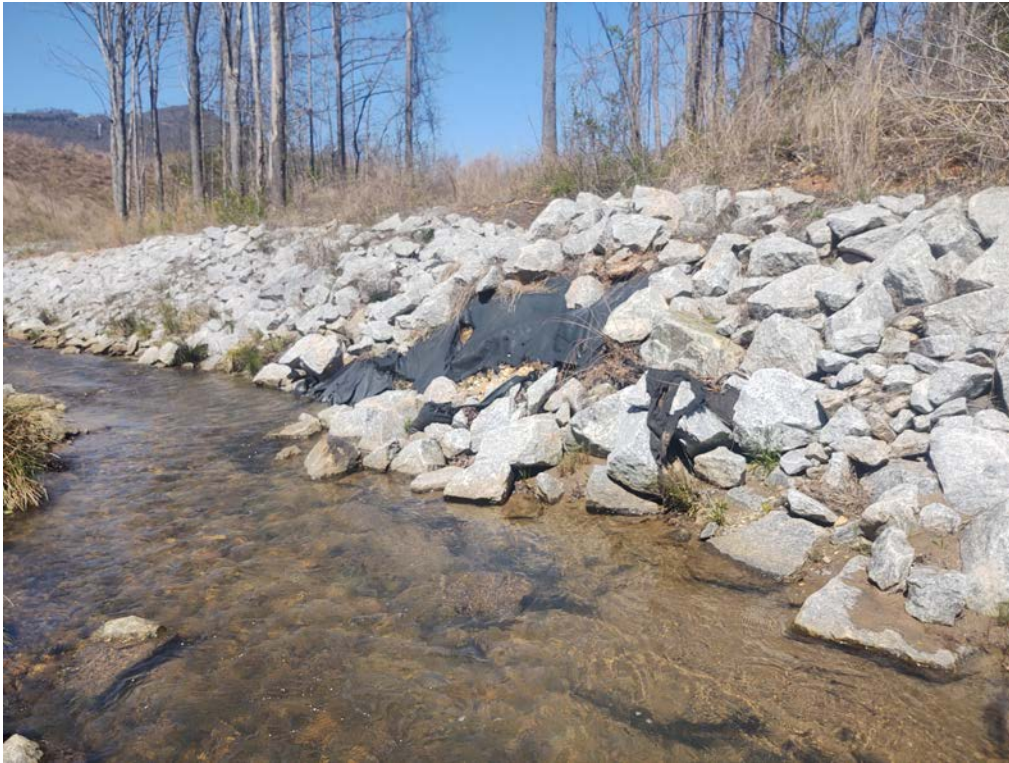
**Minor Streambank Scour North of New Boulder Wall**

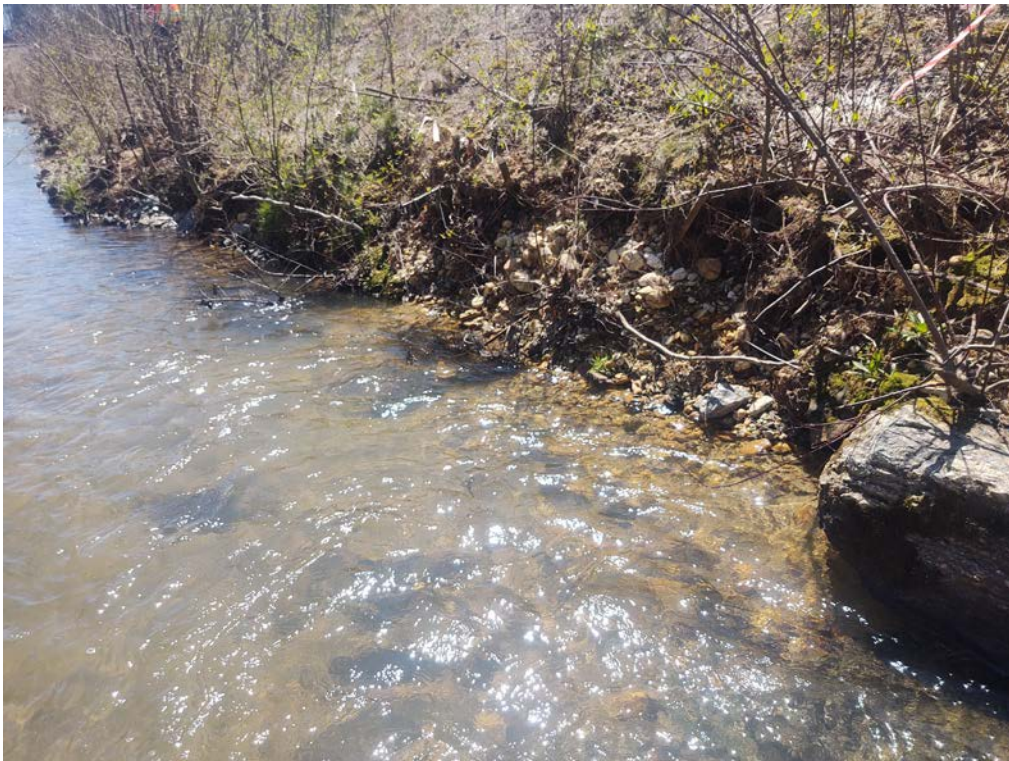
**Minor Toe Scour on West Bank of Cross Vane 1**

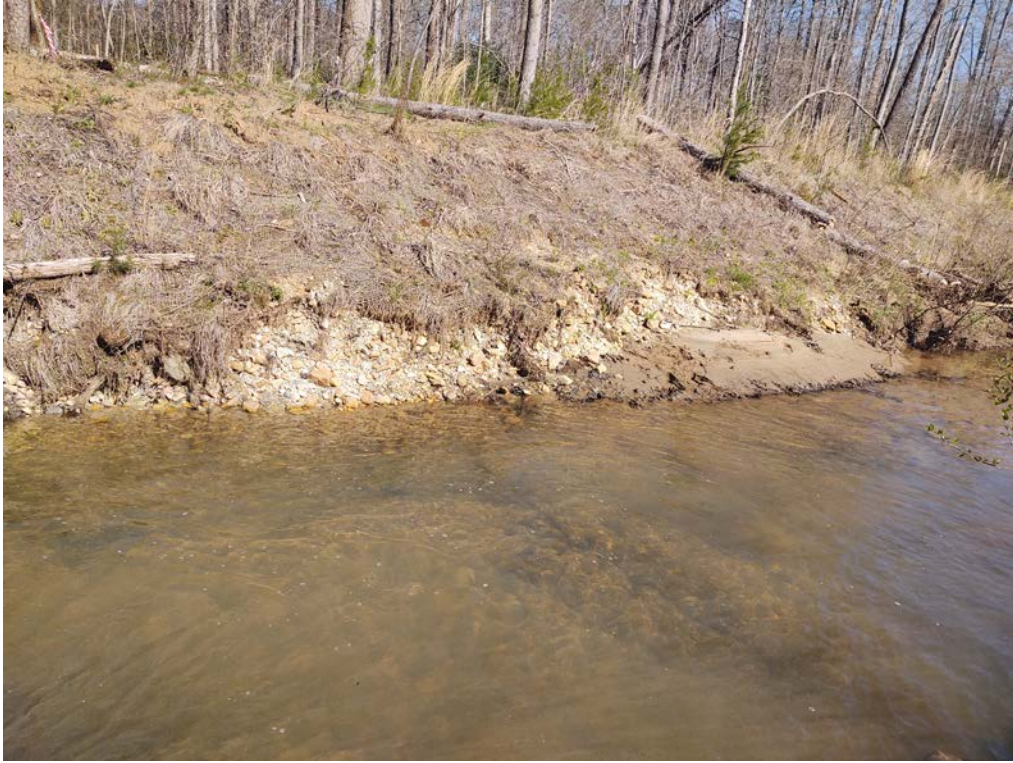
**Minor Toe Scour on East Bank Below New Boulder Wall**
