ANNUAL REPORT 2023
Year 5 Report for
Horse Creek Stream Relocation Monitoring Plan – Photo Documentation

TIP Project No. I-4729A – Interchange Improvements at I-26 and US 74
USACE Action ID No. **SAW-2017-01737**
NCDWR Project No. **2017-01737**
Polk County, NC

Date: January 2024

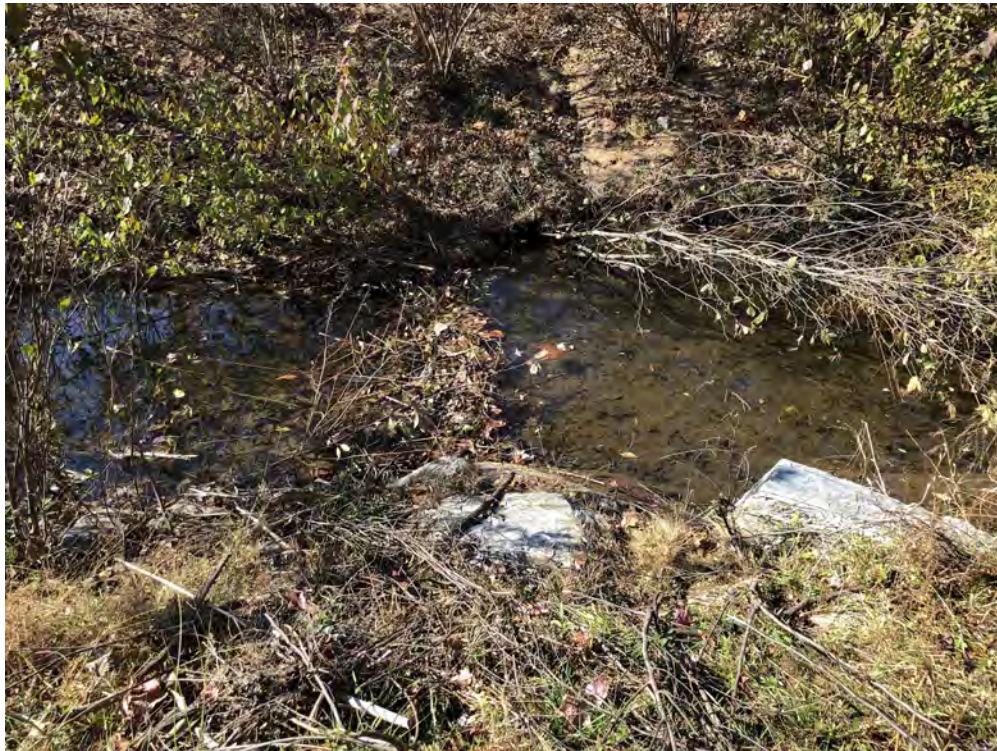
Based on the Year 5 (2023) visual/photo assessment and comparisons to the Year 4 (2022) photo documentation the channel appears well vegetated and stable. There is new beaver activity occurring along the northern end of the stream reach. There is a small beaver dam located just above Cross Section 1 (XS 1, riffle area) near the end of the streambank repairs which were completed in 2020. This dam has caused some pooling and minor accumulation of sediment in the stream channel upstream of the dam. There is also a larger beaver dam located just above Cross Section 2 (XS 2, pool area), which has impacted the stream channel by additional pooling and accumulation of sediment upstream of the dam. The streamside vegetation upstream of the two beaver dams has been thinned to a degree by this beaver activity; however, the remaining root structure should regenerate new stems in the spring along these impacted stream reaches.

Looking at Beaverdam 1 at End of Streambank Repairs just above X-Section 1

NCDOT plans to trap the beavers and remove the beaver dams from the stream channel as soon as possible. Once these dams are removed, the stream channel should flush itself of excess sediments and return to a more natural condition as designed. The overall stream channel parameters appear to be in good shape. There is one area of concern relating to streambank erosion near where the channel change ties back into the natural channel on the south end of the stream reach (see photos). NCDOT will keep this area under close observation and note any continued erosion.

NCDOT has a contract with USDA Wildlife Services for beaver removal. The Division 14 Environmental Staff contacted USDA on November 13, 2023, regarding the removal of the beavers. Josh Johnson with USDA Wildlife Services began beaver removal/trapping in early December 2023. One male beaver was trapped/removed from the area and the two dams were removed by USDA personnel. Mr. Johnson stated that this was the second time this year that he had trapped beavers in this area, which could continue to be a problem in the future.

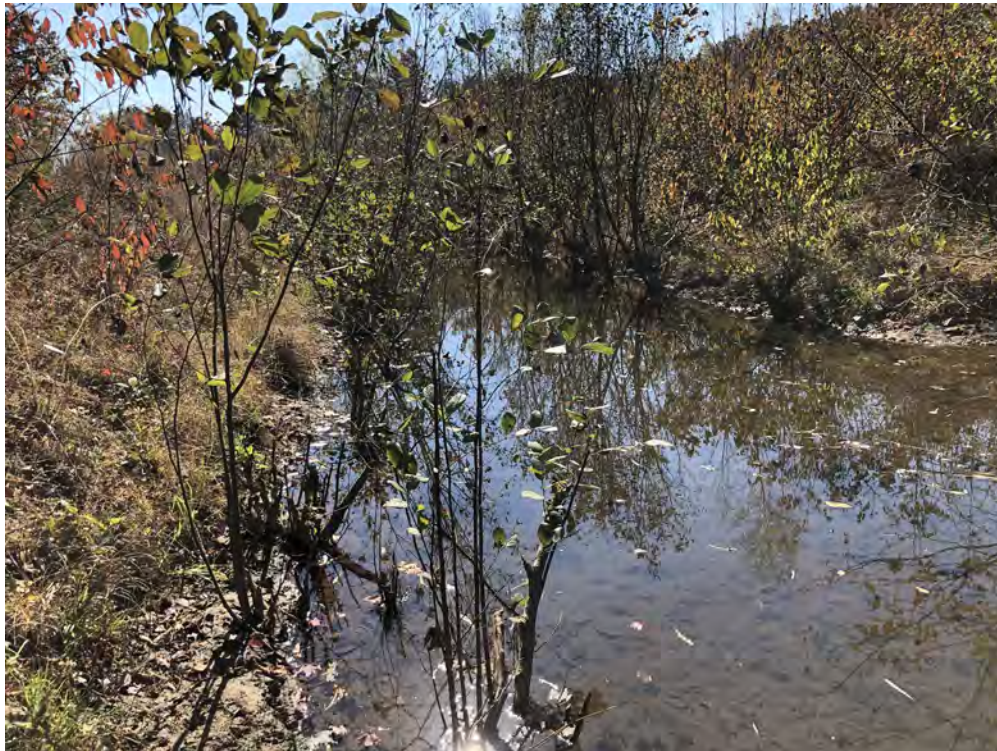
Looking Downstream from X-Section 1 – Water back-up from Beaverdam 2

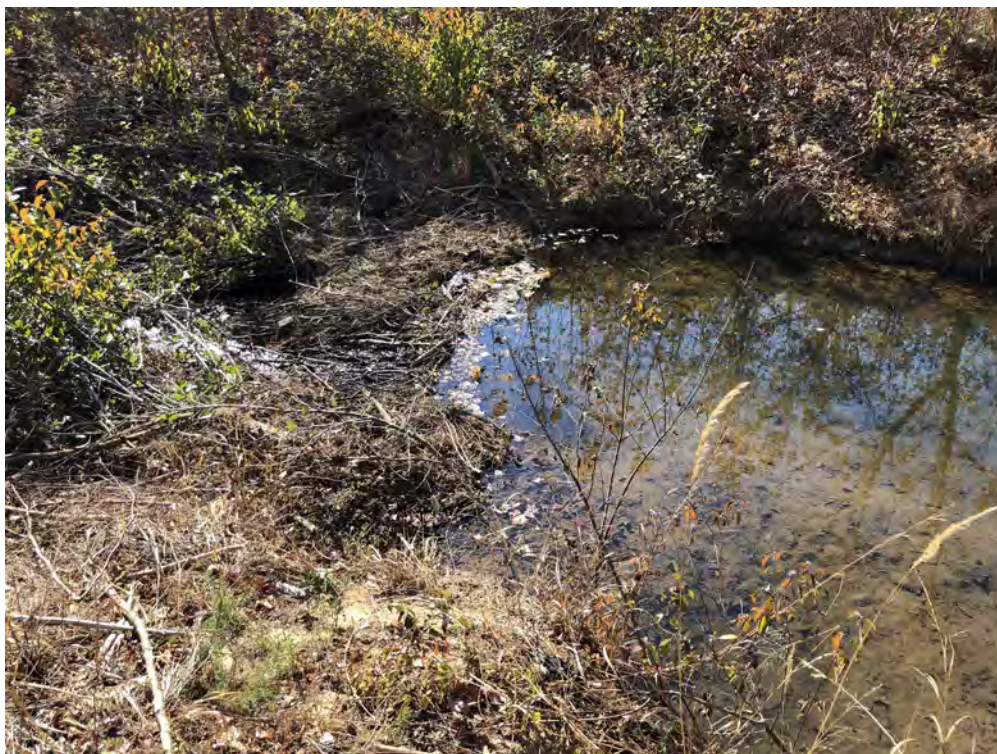
Looking at Beaverdam just upstream of X-Section 2

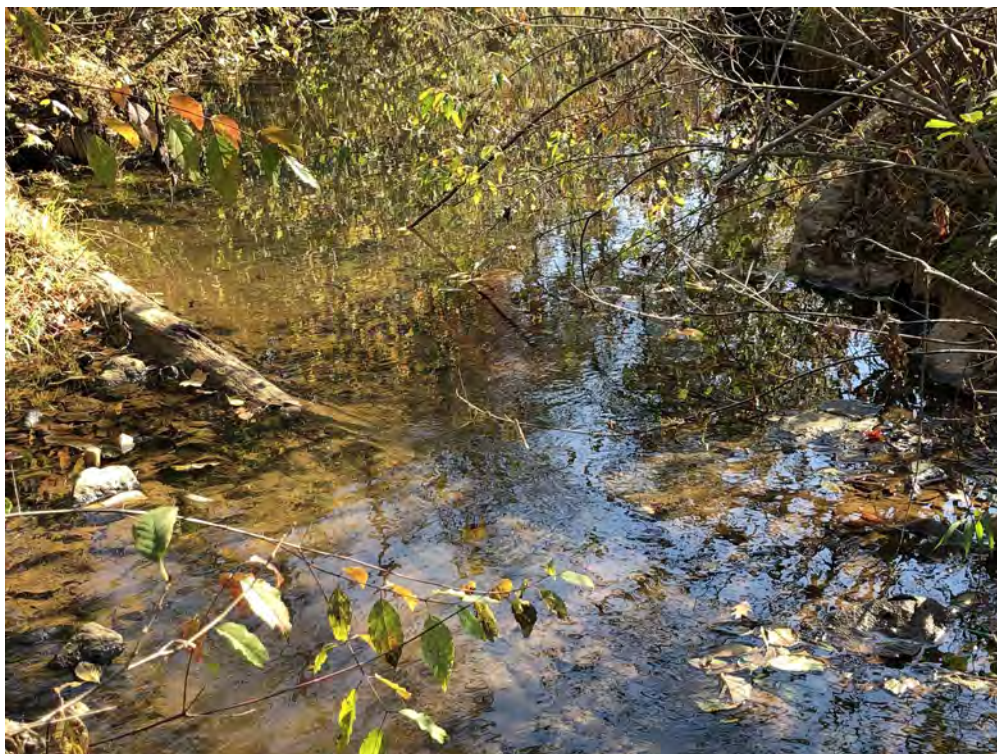
Looking at Log Vane Downstream from just below Photo Point 2

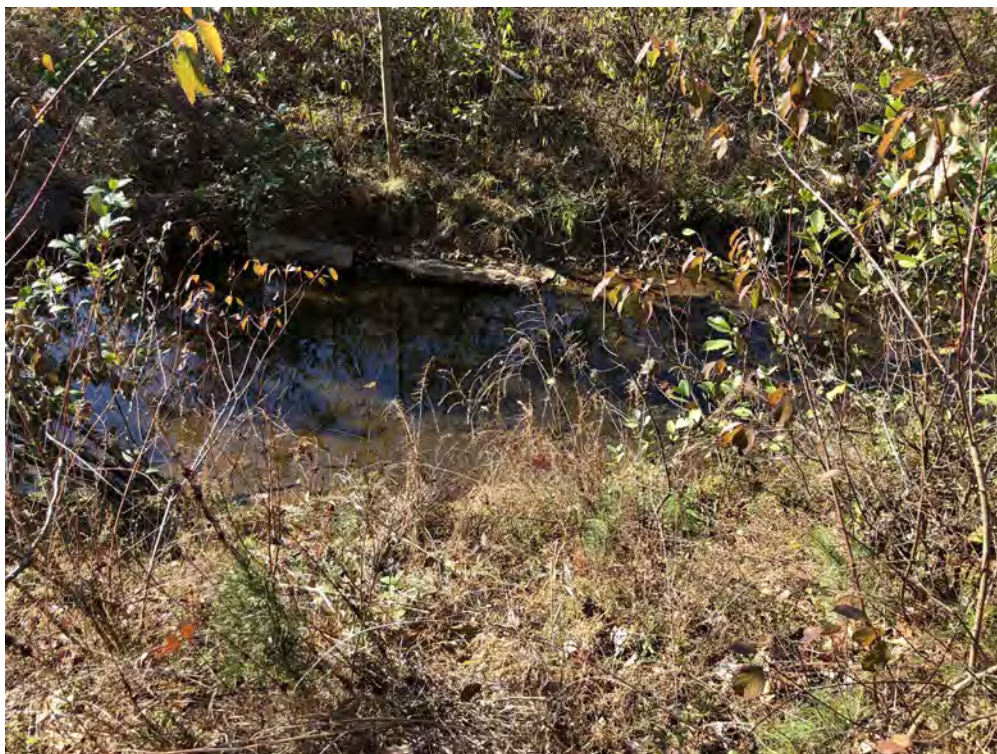
Looking at Rock Cross Vane just below X-Section 3 – East to West

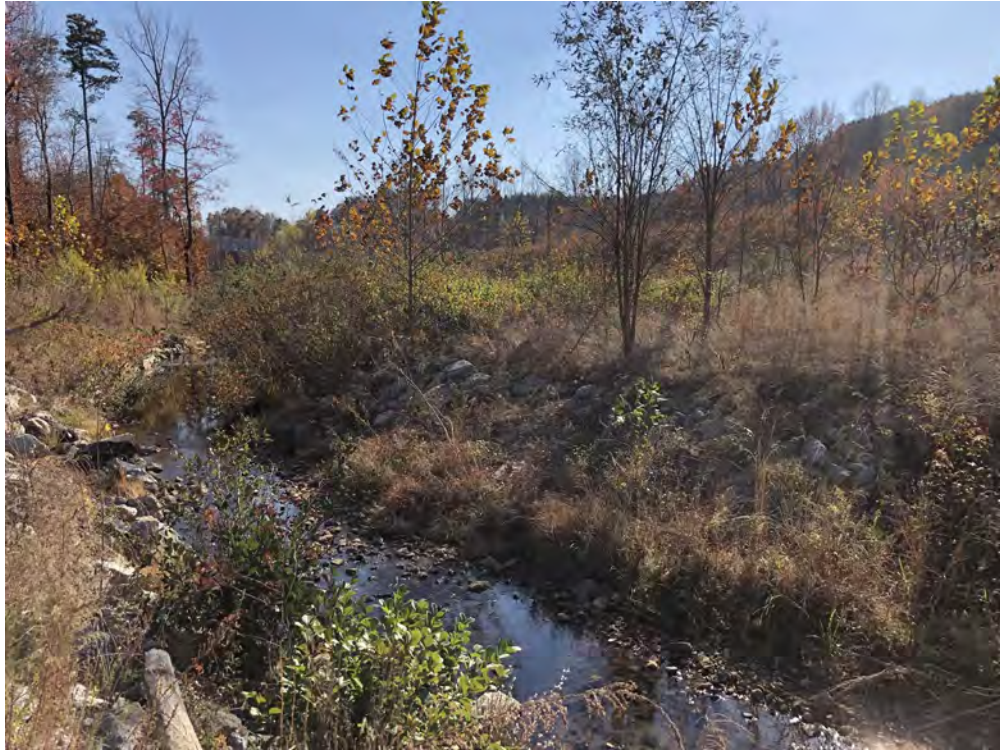
Looking Downstream below RCBC at Streambank Repairs from 2020

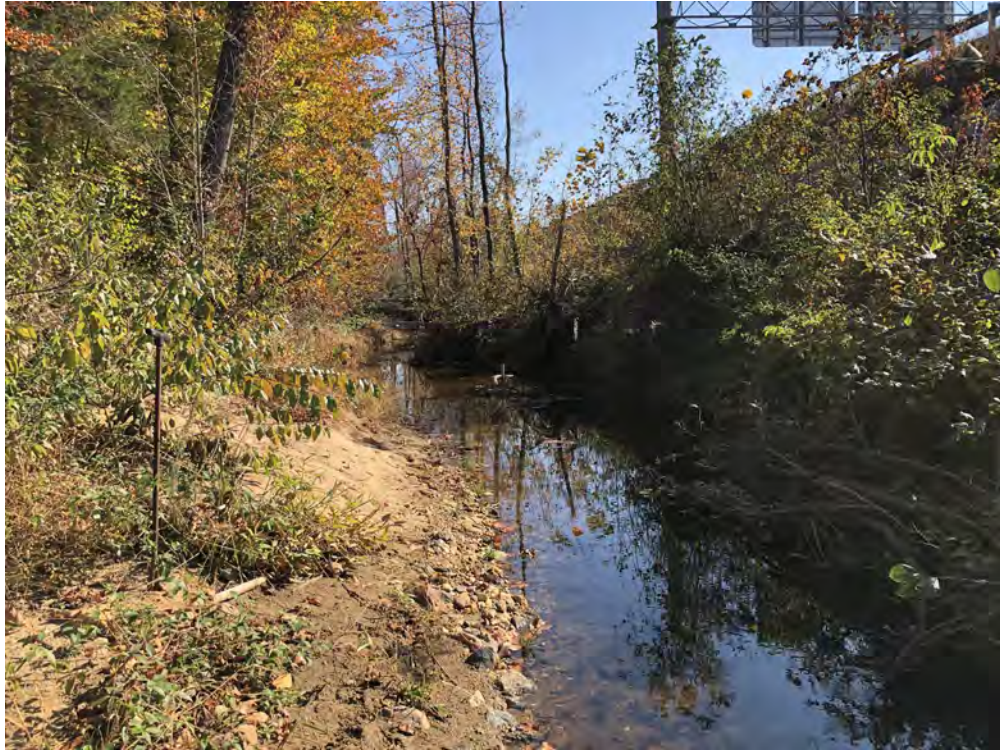
Looking Downstream from End of Channel Change – Some Streambank Erosion

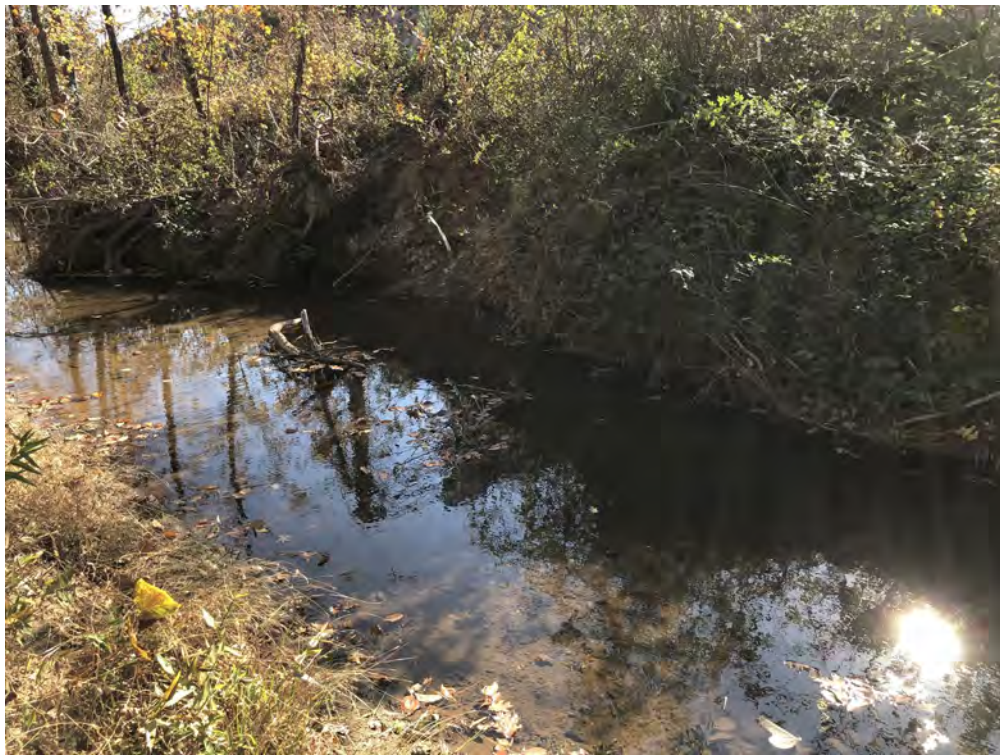
Looking Across Stream – End of Channel Change – Some Streambank Erosion
