Channel Mitigation Monitoring Sheets I, II, III, AND IV Monitoring Data Record

Project Title: R-2246B COE Action ID:	SAW-2012-01175/SAW-2009-1452
Stream Name: <u>UT to Coddle Creek – Permit Site 2</u>	DWR Number: <u>12-8969</u>
City, County and other Location Information: The proj	ect is located at the end of Roberta Church
Road in Cabarrus County, NC.	
Date Construction Completed: Final Planting: A	pril 4, 2018
Monitoring Year: (3) of 3	
Ecoregion: Southern Outer Piedmont 8 digit HUC u	ınit <u>03040105</u>
USGS Quad Name and Coordinates: Harrisburg 35.364	4741, -80.636008
Rosgen Classification:	
Length of Project: 54 linear feet	
Urban or Rural: Rural	Watershed Size: 0.98 sq. miles
Monitoring DATA collected by: M. Green	
Date: <u>7-30-20</u>	
Applicant Information:	
Name: NCDOT Roadside Environmental Unit	
Address: 1425 Rock Quarry Road Raleigh, N	NC 27610
Telephone Number: (919) 615-6733	Email address: <u>mlgreen@ncdot.gov</u>
Consultant Information:	
Name:	
Address:	
Telephone Number: I	Email address:

UT to Coddle Creek Mitigation Site

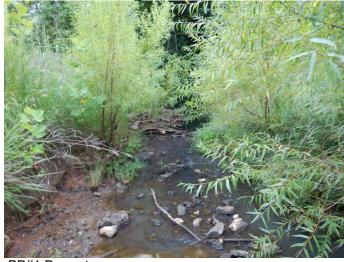
The UT to Coddle Creek onsite stream mitigation is stable for the Year 3 evaluation. A bankfull event was noted at the May 2020 site visit. Some minor bank scour exist along the left bank but remain mostly vegetated and stable at this time. NCDOT proposes to discontinue monitoring channel stability at the UT to Coddle Creek Mitigation Site.

Bank scour along left bank at PP#1
