ANNUAL REPORT FOR 2023

R-2413A&B UT to Reedy Fork Creek - Site #2 Guilford County TIP No. R-2413A&B

USACE Action ID: SAW-2013-00557

Prepared By:
Environmental Analysis Unit & Roadside Environmental Unit
North Carolina Department of Transportation
December 2023

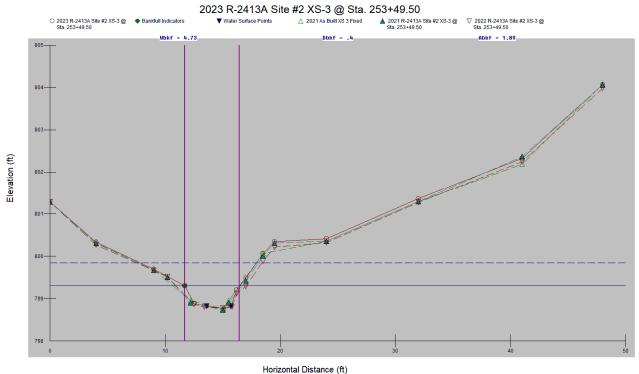
Based on visual assessment and comparisons of the as-built, MY3 (2023), XS-2 and XS-3 appear stable and are within expected thresholds for a C5 stream. NCDOT noticed the bankfull width at XS-3 has narrowed considerably from last year. This was attributed to the continued growth of a single live stake willow on the left bank in-line with the cross section. The willow has collected wrack debris which has caused sediment to deposit, effectively narrowing the channel. The channel remains closer to design parameters along much of the restored reach. Pebble counts were not required per the permit conditions and therefore were not completed. The longitudinal profile survey was not conducted in 2023. The vegetation along the stream buffer has demonstrated vigorous growth, conducting longitudinal survey would have been very challenging due to the vegetation blocking the survey equipment line of sight. NCDOT visually inspected the entire stream reach, and the stream appears stable throughout with heavy presence of streambank vegetation. All other monitoring activities will continue to be completed by NCDOT throughout the five-year monitoring period.

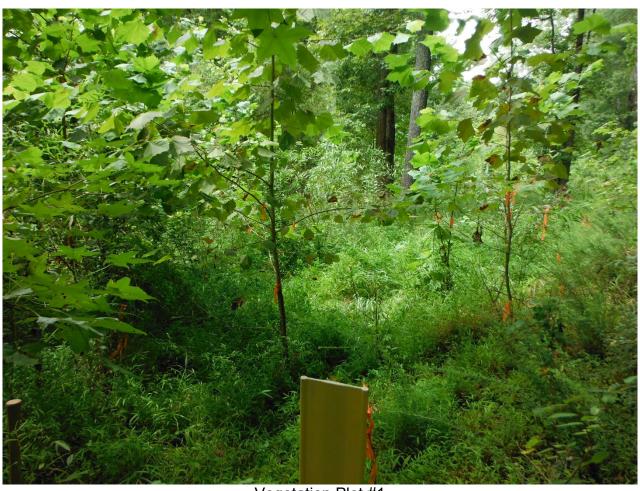
Vegetation Plot #1

Site Notes: Black Willow and Silky Dogwood live stakes that were planted along the streambank were noted as surviving.
