### **ANNUAL REPORT FOR 2023**

Middle Fork California Creek Site I Mitigation Site Madison County TIP No. R-2518A

**COE Action ID: SAW-2007-2197-357/300**

Prepared By:
Environment Analysis Unit & Roadside Environmental Unit
North Carolina Department of Transportation
December 2023

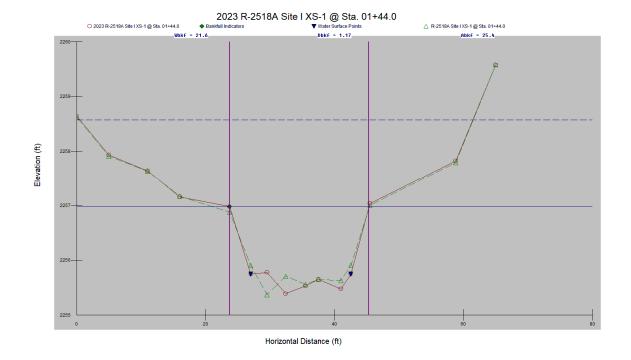
R-2518A Middle California Creek (Site I): Cross-Section #1 (Riffle) Abbreviated Morphological Summary							
Variable	As-built	MY1 (2023)	MY2 (2024)	MY3 (2025)	MY4 (2026)	MY5 (2027)	
Width of the Floodprone Area (ft)	56.3	61.0					
Bankfull Width (ft)	21.2	21.6					
Entrenchment Ratio	2.6	2.8					
Bankfull Mean Depth (ft)	1.4	1.2					
Maximum Bankfull Depth (ft)	2.3	1.6					
Width/Depth Ratio	15.7	18.5					
Bankfull Cross Sectional Area (ft <sub>2</sub> )	30.7	25.4

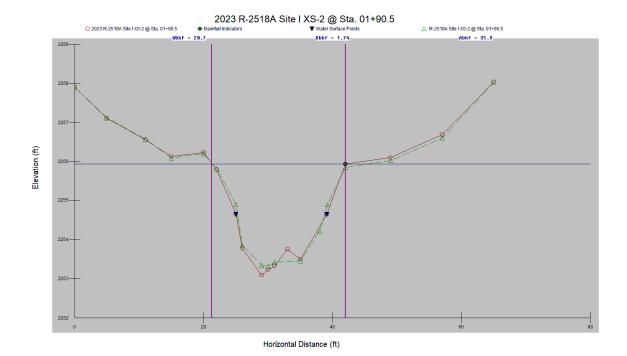
R-2518A Middle California Creek (Site I): Cross-Section #2 (Pool) Abbreviated Morphological Summary								
Variable	As-Built	MY1 (2023)	MY2 (2024)	MY3 (2025)	MY4 (2026)	MY5 (2027)		
Bankfull Width (ft)	20.2	20.7						
Bankfull Mean Depth (ft)	1.7	1.7						
Maximum Bankfull Depth (ft)	2.5	2.9						
Bankfull Cross Sectional Area (ft2)	33.3	35.9

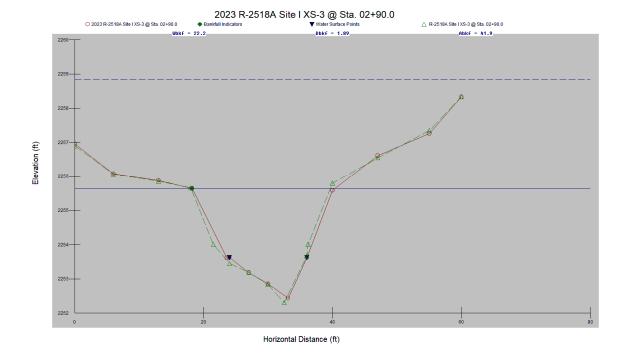
Variable	As-built	MY1 (2023)	MY2 (2024)	MY3 (2025)	MY4 (2026)	MY5 (2027)
Width of the Floodprone Area (ft)	60.0	60.0				
Bankfull Width (ft)	21.7	22.2				
Entrenchment Ratio	2.8	2.7				
Bankfull Mean Depth (ft)	2.0	1.9				
Maximum Bankfull Depth (ft)	3.4	3.2				
Width/Depth Ratio	11.0	11.8				
Bankfull Cross Sectional Area (ft2)	43.0	41.9

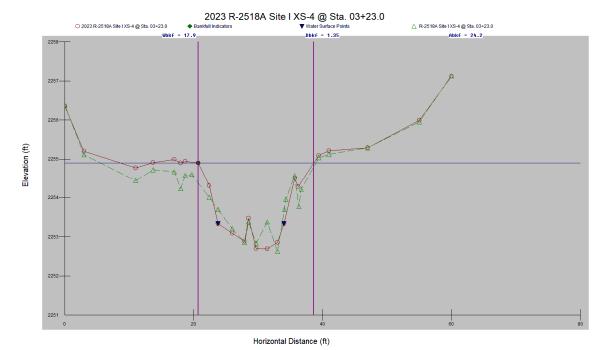
R-2518A Middle California Creek (Site I): Cross-Section #4 (Pool) Abbreviated Morphological Summary								
Variable	As-Built	MY1 (2023)	MY2 (2024)	MY3 (2025)	MY4 (2026)	MY5 (2027)		
Bankfull Width (ft)	18.3	17.9						
Bankfull Mean Depth (ft)	1.0	1.4						
Maximum Bankfull Depth (ft)	2.0	2.2						
Bankfull Cross Sectional Area (ft2)	18.0	24.2

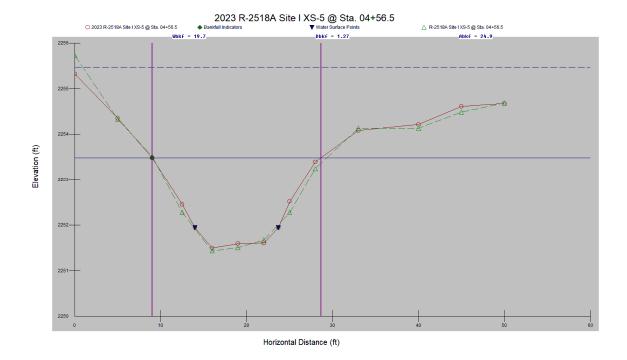
R-2518A Middle California Creek (Site I): Cross-Section #5 (Riffle) Abbreviated Morphological Summary							
Variable	As-built	MY1 (2023)	MY2 (2024)	MY3 (2025)	MY4 (2026)	MY5 (2027)	
Width of the Floodprone Area (ft)	49.5	50.0					
Bankfull Width (ft)	20.5	19.7					
Entrenchment Ratio	2.4	2.5					
Bankfull Mean Depth (ft)	1.3	1.3					
Maximum Bankfull Depth (ft)	2.1	2.0					
Width/Depth Ratio	15.6	15.5					
Bankfull Cross Sectional Area (ft <sub>2</sub> )	27.0	24.9

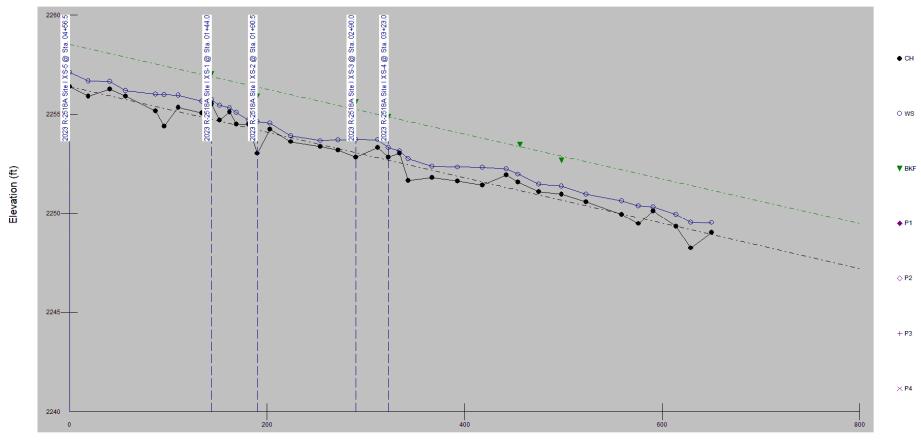
#### 2023 R-2518A Site I Profile

CH Best Fit Slope = 0.01150 BKF Best Fit Slope = 0.01130
