ANNUAL REPORT FOR 2021

Long Branch Site #5A Mitigation Site

Yancey County

Prepared By:
Roadside Environmental Unit and Environmental Analysis Unit
North Carolina Department of Transportation
September 2021

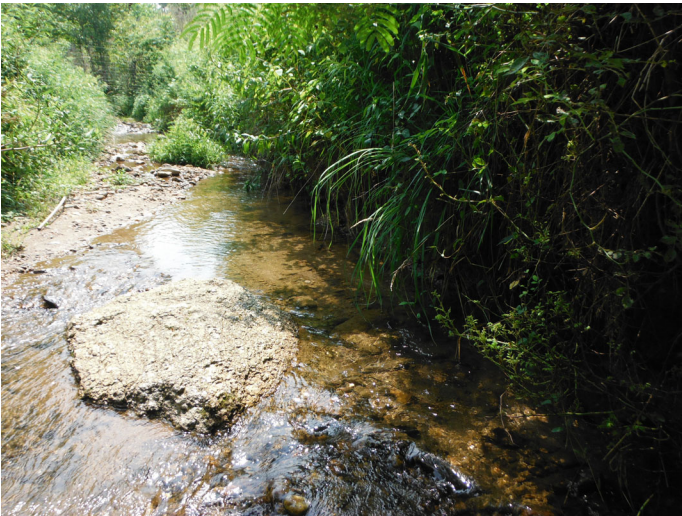
The visual assessment of the stream noted that the channel appears stable with some minor undercutting along the left bank. Little to no change was noted from the previous year. NCDOT will continue to monitor the channel stability at Site #5A in 2022.

Undercut left bank
