# ANNUAL REPORT FOR 2023

**Long Branch Site #5A Mitigation Site**

**TIP No. R-2519B**

Prepared By:  
Roadside Environmental Unit and Environmental Analysis Unit  
North Carolina Department of Transportation  
October 2023

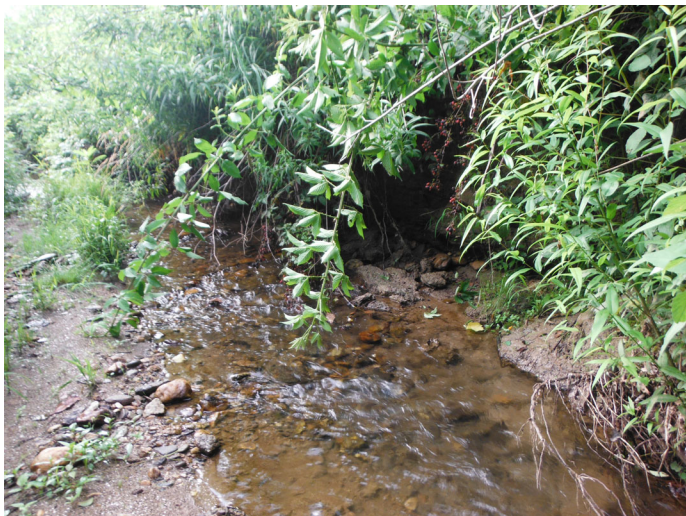
The visual assessment of the stream noted that the channel appears stable with some minor undercutting along the left bank. Little to no change was noted along the left bank from the previous year. A wrack line noted along the stream indicated a bankfull event had recently occurred. NCDOT will continue to monitor the channel stability at Site #5A in 2024.

Undercut left bank
