ANNUAL REPORT FOR 2021

Long Branch Site #6 Mitigation Site

TIP No. R-2519B

Prepared By:
Roadside Environmental Unit and Environmental Analysis Unit
North Carolina Department of Transportation
September 2021

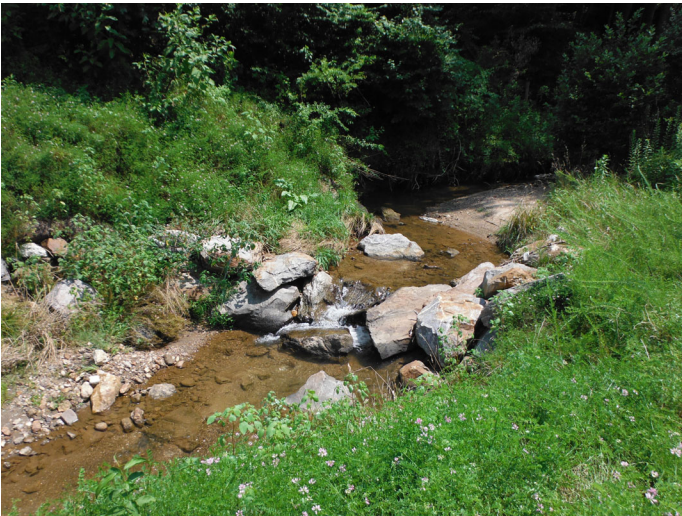
Upper crossvane

The visual assessment of the stream noted that the channel appears stable with little or no active bank erosion. The cross vane that was noted during the on-site agency review was determined to be functioning properly during the 2021 annual monitoring. NCDOT will continue to monitor the channel stability at Site #6 in 2022.
