ANNUAL REPORT FOR 2023

Long Branch Site #6 Mitigation Site

TIP No. R-2519B

Prepared By:
Roadside Environmental Unit and Environmental Analysis Unit
North Carolina Department of Transportation
October 2023

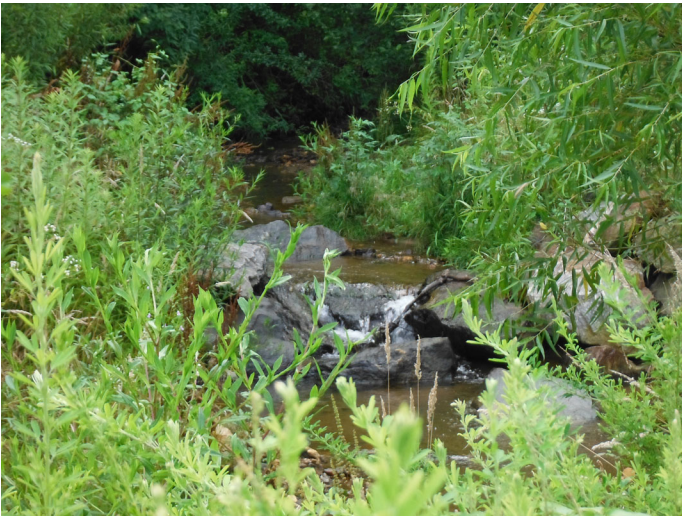
The visual assessment of the stream noted that the channel appears stable with little or no active bank erosion. The upper cross vane was functioning properly. NCDOT will continue to monitor the channel stability at Site #6 in 2024.

Upper crossvane
