# ANNUAL REPORT FOR 2023

**Long Branch Site #8 Mitigation Site**

**TIP No. R-2519B**

Prepared By:  
Roadside Environmental Unit and Environmental Analysis Unit  
North Carolina Department of Transportation  
October 2023

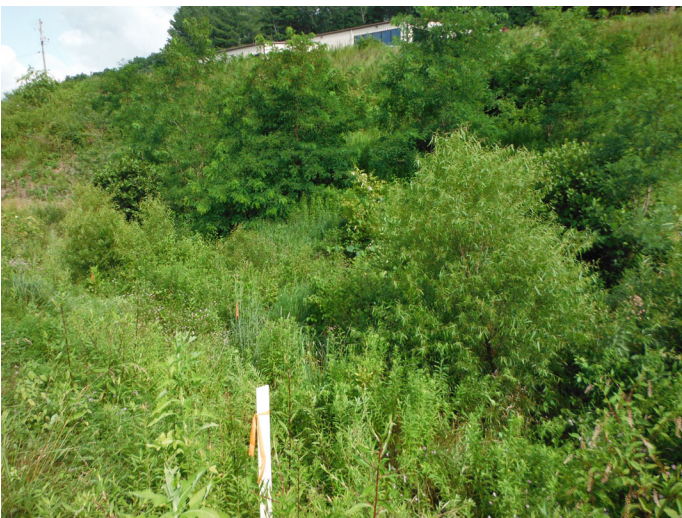
Vegetation Plot #1

**Site Notes:** The visual assessment of the streambank vegetation noted that the live stakes were surviving along the streambank. Tag alder and elderberry were noted within the site. Multiflora rose was also noted within the site. The upper reach - north side of the stream (approx. 0.25 acre) was replanted in March 2023. Recently planted seedlings within this area were noted surviving.

There was 1 vegetation monitoring plot established throughout the buffer area. The 2023 vegetation monitoring of the site revealed an average tree density of 655 trees per acre. This average is above the minimum success criteria of 290 trees per acre for Year 4. Invasive species are planned to be sprayed in 2024.
