# ANNUAL REPORT FOR 2021

**Long Branch Site #9 Mitigation Site**

**TIP No. R-2519B**

Prepared By:  
Roadside Environmental Unit and Environmental Analysis Unit  
North Carolina Department of Transportation  
September 2021

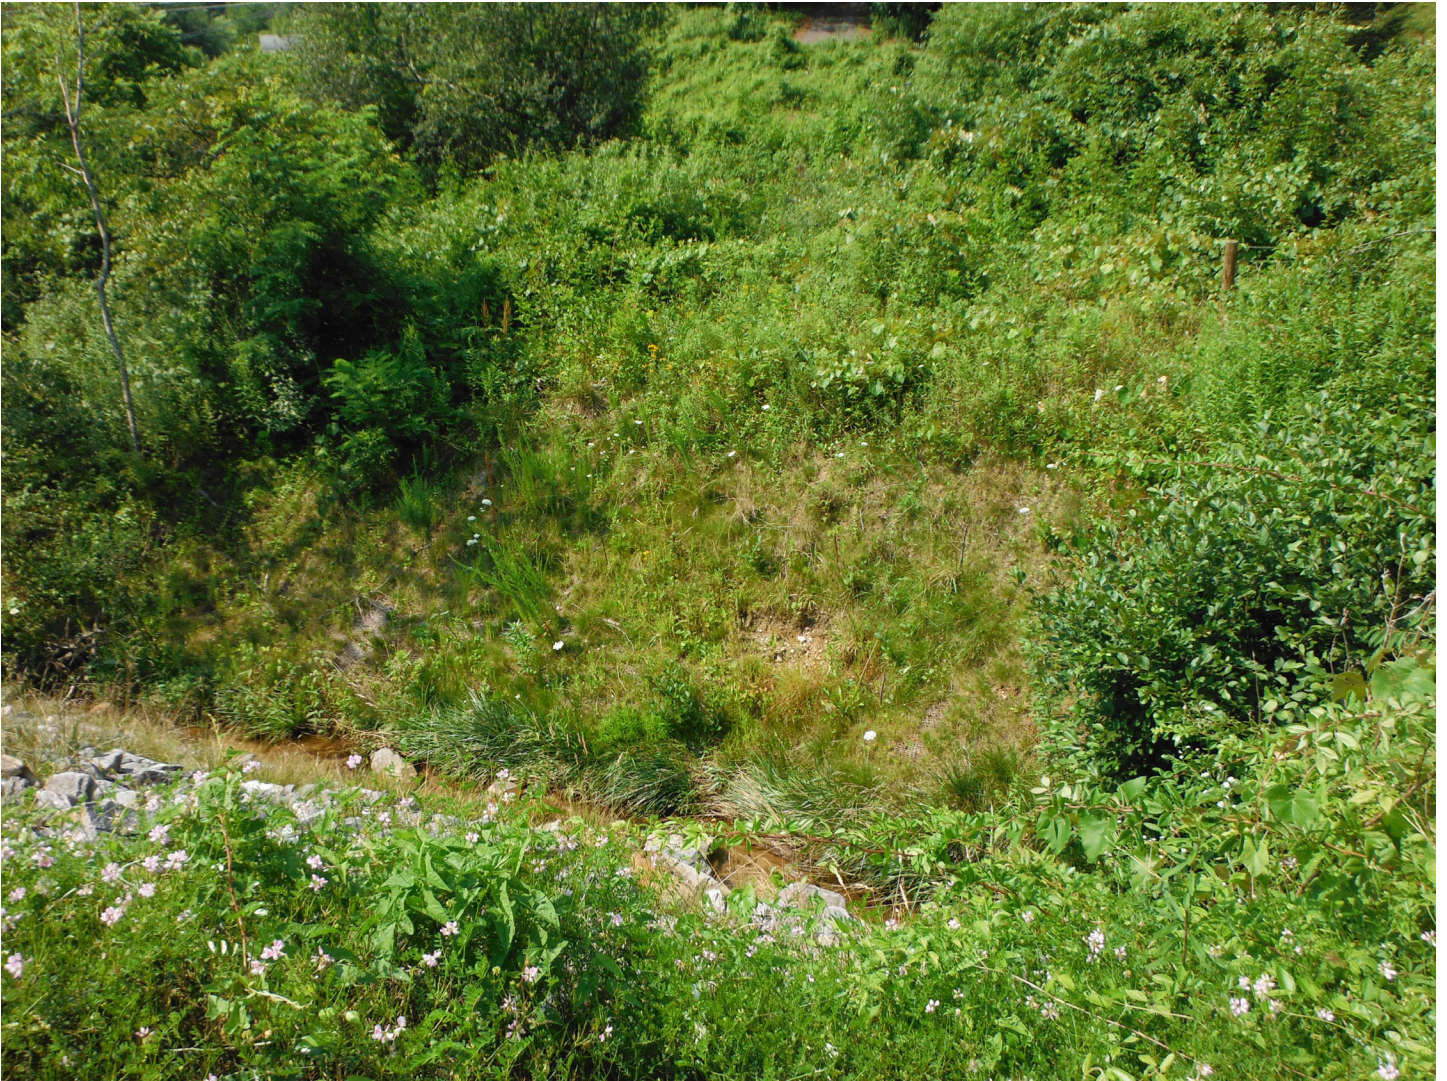
Photo Point #1

The visual assessment of the stream noted that the channel appears stable with little or no active bank erosion. NCDOT will continue to monitor the channel stability at Site #9 in 2022.

**Streambank & Buffer Vegetation:** Visual planted vegetation assessment noted the planted vegetation is surviving along the streambanks and within the buffer area at this time. A supplemental buffer planting was completed in February 2021. Planted vegetation noted surviving included Silky Dogwood, Sycamore, Northern Red Oak, and River Birch.
