ANNUAL REPORT FOR 2023

UT to Brushy Creek Site #30 Mitigation Site ONE ID #: 061-004 Mitchell County TIP No. R-2519B

COE Action ID: SAW-2004-9987181 / 2004-30631

Prepared By:
Environmental Analysis Unit and Roadside Environmental Unit
North Carolina Department of Transportation
December 2023

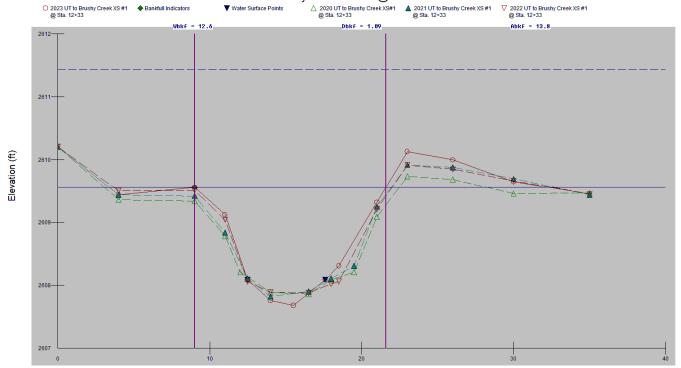
2023 UT to Brushy Creek XS #1 @ Sta. 12+33

Based on comparisons of the as-built to the MY4 (2023) monitoring data, both cross sections appear stable with little or no active bank erosion. Graphs of the cross sections are presented in Appendix A. Future survey data will vary depending on the actual location of rod placement and alignment; however, this information should remain similar in appearance. Longitudinal profile survey was not conducted because the height of the vegetation along the stream reach limits the line of sight for survey equipment. A visual inspection of the site showed that there were no visible signs of erosion along the restored stream reach.

Site #30: Cross-Section #1 (Riffle) Abbreviated Morphological Summary **Monitoring Year** 2020 2021 2022 2023 2024 Width of the Floodprone 35.0 35.0 35.0 35.0 Area (ft.) Bankfull Width (ft.) 12.8 12.5 12.8 12.6 2.7 **Entrenchment Ratio** 2.7 2.8 2.8 Bankfull Mean Depth (ft.) 1.0 1.1 1.0 1.1 **Maximum Bankfull Depth** 1.5 1.6 1.6 1.9 Width/Depth Ratio 12.9 12.0 12.1 11.6 **Bankfull Cross Sectional**

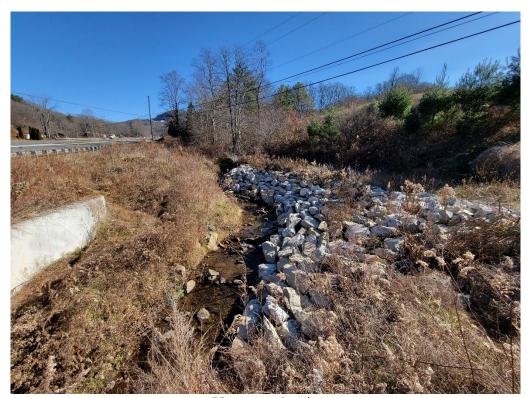
Upstream Section

Remediation work was completed at the site upstream of the US 19 highway crossing in August of 2022. The remediation work comprised of grading the left bank back and installing boulder toe protection to repair bank erosion that had continued throughout the monitoring period. A visual inspection of this area in 2023 indicates the left bank is stable and erosion has subsided. Photos of the remediation area are shown in Appendix B.

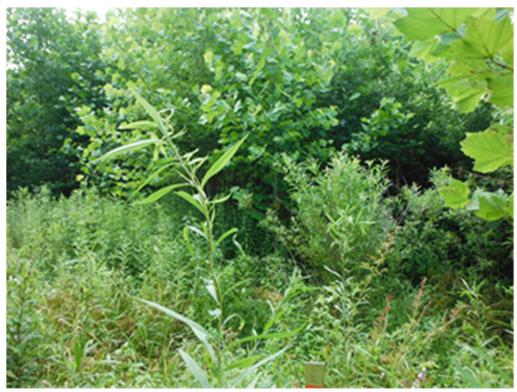
Vegetation Plot #1

Site Notes: Live stakes were surviving along the streambanks. Volunteer Sycamore were noted. Some Japanese Knotweed and Multiflora Rose were noted onsite. Invasive species were sprayed by Division 13 Roadside in September 2023

There is one vegetation monitoring plot located within the stream buffer area. The 2023 vegetation monitoring of the site revealed an average tree density of 680 trees per acre. This average is well above the minimum success criteria of 290 trees per acre for Year 4. NCDOT proposes to continue monitoring planted vegetation in 2024.

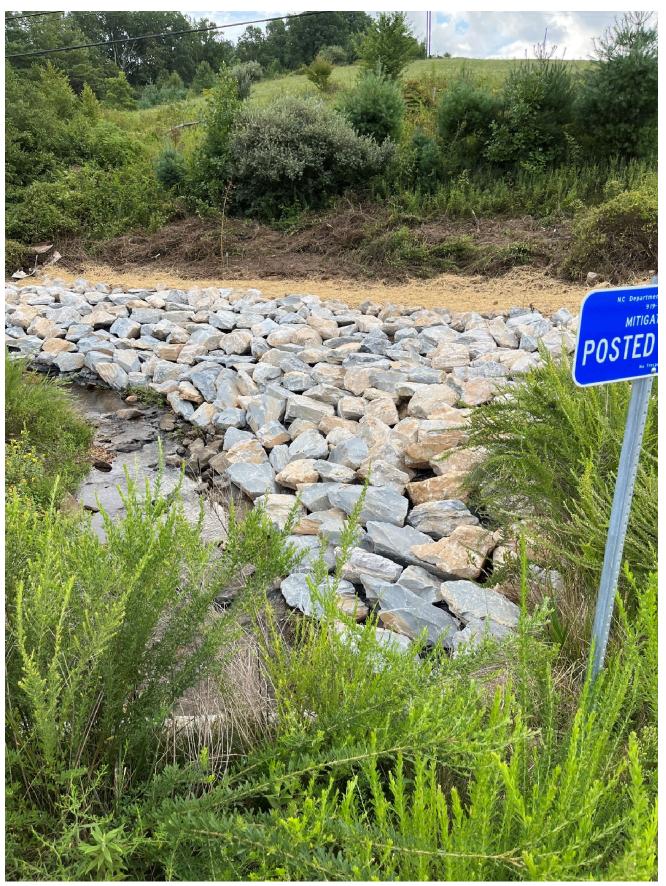
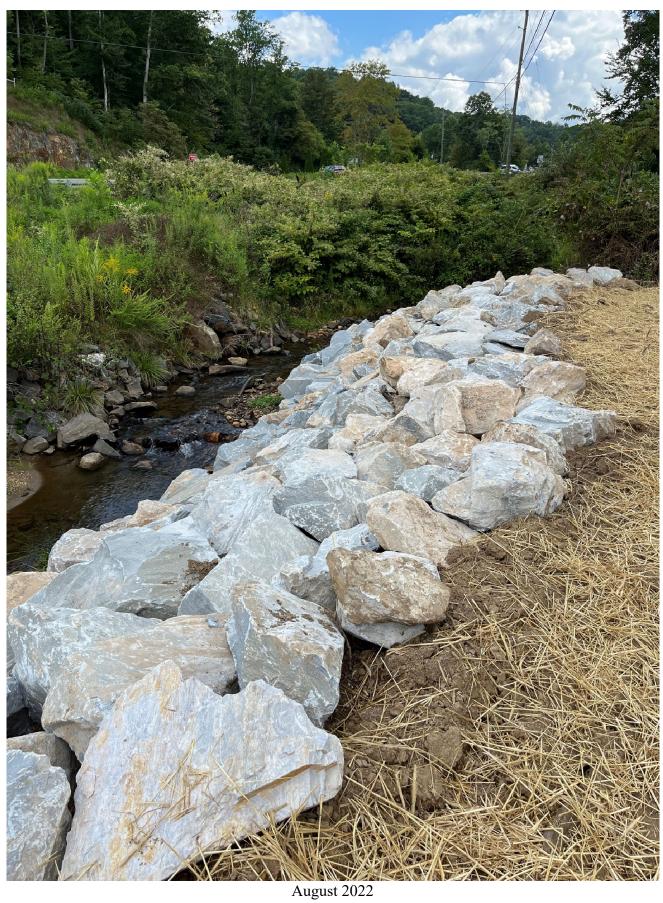
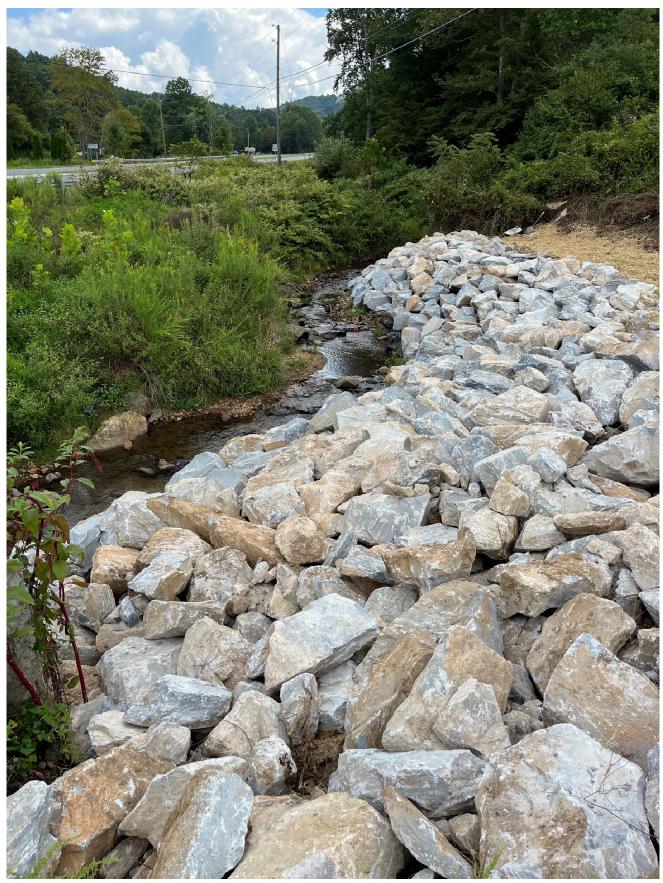
Site #30 Remediation Work

Remediation work that was completed at the site upstream of the US 19 highway crossing in August of 2022 remains stable and streambank erosion in this area has abated. Photos of the remediation efforts can be found in Appendix B.
