ANNUAL REPORT FOR 2020

Mark Edwards Site
Wayne County
TIP No. R-2554BB
USACE Action ID: SAW-2008-00252
DWR Project # 20080570

Prepared By:
Roadside Environmental Unit & Environmental Analysis Unit
North Carolina Department of Transportation
November 2020

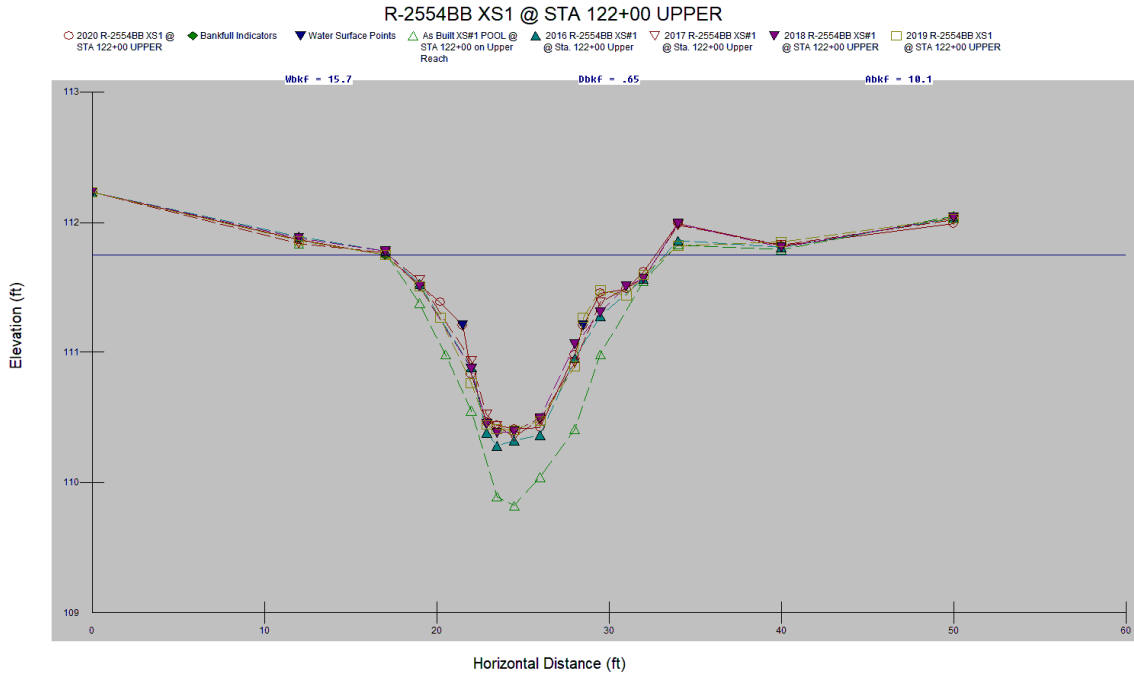
Cross-Section #1 (Pool) Abbreviated Morphological Summary*					
	2016	2017	2018	2019	2020
Bankfull Cross Sectional Area (ft²)	11.81	10.8	11.07	10.76	10.13
Maximum Bankfull Depth (ft.)	1.50	1.42	1.4	1.35	1.34
Bankfull Mean Depth (ft.)	0.72	0.68	0.69	0.66	0.65
Bankfull Width (ft.)	16.45	15.98	16	16.36	15.7

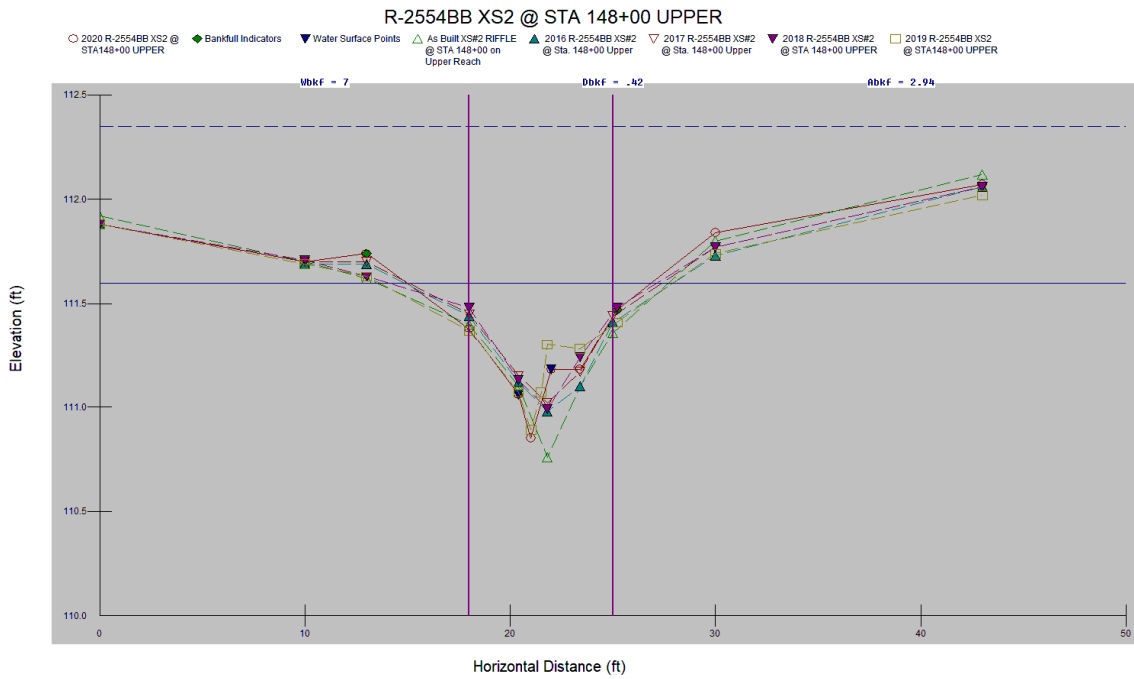
Cross-Section #2 (Riffle) Abbreviated Morphological Summary					
	2016	2017	2018	2019	2020
Bankfull Width (ft.)	7.0	7	7.2	7.2	7
Bankfull Mean Depth (ft.)	0.52	0.49	0.4	0.4	0.42
Width/Depth Ratio	13.46	14.29	18	18	16.67
Bankfull Cross Sectional Area (ft ²)	3.62	3.42	2.89	2.89	2.94
Maximum Bankfull Depth (ft.)	0.71	0.68	0.64	0.74	0.75
Width of the Floodprone Area (ft.)	43.0	43	43	43	43
Entrenchment Ratio	6.14	6.14	5.97	5.97	6.14

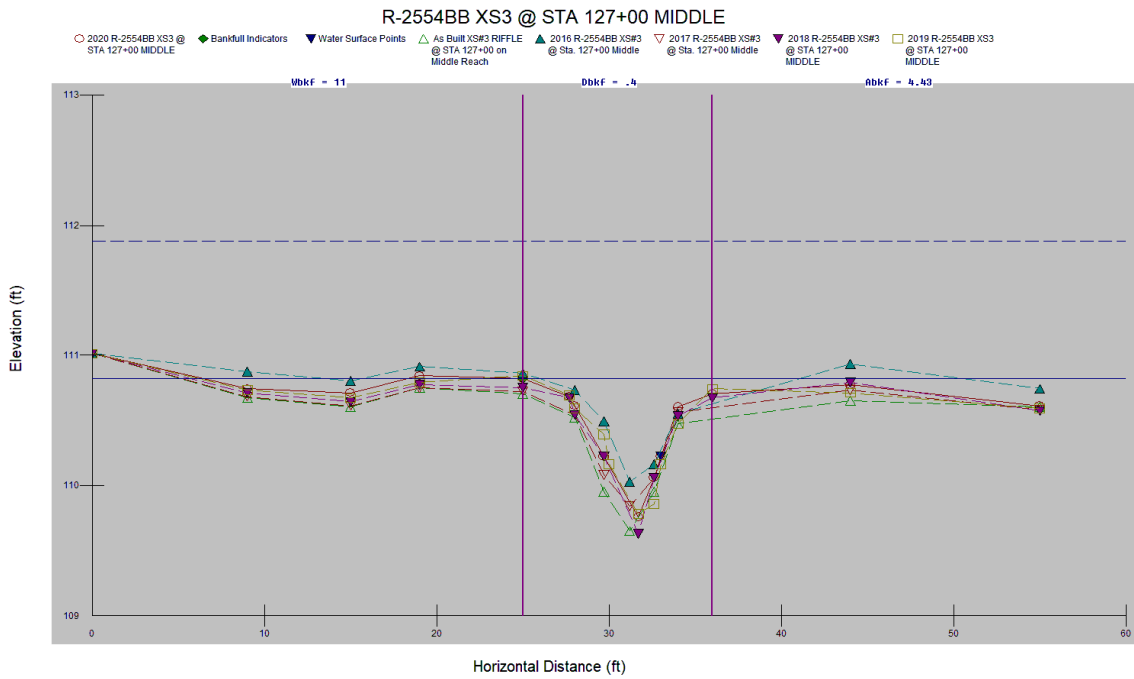
Cross-Section #3 (Riffle) Abbreviated Morphological Summary					
	2016	2017	2018	2019	2020
Bankfull Width (ft.)	9.0	9	11	11	11
Bankfull Mean Depth (ft.)	0.37	0.42	0.38	0.43	0.4
Width/Depth Ratio	24.32	21.43	28.95	25.58	27.5
Bankfull Cross Sectional Area (ft²)	3.3	3.76	4.18	4.75	4.43
Maximum Bankfull Depth (ft.)	0.83	0.88	1.12	1.06	1.06
Width of the Floodprone Area (ft.)	55.0	55	55	55	55
Entrenchment Ratio	6.11	6.11	5	5	5

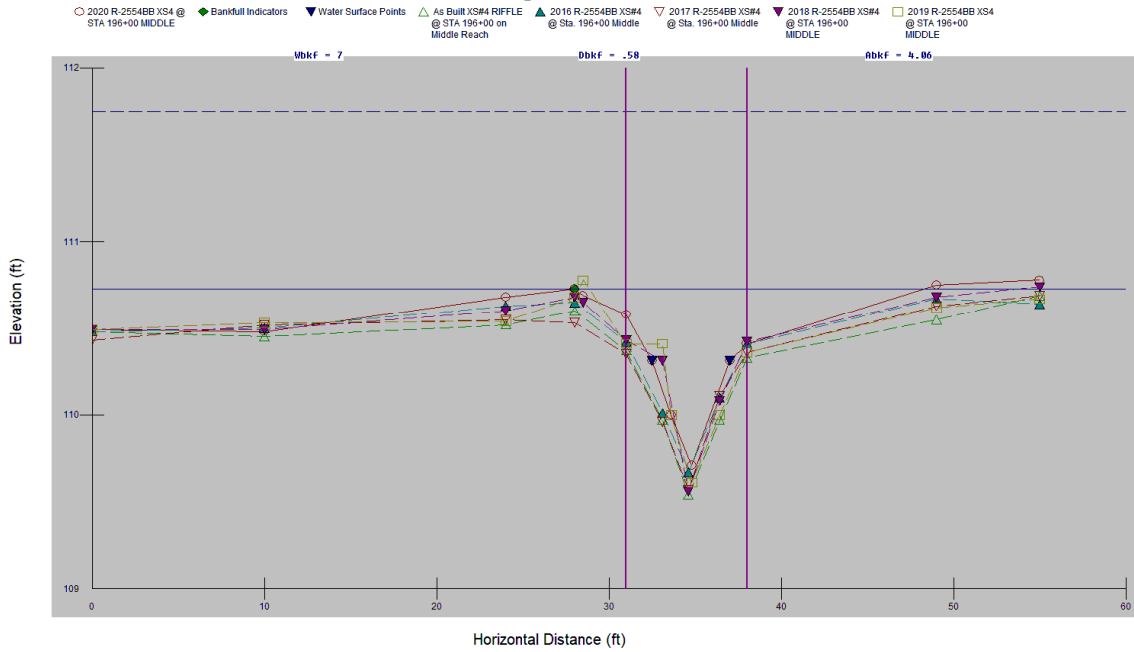
R-2554BB XS4 @ STA 196+00 MIDDLE

Cross-Section #4 (Riffle) Abbreviated Morphological Summary					
	2016	2017	2018	2019	2020
Bankfull Width (ft.)	7.0	7	7	7	7
Bankfull Mean Depth (ft.)	0.59	0.52	0.57	0.58	0.58
Width/Depth Ratio	11.86	13.46	12.28	12.07	12.07
Bankfull Cross Sectional Area (ft ²)	4.14	3.65	4	4.05	4.06
Maximum Bankfull Depth (ft.)	0.98	0.96	1.12	1.07	1.02
Width of the Floodprone Area (ft.)	55.0	55	55	55	55
Entrenchment Ratio	7.86	7.86	7.86	7.86	7.86

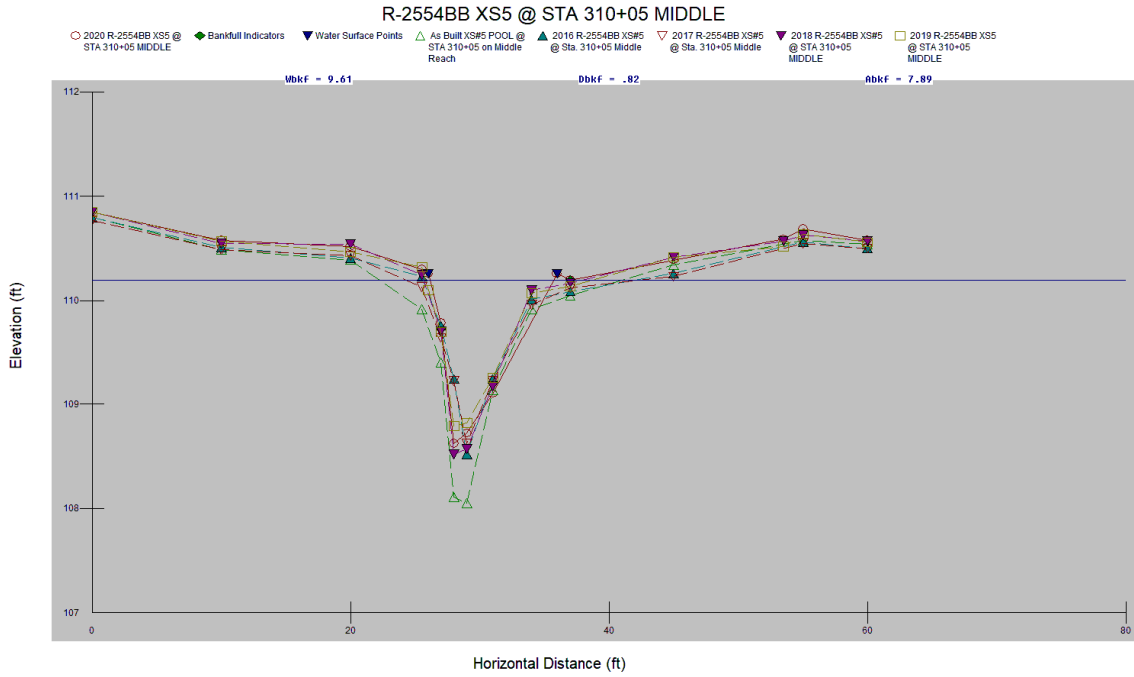
Cross-Section #5 (Pool) Abbreviated Morphological Summary*					
	2016	2017	2018	2019	2020
Bankfull Cross Sectional Area (ft²)	5.91	6.47	7.28	6.23	7.89
Maximum Bankfull Depth (ft.)	1.57	1.5	1.65	1.35	1.58
Bankfull Mean Depth (ft.)	0.53	0.56	0.65	0.56	0.82
Bankfull Width (ft.)	11.05	11.47	11.28	11.09	9.61

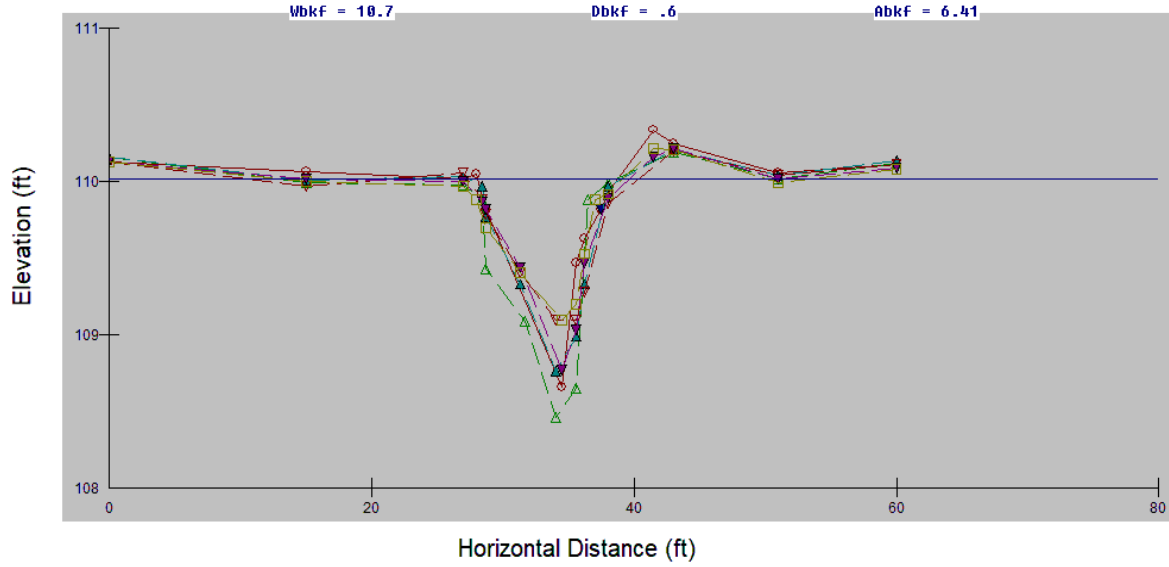
R-2554BB XS6 @ STA 552+00 MIDDLE

Cross-Section #6 (Pool) Abbreviated Morphological Summary*					
	2016	2017	2018	2019	2020
Bankfull Cross Sectional Area (ft ²)	7.09	6.8	6.28	5.1	6.41
Maximum Bankfull Depth (ft.)	1.27	0.96	1.23	0.87	1.36
Bankfull Mean Depth (ft.)	0.58	0.49	0.51	0.44	0.6
Bankfull Width (ft.)	12.25	13.94	12.43	11.58	10.68

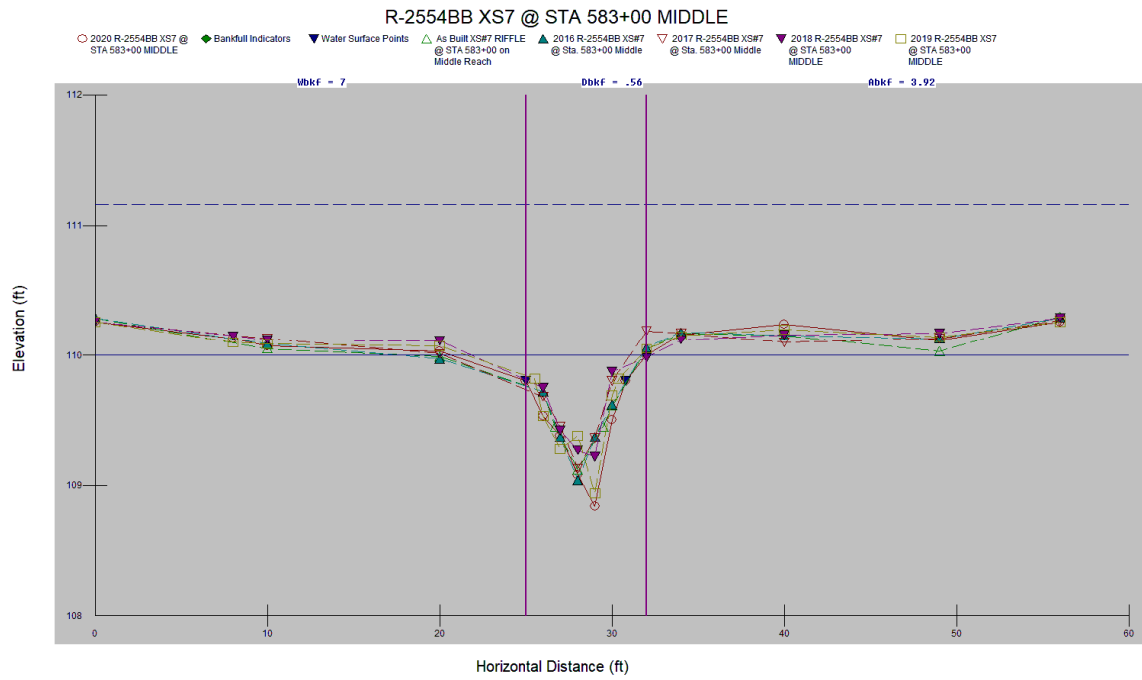
Cross-Section #7 (Riffle) Abbreviated Morphological Summary					
	2016	2017	2018	2019	2020
Bankfull Width (ft.)	6.0	6	6	6.5	7
Bankfull Mean Depth (ft.)	0.66	0.58	0.39	0.54	0.56
Width/Depth Ratio	9.09	10.34	15.38	12.04	12.5
Bankfull Cross Sectional Area (ft²)	3.95	3.47	2.31	3.48	3.92
Maximum Bankfull Depth (ft.)	1.14	1.06	0.76	1.11	1.16
Width of the Floodprone Area (ft.)	56.0	56	56	56	56
Entrenchment Ratio	9.33	9.33	9.33	8.62	8

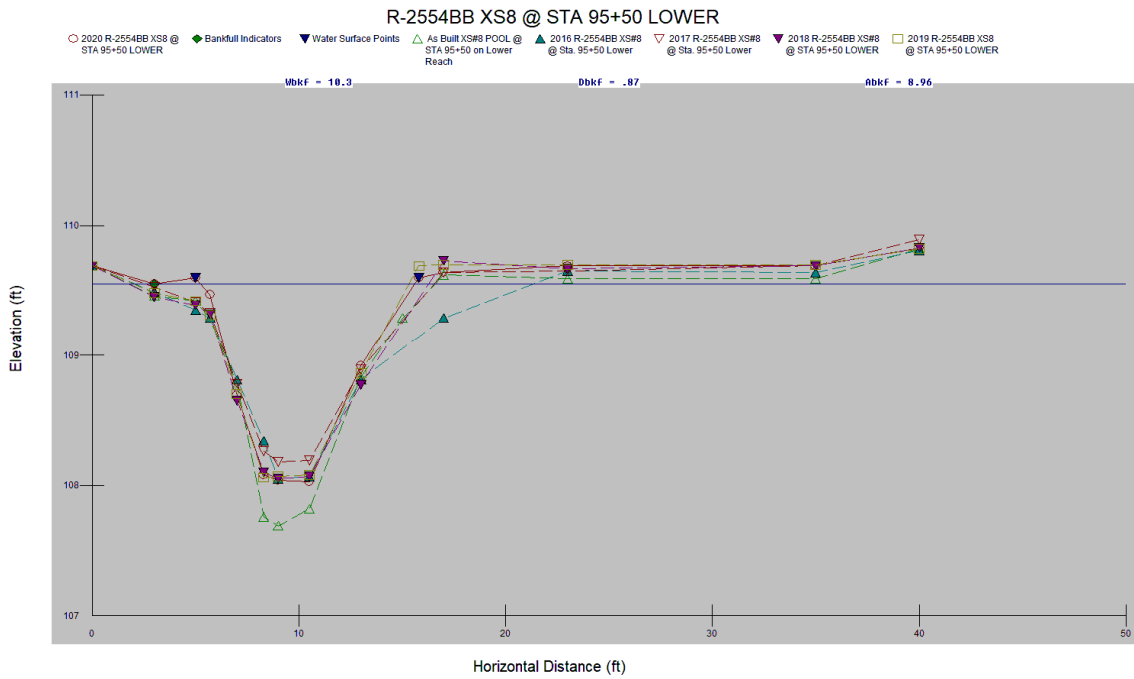
Cross-Section #8 (Pool) Abbreviated Morphological Summary*					
	2016	2017	2018	2019	2020
Bankfull Cross Sectional Area (ft²)	9.79	8.66	8.71	8.46	8.96
Maximum Bankfull Depth (ft.)	1.44	1.35	1.4	1.42	1.52
Bankfull Mean Depth (ft.)	0.56	0.65	0.68	0.7	0.87
Bankfull Width (ft.)	17.33	13.41	12.83	12.09	10.32

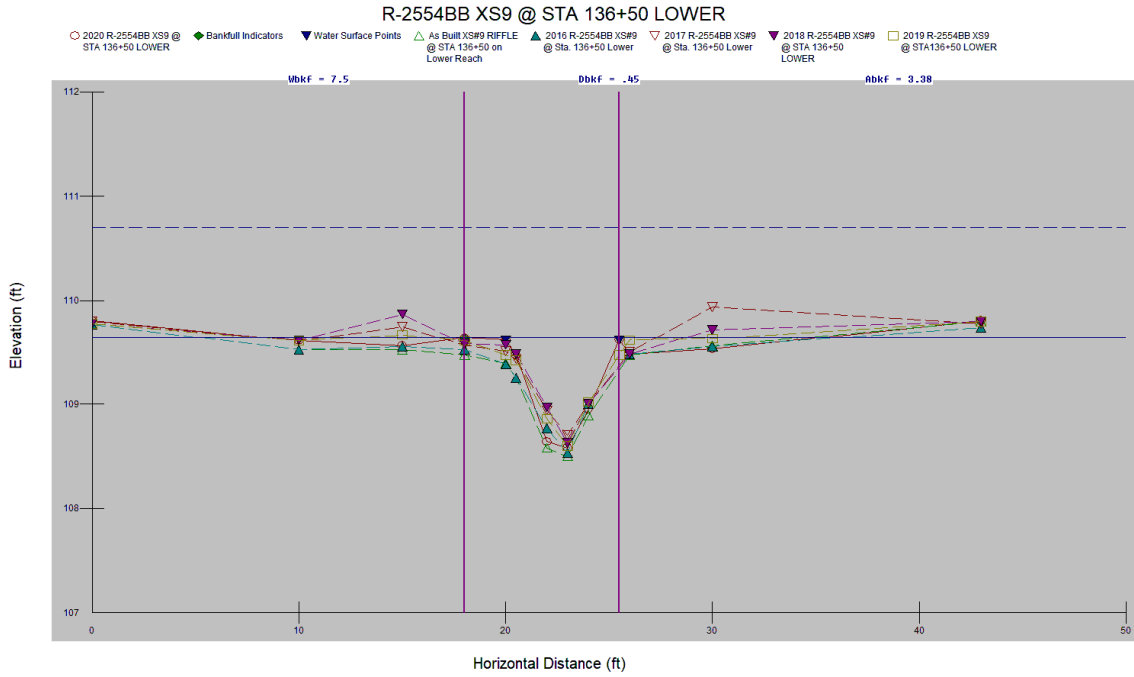
Cross-Section #9 (Riffle) Abbreviated Morphological Summary					
	2016	2017	2018	2019	2020
Bankfull Width (ft.)	8.0	8	8	7.97	7.5
Bankfull Mean Depth (ft.)	0.43	0.53	0.64	0.4	0.45
Width/Depth Ratio	18.6	15.09	12.5	19.92	16.67
Bankfull Cross Sectional Area (ft ²)	3.43	4.24	5.12	3.19	3.38
Maximum Bankfull Depth (ft.)	1.02	1.05	1.24	1.01	1.06
Width of the Floodprone Area (ft.)	43.0	43	43	43	43
Entrenchment Ratio	5.38	5.38	5.38	5.4	5.73
